The Home Inspector

Many problems with installations of LP SmartSide siding

By Reuben Saltzman | OCTOBER 6, 2015 — 6:19AM

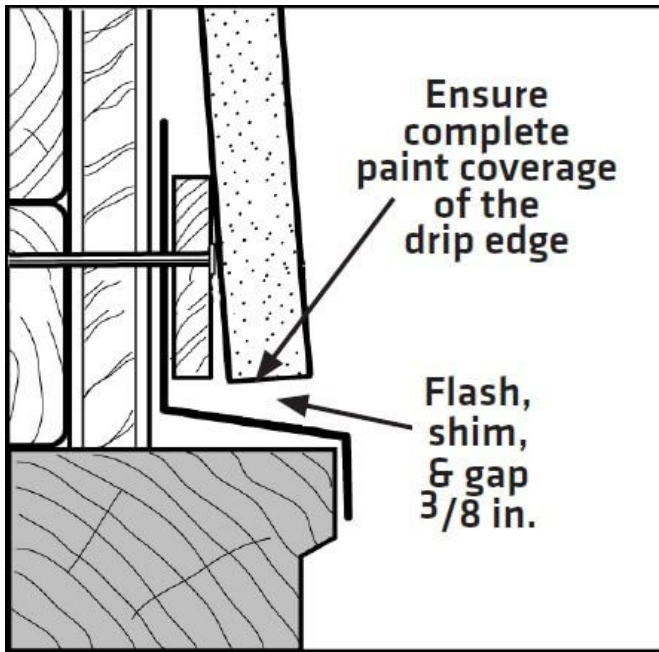
The manufacturer requires a 3/8" gap above windows and other similar penetrations.

This is rarely done.

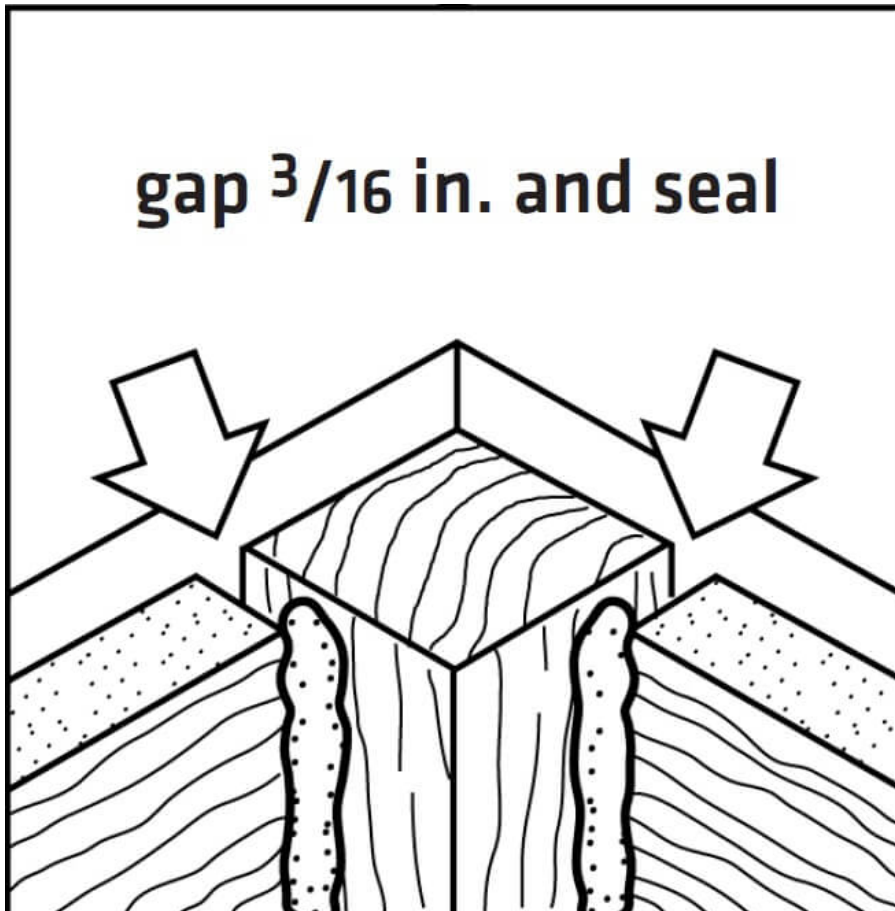
The manufacturer requires a 3/16" gap at the end of each piece of siding. This includes butt joints, and places where the siding terminates vertically against windows, doors, and other fixtures.

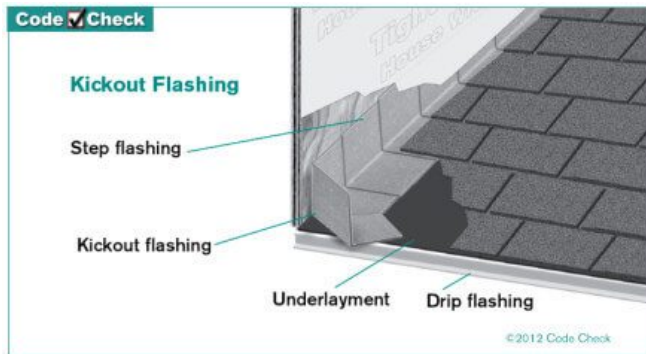
Kickout flashing (<http://www.structuretech1.com/2013/05/kickout-flashing/>) is a piece of metal at a roof end that prevents water from leaking into the wall. See below.

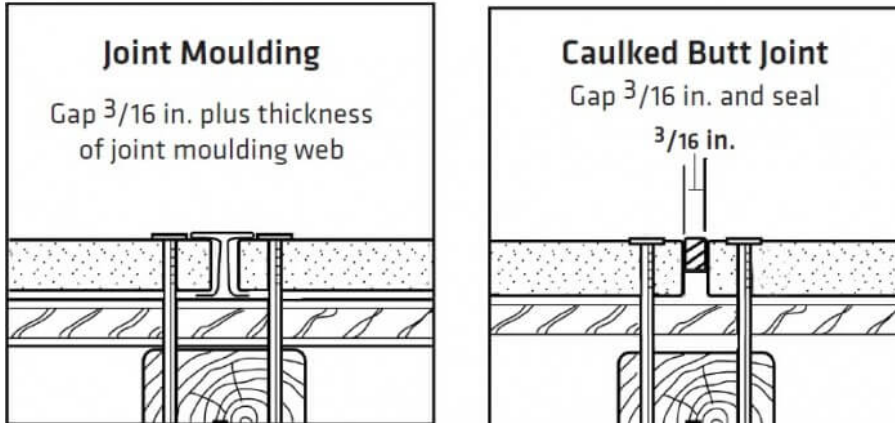
Alternate Butt Joint Treatments

There are three options for keeping water out of the butt joints. The first and second options are to have the joints caulked or have joint molding installed.

The third option is to have flashing at least 4" wide installed at the joints, as long as the ends of the siding are factory finished, and the siding is prefinished by an approved or preferred prefinisher. That means no cut edges at the butt joints. When field-cut edges are present, flashing at the joints is *not* an appropriate installation method.
