1. **HISTORIC NAME OF PROPERTY OR HISTORIC DISTRICT:** (if known)  
Concordia Historic District

**ADDRESS OF PROPERTY:**  
1009-1011 North 33rd St, Milwaukee, WI 53208

**1009-1011 NORTH 33RD STREET: CONCORDIA HISTORIC DISTRICT**  
Certificate of Appropriateness Application Submission  
October 16, 2014

## **Project Overview: Synopsis of Key Items**

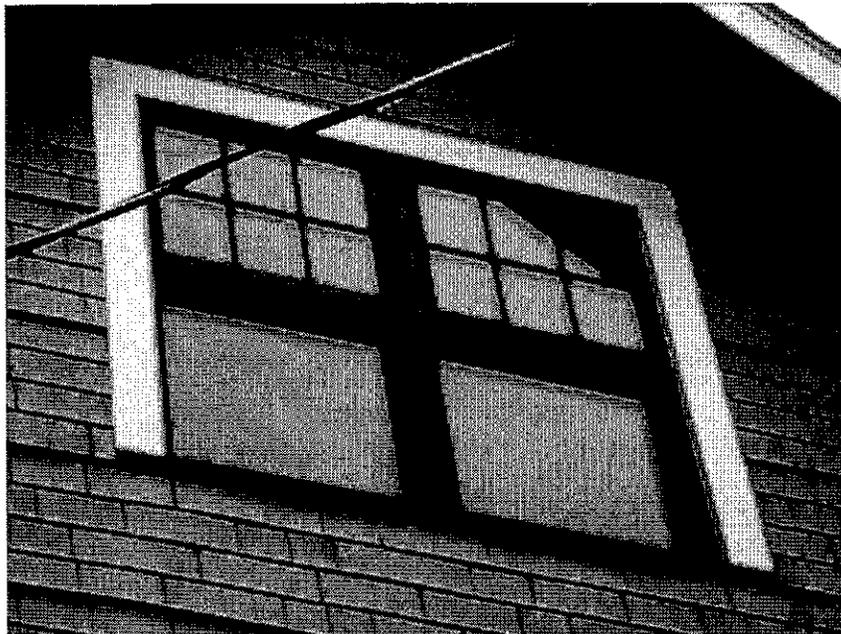
**Figure 11:** Marvin Wood Ultimate Insert Double Hung Windows to be used on the north, south, and west elevation (this window installed at 1003-05 North 33rd Street).
