***Fire Escape
Existing Conditions Report***

Site: #176 Golda Meir Lower Campus

Address: 1555 Dr. Martin Luther King Drive

RE: Fire Escape Inspection Report
Golda Meir Lower Campus
MPS Site #176
1555 Dr. Martin Luther King Drive

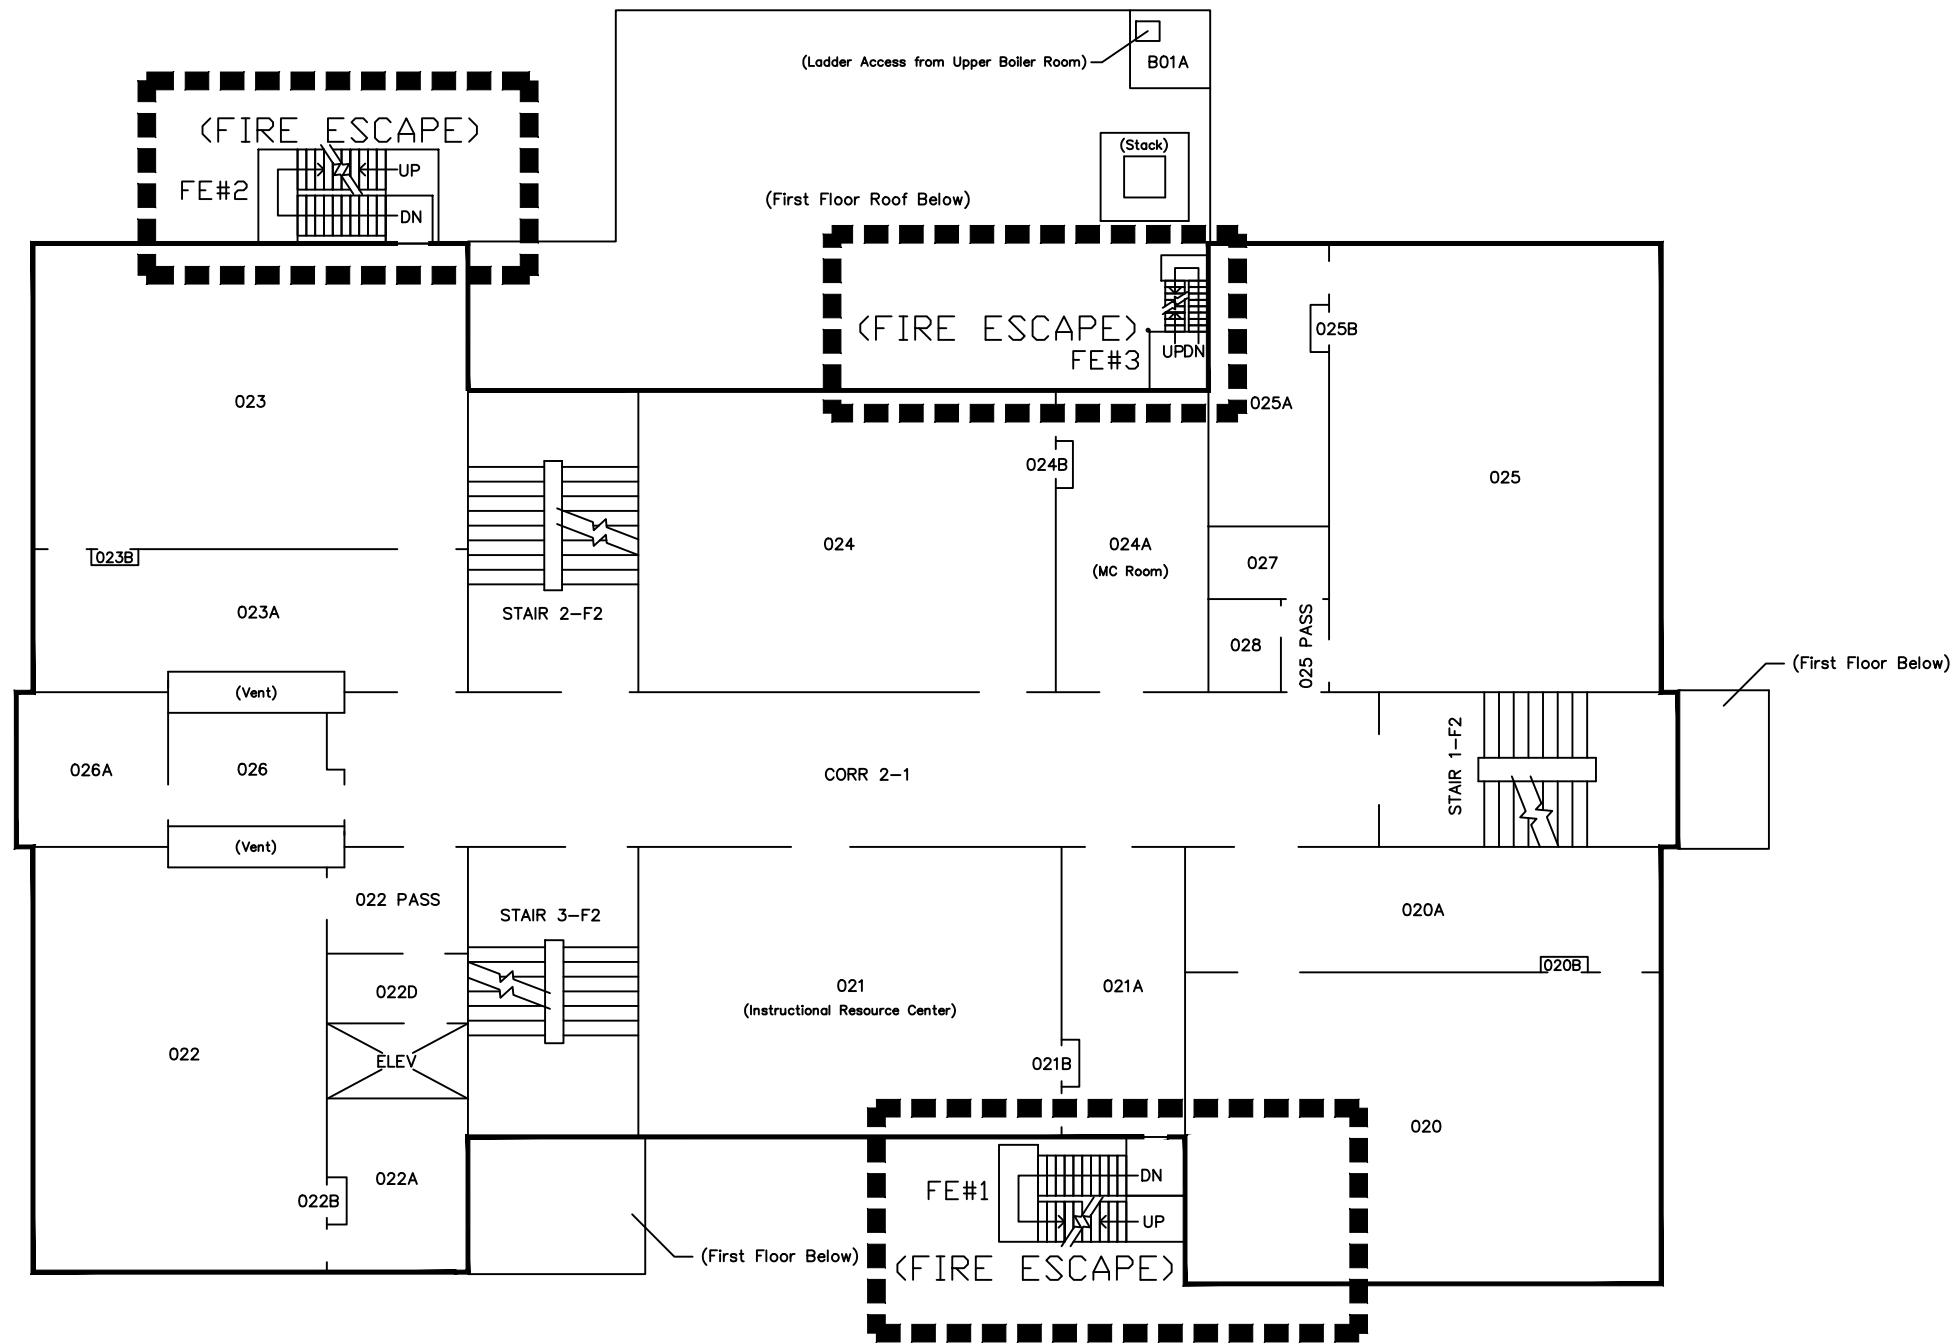
Overall View of Fire Escape #3 (Looking North East)

Fire Escape #3 is original to the building and is in poor condition. This fire escape has an immediate need for repair and we recommend closure until repairs can be made. Additionally we recommend a building code impact study to review the potential for de-commissioning and removal of this fire escape.
