Re: Pabst Sign Support Bridge Structure Review
Milwaukee, WI

Pierce Engineers, Inc., (PE) performed a site visit of the **Pabst Sign** support bridge over West Juneau Avenue at North 10th Street in Milwaukee, Wisconsin on May 19, 2025. The purpose of the site visit was to review visually the sign supporting steel truss bridge, decking, connections, and supports to provide our opinion regarding the condition of the structure and determine necessary repair work to preserve the structural integrity of the structure.

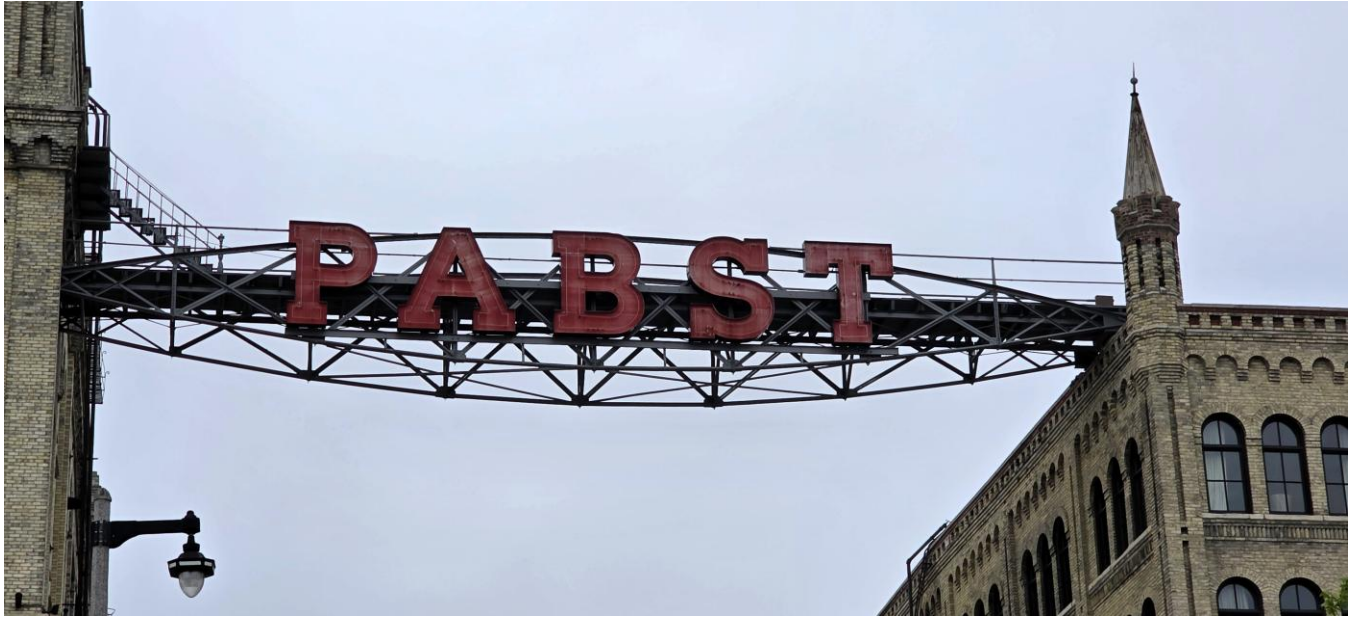
P1 Pabst sign bridge (looking west)

The different views (sides, bottom, and top) of bridge are provided in photographs P1 through P5. Note that the south ends of the bridge trusses are embedded into the exterior wall of building 25 and the north ends are resting on the parapet of building 21 as shown in Figure 2. Attached photographs P6 and P7 further illustrate these conditions.
