MPS - Existing Window Condition

MPS - NE Tower Window Condition

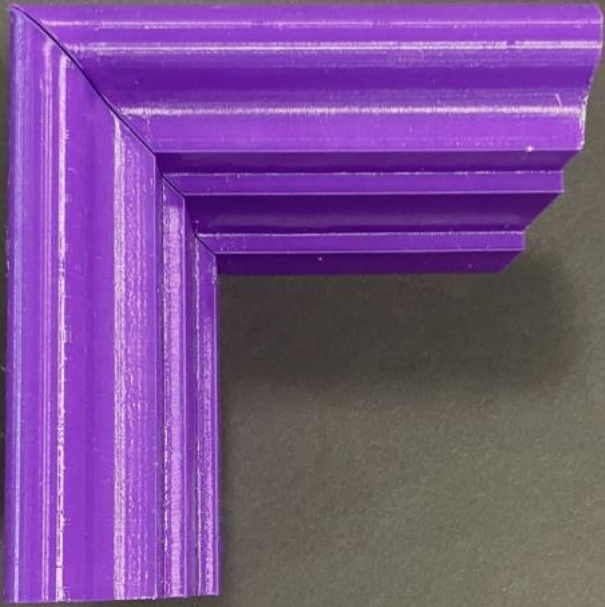
Photograph of 3-D Model replicating existing Townsend Window profile

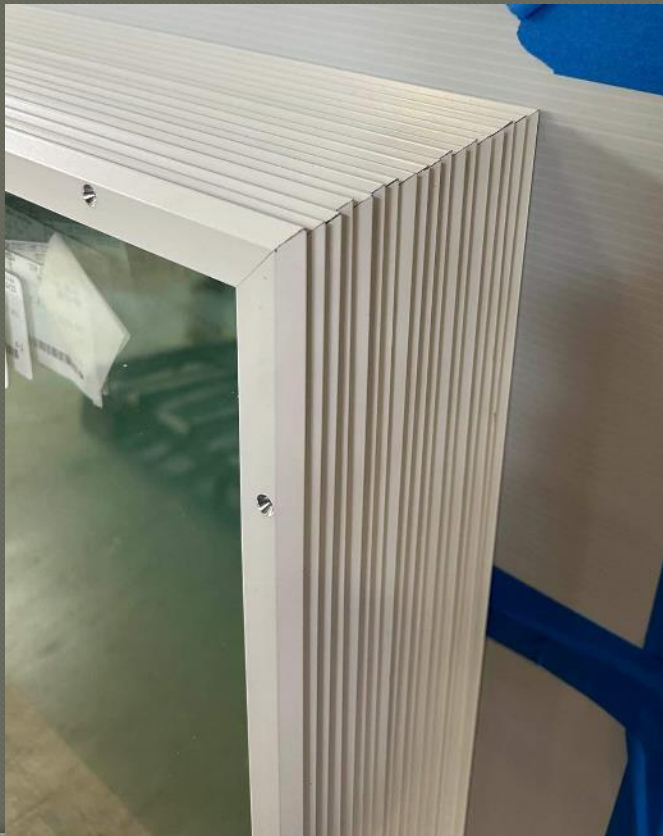
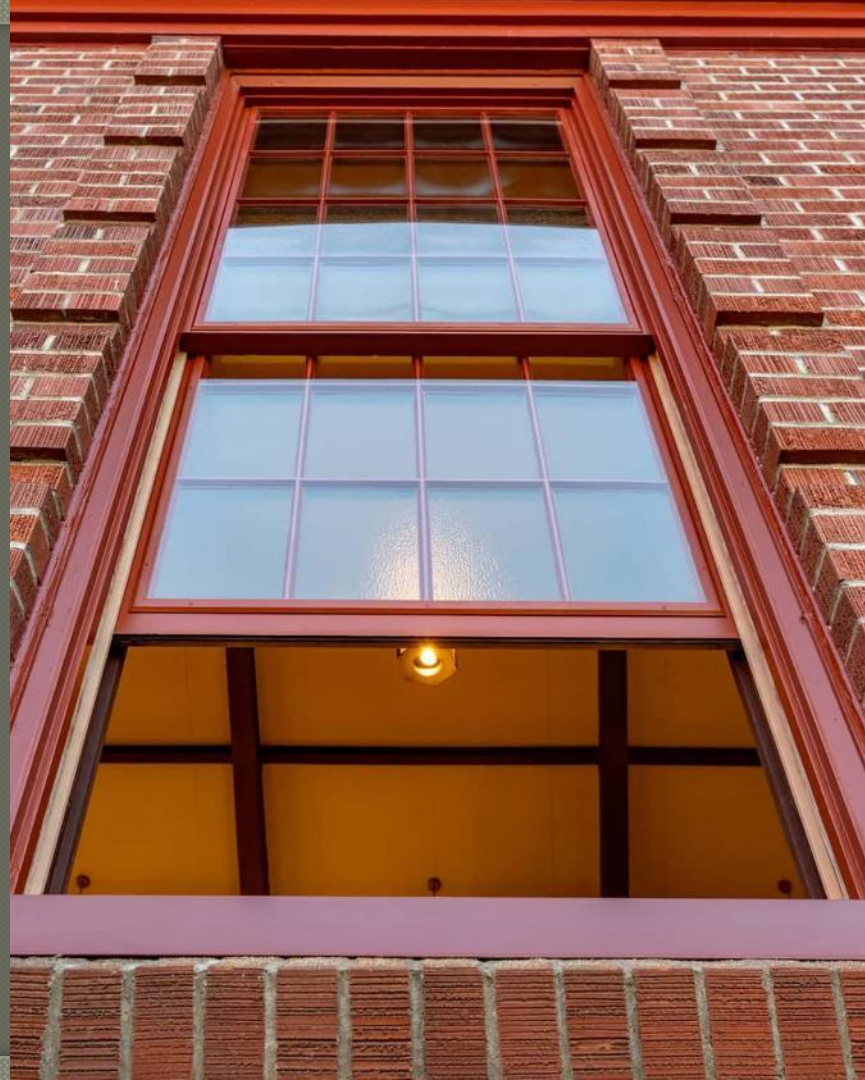
72% energy retention improvement
By attaching insulating panel to existing
window and adjusting weatherstripping

Recommendation

Approve with conditions

- Approve replacement of all ordinary, two-sash double-hung windows, all glass block windows, filled-in windows, ground floor windows, and attic windows
- Tower windows appear to be readily repairable
