INSPECTION REPORT AND ORDER TO CORRECT CONDITION

Re: 2424 W KILBOURN AV 1

I performed an exterior inspection of the property located at 947 N. 24<sup>th</sup> Street in Milwaukee, Wisconsin on January 31<sup>st</sup>, 2020. The residence is approximately 122 years old according to public records. The purpose of the inspection was to investigate a report of an existing stone foundation wall that was of concern to an existing neighbor. The stone wall was directly adjacent to a public alleyway that, according to the owner, is used frequently. Please reference the photos included in this report taken during the inspection. The only component of the structure observed is the existing stone foundation wall indicated in this report – no other part of the structure was observed.

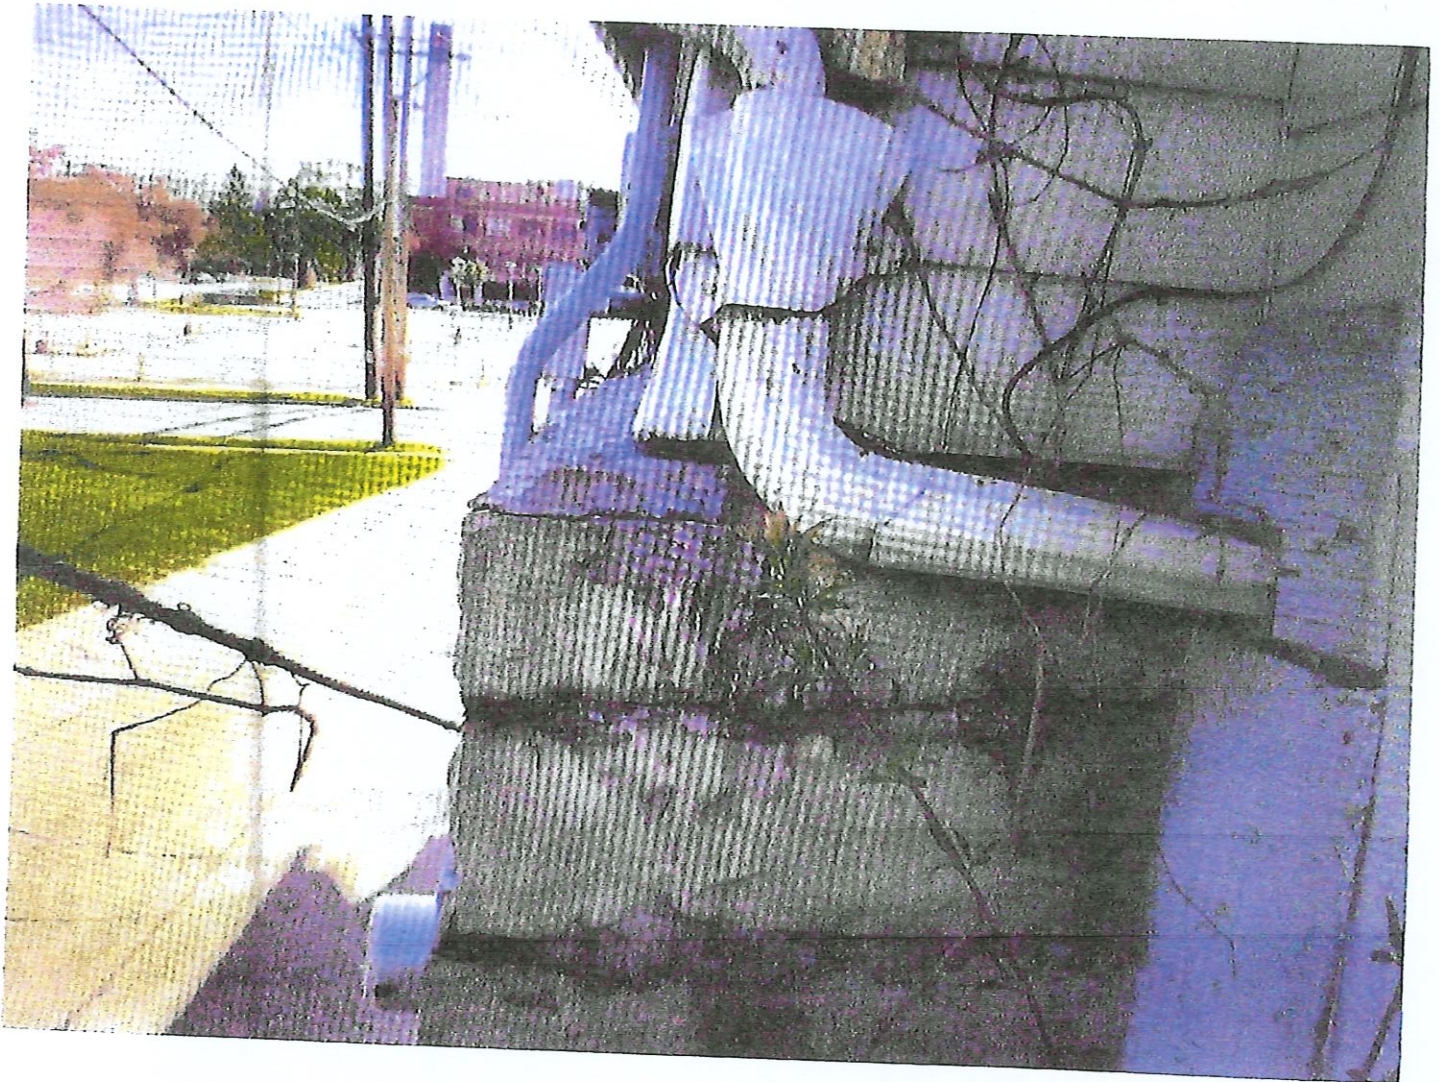
Consistent with last year the chimney[s] available to view did not have liners for use with modern gas hot water heaters or mid-or low efficient furnaces or boilers as commonly required with a City of Milwaukee building installation permit. As these buildings are appearing as SRO in use, they are construed as commercial it appears they all dwellings bo s are req observable chimneys need rebuilding, and as masonry tall typical and iler used uire a structures appear as unsafe as they did appeared last year.

Entry and egress appeared in about the same condition as the older group of buildings. Uneven varying-riser heights, handrails with no ballisters on these residential rooming house/ SRO buildings.

Many/ most have older vintage-era windows in what appear in varying states of condition and need paint and general restoration. And no difference from last year. Most notable rear entrances.

Rear view from the alley, all the lot[s] are hugely overgrown, and what appears as Dead trees, possibly Ash. Many glass panes of the garden building appear broken out and generally engulfed with overgrowth. Cars were parked on the rear lawn, and muddy ruts have been created. Litter and plastic cups and debris are evident at the rear in general and adjacent to the garbage collection areas.

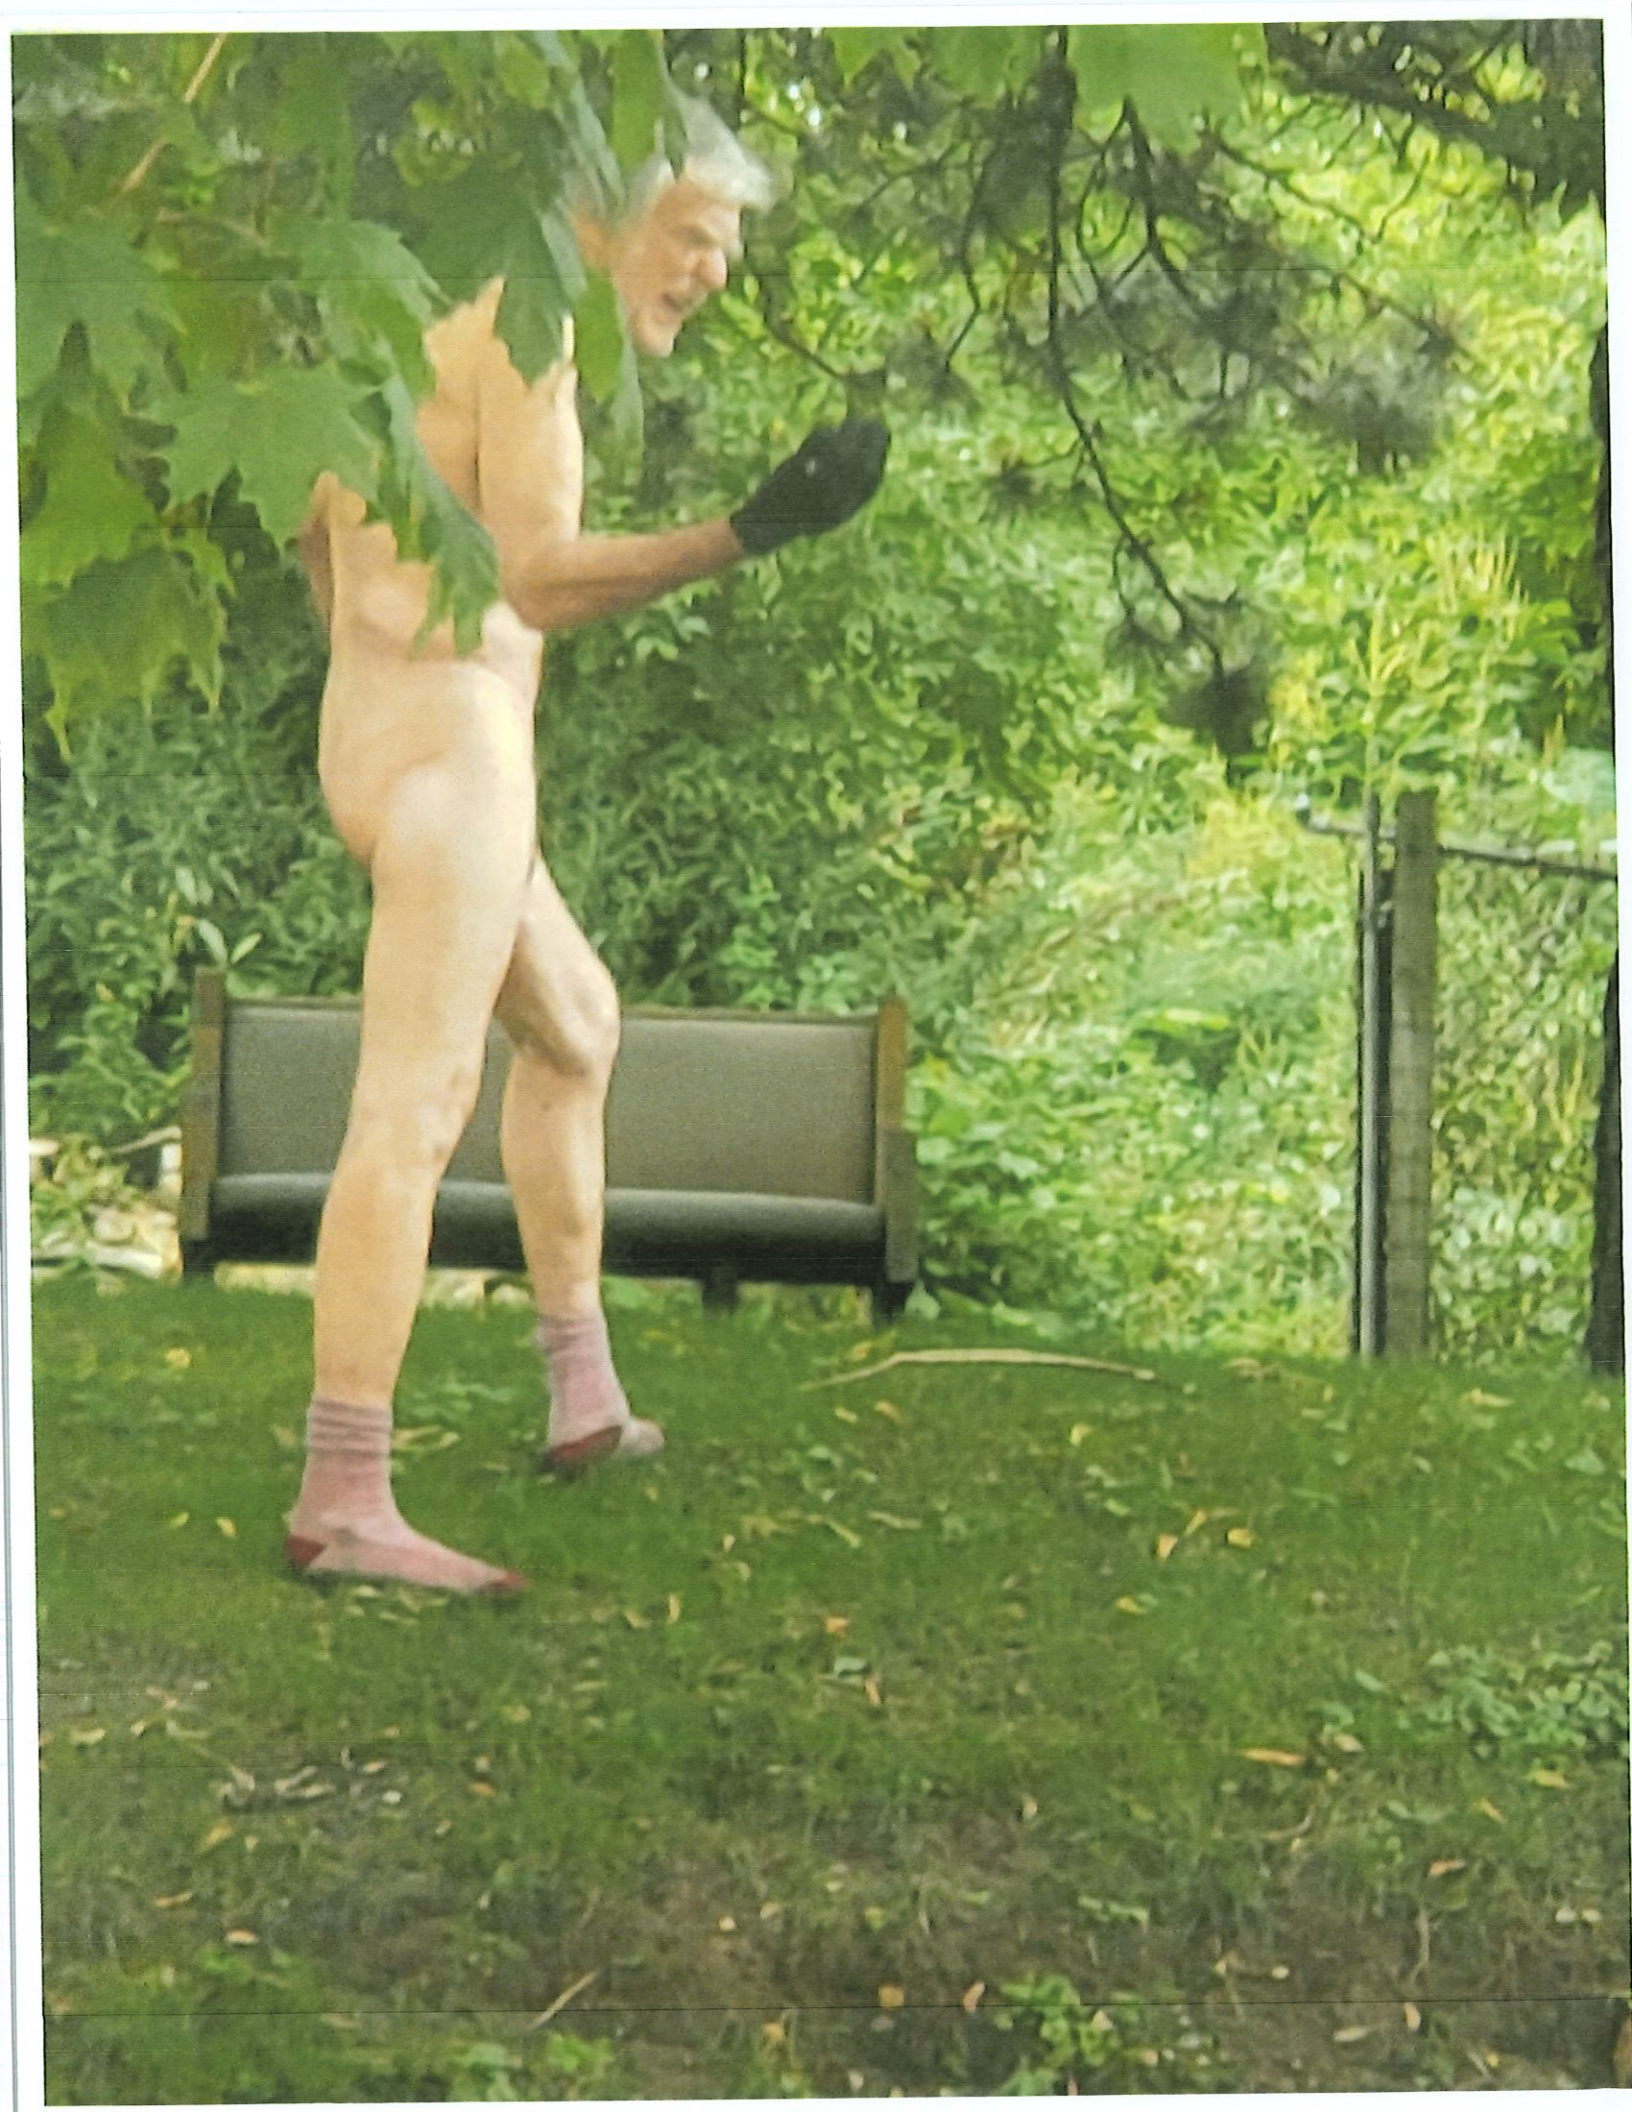
## ProBuColls “Clark Rooming Houses”

### Outside Entrance conditions of buildings

1. Photos show the condition no explanation need.
2. Exterior stairs are not to code, dangerous for the tenants to maneuver up and down. (also notice no sidewalks.)
