Facilities Condition Assessment Program

Forestry and Sanitation Central HQ

Introduction

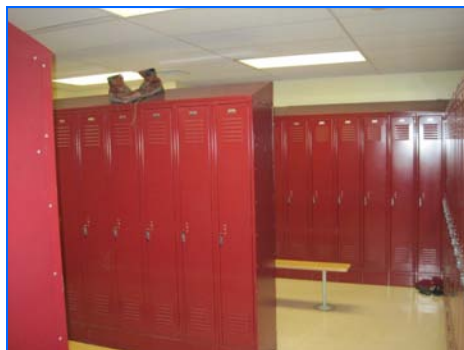
The Sanitation offices and locker rooms are located in the south portion and second floor of the Central HQ Building. The offices comprise approximately 5,400 SF of floor area and the condition of the finishes is good overall. The two locker rooms and associated rest rooms are in good condition.

Typical locker room finishes

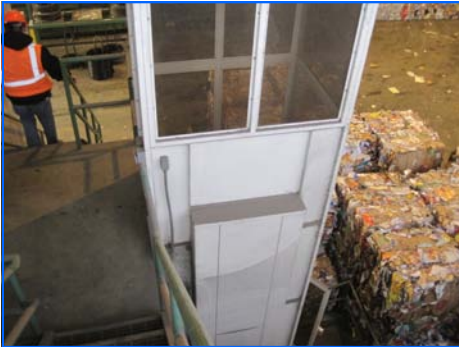
Single passenger elevator

Single passenger elevators have a useful life of up to 25 years. The City of Milwaukee anticipates replacement of the elevator by 2021.

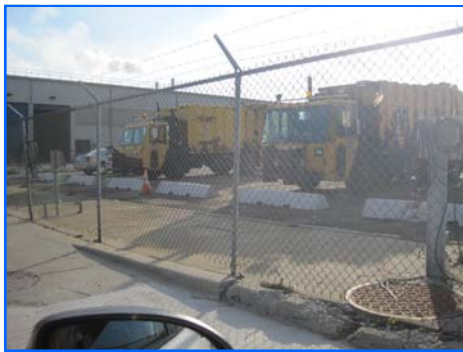
Chain link fence with barbed wire

The useful life of chain link fences is up to 25 years. The City of Milwaukee anticipates replacement of this fence by 2017.

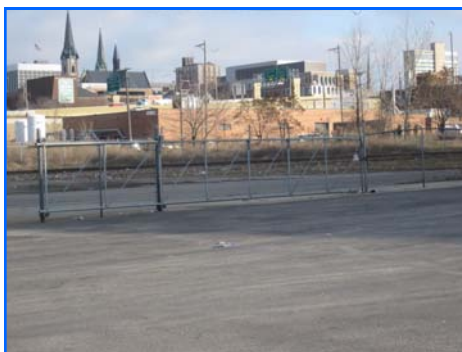
Vehicle entry gate

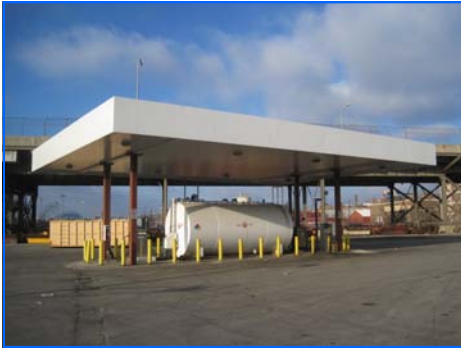
Fuel island and storage tank

The useful life of above ground storage tanks is up to 40 years. The City of Milwaukee plans replacement of the storage tank by 2027, in conjunction with replacement of the fuel island.

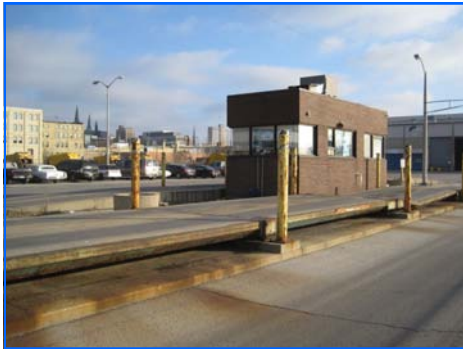
Scales and scale house

The useful life of truck scales is up to 15 years. The City of Milwaukee should anticipate the next scale replacement by 2025.

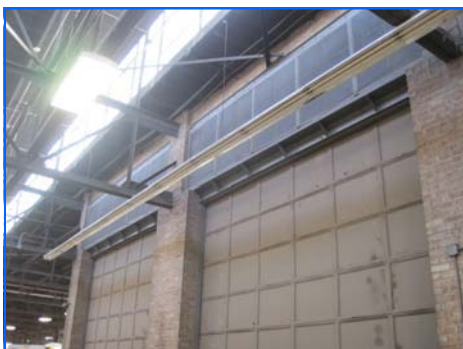
Typical interior garage door - long lived element

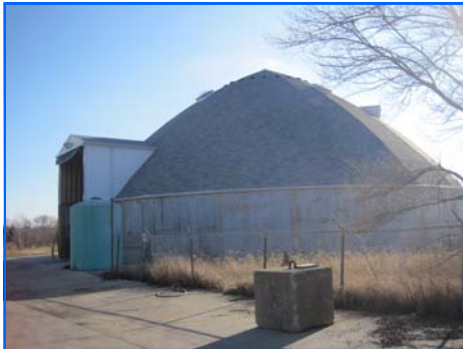
The salt dome at the Northwest Garage was constructed in 2008. The domed structure contains an asphalt shingle roof which is in good condition at an age of two years. The useful life of an asphalt shingle roof is up to 20 years. The City of Milwaukee anticipates its replacement by 2028.

Salt dome

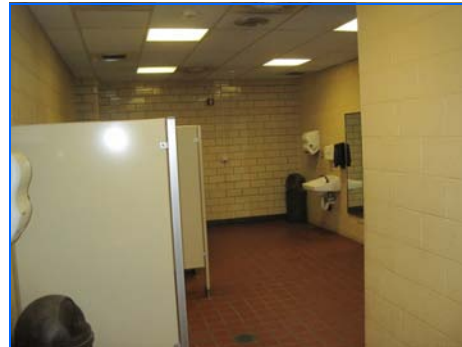
Rest room interior

The City of Milwaukee plans for updates to the rest rooms by 2024.

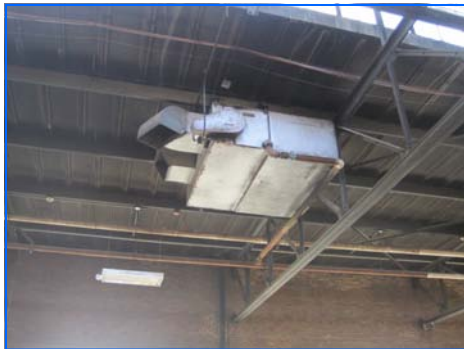
Typical AHU

Based on an energy analysis of the property, the City of Milwaukee anticipates replacement of the AHUs in the near term as part of the HVAC reconfiguration. Subsequent replacement of the AHUs is likely by 2035. These replacements are projected to be coordinated with the replacement of the building heat boilers.

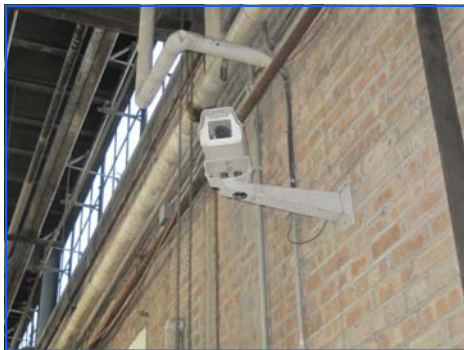
Security camera

The system is maintained annually. The useful life of security systems is up to 15 years. The City of Milwaukee anticipates replacement of the security system by 2023.

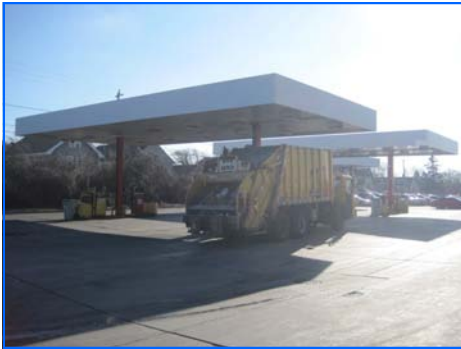
The Northwest Garage contains three fuel island structures. The condition of these structures is good overall. Exterior, open air structures have a useful life of up to 40 years. Based on their current condition, the City of Milwaukee anticipates their replacement by 2030.

Fuel Island structures
