# Certificate of Appropriateness—Amended

910 N. OLD WORLD THIRD ST. Second Ward Savings Bank

## Description of work

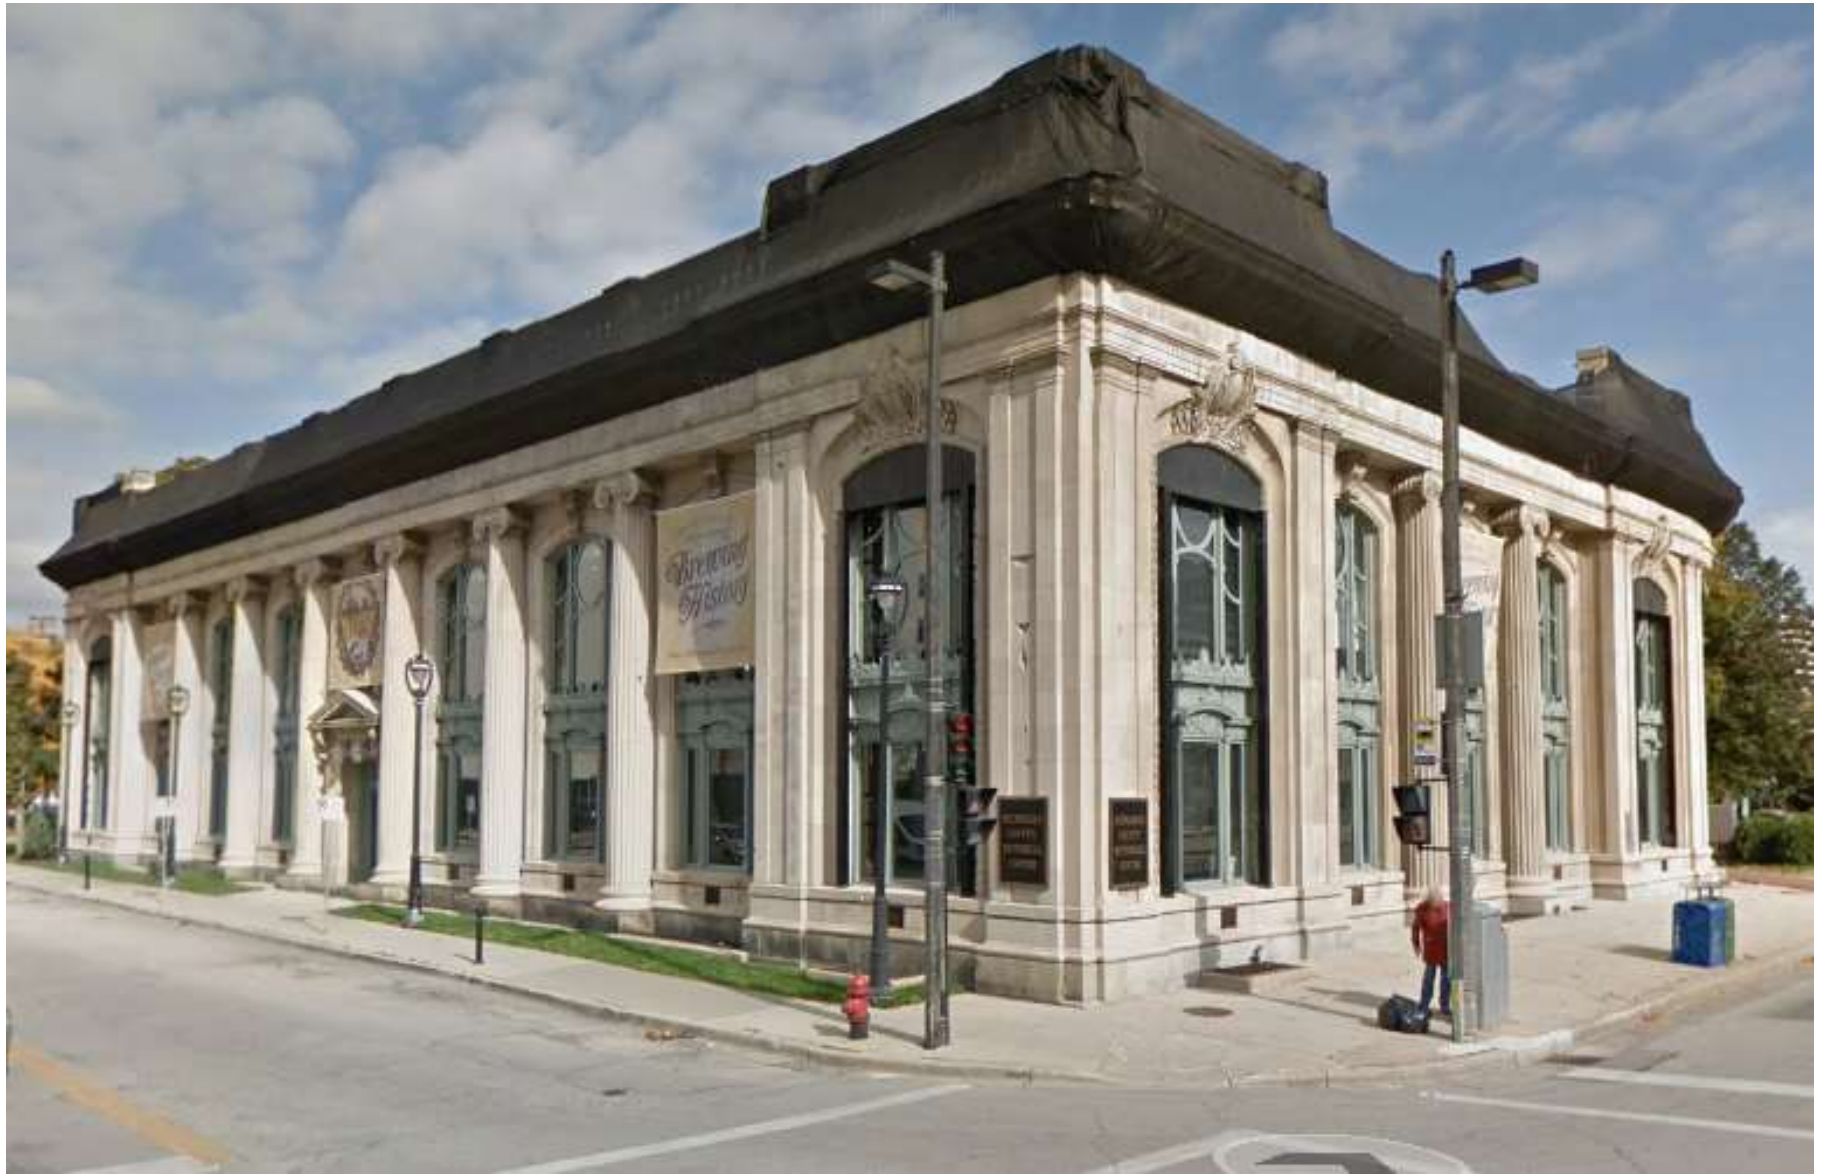
Current conditions

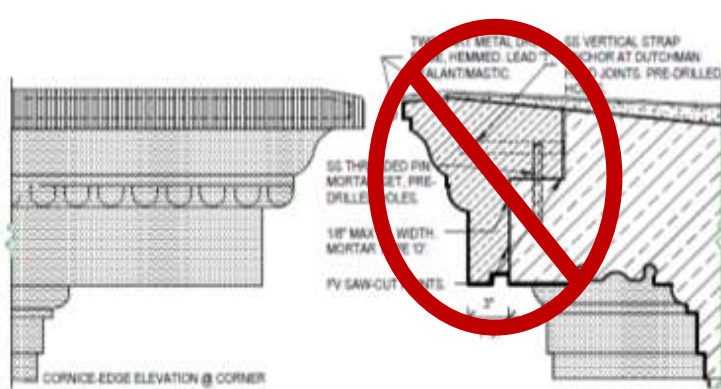
③ CORNICE DUTCHMAN - SECTION DETAIL  
1 1/2" = 1'-0"

Repair details. Disregard repair to cornice. This has been revised. Flashing and gutters remain as shown.

The severely, spalled cornice edge can be repaired by removing the damaged edge. A new piece of stone will be keyed to the existing 7000 lb. limestone unit. This limestone Dutchman method will be utilized at the cornice tip around the entire building perimeter. The new Indiana limestone will have a different patina. It will appear as an imperfect color match to its weathered receiver. (A301, 3/A401) Only the area above the egg and dart molding will be replaced with new material per the revised submission. A single, horizontal sawcut will be made to remove the damaged cornice edging, as proposed. A new mortar joint is introduced. The width of the joint is dependent upon the sawcut, however it is to be anticipated to be between 1/4-inch and 3/8-inch. The type of mortar and color will be the same as the mortar type and color adopted at the balustrade above. This modification has been reviewed structurally and approved with the same level of fastening as previously engineered for the more extensive limestone dutchman repair. (All fasteners in stainless steel.)

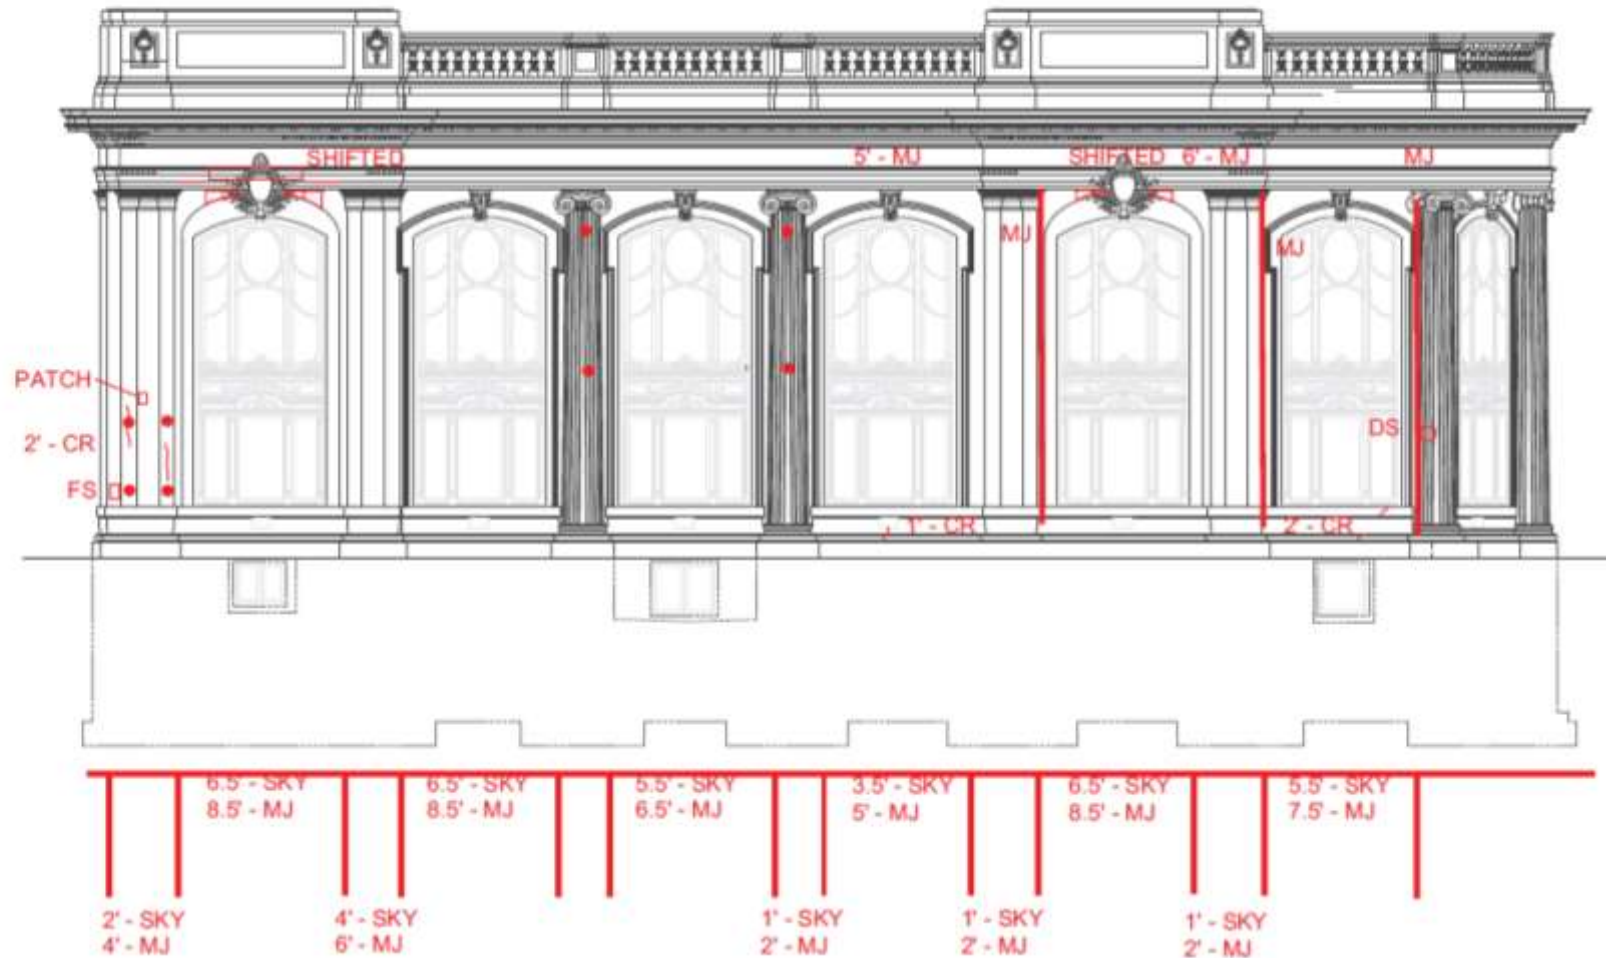
Repair areas

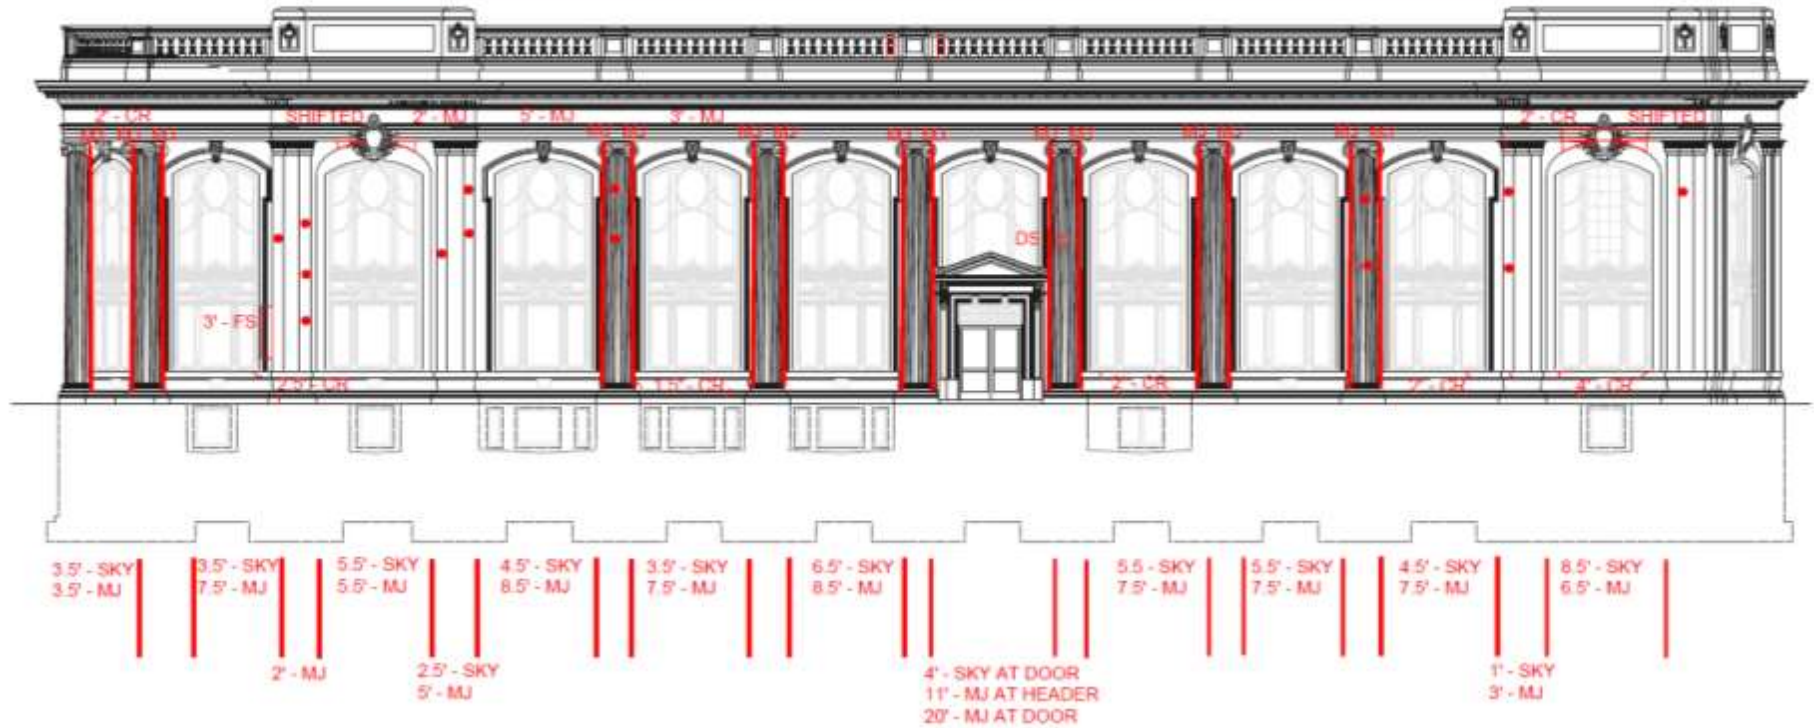
## Pere Marquette Park Elevation (EAST)

Repair areas

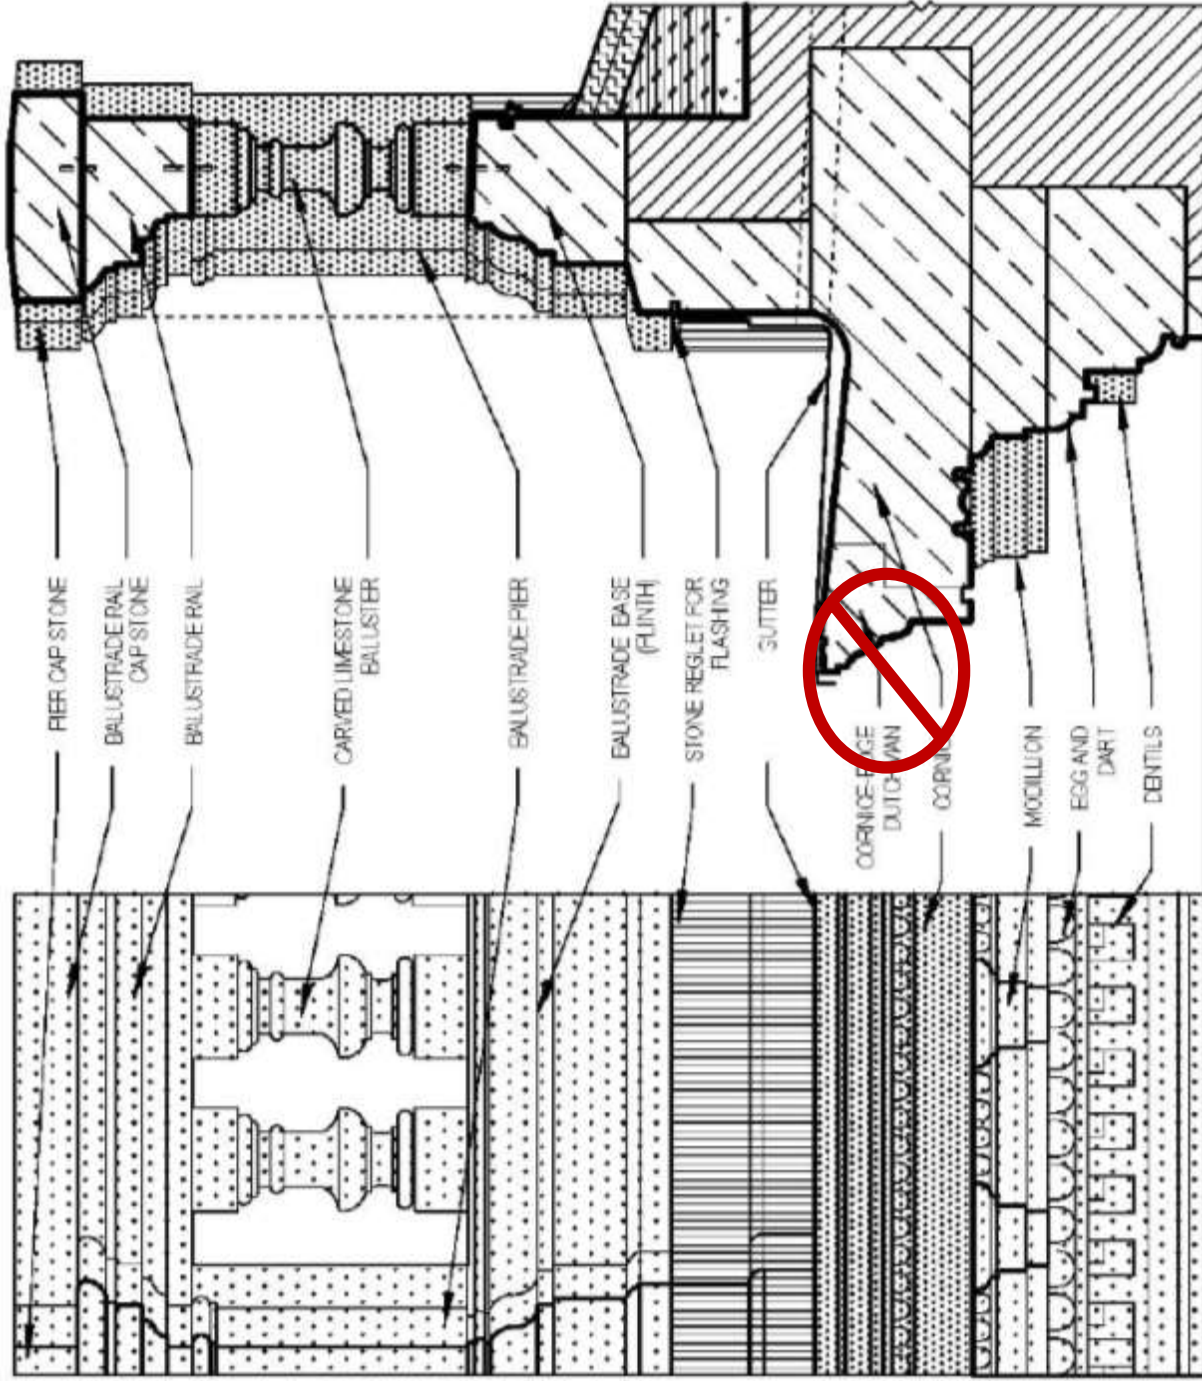
Dutchman repair of cornice shall not be performed as on this page. Revised methods are on the following pages.

**REVISED LIMESTONE DUTCHMAN EDGE**

1 1/2" x 20ga STAINLESS  
STEEL STRAP AT 1/4 POINTS  
w/ (4) 1/4"dia STAINLESS  
STEEL ELCO AGGREGATOR  
CONCRETE ANCHOR w/ 1 1/2"  
MIN EMBED, (2) EACH SIDE.  
SINK STRAP FLUSH WITH  
TOP OF STONE AS  
REQUIRED TO INSTALL NEW  
GUTTER FLASHING  
NEW DUTCHMAN  
REPAIR

1/2"dia x 6" STAINLESS  
STEEL THREADED ROD  
CENTERED ON JOINT.  
MORTAR-SET IN PRE-  
DRILLED HOLES

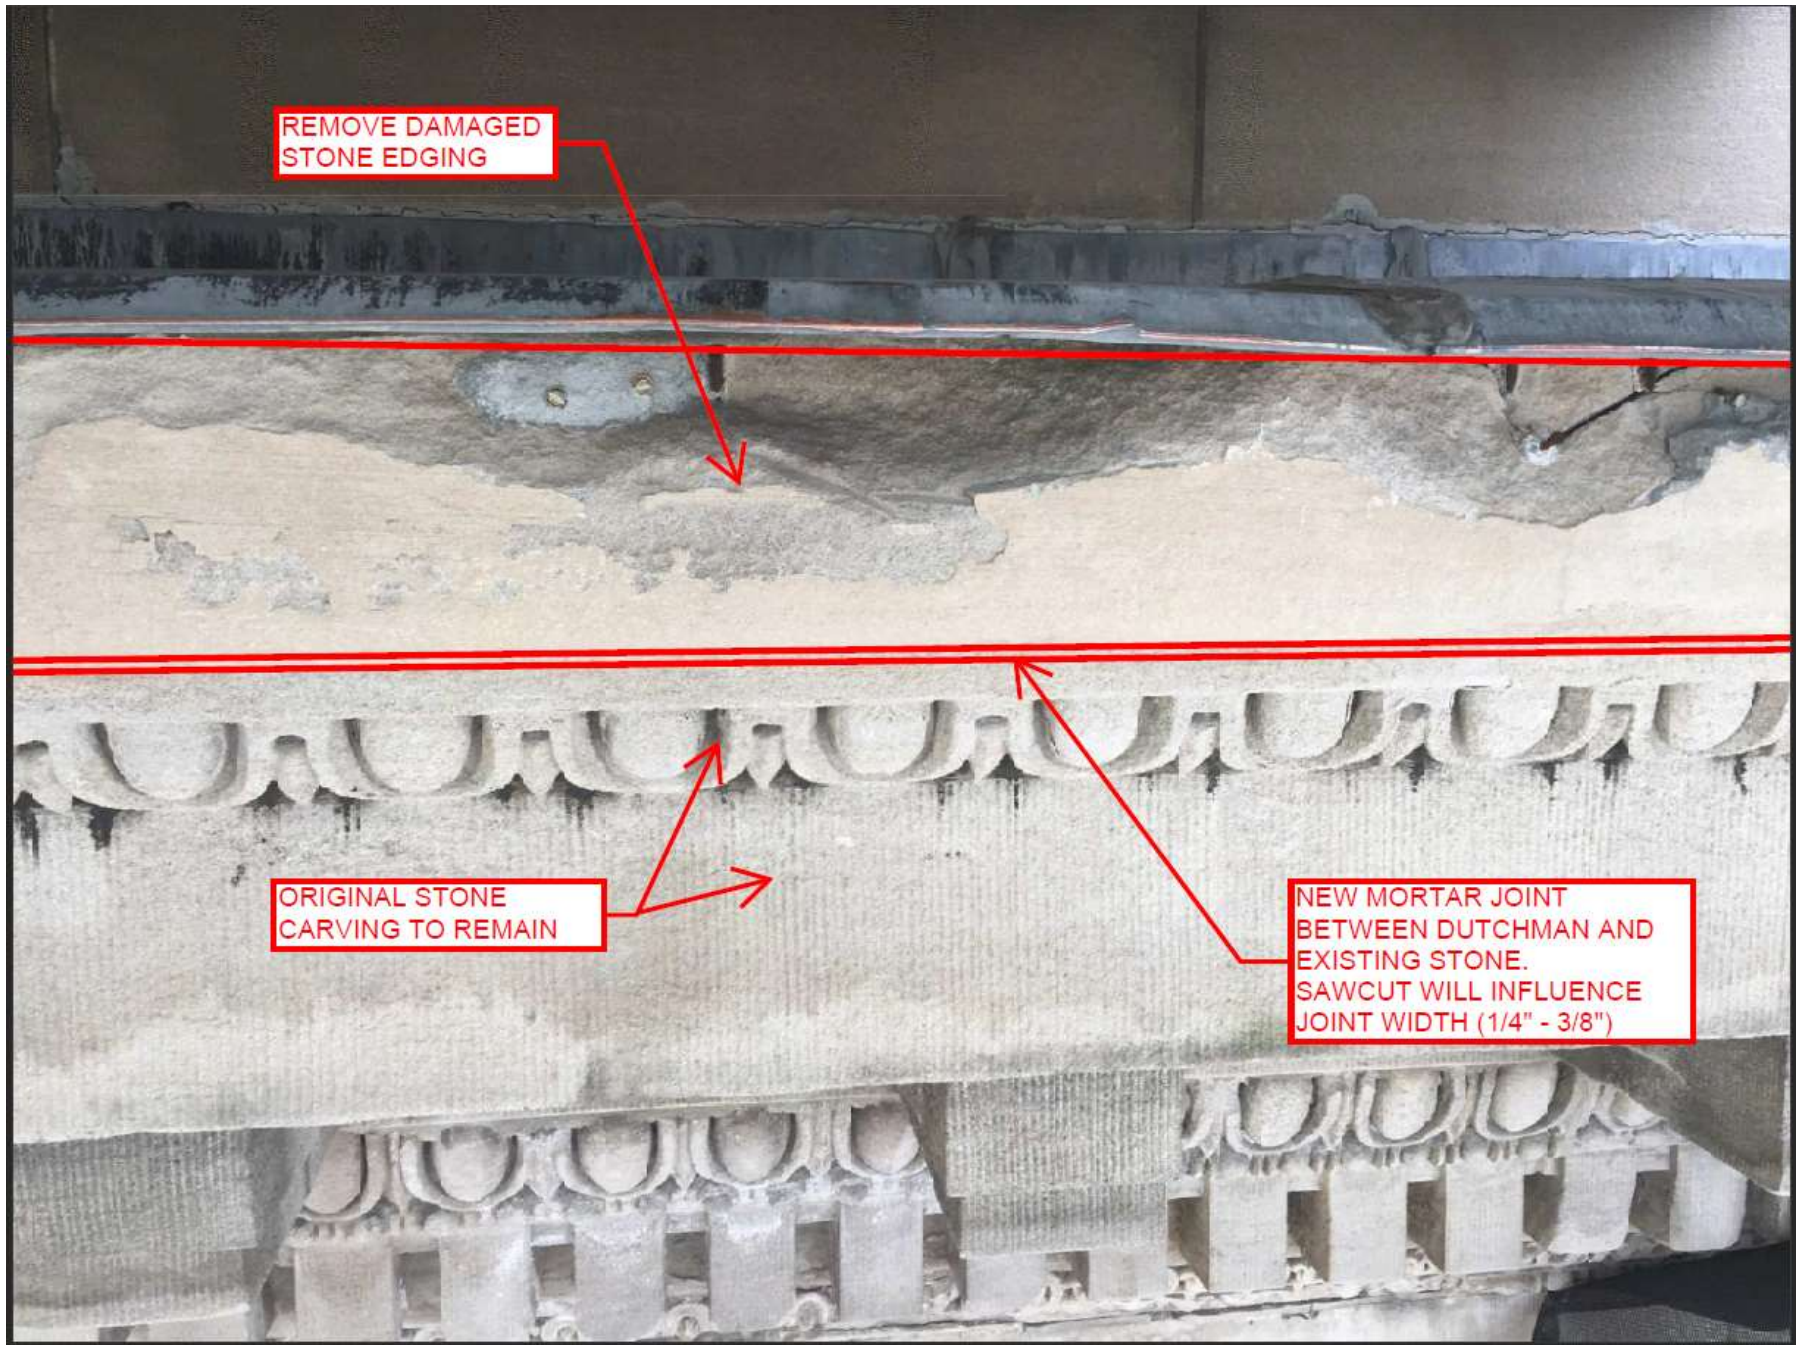
REVISED DUTCHMAN:  
DAMAGED CORNICE GUTTER EDGE  
TO BE REMOVED AND REPLACED  
WITH LIMESTONE DUTCHMAN.

REVISED DUTCHMAN EDGE PERMITS THE  
ORIGINAL FEATURES, EGG & DART AND  
CORDUROY FINISHED STONE FACING, TO  
BE RETAINED.

MODIFIED WIDTH TO BE  
REMOVED
