Certificate of Appropriateness-Corrected

Property	733 -737 W. HISTORIC MITCHELL ST.	Mitchell Street HD	
Description of work	Masonry repairs per conditions below and project narrative on following page.		
Date issued	8/10/2018; corrected 3/5/2019 and expiration date extended to 4/1/2020	PTS ID	114601 COA: masonry repairs

NORTH FACADE

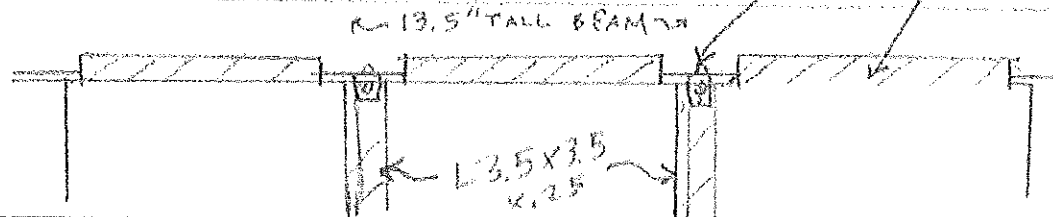
* STEEL PLATE AND
BOTTOM FLANGES ARE
RUSTED SEVERELY ABOVE
WINDOWS.

EXISTING CONDITIONS

LINTEL REPAIR:

* REMOVE RUSTED PORTION OF
STEEL BEAM (ONLY BETWEEN COLUMNS)

* INSTALL $6 \times 6 \times \frac{1}{4}$ " (MIN) ANGLE
PENDING MORE ACCURATE MEASUREMENT
OF HORIZONTAL MOVEMENT
(UP TO $L8 \times 8 \times \frac{3}{8}$ " MAY BE NEEDED)

EXISTING STEEL BEAM
BOTTOM FLANGE ABOVE
COLUMNS TO REMAIN

REMOVE STEEL AT
CORRODED AREAS
