# Certificate of Appropriateness

### Turner Hall

## **FEMA Grant Safety and Security Project**

Certificate of Appropriateness Application  
Drawings and Photo Exhibits

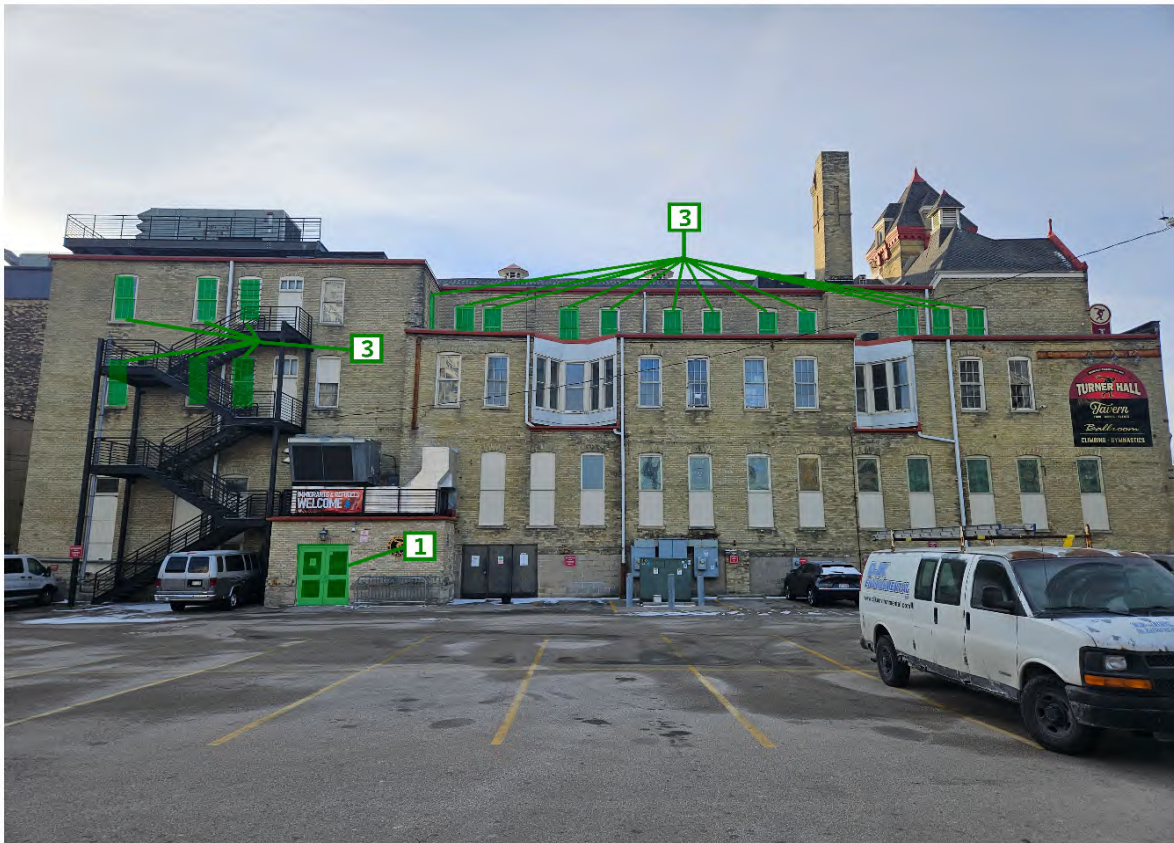
### NORTH ELEVATION - EXISTING CONDITION

- 18 WINDOWS FOR REPLACEMENT ON NORTH ELEVATION
- REPLACE NON-ORIGINAL DOORS TO ELEVATOR ENTRY

- 1** REPLACE EXISTING NON-ORIGINAL DOORS WITH NEW METAL DOORS. PAINT DOORS CREAM COLOR TO MATCH ADJACENT BRICK.
- 3** NEW WINDOWS REBUILT TO MATCH ORIGINALS. NEW GLAZING TO BE LAMINATED SAFETY GLASS.

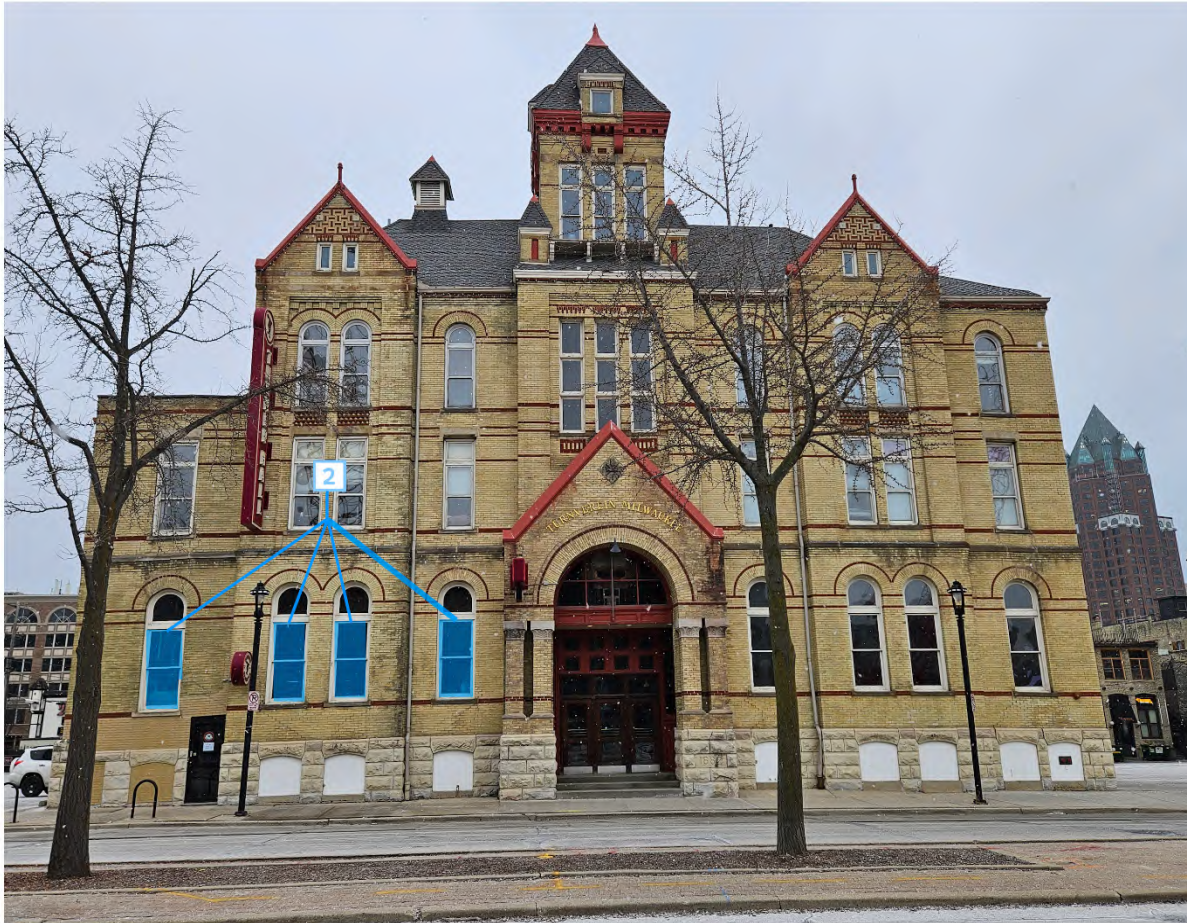
### **WEST ELEVATION – EXISTING CONDITION**

– INSTALL SAFETY FILM ON THE REMAINING FIRST FLOOR WINDOWS. EIGHT IN TOTAL.

Install 8 MIL LLUMAR SAFETY & SECURITY WINDOW FILM AT EXISTING GLAZING. SEE ATTACHED PRODUCT SPECIFICATIONS.

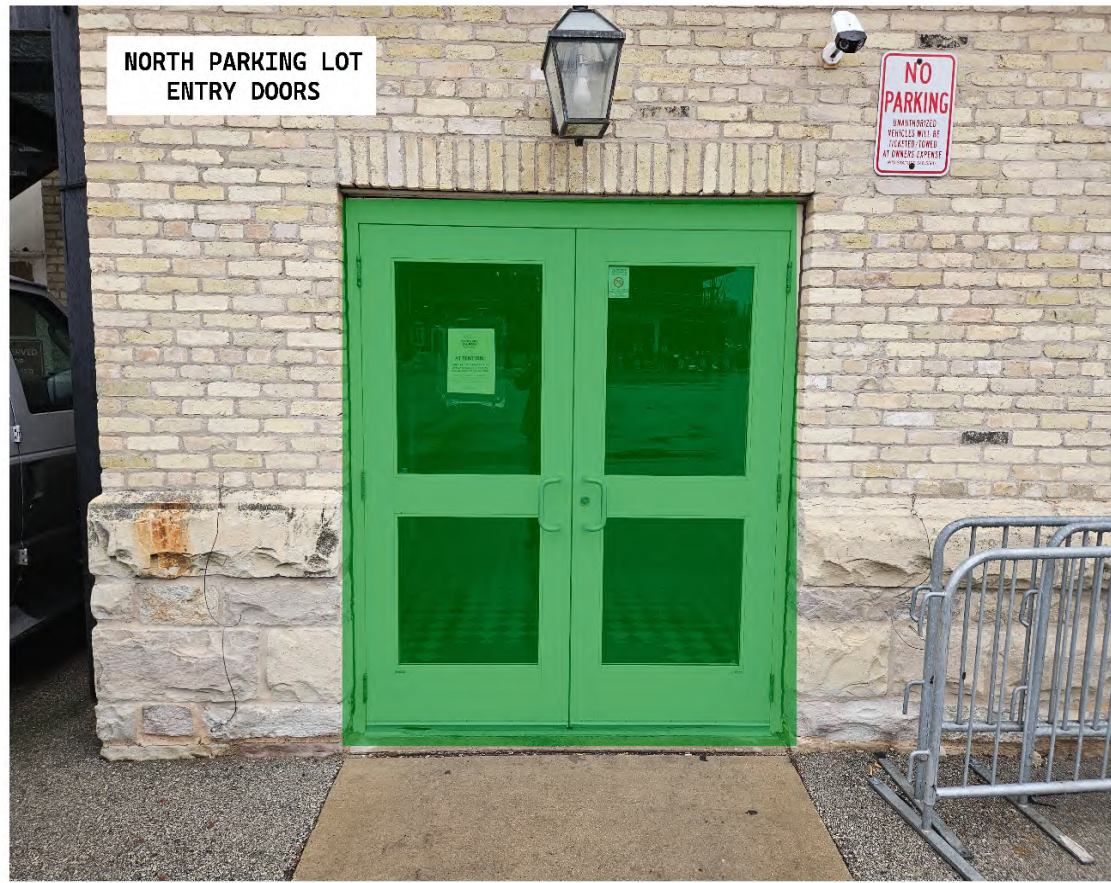
### **1 REPLACE DOORS IN KIND** EXTERIOR DOORS

1. NON-ORIGINAL METAL DOORS FROM 2005 RENOVATION TO BE REPLACED WITH IMPACT RESISTANT DOORS.
2. DOORS AND FRAME TO BE PAINTED TO MATCH ADJACENT CREAM BRICKS.

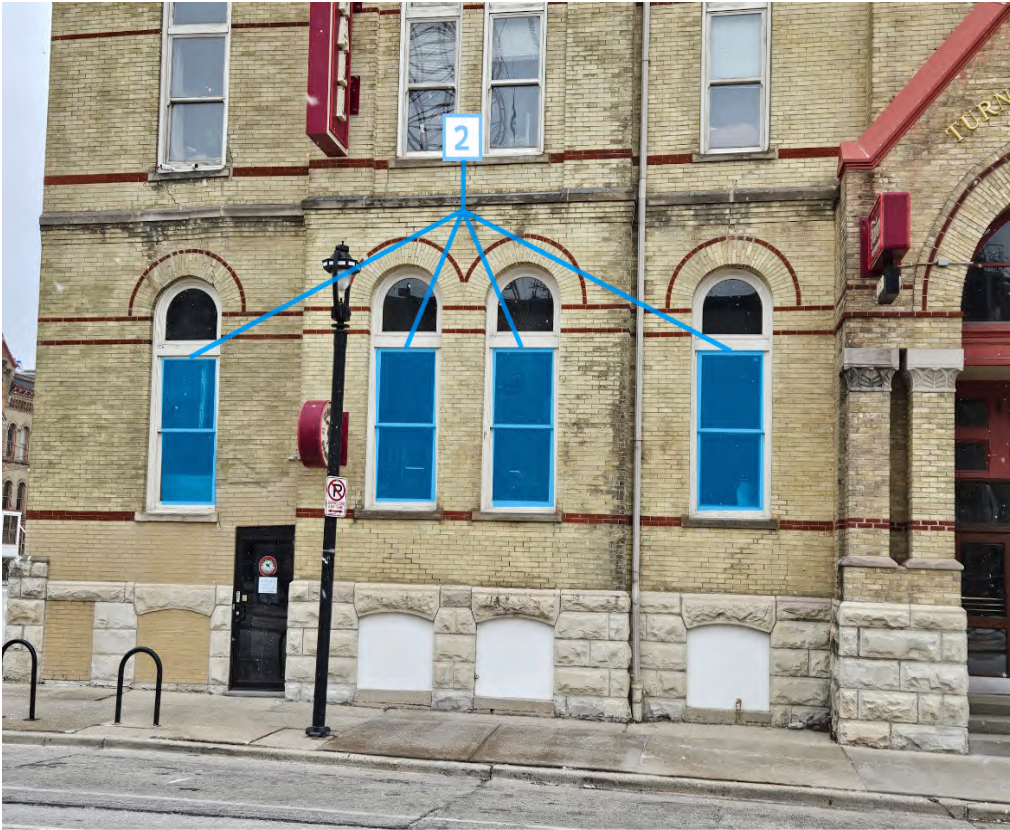
### **WEST ELEVATION - EXISTING CONDITION**

- INSTALL SAFETY FILM ON THE REMAINING FIRST FLOOR WINDOWS. EIGHT IN TOTAL.

**2** Install 8 MIL LLUMAR SAFETY & SECURITY  
WINDOW FILM AT EXISTING GLAZING. SEE  
ATTACHED PRODUCT SPECIFICATIONS.

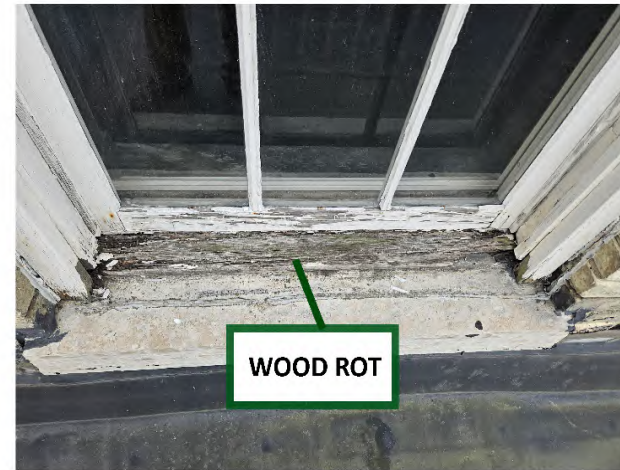
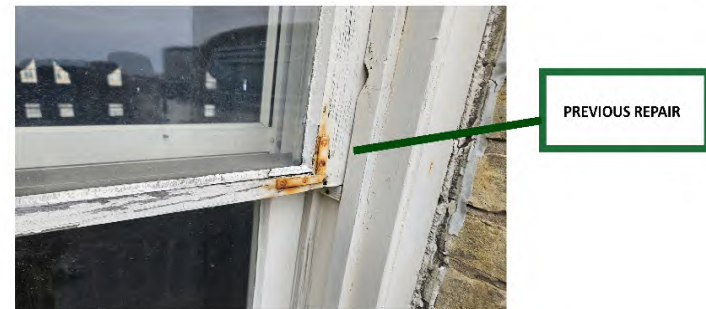
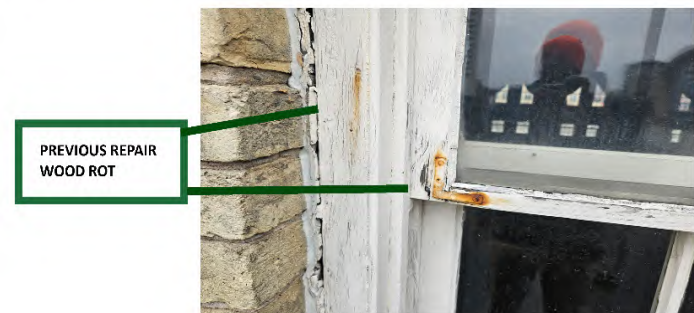
-ORIGINAL WOOD WINDOWS ON THIRD FLOOR. WEATHERING, WOOD ROT, AND PREVIOUS POOR QUALITY REPAIRS HAVE MADE IT INFEASIBLE TO REPAIR WINDOWS.

-THE SCOPE OF WORK FOR THIS PROPOSES TO REPLACE THE WINDOWS IN KIND WITH NEW WOOD WINDOWS MATCHING THE ORIGINAL CONFIGURATION AND PROFILE WITH NEW LAMINATED SAFETY GLASS

**3** NEW WOOD WINDOWS REBUILT TO MATCH ORIGINALS. NEW GLAZING TO BE LAMINATED SAFETY GLASS

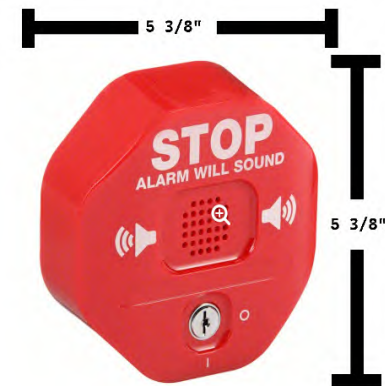
1. ALARMS MOUNTED AT ROOFTOP HATCHES.
2. ALARMS HOUSING NOT TO BE ALTERED TO ACT AS A VISUAL DETERRENT.

**4** INSTALL DOOR ALARMS  
AT VULNERABLE ENTRIES
