2804 North Grant Blvd Milwaukee, WI 53210

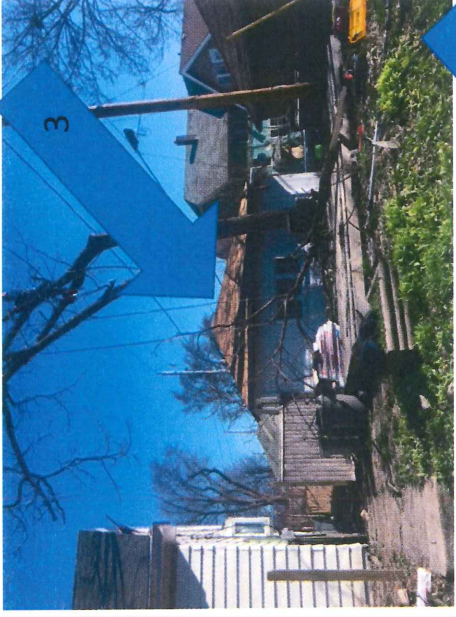
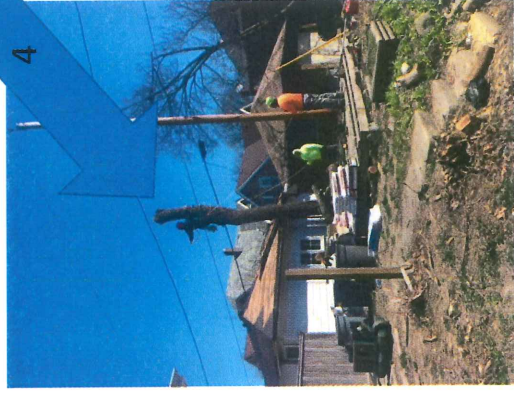
3.) Two layers of roofing shingles were removed from the garage, before a new roof was installed.

4.) The tree leaning on the garage, that was also entangled in the power lines, was removed to prevent the leaves and branches from affecting the power lines or from damaging the new roof on both the home and the garage.

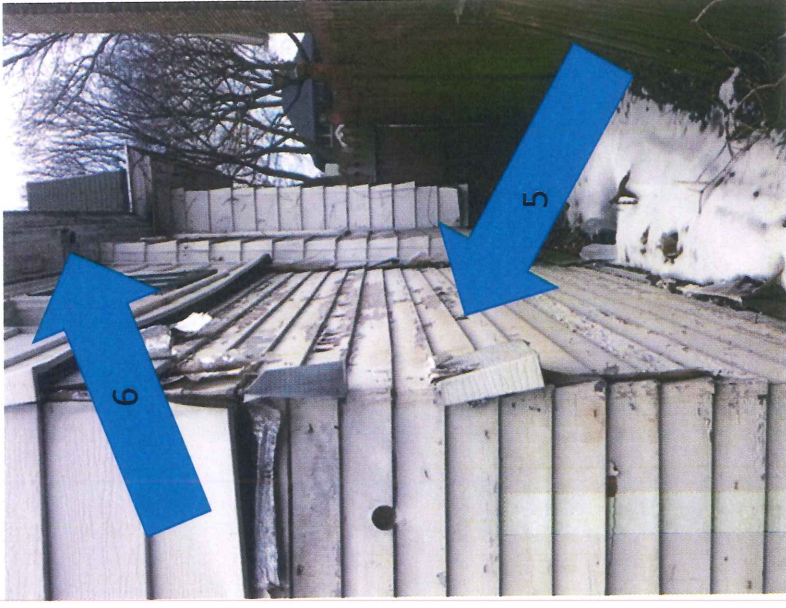
- 1.) Wood shingle siding was scraped and repainted.
- 2.) Aluminum siding was scraped and repainted.
- 3.) Wooden window frames were scraped and repainted.
- 4.) Flower bed formed on the side of the home, using stones already on the property.

- 5.) Aluminum siding that had been removed from the home prior to purchase was replaced with new aluminum siding, to match the existing siding on the home.
- 6.) Aluminum gutter that had been removed from the home prior to purchase was replaced with a new aluminum gutter to match the other gutters on the home.

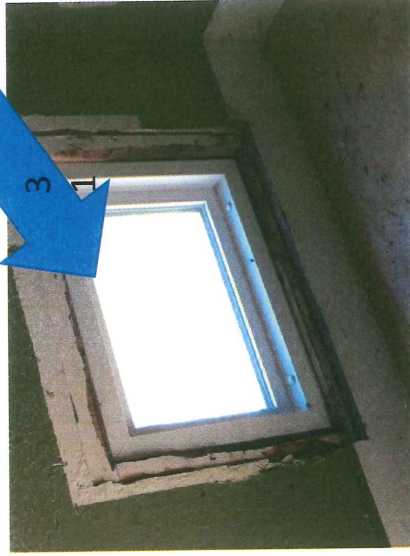
3.) Second floor window opening was covered with a board at time of purchase. There was no existing window or window frame on the property. A small window was installed to match other windows on the north side of the home.
