Certificate of Appropriateness

Re-issue/Amended

Property 1851 N. 2ND ST. **Brewers Hill Historic District**
Description of work Re-build front porch deck and roof. Retain historic carved column capitals for re-use on re-built porch. Re-build porch to match original using clear, knot-free finish lumber. Where column capital portions are missing, new pieces will be re-cast in a synthetic material. Spot replace wooden clapboard where missing or damaged with new, matching genuine wood clapboards that are smooth and knot-free.

Date issued 10/3/2014 **PTS ID** 84876 **COA, front porch re-build--reissue/amended**

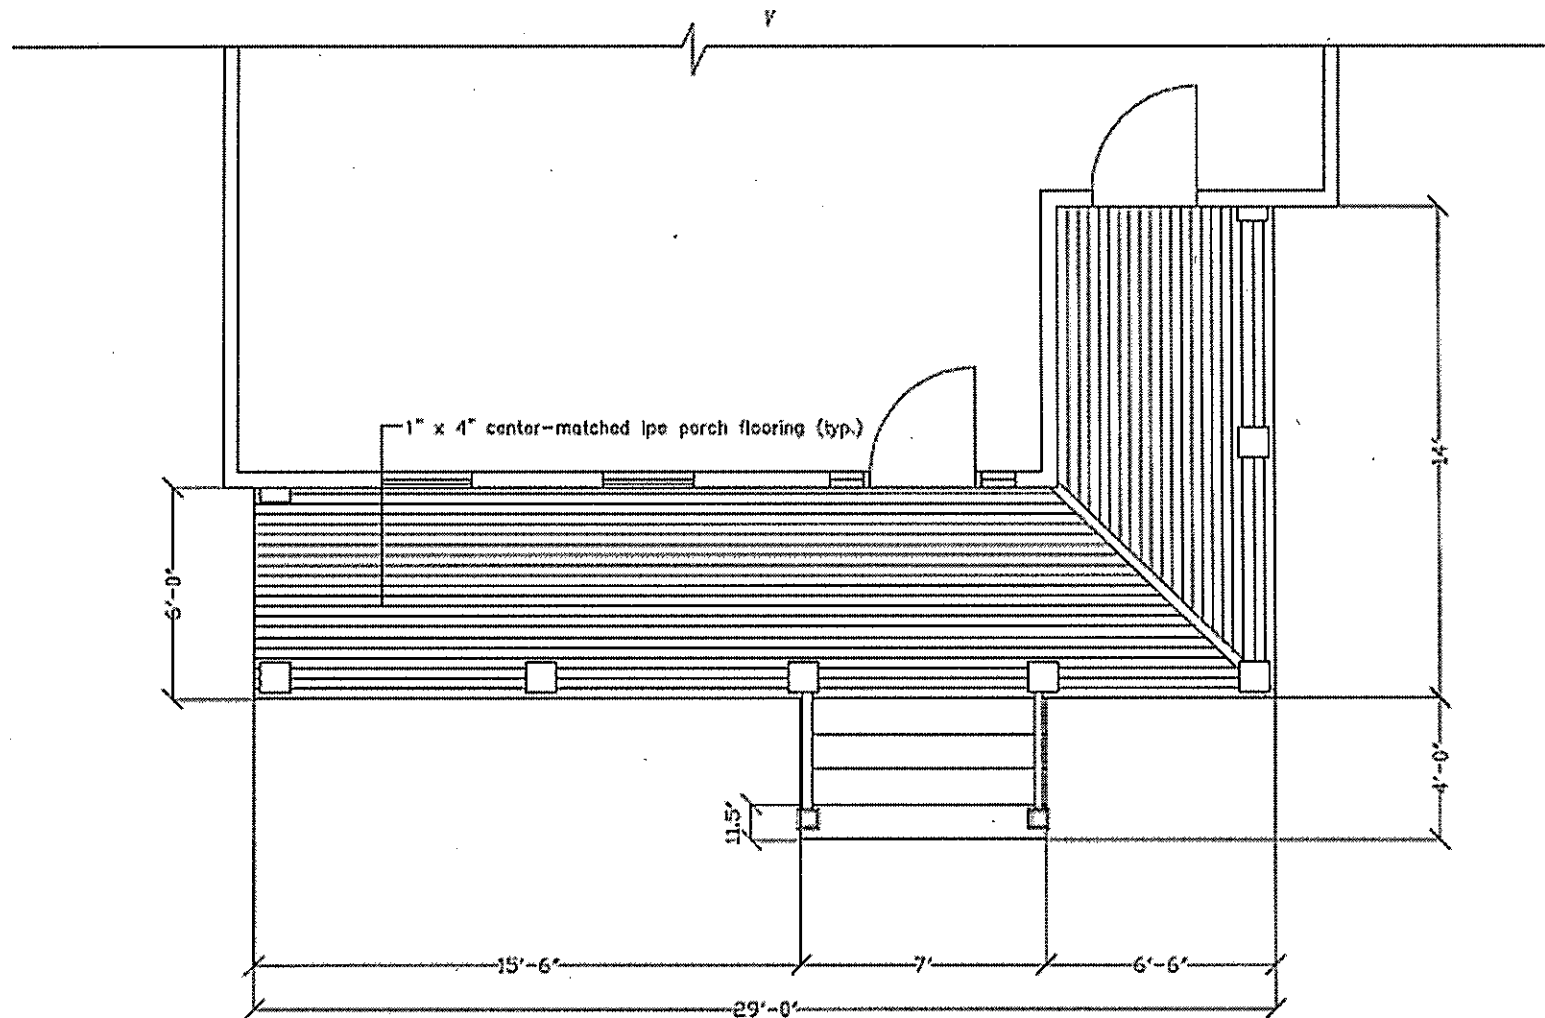
COVERED EAST ENTRY PORCH

Plan of new front porch for 1851 N. 2nd Street

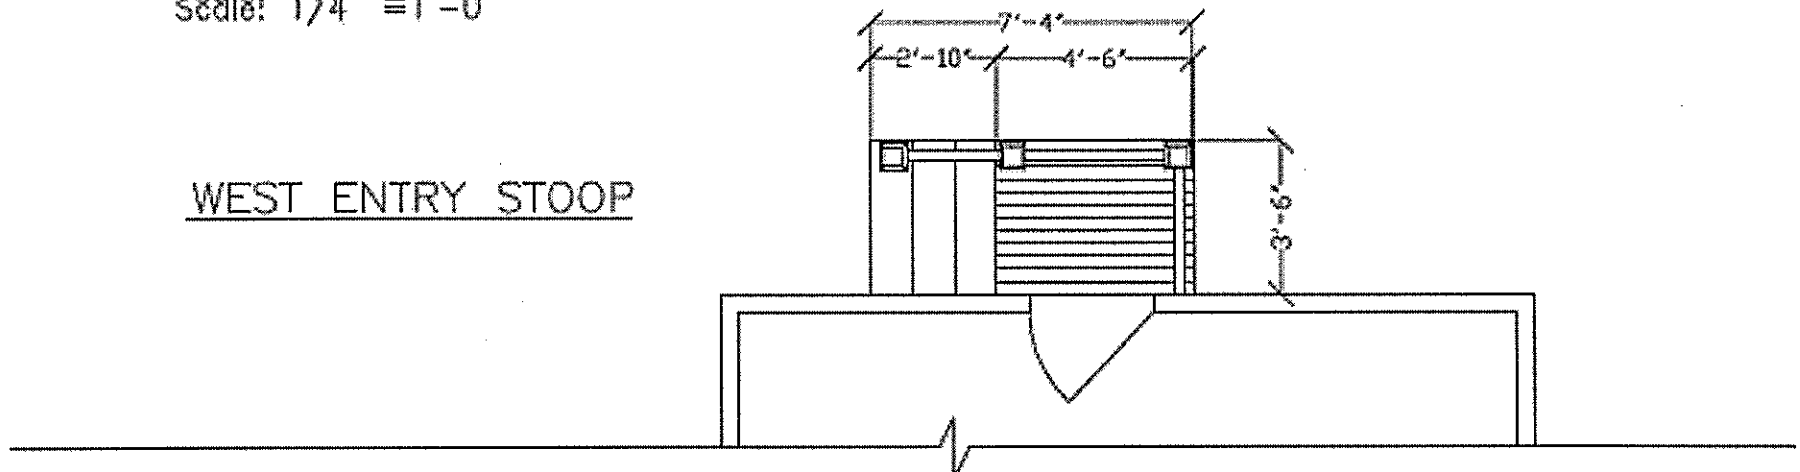
WEST ENTRY STOOP

Plan of new back door stoop. Railings and newel posts to match front porch detail included in this COA. Because there is no roof over this porch the decking boards can be gapped 3/16" for water run-off.

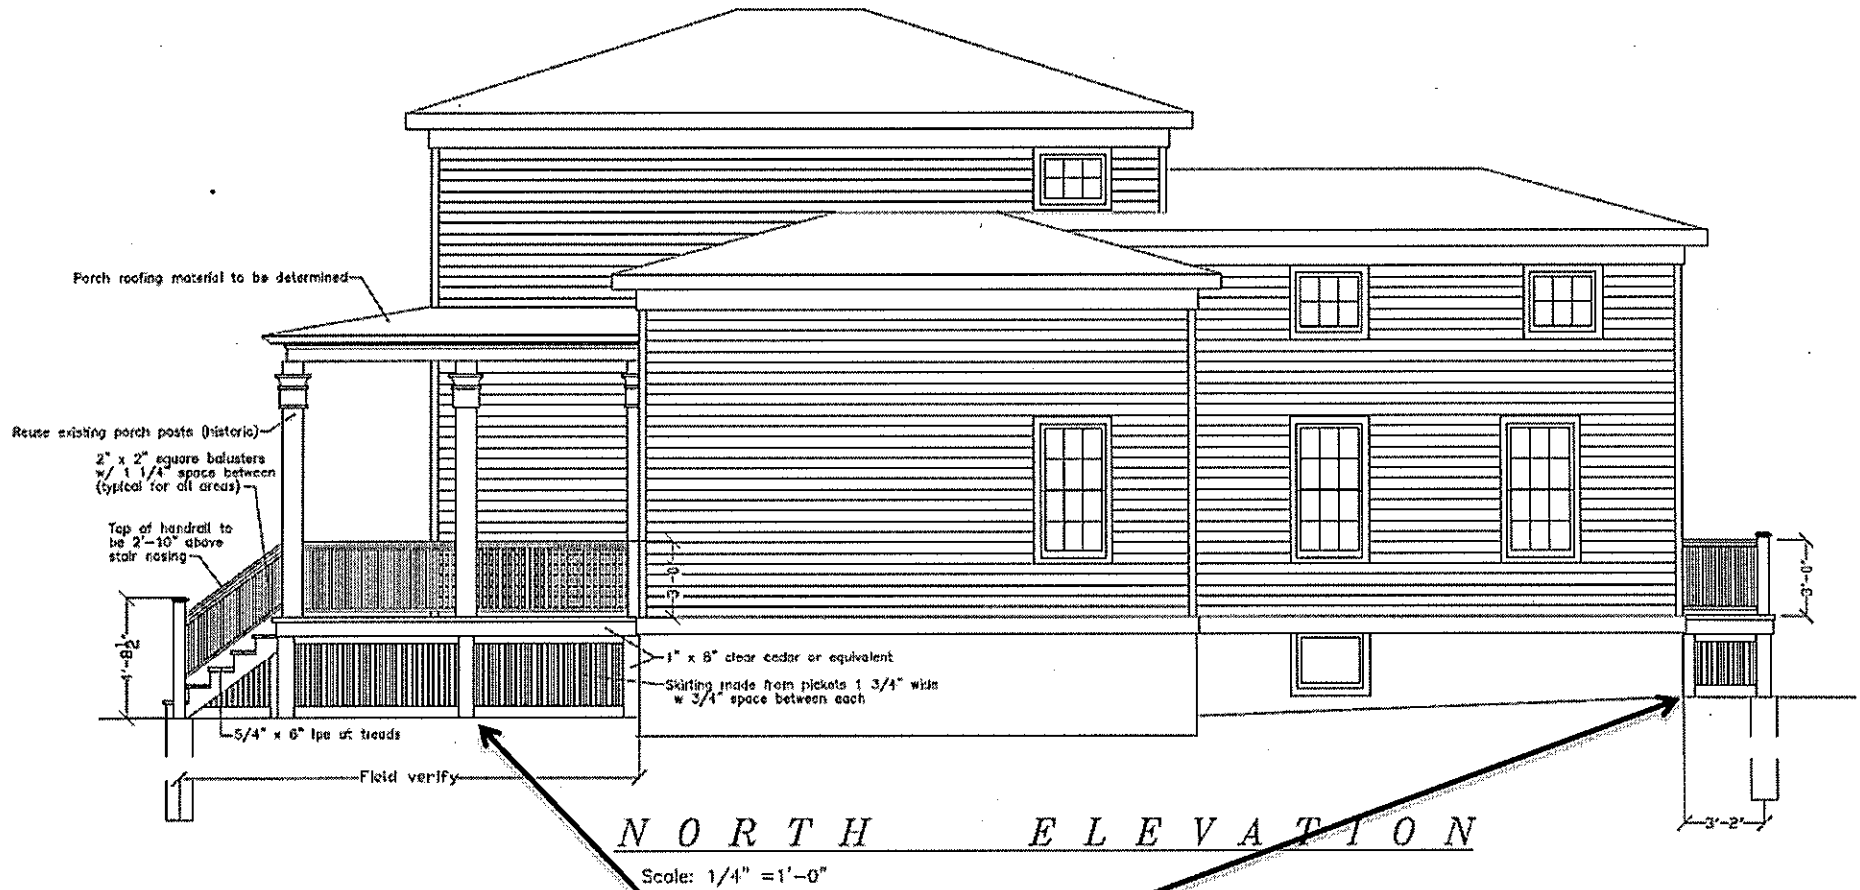
Side elevation north showing new porches on front and rear of house.

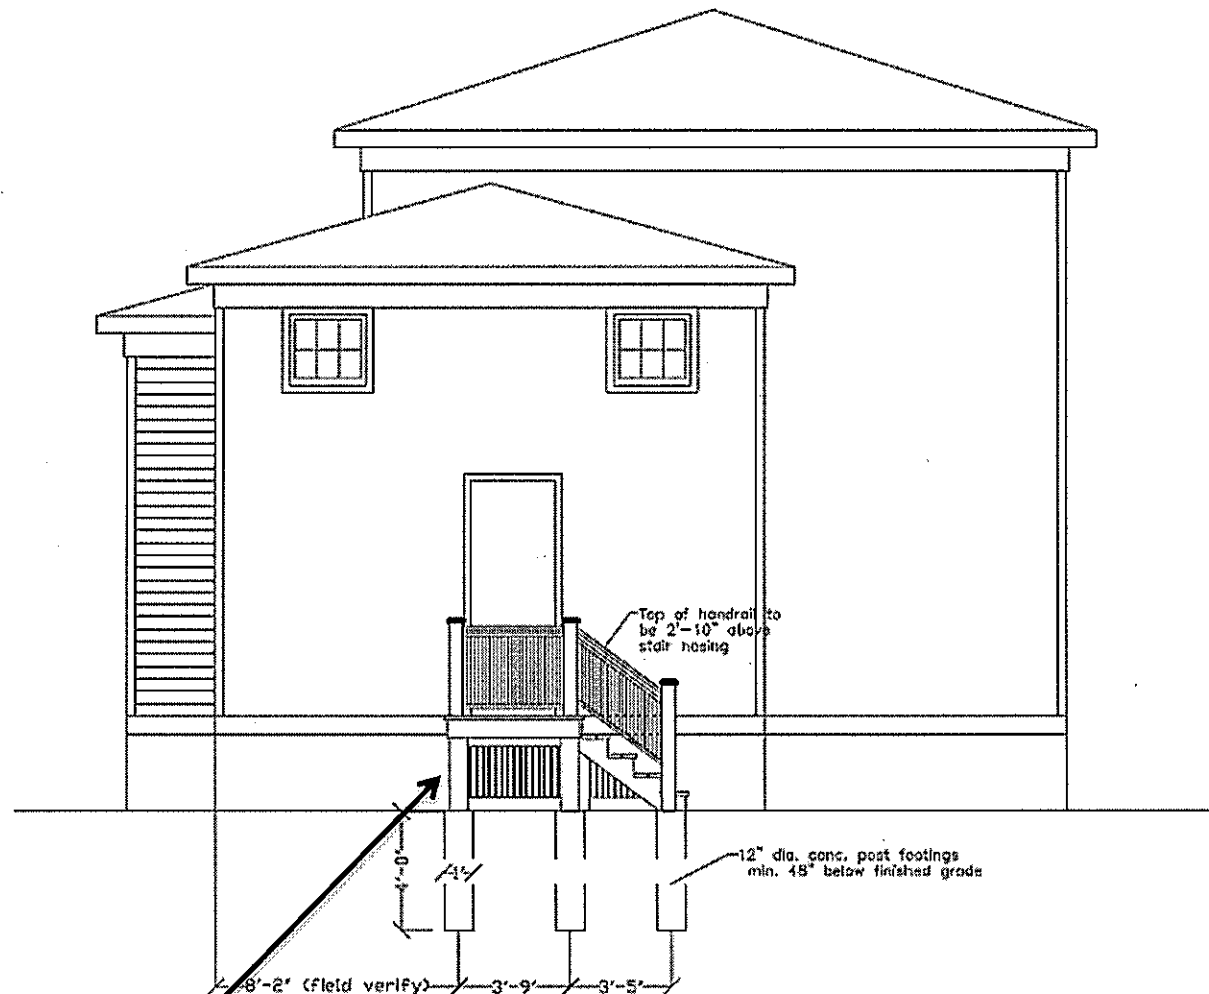
W E S T E L E V A T I O N

Rear elevation showing new stoop with newels, and skirting and foundation piers that extend 48" below the grade.

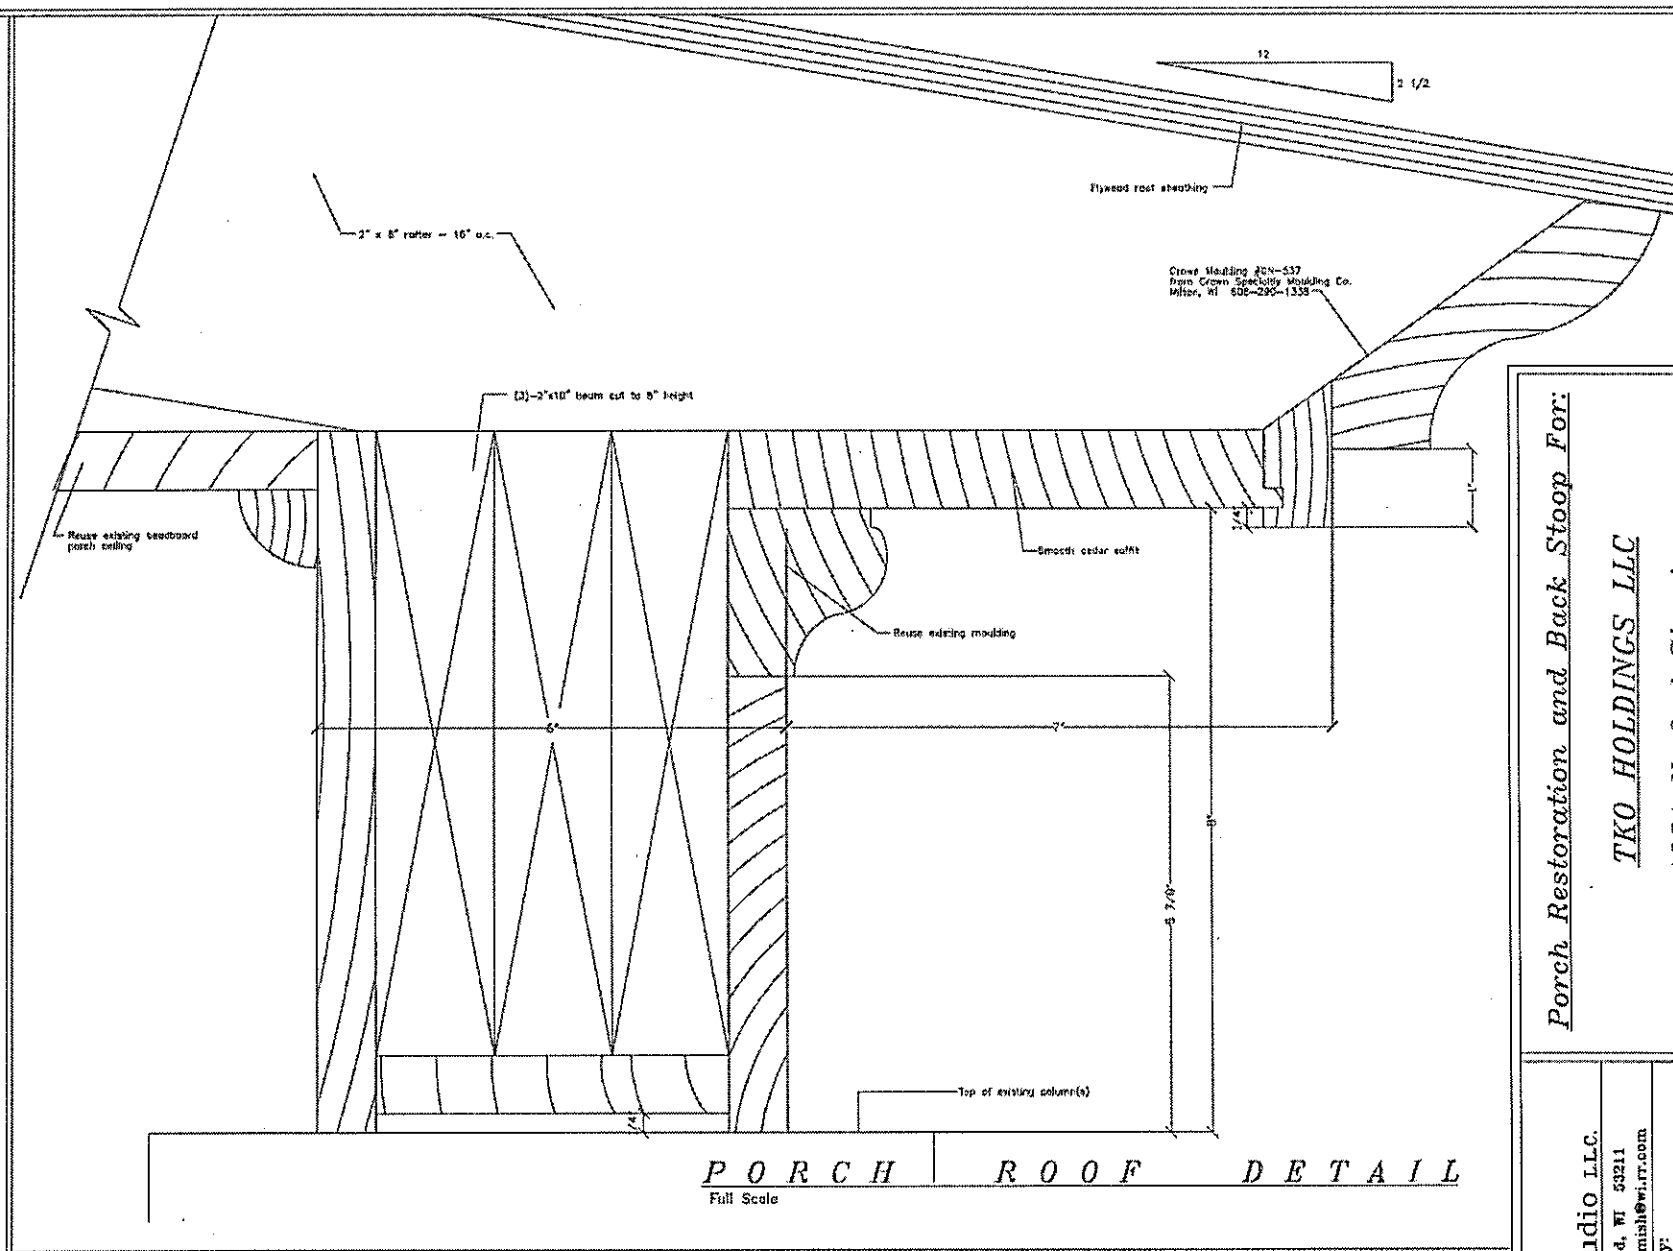
Section drawings of front porch overhang. PLEASE NOTE: Molding on edge of roof must match exactly the profile shown as that is an exact copy of the original.

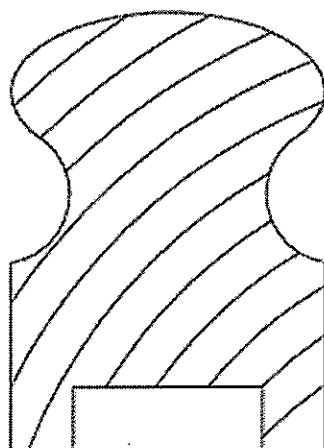
H A N D R A I L

Graspable Handrail
Crown Specialty Mouldings
#HR-548
808-290-1338
Milwaukee, WI

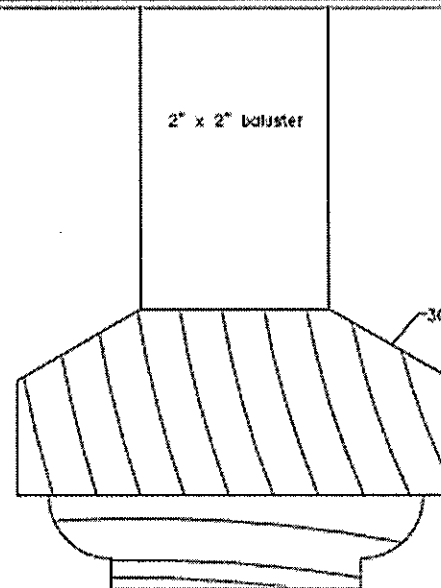
B O T T O M R A I L

Bottom rail to be site-made
2" x 4" with beveled corners
Bottom piece 3/4" thick with
round-over and fillet edging
Screw together

Section of guardrail/handrail for front porch

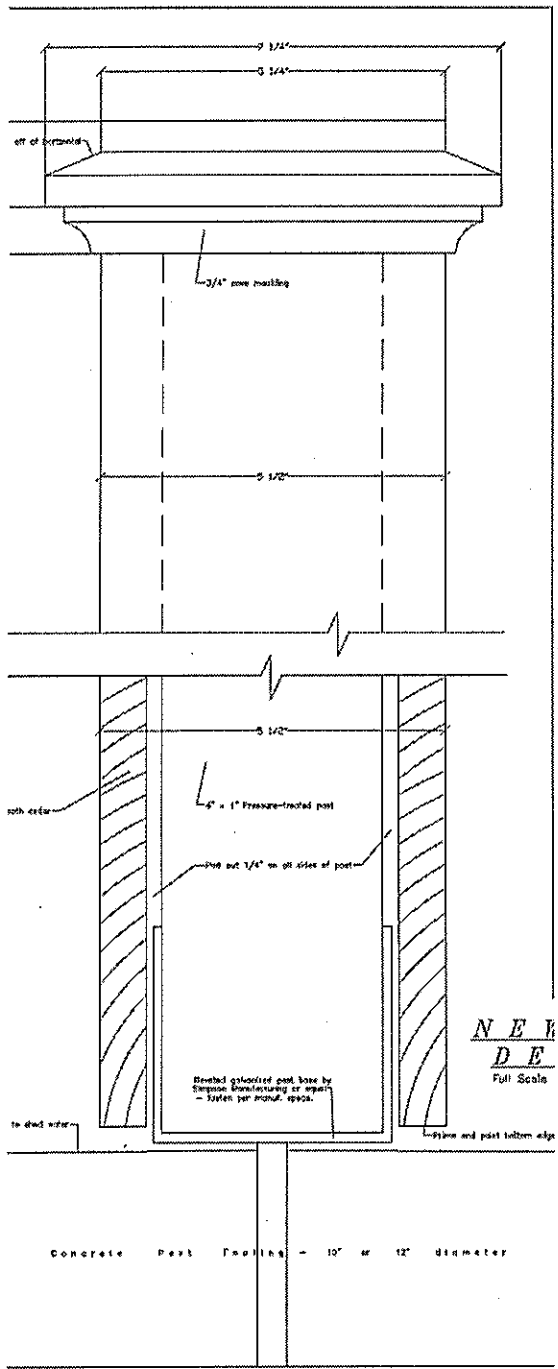
Section of newel posts to be located at the bottom of each side of the front steps.
