Scot W. McLean, ASHI  
333 W. Brown Deer Rd. #117, Bayside, WI 53217  
Phone: 414-228-6573  
<http://www.tandcinspection.com>

# Report Index

## *Inspection Summary*

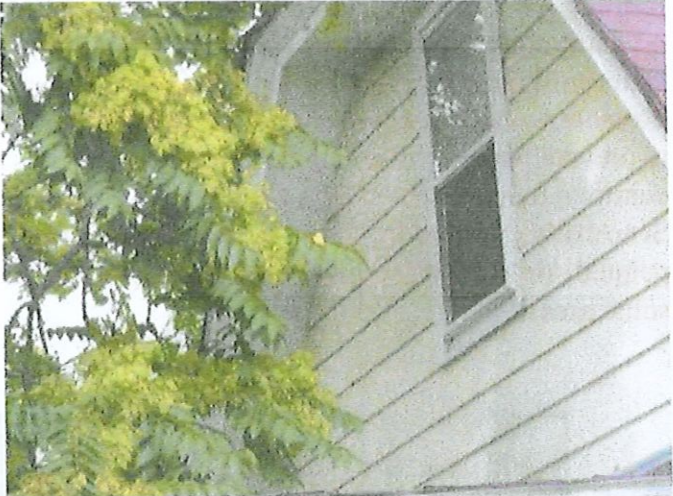
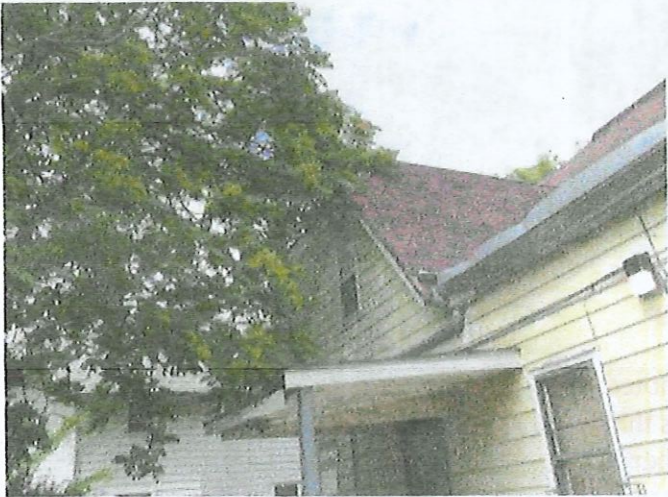
Older/worn, Loose siding, Misaligned, Missing sections/corners, Holes/gaps. Seal to prevent pest/water infiltration. Holes, Dents Vintage installation Evaluate now for common maintenance needs. Seal any gaps/openings. Seasonally evaluate for future maintenance needs.

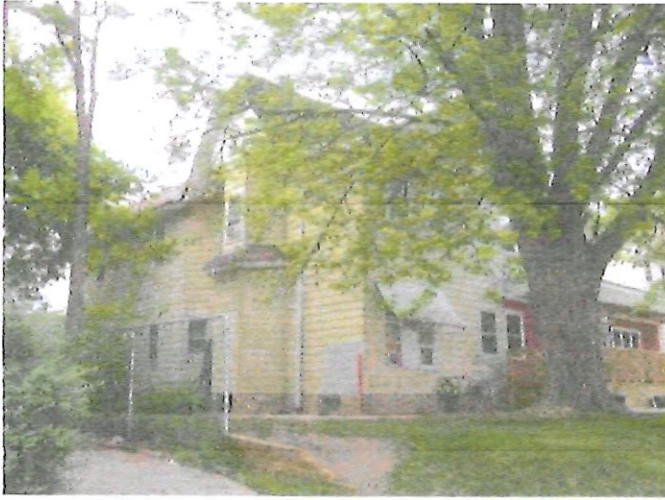
Wood:

Older/worn, Small areas of significant deterioration noted. Evaluate for repair needs including interior structures and framing for water intrusion/migration issues. Needs touch up paint/putty/caulk sealant, Holes/gaps. Seal to prevent water infiltration. Loose siding, Missing sections, Possible woodpecker/vermin holes. Cracked boards. Seal to prevent water intrusion/deterioration. Evaluate now for common maintenance needs. Seal any gaps/openings. Seasonally evaluate for future maintenance needs. Lifting painted surfaces with adjacent chip on the ground noted in some areas.

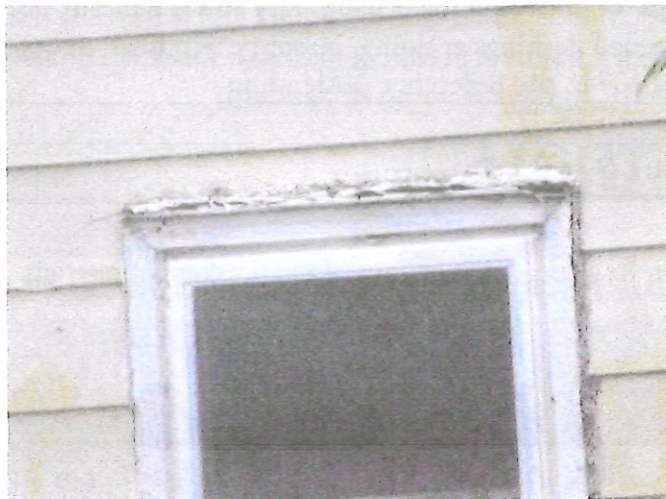
Some/ most- Older/worn, Vintage/Original era, Needs maintenance/caulk sealant/putty/paint. Gaps/openings observed. Unconventional installation of cladding will not protect trim and structure from water migration/leakage. Needs repair/flashing. Significant deterioration noted at approximately 75% or more of windows/trim. Significant deterioration noted at most windows/trim. Peeling paint, Spalling/shaling/surface deterioration at sills. Missing flashing. Add flashing to prevent deterioration and other water penetration issues. Putty/glazing loss/lifting at window(s).

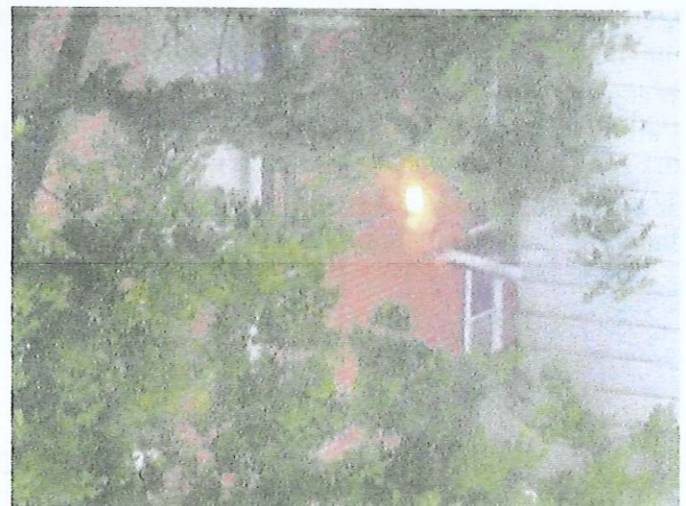
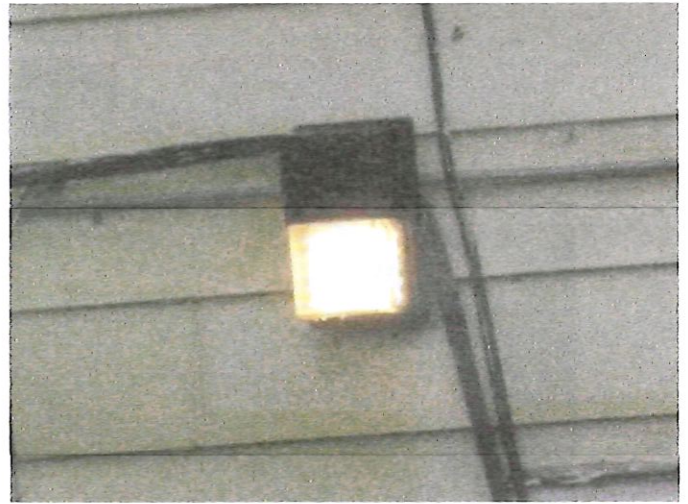
Older/worn, Possibly some sodium vapor bright lighting is commonly not allowed in a neighborhood setting.

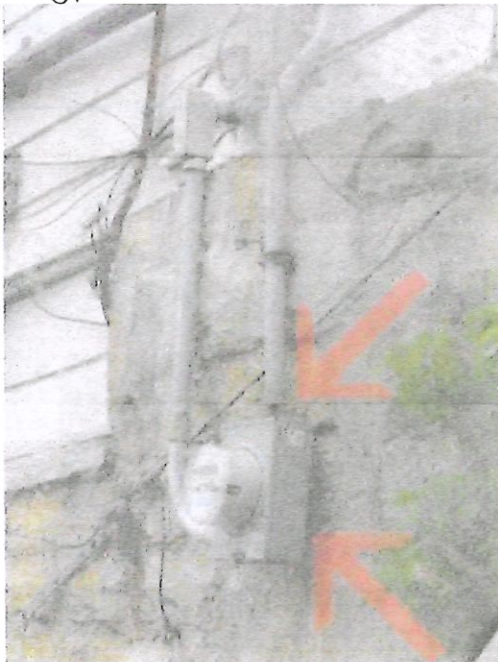
Electric Service Type (7) (a) 4.

Overhead, Cloth vintage era service wire at mast head at exterior. Older/worn. There appears to be fraying present. Overhead, Improperly fastened service conduit, Corrosion noted at service conduit. May need replacement in coming years. Consult an electrician for recommendations. Pulling away from building. This can pull on and detach the service wire connections. Have evaluated and repaired as needed by a licensed electrician for safety and good function. Detached conduit at alley,.

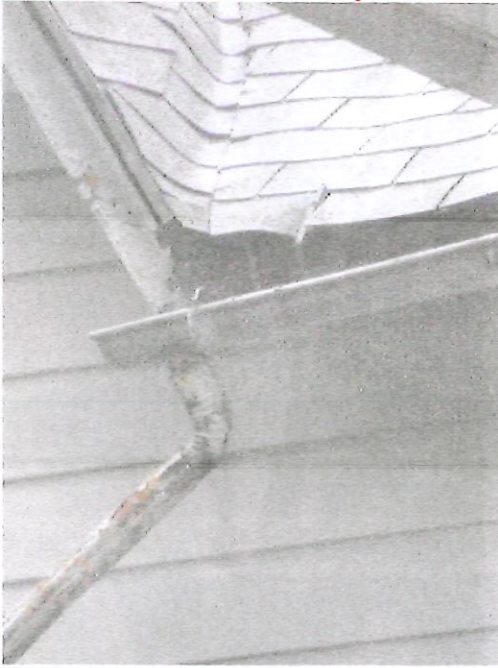
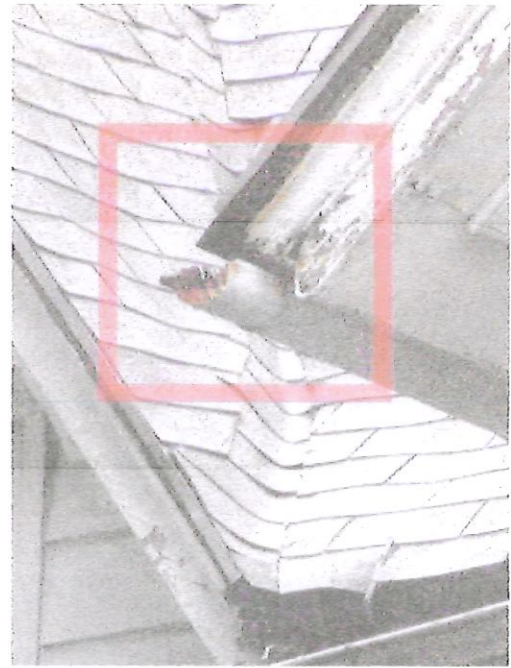
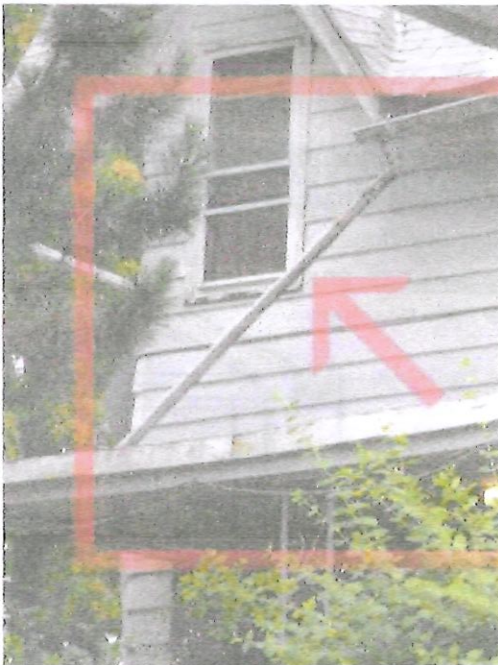
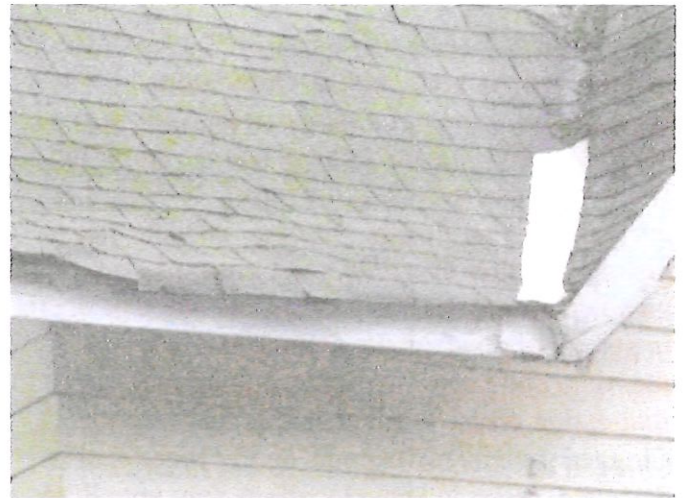
gutter. Add as prudent. Not aligned to roof edge, Trees nearby. Gutters will require frequent cleaning. Monitor for overflowing and clean as necessary. Repair/replace gutters and downspouts as needed. Add gutters where missing to protect the building, foundation, and structure as prudent.

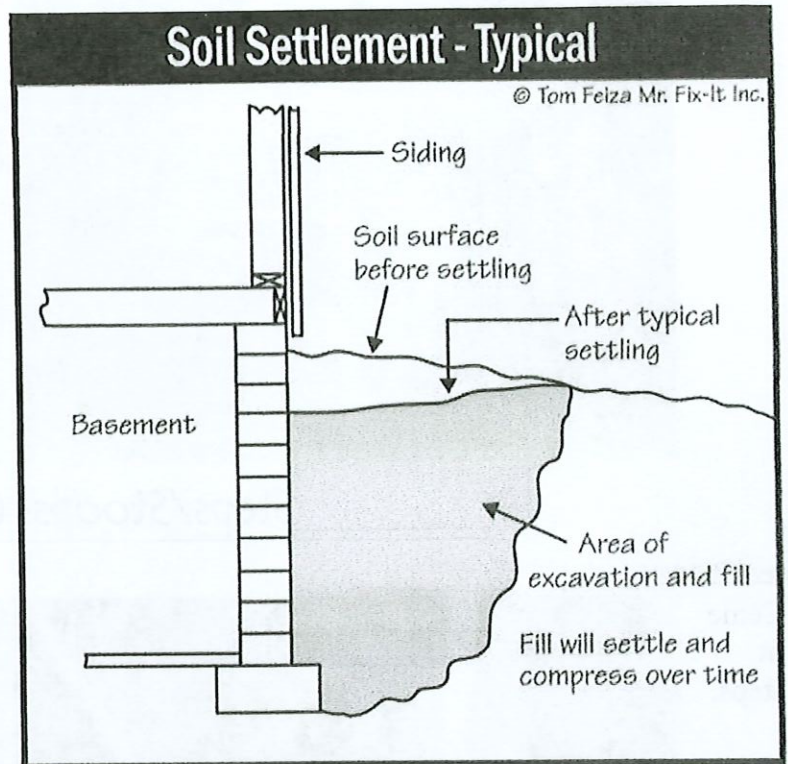
Current landscaping/retaining wall may restrict proper drainage, Low or flat areas: West, Various locations. Grading under deck slopes towards building or is flat and will not drain water away effectively. Slope brown dirt away from building 1" per foot for 6 feet in low/flat areas now and correct grading as necessary at all surfaces around the building. See note 111 in Reference Addendum. Ask yourself where the water is going to go: Into the basement or away from the building?  
Suggest correcting grading concerns at walk.

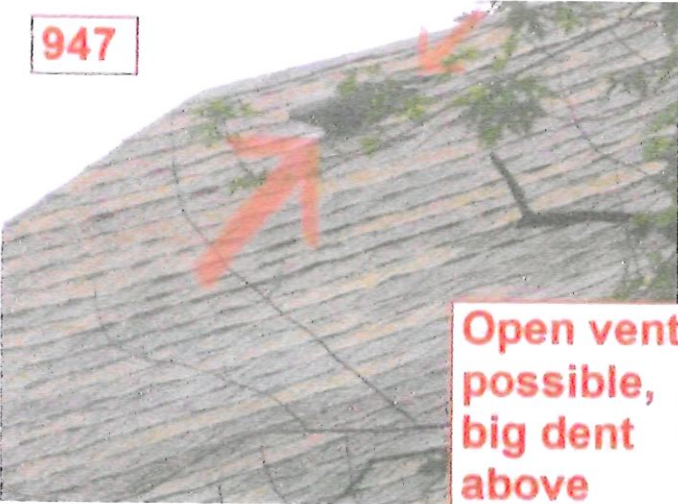
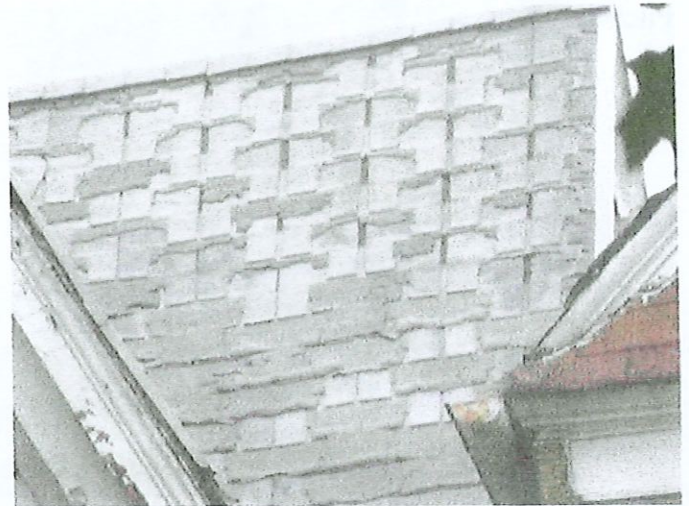
Visibility and Limitations: (4)(a) 1.

Height restricts inspection, Configuration restricts inspection. Lot configuration, Much of the roof was not visible at the time of inspection due to reasons noted. Observations and opinions are limited to visible portions only. Dormer roof(s) not visible/fully visible at the time of inspection. There is not enough information available to form a complete or meaningful opinion. Seek full evaluation by a qualified roofing specialist in a timely manner. Trees leaning and scraping on several roof systems, flashings, gutters, and siding on most all structures. Vermin, squirrel, possum, mice, rats, wasp and bird, bat common access points given size.

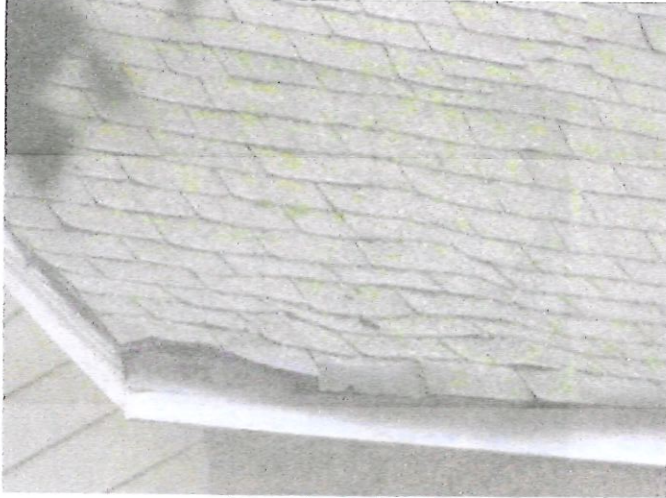
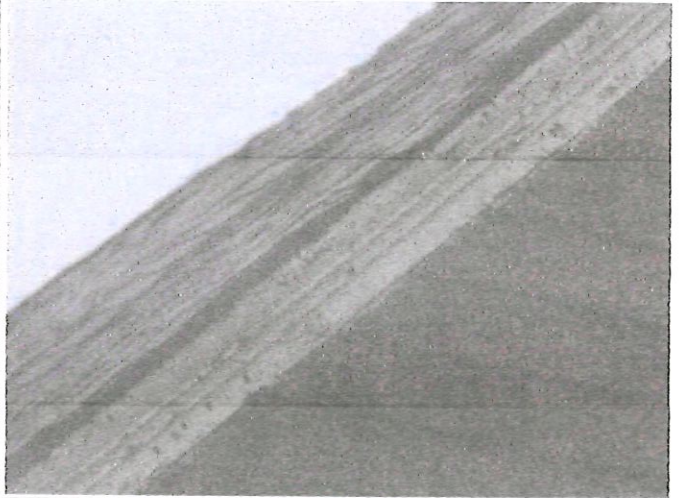
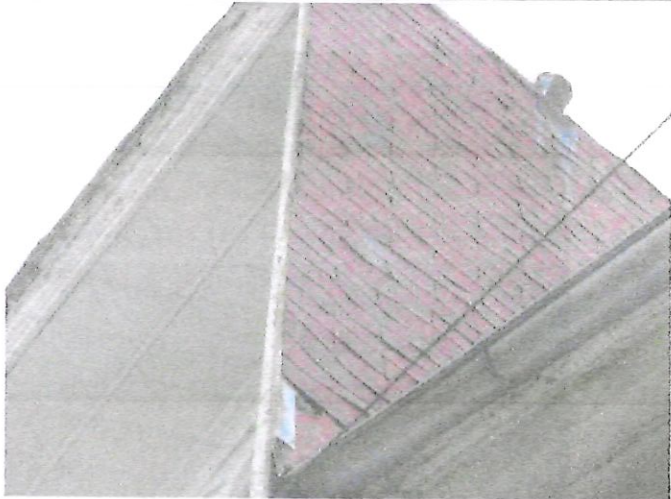
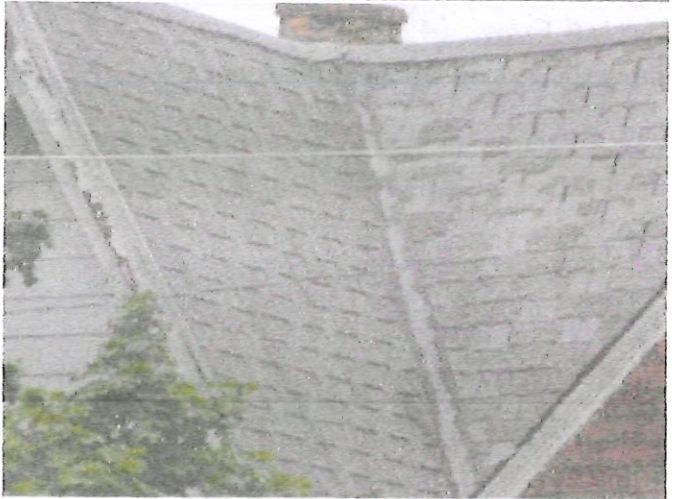
Approx Layers: (4)(a) 1.

See note 116 in Reference Addendum. Two asphalt layers and a wood layer observed, Three asphalt layers and a wood layer observed.

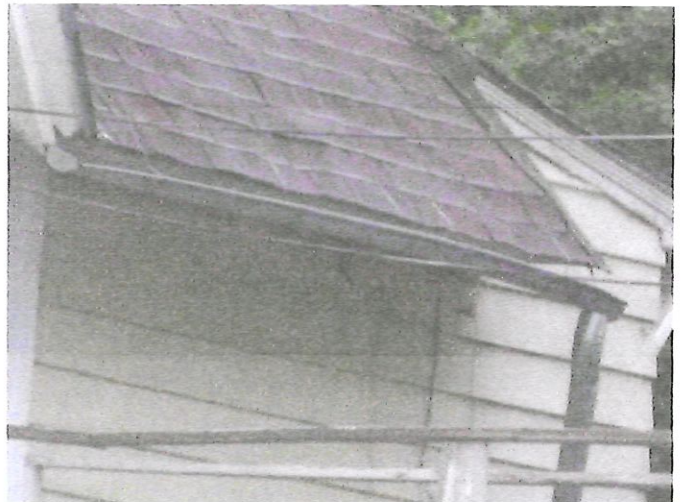
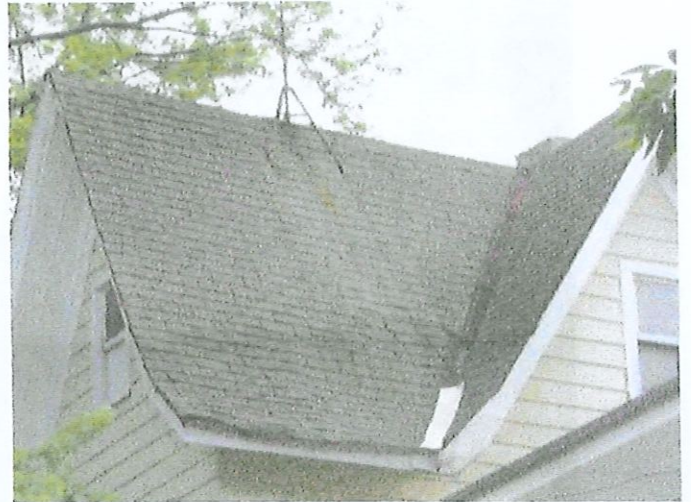
Material: (4)(a) 1.

Asphalt/fiberglass shingle, Questionable installation of asphalt/fiberglass shingles at some low slope roofs. If premature wear, ice damming, or leakage occurs, consider replacement with a flat roofing material. Asphalt roll.

Serious signs of wear/aging. Some general observations include: Brittle/loss of elasticity/inflexible, Granule loss, Curling, Shrinkage, Waviness. Underlayment and decking structure are hidden from view and can not be evaluated by our visual Inspection; therefore, our observational review is not a guarantee or warranty against roof system leaks, seepage or structural condition, nor is a certification. Expect leaks. Cracking, Missing/loose/broken shingles/tabs. This may indicate a general area of loose/detached shingles that may not appear to be loose. Tar/caulk sealant patching may indicate a history of and potential for leakage. Ask owner for history. Exposed nail heads, Algae (dark streaking/staining) present on shingles. This discolors the shingles but does not generally harm the roof or structure. Replaced shingles noted. Ask seller for history. This may indicate a general area of loose/detached shingles that may not appear to be loose. More wear noted at some locations than others (possible ice chipping). Fiberglass visible through granules. See note 117 in Reference Addendum. Physical damage, Short shingle installation (not enough overlap of shingles). Pieces of shingles in yard/driveway, Shingles at peak are worn. This is common and easily repairable. Appears as insufficient overlap of dimensional shingles. Nail popping, Lacks drip edge flashing. Lacks gable end flashing. Trim overhanging trees, Caulk sealant is a short term patch and subject to deterioration and seepage if not maintained. Multiple roofs present. Roofs were installed at different times and are in different conditions. Generalized and accurate over all observations of several roof surface systems. Structure unknown at interior. lichen growth noted.

Re-roof as soon as possible. Correct any roof deficiencies in a timely manner to prevent damage to structure and finishes. Expect leaks. The next re-roof will require a tear-off of the old roofing layers. Flashing(s) may need to be re-anchored/secured/replaced.

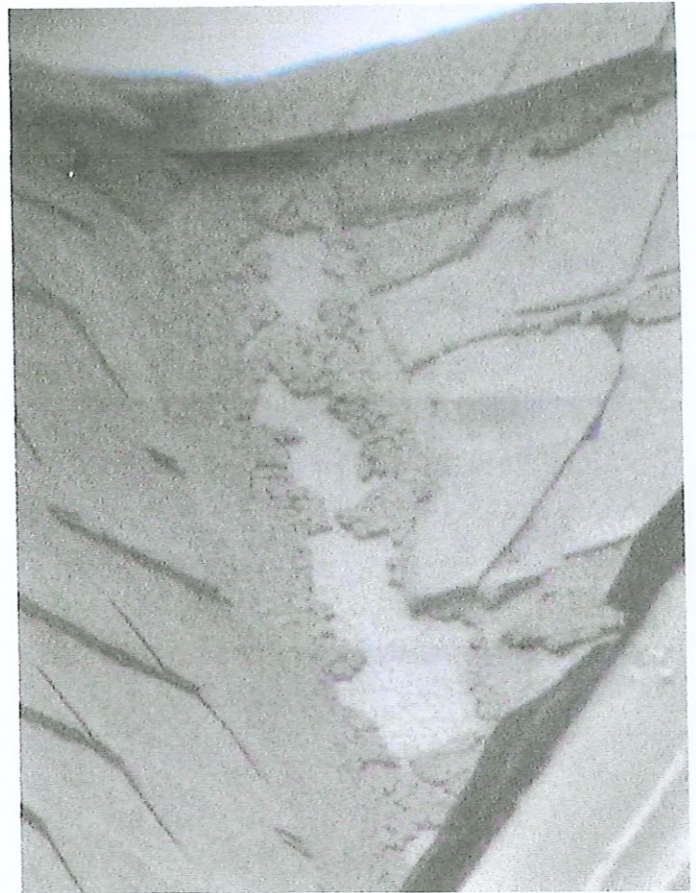
Plumbing vents: (4)(a) 4.

No/restricted access Synthetic flashing material present. Monitor for holes/cracks/folds/wear at collar. Cast iron plumbing vents typically need a lead flashing that covers exposed areas of the pipe above the roofline. A synthetic flashing boot is not designed for this installation and will leak. Repair/replace as needed. It appears that the flashing from the previous roof installation has been re-used for current roof. Lifting/gaps/openings noted. Needs maintenance. Sealed with roofing mastic/caulk sealant. See note 120 in Reference Addendum. Holes/gaps/cracks. Needs replacement now.

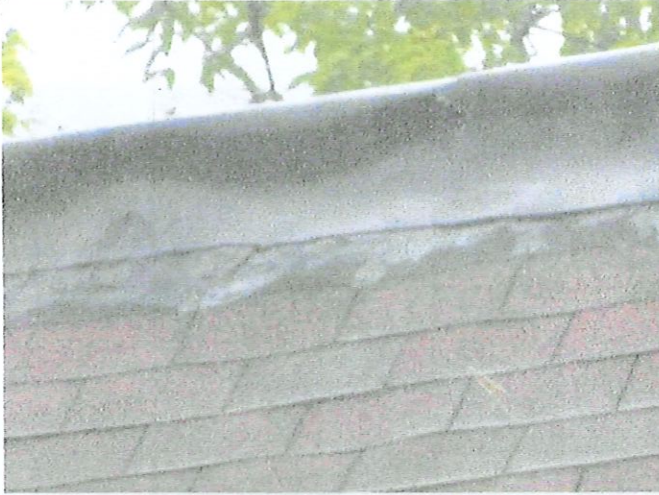
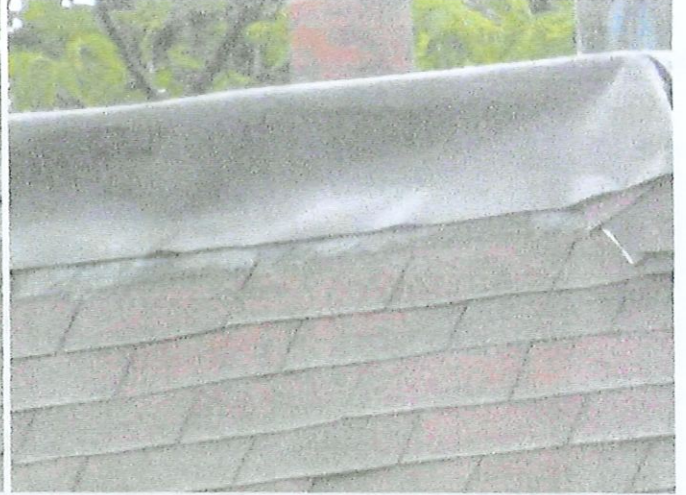
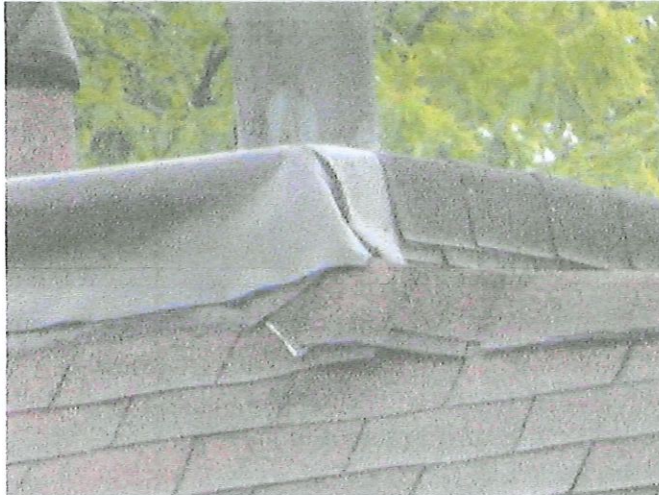
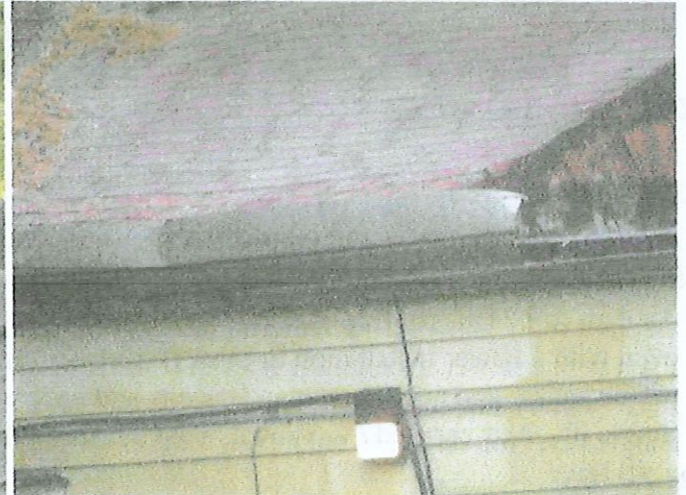
Visibility and Limitations: (4)(a) 1.

Height restricts inspection, Configuration restricts inspection. Lot configuration, Much of the roof was not visible at the time of inspection due to reasons noted. Observations and opinions

are  
limited  
to  
visible  
portions  
only.

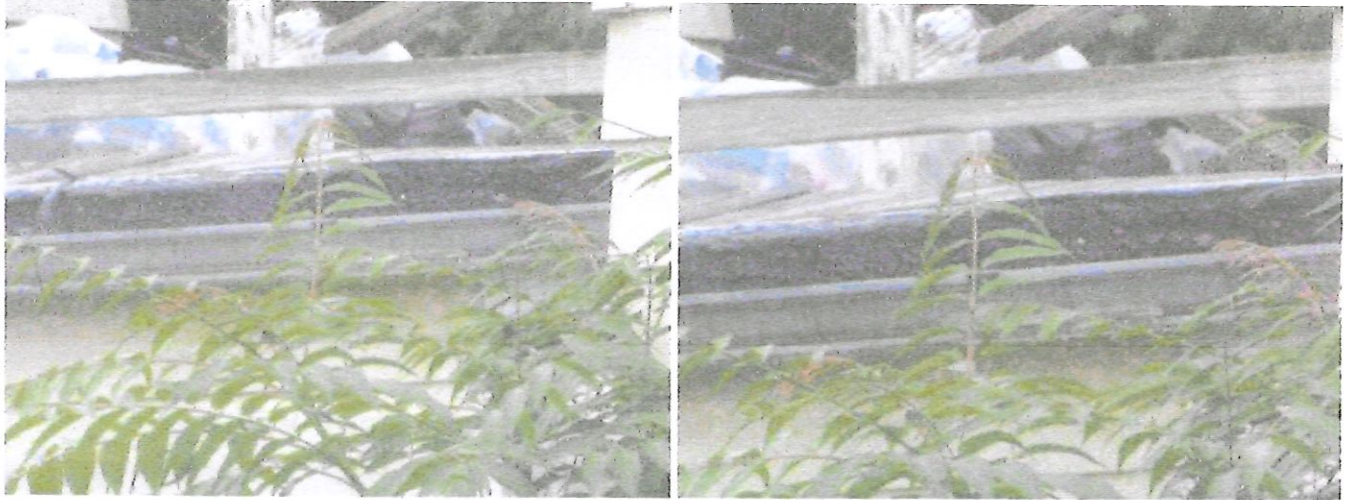
Roof Type: (4) (a) 1.

Flat roof.

Serious signs of aging. Unconventional installation, Curious repairs/installation, Flat roofs generally have a useful life span of approximately 20 years if they are well maintained each season.

Expect to re-roof soon. Correct roof deficiencies to prevent damage to structure and finishes. Consult roofing contractor now for recommendations regarding maintenance needs, longevity, usefulness, and preservation.

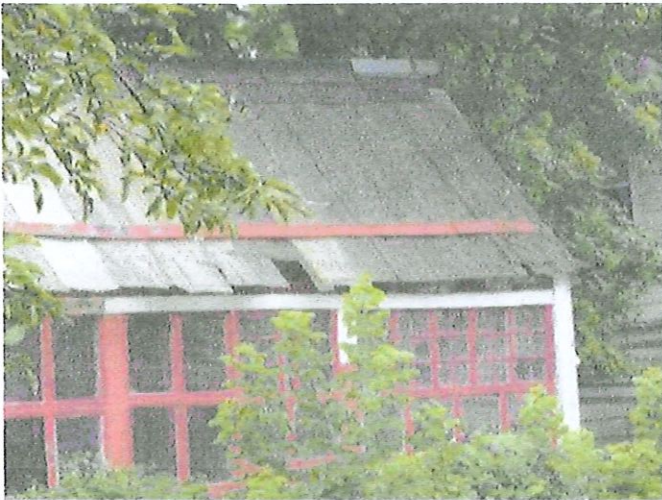
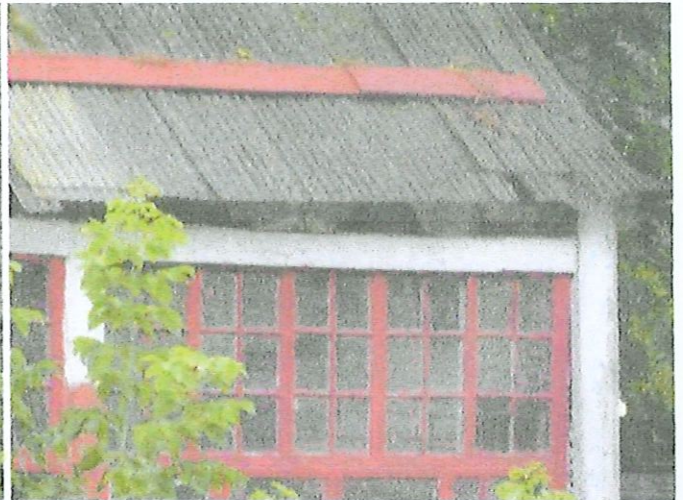
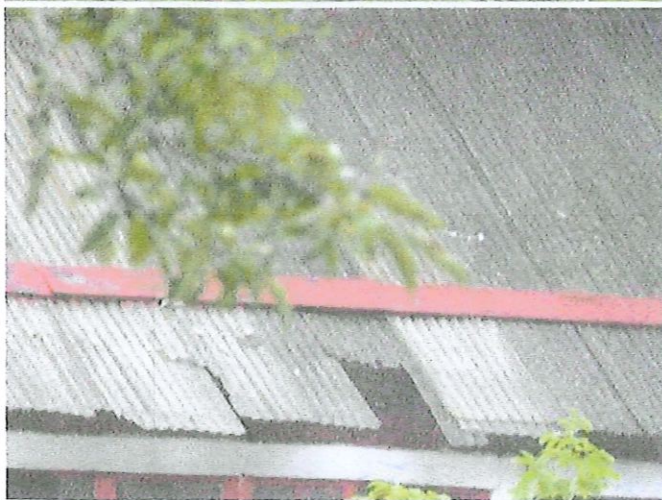
visibility and Limitations: (4) (a) 1.

Height restricts inspection, Steep slope, Configuration restricts inspection. Lot configuration, Most of the roof was not visible at the time of inspection due to reasons noted. Observations and opinions are limited to visible

e  
portio  
ns  
only.  
There  
is not  
enoug  
h  
infor  
matio  
n  
availa  
ble to  
form  
a  
comp  
lete  
or  
meani  
ngful  
opini  
on.  
Seek  
full  
evalu  
ation  
by a  
qualif  
ied  
roofin  
g  
speci  
alist  
in a  
timel  
y  
mann  
er.

Serious signs of wear/aging. Some general observations include: Cracking, More wear noted at some locations than others (possible ice chipping). See note 117 in Reference Addendum. Physical damage, See note 117 in Reference Addendum. Short shingle installation (not enough overlap of shingles). Nail popping, A patterns of nail popping is often related to attic venting and humidity issues. Bowed/sagging, Underlayment and decking structure are hidden from view and can not be evaluated by our visual Inspection; therefore, our observational review is not a guarantee or warranty against roof system leaks, seepage or structural condition, nor is a certification. Expect leaks. Low spots. Underlayment and decking structure are hidden from view and can not be evaluated by our visual Inspection; therefore, our observational review is not a guarantee or warranty against roof system leaks, seepage or structural condition, nor is a certification. Expect leaks. Lacks drip edge flashing, Lacks gable end flashing. Trim overhanging trees.

Suggest evaluation now by roof specialist. Re-roof as soon as possible. Correct any roof deficiencies in a timely manner to prevent damage to structure and finishes. Expect leaks. Ask the seller for any repair or installation documentation and warranty information. Often, warranties are an add on extended service that building owners may or may not sign up to receive. Verify presence and extent (materials only or materials and labor) of warranty by reading the repair/installation contract.

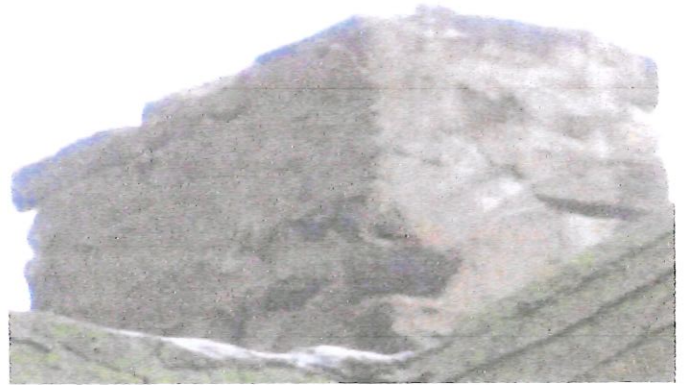
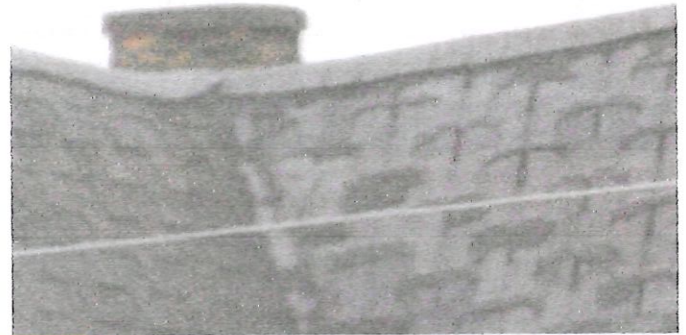
Visibility and Limitations: (4)(a) 4.

Stucco-like plaster covering present commonly holds water. It is a temporary short term patch that often covers structural deterioration and can lead to rapid further deterioration of the chimney structure. Seek further evaluation of chimney system. Painted. This restricts view of chimney condition. Ask seller for history and consider further evaluation of chimney system.

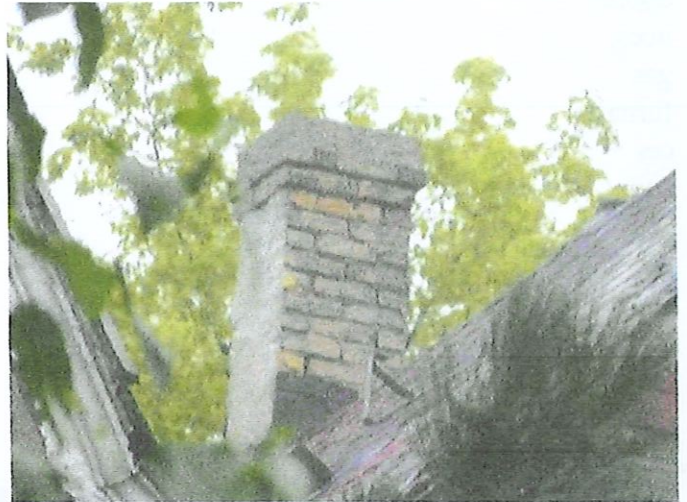
Chimney Cap: (4)(a) 4.

Top of chimney is not observed/evaluated. Major cracks, Wear/tar/patching/cracks noted at sides of chimney cap. Evaluate chimney system by a qualified contractor. Prior repairs noted. Older/worn, Missing/damaged brick/stone, Suggest renewing chimney cap. Consult a chimney or masonry restoration specialist.

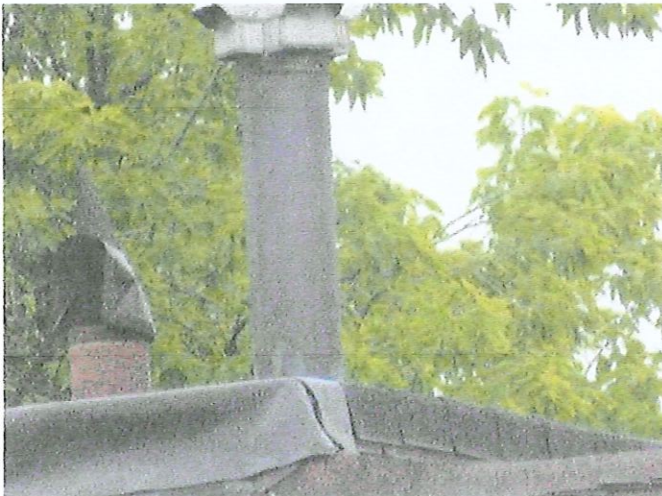
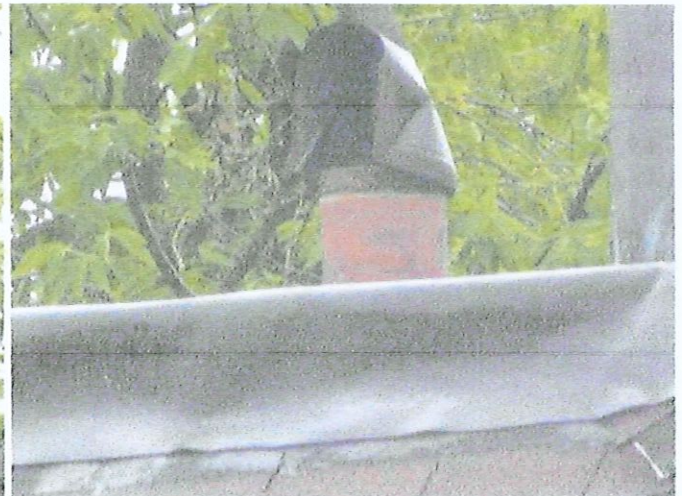
Flue Type:

Interior or not visible, No liner, as is typically required with modern use with spent fuel gasses

from  
applia  
nces,  
gas  
furna  
ces  
and  
gas  
hot  
water  
tank.  
Metal

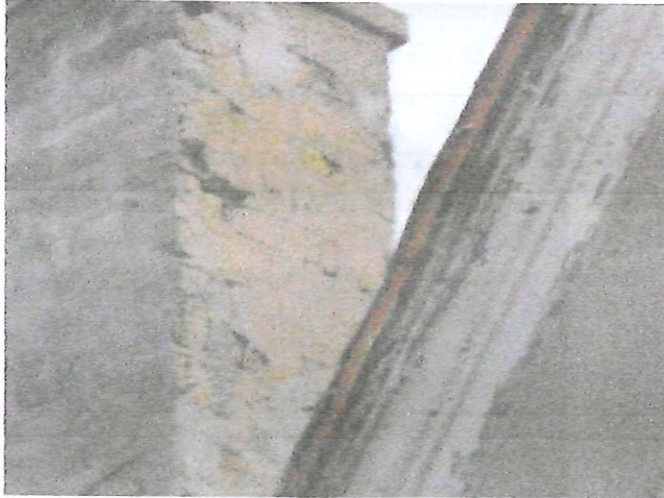
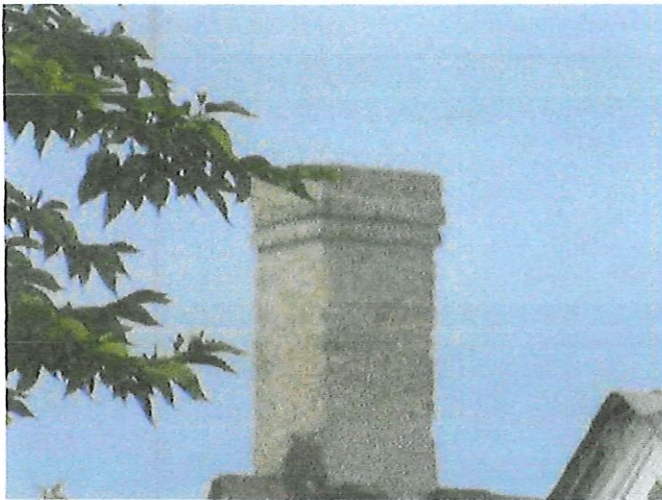
Flue: (4)(a) 4.

Interi  
or not  
inspe  
cted.  
No  
opini  
on  
offere  
d.  
Dama  
ge/cra  
cks/fl  
aking  
/shali  
ng  
noted  
at  
expos  
ed  
flue  
tile at  
top of  
chim  
ney.  
Flaki  
ng/sh  
aling/  
crack  
ed,  
Missi  
ng.

Older/worn, Unconventional/temporary repairs noted, Typical loose mortar, Typical brick spalling/shaling, Prior tuckpointing observed. Areas that were tuckpointed have re-cracked. Unconventional/temporary repairs, Caulking/mastic materials on masonry often means there has been water intrusion or other issues. Verify and repair as needed. Caulking/mastic is not a structural repair. Suggest separate inspection by chimney specialist now.
