Safeco Insurance Company of America

Claim Number: 465410366002
Insured Name: Joel Benway Katherine Benway
Date of Loss: July 15, 2017
Policy Number: OZ4593144
Underwriting Company: Safeco Insurance Company of America

Claim Number: 465410366002 **Policy Number:** OZ04593144 **Type of Loss:** Wind

Price List: WIMW8X_SEP17
Restoration/Service/Remodel
Estimate: JOEL BENWAY__
KATHERI

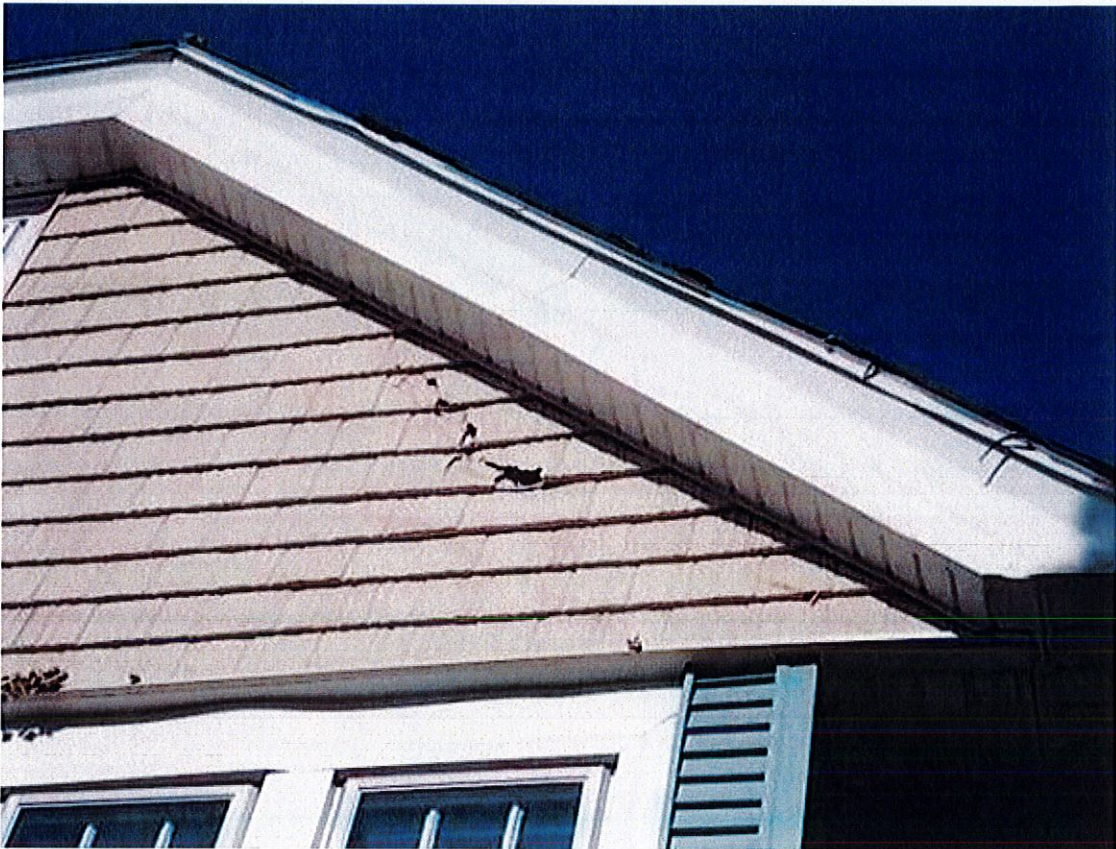
26-Front Elevation
Close up of metal shake siding

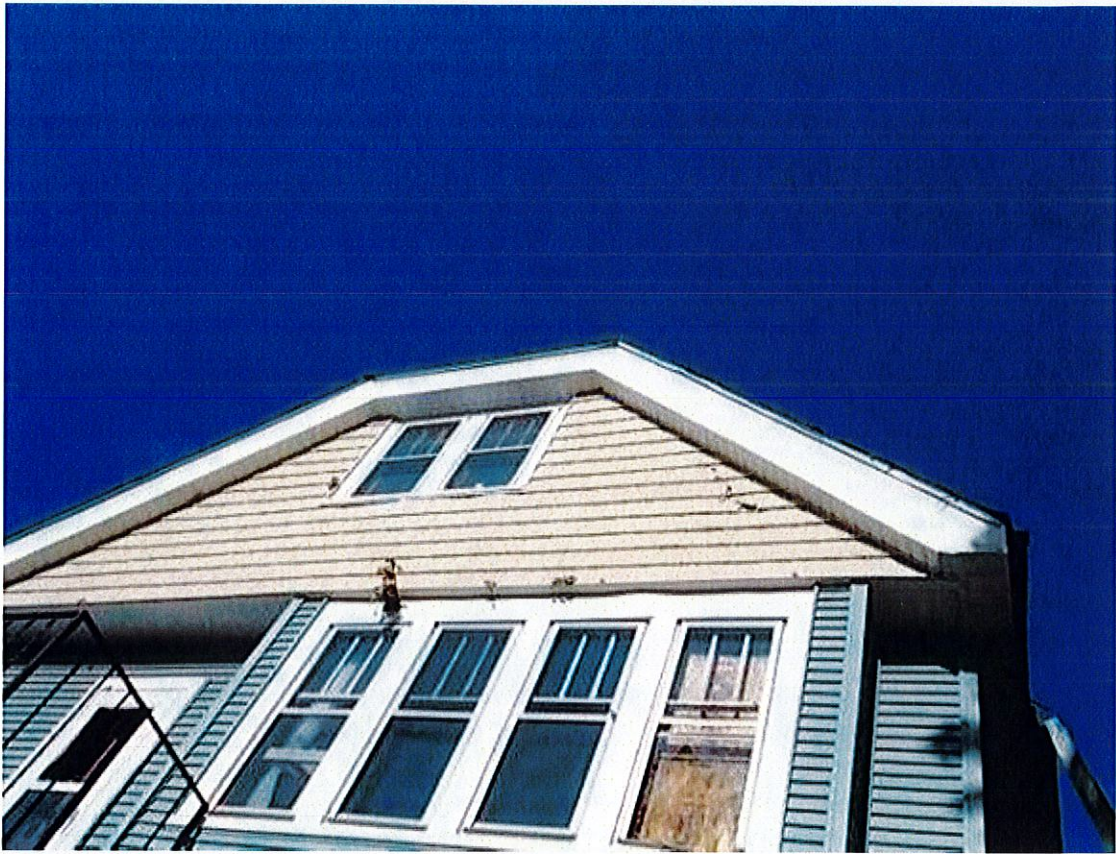
27-Front Elevation
Close up of metal shake siding
