# Collision Analysis & Reconstruction Report

**Incident Report Number: 131640069**  
**DOT Document Number: QQJG3V2**  
**Crash Date: Thursday, June 13, 2013, 11:47 a.m.**

**Location: 4975 N. Teutonia Ave.**  
**City of Milwaukee**  
**Milwaukee County, Wisconsin**

Officer Christopher Bruns  
Officer Richard Schnier  
Milwaukee Police Department  
Neighborhood Task Force  
Crash Reconstruction Unit

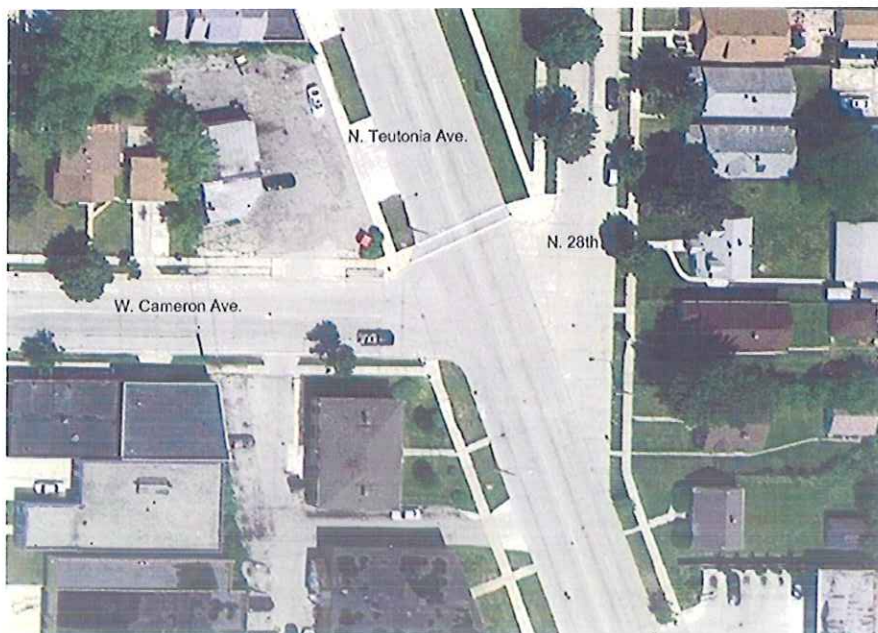
*Figure 2 – This photograph obtained from Google Maps illustrates the general design and setting of the crash scene. The photograph was not taken on the day of the crash and is not intended to depict the conditions at that time.*
