5. DESCRIPTION OF PROJECT:

611 North Broadway

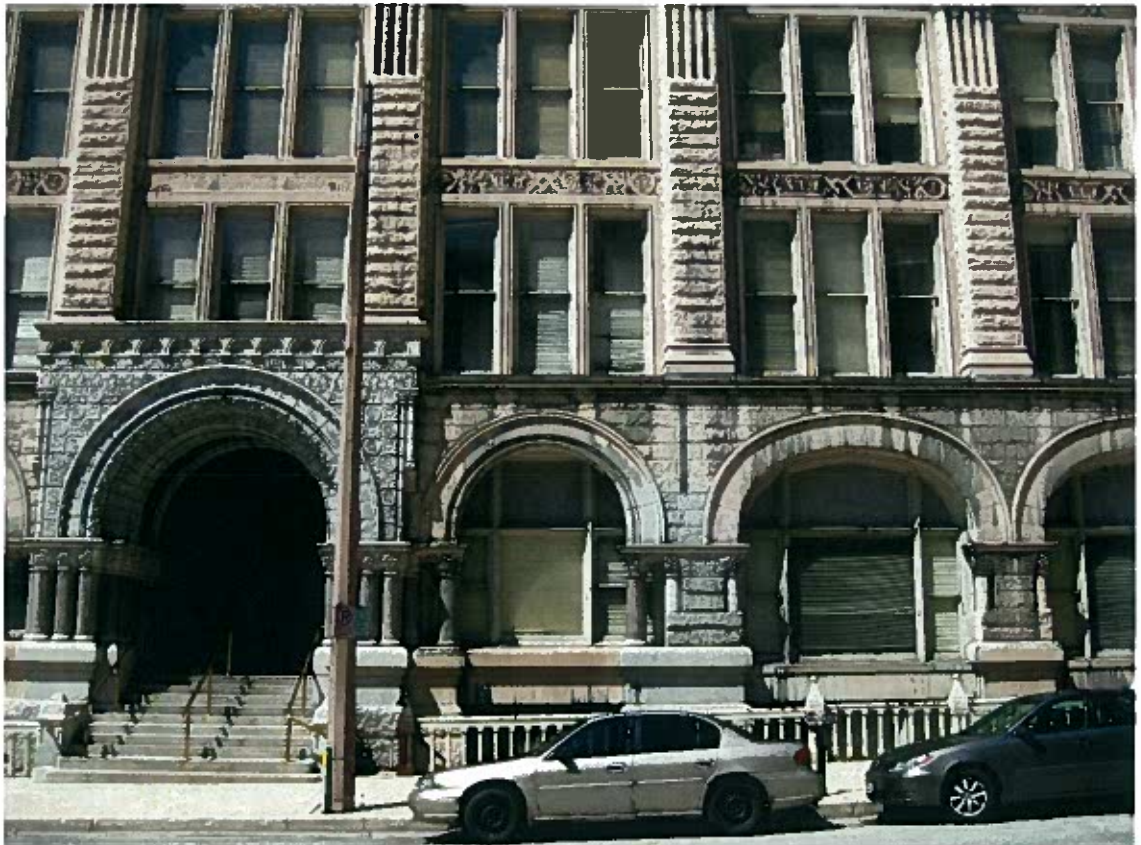
Photo 12: Broadway Façade entry detail

The primary and secondary entrances on Broadway and Michigan Street have been replaced with aluminum storefront, which is in satisfactory condition.

Existing aluminum storefront doors on the Broadway and Michigan facades will be removed and replaced with new medium stile aluminum doors. Flush hollow metal will be installed along the alley.
