# Facilities Condition Assessment Program

## Port of Milwaukee Analysis Update

August 2012

## BRADFORD AND COIL BUILDINGS

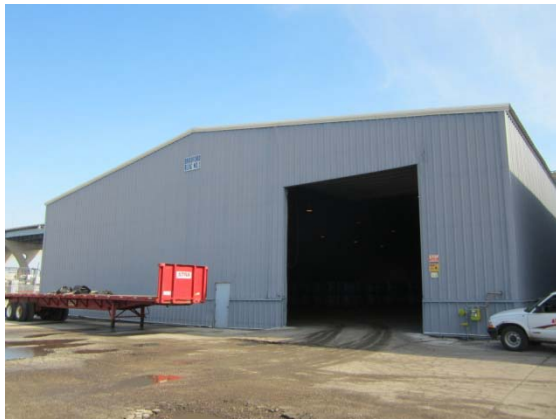
Bradford 1 includes three overhead garage doors. The inspection reveals that the east door contains damaged and rusted panels. The south door was closed and appeared in good condition, and its location adjacent to the Bradford 2 building indicates the likelihood of low use. The west door appears to be heavily used and in satisfactory condition, although the door frame was damaged presumably by vehicle and freight movement.

West overhead door with high use

The useful life of garage doors in this capacity is up to 15 years. Port of Milwaukee should plan for phased replacement of one garage door and operator every two years from 2016 through 2020, and again beginning by 2031.

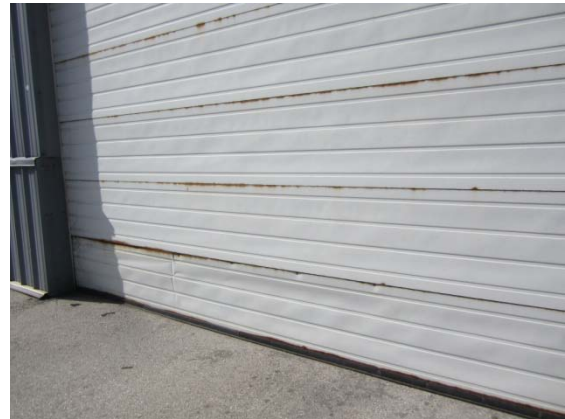
East overhead door with damage and rust

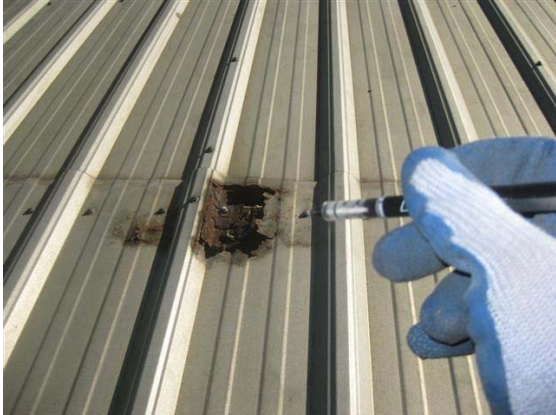
Bradford 1 includes a 160 square metal roof. The roofs are inspected and maintained by a third party. The last inspection occurred in 2012 where the roofs are indicated to be in fair condition. The inspection revealed the onset of rust at the roof edges and flashing. Additionally, the southwest corner was reported as damaged.

Rusted roof section – O+M repair

The useful life of metal roofs is up to 35 years. Its replacement is anticipated by 2030. Near term maintenance should be funded from the operating budget.

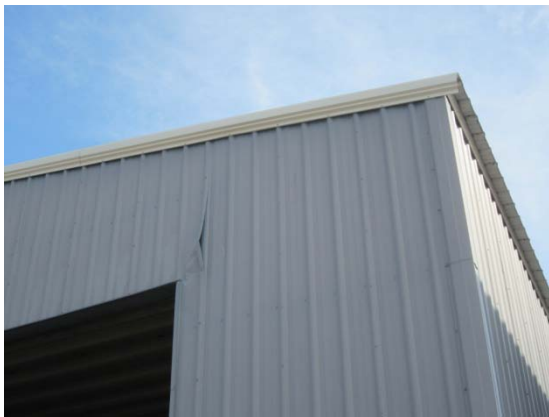
Bradford 1 contains 15,000 square feet of corrugated siding. The siding is at an age of 18 years. The inspection revealed isolated occurrences of damaged/bent siding mostly concentrated around overhead and service doors. The damage is consistent with the age and use of the facility. The useful life of exterior siding is up to 40 years. Port of Milwaukee should anticipate its replacement by 2032.

Damaged siding at west elevation

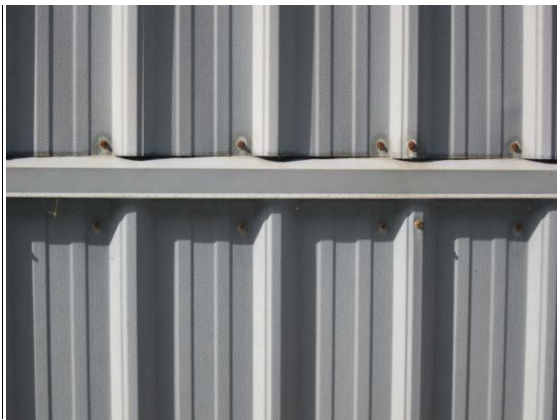
Rusted metal fasteners at siding

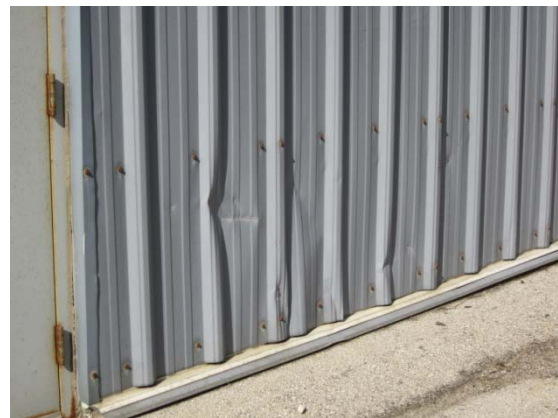
Damaged siding at east elevation

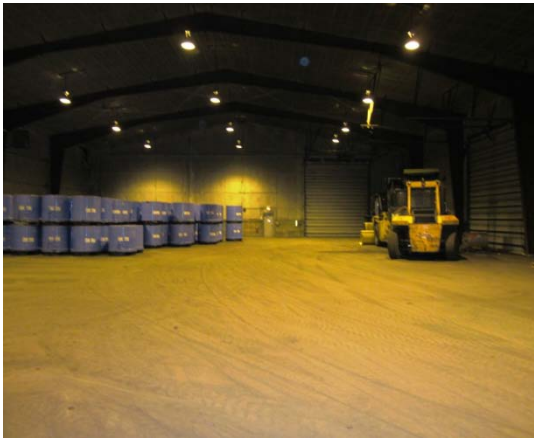
Bradford 1 interior includes 18 pendant light fixtures that are original to the building. Port of Milwaukee should replace the light fixtures by 2032.

Interior photograph – note light fixtures

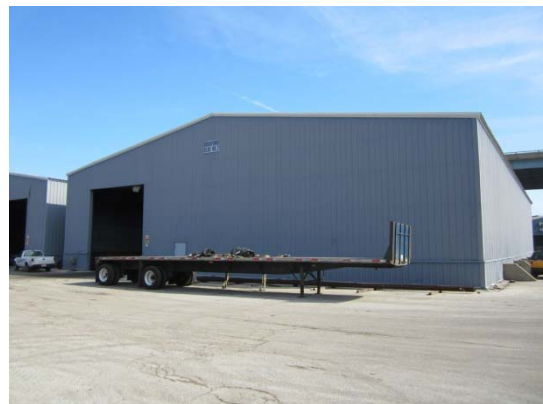
Bradford 2 includes three overhead garage doors. The north door was closed and appeared in good condition, and its location adjacent to the Bradford 1 building indicates the likelihood of low use. The west door appears to be heavily used and in satisfactory condition, although the lower door frame was damaged presumably by vehicle/freight movement.

West overhead door with high usage

The useful life of garage doors in this capacity is up to 15 years. Port of Milwaukee should plan for phased replacement of one garage door and operator every two years from 2016 through 2020, and again beginning by 2031.

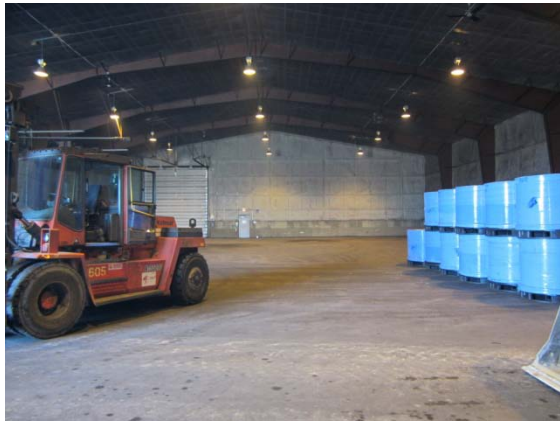
Bradford 2 interior includes 18 pendant light fixtures that are original to the building. Port of Milwaukee should replace the light fixtures by 2032.

Interior photograph – note light fixtures

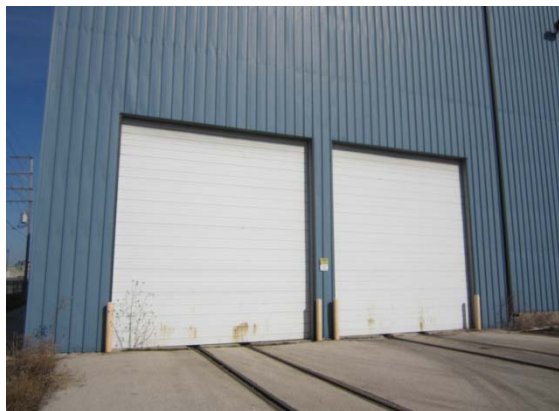
The Coil warehouse includes ten overhead garage doors. The inspection reveals that the two SW and NW doors contain rusted lower panels. The two east doors appear to be heavily used and in satisfactory condition, although the door frames were damaged presumably by vehicle and freight movement. The remaining south and north doors were closed and appeared in good condition. The useful life of garage doors in this capacity is up to 15 years. For budgetary purposes, Port of Milwaukee should plan for phased replacement of one garage door and operator every two years from 2016 through 2020, and again beginning by 2031.

SW overhead door rusted lower panels

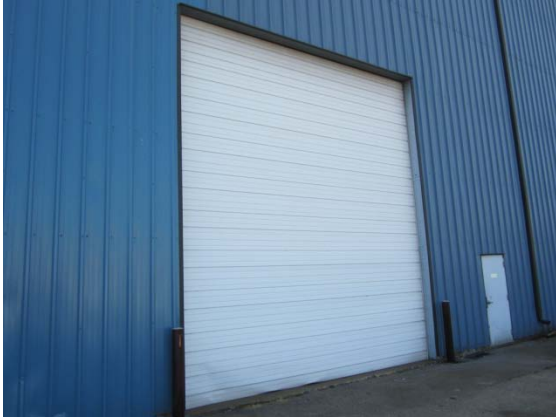
North overhead door with lower panel  
damage

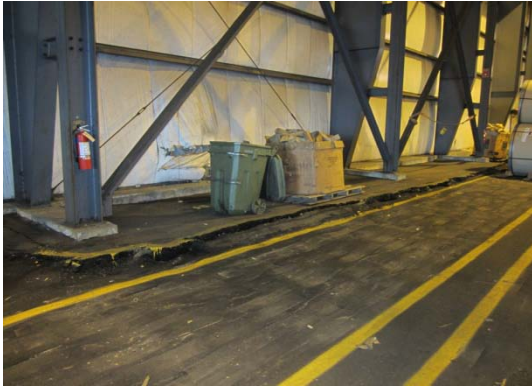
Sunken and rutted asphalt pavement

The useful life of interior asphalt pavement is up to 40 years. Port of Milwaukee should conduct interim repairs from the O+M budget as needed. Large replacements are considered capital expenditures. Therefore, the condition of the pavement should be monitored annually to prepare for capital repairs.

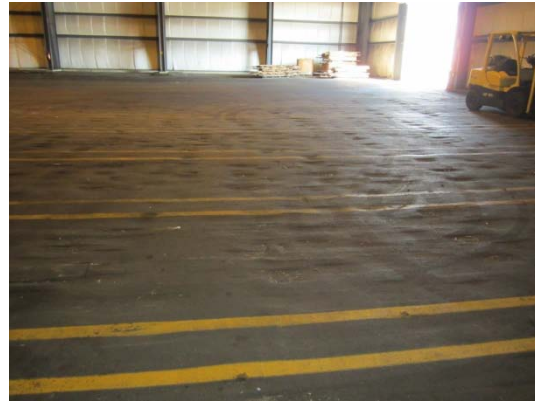
Asphalt pavement ruts and divots

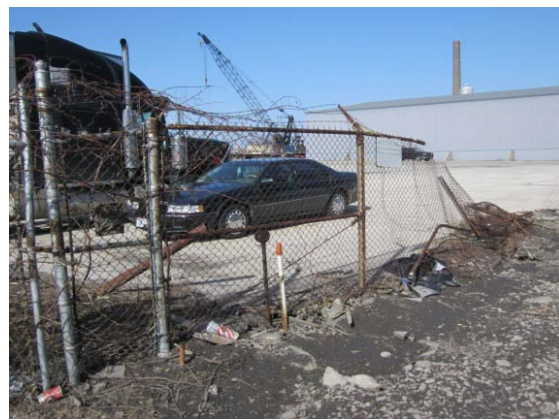
Bradford and Coil Buildings contains a 1,385 linear foot chain link fence encompassing the three buildings. The fence appears in satisfactory condition overall. However, a few isolated locations of damaged fence exist.

Failed fence at east

The useful life of a chain link fence is up to 35 years. Port of Milwaukee should anticipate its complete replacement by 2019 in conjunction with asphalt pavement replacement, and fund interim repairs from the operating budget.

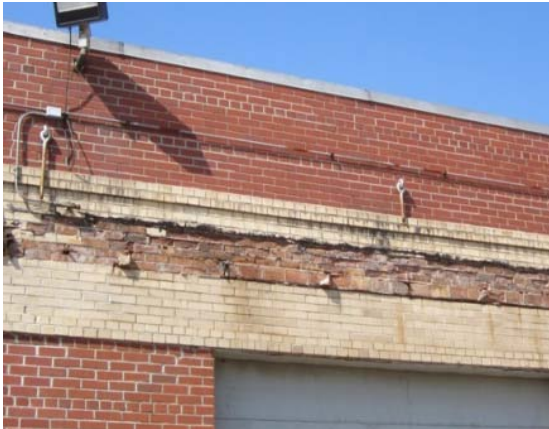
Unfinished masonry work at awning

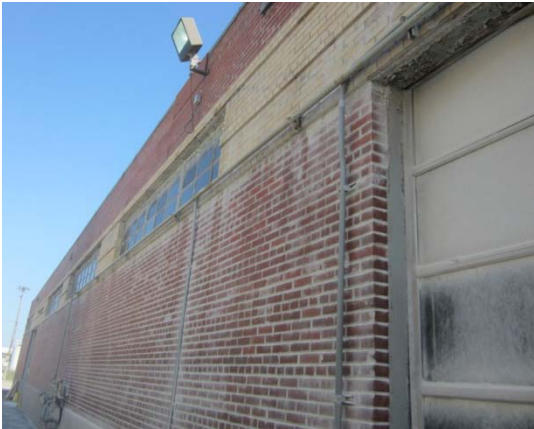
West elevation rusting lintels

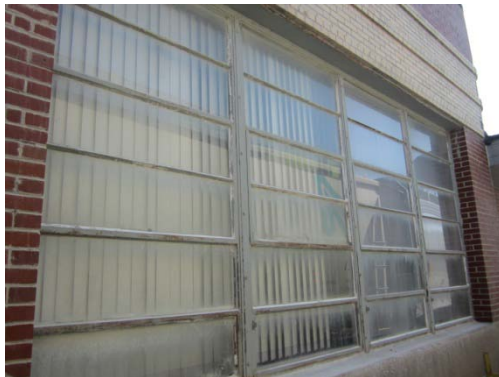
Milwaukee Bulk Terminal includes 1,375 square feet of windows. Typical useful life expectancy for windows is up to 35 years. The inspection revealed that the windows exhibited the onset of rust at frames. The window at the southwest corner experiences leaks. The windows likely vary in age with a majority either original to building construction or replaced decades ago. The Port of Milwaukee should anticipate window replacement by 20XX. Isolated window replacements should be conducted from the operating budget.

Window at southwest elevation with reported leaks

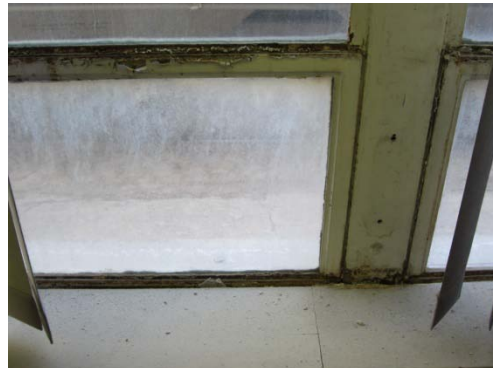
SW window rusted interior frame

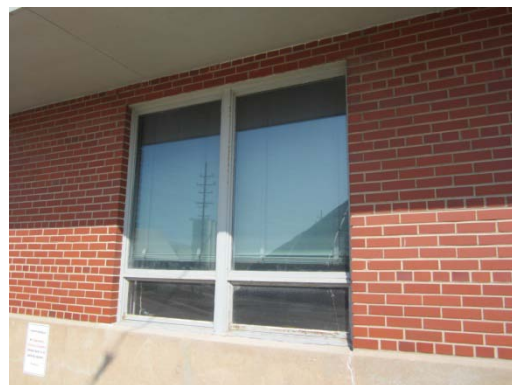
East elevation window possibly replaced

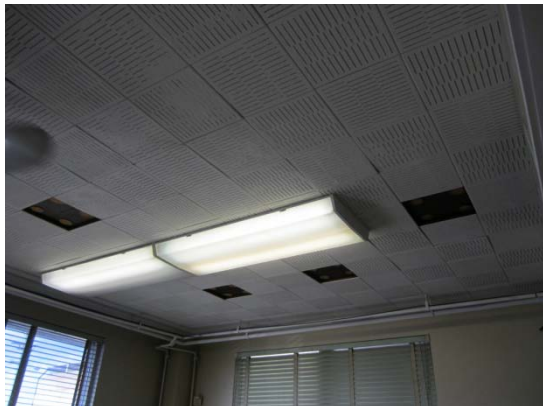
Milwaukee Bulk Terminal includes 50 fluorescent light fixtures and 4 wall mounted light fixtures throughout the office spaces. Useful life of light fixtures is up to 35 years. The Port of Milwaukee should anticipate their replacement by 20XX in conjunction with interior renovations.

Fluorescent light fixtures

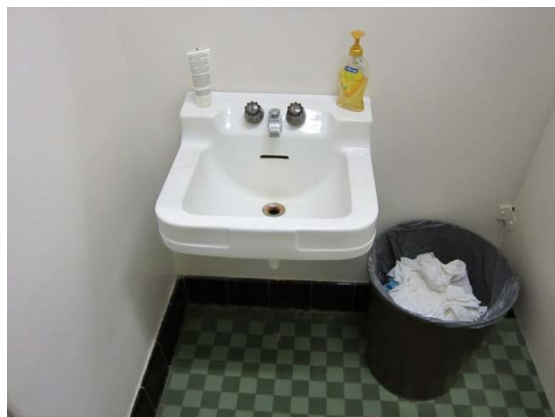
Ladies room tile floor/sink

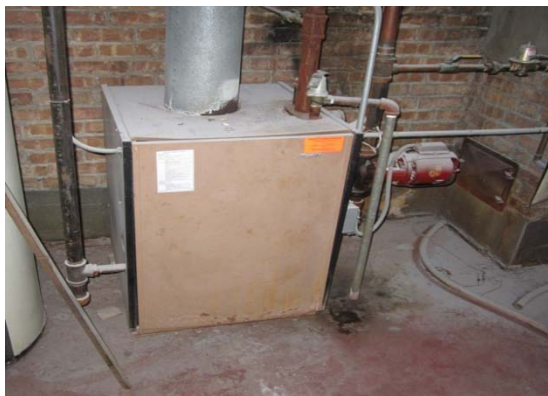
Milwaukee Bulk Terminal Warehouse includes one building heat boiler in the mechanical room with a capacity of 1,500 MBH. The boiler is 27 years of age. The useful life of boilers in this capacity is up to 30 years. The Port of Milwaukee anticipates its replacement by 2017.

Building heat boiler

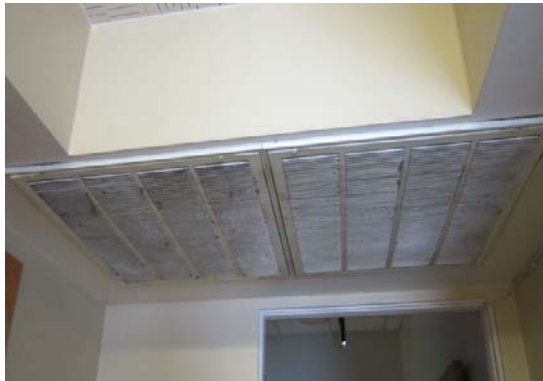
Unit-1 return air and evaporator

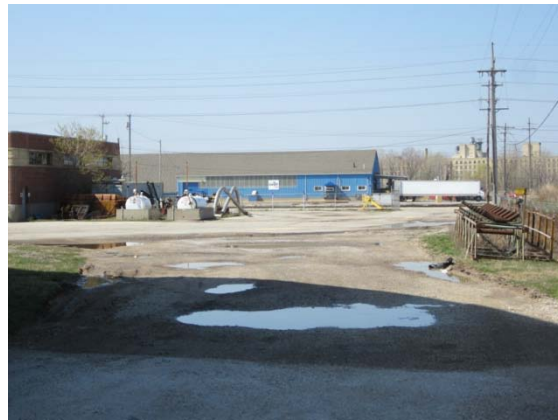
North cracking and potholes

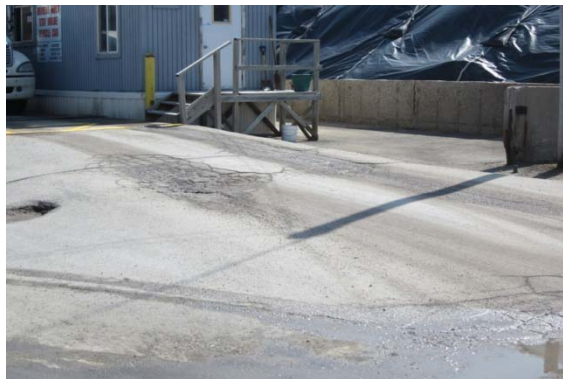
Longitudinal cracking near scale house

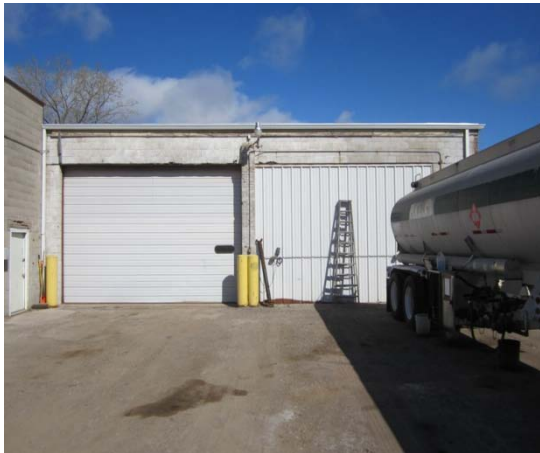
South elevation overhead garage door

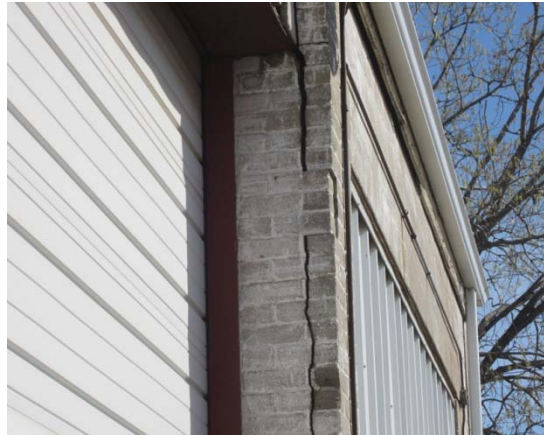
Cracked brick at south elevation

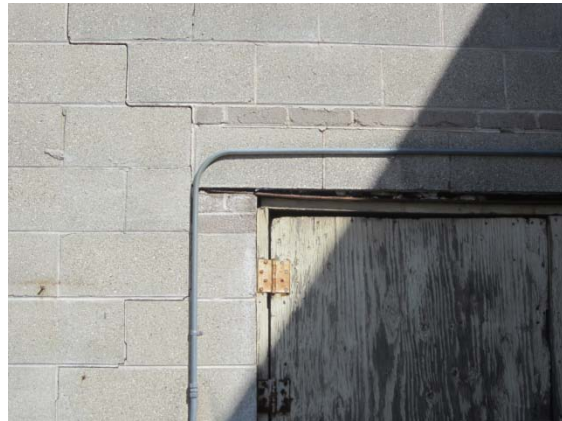
Step crack and lintel deflection

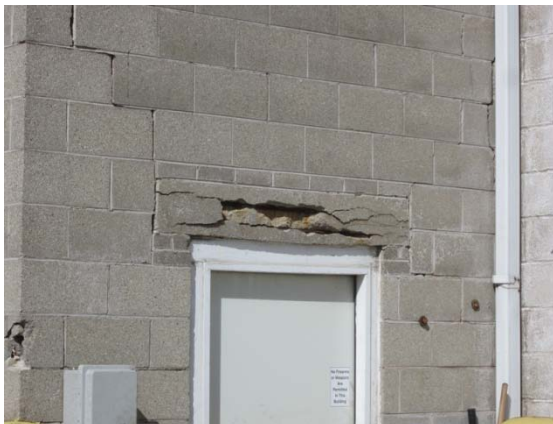
Deteriorated lintel at south elevation

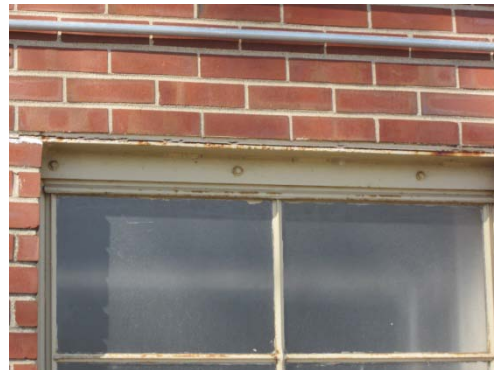
Onset of rust at window

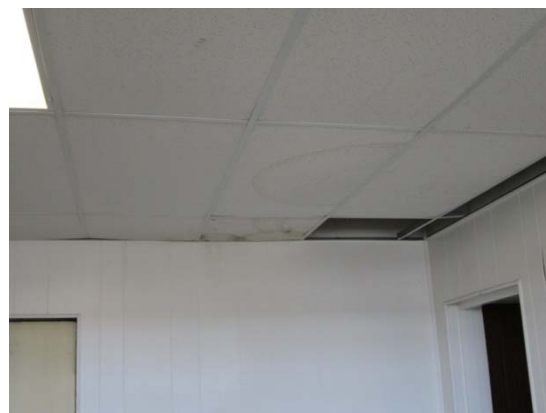
Stained and missing ceiling tiles

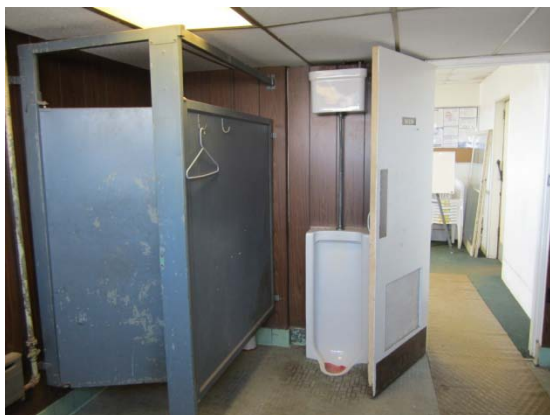
Rest room finishes

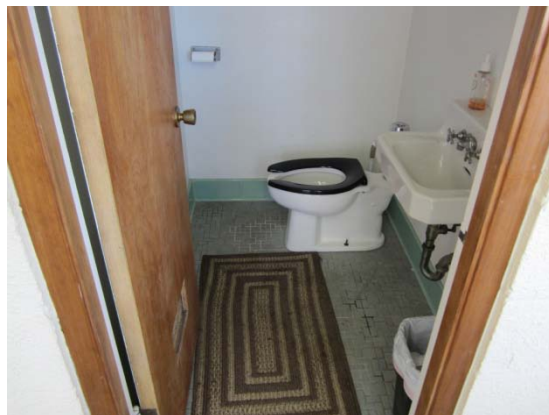
Rest room finishes

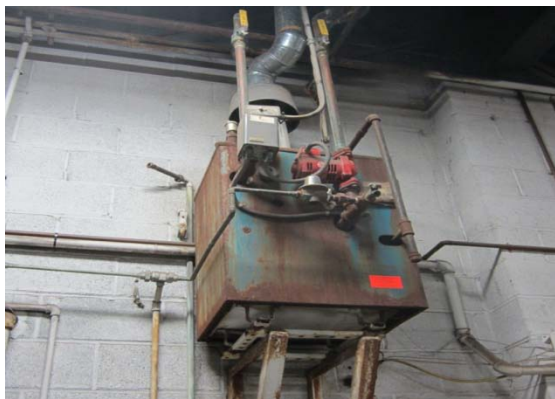
Forestry South HQ includes one building heat boiler in the mechanical room. The boiler is reported in poor operating condition at an unknown age. The useful life of boilers in this capacity is up to 30 years. The City of Milwaukee anticipates its replacement by 20XX.

Building heat boiler

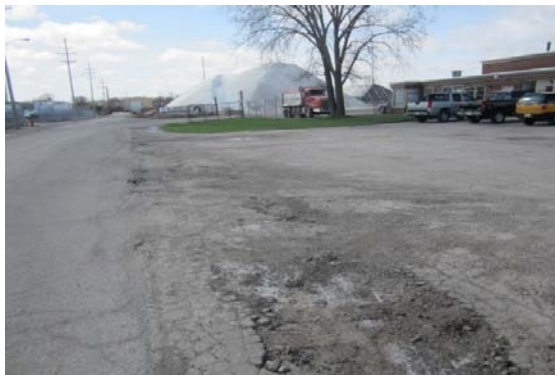
North American Salt Building property contains 625 square yards of asphalt pavement. The remaining lot is comprised of gravel. The inspection revealed the entrance area of asphalt pavement is uneven, crumbling and eroding. The overall condition of the pavement is fair. Port of Milwaukee should anticipate asphalt pavement replacement by 20XX.

Entrance Asphalt driveway overview

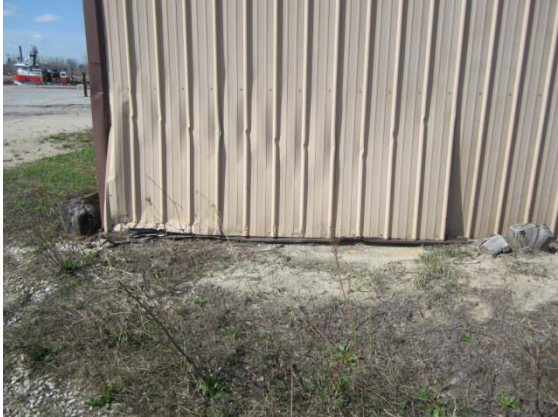
Sandblast Shed includes approximately 3,710 square feet of corrugated metal siding and 190 square feet of fiberglass siding. The siding is likely original to the facility. The inspection revealed isolated occurrences of damaged/bent siding. The useful life of exterior siding is up to 35 years. Port of Milwaukee should anticipate its replacement by 2018, unless the Sandblast Shed is removed prior to these capital repairs.

Damaged siding at east elevation

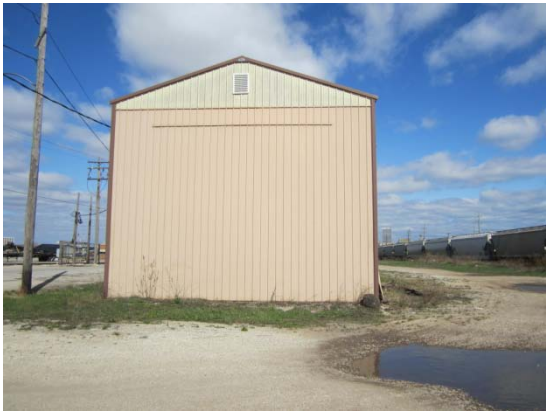
Rusted metal fasteners at siding

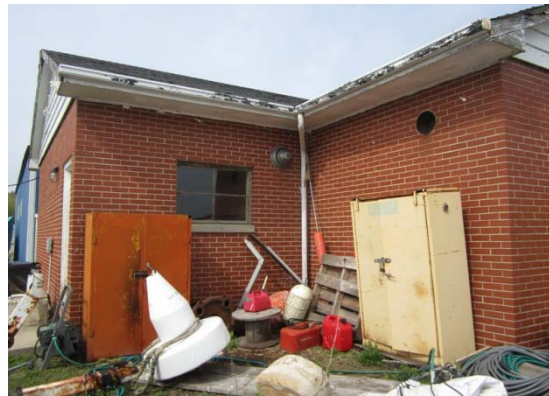
Gutters and downspout

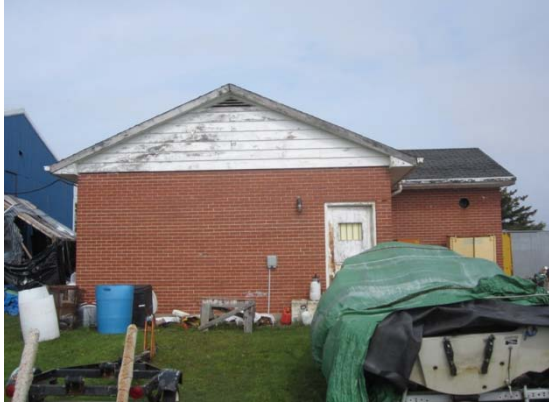
Brick from the east elevation

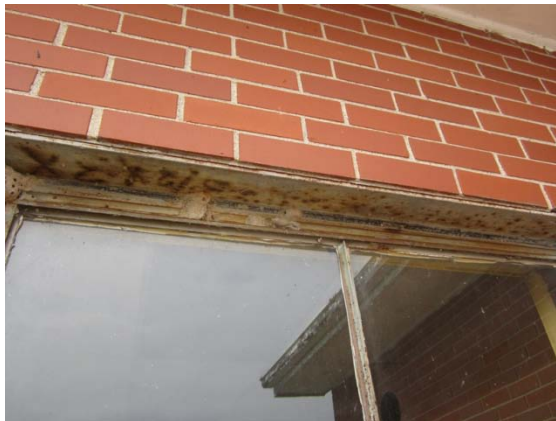
Rusted window lintel

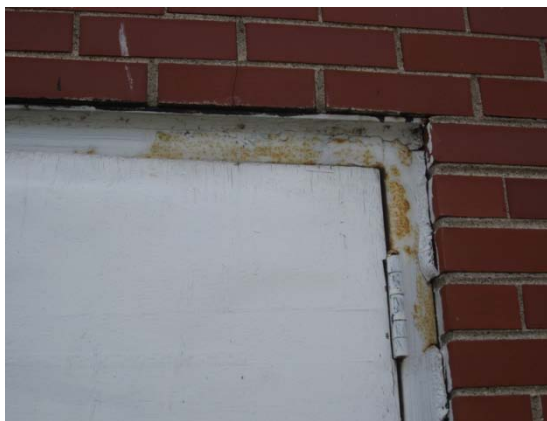
Displaced door frame caulking

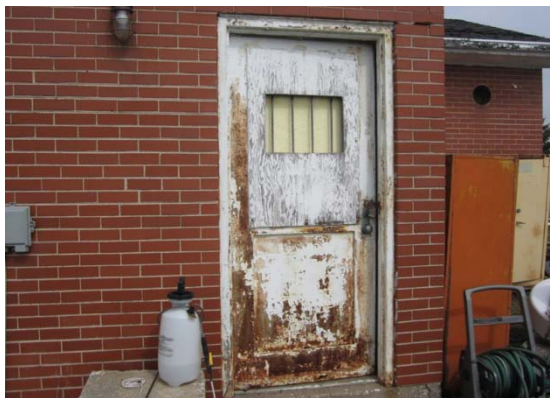
Sea Scout Building 1 includes a combination of metal and wood doors. The inspection reveals that all the doors are in very poor condition. The Port should anticipate phased replacement of 2 doors every seven years beginning by 2012.

Rusting metal door

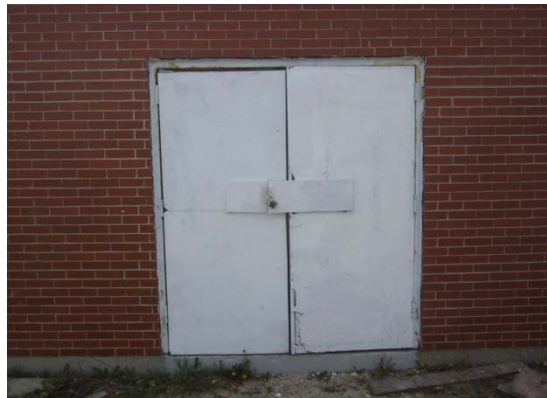
Damaged wooden doors

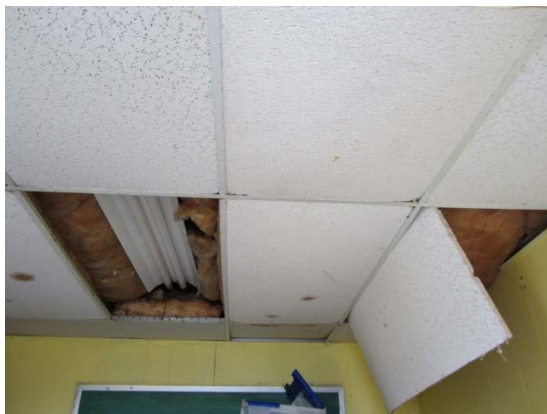
The inspection revealed that the interior spaces were in satisfactory condition. Several acoustic ceiling tiles exhibited water damage and soiled wall surfaces consistent with age were observed. The Port has no plans for renovations in the near future.

Acoustic ceiling tile missing

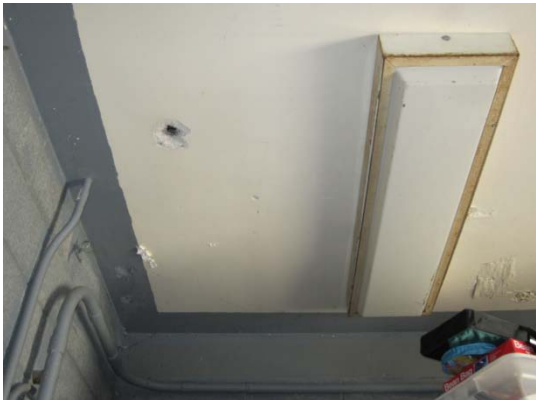
Hole in the ceiling and lighting fixture

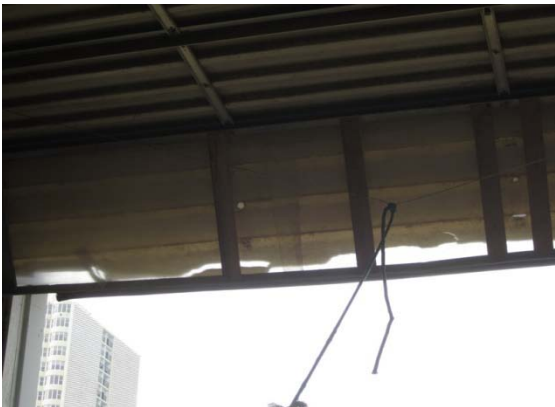
Sea Scout Building includes one fiberglass overhead garage door and one service door. The garage door was open and appeared in fair condition.

Overhead door with fiberglass damage

The useful life of garage doors in this capacity is up to 15 years. Port of Milwaukee should plan replacement of the garage door and service door by 20XX.

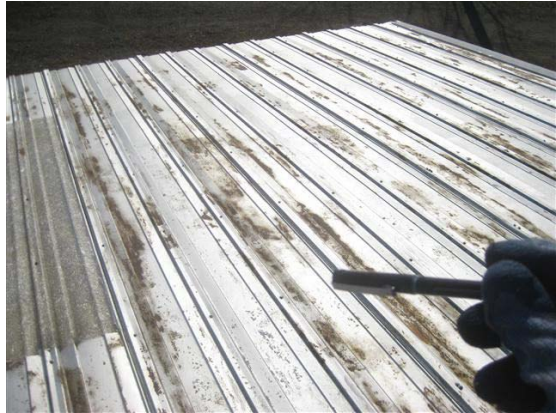
Sea Scout Building 2 includes a 1,725 square metal roof. The roofs are inspected and maintained by a third party. The last inspection occurred in 2012 where the roofs are indicated to be in poor condition. The inspection revealed the field of roofing is deteriorated and rusting 30 percent throughout. The useful life of metal roofs is up to 35 years. Its replacement is anticipated by 20XX.

Rusted roof section

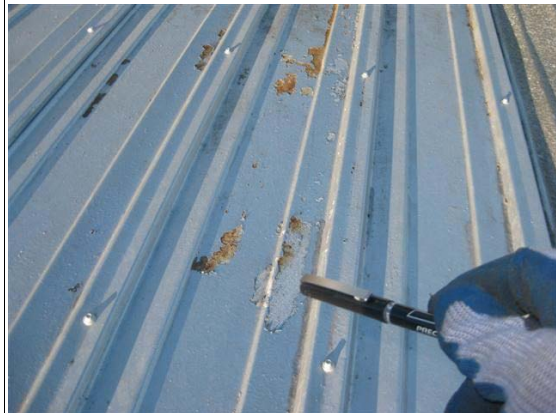
Damaged roof section

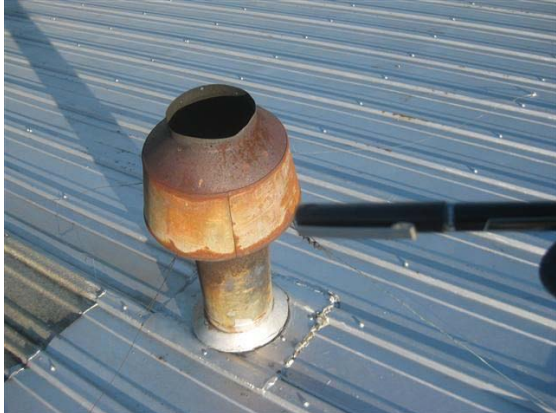
Rusted heater vent

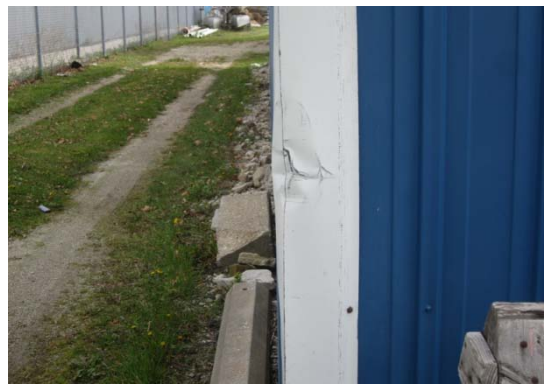
Sea Scout Building 2 contains 2,750 square feet of corrugated siding. The siding is at an unknown years. The inspection revealed isolated occurrences of damaged/bent siding mostly concentrated around overhead and service doors. The damage is consistent with the age and use of the facility. The useful life of exterior siding is up to 35 years. Port of Milwaukee should anticipate its replacement by 2032.

Damaged siding NW corner

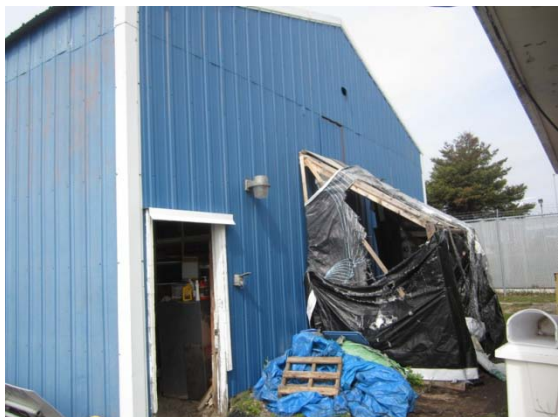
Rusted siding at SW elevation

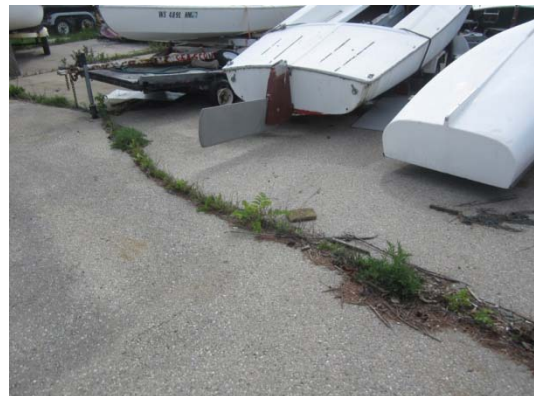
The Sea Scout Facility contains 817 SY of asphalt pavement at the entrance and boat storage lot. The inspection revealed isolated locations of asphalt transverse and longitudinal cracking. The overall condition of the pavement is in satisfactory condition.

Large cracking and grass growing

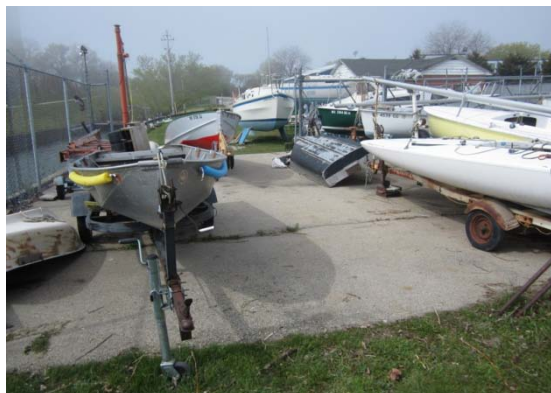
East elevation cracking asphalt pavement

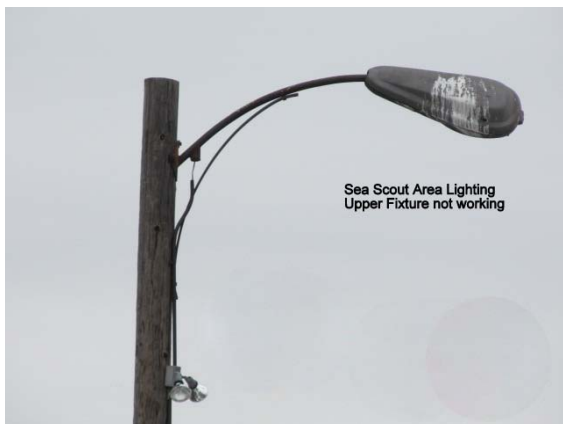
<b>Part / Equipment Name</b>	<b>Year Installed</b>	<b>Manufacturer Material</b>	<b>Capacity / Area / Size</b>	<b>Condition</b>
<b>Electrical - Secondary</b>				
Utility Service-WE Energies	1960	Transformer RTE	200Amp 120/208 4-wire	6
Utility Revenue Meter	1960	Erickson	200Amp/120/208/3ph 4-wire	6
3phase Disconnect 100Amp	1960	ITE	100 Amp breakers	5
Transition Box	1660	Square-D		5
Sea Scout Bldg. Service Disconnect	1960	Square-D	100Amp 120/208/3phase 4-wire	5
Transformer	1960		208/240-1ph Step up	4
<b>Electrical - Distribution</b>				
Distribution Panel MDP	1960	Unknown Possible ITE	100 Amp MLO 120/240 28 position	4
Entire Site requires a major electrical upgrade and replacement. Outside	1960	Various		4
Exterior and Interior Lighting needs to be redone.	1960	Various		4

Non-functional light fixture

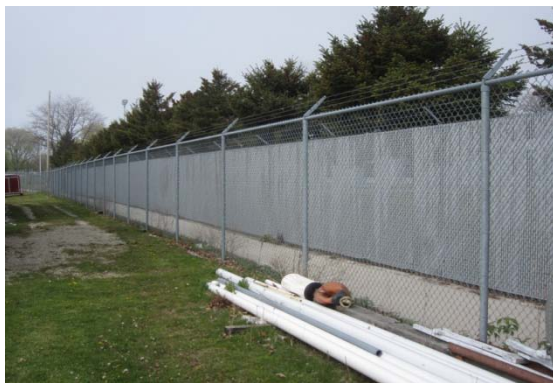
The fences appear in good condition in most all areas, but on the gates there in some rust accumulating. The useful life of a chain link fence is up to 35 years. Port of Milwaukee should anticipate its replacement by 20XX.

Rusted/Misaligned chain link fence

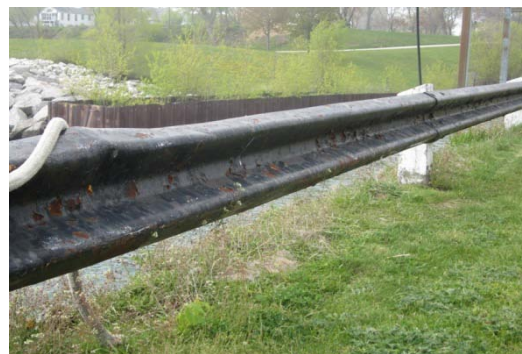
The Sea Scout Facility includes 190 linear feet of guard rail and 16 wood posts. The wood posts exhibit some form of deterioration with at least one that appears non-functional. The guard rail exhibits rust, and should be primed/painted as an operating expenditure or coordinated with another capital painting project. The useful life of guard rails is up to 35 years. Port of Milwaukee should anticipate its replacement by 20XX.

Guard rail rusting and dented

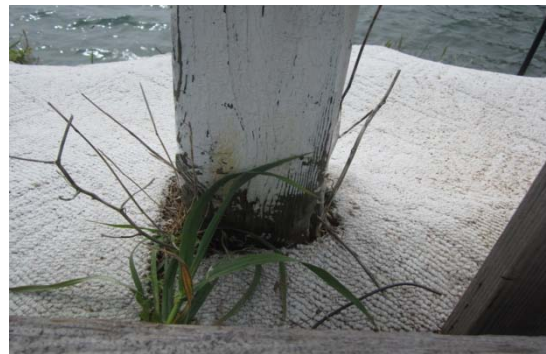
Paint finish deterioration at landscape line

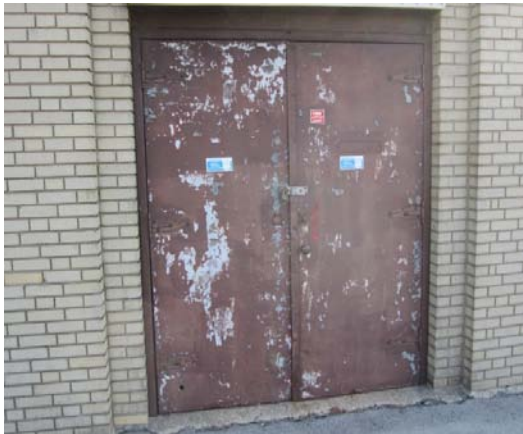
Seamen’s Club Building exterior includes six metal doors exterior doors. The inspection reveals that garage/utility room doors are in fair/poor condition. The remaining doors are in satisfactory condition. The useful life of doors is up to 35 years. Based on the condition the Port of Milwaukee should anticipate phased replacement/refurbishment of two metal doors by 20XX and again by 20XX.

West mechanical room doors

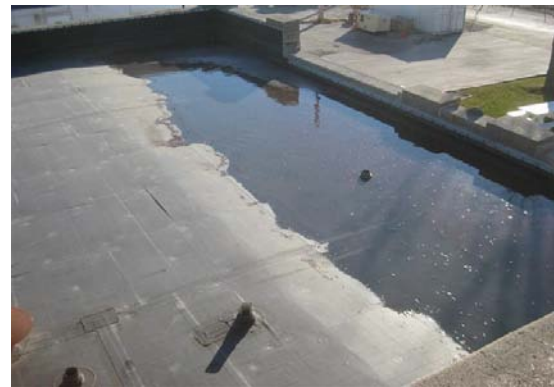
Ponding water R-1, drain stopped up

- 1) Roof Repairs

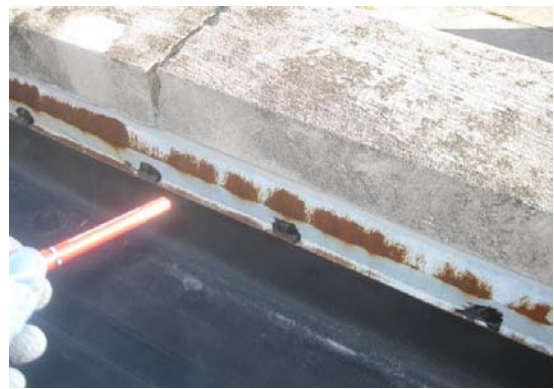
Counter flashing R-2 rusted

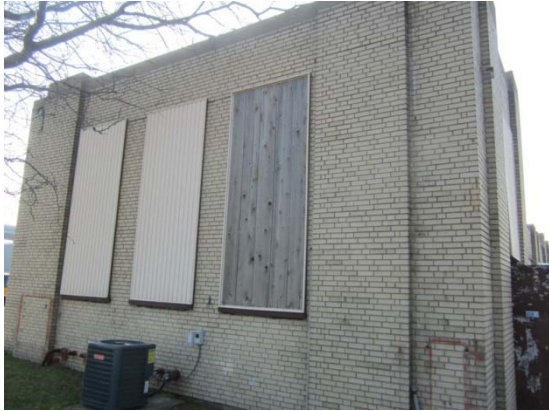
Boarded Brick windows north elevation

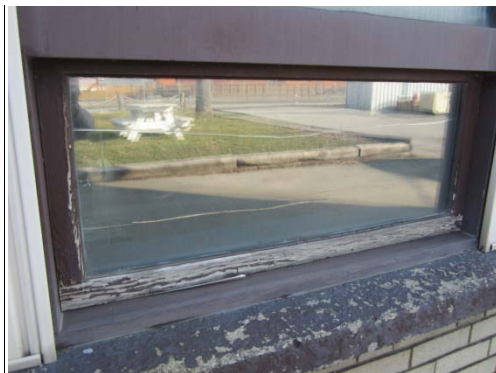
North American Salt Company includes 380 square feet of windows. Typical useful life expectancy for windows is up to 35 years. The inspection revealed that the west elevation windows appeared original to building construction and exhibited paint finish deterioration at the frames. The east elevation windows appeared to have been replaced, though the date/time of replacement is unknown. The north elevation windows are boarded and not included in the capital budget.

Paint finish deterioration at wood frame

Based on varied conditions, the Port of Milwaukee should anticipate phased window replacement beginning by 20XX.

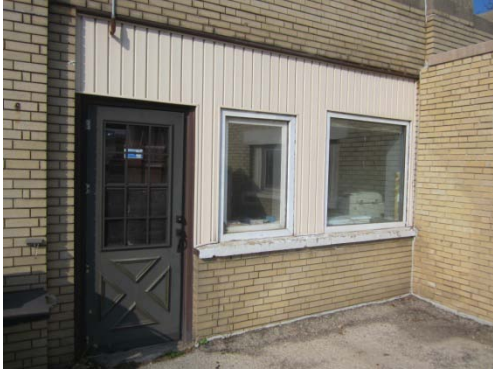
East elevation windows – replaced  
(not original)

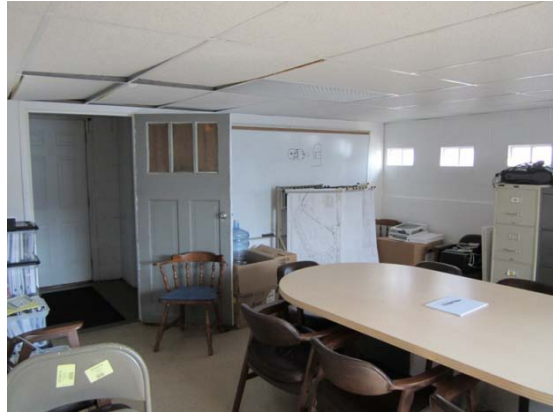
Acoustic ceiling tiles loose

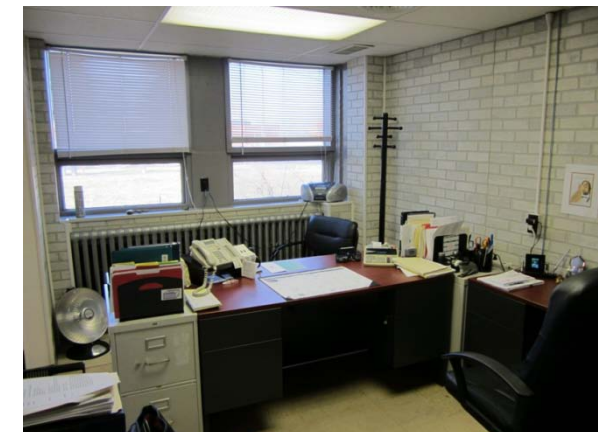
Office with abandon radiator

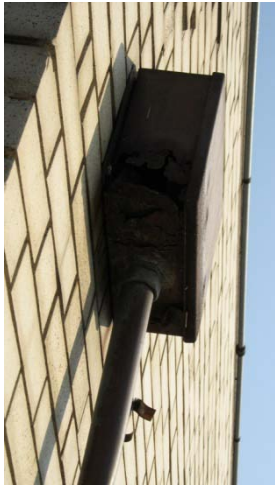
Weathered exterior conduit

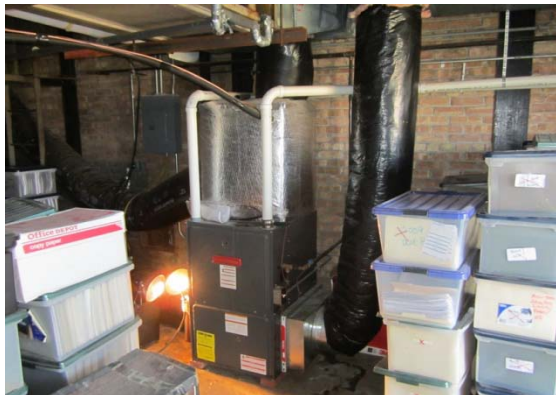
Interior forced air furnace

Seaman’s Club comprises one split system. The split system comprises of an internal forced air furnace and an external condensing unit. The useful life of split systems is up to 20 years. The Port of Milwaukee anticipates their replacement by 20XX. Interim partial replacements and repairs are funded by O + M.

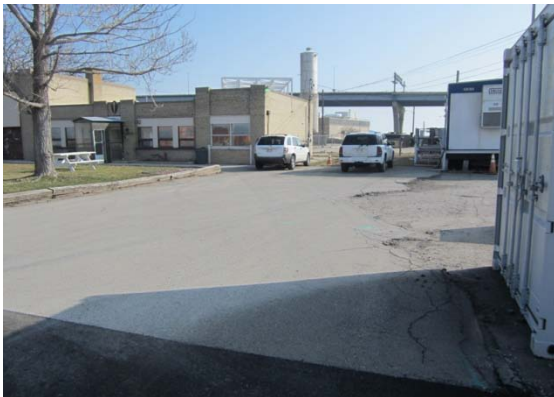
Entrance Asphalt driveway overview

Seamen’s Club property contains 750 square yards of asphalt pavement throughout the property. The inspection revealed that the southwest driveway pavement exhibited failed pavement, an adjacent overlay, transverse/longitudinal cracking. The walkway was in good condition. Additionally, the driveway apron was recently replaced and in good overall condition. Port of Milwaukee should anticipate phased asphalt pavement by 20XX and again by 20XX.

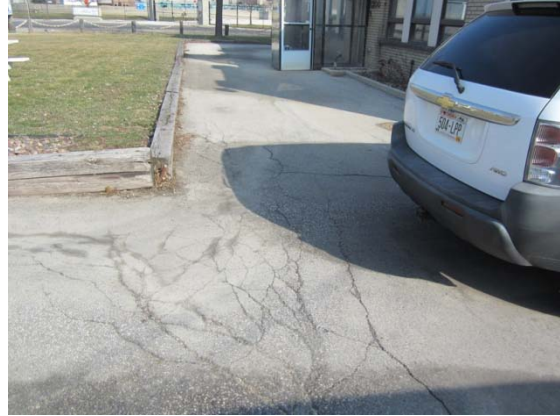
Front entrance asphalt cracking
