# Facilities Condition Assessment Program

## Port of Milwaukee Analysis Update

August 2012

## BRADFORD AND COIL BUILDINGS

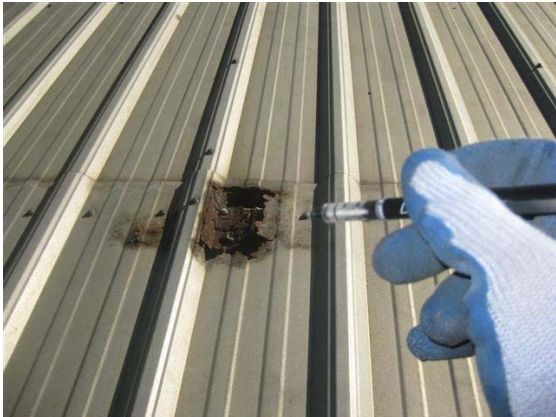
Bradford 1 includes a 160 square metal roof. The roofs are inspected and maintained by a third party. The last inspection occurred in 2012 where the roofs are indicated to be in fair condition. The inspection revealed the onset of rust at the roof edges and flashing. Additionally, the southwest corner was reported as damaged.

Rusted roof section – O+M repair

The useful life of metal roofs is up to 35 years. Its replacement is anticipated by 2030. Near term maintenance should be funded from the operating budget.

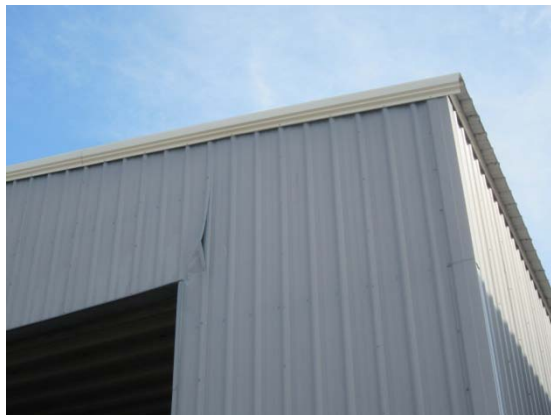
Bradford 1 contains 15,000 square feet of corrugated siding. The siding is at an age of 18 years. The inspection revealed isolated occurrences of damaged/bent siding mostly concentrated around overhead and service doors. The damage is consistent with the age and use of the facility. The useful life of exterior siding is up to 40 years. Port of Milwaukee should anticipate its replacement by 2032.

Damaged siding at west elevation

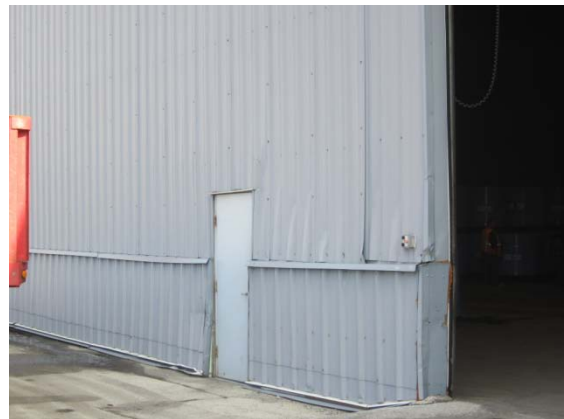
Damaged siding at doors at west elevation

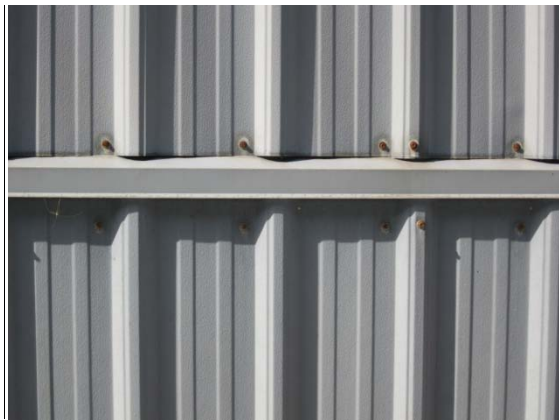
Rusted metal fasteners at siding

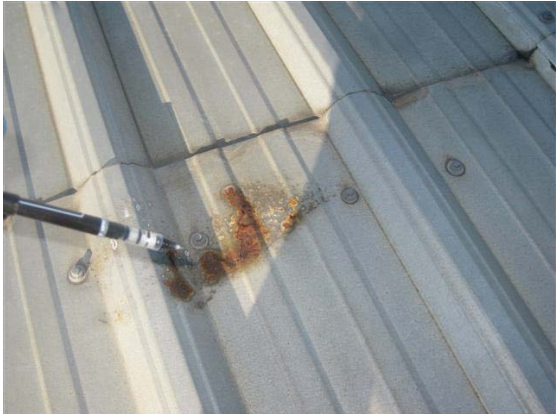
Bradford 2 includes a 160 square metal roof. The roofs are inspected and maintained by a third party. The last inspection occurred in 2012 where the roofs are indicated to be in fair condition. The inspection revealed the onset of rust at the roof edges and flashing. Additionally, the northeast corner was reported as damaged.

Rusted roof section – O+M repair

The useful life of metal roofs is up to 35 years. Its replacement is anticipated by 2030.

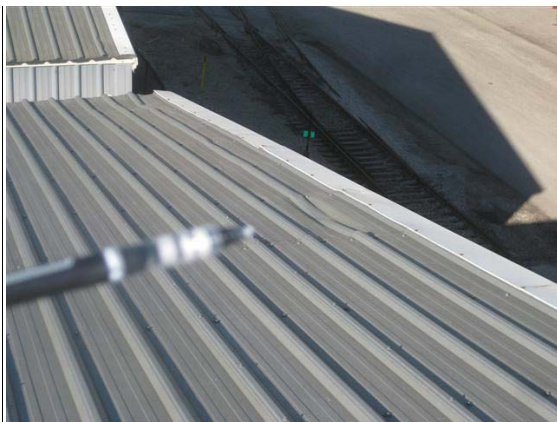
Damaged roof section

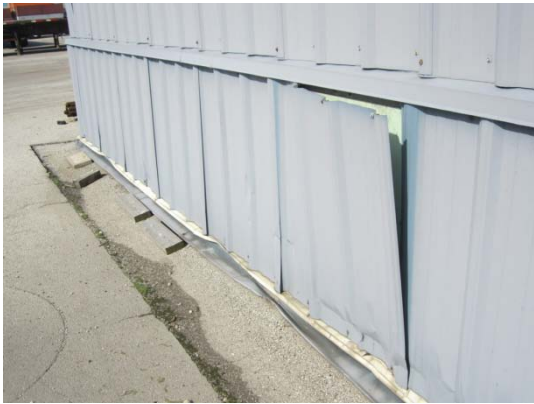
Bradford 2 contains 15,000 square feet of corrugated siding. The siding is at an age of 18 years. The inspection revealed isolated occurrences of damaged/bent siding mostly concentrated around overhead and service doors. The damage is consistent with the age and use of the facility. The useful life of exterior siding is up to 35 years. Port of Milwaukee should anticipate its replacement by 2032.

Damaged siding at south elevation

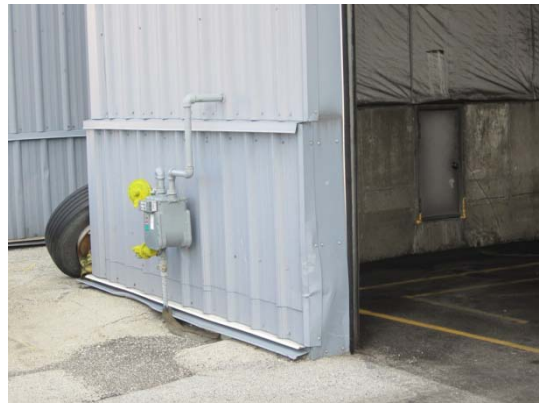
Damaged siding at doors at west elevation

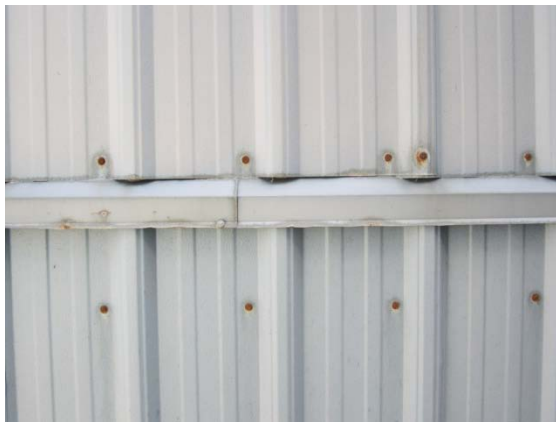
Rusted metal fasteners at siding

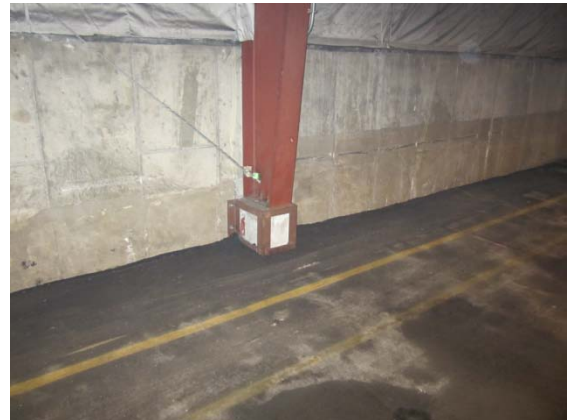
Pavement overlay at building perimeter

The useful life of interior asphalt pavement is up to 40 years. Port of Milwaukee should conduct interim repairs from the O+M budget as needed. Large replacements are considered capital expenditures. Therefore, the condition of the pavement should be monitored annually to prepare for capital repairs.

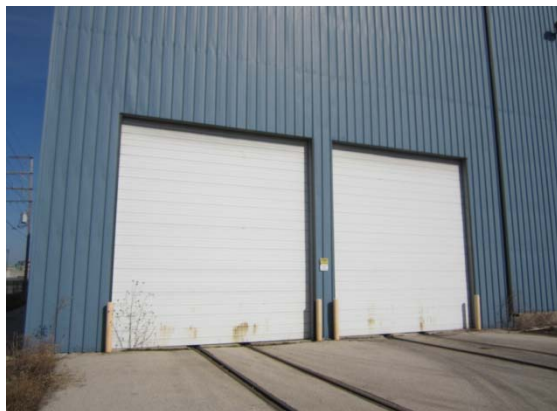
The Coil warehouse includes ten overhead garage doors. The inspection reveals that the two SW and NW doors contain rusted lower panels. The two east doors appear to be heavily used and in satisfactory condition, although the door frames were damaged presumably by vehicle and freight movement. The remaining south and north doors were closed and appeared in good condition. The useful life of garage doors in this capacity is up to 15 years. For budgetary purposes, Port of Milwaukee should plan for phased replacement of one garage door and operator every two years from 2016 through 2020, and again beginning by 2031.

SW overhead door rusted lower panels

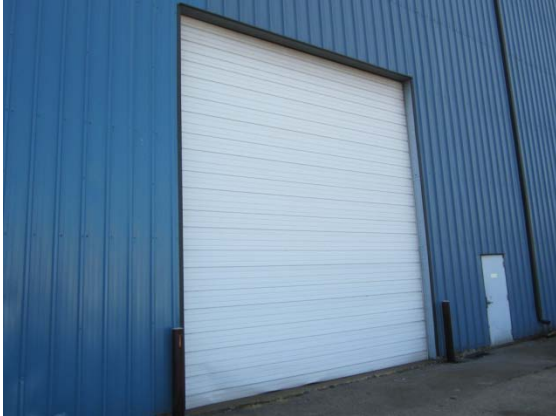
North overhead door with lower panel  
damage

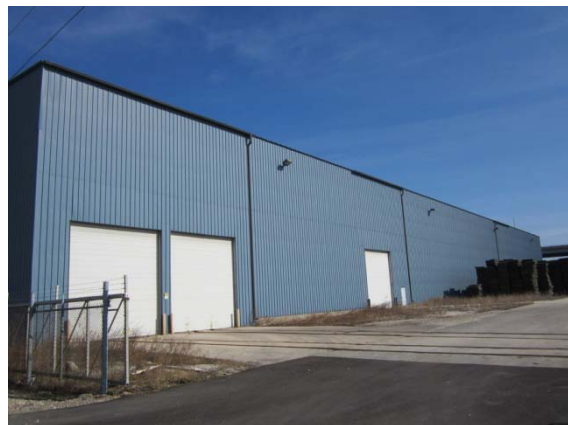
The Coil Warehouse includes 300 linear feet of gutters and 300 linear feet of downspouts. The useful life of gutters and downspouts is 35 years. Replacement of gutters and downspouts should be conducted with the metal roof replacement by 2029.

South building gutters & downspouts

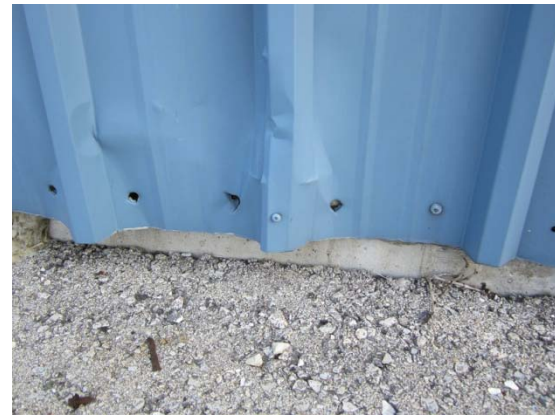
Missing fasteners west elevation

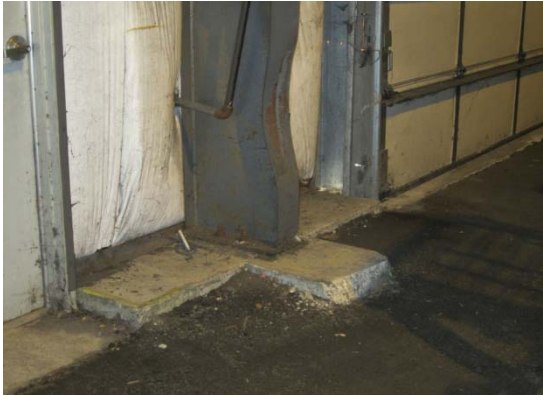
Pavement overlay at building perimeter

The useful life of interior asphalt pavement is up to 40 years. Port of Milwaukee should conduct interim repairs from the O+M budget as needed. Large replacements are considered capital expenditures. Therefore, the condition of the pavement should be monitored annually to prepare for capital repairs.

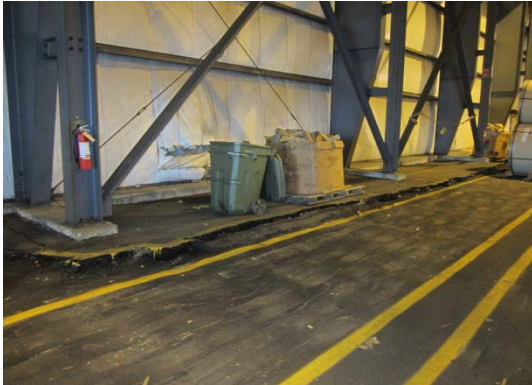
Sunken and rutted asphalt pavement

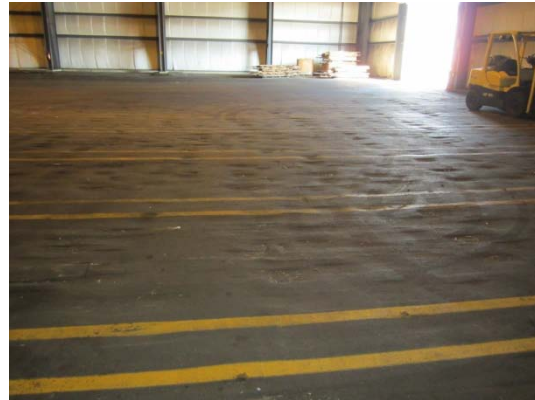
Asphalt pavement ruts and divots

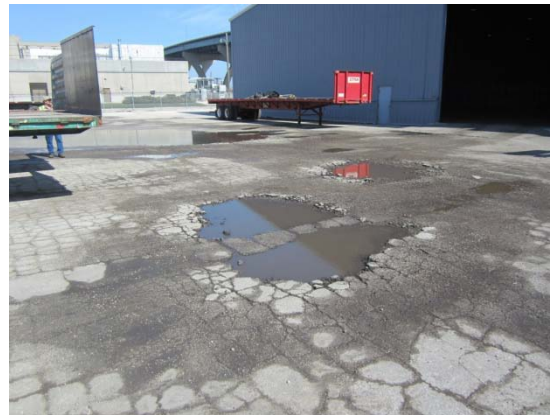
Bradford and Coil Buildings contains 25,800 SY of asphalt pavement surrounding the three buildings. The pavement is in satisfactory condition. The inspection revealed locations of failed pavement in the form of alligator cracking and transverse cracking throughout the property. In the main lot, pothole erosion, large water pooling, and alligator cracking were observed. Near the north and west entrance, a high concentration of failed pavement was observed.

Large cracking and water pooling at the southwest entrance

The overall condition of the pavement is in satisfactory condition. Phased asphalt pavement replacement is of up to 8,600 square yards is anticipated every five years beginning by 2014. Asphalt pavement maintenance, including crack filling and partial replacements, at the remaining pavement should be conducted in conjunction with pavement replacement.

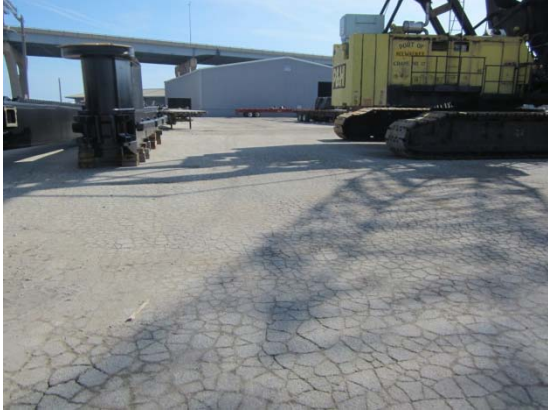
Severe cracking asphalt pavement

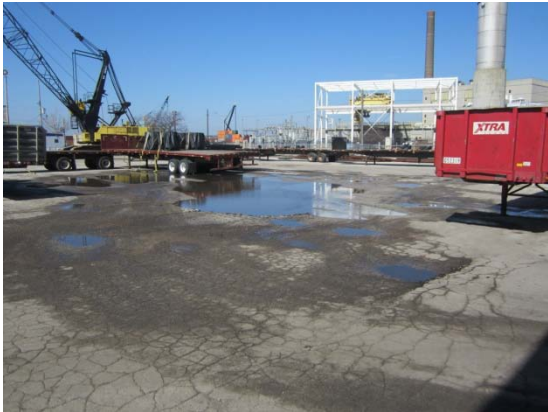
Water pooling & failed pavement

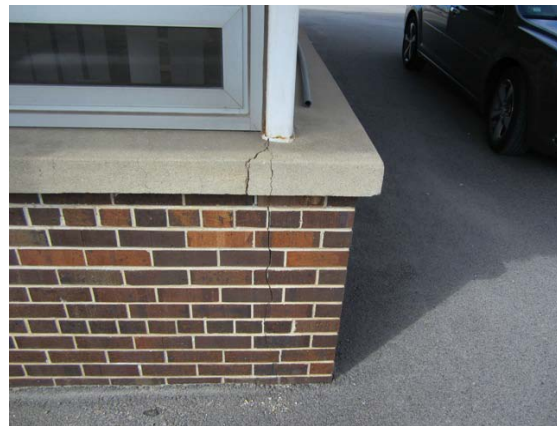
IMC Salt Office Building exterior comprises 1,090 square feet of brick masonry and 515 square feet of painted concrete masonry unit (CMU). The brick and CMU masonry is in good overall condition. Visual onsite inspection of the brick masonry and CMU identified few locations of isolated cracks. Additionally, the inspection revealed cohesion/adhesion caulk failure along the soffit, window and door frames. For budgetary purposes, the Port of Milwaukee bases its cost estimate for masonry and sealant work on the following:

Cracked brick and sill at SE corner

- Repair and replace cracked/crumbling sill and brick
- Caulk and repaint soffit, fascia and awning: square feet
- Repaint and seal windows/doors/frames and lintels
- Paint exposed metal surfaces

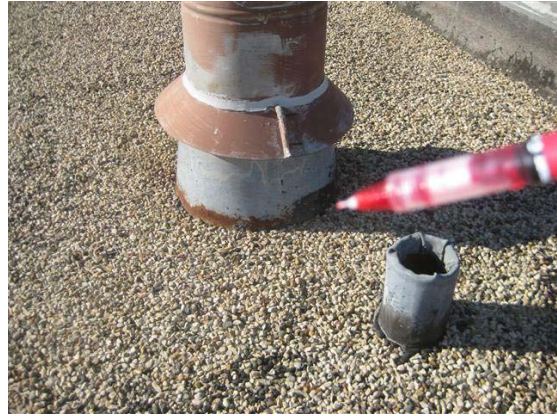
Roof-2 metal penetration rust

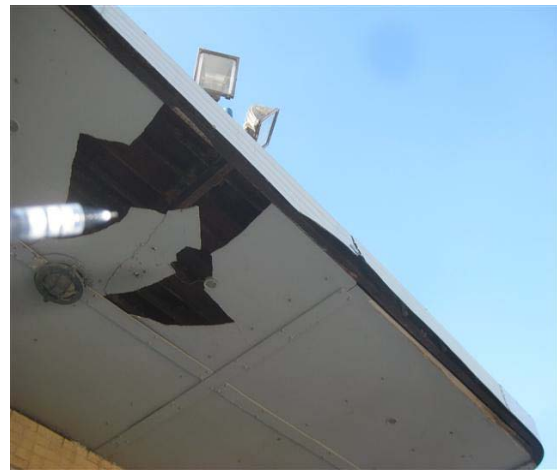
Roof-4 soffit from awning collapsing

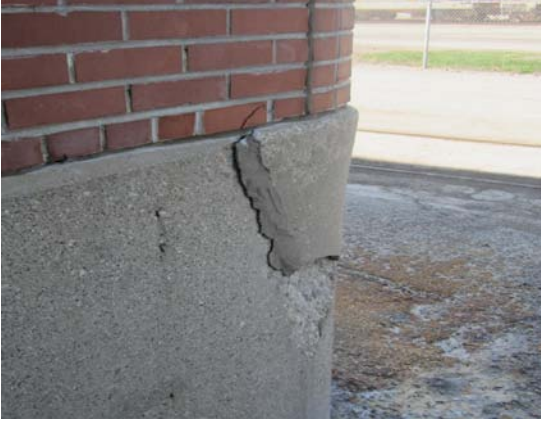
Spalled concrete at NW corner

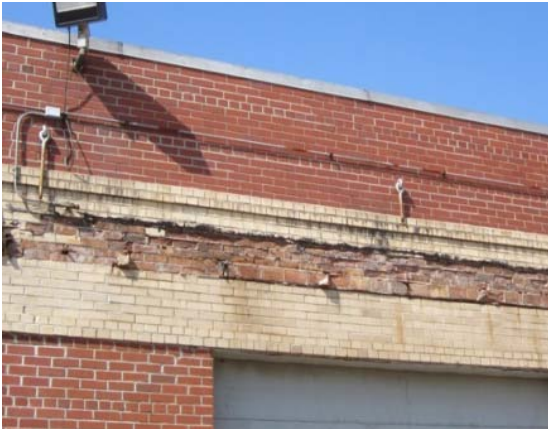
Unfinished masonry work at awning

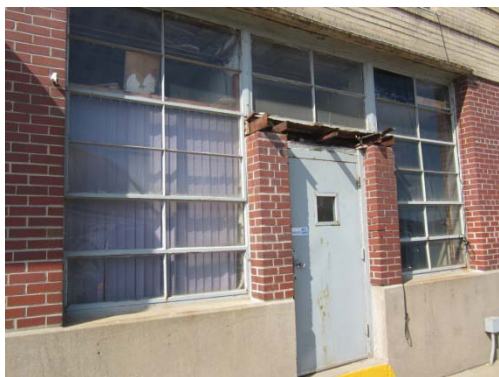
Window system at east elevation

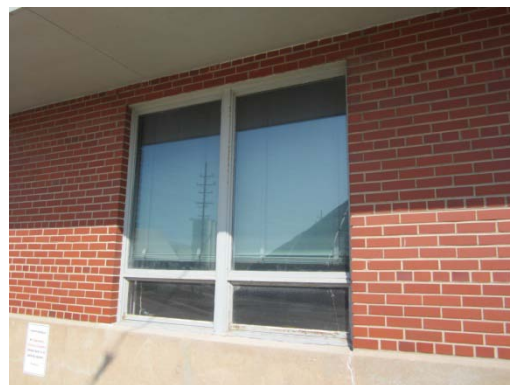
East elevation window possibly replaced

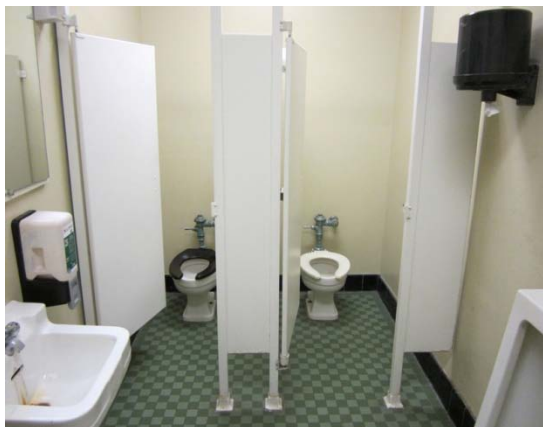
The rest rooms are in satisfactory condition. Rest rooms have a useful life of up to 35 years. The Port of Milwaukee plans rest rooms renovation in conjunction with other interior renovations by 20XX.

Men's room toilets, partitions

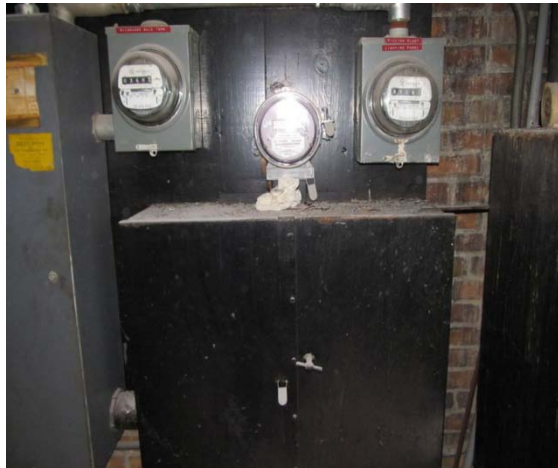
Incoming service with revenue meter

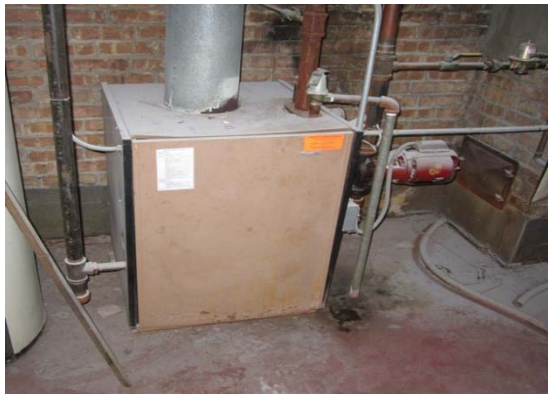
Milwaukee Bulk Terminal Warehouse includes one building heat boiler in the mechanical room with a capacity of 1,500 MBH. The boiler is 27 years of age. The useful life of boilers in this capacity is up to 30 years. The Port of Milwaukee anticipates its replacement by 2017.

Building heat boiler

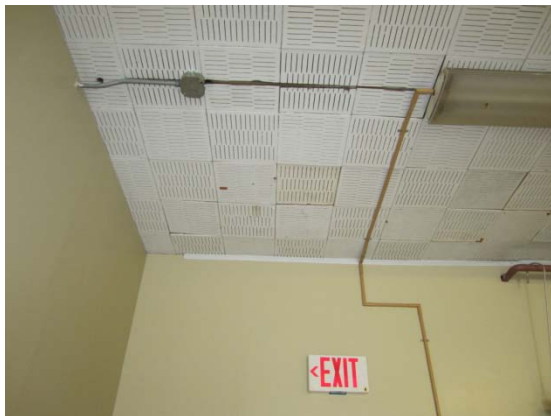
Milwaukee Bulk Terminal Warehouse life safety system is comprised of exit/emergency lights and associated wiring. Life safety systems have a useful life of up to 25 years. Replacement of the life safety system is anticipated by 20XX.

Emergency/Exit light fixture

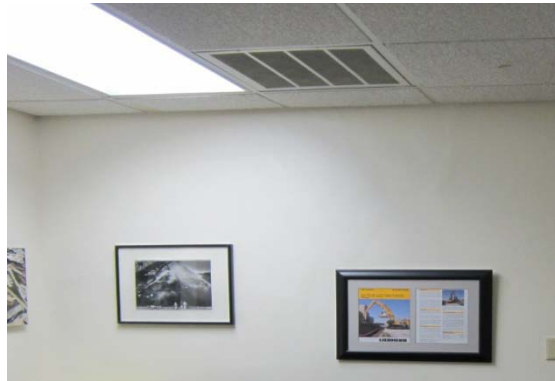
Unit-2 return air and evaporator

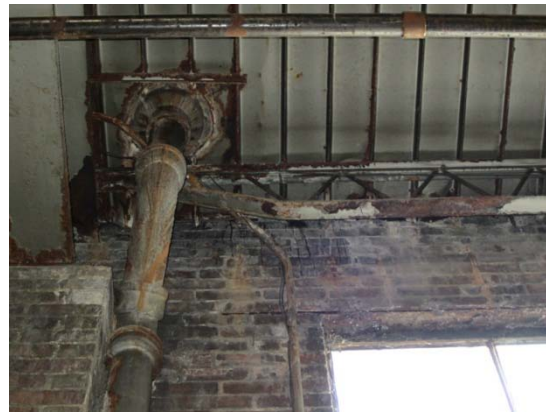
Rusted steel components

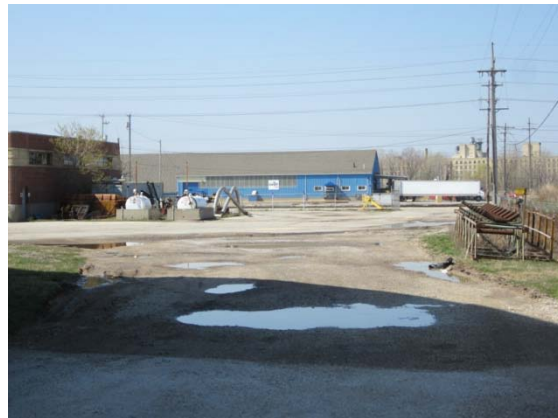
North cracking and potholes

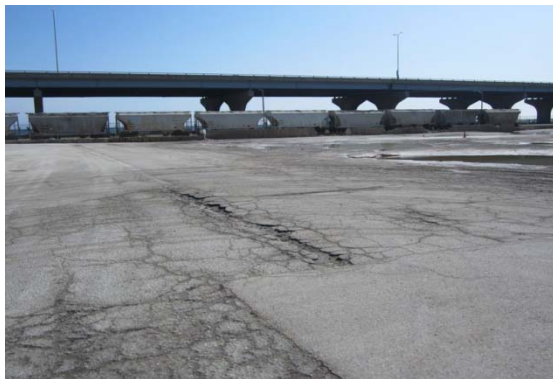
Alligator cracks and prior repairs

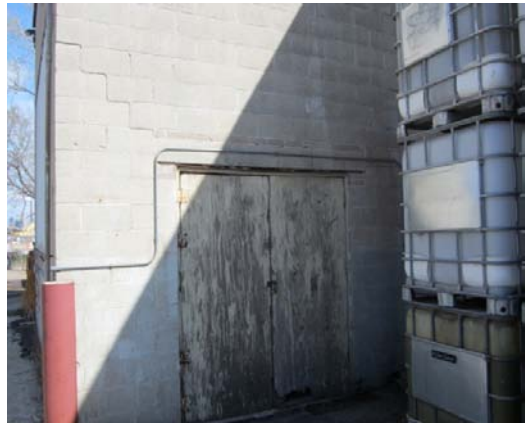
West service doors with deterioration

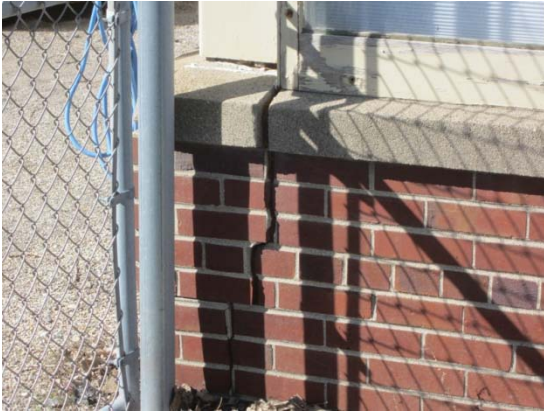
The brick masonry and CMU is in fair overall condition. Visual onsite inspection of the brick masonry and CMU identified multiple locations of cracked brick/CMU and mortar.

Cracked brick mortar at east elevation

- Façade inspection
- Brick/CMU replacement of up to 350 square feet
- Repointing of up to 525 square feet
- Sealant replacement of up to 625 linear feet
- Lintel replacement of up to 50 linear feet

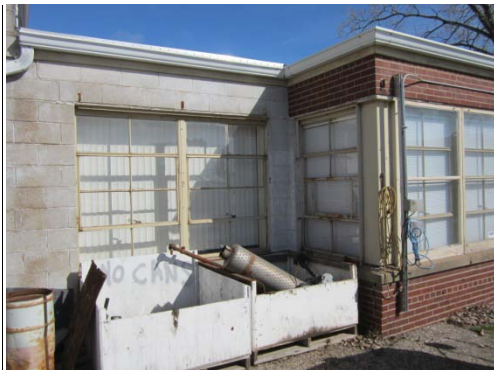
North American Salt Company includes 380 square feet of windows. Typical useful life expectancy for windows is up to 35 years. The inspection revealed that the windows exhibited the onset of rust at frames. The window at the southwest corner experiences leaks. The windows likely vary in age with a majority either original to building construction or replaced decades ago. The Port of Milwaukee should anticipate window replacement by 20XX. Isolated window replacements should be conducted from the operating budget.

South elevation windows

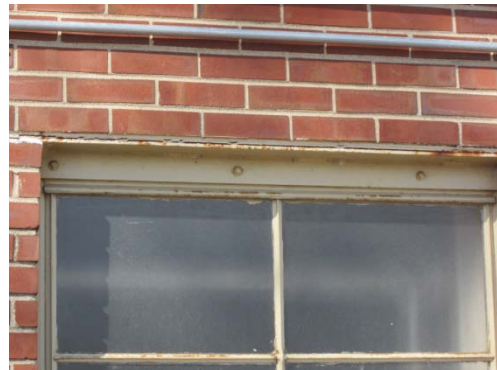
Onset of rust at window

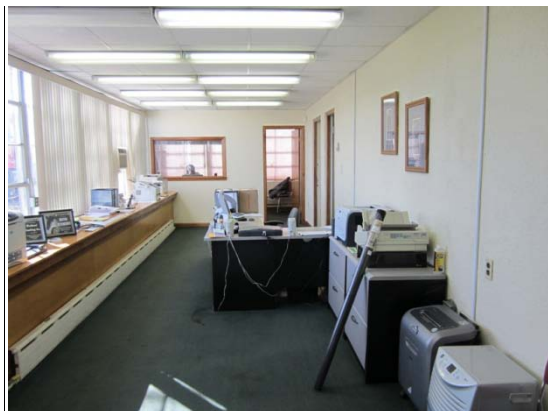
North American Salt Building comprises various interior finishes that are in fair condition overall. These components are associated with the office spaces and storage rooms. The inspection revealed dated interiors and various isolated locations of deterioration. The useful life of interior renovations is up to 20 years.

Front office area

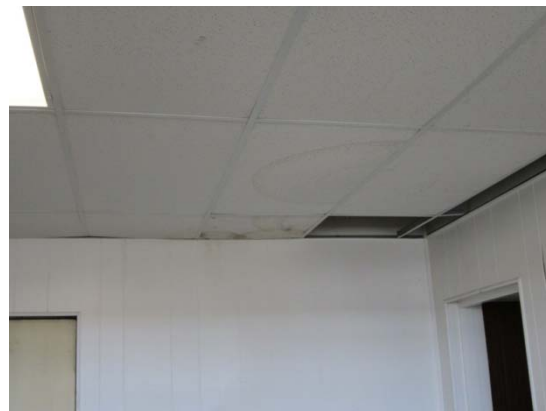
Stained and missing ceiling tiles

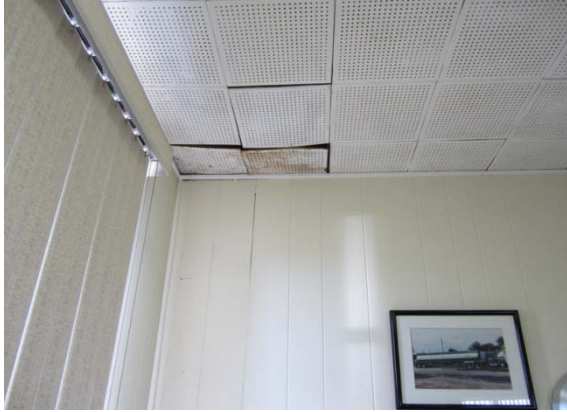
Ceiling water damage

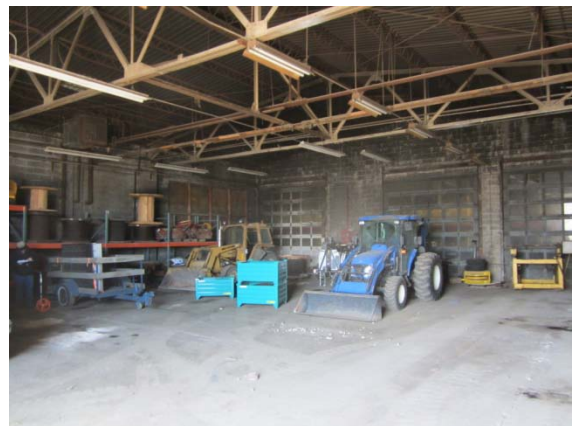
North American Salt Company includes two garages. One is occupied by the lessee and the Port of Milwaukee occupies the other for storage. Forty-four light fixtures exist within the two garages. Warehouse interior includes 42 fluorescent light fixtures and seven pendant light fixtures. The fixtures appear in satisfactory condition. Port of Milwaukee should anticipate their replacement by 20XX.

Light fixtures at Port garage

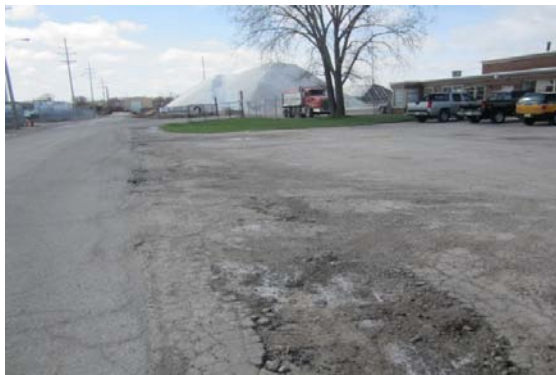
North American Salt Building property contains 625 square yards of asphalt pavement. The remaining lot is comprised of gravel. The inspection revealed the entrance area of asphalt pavement is uneven, crumbling and eroding. The overall condition of the pavement is fair. Port of Milwaukee should anticipate asphalt pavement replacement by 20XX.

Entrance Asphalt driveway overview

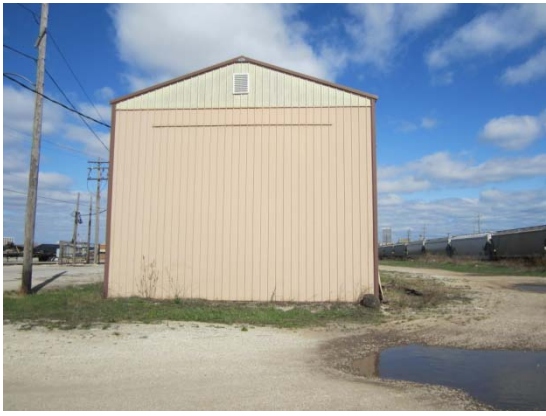
Rusted metal fasteners at siding

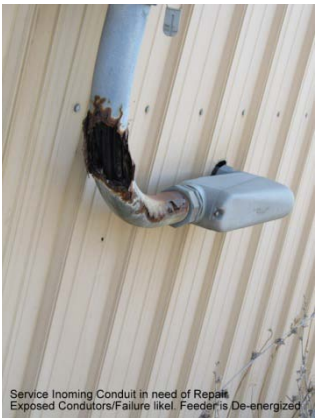
Sandblast Shed includes primary and secondary services. The primary service includes a utility meter that was replaced in 1995 (17 years) and reported in good operational condition. Additionally, the primary meter includes incoming service and distribution in critical and failed condition. The secondary service is noted in failed condition. Port of Milwaukee should determine long-term usage of the Sandblast Shed and property prior to conducting capital expenditures. However, for the purposes of this analysis, the critical and failed components should be replaced in 2012.

De-energized incoming service

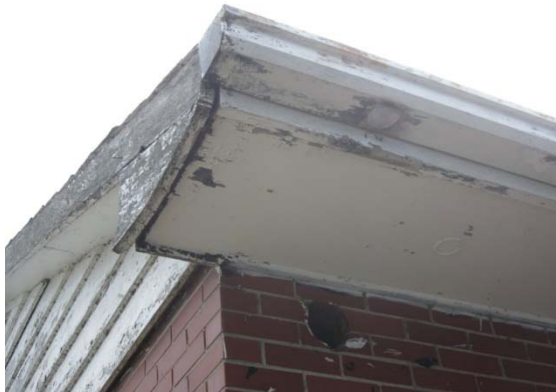
Sea Scout Building 1 includes 66 linear feet of gutters and 13 linear feet of downspouts at the building. The useful life of gutters and downspouts is 20 years. Replacement of gutters and downspouts should be conducted with the metal roof replacement by 2012.

Gutters with no downspout

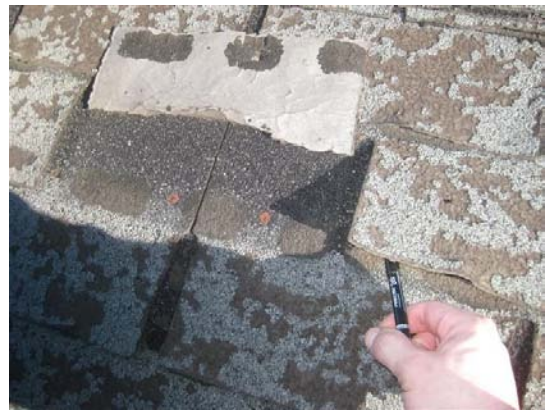
Roof Shingle deterioration

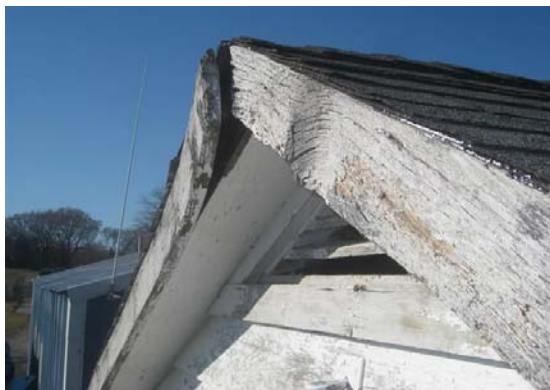
Wood fascia is weathered, damaged, and rotting

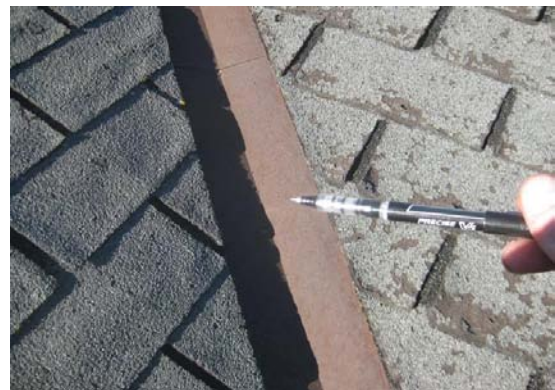
Valley flashings are rusting

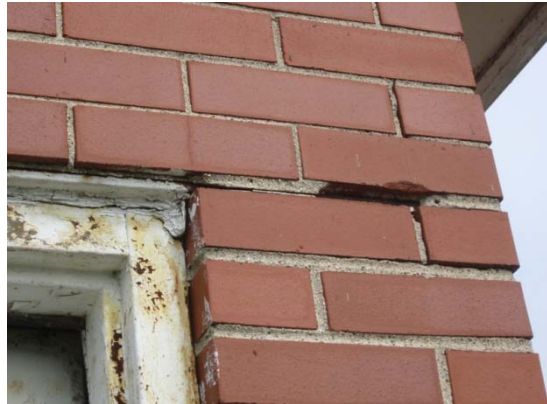
Cracked brick mortar at east elevation

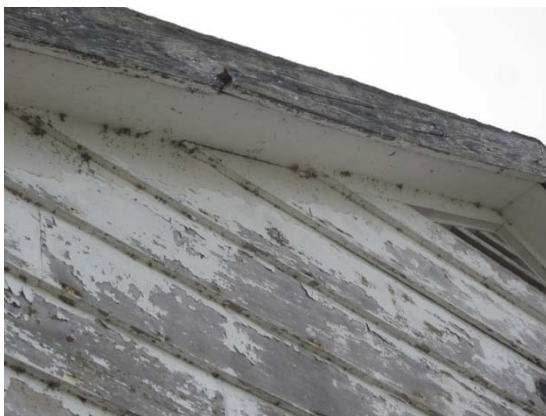
Paint finish deterioration and exposed/deteriorated wood siding

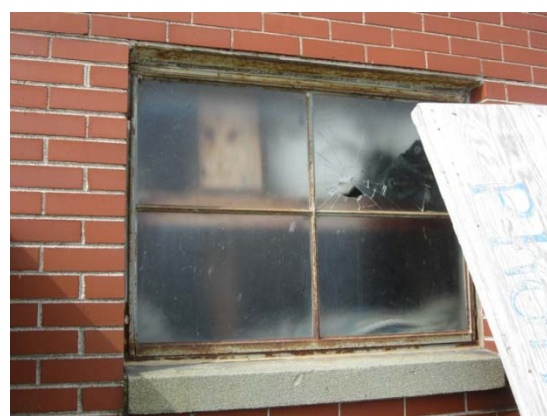
Broken window and rusted frame

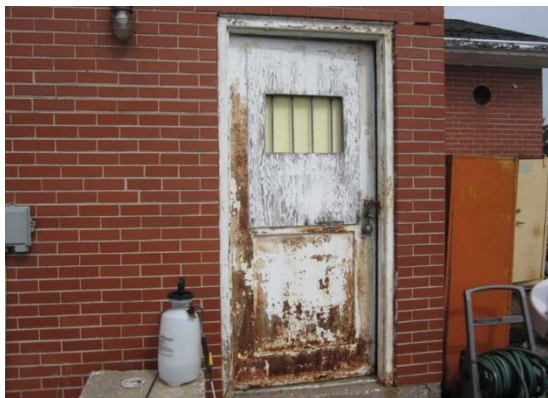
Sea Scout Building 1 includes a combination of metal and wood doors. The inspection reveals that all the doors are in very poor condition. The Port should anticipate phased replacement of 2 doors every seven years beginning by 2012.

Rusting metal door

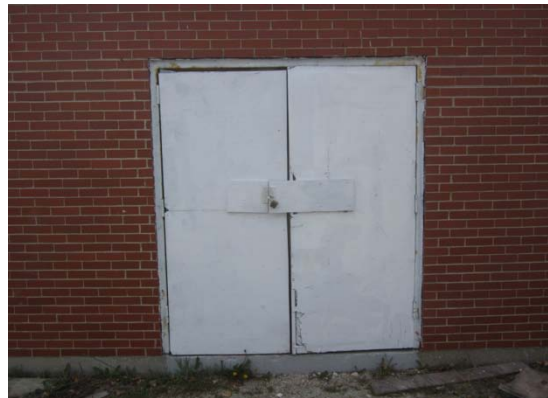
Damaged wooden doors

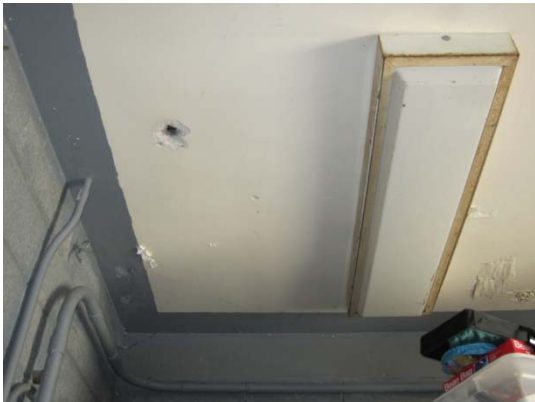
Hole in the ceiling and lighting fixture

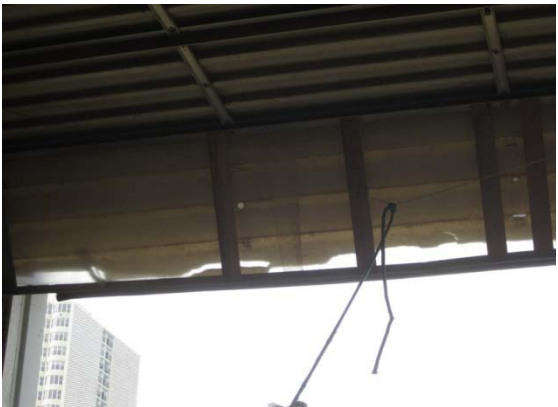
Sea Scout Building includes one fiberglass overhead garage door and one service door. The garage door was open and appeared in fair condition.

Overhead door with fiberglass damage

The useful life of garage doors in this capacity is up to 15 years. Port of Milwaukee should plan replacement of the garage door and service door by 20XX.

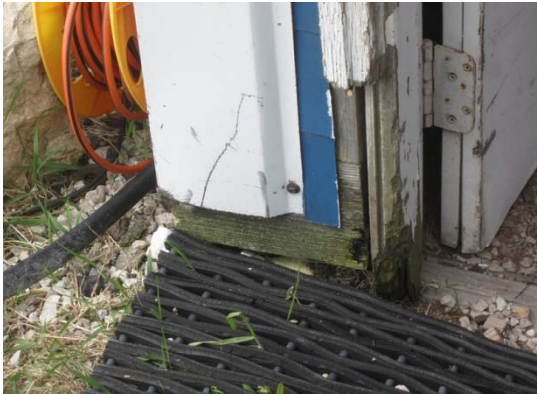
Door with lower door frame damage

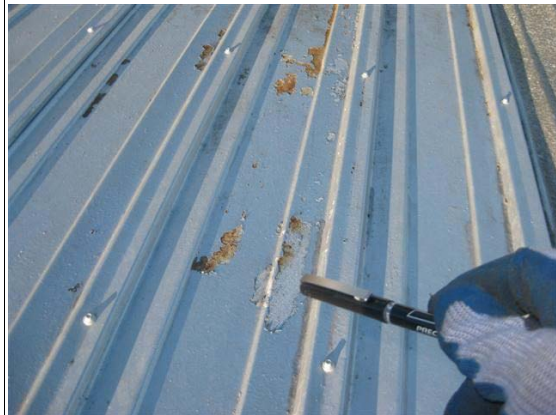
Sea Scout Building 2 includes a 1,725 square metal roof. The roofs are inspected and maintained by a third party. The last inspection occurred in 2012 where the roofs are indicated to be in poor condition. The inspection revealed the field of roofing is deteriorated and rusting 30 percent throughout. The useful life of metal roofs is up to 35 years. Its replacement is anticipated by 20XX.

Damaged roof section

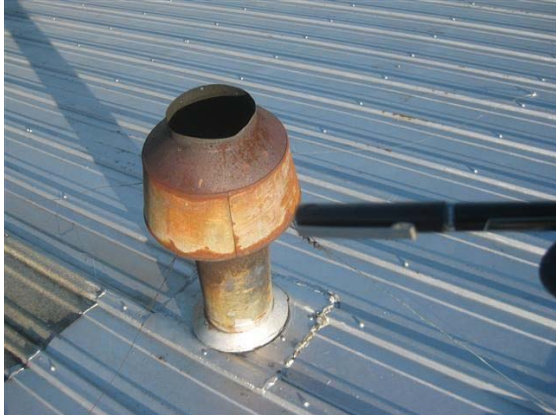
Rusted heater vent

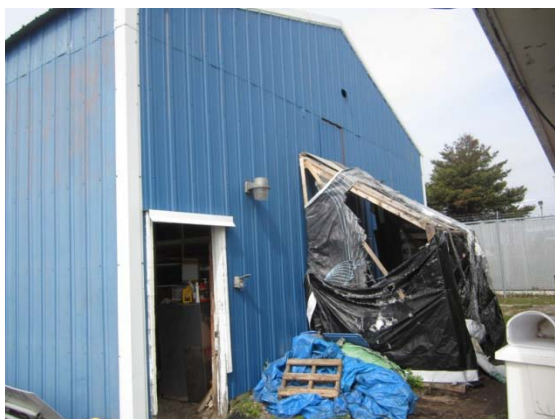
Rusted siding at SW elevation

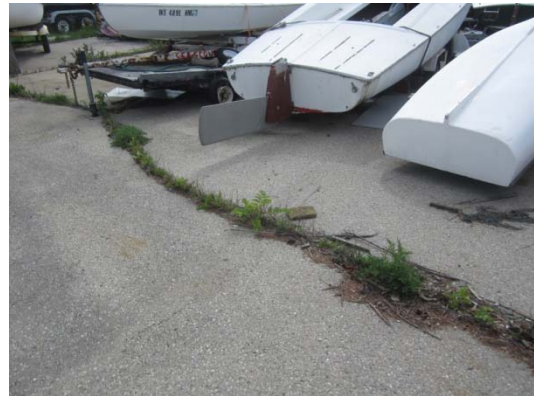
The Sea Scout Facility contains 817 SY of asphalt pavement at the entrance and boat storage lot. The inspection revealed isolated locations of asphalt transverse and longitudinal cracking. The overall condition of the pavement is in satisfactory condition.

Large cracking and grass growing

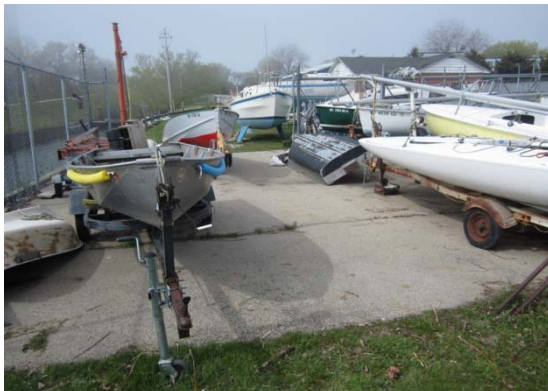
East elevation cracking asphalt pavement

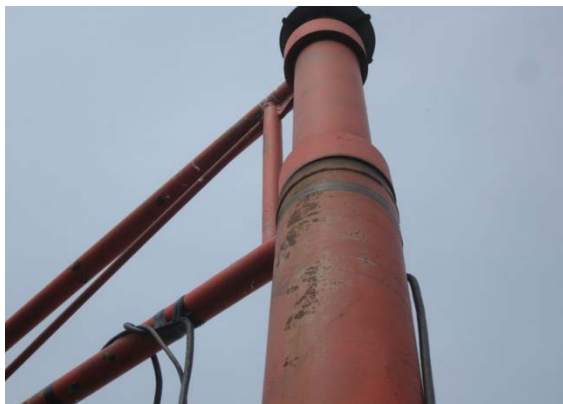
Onset of rust

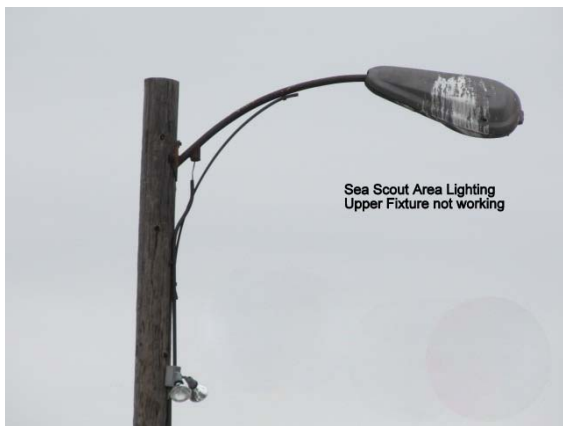
Non-functional light fixture

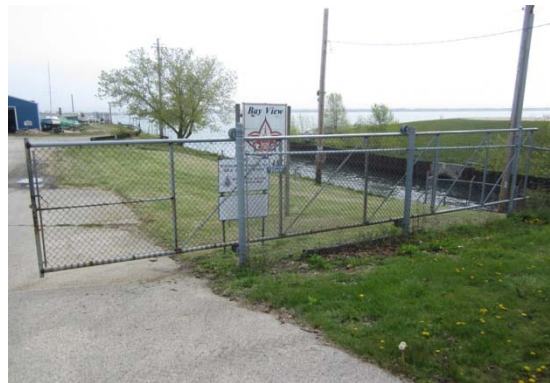
The fences appear in good condition in most all areas, but on the gates there in some rust accumulating. The useful life of a chain link fence is up to 35 years. Port of Milwaukee should anticipate its replacement by 20XX.

Gates and operators with some rust

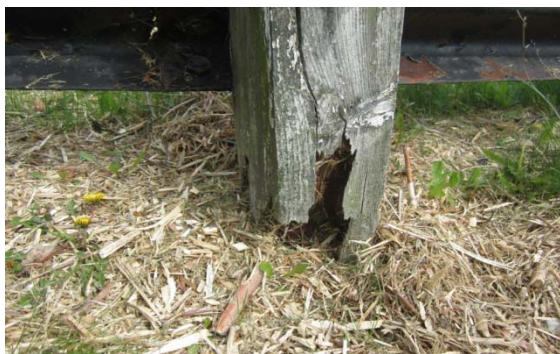
Deterioration at post

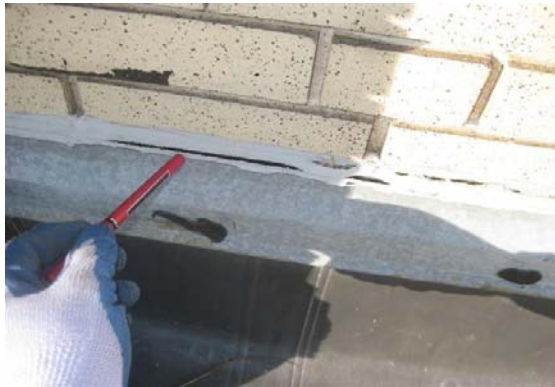
Flashing sealants for R-1 is cracking

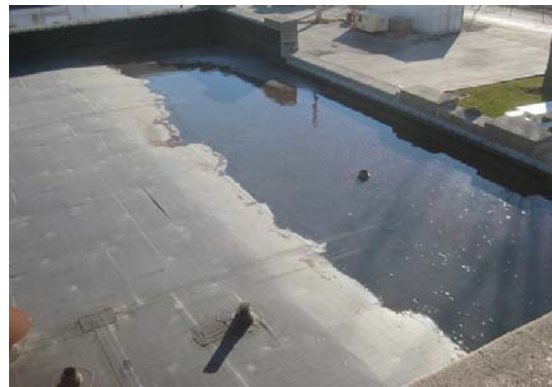
Ponding water R-1, drain stopped up

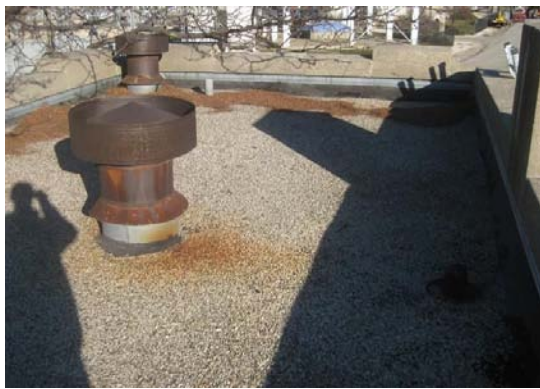
Tree debris on R-3 and gutters clogged

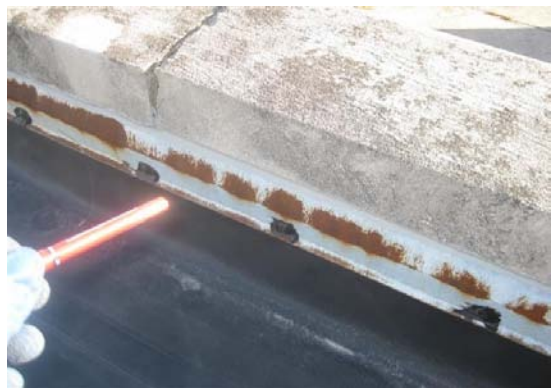
Counter flashing R-2 rusted

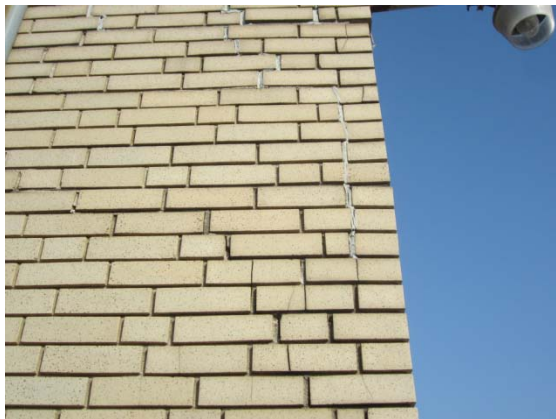
Cracked brick and sealant (not mortar) repair

- Façade inspection
- Brick/CMU replacement of up to 60 square feet
- Repointing of up to 185 square feet
- Sealant replacement of up to 475 linear feet

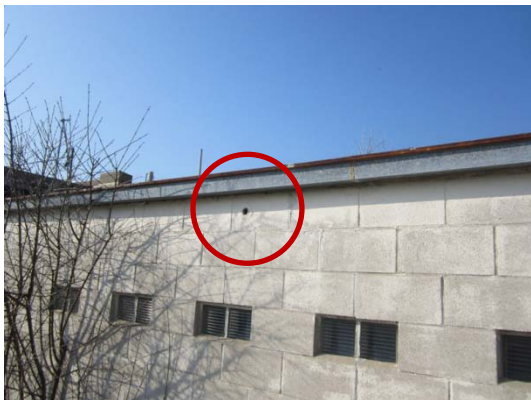
East elevation 2" hole in CMU

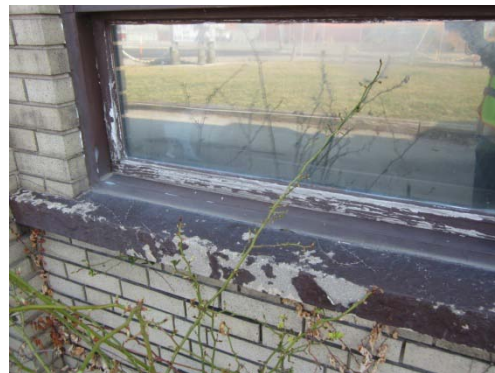
Paint finish deterioration at wood frame

Based on varied conditions, the Port of Milwaukee should anticipate phased window replacement beginning by 20XX.

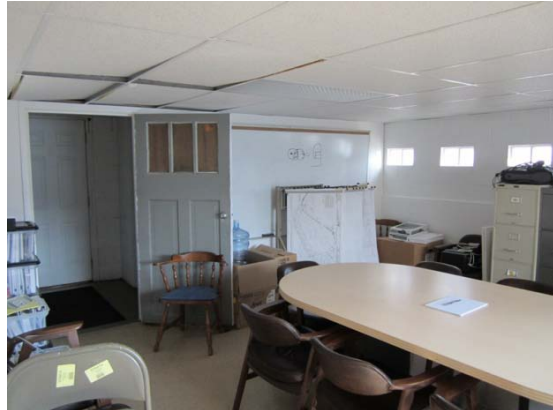
Acoustic ceiling tiles loose

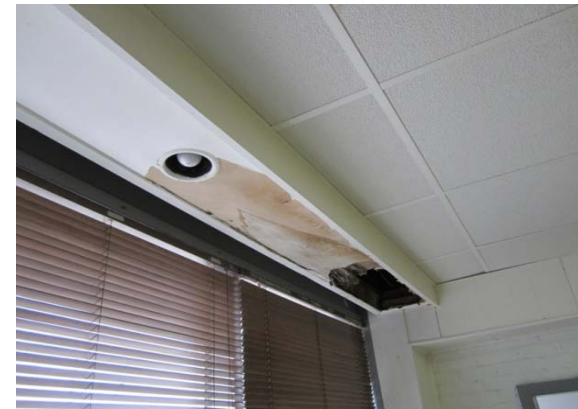
Ceiling water damage

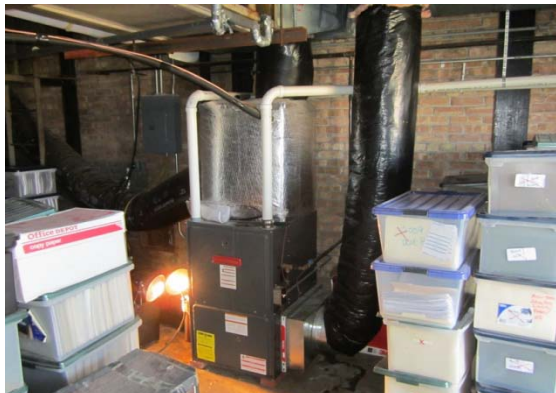
Interior forced air furnace

Seaman’s Club comprises one split system. The split system comprises of an internal forced air furnace and an external condensing unit. The useful life of split systems is up to 20 years. The Port of Milwaukee anticipates their replacement by 20XX. Interim partial replacements and repairs are funded by O + M.

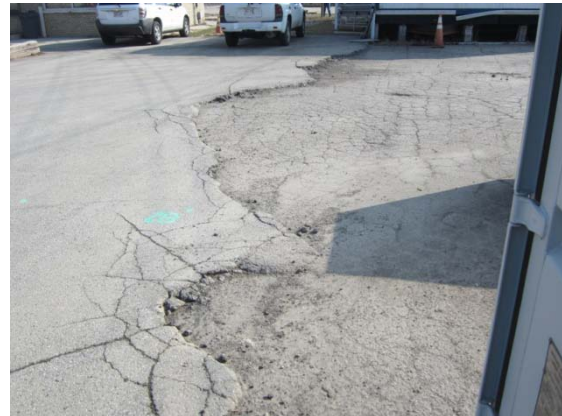
Seamen’s Club property contains 750 square yards of asphalt pavement throughout the property. The inspection revealed that the southwest driveway pavement exhibited failed pavement, an adjacent overlay, transverse/longitudinal cracking. The walkway was in good condition. Additionally, the driveway apron was recently replaced and in good overall condition. Port of Milwaukee should anticipate phased asphalt pavement by 20XX and again by 20XX.

Serious erosion and uneven asphalt

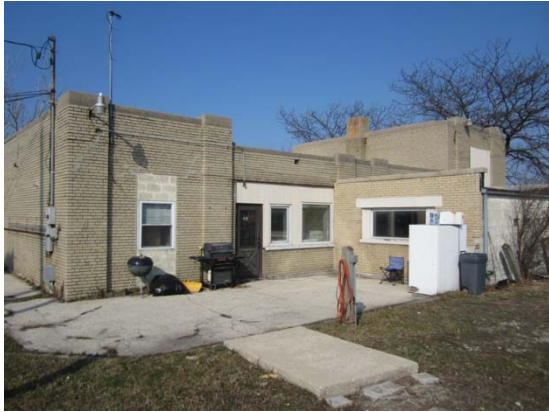
East elevation cracking asphalt pavement

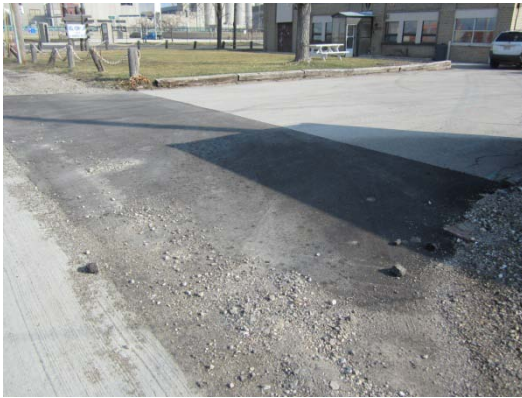
Recently replaced driveway apron
