## WISCONSIN LAKEFRONT PROPERTY MANAGEMENT LLC

Claim: Water Main Break Property Damage  
Property: Manorview Apartments  
Address: 8509 W Oklahoma Ave., Milwaukee, WI 53227  
Owner: Manorview Apartment Homes LLC  
Managing Member: Eileen Robarge  
Owner Contact Info: (858)761-2980, [erobarge@windwardcovelc.com](mailto:erobarge@windwardcovelc.com)  
Property Manager: Allen Boelk  
Property Manager Contact Info: (414)322-6677 [allenb@windwardcovelc.com](mailto:allenb@windwardcovelc.com)  
Administator Contact: Ann Henry 866-542-5851 [annh@windwardcovelc.com](mailto:annh@windwardcovelc.com)  
Business Registered Mailing Address: 4712 Whispering Oak Court, Apt. 16, Sheboygan, WI 53083  
Date of Event: January 24<sup>th</sup> 2025, Time: Noticed at 6:30 am

GZA GeoEnvironmental, Inc. (GZA) is pleased to submit this Memorandum ("Memo") to Wisconsin Lakefront Property Management LLC ("Client") for the above-referenced project located at 8509 West Oklahoma Avenue in Milwaukee, Wisconsin ("Site"). A Site Location Plan is provided as **Figure 1**. This Memo provides a summary of findings and recommendations from GZA's Site visit and fieldwork performed on April 30, 2025, and subsequent labo

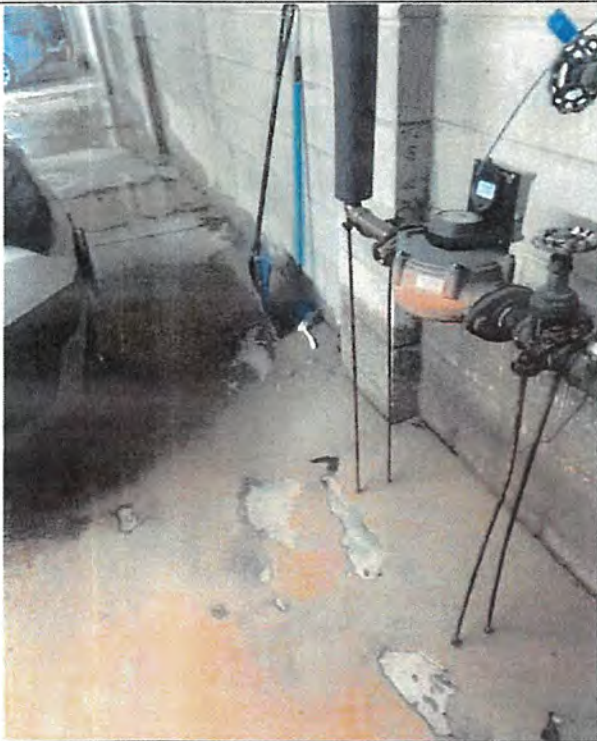
| <b>Description:</b><br>Client-provided photograph at the time of the water main break. Condition of basement/parking structure. | | | |

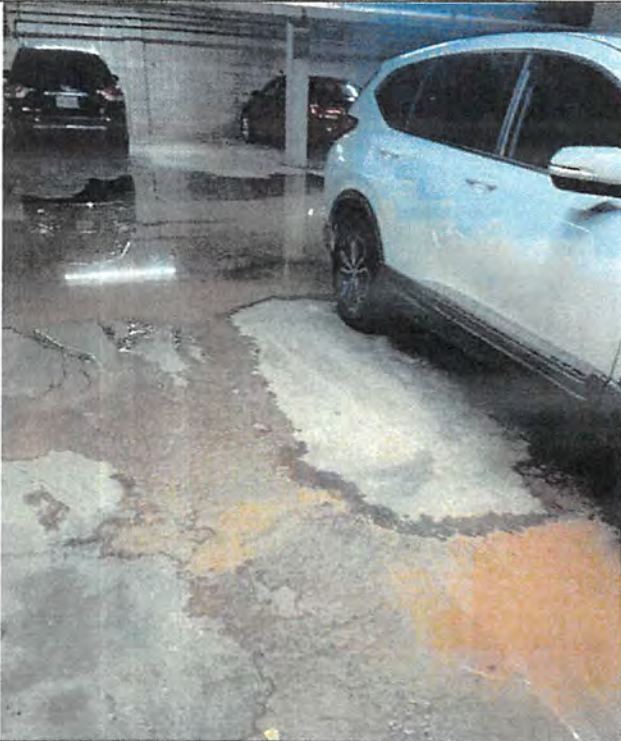
| <b>Description:</b><br>Client-provided photograph at the time of the water main break. Condition of basement/parking structure. | | | |

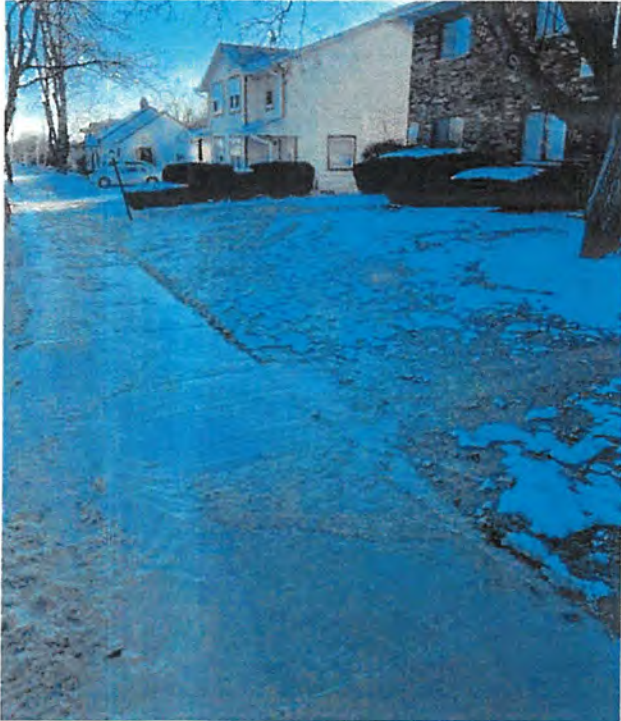
| <b>Description:</b><br>Client-provided photograph at the time of the water main break.<br>Condition of property. | | | |

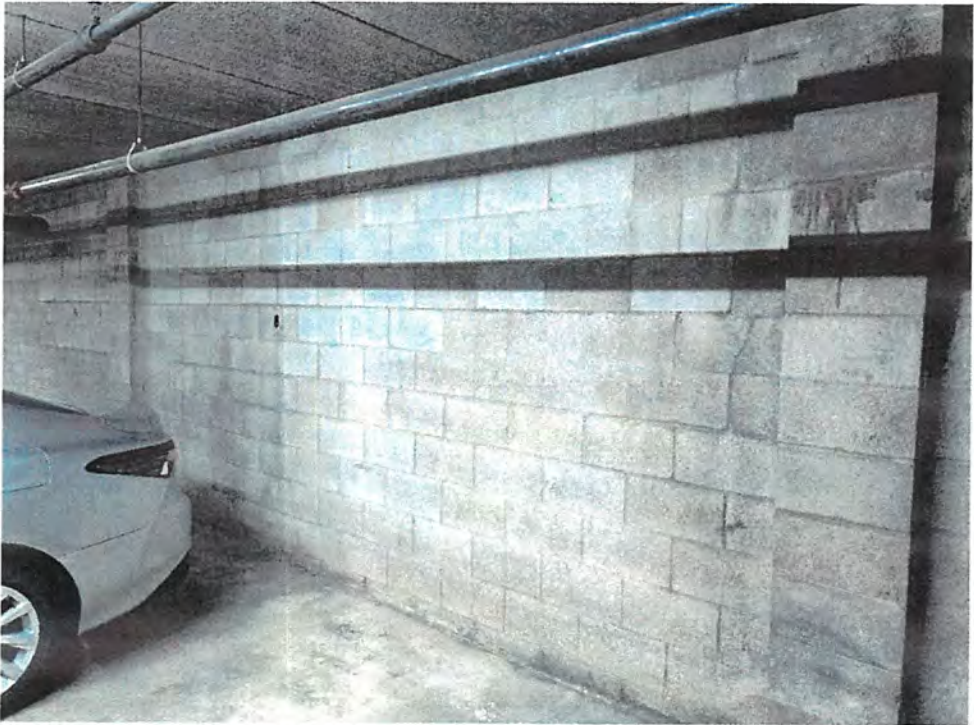
| <b>Description:</b><br>Parking area 8, northern wall of basement/parking structure. | | |

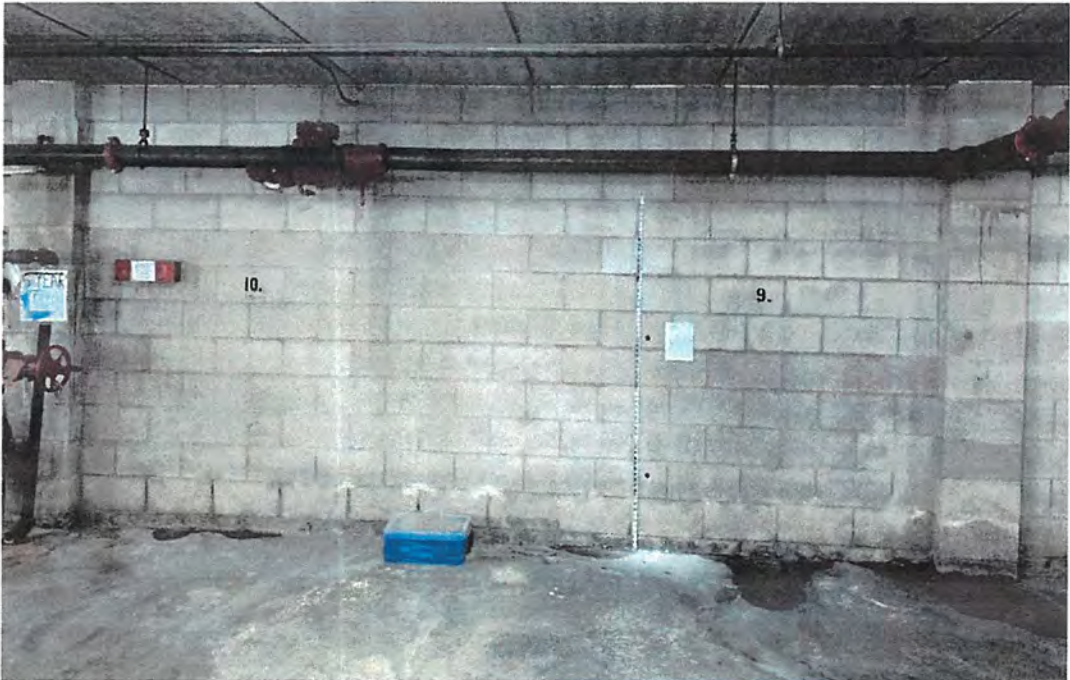
| <b>Photo No.</b><br>30 | <b>Date:</b><br>4/30/25 | |

| <b>Description:</b><br>Parking areas 9 & 10 along northern wall of basement/parking structure. Observation boreholes present. | | |

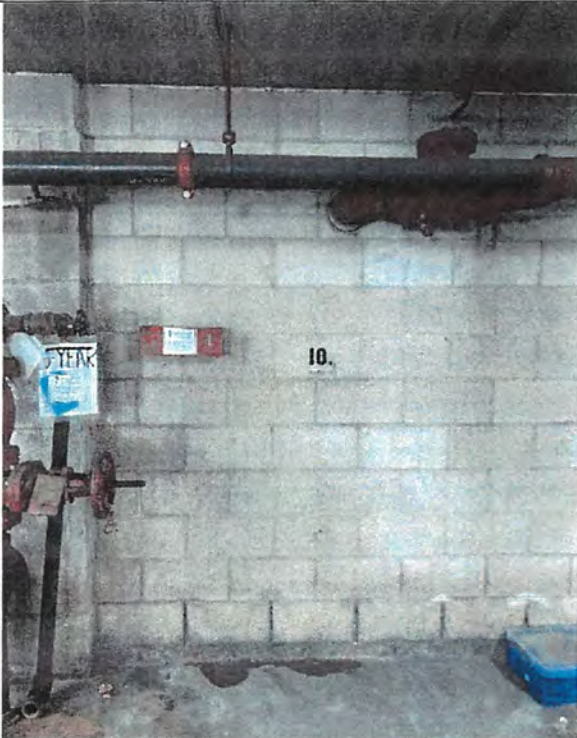
| <b>Photo No.</b><br>32 | <b>Date:</b><br>4/30/25 | |

| <b>Description:</b><br>Parking area 10 along northern wall of basement/parking structure. | | |

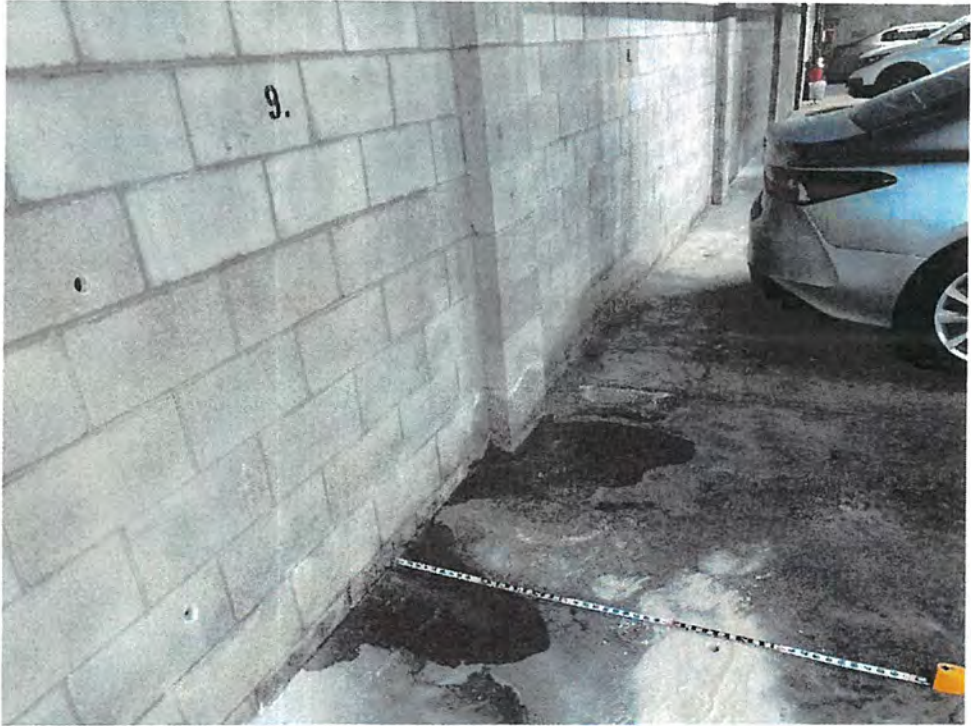
| <b>Photo No.</b><br>33 | <b>Date:</b><br>4/30/25 | | |

| <b>Description:</b><br>Parking area 9 along northern wall of basement/parking structure. Observation boreholes present. | | | |

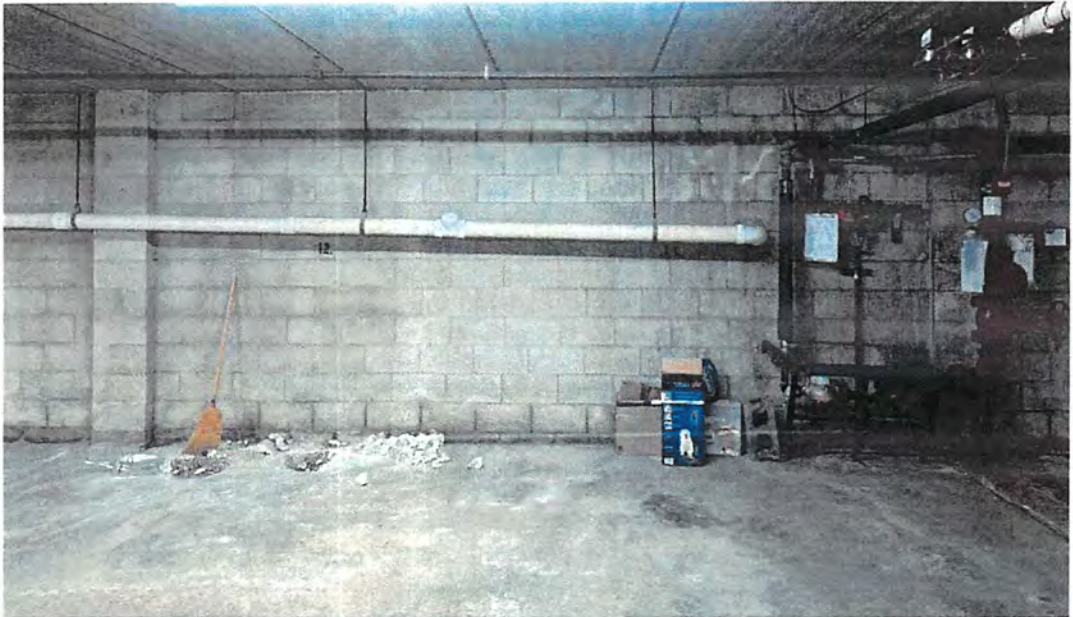
| <b>Photo No.</b><br>34 | <b>Date:</b><br>4/30/25 | |

| <b>Description:</b><br>Parking area 9 along northern wall of basement/parking structure. Observation test pit present. | | |

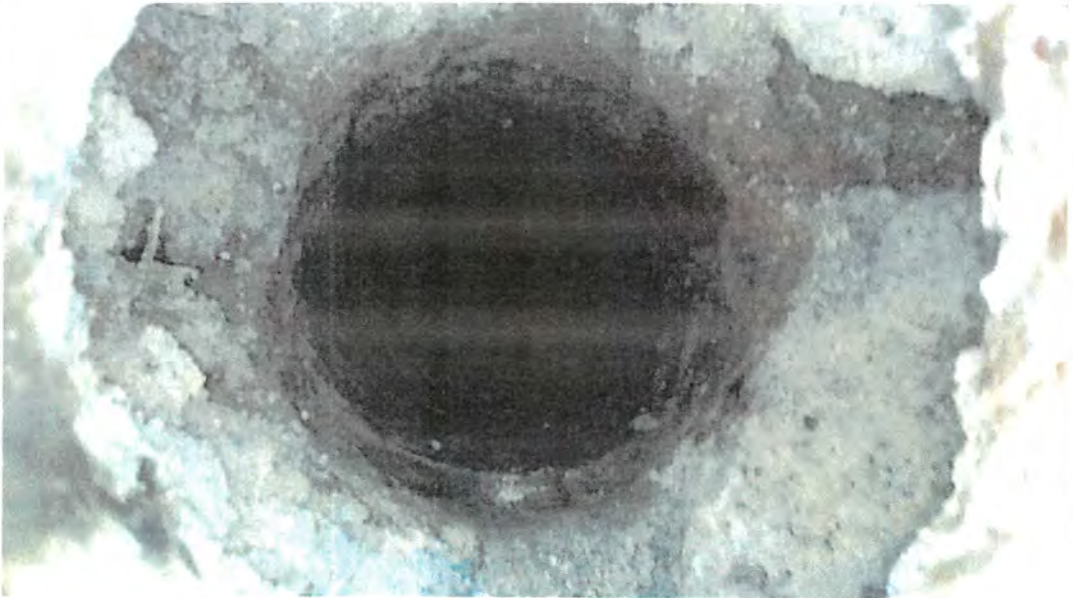
| <b>Photo No.</b><br>8 | <b>Date:</b><br>4/30/25 | |

| <b>Description:</b><br>Soil conditions near parking areas 4 and 5 (upper observational borehole). Image shows soils and void space just north of CMU block wall. | | |

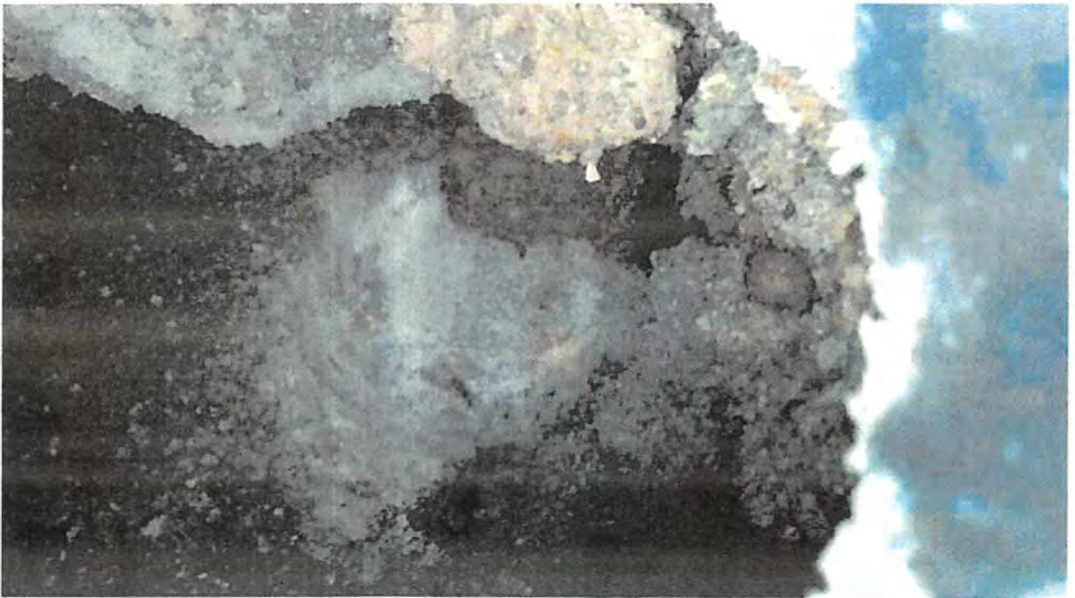
| <b>Photo No.</b><br>16 | <b>Date:</b><br>4/30/25 | |

| <b>Description:</b><br>Soil conditions near parking area 13 (lower observational borehole). Image shows soils and void space just north of CMU block wall. | | |

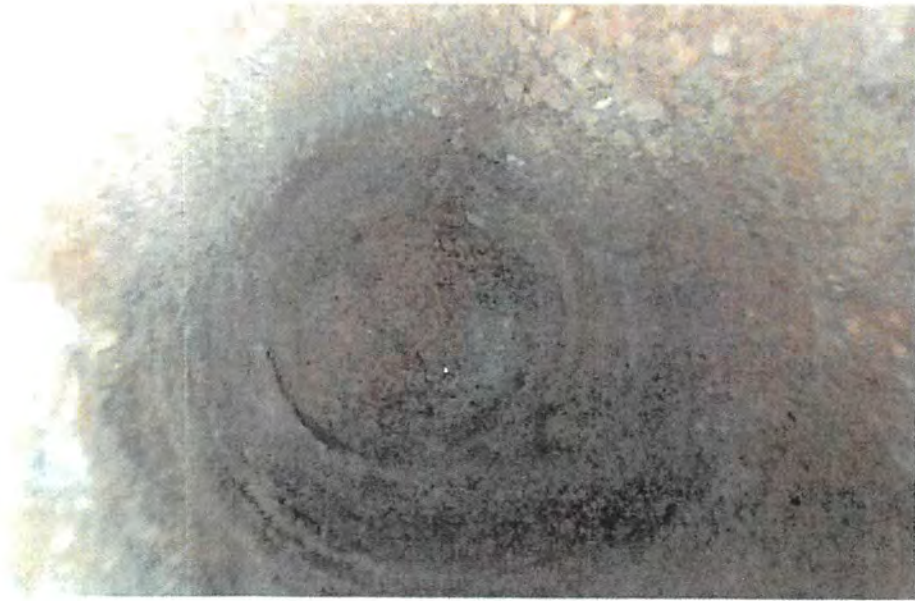
| <b>Photo No.</b><br>20 | <b>Date:</b><br>4/30/25 | |

| <b>Description:</b><br>Soil conditions near parking area 14 (upper observational borehole). | | |
