## WISCONSIN LAKEFRONT PROPERTY MANAGEMENT LLC

Claim: Water Main Break Property Damage  
Property: Manorview Apartments  
Address: 8509 W Oklahoma Ave., Milwaukee, WI 53227  
Owner: Manorview Apartment Homes LLC  
Managing Member: Eileen Robarge  
Owner Contact Info: (858)761-2980, [erobarge@windwardcovelc.com](mailto:erobarge@windwardcovelc.com)  
Property Manager: Allen Boelk  
Property Manager Contact Info: (414)322-6677 [allenb@windwardcovelc.com](mailto:allenb@windwardcovelc.com)  
Administator Contact: Ann Henry 866-542-5851 [annh@windwardcovelc.com](mailto:annh@windwardcovelc.com)  
Business Registered Mailing Address: 4712 Whispering Oak Court, Apt. 16, Sheboygan, WI 53083  
Date of Event: January 24<sup>th</sup> 2025, Time: Noticed at 6:30 am

GZA GeoEnvironmental, Inc. (GZA) is pleased to submit this Memorandum ("Memo") to Wisconsin Lakefront Property Management LLC ("Client") for the above-referenced project located at 8509 West Oklahoma Avenue in Milwaukee, Wisconsin ("Site"). A Site Location Plan is provided as **Figure 1**. This Memo provides a summary of findings and recommendations from GZA's Site visit and fieldwork performed on April 30, 2025, and subsequent labo

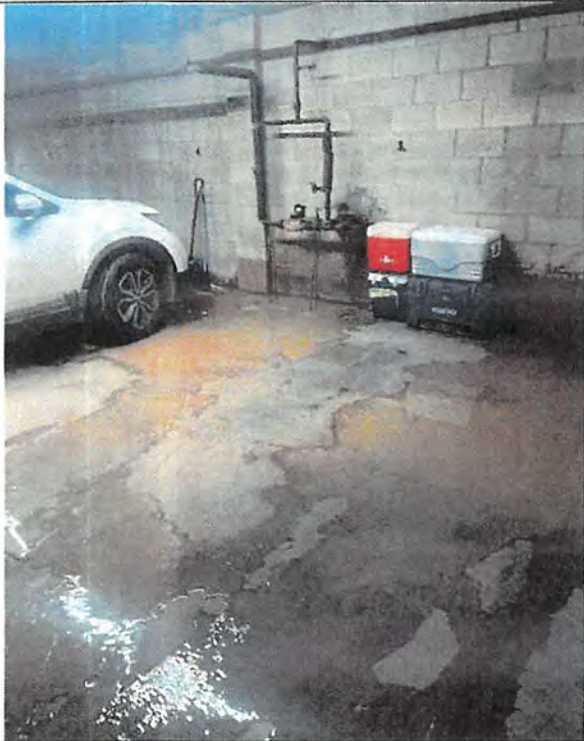
| <b>Photo No.</b><br>2 | <b>Date:</b><br>1/24/25 | |

| <b>Description:</b><br>Client-provided photograph at the time of the water main break.<br>Condition of basement/parking structure. | | |

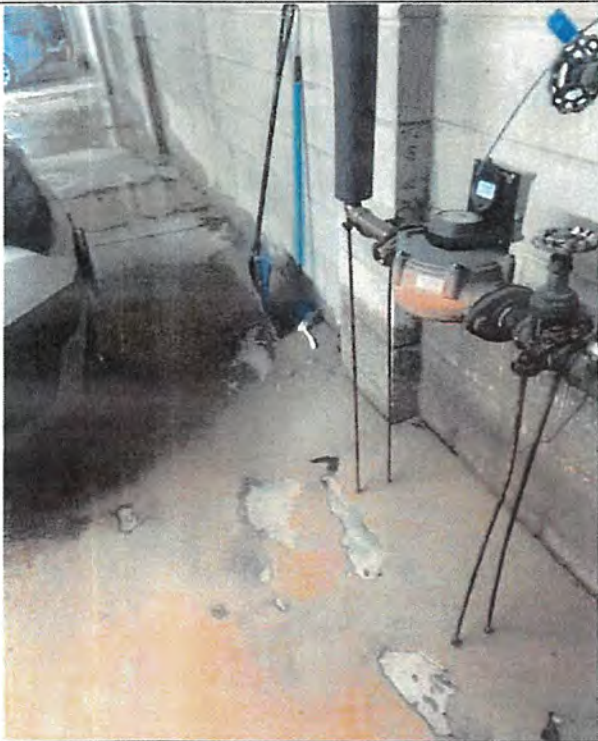
| <b>Photo No.</b><br>4 | <b>Date:</b><br>1/24/25 | | |

| <b>Description:</b><br>Client-provided photograph at the time of the water main break. Condition of basement/parking structure. | | | |

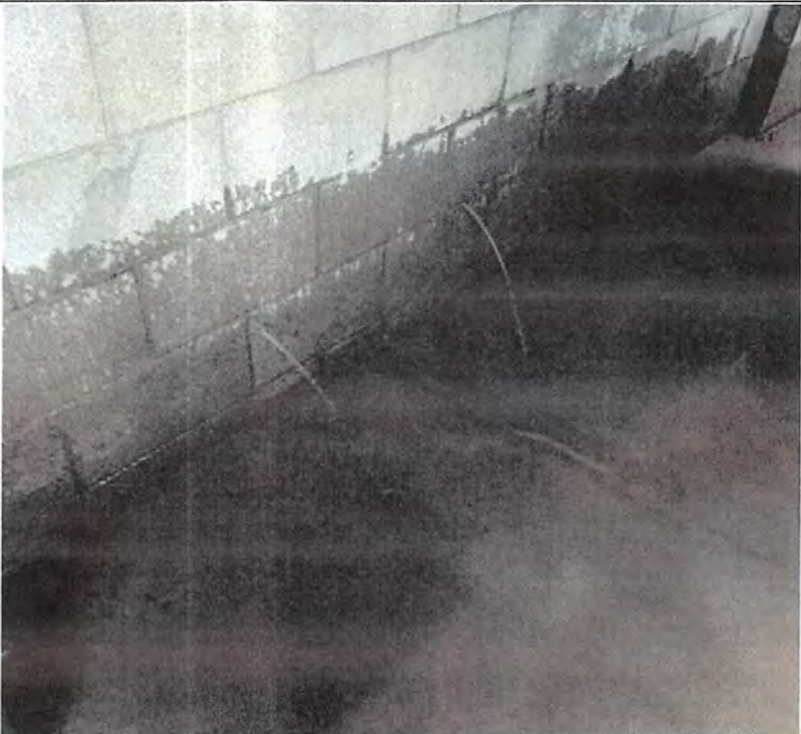
| <b>Photo No.</b><br>8 | <b>Date:</b><br>1/24/25 | | | |

| <b>Description:</b><br>Client-provided photograph at the time of the water main break. Condition of basement/parking structure. | | | | |

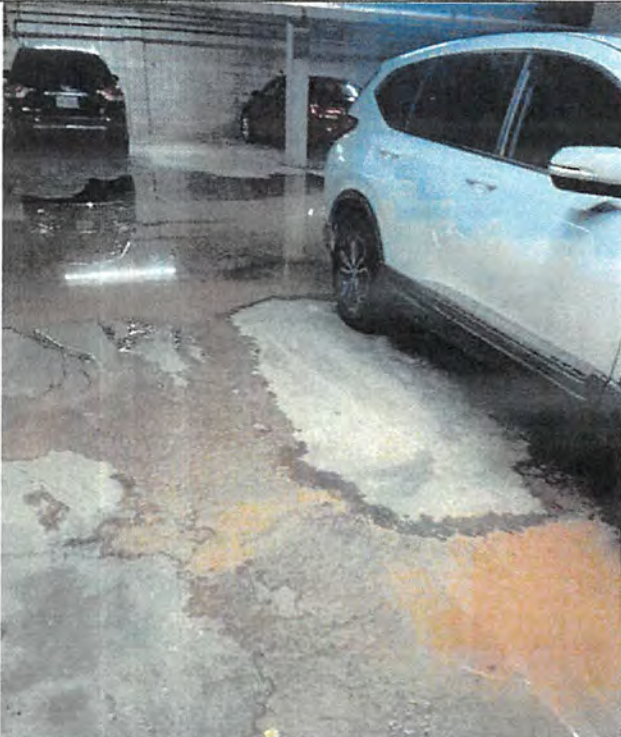
| <b>Photo No.</b><br>10 | <b>Date:</b><br>1/24/25 | |

| <b>Description:</b><br>Client-provided photograph at the time of the water main break.<br>Condition of basement/parking structure. | | |

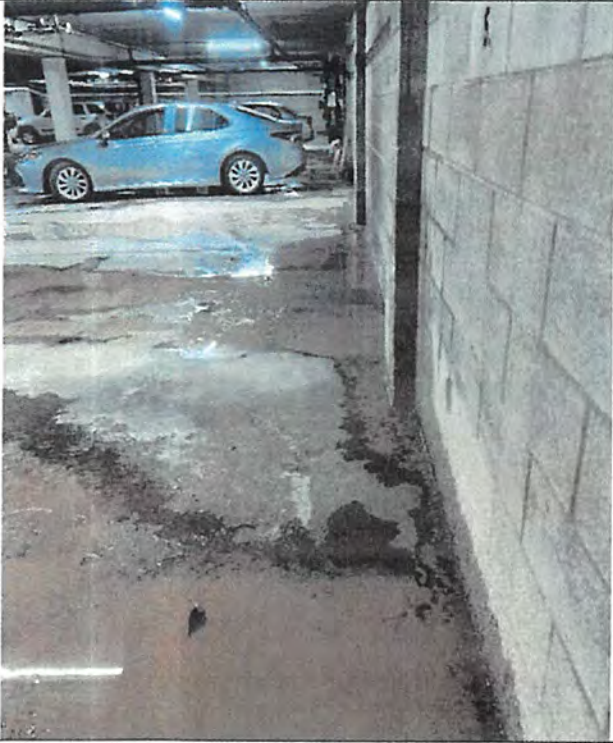
| <b>Photo No.</b><br>12 | <b>Date:</b><br>1/24/25 | |

| <b>Description:</b><br>Client-provided photograph at the time of the water main break.<br>Condition of basement/parking structure. | | |

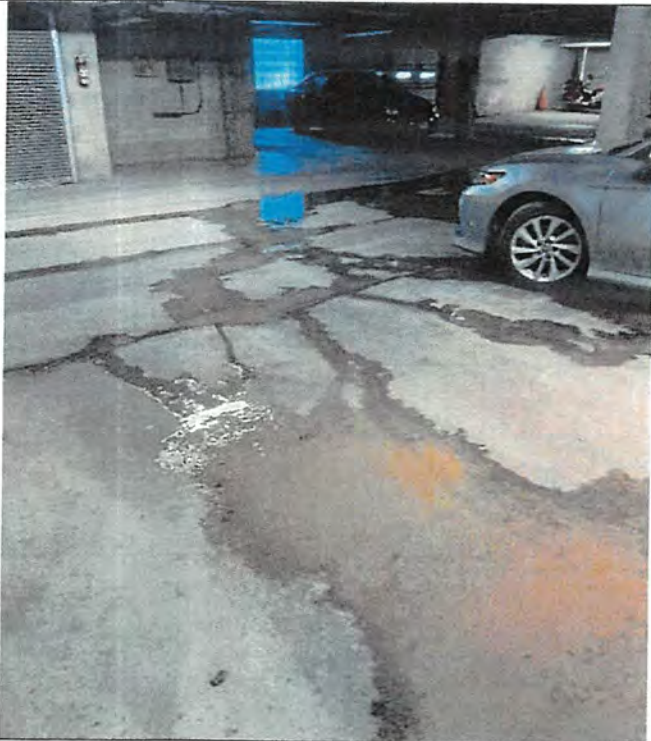
| <b>Photo No.</b><br>14 | <b>Date:</b><br>1/24/25 | |

| <b>Description:</b><br>Client-provided photograph at the time of the water main break. Condition of basement/parking structure. | | |

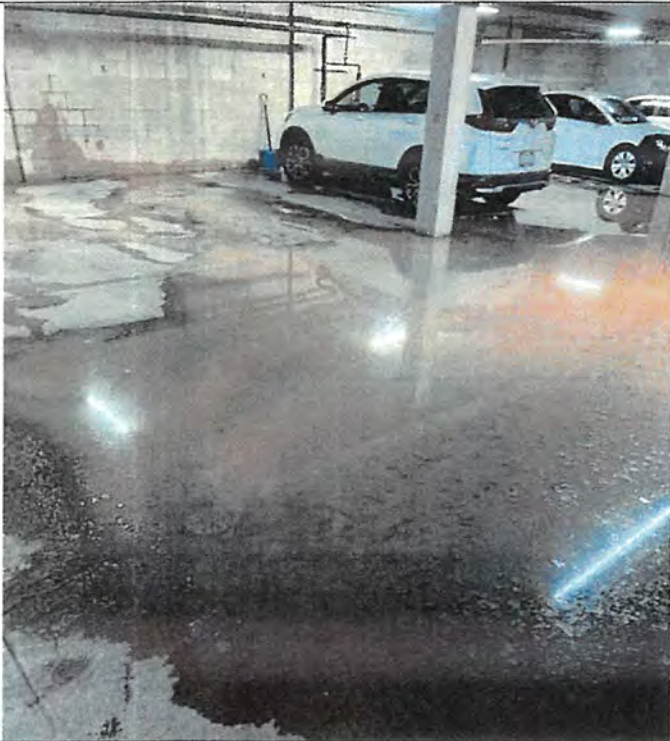
| <b>Photo No.</b><br>16 | <b>Date:</b><br>1/24/25 | |

| <b>Description:</b><br>Client-provided photograph at the time of the water main break.<br>Condition of basement/parking structure. | | |

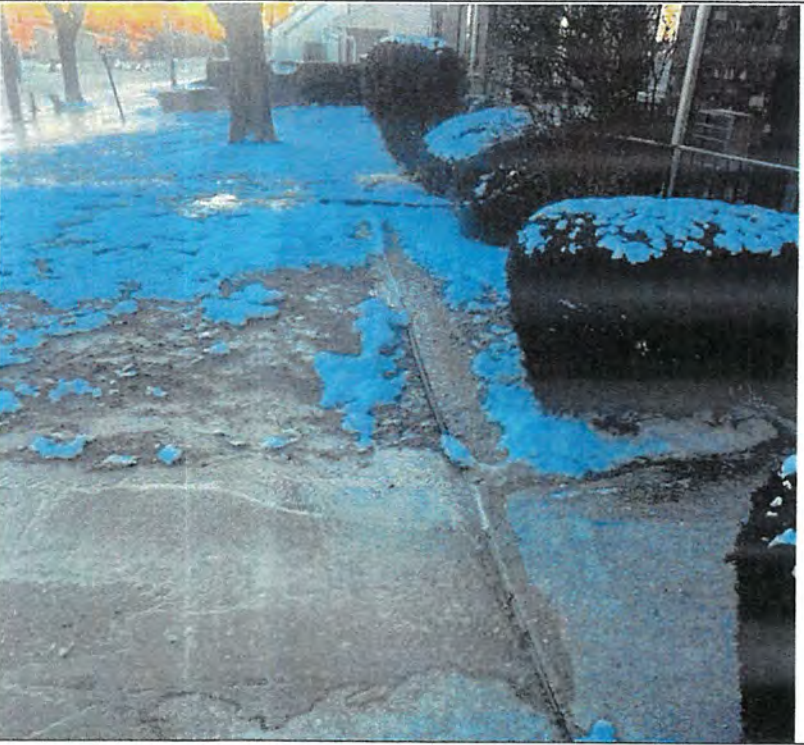
| <b>Photo No.</b><br>18 | <b>Date:</b><br>1/24/25 | |

| <b>Description:</b><br>Client-provided photograph at the time of the water main break.<br>Condition of property. | | |

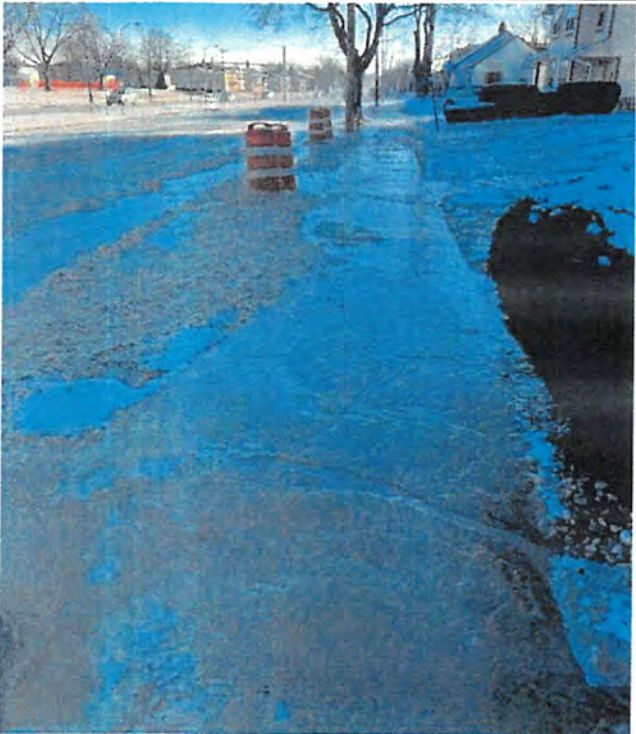
| <b>Photo No.</b><br>20 | <b>Date:</b><br>1/24/25 | | | |

| <b>Description:</b><br>Client-provided photograph at the time of the water main break.<br>Condition of property. | | | | |

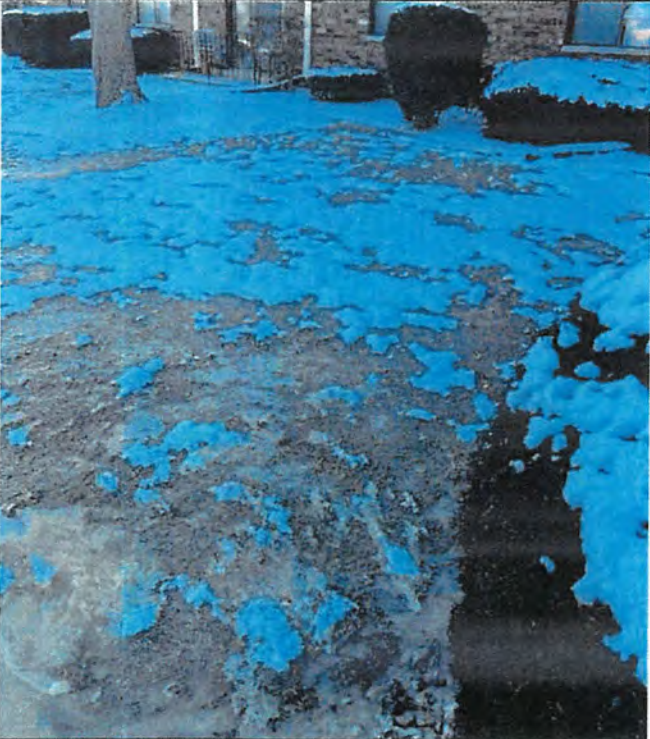
| <b>Photo No.</b><br>22 | <b>Date:</b><br>1/24/25 | |

| <b>Description:</b><br>Client-provided photograph at the time of the water main break.<br>Condition of property. | | |

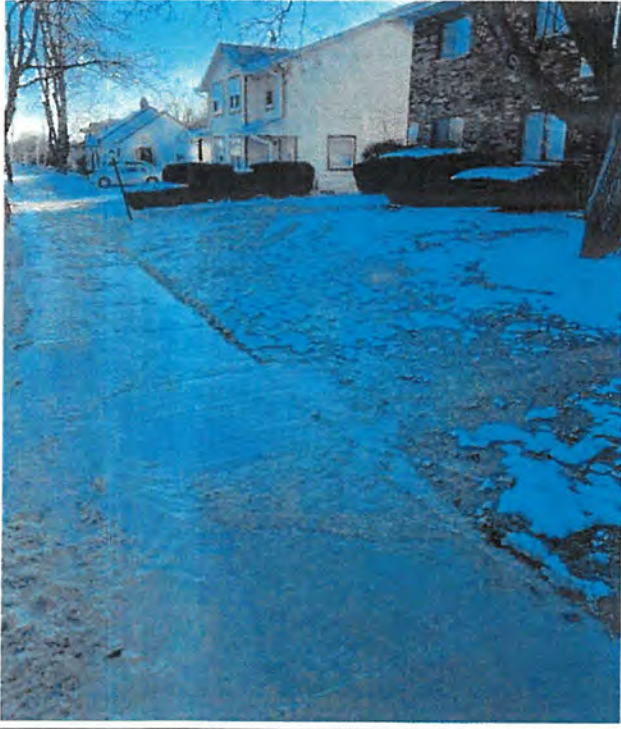
| <b>Photo No.</b><br>24 | <b>Date:</b><br>1/24/25 | | |

| <b>Description:</b><br>Client-provided photograph at the time of the water main break.<br>Condition of property. | | | |

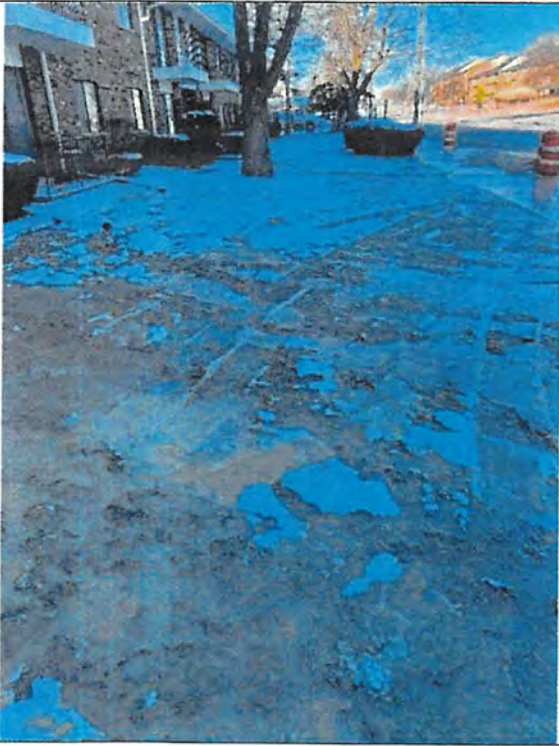
| <b>Photo No.</b><br>26 | <b>Date:</b><br>1/24/25 | | |

| <b>Description:</b><br>Client-provided photograph at the time of the water main break.<br>Condition of property. | | | |

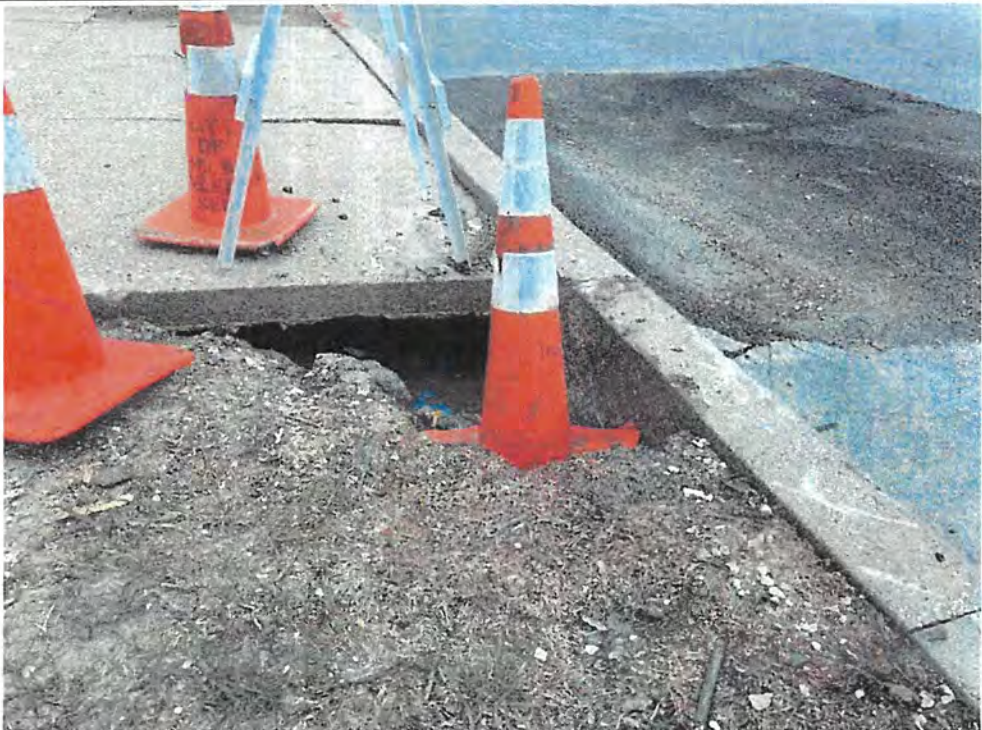
| <b>Photo No.</b><br>12 | <b>Date:</b><br>4/30/25 | |

| <b>Description:</b><br>Area of water main repair on Oklahoma Avenue. | | |

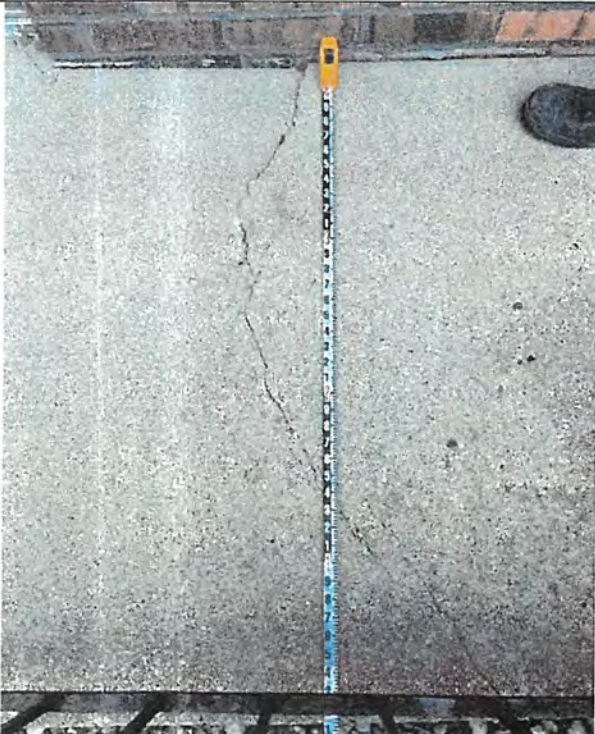
| <b>Photo No.</b><br>14 | <b>Date:</b><br>4/30/25 | |

| <b>Description:</b><br>Separation and cracking of patio from structure on north side of building. | | |

- GZA recommends repairing or replacing the exterior concrete slabs north of the building that have cracked and/or settled as a result of the surface subsidence. Additional gravel backfill may be necessary to establish grades below said slabs.

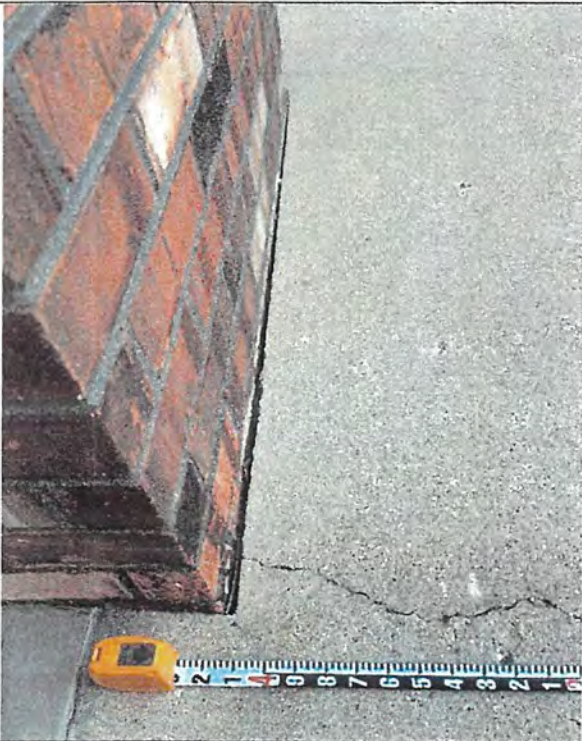
| <b>Photo No.</b><br>16 | <b>Date:</b><br>4/30/25 | |

| <b>Description:</b><br>Separation and cracking of patio from structure on north side of building. | | |

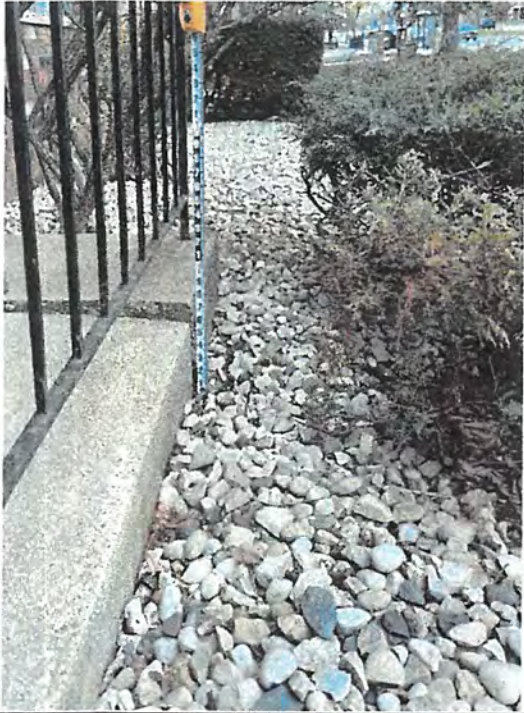
| <b>Photo No.</b><br>17 | <b>Date:</b><br>4/30/25 | | |

| <b>Description:</b><br>Settlement and separation of patio from structure on north side of building. | | | |

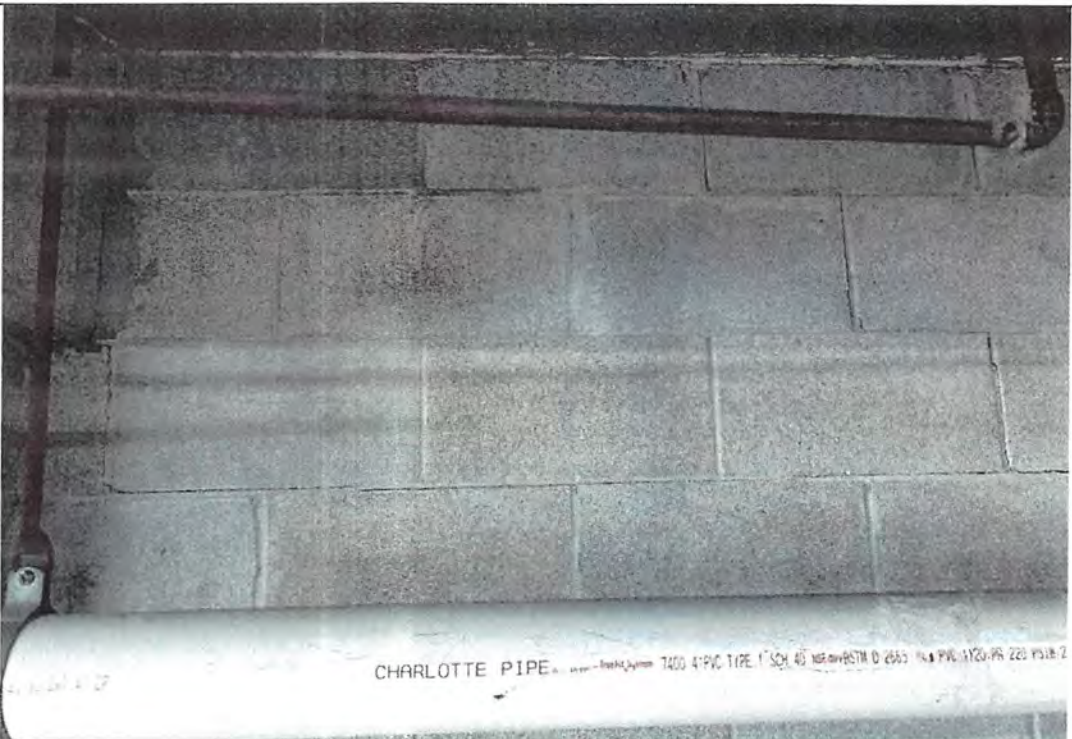
| <b>Photo No.</b><br>18 | <b>Date:</b><br>4/30/25 | |

| <b>Description:</b><br>Cracking of mortar on western wall of basement/parking structure. | | |

- A secondary internal drain tile discharging to the sump pump system could be considered.
- GZA observed cracking and deterioration of the mortar joints. GZA recommends repointing the mortar joints in the CMU block basement wall.

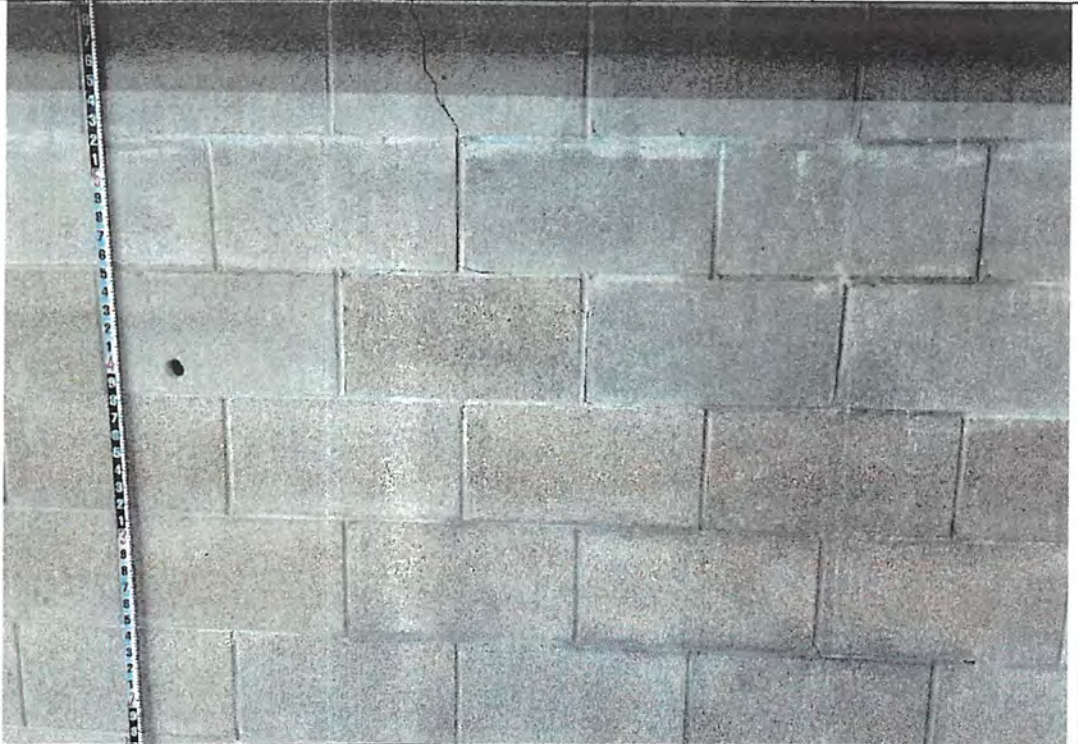
| <b>Photo No.</b><br>21 | <b>Date:</b><br>4/30/25 | | |

| <b>Description:</b><br>Cracking of mortar and block on western wall of basement/parking structure. Observation borehole present. | | | |

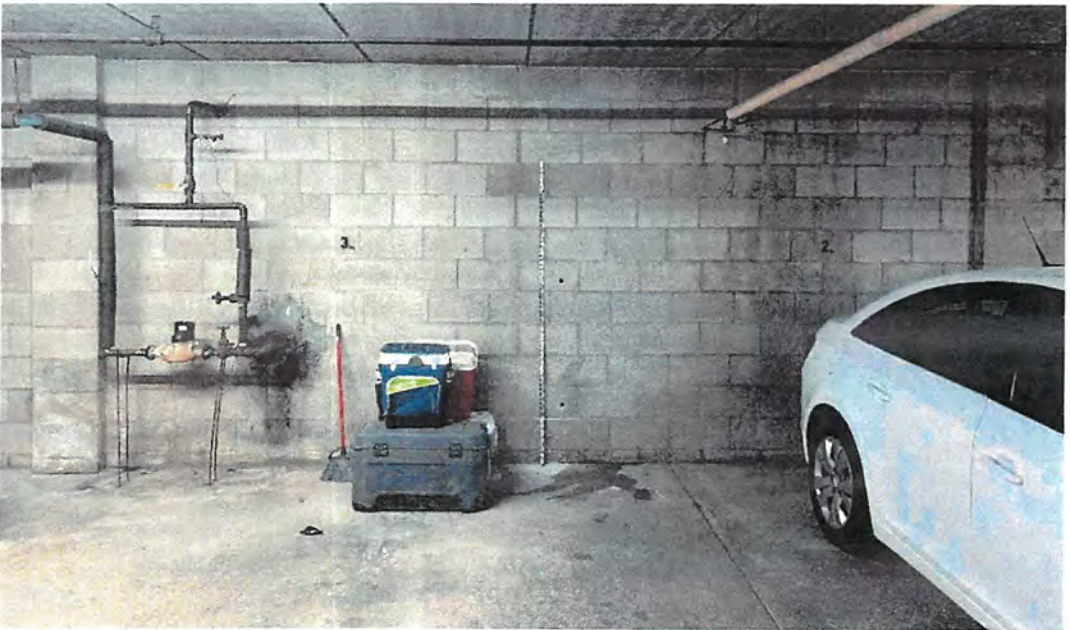
| <b>Photo No.</b><br>22 | <b>Date:</b><br>4/30/25 | |

| <b>Description:</b><br>Parking areas 2 & 3 along northern wall of basement/parking structure. Observation boreholes present. | | |

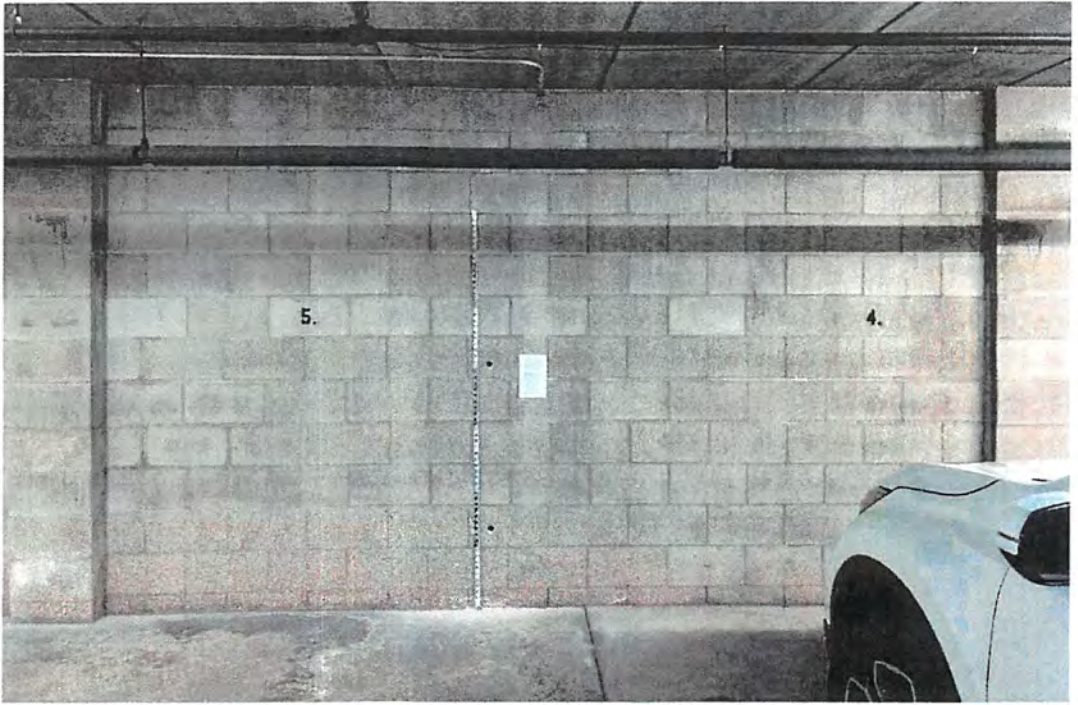
| <b>Photo No.</b><br>23 | <b>Date:</b> | | |

| <b>Description:</b><br>Parking areas 4 & 5 along northern wall of basement/parking structure. Observation boreholes present. | | | |

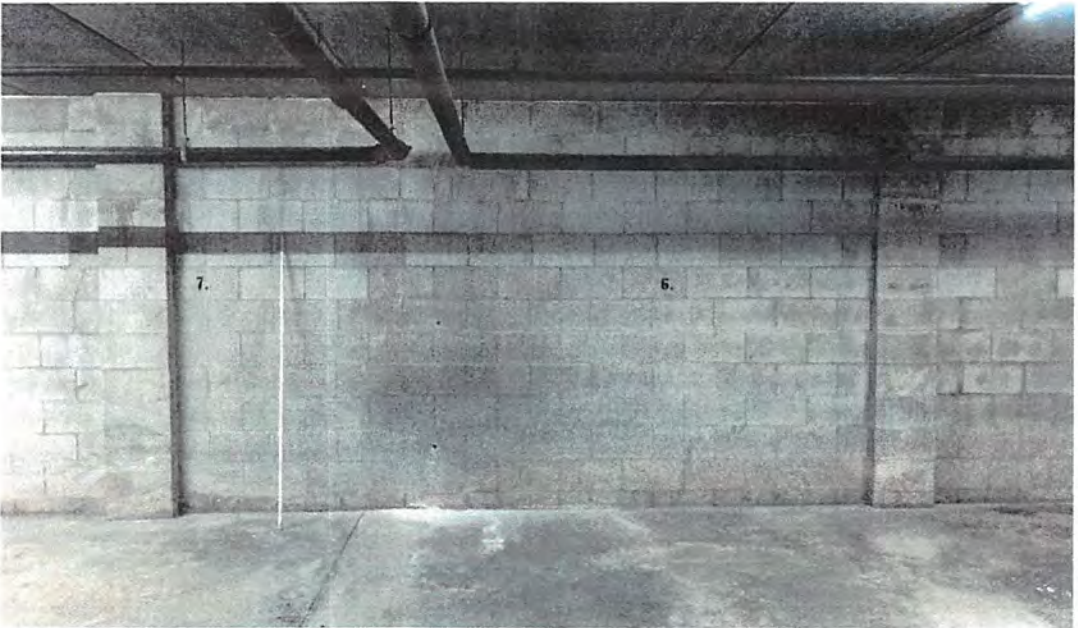
| <b>Photo No.</b><br>24 | <b>Date:</b><br>4/30/25 | |

| <b>Description:</b><br>Parking areas 6 & 7 along northern wall of basement/parking structure. Observation boreholes present. | | |

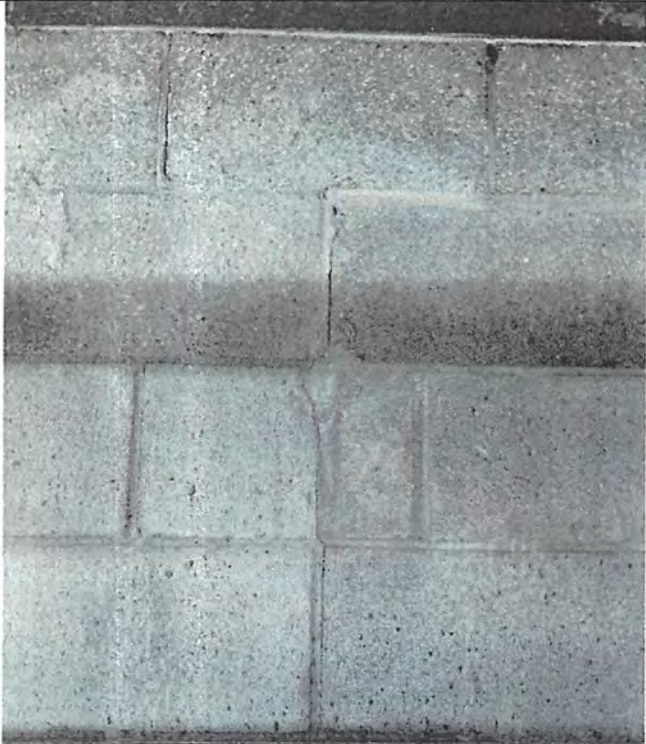
| <b>Photo No.</b><br>25 | <b>Date:</b><br>4/30/25 | | | |

| <b>Description:</b><br>Cracking of mortar on northern wall of basement/parking structure near parking areas 6 & 7. | | | | |

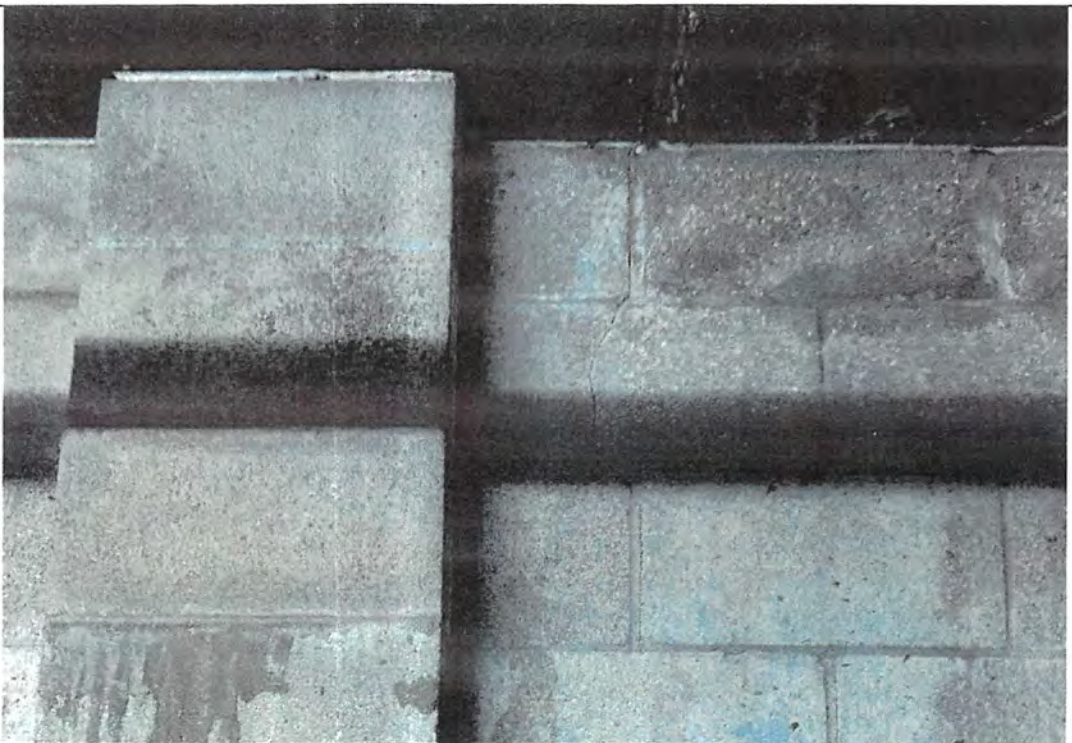
| <b>Photo No.</b><br>26 | <b>Date:</b> | |

| <b>Description:</b><br>Cracking of mortar and block on northern wall of basement/parking structure near parking areas 6 & 7. | | |

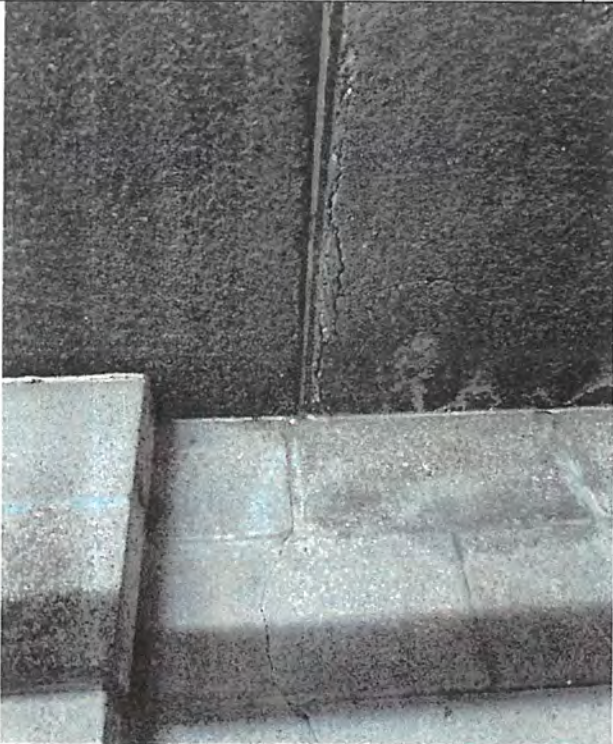
| <b>Photo No.</b><br>27 | <b>Date:</b><br>4/30/25 | | |

| <b>Description:</b><br>Cracking of mortar and block on northern wall of basement/parking structure near parking areas 6 & 7. | | | |

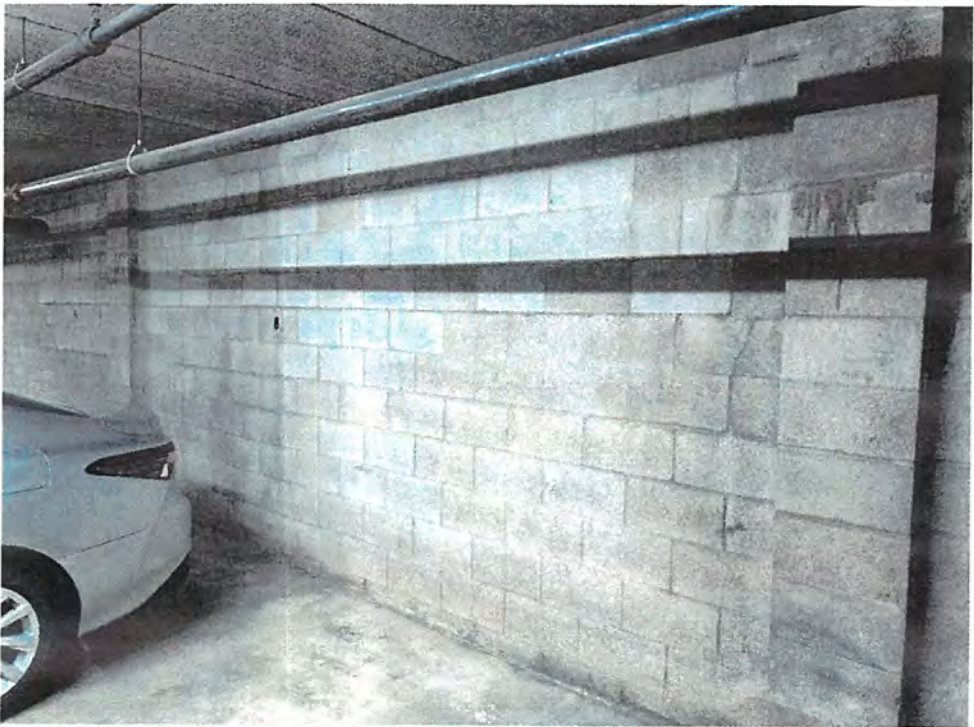
| <b>Description:</b><br>Parking area 8, northern wall of basement/parking structure. | | |

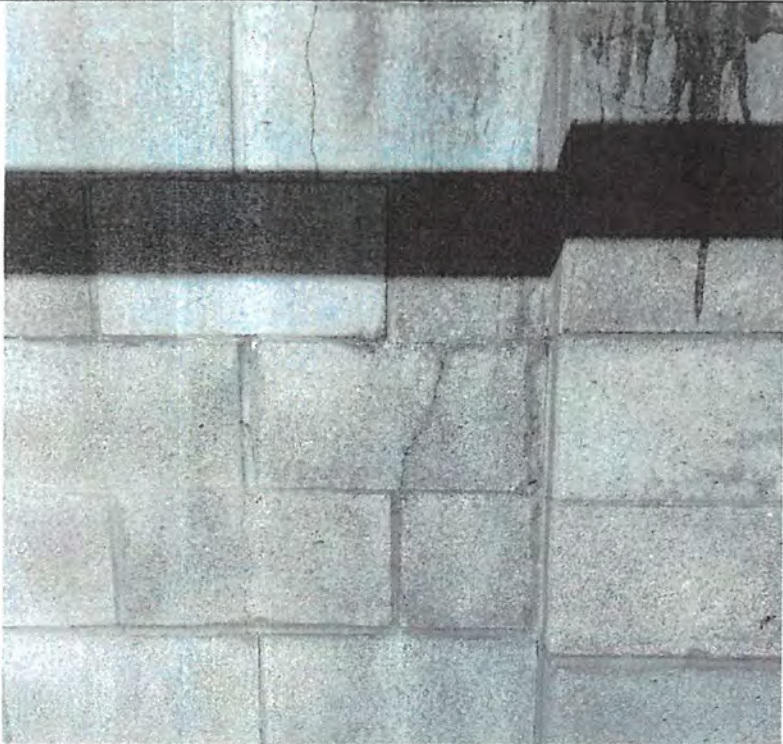
| <b>Description:</b><br>Cracking of mortar and block on northern wall of basement/parking structure near parking area 8. | | | |

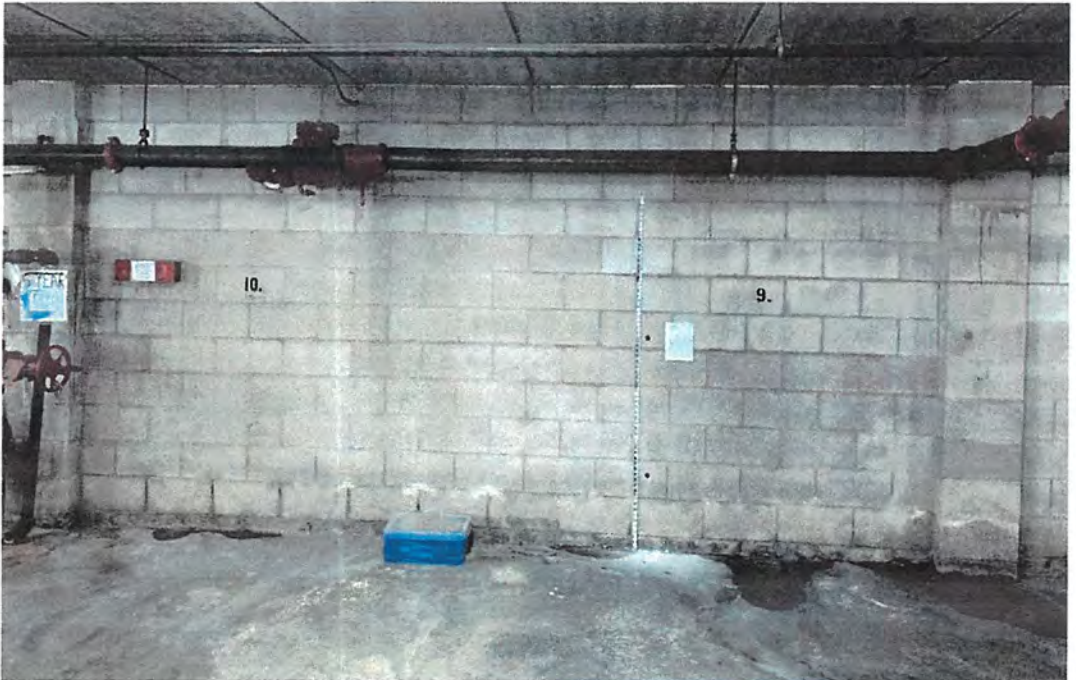
| <b>Description:</b><br>Parking areas 9 & 10 along northern wall of basement/parking structure. Observation boreholes present. | | |

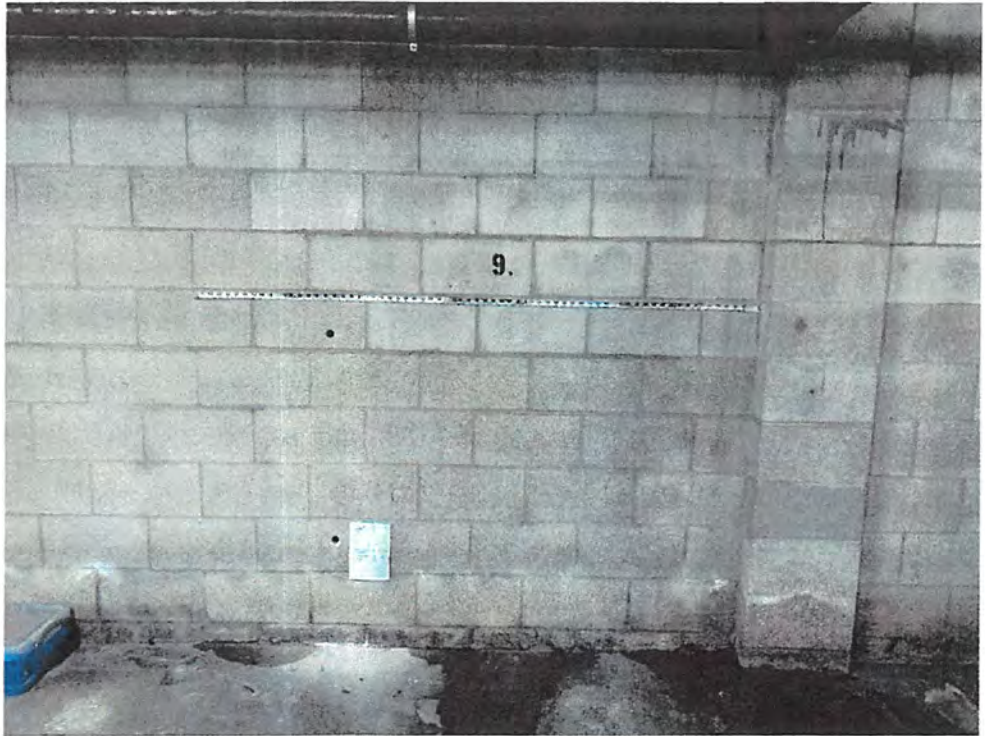
| <b>Description:</b><br>Parking area 9 along northern wall of basement/parking structure. Observation boreholes present. | | | |

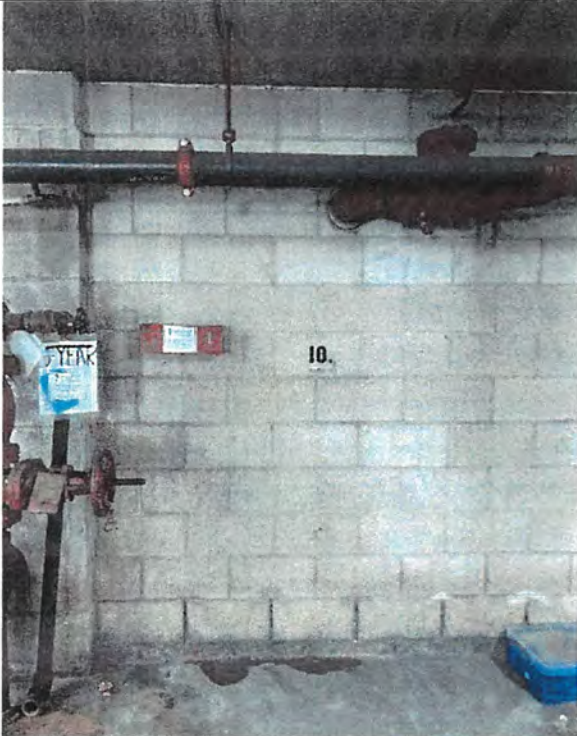
| <b>Description:</b><br>Parking area 10 along northern wall of basement/parking structure. | | |

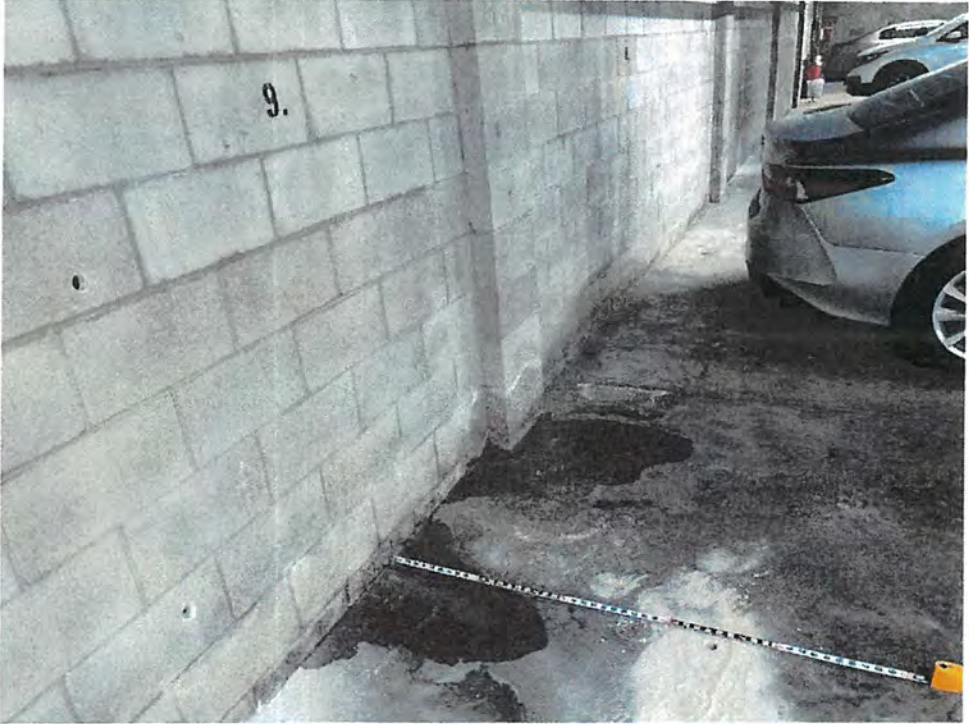
| <b>Description:</b><br>Parking area 9 along northern wall of basement/parking structure. Observation boreholes present. | | | |

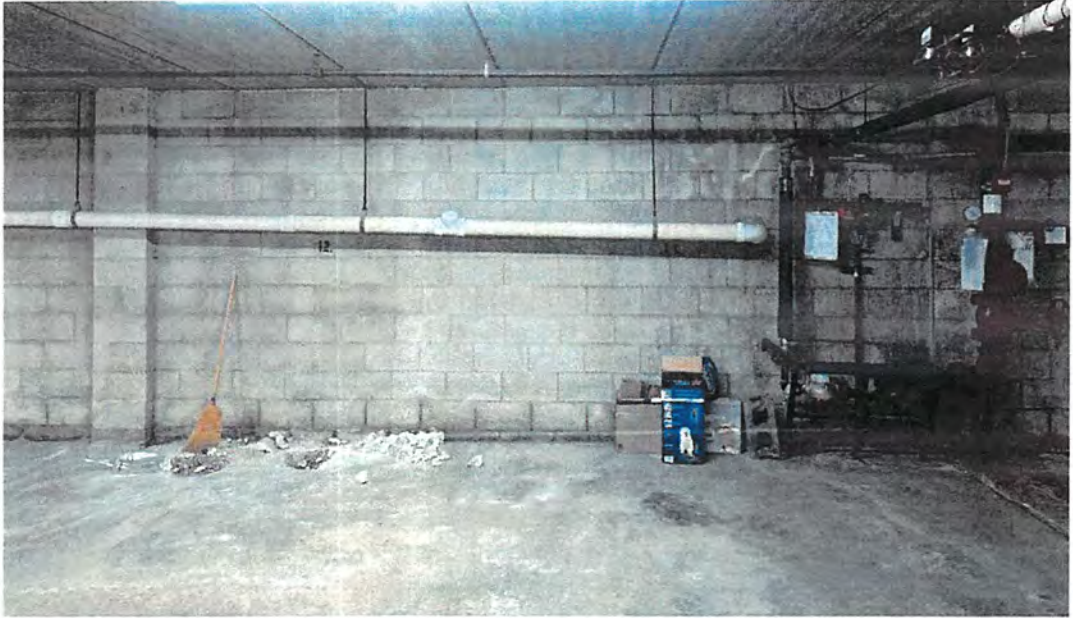
| <b>Description:</b><br>Parking area 9 along northern wall of basement/parking structure. Observation test pit present. | | |

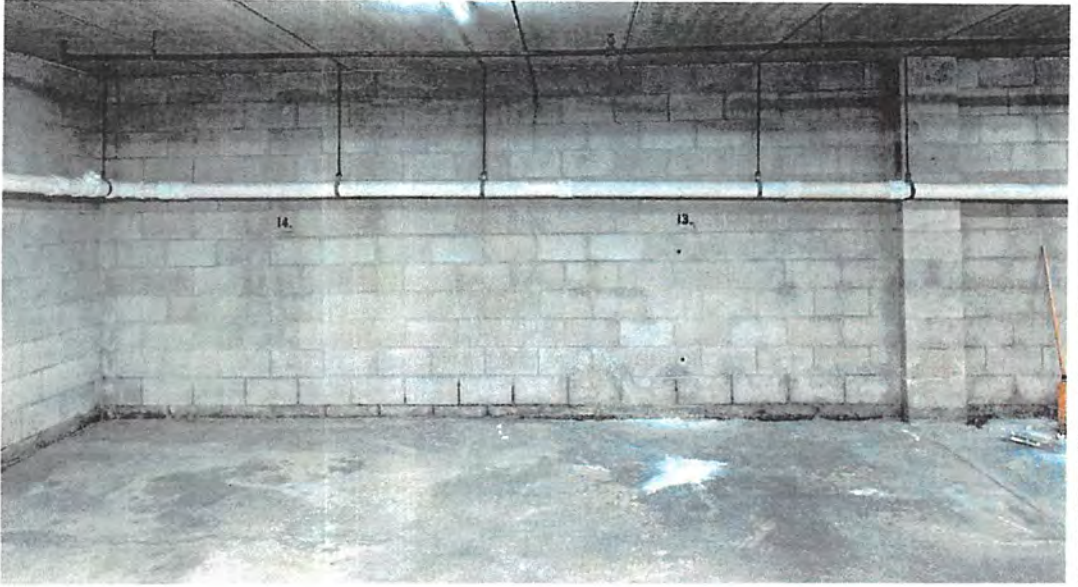
| <b>Description:</b><br>Parking area 13 & 14 along northern wall of basement/parking structure. Observation boreholes present. | | | |

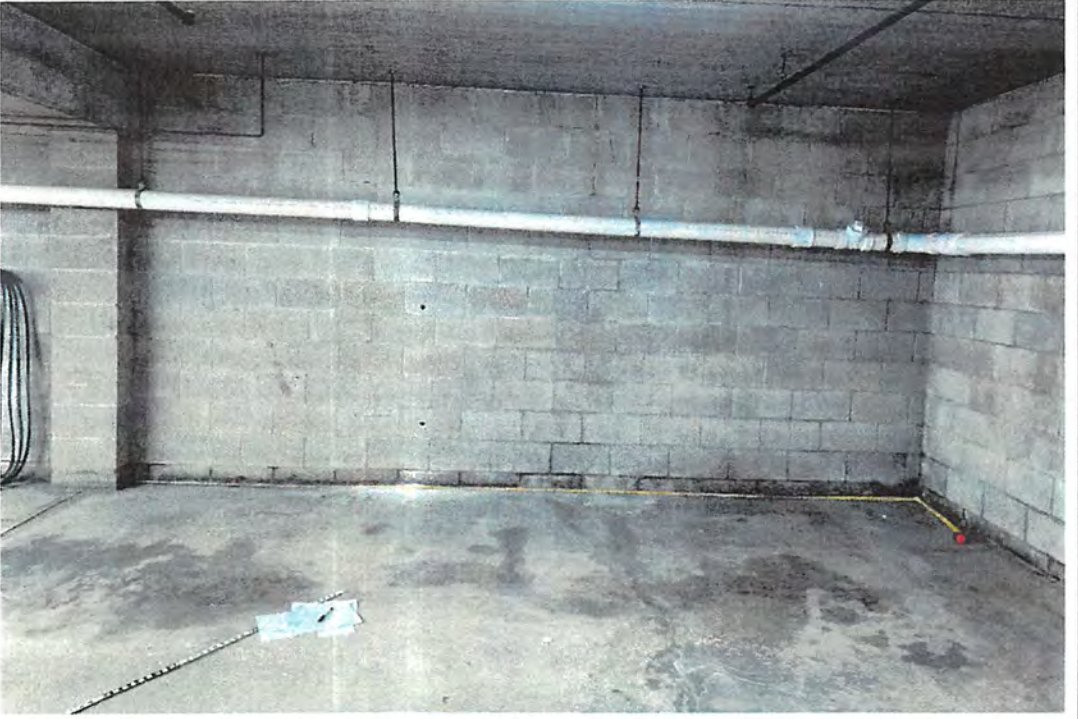
| <b>Description:</b><br>Western wall of basement/parking structure. Observation holes present. | | |

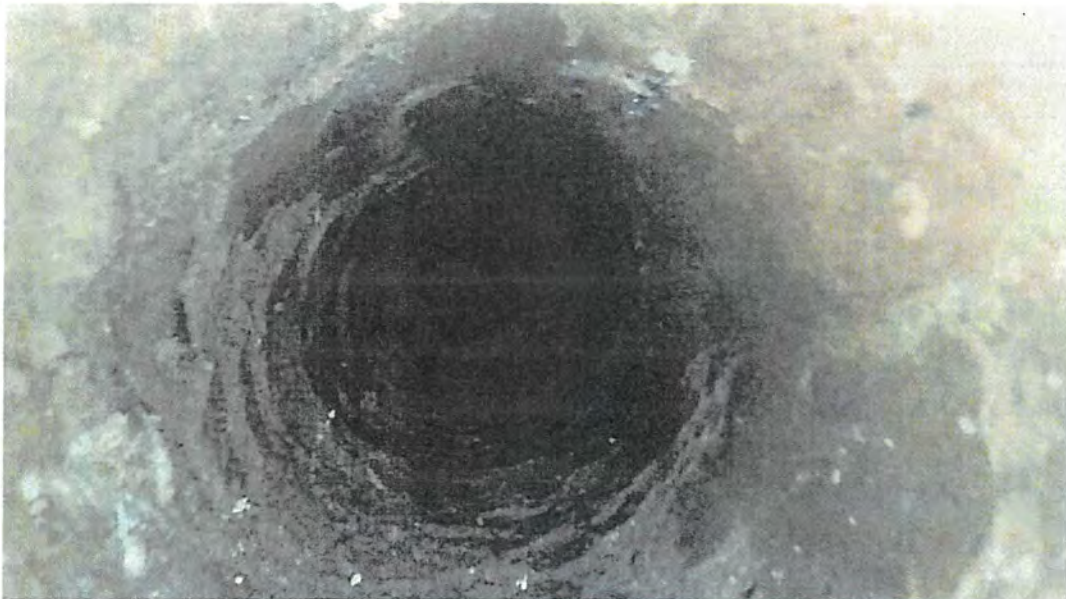
| <b>Description:</b><br>Soil conditions near parking area 2 and 3 (lower observational borehole). Image shows soils just north of CMU block wall. | | | |

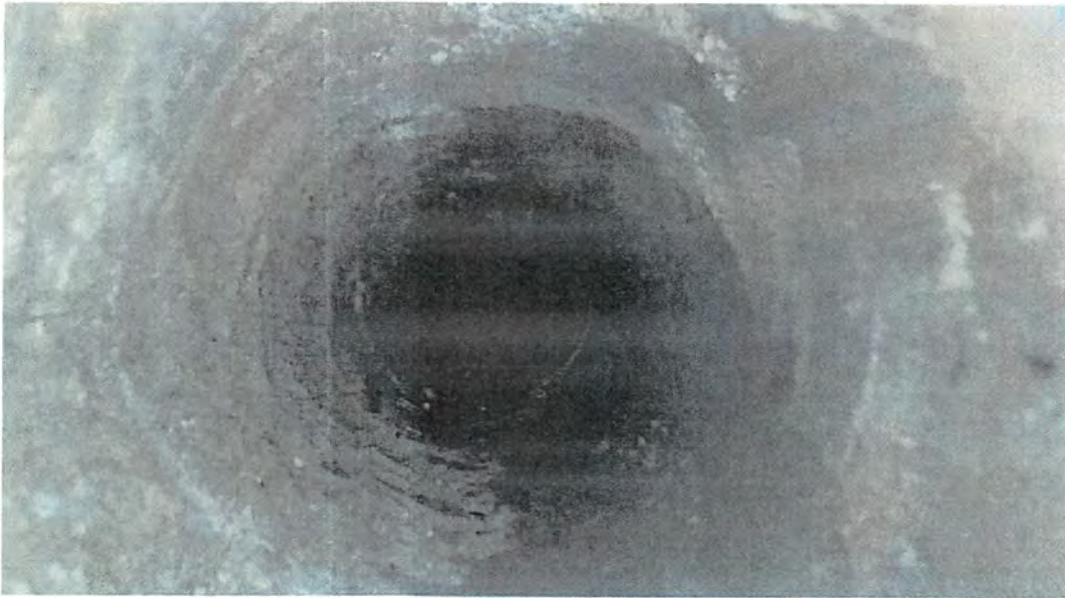
| <b>Description:</b><br>Soil conditions near parking area 2 and 3 (upper observational borehole). Image shows soils just north of CMU block wall. | | |

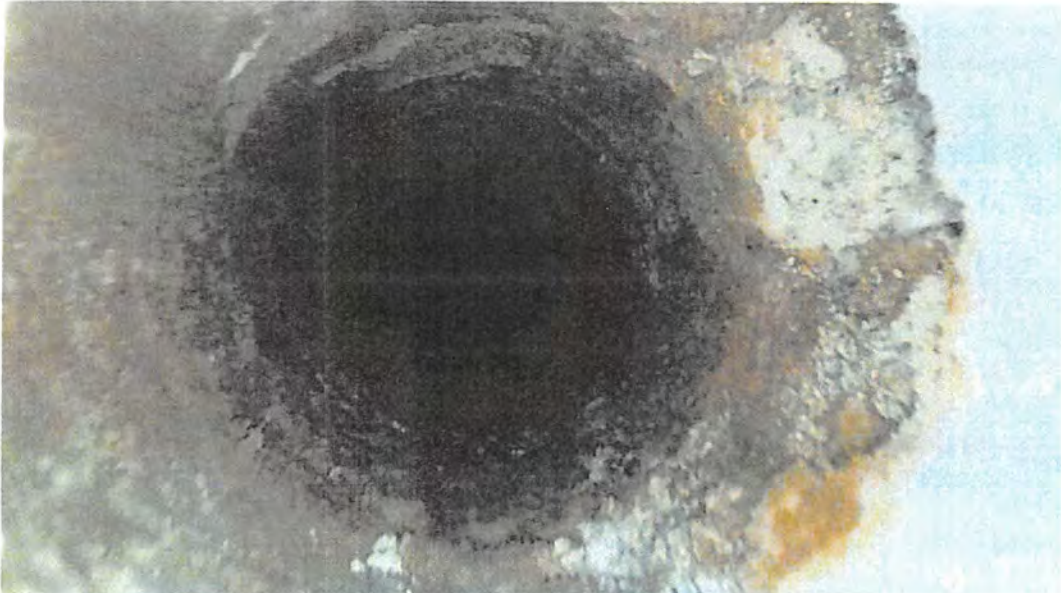
| <b>Description:</b><br>Soil conditions near parking areas 4 and 5 (lower observational borehole). Image shows soils just north of CMU block wall. | | | |
