## WISCONSIN LAKEFRONT PROPERTY MANAGEMENT LLC

Claim: Water Main Break Property Damage  
Property: Manorview Apartments  
Address: 8509 W Oklahoma Ave., Milwaukee, WI 53227  
Owner: Manorview Apartment Homes LLC  
Managing Member: Eileen Robarge  
Owner Contact Info: (858)761-2980, [erobarge@windwardcovelc.com](mailto:erobarge@windwardcovelc.com)  
Property Manager: Allen Boelk  
Property Manager Contact Info: (414)322-6677 [allenb@windwardcovelc.com](mailto:allenb@windwardcovelc.com)  
Administator Contact: Ann Henry 866-542-5851 [annh@windwardcovelc.com](mailto:annh@windwardcovelc.com)  
Business Registered Mailing Address: 4712 Whispering Oak Court, Apt. 16, Sheboygan, WI 53083  
Date of Event: January 24<sup>th</sup> 2025, Time: Noticed at 6:30 am

GZA GeoEnvironmental, Inc. (GZA) is pleased to submit this Memorandum ("Memo") to Wisconsin Lakefront Property Management LLC ("Client") for the above-referenced project located at 8509 West Oklahoma Avenue in Milwaukee, Wisconsin ("Site"). A Site Location Plan is provided as **Figure 1**. This Memo provides a summary of findings and recommendations from GZA's Site visit and fieldwork performed on April 30, 2025, and subsequent labo

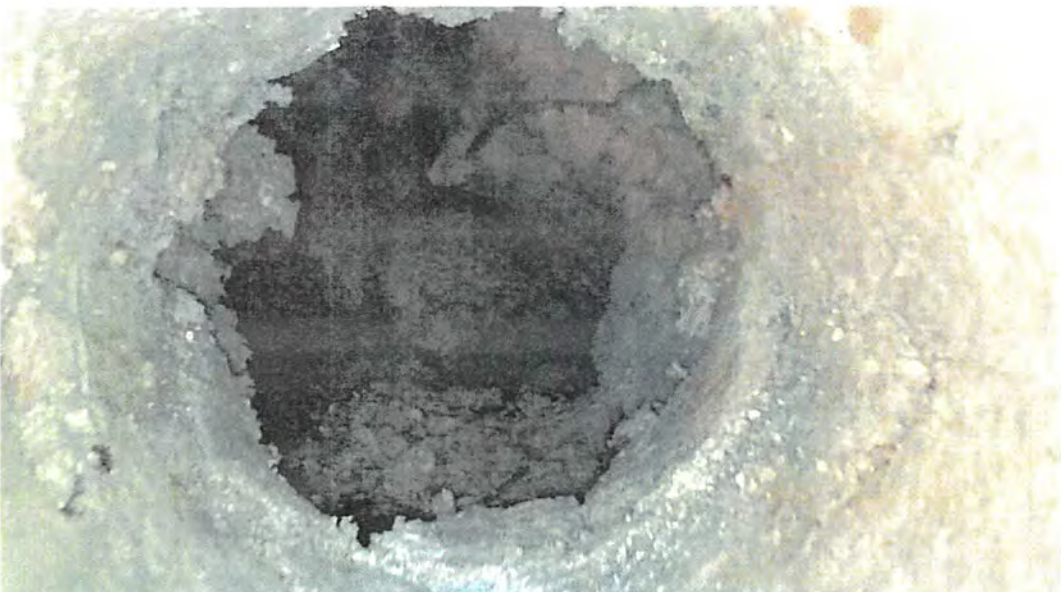
| <b>Description:</b><br>Soil conditions near parking areas 4 and 5 (upper observational borehole). Image shows soils and void space just north of CMU block wall. | | |

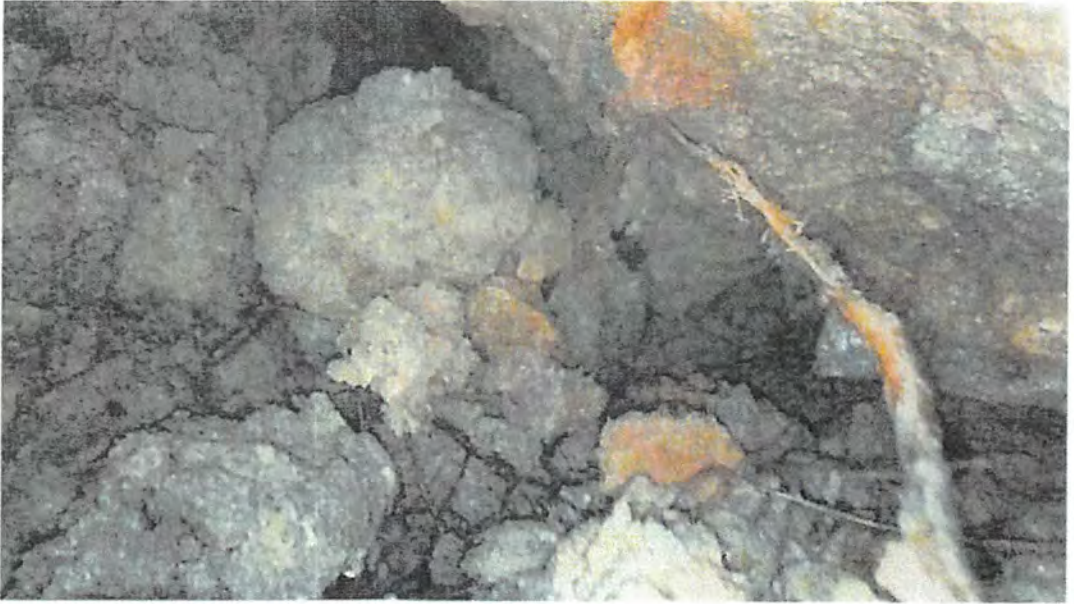
| <b>Description:</b><br>Soil conditions near parking areas 4 and 5 (upper observational borehole). Image shows soils and void space just north of CMU block wall. | | | |

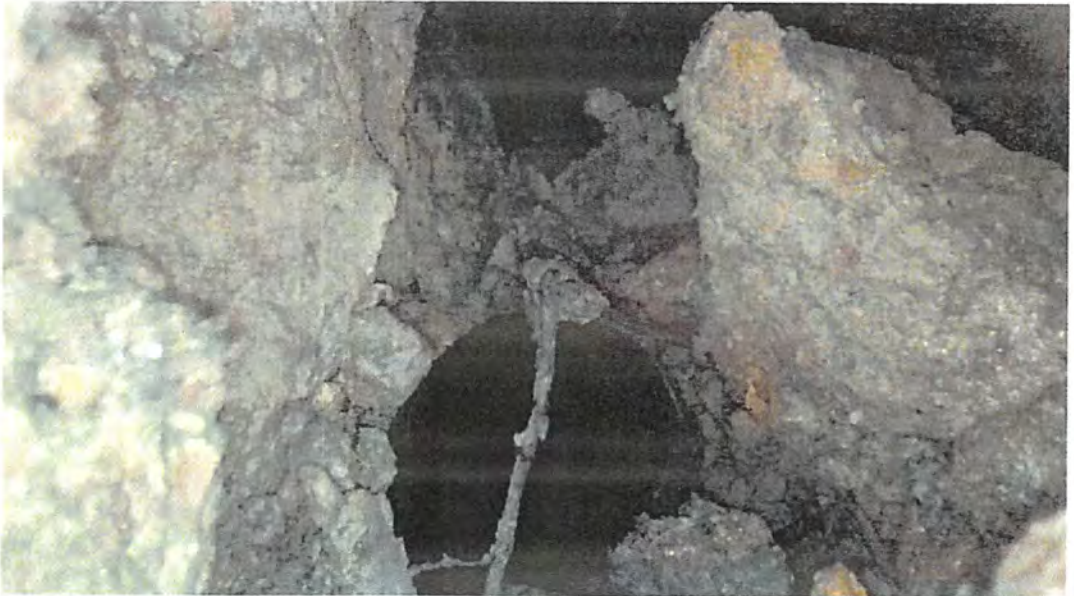
| <b>Description:</b><br>Soil conditions near parking areas 4 and 5 (upper observational borehole). Image shows soils and void space just north of CMU block wall. | | |

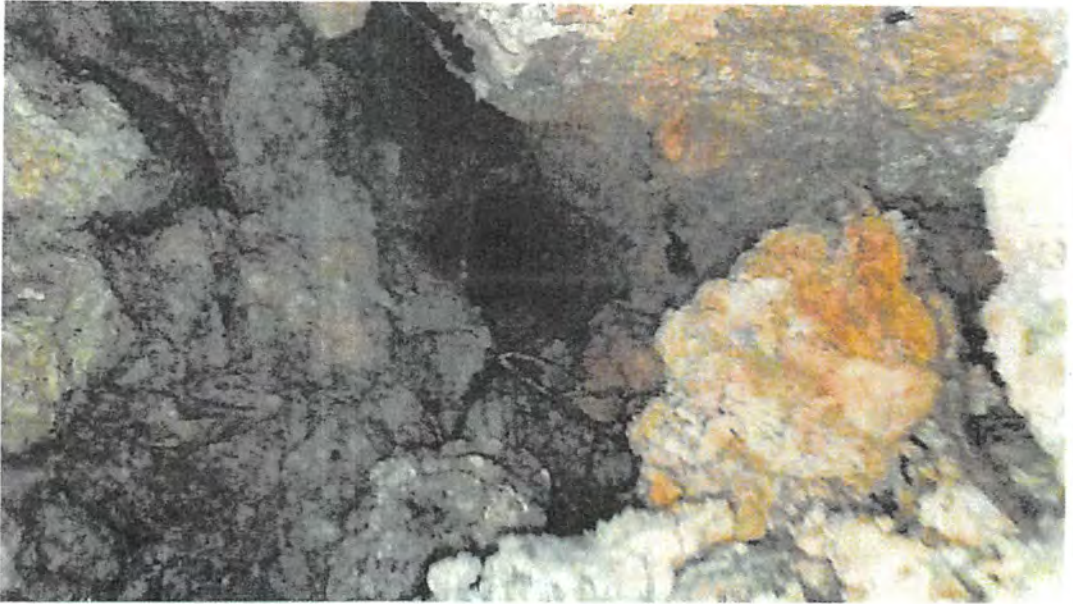
| <b>Description:</b><br>Soil conditions near parking areas 4 and 5 (upper observational borehole). Image shows soils and void space just north of CMU block wall. | | | |

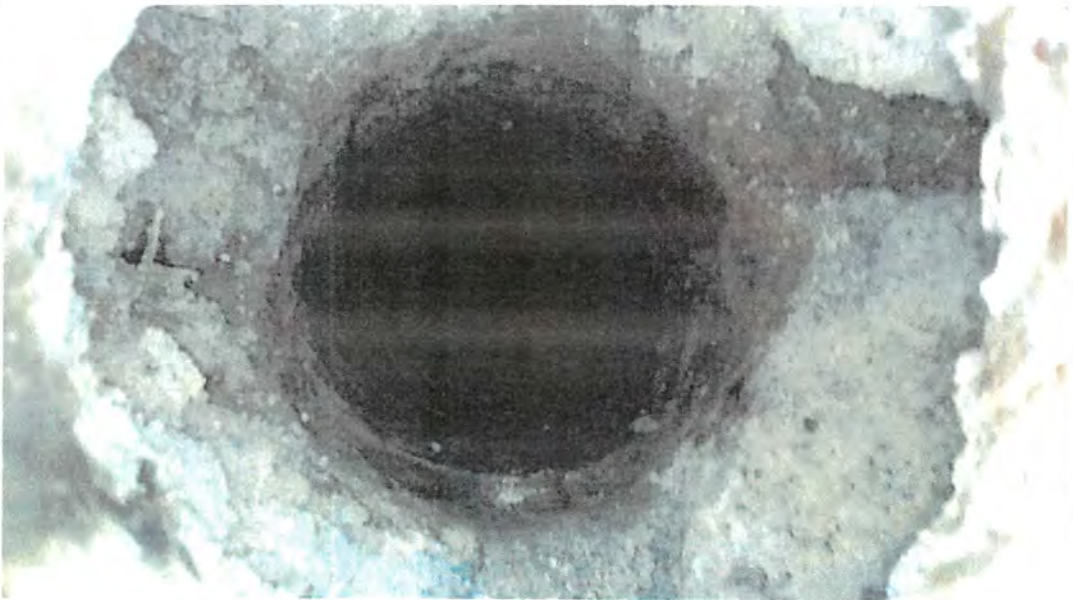
| <b>Description:</b><br>Soil conditions near parking areas 4 and 5 (upper observational borehole). Image shows soils and void space just north of CMU block wall. | | |

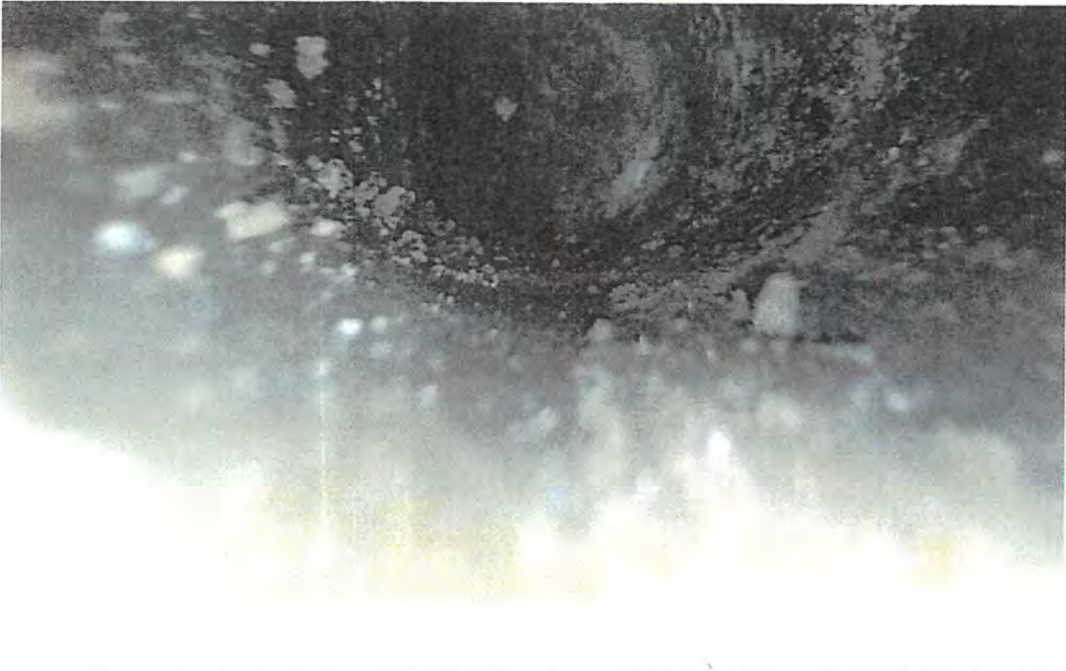
| <b>Description:</b><br>Soil conditions near parking area 6 and 7 (upper observational borehole). Image shows soils just north of CMU block wall. | | | |

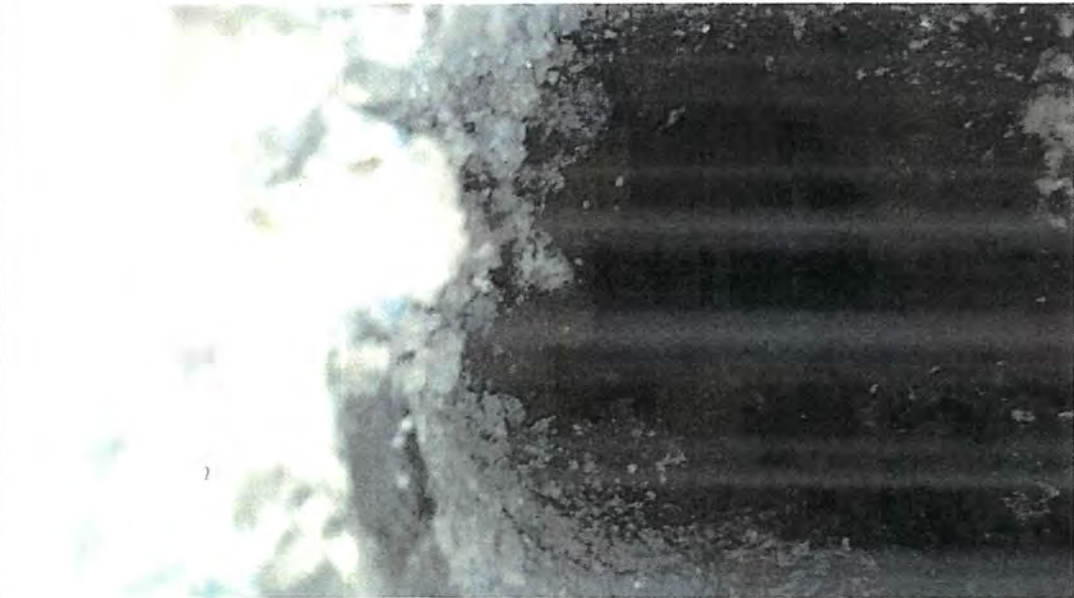
| <b>Description:</b><br>Soil conditions near parking areas 6 and 7 (upper observational borehole). Image shows soils and void space just north of CMU block wall. | | |

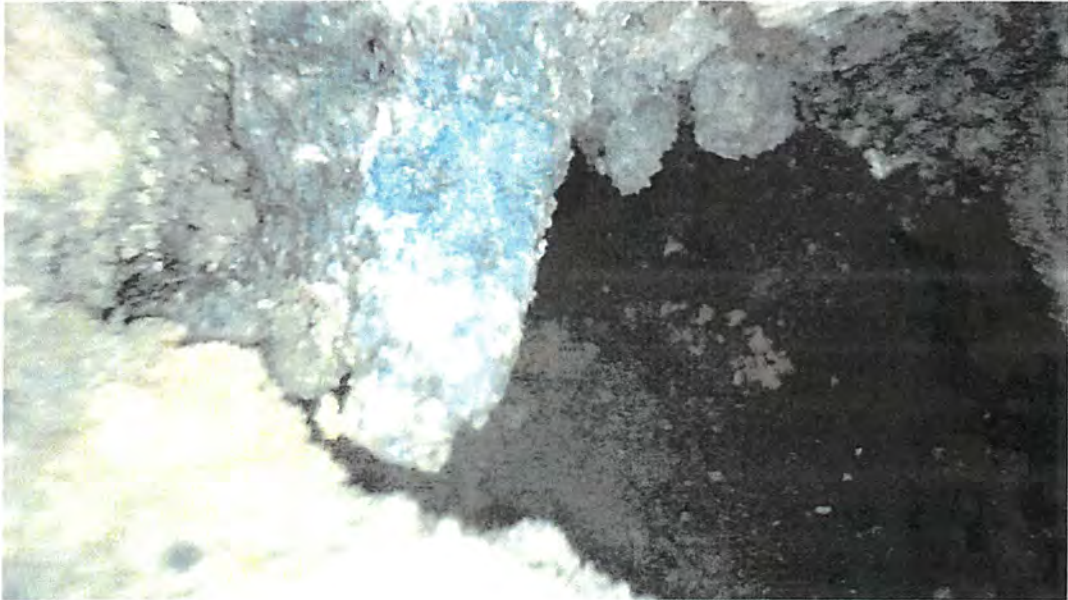
| <b>Description:</b><br>Soil conditions near parking areas 6 and 7 (upper observational borehole). Image shows soils and void space just north of CMU block wall. | | | |

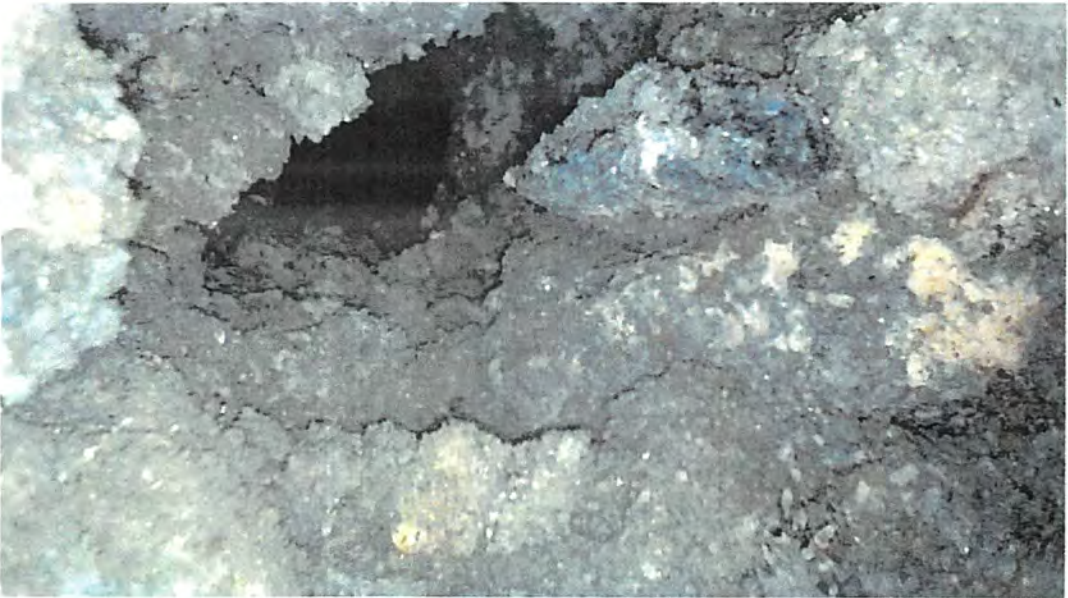
| <b>Description:</b><br>Soil conditions near parking areas 6 and 7 (upper observational borehole). Image shows soils and void space just north of CMU block wall. | | | |

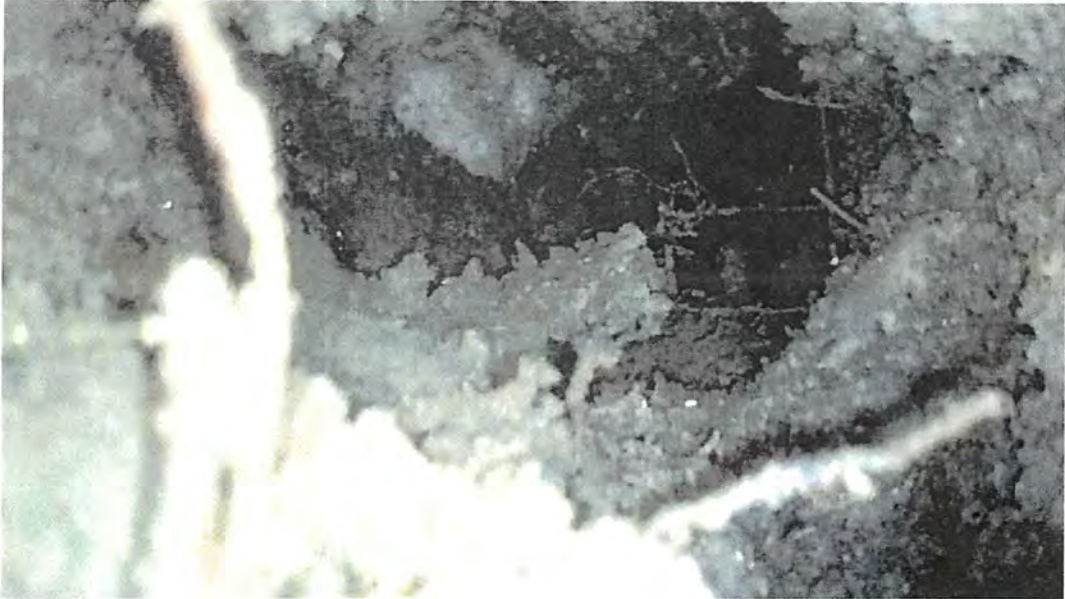
| <b>Description:</b><br>Soil conditions near parking areas 6 and 7 (upper observational borehole). Image shows soils and void space just north of CMU block wall. | | | |

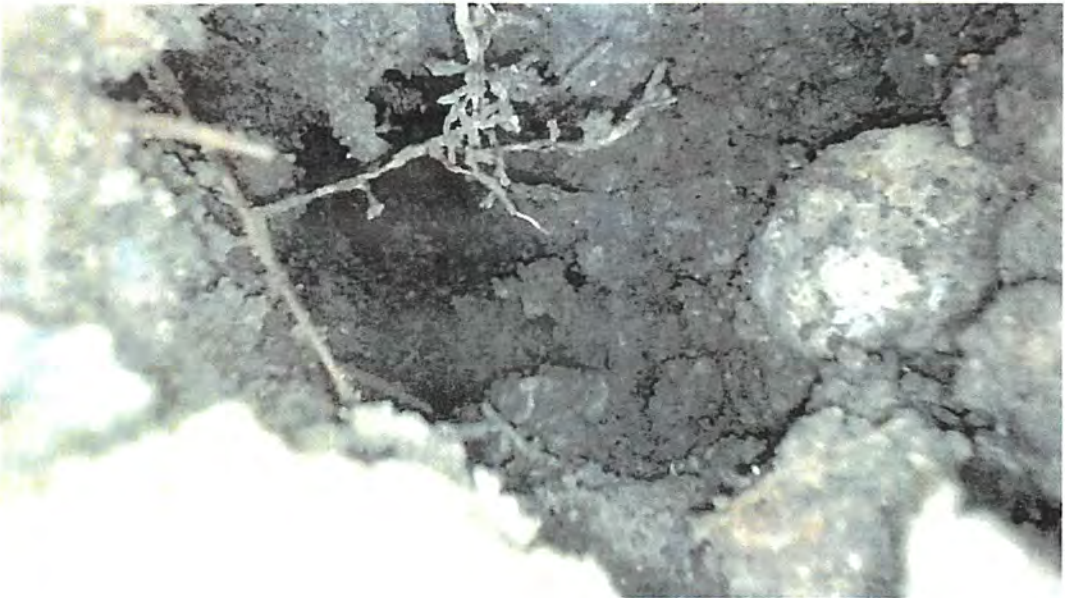
| <b>Description:</b><br>Soil conditions near parking areas 6 and 7 (upper observational borehole). Image shows soils and void space just north of CMU block wall. | | |

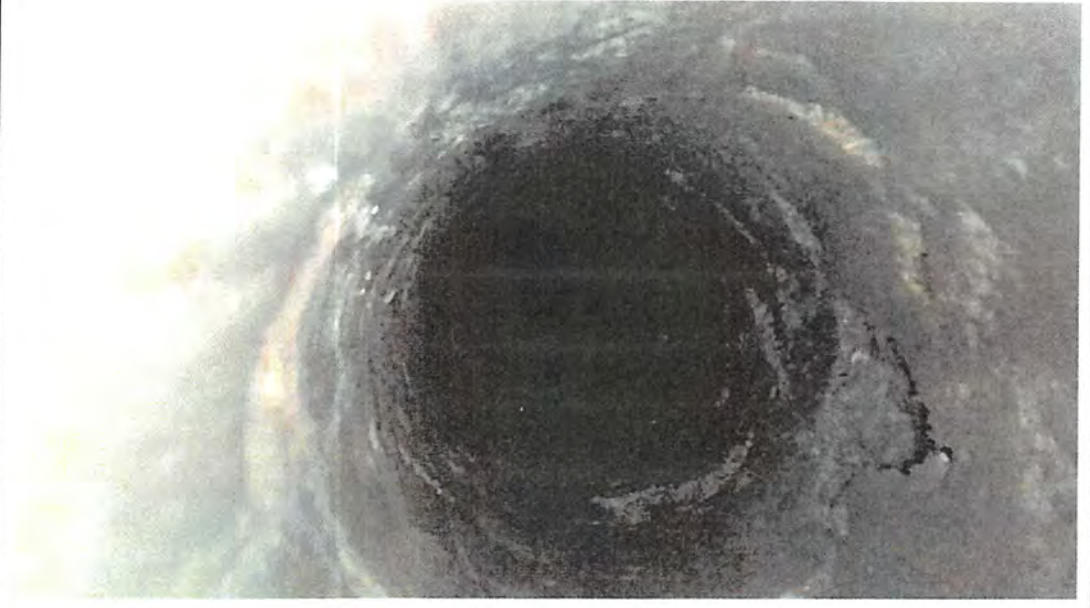
| <b>Description:</b><br>Soil conditions near parking area 9 and 10 (upper observational borehole). Image shows soils just north of CMU block wall. | | | |

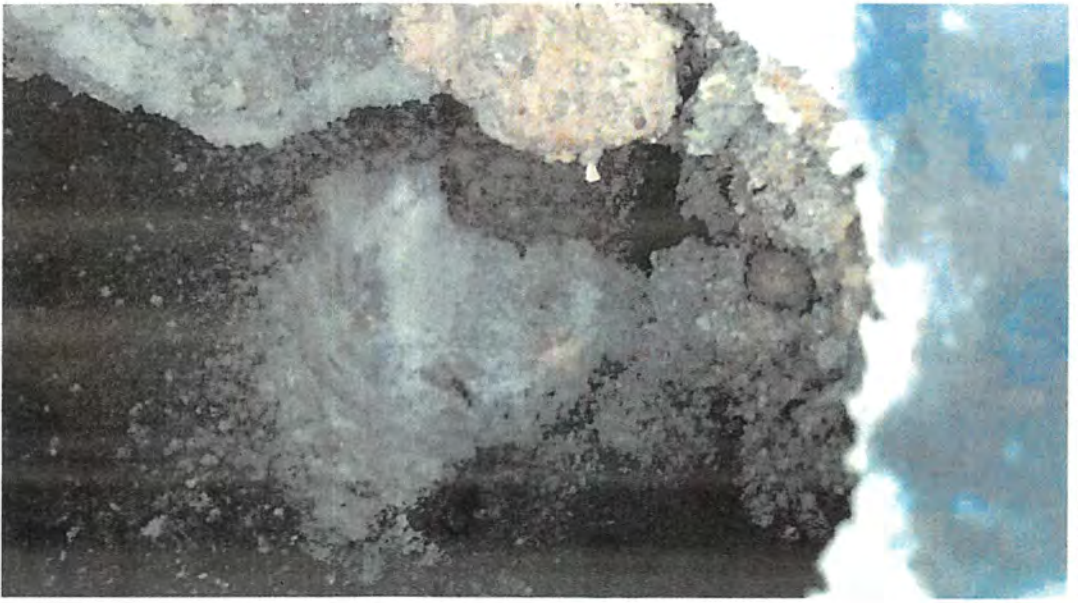
| <b>Description:</b><br>Soil conditions near parking area 13 (lower observational borehole). Image shows soils and void space just north of CMU block wall. | | |

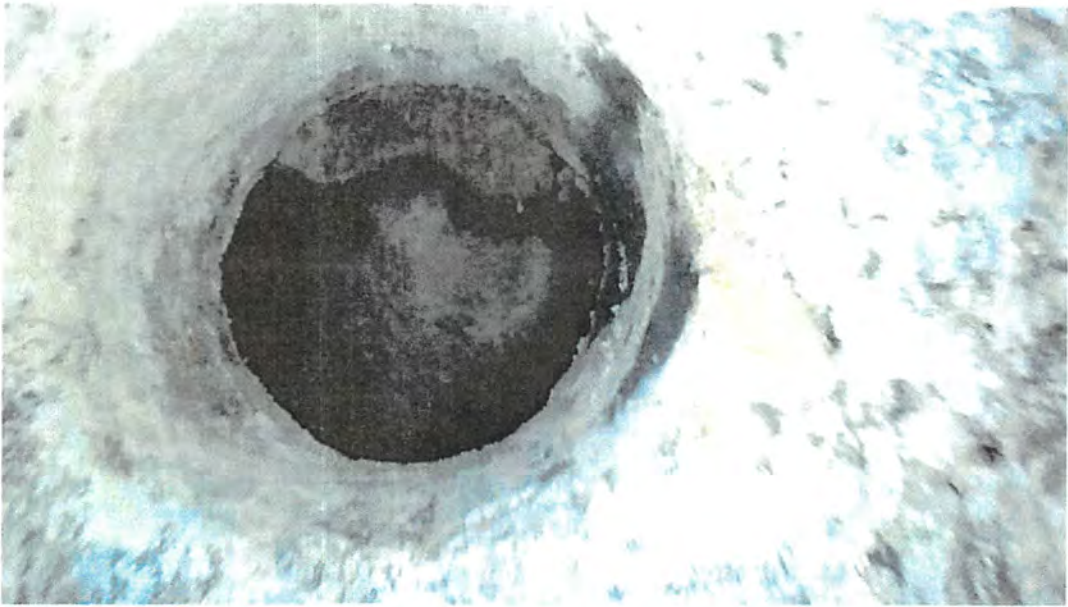
| <b>Description:</b><br>Soil conditions near parking area 13 (lower observational borehole). Image shows soils and void space just north of CMU block wall. | | | |

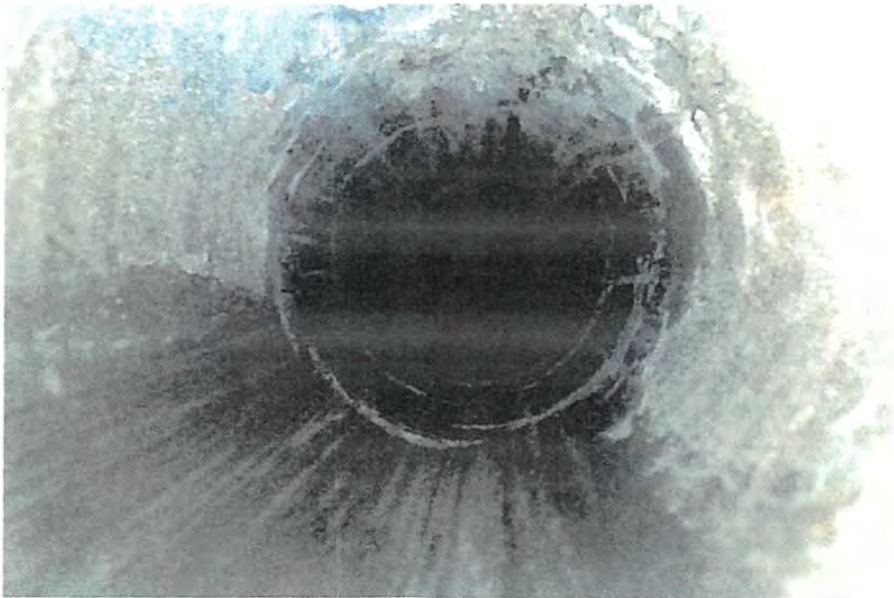
| <b>Description:</b><br>Soil conditions near parking area 14 (lower observational borehole). | | |

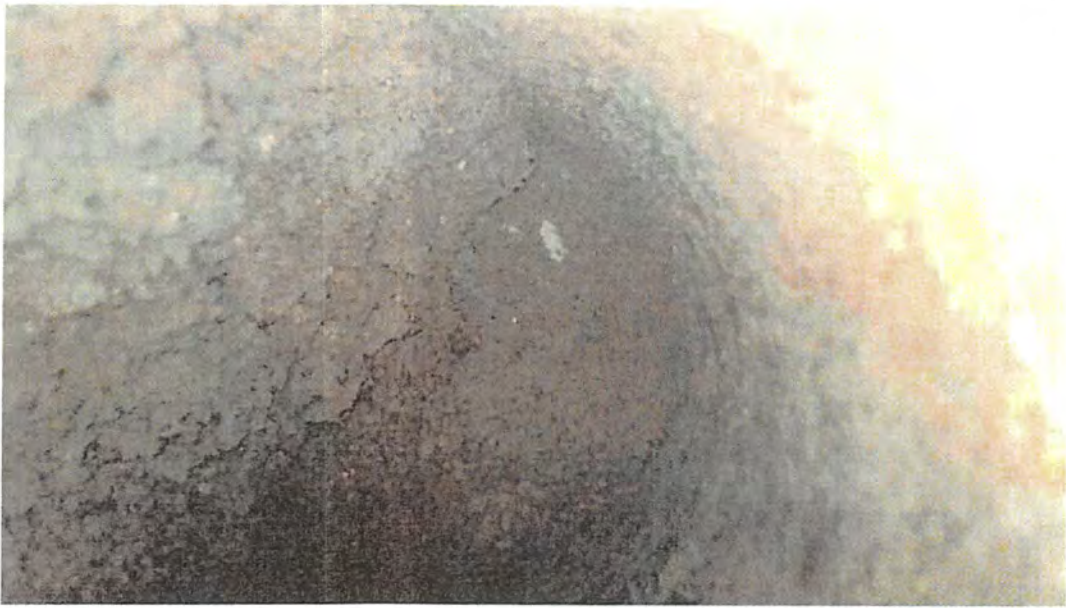
| <b>Description:</b><br>Soil conditions near parking area 14 (upper observational borehole). | | | |

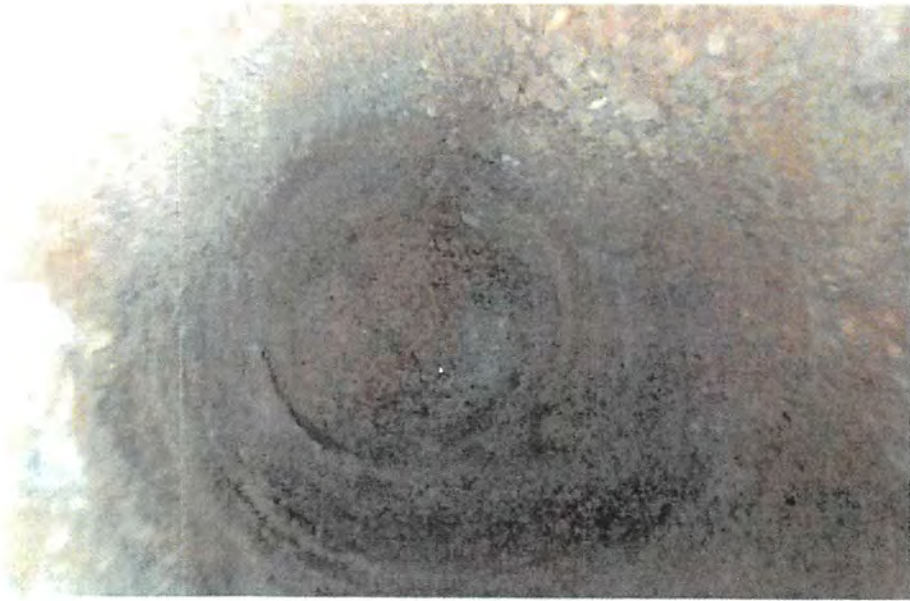
| <b>Description:</b><br>Soil conditions near parking area 14 (upper observational borehole). | | |

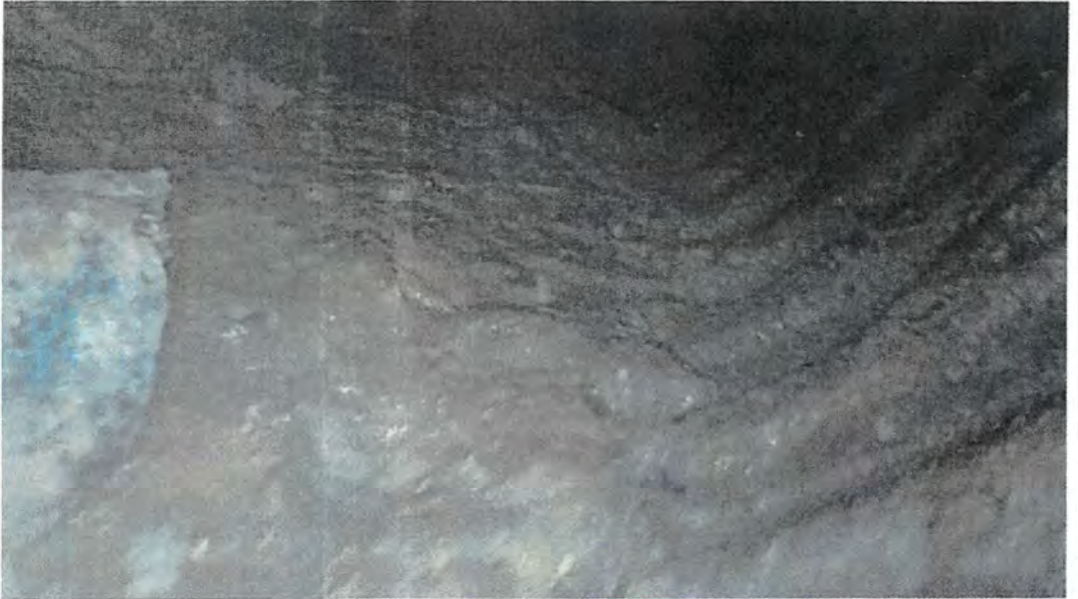
| <b>Description:</b><br>Interior drain tile of northern wall in basement/ parking structure. | | | |

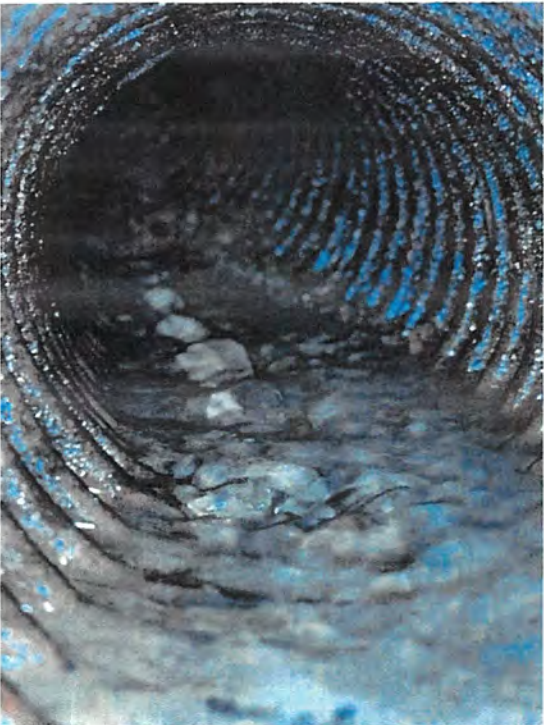
| <b>Description:</b><br>Interior drain tile of western wall in basement/ parking near sump crock. Relatively clear with minor infill. | | |

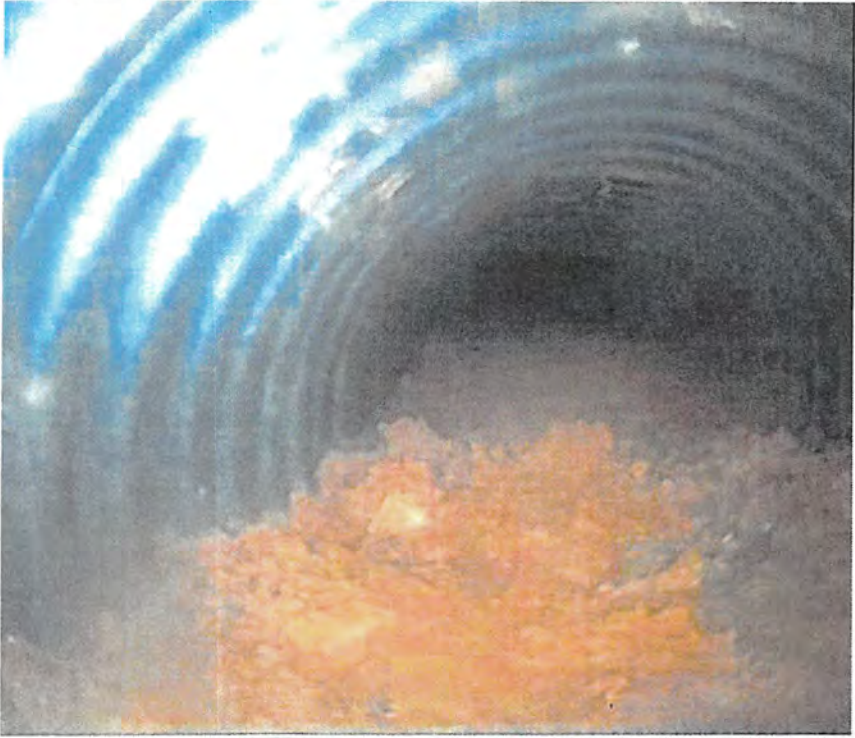
| <b>Description:</b><br>Interior drain tile of western wall in basement/ parking approximately 4 feet from sump crock. Drain tile approximately half-full of sediment. | | | |

- Remove concrete floor along perimeter of work area down to footing exposing clogged drain tile.
  - Ripout & replace approximately 205' of clogged inside drain tile within foundation.
