Department Copy

Dear Jim,

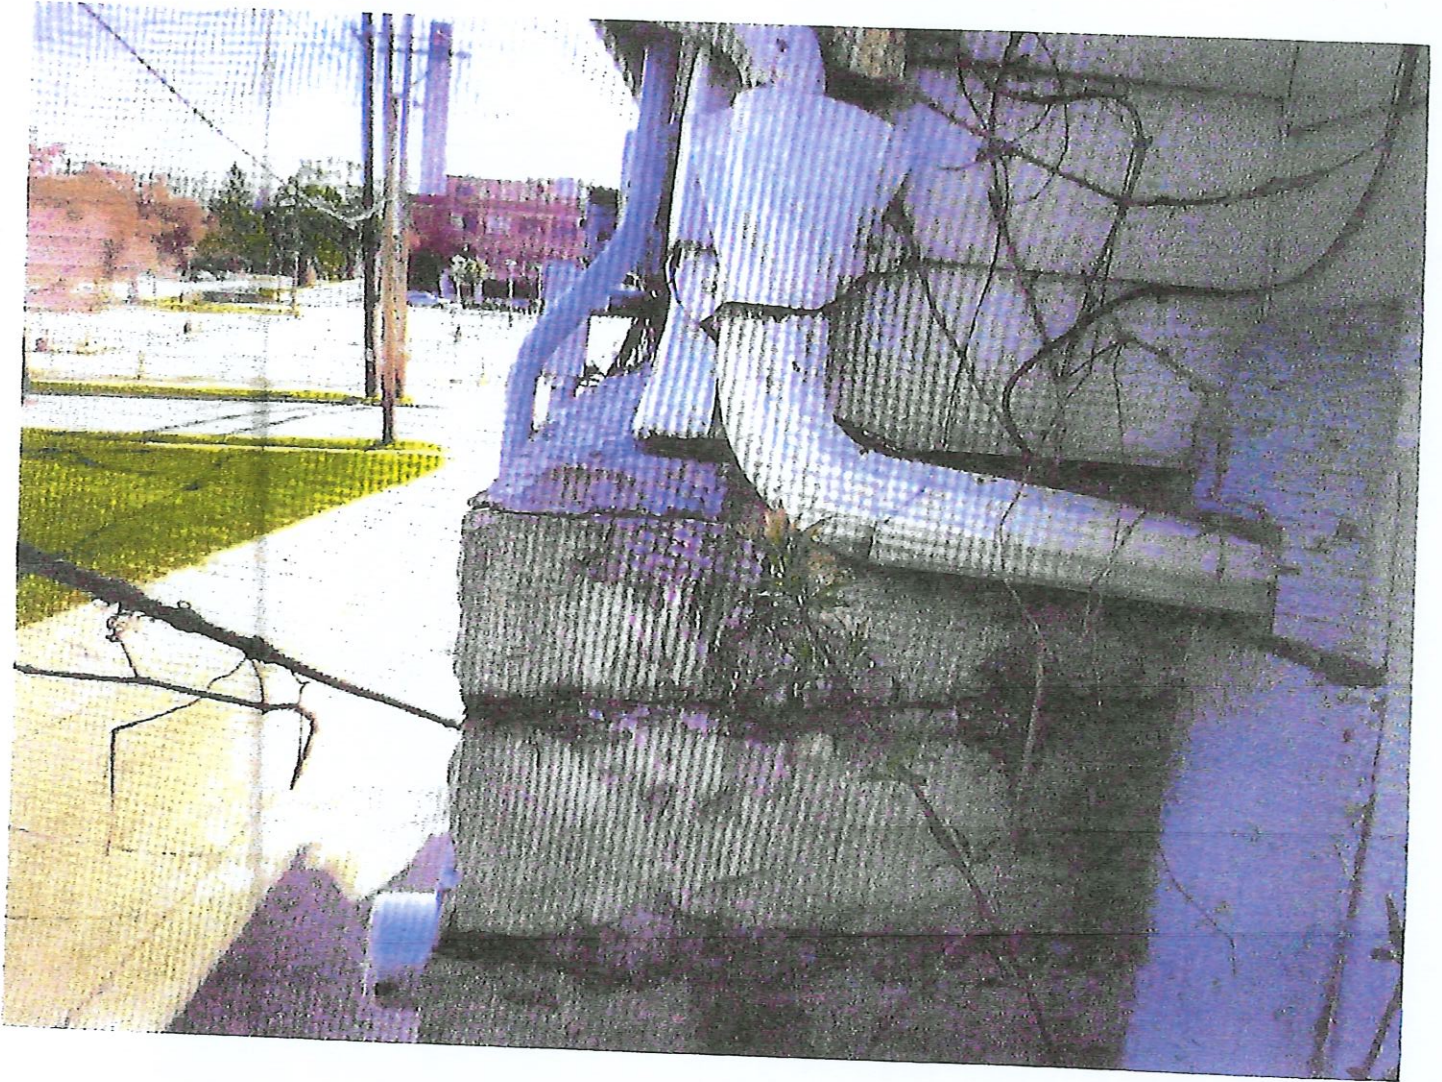
[Sent from Yahoo Mail on Android](#)

During the day about 4:00 pm, I noticed most of the properties had a modern roofing layer applied to the roof system. I was unable to determine how many layers there may be, but certainly, the venting does not comply with manufacturer specifications and may void the warranty and lessen the functional life of the roof. Installation of the roof covering is a common re-insurance issue given how bad it was on the surfaces.

State of Wisconsin Boiler Certification permit every 3 years, and any unsafe or incorrect venting would be required to be repaired now. Suggest verification and or status is needed for good function and safety. This observation, I offered last year, and at the City Hearing I noted the City was on Notice about this possible impending safety issue.

Entry and egress appeared in about the same condition as the older group of buildings. Uneven varying-riser heights, handrails with no ballisters on these residential rooming house/ SRO buildings.

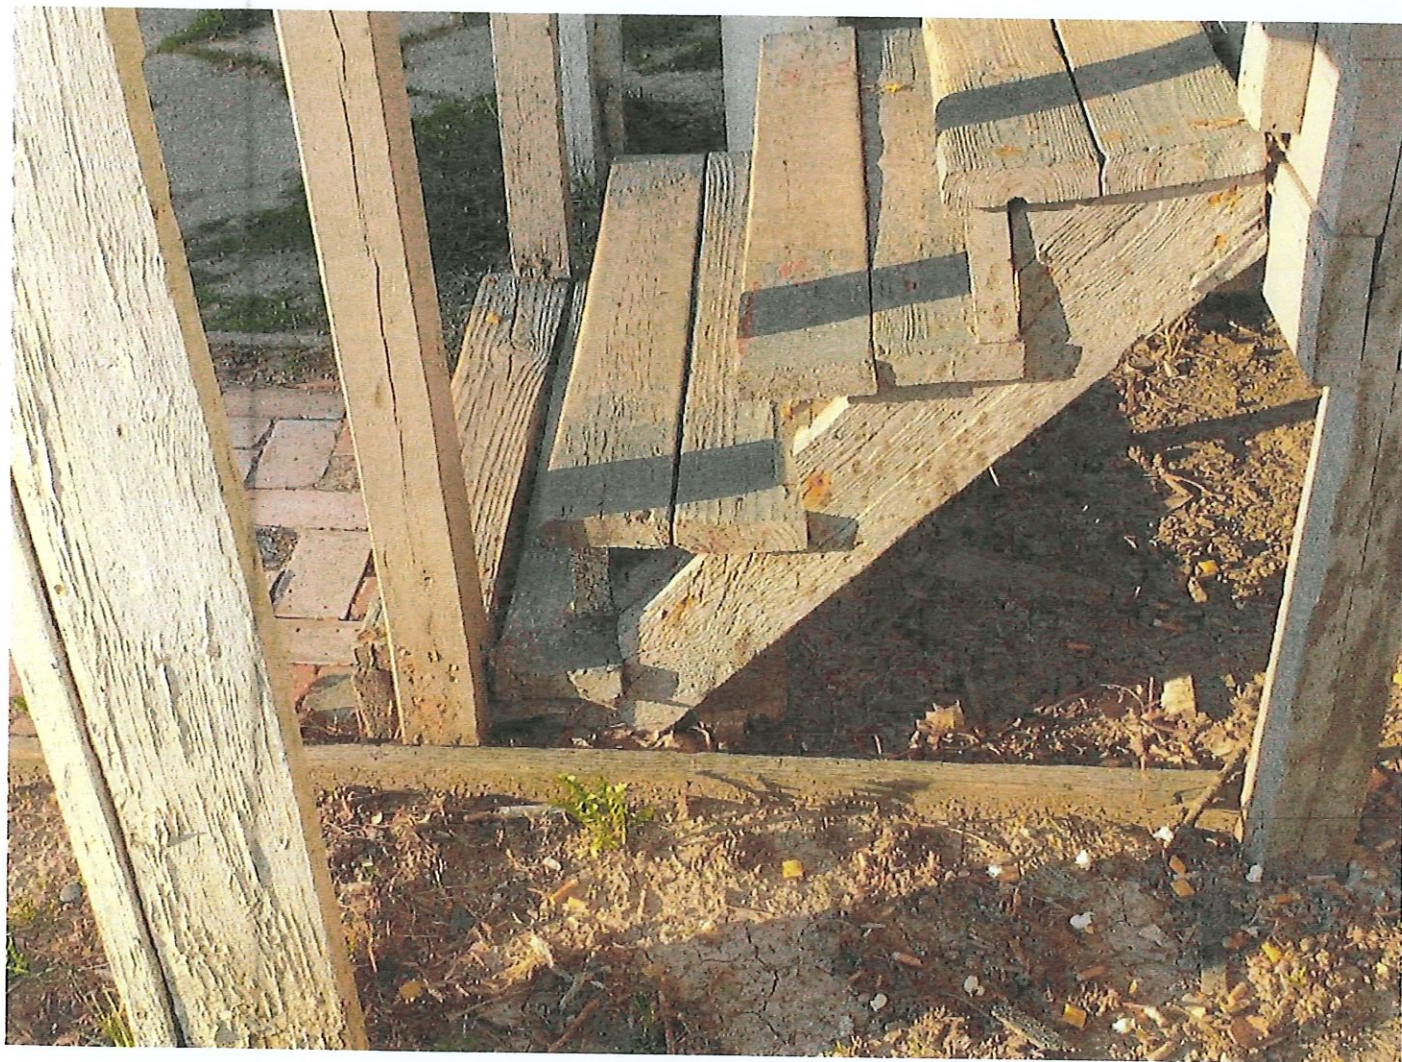
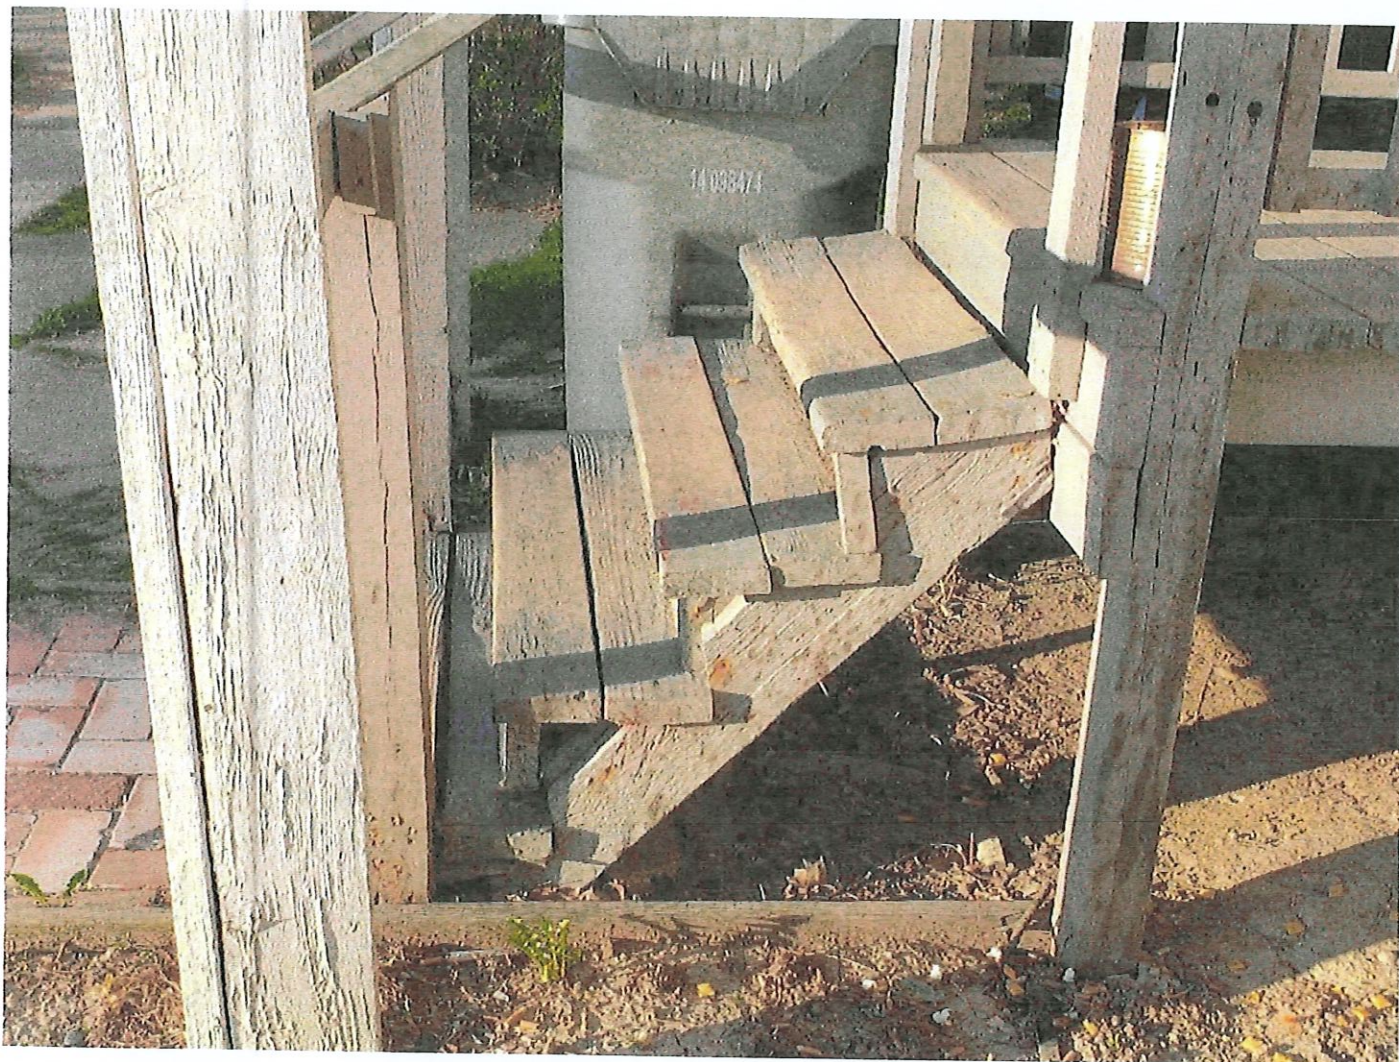
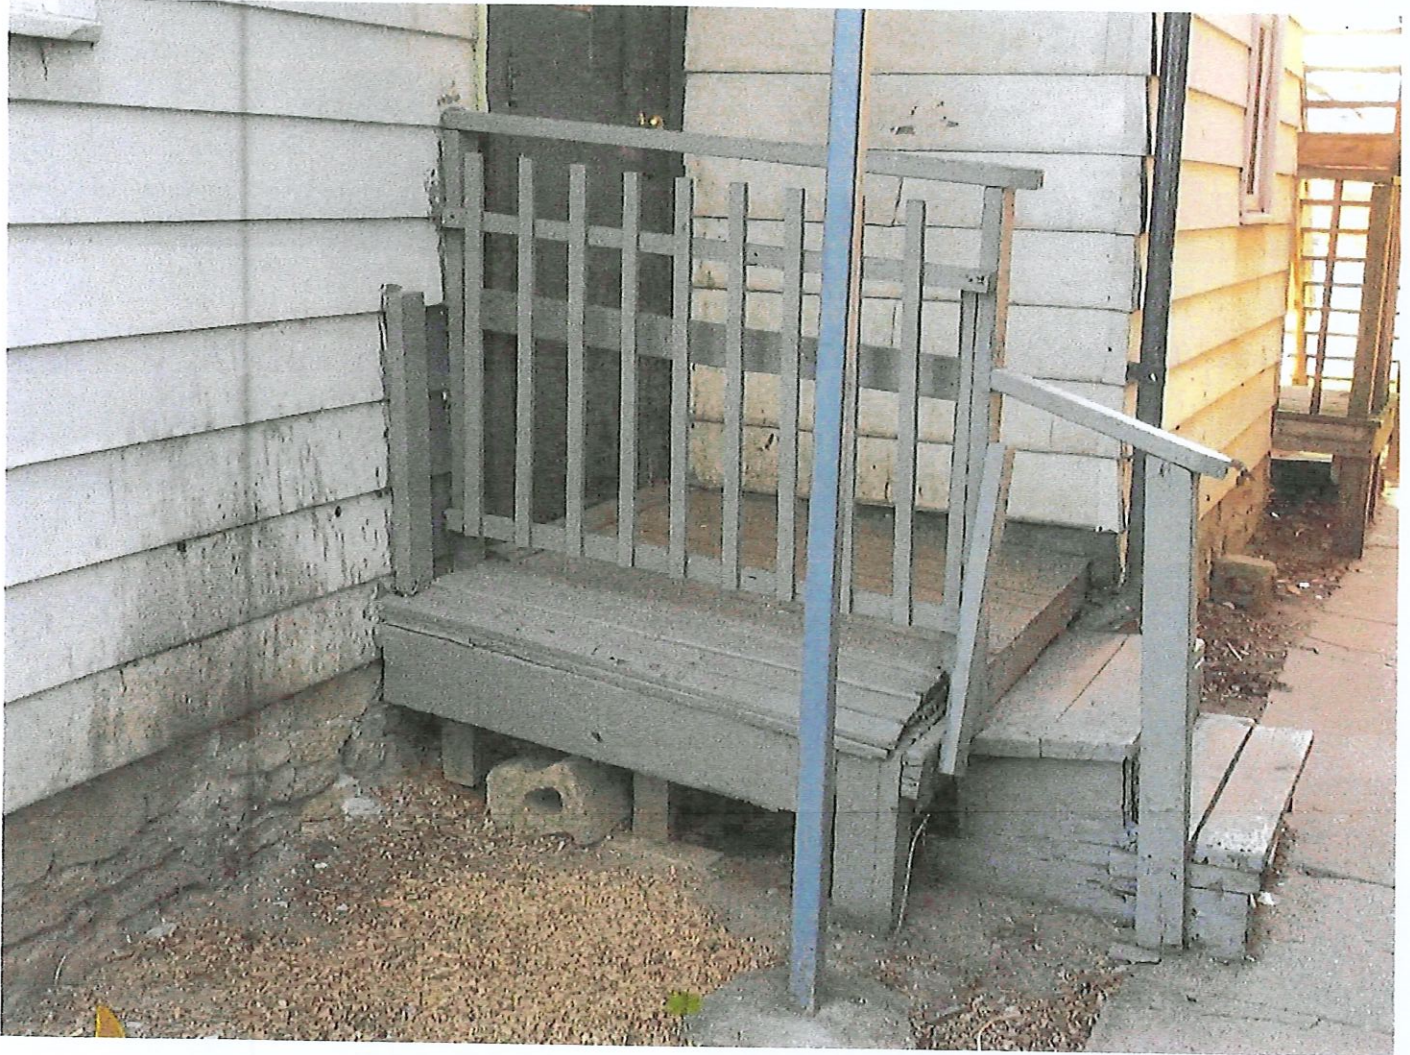
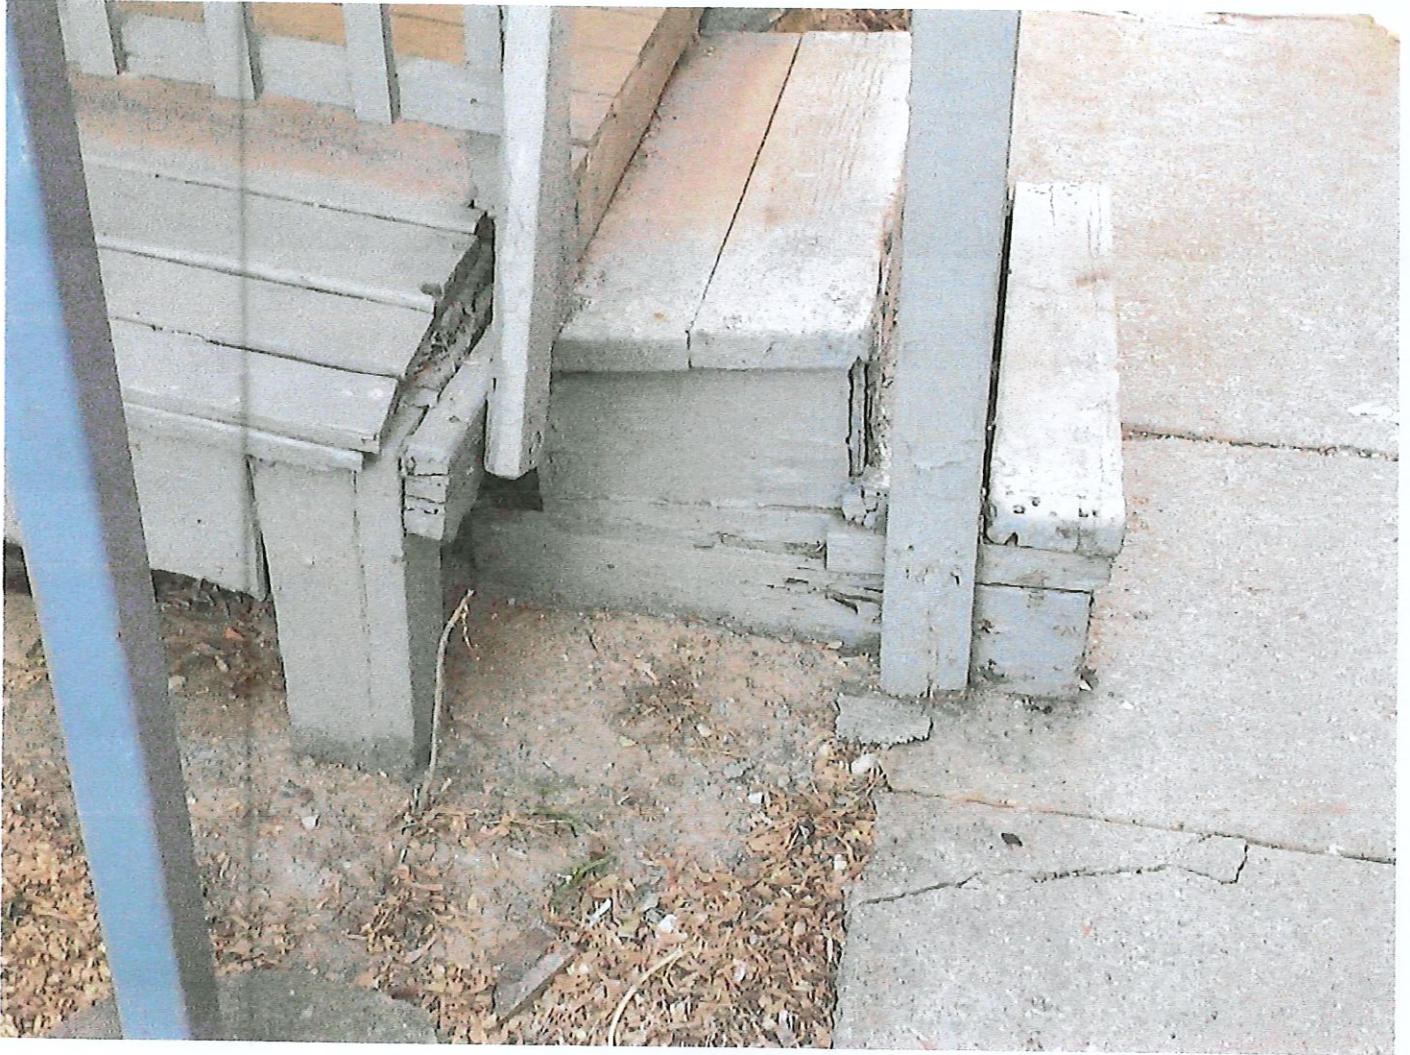
ProBuColls “Clark Rooming Houses”

Outside Entrance conditions of buildings
