# Window Condition Survey

McKinley School Renovation

2001 W. Vliet St.  
Milwaukee WI, 53205

## **McKinley School Restoration Window Condition Survey**

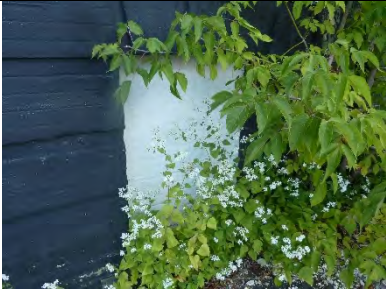
Room	Window	Window Configuration Type	Replace	Repair
001	N124	Bricked-in window	✓

<p>N124-01: Interior view of lower sash</p> <p><b>Condition Comments</b></p> <ul style="list-style-type: none"> <li>- Opening is bricked in at the exterior – cover with glazed brick at interior.</li> <li>- Brick to be removed for new historic replacement window.</li> </ul>

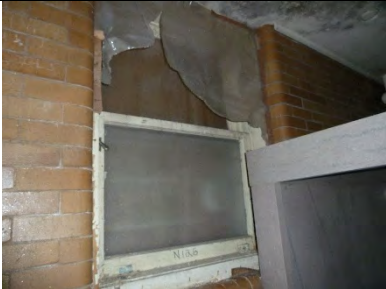
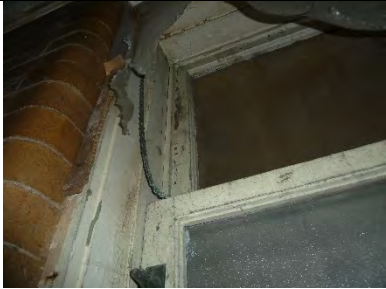
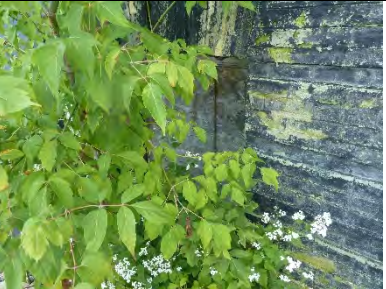
Room	Window	Window Configuration Type	Replace	Repair
001	N125	In-swing hopper w/ fixed upper sash	✓

<p>N125-01: Interior view      N125-02: Interior view of upper sash      N125-03: Exterior view</p> <p><b>Condition Comments</b></p> <ul style="list-style-type: none"> <li>- Obscured glazing in both panels.</li> <li>- Interior jamb water damaged.</li> <li>- Interior side of sashes and casings covered in staples from sheet plastic covering.</li> <li>- Paint is crazed (multiple layers of paint / lead paint).</li> <li>- Exterior sill is rotted due to exposure and being adjacent to grade and little paint coverage. Glazing caulk is tested as having ACM.</li> </ul>

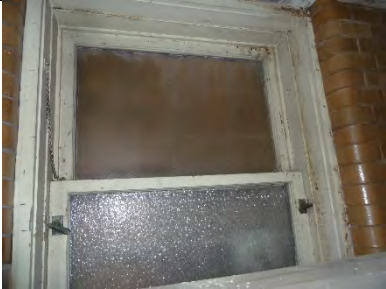
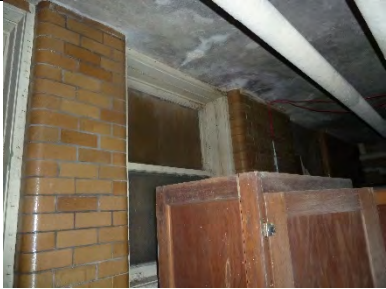
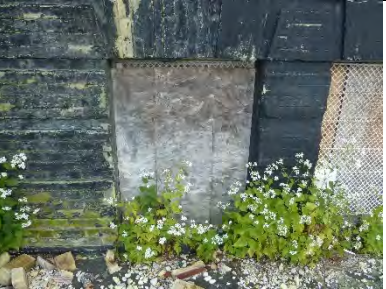
Room	Window	Window Configuration Type	Replace	Repair
001	N126	In-swing hopper w/ fixed upper sash	✓

<p>N126-01: Interior view      N126-02: Water damage at ceiling above      N126-03: Exterior view</p> <p><b>Condition Comments</b></p> <ul style="list-style-type: none"> <li>- Obscured glazing in both panels.</li> <li>- Interior jamb water damaged.</li> <li>- Interior side of sashes and casings covered in staples from sheet plastic covering.</li> <li>- Paint is crazed (multiple layers of paint / lead paint).</li> <li>- Exterior sill is rotted due to exposure and being adjacent to grade and little paint coverage. Glazing caulk is tested as having ACM.</li> </ul>

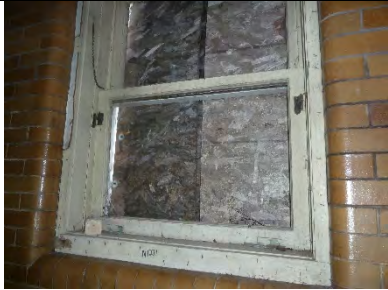
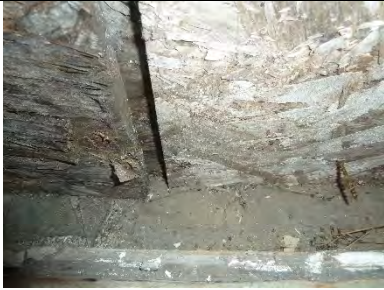
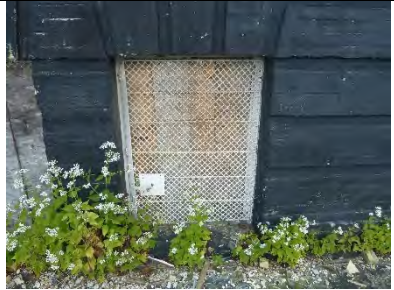
Room	Window	Window Configuration Type	Replace	Repair
001	N127	In-swing hopper w/ fixed upper sash	✓

<p>N127-01: Interior view                      N127-02: Condition of exterior sill                      N127-03: Exterior view</p> <p><b>Condition Comments</b></p> <ul style="list-style-type: none"> <li>- Obscured glazing in both panels broken.</li> <li>- Interior jamb water damaged.</li> <li>- Hopper sash won't open (swelled)</li> <li>- Interior side of sashes and casings covered in staples from sheet plastic covering.</li> <li>- Paint is crazed (multiple layers of paint / lead paint).</li> <li>- Exterior sill is rotted due to exposure and being adjacent to grade and little paint coverage.</li> <li>- Glazing caulk is tested as having ACM.</li> <li>- Security screen mountings are mortised into the brickmold.</li> </ul>

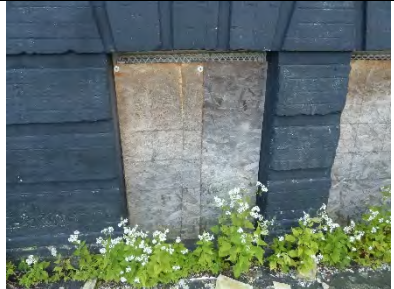
Room	Window	Window Configuration Type	Replace	Repair
001	N128	In-swing hopper w/ fixed upper sash	✓

<p>N128-01: Interior view                      N128-02: Interior view sill and sash corner                      N128-03: Exterior view</p> <p><b>Condition Comments</b></p> <ul style="list-style-type: none"> <li>- Obscured glazing in upper sash / wired and obscured in lower sash.</li> <li>- Interior jamb water damaged.</li> <li>- Hopper sash won't open (swelled)</li> <li>- Interior side of sashes and casings covered in staples from sheet plastic covering.</li> <li>- Paint is crazed (multiple layers of paint / lead paint).</li> <li>- Exterior sill is rotted due to exposure and being adjacent to grade and little paint coverage.</li> <li>- Glazing caulk is tested as having ACM.</li> <li>- Security screen mountings are mortised into the brickmold.</li> </ul>

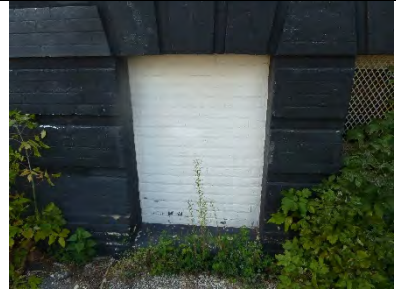
W102-01: Exterior view

Room	Window	Window Configuration Type	Replace	Repair
001	W102	In-swing hopper w/ fixed upper sash	✓	
<b>Condition Comments</b> <ul style="list-style-type: none"> <li>- Opening is bricked in at the exterior – cover with glazed brick at interior.</li> <li>- Brick to be removed for new historic replacement window.</li> </ul>

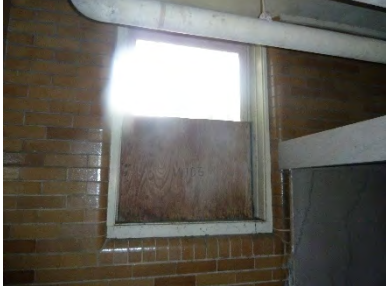
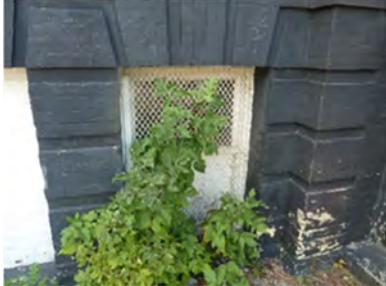
Room	Window	Window Configuration Type	Replace	Repair
001	W103	In-swing hopper w/ fixed upper sash	✓

<p>W103-01: Interior view</p> <p>W103-02: Exterior view</p>				
<b>Condition Comments</b> <ul style="list-style-type: none"> <li>- Obscured patterned glazing in upper sash.</li> <li>- Lower sash missing.</li> <li>- Interior jamb water damaged.</li> <li>- Interior side of sashes and casings covered in staples from sheet plastic covering.</li> <li>- Paint is crazed (multiple layers of paint / lead paint).</li> <li>- Exterior sill is rotted due to exposure and being adjacent to grade and little paint coverage.</li> <li>- Glazing caulk is tested as having ACM.</li> <li>- Security screen mountings are mortised into the brickmold.</li> </ul>

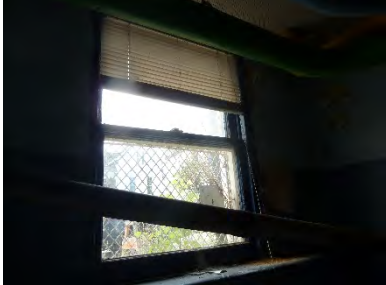
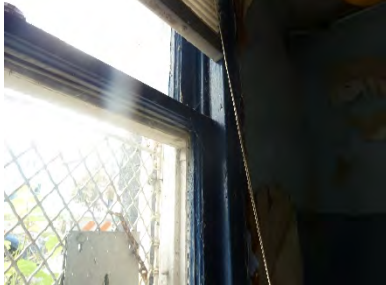
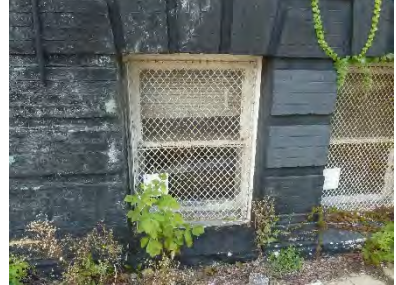
Room	Window	Window Configuration Type	Replace	Repair
002	W104	Double-hung	✓

<p>W104-01: Interior view</p> <p>W104-02: View of spring sash lift at jamb</p> <p>W104-03: Exterior view</p>				
<b>Condition Comments</b> <ul style="list-style-type: none"> <li>- Broken glazing at lower sash.</li> <li>- Both sashes screwed into place at exterior</li> <li>- Sash is non-operable. Retro-fitted spring balances are rusted and plastic cover is brittle / cracked. Sash was originally pinned in place.</li> <li>- Paint is crazed (multiple layers of paint / lead paint).</li> <li>- Exterior sill is rotted due to exposure and being adjacent to grade and little paint coverage. 1/2" blade penetration.</li> <li>- Security screen mountings are mortised into the brickmold.</li> <li>- Glazing caulk is tested as having ACM.</li> </ul>

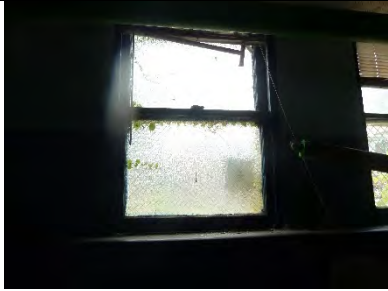
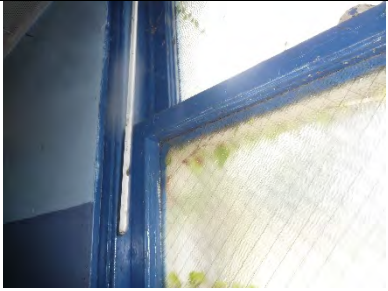
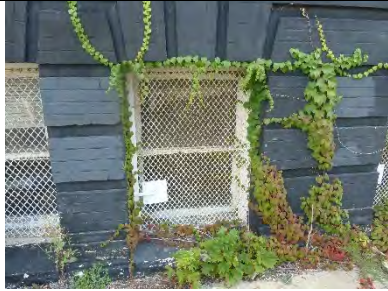
Room	Window	Window Configuration Type	Replace	Repair
002	W105	Double-hung with fixed transom above	✓

<p>W105-01: Interior view      W105-02: Broken spring sash lift at jamb      W105-03: Exterior view</p> <p><b>Condition Comments</b></p> <ul style="list-style-type: none"> <li>- Broken obscured glazing at both sashes.</li> <li>- Sash is non-operable. Retro-fitted spring balances are rusted and plastic cover is brittle / cracked. Sash was originally pinned in place.</li> <li>- Paint is crazed (multiple layers of paint / lead paint).</li> <li>- Exterior sill is rotted due to exposure and being adjacent to grade and little paint coverage. 3/8" blade penetration.</li> <li>- Exterior face of lower sash rail in poor condition.</li> <li>- Security screen mountings are mortised into the brickmold.</li> <li>- Glazing caulk is tested as having ACM.</li> </ul>

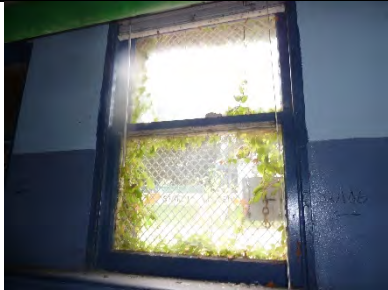
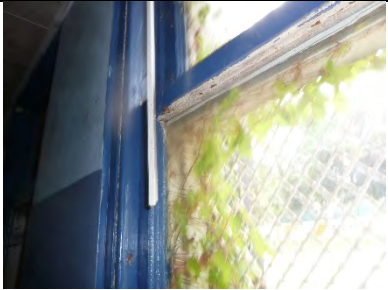
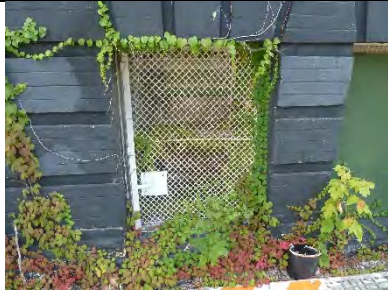
Room	Window	Window Configuration Type	Replace	Repair
002	W106	Double-hung with fixed transom above	✓

<p>W106-01: Interior view of lower sash      W106-02: Broken spring sash lift at jamb      W106-03: Interior view of upper sash</p> <p><b>Condition Comments</b></p> <ul style="list-style-type: none"> <li>- Broken glazing at lower sash.</li> <li>- Sash is non-operable. Retro-fitted spring balances are rusted and plastic cover is brittle / cracked. Sash was originally pinned in place.</li> <li>- Paint is crazed (multiple layers of paint / lead paint).</li> <li>- Exterior sill is rotted due to exposure and being adjacent to grade and little paint coverage. 1/2" blade penetration.</li> <li>- Exterior face of lower sash rail in poor condition.</li> <li>- Security screen mountings are mortised into the brickmold.</li> <li>- Glazing caulk is tested as having ACM.</li> </ul>

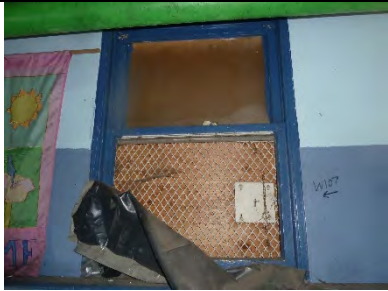
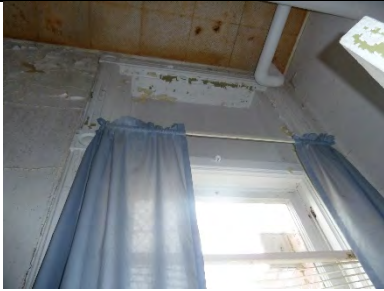
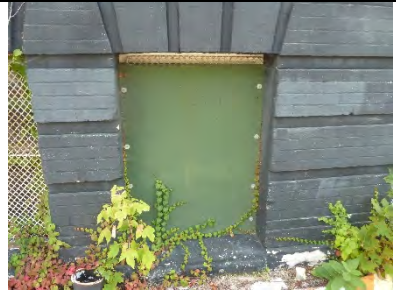
Room	Window	Window Configuration Type	Replace	Repair
002	W107	Double-hung with fixed transom above	✓

<p>N244-01: Interior view of lower sash      N244-02: Interior view of upper sash      N244-03: Exterior sill and security grille mortise into brickmold</p> <p><b>Condition Comments</b></p> <ul style="list-style-type: none"> <li>- Broken glazing at lower sash / obscured glazing at upper.</li> <li>- Sash is non-operable. Retro-fitted spring balances are rusted and plastic cover is brittle / cracked. Sash was originally pinned in place.</li> <li>- Paint is crazed (multiple layers of paint / lead paint).</li> <li>- Exterior sill is rotted due to exposure and being adjacent to grade and little paint coverage. 1/4" blade penetration.</li> <li>- Interior sill is water damaged.</li> <li>- Security screen mountings are mortised into the brickmold.</li> <li>- Glazing caulk is tested as having ACM.</li> </ul>

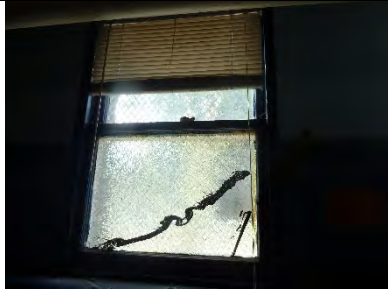
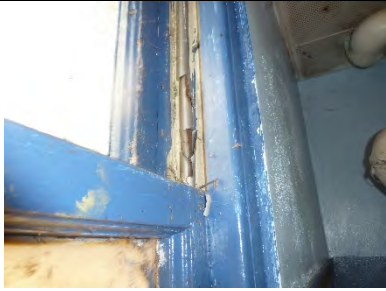
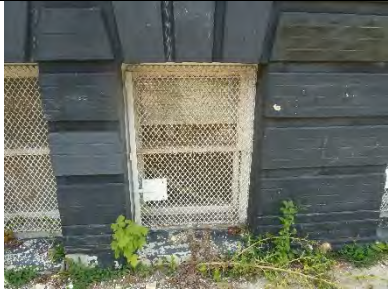
Room	Window	Window Configuration Type	Replace	Repair
003	W111	Double-hung	✓

<p>W111-01: Interior view      W111-02: Rusted spring balance and brittle casing      W111-03: Exterior view</p> <p><b>Condition Comments</b></p> <ul style="list-style-type: none"> <li>- Obscured wired glazing at lower sash / clear glazing at upper sash.</li> <li>- Sash is non-operable. Retro-fitted spring balances are rusted and plastic cover is brittle / cracked. Sash was originally pinned in place.</li> <li>- Paint is crazed (multiple layers of paint / lead paint).</li> <li>- Exterior sill is rotted due to exposure and being adjacent to grade and little paint coverage. 3/8" blade penetration.</li> <li>- Bottom rail of lower sash decayed at left corner (exterior)</li> <li>- Security screen mountings are mortised into the brickmold.</li> <li>- Glazing caulk is tested as having ACM.</li> </ul>

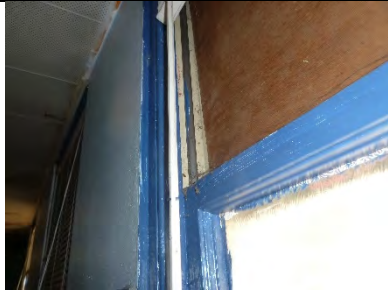
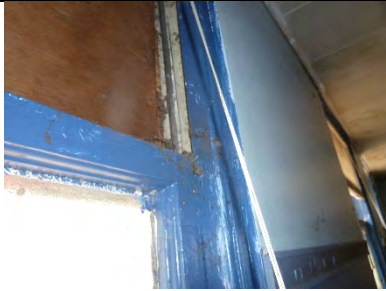
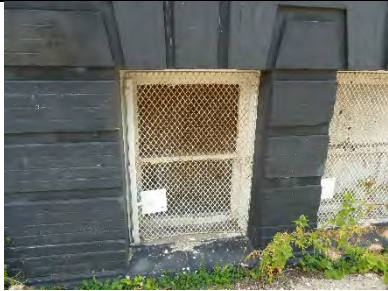
Room	Window	Window Configuration Type	Replace	Repair
003	W112	Double-hung	✓

<p>W112-01: Interior view spring balance      W112-02: Panel at upper      W112-03: Exterior view</p> <p><b>Condition Comments</b></p> <ul style="list-style-type: none"> <li>- Obscured patterned glazing at lower sash. Plywood panel at upper sash.</li> <li>- Sash is non-operable. Retro-fitted spring balances are rusted and plastic cover is brittle / cracked. Sash was originally pinned in place.</li> <li>- Paint is crazed (multiple layers of paint / lead paint).</li> <li>- Exterior sill is rotted due to exposure and being adjacent to grade and little paint coverage. 3/8" blade penetration.</li> <li>- Security screen mountings are mortised into the brickmold.</li> <li>- Glazing caulk is tested as having ACM.</li> </ul>

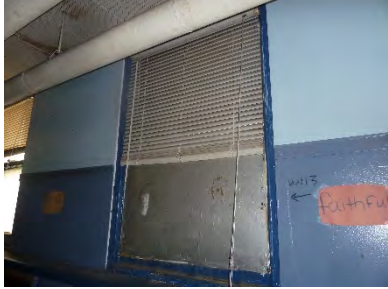
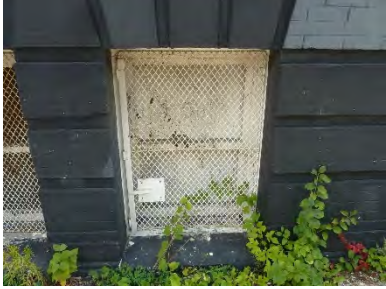
Room	Window	Window Configuration Type	Replace	Repair
003	W113	Double-hung	✓

<p>W113-01: Interior view</p> <p>W113-02: Interior view of upper sash</p> <p><b>Condition Comments</b></p> <ul style="list-style-type: none"> <li>- Both sashes covered at interior.</li> <li>- Both sashes fixed in place.</li> <li>- Paint is crazed (multiple layers of paint / lead paint).</li> <li>- Exterior sill is rotted due to exposure and being adjacent to grade and little paint coverage. 1/2" blade penetration at exterior on left.</li> <li>- Interior sill is water damaged.</li> <li>- Security screen mountings are mortised into the brickmold.</li> <li>- Glazing caulk is tested as having ACM.</li> </ul>

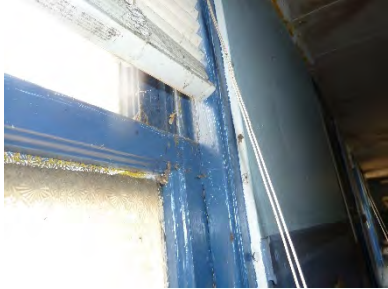
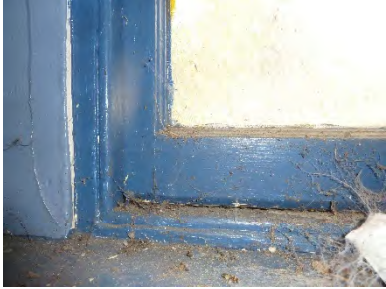
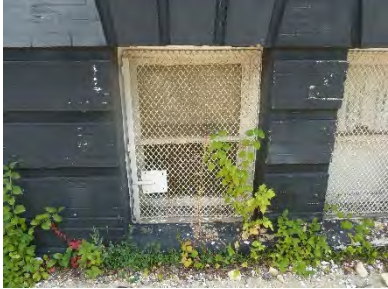
Room	Window	Window Configuration Type	Replace	Repair
003	W114	Double-hung	✓

<p>W114-01: Interior view of lower sash</p> <p>W114-02: Interior view of upper sash &amp; transom</p> <p>W114-03: Lower sash rot at lower right</p> <p><b>Condition Comments</b></p> <ul style="list-style-type: none"> <li>- Obscured glazing intact at both sashes.</li> <li>- Sash is non-operable. Retro-fitted spring balances are rusted and plastic cover is brittle / cracked. Sash was originally pinned in place.</li> <li>- Paint is crazed (multiple layers of paint / lead paint).</li> <li>- Exterior sill is rotted due to exposure and being adjacent to grade and little paint coverage. 1/4" - 3/8" blade penetration.</li> <li>- Lower left corner of bottom sash is rotted at exterior side.</li> <li>- Interior sill is water damaged.</li> <li>- Security screen mountings are mortised into the brickmold.</li> <li>- Glazing caulk is tested as having ACM.</li> </ul>

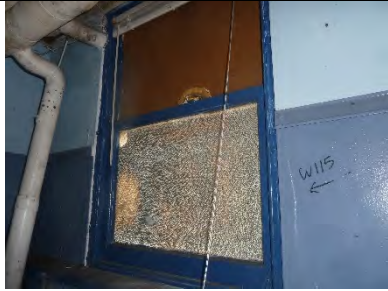
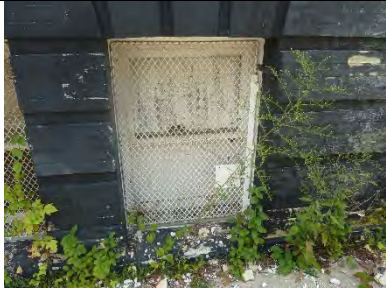
Room	Window	Window Configuration Type	Replace	Repair
003	W115	Double-hung	✓

<p>W115-01: Interior view of lower sash      W115-02: Interior view of upper sash</p> <p><b>Condition Comments</b></p> <ul style="list-style-type: none"> <li>- Obscured wired glazing at lower sash – fiberboard panel at upper with no glazing behind.</li> <li>- Both sashes fixed in place</li> <li>- Paint is crazed (multiple layers of paint / lead paint).</li> <li>- Exterior sill is rotted due to exposure and being adjacent to grade and little paint coverage. 1/4" blade penetration.</li> <li>- Bottom sash rail corners decayed at exterior.</li> <li>- Security screen mountings are mortised into the brickmold.</li> <li>- Glazing caulk is tested as having ACM.</li> </ul>

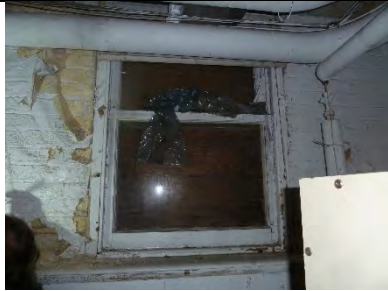
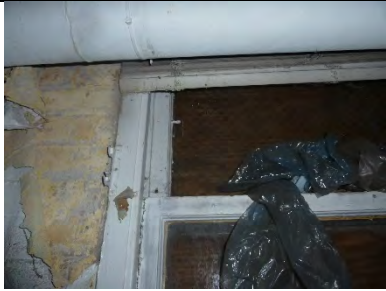
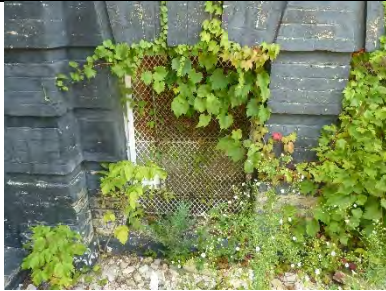
Room	Window	Window Configuration Type	Replace	Repair
004	W116	Double-hung	✓

<p>W116-01: Interior view of window      W116-02: Sash meeting rail      W116-03: Exterior view.</p> <p><b>Condition Comments</b></p> <ul style="list-style-type: none"> <li>- Clear glazing at lower - obscured wired glazing at upper.</li> <li>- Windows are fixed – pinned in place.</li> <li>- Sash is non- operable. Retro-fitted spring balances are rusted and plastic cover is brittle / cracked. Sash was originally pinned in place.</li> <li>- Paint is crazed (multiple layers of paint / lead paint).</li> <li>- Exterior sill is severely rotted due to exposure and being adjacent to grade and little paint coverage. 4" blade penetration (to the hilt).</li> <li>- No pull hardware.</li> <li>- Security screen mountings are mortised into the brickmold.</li> <li>- Glazing caulk is tested as having ACM.</li> </ul>

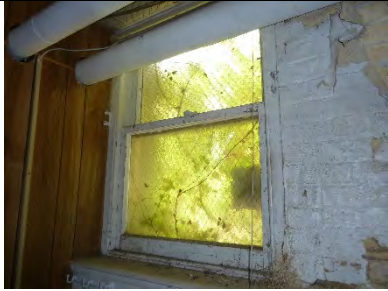
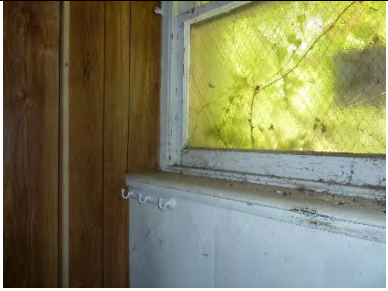
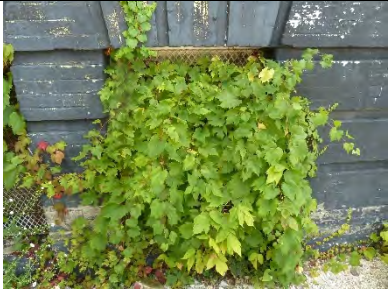
Room	Window	Window Configuration Type	Replace	Repair
004	W117	Double-hung	✓

<p>W117-01: Interior view                      W117-02: Mold growth at sill                      W117-03: Exterior view</p> <p><b>Condition Comments</b></p> <ul style="list-style-type: none"> <li>- Obscured Wired glazing broken at lower sash.</li> <li>- Sash is non-operable. No pull / no springs.</li> <li>- Paint is crazed (multiple layers of paint / lead paint).</li> <li>- Exterior sill is decayed due to exposure and being adjacent to grade and little paint coverage. 3/8" blade penetration.</li> <li>- Interior sill shows signs of mold.</li> <li>- Security screen mountings are mortised into the brickmold.</li> <li>- Glazing caulk is tested as having ACM.</li> </ul>

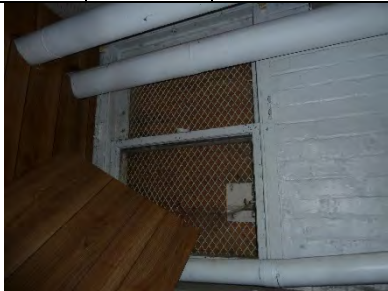
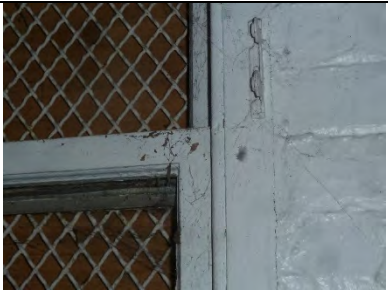
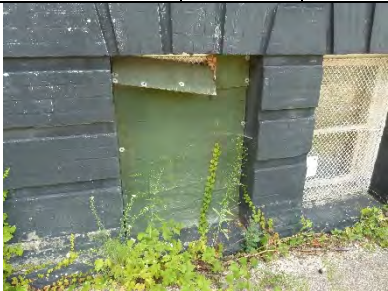
Room	Window	Window Configuration Type	Replace	Repair
004	W118	Double-hung	✓

<p>W118-01: Interior view                      W118-02: Decay at lower right corner of upper sash (behind)                      W118-03: Window boarded at the exterior</p> <p><b>Condition Comments</b></p> <ul style="list-style-type: none"> <li>- Missing glazing at both sashes.</li> <li>- Sash is non-operable. No pull / no springs.</li> <li>- Paint is crazed (multiple layers of paint / lead paint).</li> <li>- Exterior sill is decayed due to exposure and being adjacent to grade and little paint coverage. 3/8" blade penetration.</li> <li>- Security screen mountings are mortised into the brickmold.</li> <li>- Glazing caulk is tested as having ACM.</li> </ul>

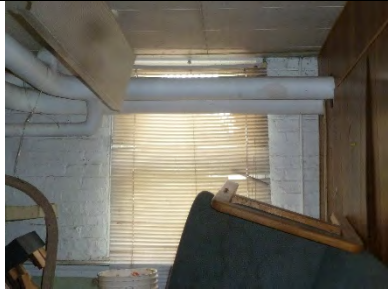
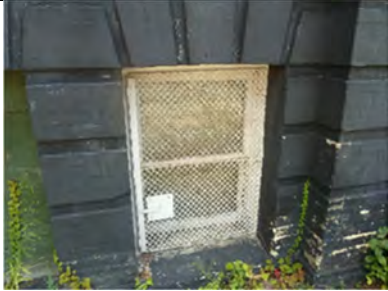
Room	Window	Window Configuration Type	Replace	Repair
004	W119	Double-hung	✓

<p>W118-01: Interior view                      W119-02: Exterior view</p> <p><b>Condition Comments</b></p> <ul style="list-style-type: none"> <li>- Clear glazing at both sashes.</li> <li>- Could not access the window from the interior due to piled up debris.</li> <li>- Paint is crazed (multiple layers of paint / lead paint).</li> <li>- Exterior sill is decayed due to exposure and being adjacent to grade and little paint coverage. 3/8" blade penetration.</li> <li>- Security screen mountings are mortised into the brickmold.</li> <li>- Glazing caulk is tested as having ACM.</li> </ul>

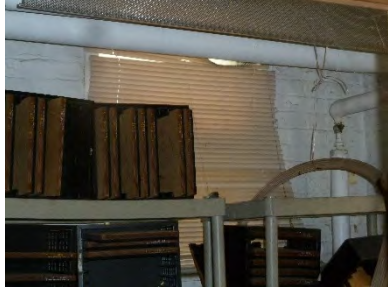
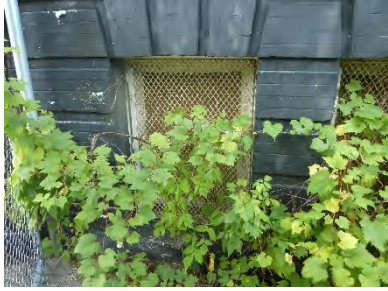
Room	Window	Window Configuration Type	Replace	Repair
004	S100	Double-hung	✓

<p>S100-01: Interior view of lower sash                      S100-02: Exterior view</p> <p><b>Condition Comments</b></p> <ul style="list-style-type: none"> <li>- Obscured glazing at both sashes.</li> <li>- Could not access the window from the interior due to piled up debris.</li> <li>- Paint is crazed (multiple layers of paint / lead paint).</li> <li>- Exterior sill is decayed due to exposure and being adjacent to grade and little paint coverage. 3/8" blade penetration.</li> <li>- Security screen mountings are mortised into the brickmold.</li> <li>- Glazing caulk is tested as having ACM.</li> </ul>

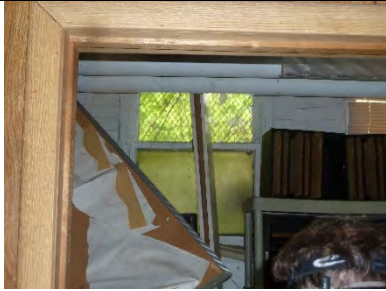
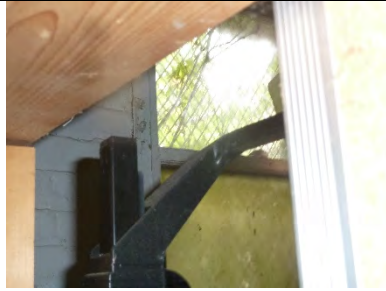
Room	Window	Window Configuration Type	Replace	Repair
004	S101	Double-hung	✓

S101--01: Interior view

S101-02: Interior view

- Obscured glazing at lower sash, clear at upper sash.
- Could not access the window from the interior due to piled up debris.
- Missing the interior stops. Wood blocks are nailed on to act as stops.
- Paint is crazed (multiple layers of paint / lead paint).
- Exterior sill is decayed due to exposure and being adjacent to grade and little paint coverage.
- Security screen mountings are mortised into the brickmold.
- Glazing caulk is tested as having ACM.

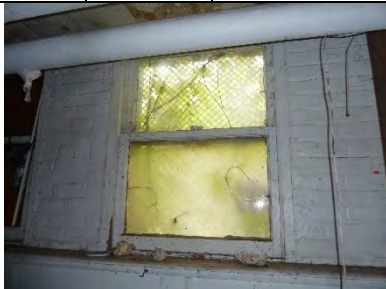
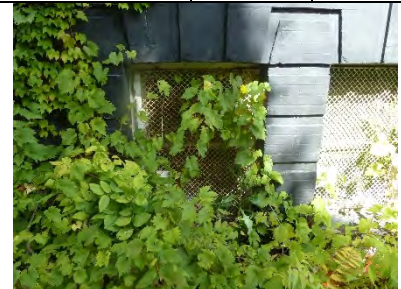
Room	Window	Window Configuration Type	Replace	Repair
004	S102	Double-hung	✓

S102-01: Interior view

S102--03: Exterior view

- Plexiglas at lower sash / clear glazing at upper.
- Upper sash is racked leaving slight gap at upper right.
- Paint is crazed (multiple layers of paint / lead paint).
- Exterior sill is decayed due to exposure and being adjacent to grade and little paint coverage. 1/4" - 3/8" blade penetration.
- Security screen mountings are mortised into the brickmold.
- Glazing caulk is tested as having ACM.

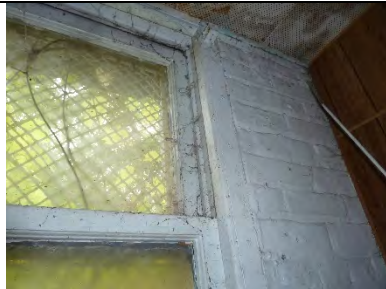
S102-02: Open corner at upper sash right

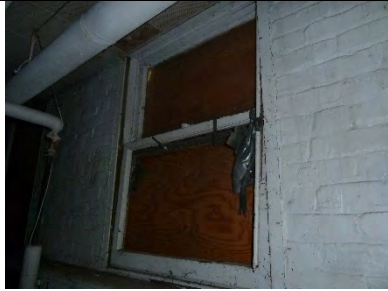
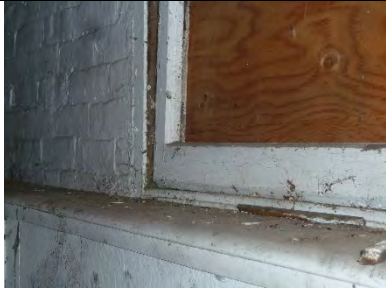
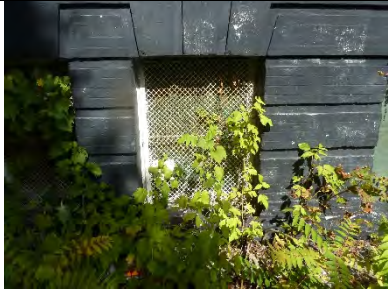
Room	Window	Window Configuration Type	Replace	Repair
004	S103	Double-hung	✓

<p>S103-01: Interior view                      S103-02: Missing interior stops                      S103-03: Exterior view</p> <p><b>Condition Comments</b></p> <ul style="list-style-type: none"> <li>- Missing glazing at lower sash – upper sash is clear glass.</li> <li>- Upper sash is racked leaving slight gap.</li> <li>- Paint is crazed (multiple layers of paint / lead paint).</li> <li>- Exterior sill is decayed due to exposure and being adjacent to grade and little paint coverage.</li> <li>- Security screen mountings are mortised into the brickmold.</li> <li>- Glazing caulk is tested as having ACM.</li> </ul>

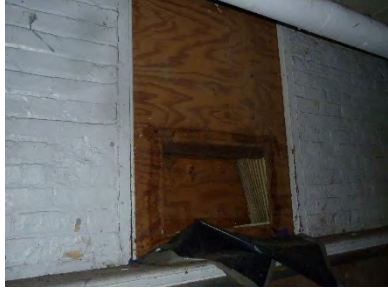
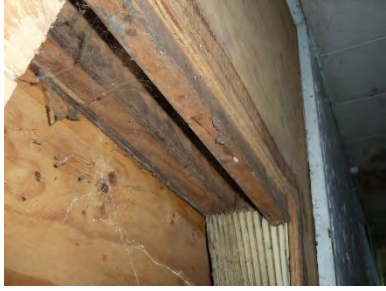
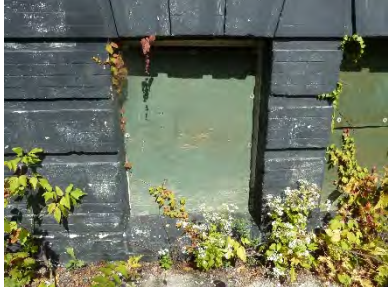
Room	Window	Window Configuration Type	Replace	Repair
004	S104	Double-hung	✓

<p>S104-01: Interior view                      S104-02: Condition of bottom rail at lower sash                      S104-03: Exterior sill rot</p> <p><b>Condition Comments</b></p> <ul style="list-style-type: none"> <li>- Both sashes are missing. Cover with plywood on wood framing.</li> <li>- Exterior plywood covers up exterior sill preventing full inspection.</li> <li>- Paint is crazed (multiple layers of paint / lead paint).</li> <li>- Exterior plywood full cover all the framing and sill. Exterior sill shows decay from the interior side.</li> <li>- Security screen has been removed.</li> <li>- Glazing caulk is tested as having ACM.</li> </ul>

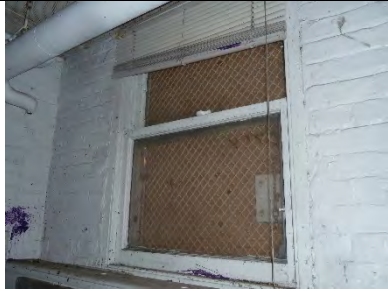
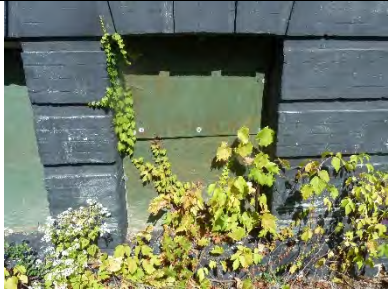
Room	Window	Window Configuration Type	Replace	Repair
004	S105	Double-hung	✓

<p>S105-01: Interior view                      S105-03: Exterior view</p> <p><b>Condition Comments</b></p> <ul style="list-style-type: none"> <li>- Clear glazing in both sashes.</li> <li>- Lower sash is screwed into place and painted shut. Upper sash is fixed in place but has a gap above.</li> <li>- Paint is crazed (multiple layers of paint / lead paint).</li> <li>- Exterior plywood full cover all the framing and sill.</li> <li>- Security screen mountings are mortised into the brickmold.</li> <li>- Glazing caulk is tested as having ACM.</li> </ul>

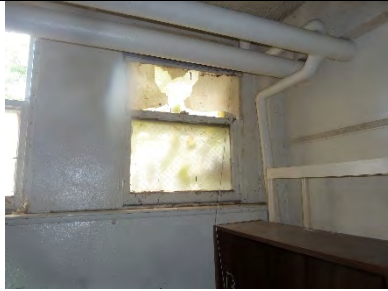
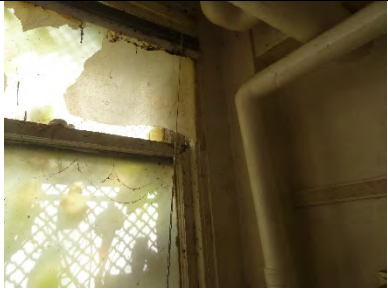
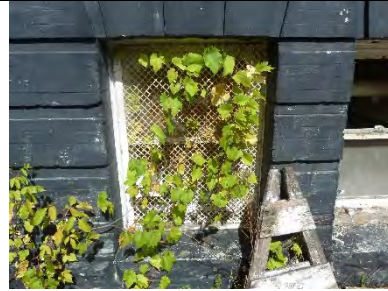
Room	Window	Window Configuration Type	Replace	Repair
005	S106	Double-hung	✓

<p>S106-01: Interior view                      S106-02: Decayed upper right corner on lower sash                      S106-03: Exterior view</p> <p><b>Condition Comments</b></p> <ul style="list-style-type: none"> <li>- Obscured glazing in both sashes.</li> <li>- Both sashes are fixed into place.</li> <li>- Exterior sill is decayed due to exposure and being adjacent to grade and little paint coverage. 1/4" - 3/8" blade penetration.</li> <li>- Paint is crazed (multiple layers of paint / lead paint).</li> <li>- Security screen mountings are mortised into the brickmold.</li> <li>- Glazing caulk is tested as having ACM.</li> </ul>

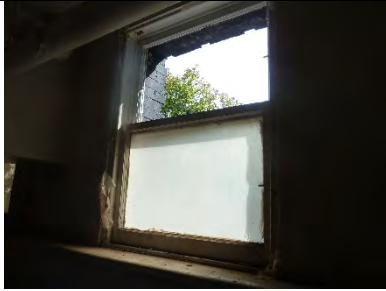
S107-01: Interior view

- Obscured glazing in lower sash / upper sash missing glazing.
- Both sashes are fixed into place.
- Exterior sill is decayed due to exposure and being adjacent to grade and little paint coverage. 1/4" - 3/8" blade penetration.
- Interior sill is damaged.
- Paint is crazed (multiple layers of paint / lead paint).
- Security screen has been removed.
- Glazing caulk is tested as having ACM.

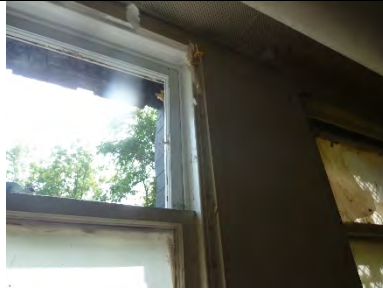
S107-02: Staples at frame

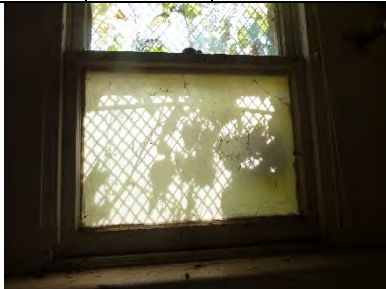
S108-01: Interior view

- Obscured glazing in lower sash / clear glazing in upper sash.
- Both sashes are fixed into place.
- Exterior sill is very decayed due to exposure and being adjacent to grade and little paint coverage. 3/4" blade penetration.
- Interior sill is water damaged.
- Paint is crazed (multiple layers of paint / lead paint).
- Security screen mountings are mortised into the brickmold.
- Glazing caulk is tested as having ACM.

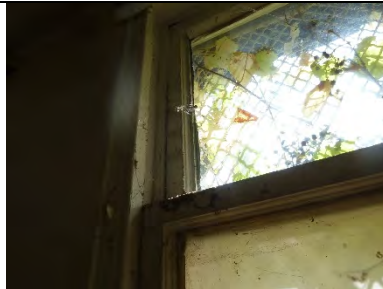
S108-02: Lower right corner of upper sash broken

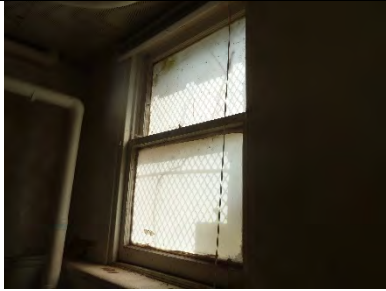
S109-01: Interior view

- Obscured glazing in both sashes.
- Both sashes are fixed into place.
- Sash is non-operable. Retro-fitted spring balances are rusted and plastic cover is brittle / cracked. Sash was originally pinned in place.
- Exterior sill is decayed due to exposure and being adjacent to grade and little paint coverage. 1/4" blade penetration.
- Interior sill shows signs of water damage / mold
- Paint is crazed (multiple layers of paint / lead paint).
- Security screen mountings are mortised into the brickmold.
- Glazing caulk is tested as having ACM.

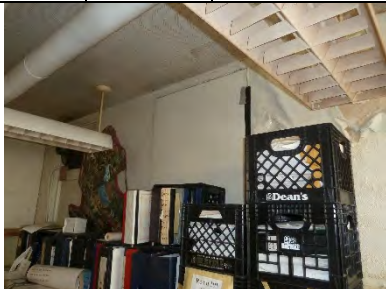
S110-01: Interior view

- Window opening is covered at the interior at the face of the wall and is inaccessible.
- Water damage is apparent at the adjacent wall and ceiling above.
- Exterior side of the opening has been covered with plywood preventing access to the exterior side of the window.
- Paint is crazed (multiple layers of paint / lead paint).
- Glazing caulk is tested as having ACM.

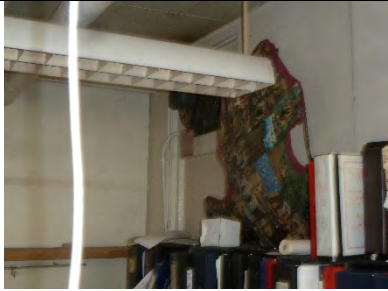
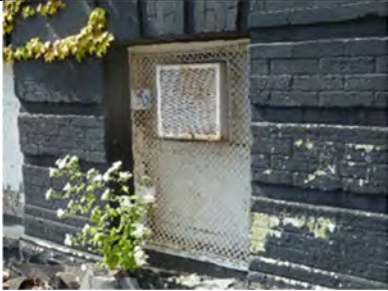
Room	Window	Window Configuration Type	Replace	Repair
005	S111	Double-hung	✓

<p>S111-01: Interior view                      S111-03: Exterior view</p> <p><b>Condition Comments</b></p> <ul style="list-style-type: none"> <li>- Window sashes have been removed.</li> <li>- Both sashes are fixed into place.</li> <li>- Sash is non-operable. Retro-fitted spring balances are rusted and plastic cover is brittle / cracked. Sash was originally pinned in place.</li> <li>- Exterior sill is decayed due to exposure and being adjacent to grade and little paint coverage. 1/4" blade penetration.</li> <li>- Interior sill shows signs of water damage / mold</li> <li>- Paint is crazed (multiple layers of paint / lead paint).</li> <li>- Security screen mountings are mortised into the brickmold.</li> <li>- Glazing caulk is tested as having ACM.</li> </ul>

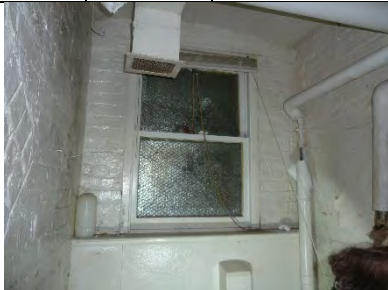
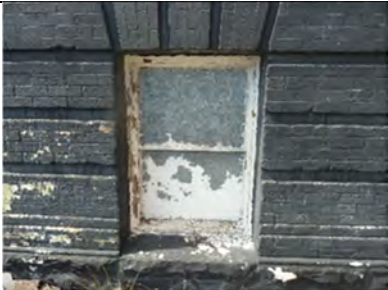
Room	Window	Window Configuration Type	Replace	Repair
006A	S112	Double-hung	✓

<p>S112-01: Interior view                      S112-03: Galvanized metal cover at exterior of window.</p> <p><b>Condition Comments</b></p> <ul style="list-style-type: none"> <li>- Broken obscured wired glazing in both sashes.</li> <li>- Lower sash is painted in place.</li> <li>- Old rope and pulley system for used for raising the sash is still attached.</li> <li>- Paint at the exposed exterior brickmold, sill and jambs has mostly flaked off.</li> <li>- Exterior sill is decayed due to exposure and being adjacent to grade and little paint coverage. 1/4" - 3/8" blade penetration.</li> <li>- Glazing caulk is tested as having ACM.</li> </ul>

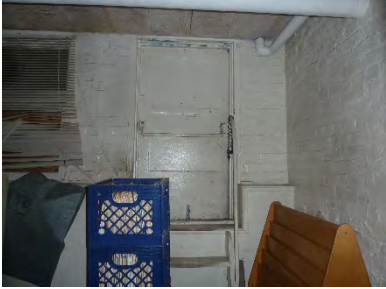
<p>S113-01: Interior view</p>

<p>S113-02: Exterior view</p>		
<p><b>Condition Comments</b></p> <ul style="list-style-type: none"> <li>- Window sashes and framing have been removed and the opening has been converted to an access/exit door.</li> <li>- Door and door frame will be removed and the opening returned to use as a window.</li> </ul>				
Room	Window	Window Configuration Type	Replace	Repair
006	S114	Double-hung	✓

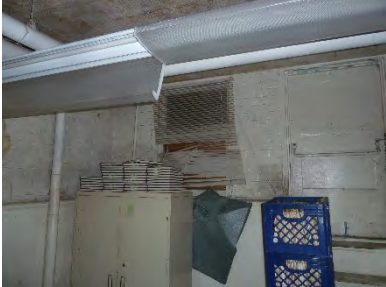
<p>S114-01: Interior view</p>

<p>S114-02: Exterior view</p>		
<p><b>Condition Comments</b></p> <ul style="list-style-type: none"> <li>- Broken glazing at both sashes.</li> <li>- Window was inaccessible to close inspection due to debris and equipment.</li> <li>- Exterior side of window opening fully blocked with plywood.</li> <li>- Paint is crazed (multiple layers of paint / lead paint).</li> <li>- Glazing caulk is tested as having ACM.</li> </ul>

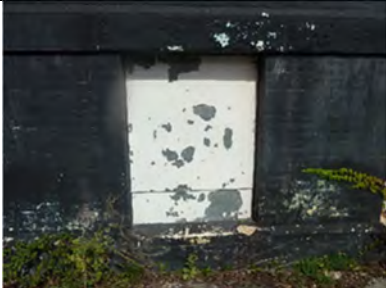
<p>S115-02: Exterior view</p>		
<p><b>Condition Comments</b></p> <ul style="list-style-type: none"> <li>- Window is inaccessible for inspection – blocked by old freezers and debris.</li> <li>- Room is always very damp with condensation due to open windows into the adjacent Light Court B.</li> <li>- Exterior side is covered with painted galvanized sheet metal cover for full width and height of opening.</li> </ul>

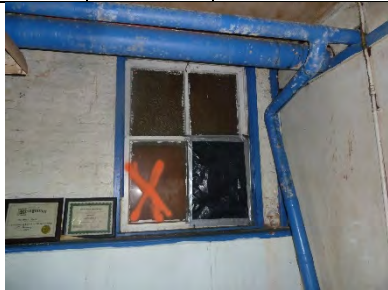
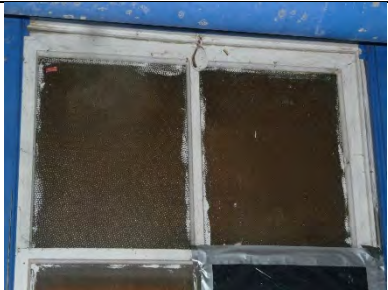
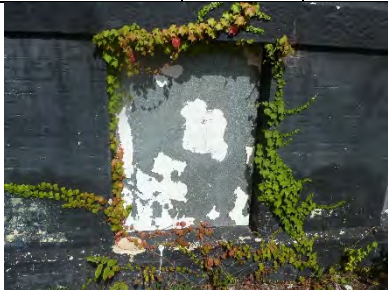
Room	Window	Window Configuration Type	Replace	Repair
013A	S116	Double-hung with 2 / 2 muntin pattern	✓

<p>S116-01: Interior view of lower sash      S116-02: Interior view of upper sash      S116-03: Lower sash corner water damage</p> <p><b>Condition Comments</b></p> <ul style="list-style-type: none"> <li>- Wired glass in upper lights and lower left light</li> <li>- Lower right sash has broken glazing and is cover with plastic.</li> <li>- Sash is non- operable. Retro-fitted spring balances are rusted and plastic cover is brittle / cracked. Sash was originally pinned in place.</li> <li>- Pulley for old rope system used for raising the sash is still attached.</li> <li>- Exterior side is covered with painted galvanized sheet metal cover for full width and height of opening.</li> <li>- Interior sill shows signs of water damage / mold</li> <li>- Glazing caulk is tested as having ACM.</li> <li>- Window header is not level.</li> <li>- Interior trims are damaged.</li> </ul>

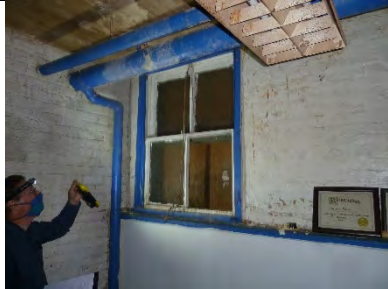
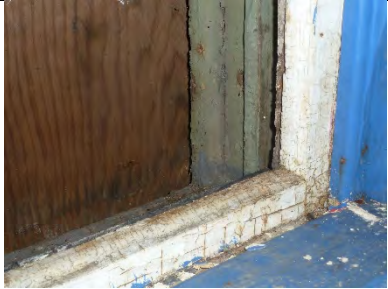
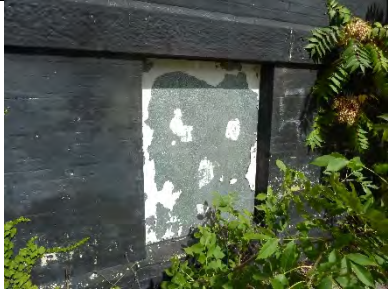
Room	Window	Window Configuration Type	Replace	Repair
013A	S117	Double-hung with 2 / 2 muntin pattern	✓

<p>S117-01: Interior view of lower sash      S117-02: View of meeting rail lock area damage      S117-03: Looking down at exterior sill</p> <p><b>Condition Comments</b></p> <ul style="list-style-type: none"> <li>- Patterned glass in upper lights and missing glass in lower sash.</li> <li>- Lower right sash has broken glazing and is cover with plastic.</li> <li>- Sash is non- operable. Retro-fitted spring balances are rusted and plastic cover is brittle / cracked. Sash was originally pinned in place.</li> <li>- Pulley for old rope system used for raising the sash is still attached.</li> <li>- Exterior side is covered with painted galvanized sheet metal cover for full width and height of opening.</li> <li>- Interior sill shows signs of water damage / mold</li> <li>- Glazing caulk is tested as having ACM.</li> <li>- Window header is not level.</li> <li>- Interior trims are damaged.</li> <li>- Wood spreader install between jambs at meeting rail level.</li> </ul>

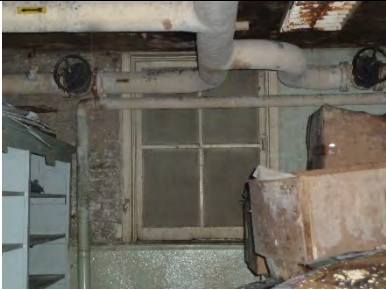
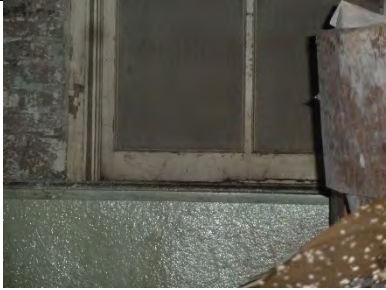
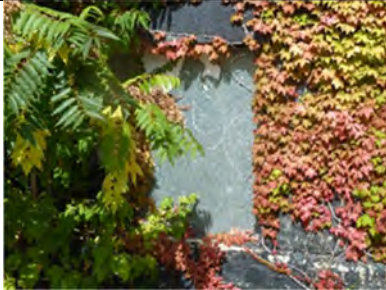
Room	Window	Window Configuration Type	Replace	Repair
014	S118	Outswing casement with muntins	✓

<p>S118-01: Interior view of lower sash      S118-02: Interior view of upper sash      S118-03: Exterior sill condition</p> <p><b>Condition Comments</b></p> <ul style="list-style-type: none"> <li>- Single sash with horizontal and vertical muntins.</li> <li>- No visible hinges, but there is a handle that appears to be for an outswing casement configuration.</li> <li>- Inaccessible from the interior due to debris.</li> <li>- Water damage at ceiling above.</li> <li>- Interior sill shows signs of water damage / mold</li> <li>- Glazing caulk is tested as having ACM.</li> </ul>

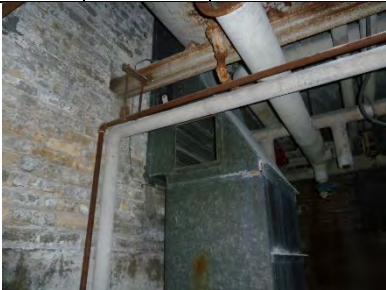
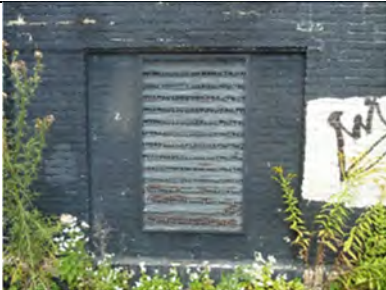
Room	Window	Window Configuration Type	Replace	Repair
017	N111	Vent	✓

<p>N111-01: Interior view vent      N111-02: Exterior view</p> <p><b>Condition Comments</b></p> <ul style="list-style-type: none"> <li>- Existing louvered vent connected to old ductwork.</li> </ul>

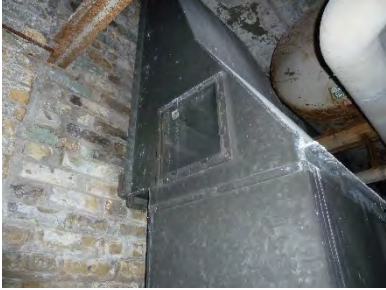
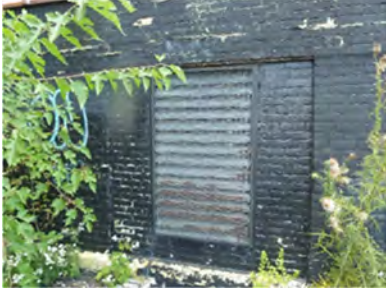
Room	Window	Window Configuration Type	Replace	Repair
017	N112	Vent	✓

<p>N112-01: Interior view vent      N112-02: Exterior view</p> <p><b>Condition Comments</b></p> <ul style="list-style-type: none"> <li>- Existing louvered vent connected to old ductwork.</li> </ul>

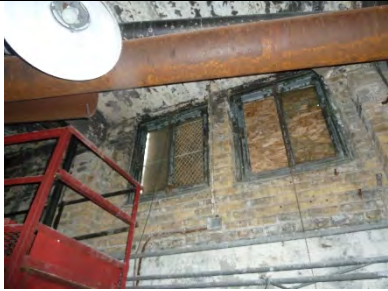
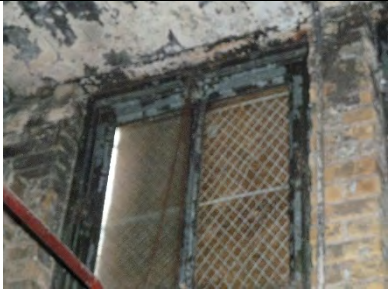
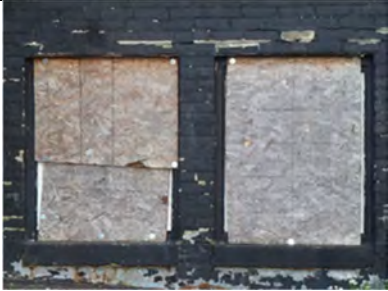
Room	Window	Window Configuration Type	Replace	Repair
017	N118	Center-pivot hopper steel sash fire window	✓

<p>N118-01: Interior view at left      N118-02: Interior view      N118-03: Exterior at right</p> <p><b>Condition Comments</b></p> <ul style="list-style-type: none"> <li>- Existing steel sash is rusted.</li> <li>- Wired glazing is broken / missing.</li> <li>- Jambs are swelled by rust.</li> <li>- Glazing caulk is tested as having ACM.</li> </ul>

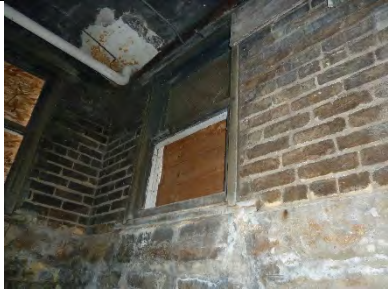
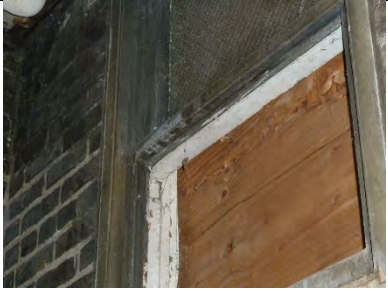
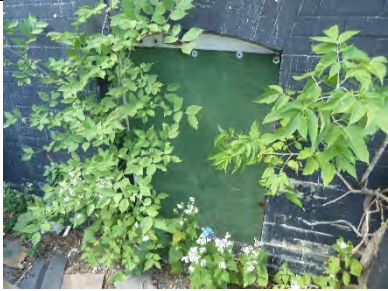
Room	Window	Window Configuration Type	Replace	Repair
018	N119	Double-hung with arched header	✓

<p>N119-01: Interior view      N119-02: Interior view of header      N119-03: Exterior view</p> <p><b>Condition Comments</b></p> <ul style="list-style-type: none"> <li>- Missing glazing at lower sash / broken obscured wired glazing at upper.</li> <li>- Sill in very poor condition.</li> <li>- Covered by plywood panel at exterior.</li> <li>- Glazing caulk is tested as having ACM.</li> </ul>

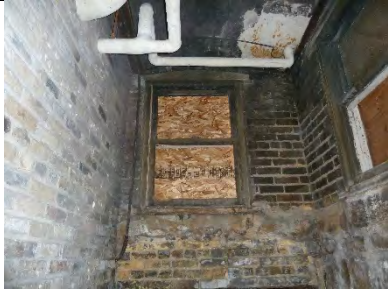
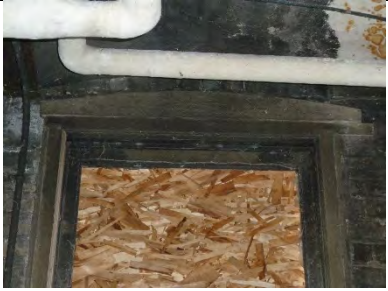
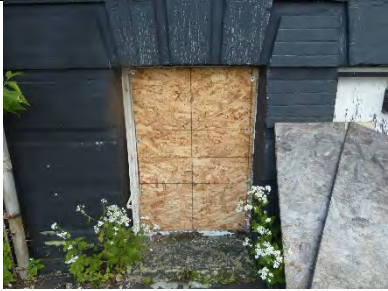
Room	Window	Window Configuration Type	Replace	Repair
018	N120	Double-hung with arched header	✓

<p>N120-01: Interior view      N120-02: Interior view of header      N120-03: Exterior view</p> <p><b>Condition Comments</b></p> <ul style="list-style-type: none"> <li>- Missing glazing at both sashes.</li> <li>- Sill in very poor condition.</li> <li>- Covered by plywood panel at exterior.</li> <li>- Glazing caulk is tested as having ACM.</li> </ul>

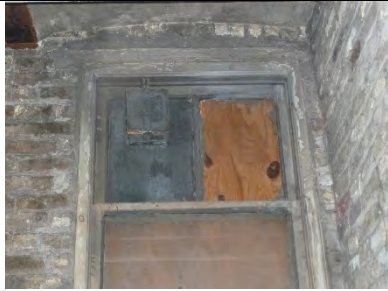
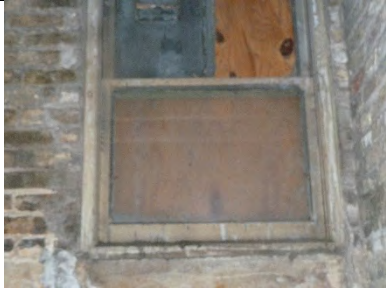
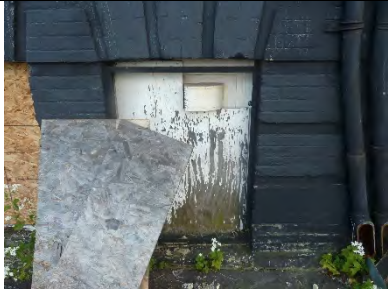
Room	Window	Window Configuration Type	Replace	Repair
018	N121	Double-hung with arched header	✓

<p>N121-01: Interior view                      N121-02: View of interior sill                      N121-03: Exterior view</p> <p><b>Condition Comments</b></p> <ul style="list-style-type: none"> <li>- Missing glazing at both sashes.</li> <li>- Panel vent in half of upper sash.</li> <li>- Sill in very poor condition.</li> <li>- Covered by plywood panel at exterior.</li> <li>- Glazing caulk is tested as having ACM.</li> </ul>

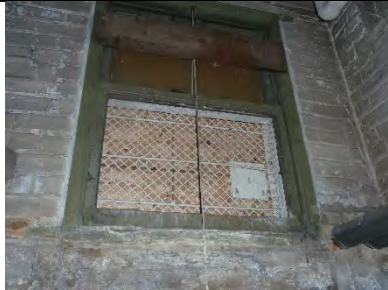
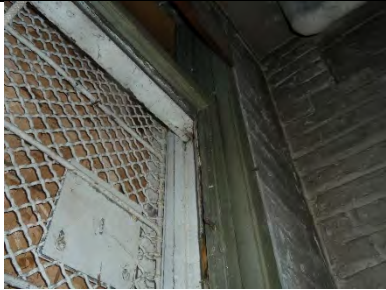
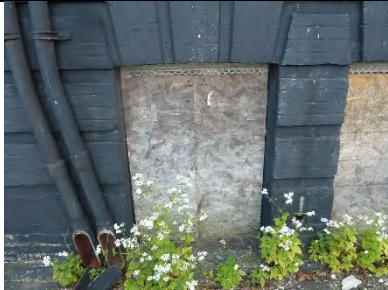
Room	Window	Window Configuration Type	Replace	Repair
019	N122	Double-hung with 2 /4 cottage sash configuration	✓

<p>N122-01: Interior view                      N122-02: Interior view of header                      N122-03: Exterior view</p> <p><b>Condition Comments</b></p> <ul style="list-style-type: none"> <li>- Missing glazing at lower sash / broken obscured wired glazing at upper.</li> <li>- Sill in very poor condition.</li> <li>- Covered by board at exterior.</li> <li>- Glazing caulk is tested as having ACM.</li> </ul>

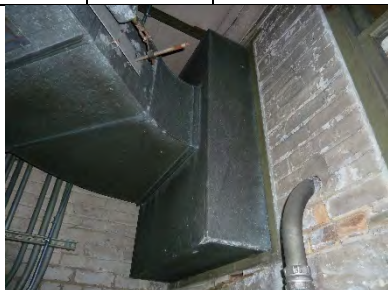
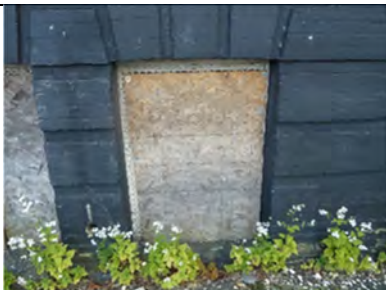
Room	Window	Window Configuration Type	Replace	Repair
019	N123	Vent	✓

<p>N123-01: Interior view of lower sash                      N123-02: View of rotted exterior sill – broken muntin connection</p> <p><b>Condition Comments</b></p> <ul style="list-style-type: none"> <li>- Vent outlet for duct.</li> <li>- Covered by board at exterior.</li> </ul>

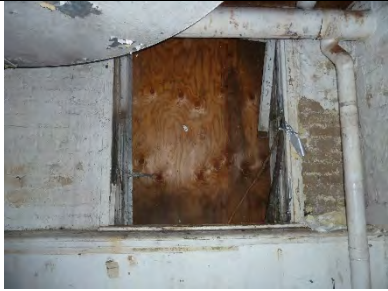
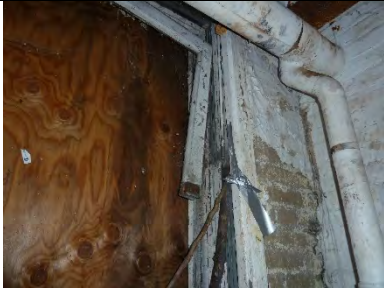
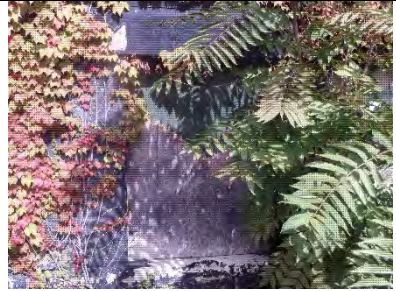
Room	Window	Window Configuration Type	Replace	Repair
021	S119	Double-hung with 2 /2 sash configuration	✓

<p>S119-01: Interior view                      S119-02: Broken frame                      S119-03: Exterior view</p> <p><b>Condition Comments</b></p> <ul style="list-style-type: none"> <li>- Sashes are missing.</li> <li>- Frame is broken out.</li> <li>- Boarded on the exterior with plywood.</li> </ul>				
021	S120	Double-hung with 2 /2 sash configuration (assumed)	✓

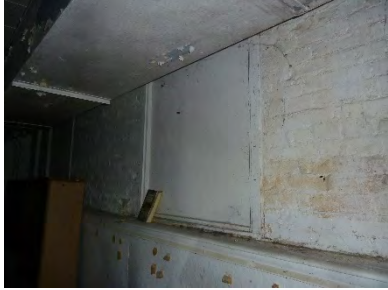
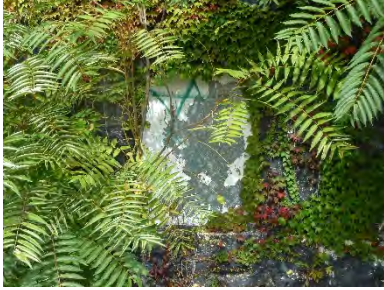
<p>S120-01: Interior view                      S120-02: Exterior view</p> <p><b>Condition Comments</b></p> <ul style="list-style-type: none"> <li>- Covered with plywood at interior.</li> <li>- Covered with galvanized metal sheet at exterior.</li> </ul>				
021	S121	Double-hung with 2 /2 sash configuration (assumed)	✓

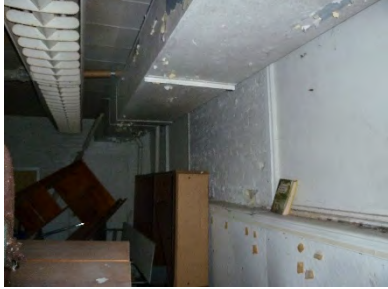
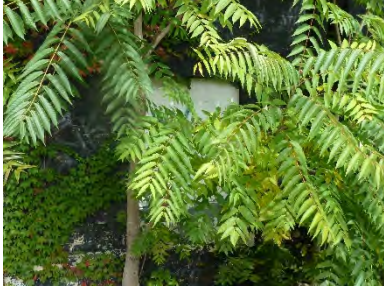
<p>S121-01: Interior view                      S121-02: Exterior view</p> <p><b>Condition Comments</b></p> <ul style="list-style-type: none"> <li>- Covered with plywood at interior.</li> <li>- Covered with galvanized metal sheet at exterior.</li> </ul>
