# Window Condition Survey

McKinley School Renovation

2001 W. Vliet St.  
Milwaukee WI, 53205

## **McKinley School Restoration Window Condition Survey**

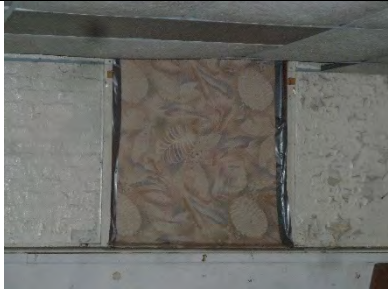
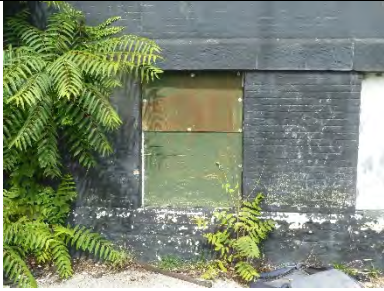
Room	Window	Window Configuration Type	Replace	Repair
022	S122	Double-hung with 2 /2 sash configuration (assumed)	✓

<p>S122-01: Interior view                      S122-02: Exterior view</p> <p><b>Condition Comments</b></p> <ul style="list-style-type: none"> <li>- Covered with plywood at interior.</li> <li>- Covered with galvanized metal sheet at exterior.</li> <li>- Evidence of water damage at sill.</li> </ul>

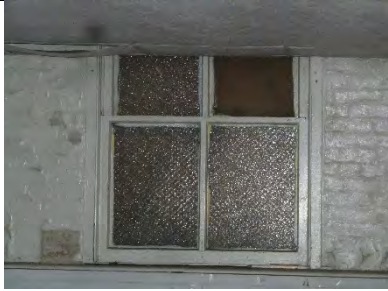
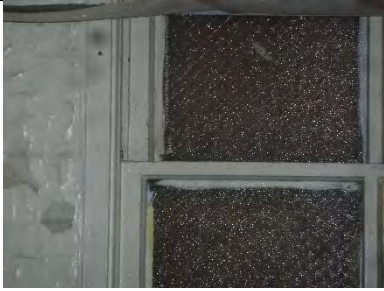
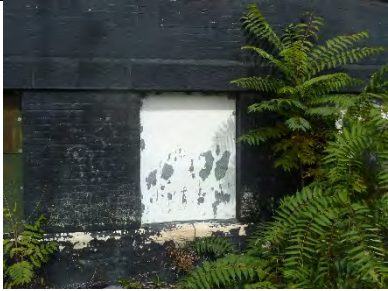
Room	Window	Window Configuration Type	Replace	Repair
022	S123	Double-hung with 2 /2 sash configuration	✓

<p>S123-01: Interior view                      S123-02: Meeting rail condition                      S123-03: Exterior view</p> <p><b>Condition Comments</b></p> <ul style="list-style-type: none"> <li>- Obscured wired glazing at both / missing glass at upper right.</li> <li>- Sash is non- operable. Retro-fitted spring balances are rusted and plastic cover is brittle / cracked. Sash was originally pinned in place.</li> <li>- Covered with galvanized metal sheet at exterior.</li> <li>- Evidence of water damage at sill.</li> </ul>

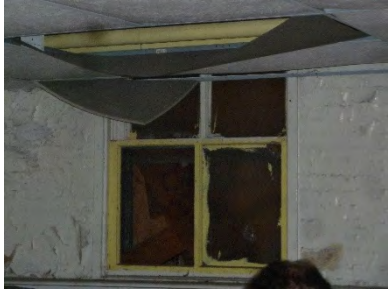
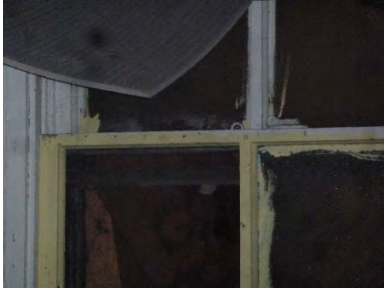
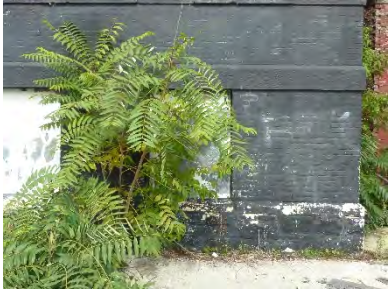
Room	Window	Window Configuration Type	Replace	Repair
022	S124	Double-hung with 2 /2 sash configuration	✓

<p>S124-01: Interior view                      S124-02: Meeting rail                      S124-03: Exterior view</p> <p><b>Condition Comments</b></p> <ul style="list-style-type: none"> <li>- Obscured wired glazing at both / missing glass at upper &amp; lower.</li> <li>- Sash is non- operable. Retro-fitted spring balances are rusted and plastic cover is brittle / cracked. Sash was originally pinned in place.</li> <li>- Covered with galvanized metal sheet at exterior.</li> <li>- Exterior sill is rotten</li> </ul>

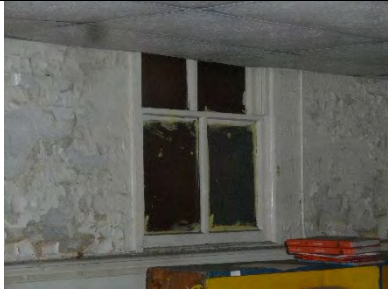
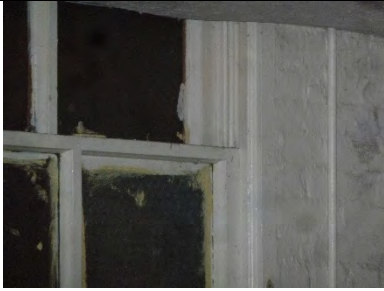
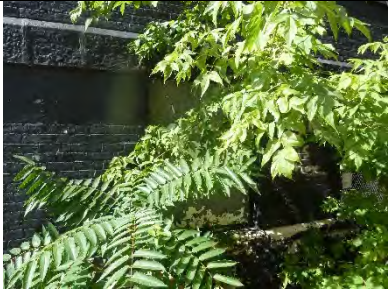
Room	Window	Window Configuration Type	Replace	Repair
022	S125	Double-hung with 2 /2 sash configuration	✓

<p>S125-01: Interior view                      S125-02: View of rotted exterior sill                      S125-03: Exterior view</p> <p><b>Condition Comments</b></p> <ul style="list-style-type: none"> <li>- Obscured wired glazing at both / missing glass at upper &amp; lower.</li> <li>- Sash is non- operable. Retro-fitted spring balances are rusted and plastic cover is brittle / cracked. Sash was originally pinned in place.</li> <li>- Covered with galvanized metal sheet at exterior.</li> <li>- Exterior sill is rotten</li> </ul>				
022	S126	Double-hung with 2 /2 sash configuration	✓

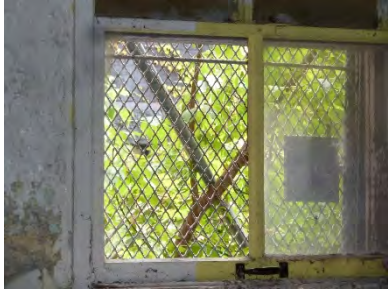
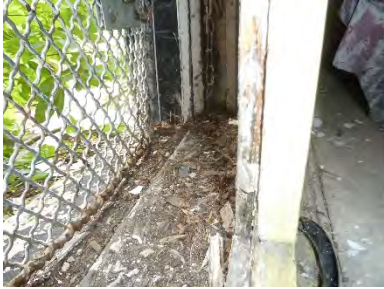
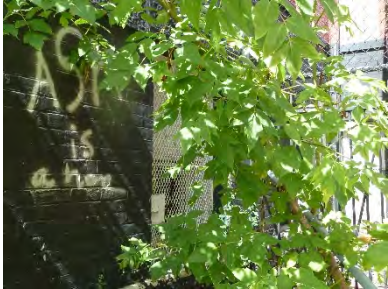
<p>S126-01: Interior view                      S126-02: Rotted exterior sill                      S126-03: Exterior view</p> <p><b>Condition Comments</b></p> <ul style="list-style-type: none"> <li>- Broken clear glazing at lower sash / panels at upper sash.</li> <li>- Sash is non- operable. Retro-fitted spring balances are rusted and plastic cover is brittle / cracked. Sash was originally pinned in place.</li> <li>- Exterior sill is rotted .</li> <li>- Exterior stops &amp; jamb decayed / water damaged.</li> <li>- Security screen mountings are mortised into the brickmold.</li> </ul>

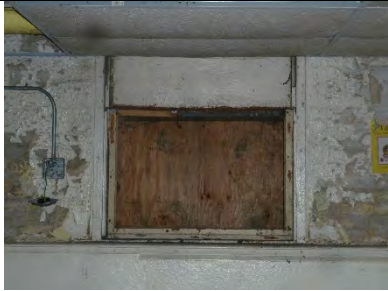
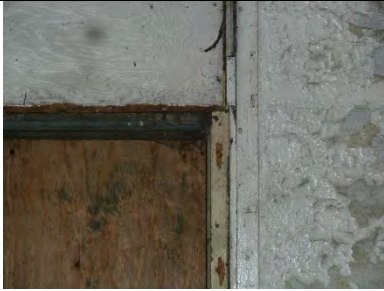
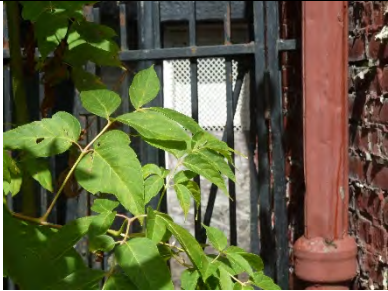
022	S127	Double-hung with 2 /2 sash configuration	✓

<p>S127-01: Interior view                      S127-02: Interior view of upper sash                      S127-03: Exterior view</p> <p><b>Condition Comments</b></p> <ul style="list-style-type: none"> <li>- Lower sash missing glazing and muntin.</li> <li>- Upper sash cover w/ plywood at exterior.</li> <li>- Exterior sill is rotted .</li> <li>- Exterior stops &amp; jamb decayed / water damaged.</li> <li>- Security screen mountings are mortised into the brickmold.</li> </ul>

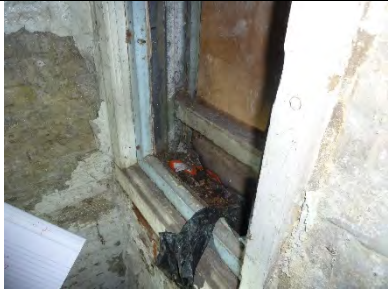
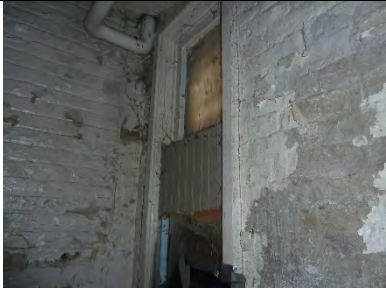
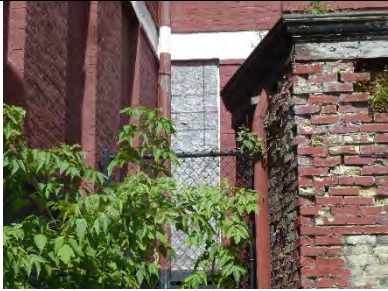
Room	Window	Window Configuration Type	Replace	Repair
022A	S143	Double-hung	✓

<p>S143-01: Interior view of lower sill      S143-02: Interior view of upper sash      S143-02: Exterior view</p> <p><b>Condition Comments</b></p> <ul style="list-style-type: none"> <li>- Lower sash broken and missing glazing.</li> <li>- Covered w/ board at exterior.</li> <li>- Exterior sill is rotted .</li> <li>- Exterior stops &amp; jamb decayed / water damaged.</li> </ul>				
023	N108	Bricked-in masonry opening	✓

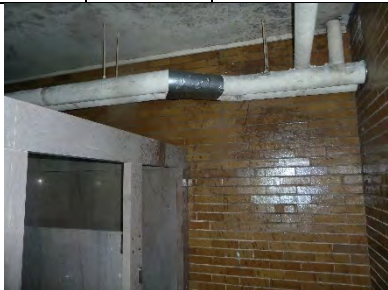
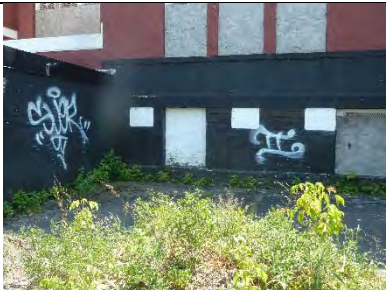
<p>N108-01: Interior view of lower sash      N108-02: Exterior bricked in (white recess at center)</p> <p><b>Condition Comments</b></p> <ul style="list-style-type: none"> <li>- Bricked in opening at exterior / glazed brick wall at interior.</li> </ul>				
023	N109	Ganged fixed over inswing hoppers with 2 /2 sash configuration	✓

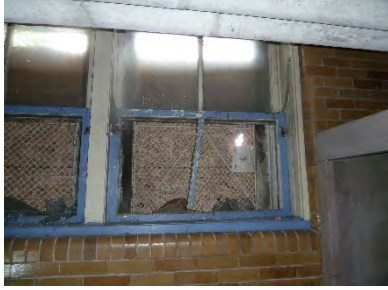
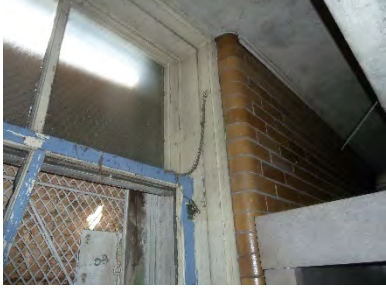
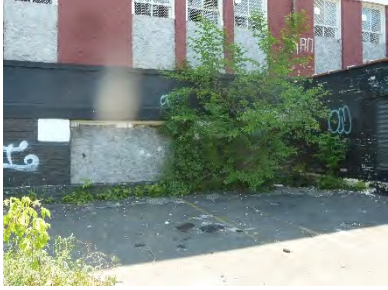
<p>N109-01: Interior view of lower sash      N109-02: Interior view of upper sash      N109-03: Exterior view</p> <p><b>Condition Comments</b></p> <ul style="list-style-type: none"> <li>- Glazing broken / missing at lower sash on both sides / obscured at upper.</li> <li>- Muntin at lower right sash broken.</li> <li>- Paint is crazed (multiple layers of paint / lead paint).</li> <li>- Exterior sill is decayed.</li> <li>- Security screen mountings are mortised into the brickmold.</li> <li>- Upper sashes fixed in place.</li> <li>- Glazing caulk is tested as having ACM.</li> <li>- Boarded up at exterior.</li> </ul>

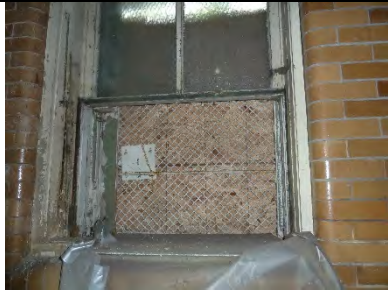
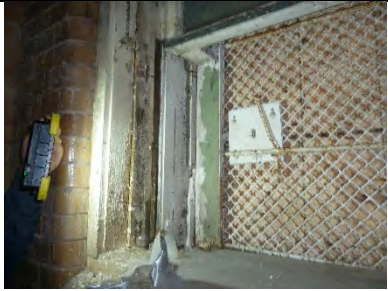
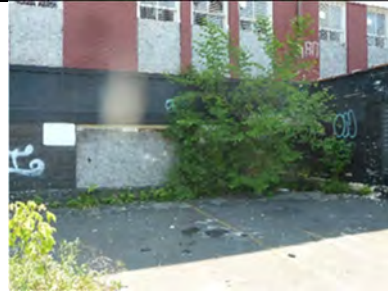
Room	Window	Window Configuration Type	Replace	Repair
023	N110	Fixed over inswing hopper with 2 / 2 sash configuration	✓

<p>N110-01: Interior view of lower sash      N110-02: Jamb and interior sill condition      N110-03: Window opening in corner behind tree</p> <p><b>Condition Comments</b></p> <ul style="list-style-type: none"> <li>- Lower hopper sash is missing.</li> <li>- Glazing at upper sash is obscured wired.</li> <li>- Sash ropes broken.</li> <li>- Paint is crazed (multiple layers of paint / lead paint).</li> <li>- Exterior sill is decayed.</li> <li>- Exterior jambs and stops decayed.</li> <li>- Security screen mountings are mortised into the brickmold.</li> <li>- Upper sash fixed in place.</li> <li>- Glazing caulk is tested as having ACM.</li> </ul>

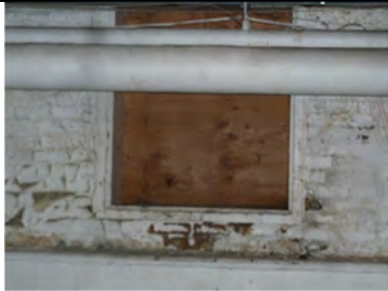
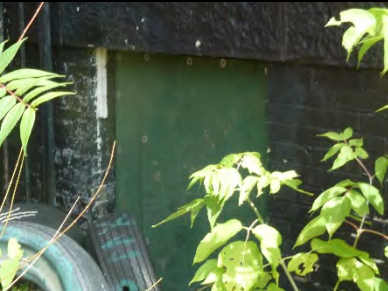
Room	Window	Window Configuration Type	Replace	Repair
026	S128	Double-hung with 2 / 2 sash configuration (assumed)	✓

<p>S128-01: Interior view      S128-02: Exterior view</p> <p><b>Condition Comments</b></p> <ul style="list-style-type: none"> <li>- Sashes and jambs missing at interior.</li> <li>- Covered with plywood at both exterior and interior.</li> </ul>

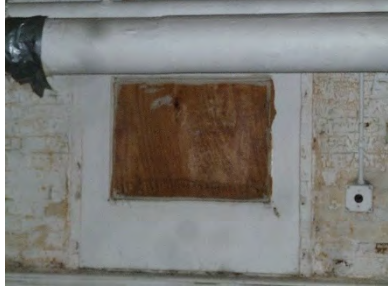
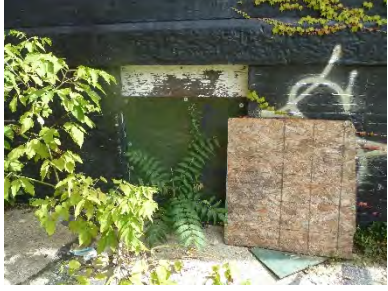
Room	Window	Window Configuration Type	Replace	Repair
026	S129	Double-hung with 2 / 2 sash configuration (assumed)	✓

<p>S129-01: Interior view      S129-02: Exterior view</p> <p><b>Condition Comments</b></p> <ul style="list-style-type: none"> <li>- Window boarded with plywood at both sides.</li> </ul>

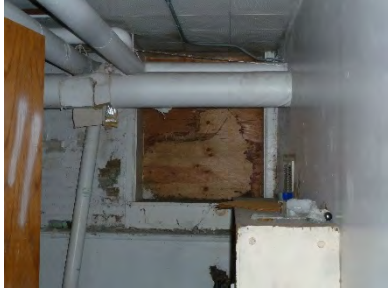
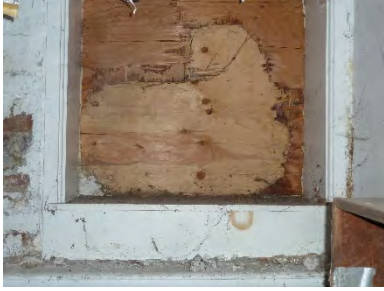
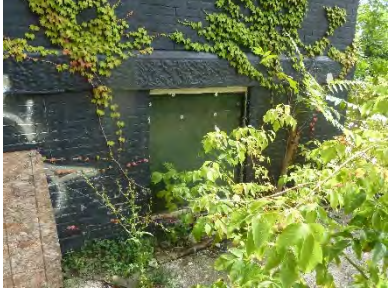
Room	Window	Window Configuration Type	Replace	Repair
026	S130	Double-hung with 2/2 sash configuration (assumed)	✓

<p>S130-01: Interior view of lower sash      S130-02: Interior sill condition      S130-03: Exterior view</p> <p><b>Condition Comments</b></p> <ul style="list-style-type: none"> <li>- Sashes and jambs missing at interior.</li> <li>- Covered with plywood at both exterior and interior.</li> </ul>				
Room	Window	Window Configuration Type	Replace	Repair
026	S131		✓

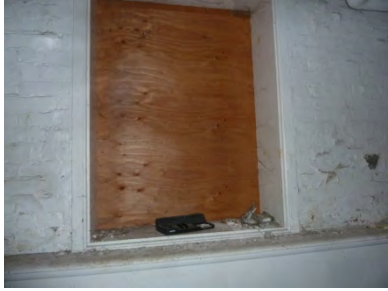
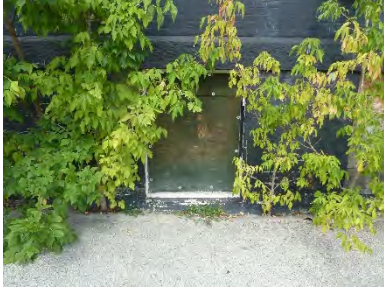
<p>S131-01: Interior view      S131-02: Exterior view</p> <p><b>Condition Comments</b></p> <ul style="list-style-type: none"> <li>- Sashes and jambs missing at interior.</li> <li>- Covered with plywood at both exterior and interior.</li> <li>- Exterior sill is decayed - 1/4"-1/2" blade penetration.</li> </ul>				
Room	Window	Window Configuration Type	Replace	Repair
026	S132	Access door (Double-hung with 2/2 sash configuration original)	✓

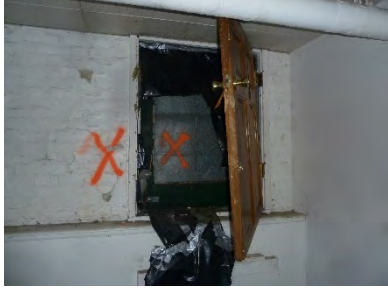
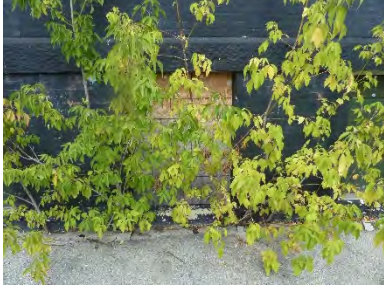
<p>S132-01: Interior view of lower sash      S132-02: Exterior view</p> <p><b>Condition Comments</b></p> <ul style="list-style-type: none"> <li>- Converted to access door.</li> <li>- Will be converted back into a window opening.</li> </ul>

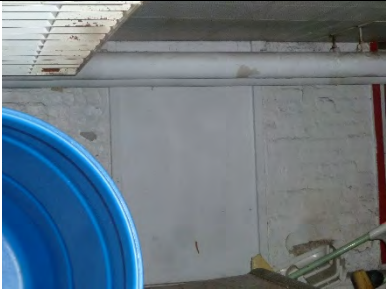
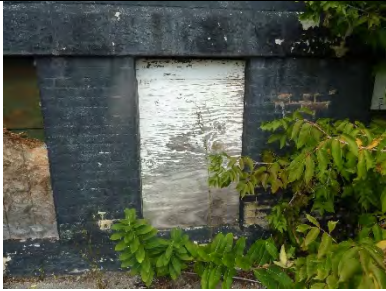
Room	Window	Window Configuration Type	Replace	Repair
027	S136	Double-hung (assumed)	✓

<p>S136-01: Interior view of lower sash      S136-02: Exterior view</p> <p><b>Condition Comments</b></p> <ul style="list-style-type: none"> <li>- Covered with gypsum board at interior.</li> <li>- Covered with plywood panel at exterior.</li> <li>- Unknown whether original window is behind the boards.</li> </ul>				
027	S137	Double-hung	✓

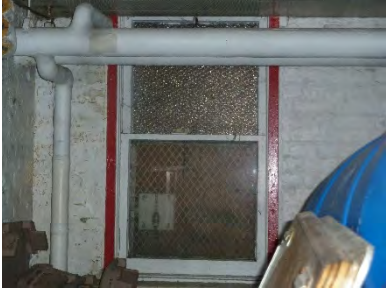
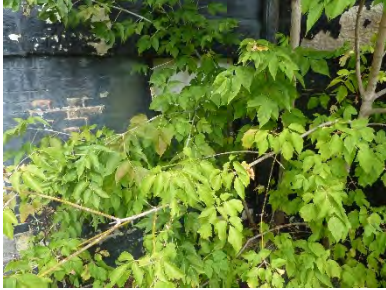
<p>S137-01: Interior view of lower sash      S137-02: Exterior view (behind tree)</p> <p><b>Condition Comments</b></p> <ul style="list-style-type: none"> <li>- Obscured glazing at upper sash / clear glazing at lower sash.</li> <li>- Exterior sill and jambs decayed and in poor condition.</li> <li>- Exterior boarded up.</li> </ul>				
027B	S138	Double-hung with 2/2 sash configuration	✓

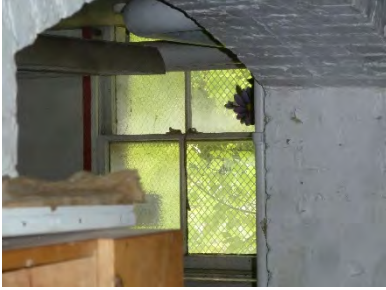
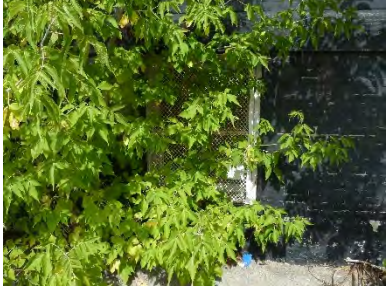
<p>S138-01: Interior view      S138-02: Exterior view (behind tree)</p> <p><b>Condition Comments</b></p> <ul style="list-style-type: none"> <li>- Obscured wired glazing and clear mixed at both sashes.</li> <li>- Paint is crazed (multiple layers of paint / lead paint).</li> <li>- Exterior sill is decayed - 1/2" blade penetration.</li> <li>- Security screen mountings are mortised into the brickmold.</li> <li>- Glazing caulk is tested as having ACM.</li> <li>- Close-up interior inspection not done: window is inaccessible due to debris.</li> </ul>

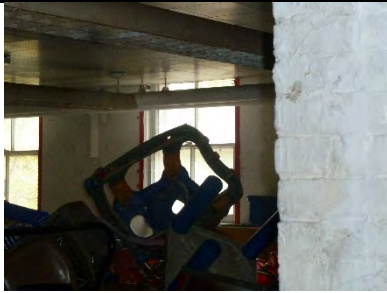
S139-01: Interior view

- Obscured wired glazing at lower sash and mixed with clear at upper sash.
- Exterior sill and jambs decayed and in poor condition.
- Paint is crazed (multiple layers of paint / lead paint).
- Exterior sill is decayed - 1/4"-3/8" blade penetration.
- Security screen mountings are mortised into the brickmold.
- Glazing caulk is tested as having ACM.
- Close-up interior inspection not done: window is inaccessible due to debris

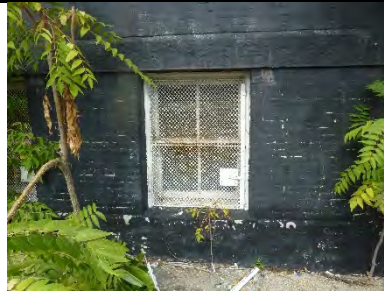
S139-02: Exterior view

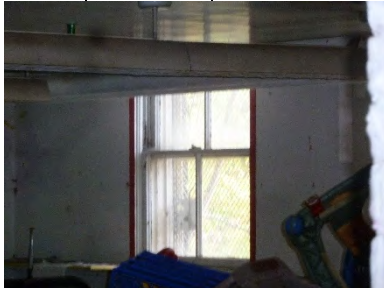
S140-01: Interior view

- Clear glazing at both sashes.
- Exterior sill and jambs decayed and in poor condition.
- Paint is crazed (multiple layers of paint / lead paint).
- Security screen mountings are mortised into the brickmold.
- Glazing caulk is tested as having ACM.
- Close-up interior inspection not done: window is inaccessible due to debris

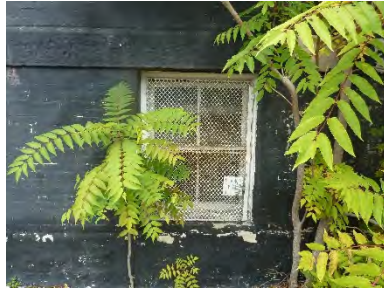
S140-02: Exterior view

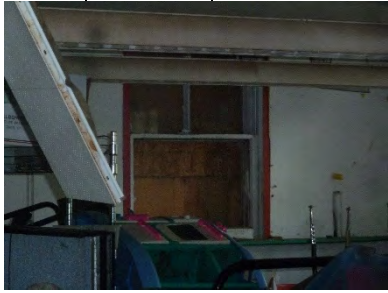
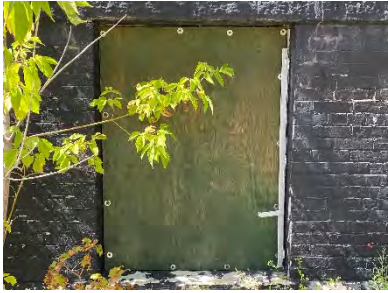
Room	Window	Window Configuration Type	Replace	Repair
027B	E100	Double-hung with 2/2 sash configuration	✓

E100-01: Interior view E100-02: Exterior view		
<b>Condition Comments</b>				
<ul style="list-style-type: none"> <li>- Broken glazing and muntin at lower sash</li> <li>- Boarded up with plywood at the exterior.</li> <li>- Glazing caulk is tested as having ACM.</li> <li>- Close-up interior inspection not done: window is inaccessible due to debris</li> </ul>				
Room	Window	Window Configuration Type	Replace	Repair
027B	E100.1	Door in window opening	✓

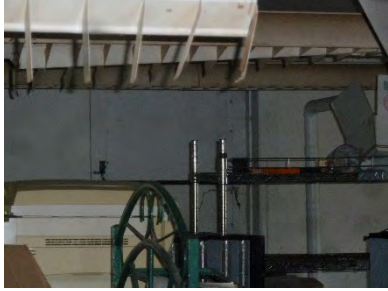
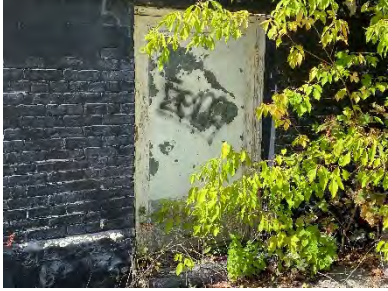
E100.1-01: Interior view E100.1-02: Exterior view		
<b>Condition Comments</b>				
<ul style="list-style-type: none"> <li>- Door located in former window opening.</li> <li>- Close-up interior inspection not done: window is inaccessible due to debris</li> <li>- Door will be abandoned and turned back into a window.</li> </ul>

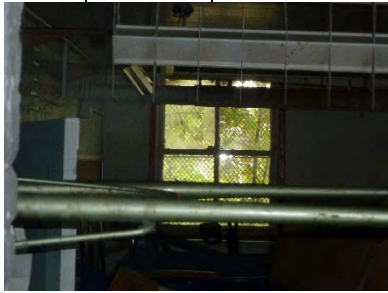
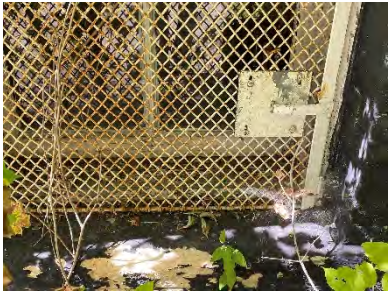
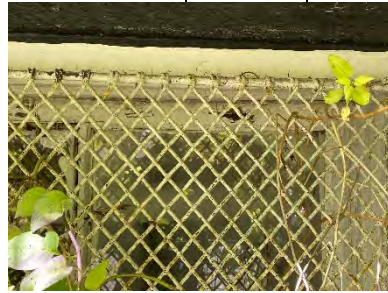
Room	Window	Window Configuration Type	Replace	Repair
027B	E101	Double-hung with 2/2 sash configuration	✓

E101-01: Interior view E101-02: Exterior view E101-03: Rotted hole in upper rail		
<b>Condition Comments</b>				
<ul style="list-style-type: none"> <li>- Clear glazing at both sashes.</li> <li>- Exterior sill and jambs decayed and in poor condition.</li> <li>- Rotted hole in brickmold at exterior lintel.</li> <li>- Security screen mountings are mortised into the brickmold.</li> <li>- Glazing caulk is tested as having ACM.</li> <li>- Close-up interior inspection not done: window is inaccessible due to debris</li> </ul>

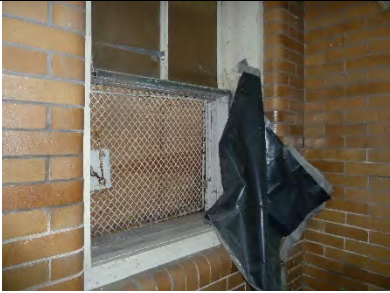
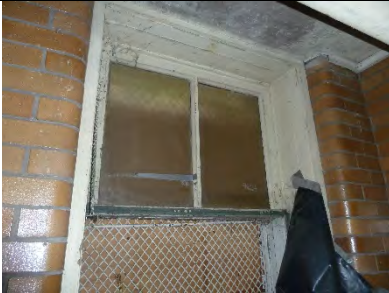
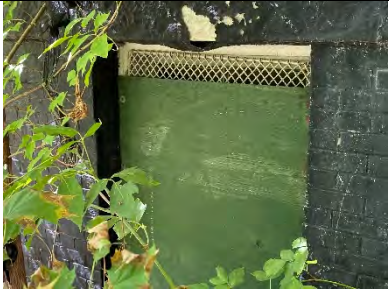
Room	Window	Window Configuration Type	Replace	Repair
029	E102	Fixed sash over in-swing hopper (2/2 muntins)	✓

<p>E102-01: Interior view of lower sash      E102-02: Interior view of upper sash      E102-03: Exterior view</p> <p><b>Condition Comments</b></p> <ul style="list-style-type: none"> <li>- Missing lower hopper sash.</li> <li>- Sill is in poor condition.</li> <li>- Exterior sill is decayed – 3/8" blade penetration.</li> <li>- Security screen mountings are mortised into the brickmold.</li> <li>- Upper sash painted in place.</li> <li>- Glazing caulk is tested as having ACM.</li> </ul>

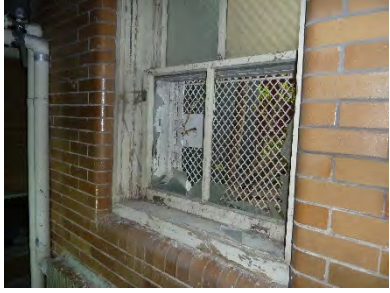
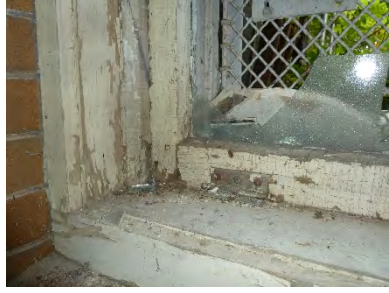
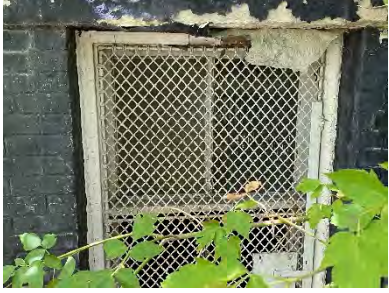
Room	Window	Window Configuration Type	Replace	Repair
029	E102.1	Fixed sash over in-swing hopper (2/2 muntins)	✓

<p>E102.1-01: Interior view of lower sash      E102.1-02: Interior view sash corner      E102.1-03: Exterior view</p> <p><b>Condition Comments</b></p> <ul style="list-style-type: none"> <li>- Glazing missing at lower sash / broken at upper sash.</li> <li>- Paint is crazed (multiple layers of paint / lead paint).</li> <li>- Interior and exterior sills in poor condition.</li> <li>- Exterior jambs and stops decayed.</li> <li>- Security screen mountings are mortised into the brickmold.</li> <li>- Upper sash painted in place.</li> <li>- Glazing caulk is tested as having ACM.</li> </ul>

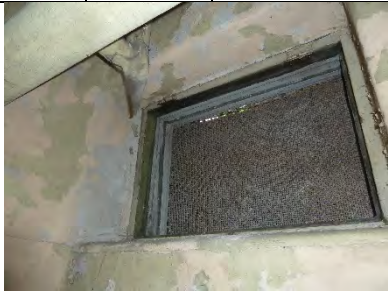
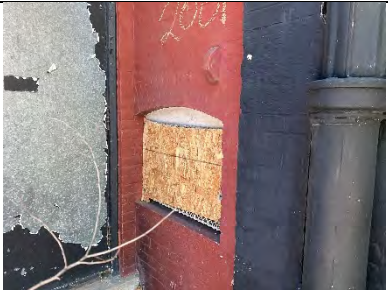
<p>E103.1-01: Interior view      E103.1-02: Exterior view</p> <p><b>Condition Comments</b></p> <ul style="list-style-type: none"> <li>- No sash in frame.</li> <li>- Boarded up at exterior.</li> </ul>				
031	E103	Double-hung with 2/2 sash configuration	✓

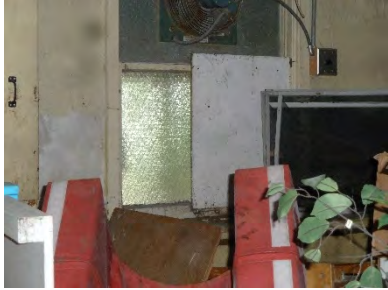
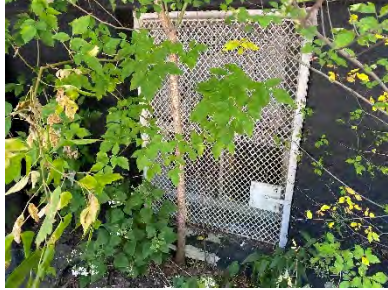
<p>E103-01: Interior view      E103-02: Fan panel at upper sash      E103-03: Exterior view</p> <p><b>Condition Comments</b></p> <ul style="list-style-type: none"> <li>- Obscured wired glazing at lower sash.</li> <li>- Upper sash is fixed panel with exhaust fan mounted.</li> <li>- Center muntin at upper sash was removed to center the fan.</li> <li>- Exterior sill is decayed.</li> <li>- Security screen mountings are mortised into the brickmold.</li> </ul>

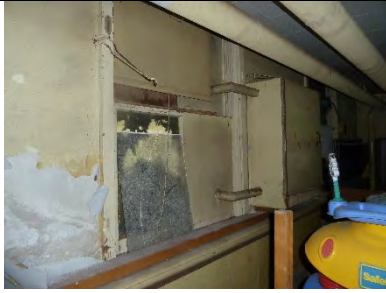
E104-01: Interior view

- Upper sash replaced by panel.
- Lower sash fixed in place.
- Obscured glazing in left panel of lower sash and wood panel in right side with pipe penetrations.
- Security screen mountings are mortised into the brickmold.

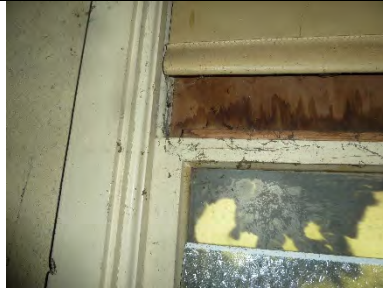
E104-02: Interior view of upper sash

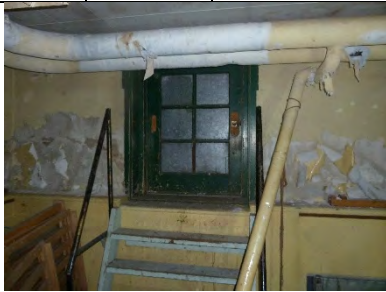
E105-01: Interior view of exit door

- Wood door and frame with sheet metal panel at exterior.
- To be removed and replaced with new window to match existing lower level windows in this area.

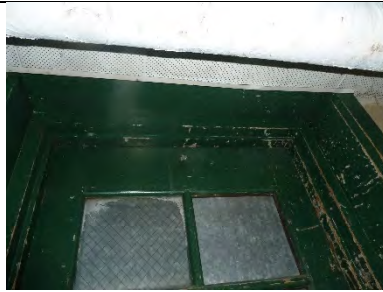
E105-02: Head at exit door

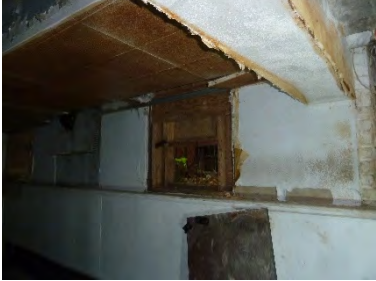
<p>LC100-01: Interior view at center</p> <p><b>Condition Comments</b></p> <ul style="list-style-type: none"> <li>- Window removed and framed in with lumber.</li> </ul>				
Light Court B	LC101	Abandoned: Double-hung w/arched wood head at exterior original	✓

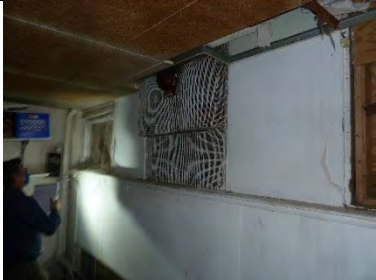
<p>LC101-01: Interior view at center</p> <p><b>Condition Comments</b></p> <ul style="list-style-type: none"> <li>- Converted into a vent.</li> </ul>				
Light Court B	LC101.1	Double-hung with arched wood trim head at exterior	✓

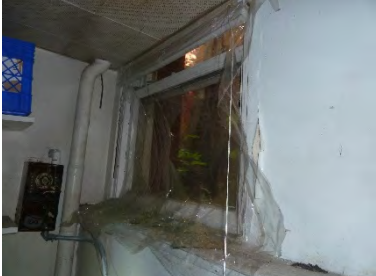
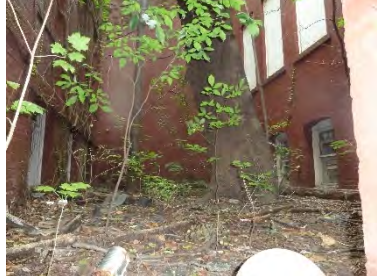
<p>LC101.1-01: Interior view of lower sash</p> <p>LC101.1-02: Exterior view at right just right of tree</p> <p><b>Condition Comments</b></p> <ul style="list-style-type: none"> <li>- Glazing missing /broken at both sashes.</li> <li>- Paint is crazed (multiple layers of paint / lead paint).</li> <li>- Exterior sill and jambs in very poor condition.</li> <li>- Upper sash painted in place.</li> <li>- Heavy water damage at adjacent walls and ceiling.</li> <li>- Glazing caulk is tested as having ACM.</li> <li>-</li> </ul>

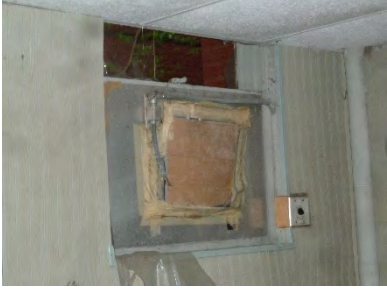
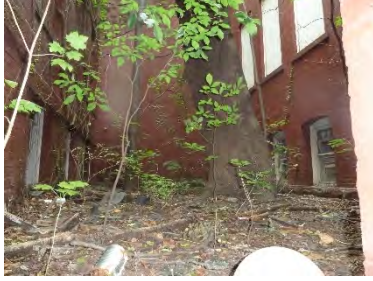
<p>LC102-01: Interior view of lower sash      LC102-02: Exterior at right</p> <p><b>Condition Comments</b></p> <ul style="list-style-type: none"> <li>- Glazing broken at upper sash.</li> <li>- Paint is crazed (multiple layers of paint / lead paint).</li> <li>- Bottom sash has been converted into a vent.</li> <li>- Heavy water damage at adjacent walls and ceiling.</li> <li>- Glazing caulk is tested as having ACM.</li> </ul>				
Room	Window	Window Configuration Type	Replace	Repair
Light Court B	LC103	Double-hung with arched wood trim head at exterior	✓

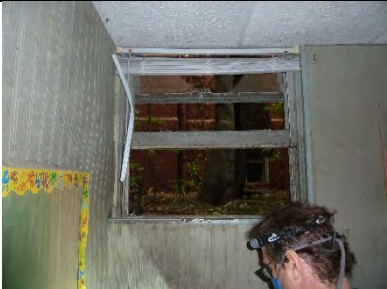
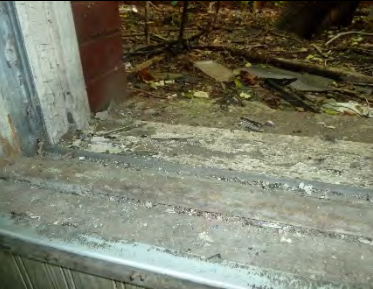
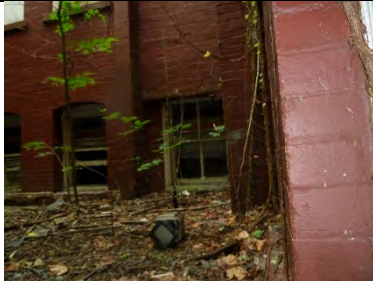
<p>LC103-01: Interior view      LC103-02: Exterior sill      LC103-03: Exterior view at left</p> <p><b>Condition Comments</b></p> <ul style="list-style-type: none"> <li>- Glazing missing /broken at both sashes.</li> <li>- Exterior sill in poor condition.</li> <li>- Bottom rail of lower sash in poor condition.</li> <li>- Paint is crazed (multiple layers of paint / lead paint).</li> <li>- Heavy water damage at adjacent walls and ceiling.</li> <li>- Glazing caulk is tested as having ACM.</li> </ul>

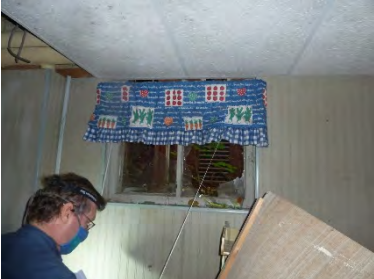
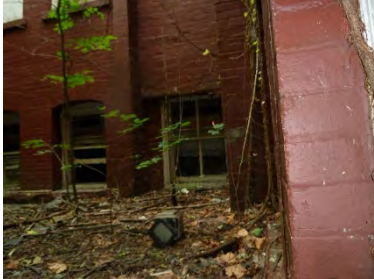
Room	Window	Window Configuration Type	Replace	Repair
Light Court B	LC104	Double-hung with 2/2 muntin configuration	✓

<p>LC104-01: Interior view      LC104-02: Exterior view at right</p> <p><b>Condition Comments</b></p> <ul style="list-style-type: none"> <li>- Glazing missing /broken at both sashes.</li> <li>- Exterior sill in poor condition.</li> <li>- Heavy water damage at adjacent walls and ceiling.</li> </ul>

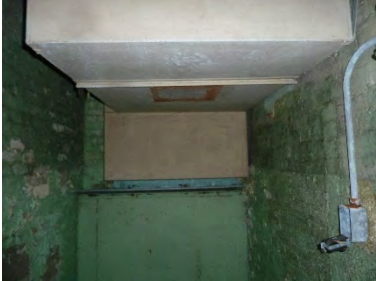
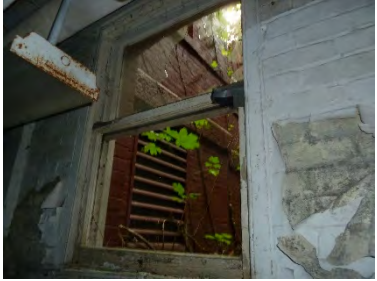
Room	Window	Window Configuration Type	Replace	Repair
Light Court B	LC105	Vent	✓

<p>LC105-01: Interior view      LC105-02: Exterior view through window</p> <p><b>Condition Comments</b></p> <ul style="list-style-type: none"> <li>- Converted to a vent.</li> </ul>

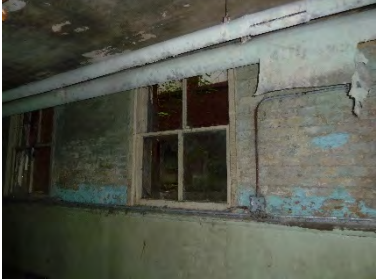
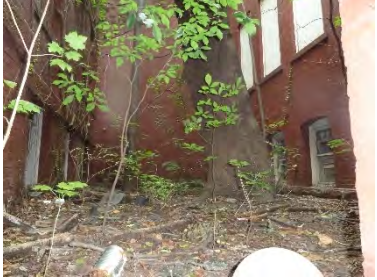
Room	Window	Window Configuration Type	Replace	Repair
Light Court B	LC106	Double-hung with 2/2 muntin configuration

<p>LC106-01: Interior view      LC106-02: Exterior view at left</p> <p><b>Condition Comments</b></p> <ul style="list-style-type: none"> <li>- Glazing missing /broken at both sashes.</li> <li>- Paint is crazed (multiple layers of paint / lead paint).</li> <li>- Exterior sill is rotten.</li> <li>- Upper sash painted in place.</li> <li>- Heavy water damage at adjacent walls and ceiling.</li> <li>- Glazing caulk is tested as having ACM.</li> </ul>

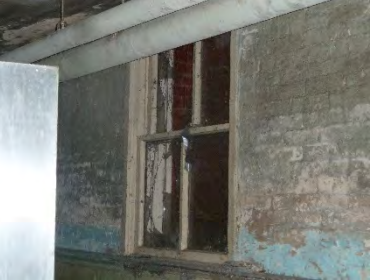
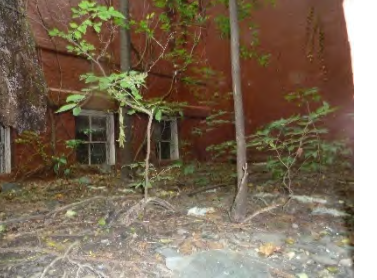
Room	Window	Window Configuration Type	Replace	Repair
Light Court B	LC107	Double-hung with 2/2 muntin configuration	✓

<p>LC107-01: Interior view of lower sash      LC107-02: Exterior – at left</p> <p><b>Condition Comments</b></p> <ul style="list-style-type: none"> <li>- Glazing missing /broken at both sashes.</li> <li>- Paint is crazed (multiple layers of paint / lead paint).</li> <li>- Interior and exterior sills in very poor condition.</li> <li>- Upper sash painted in place.</li> <li>- Heavy water damage at adjacent walls and ceiling.</li> <li>- Glazing caulk is tested as having ACM.</li> </ul>

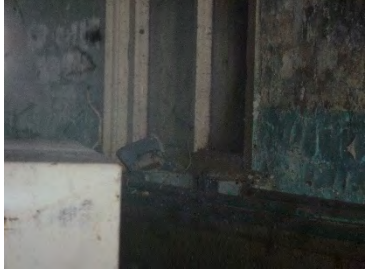
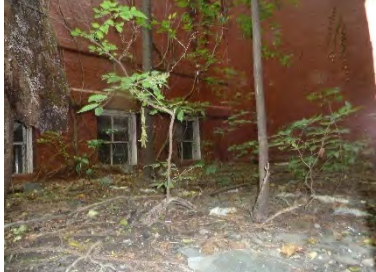
<p>LC108-01: Interior view                      LC108-02: Exterior – at right</p> <p><b>Condition Comments</b></p> <ul style="list-style-type: none"> <li>- Glazing missing /broken at both sashes.</li> <li>- Paint is crazed (multiple layers of paint / lead paint).</li> <li>- Interior and exterior sills in very poor condition.</li> <li>- Heavy water damage at adjacent walls and ceiling.</li> <li>- Glazing caulk is tested as having ACM.</li> </ul>				
Light Court B	LC110	Double-hung with arched wood trim head at exterior	✓

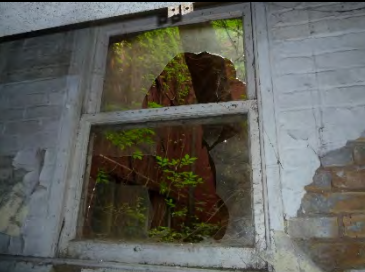
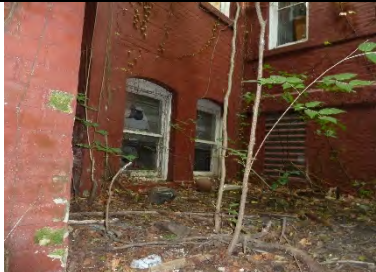
<p>LC110-01: Interior view at center                      LC110-02: Exterior view at left</p> <p><b>Condition Comments</b></p> <ul style="list-style-type: none"> <li>- Glazing missing /broken at both sashes.</li> <li>- Paint is crazed (multiple layers of paint / lead paint).</li> <li>- Interior and exterior sills in very poor condition.</li> <li>- Both sashes fixed in place</li> <li>- Heavy water damage at adjacent walls.</li> </ul>

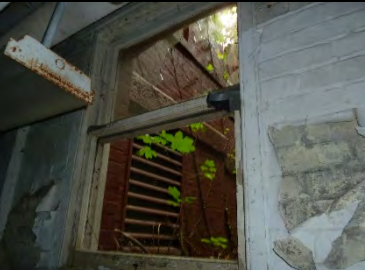
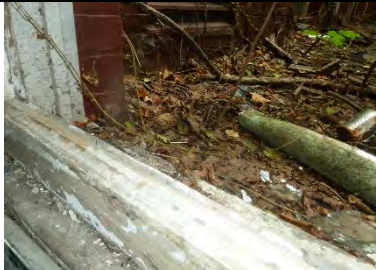
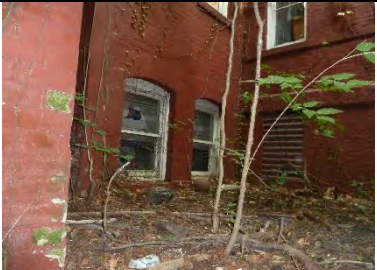
Light Court B	LC111	Double-hung with arched wood trim head at exterior	✓

<p>LC111-01: Interior view at center                      LC111-02: Lower sash rail and sill                      LC111-03: Exterior view at center</p> <p><b>Condition Comments</b></p> <ul style="list-style-type: none"> <li>- Glazing missing /broken at both sashes.</li> <li>- Paint is crazed (multiple layers of paint / lead paint).</li> <li>- Interior and exterior sills in very poor condition.</li> <li>- Both sashes fixed in place.</li> <li>- Heavy water damage at adjacent walls.</li> </ul>

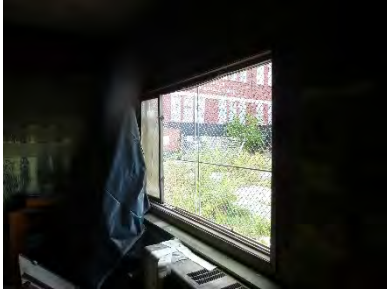
W123-01: Interior view of lower sash

- Smoke / fire damage.
- Missing fixed center and right slider sashes.
- Broken glazing in remaining slider unit
- Vinyl seals and track deformed.
- Non-original window in this portion of building.

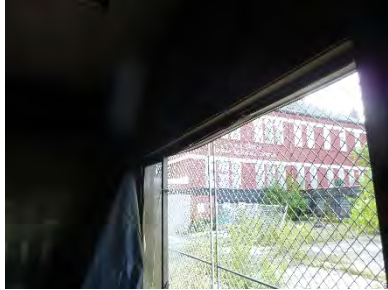
W123-03: Severely rotted sill and jamb

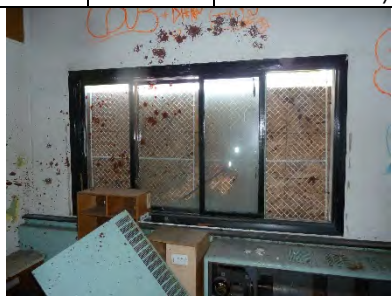
<p>W121-01: Interior view of lower sash</p> </div> <div style="text-align: center;">

<p>W121-03: Exterior view</p> </div> </div> <p><b>Condition Comments</b></p> <ul style="list-style-type: none"> <li>- Smoke / fire damage.</li> <li>- Broken glazing in slider sash.</li> <li>- Vinyl seals and track deformed.</li> <li>- Non-original window in this portion of building.</li> <li>- Slider sashes don't move.</li> <li>- Sashes are water damage and warped.</li> </ul>

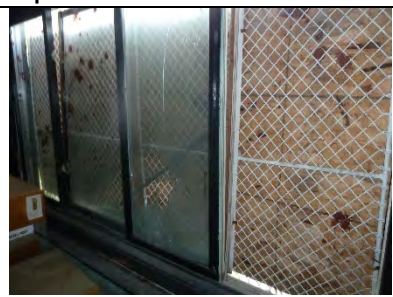
<p>W121-02: Warped slider sash frame</p> </div> <div style="text-align: center;">

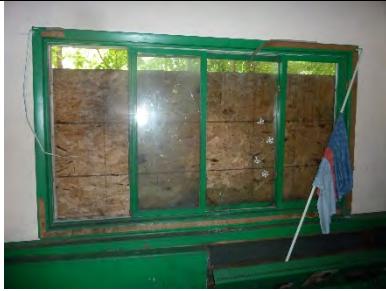
E112-01: Interior view

- Smoke / fire damage.
- Broken glazing in fixed sash.
- Vinyl seals and track deformed.
- Non-original window in this portion of building.
- Sashes are water damaged.

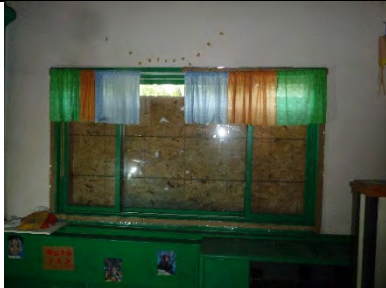
E113-01: Interior view

- Smoke / fire damage.
- Vinyl seals and track deformed.
- Non-original window in this portion of building.
- Sashes are water damaged.

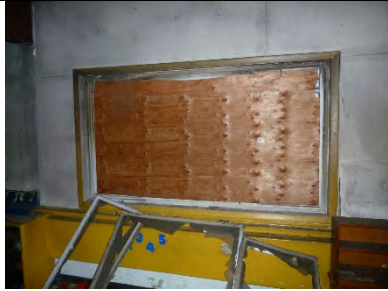
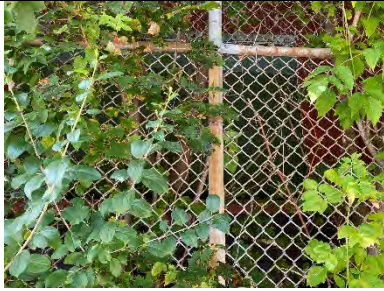
E110-01: Interior view		E110-02: Exterior view		
<b>Condition Comments</b>				
<ul style="list-style-type: none"> <li>- Smoke / fire damage.</li> <li>- No window sashes – boarded up.</li> <li>- Non-original window in this portion of building.</li> </ul>				
043	E111	OXO sliders w/ fixed picture window	✓

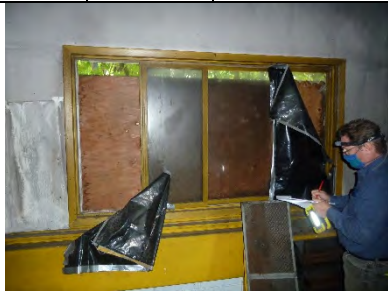
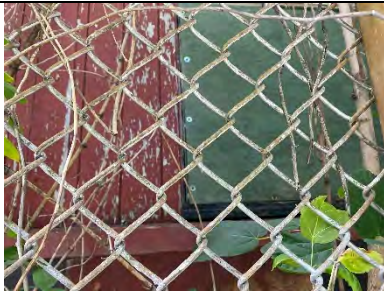
E111-01: Interior view		E111-02: Exterior view		
<b>Condition Comments</b>				
<ul style="list-style-type: none"> <li>- Smoke / fire damage.</li> <li>- Broken glazing in slider sash.</li> <li>- Vinyl seals and track deformed.</li> <li>- Non-original window in this portion of building.</li> <li>- Slider sashes don't move.</li> <li>- Sashes are water damaged and warped.</li> </ul>				
044	E108	OXO sliders w/ fixed picture window	✓

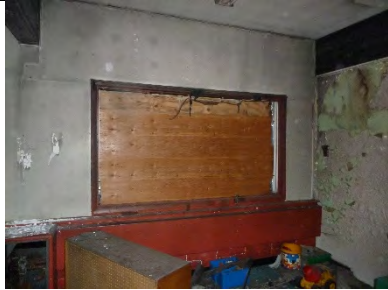
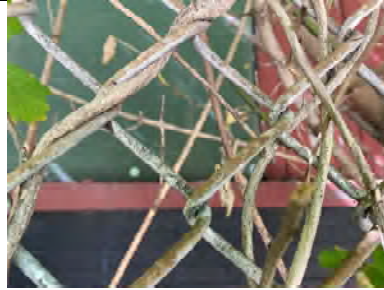
E108-01: Interior view		E108-02: Exterior view – inaccessible and overgrown

<b>Condition Comments</b>				
<ul style="list-style-type: none"> <li>- Smoke / fire damage.</li> <li>- No window sashes – boarded up.</li> <li>- Non-original window in this portion of building.</li> </ul>

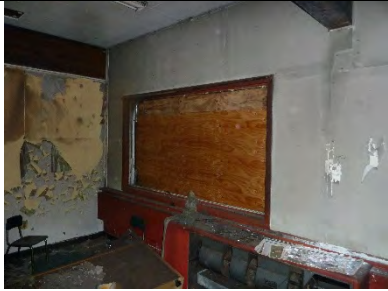
<p>E109-01: Interior view</p>

<p>E109-02: Exterior view – inaccessible and overgrown</p>		
<p><b>Condition Comments</b></p> <ul style="list-style-type: none"> <li>- Smoke / fire damage.</li> <li>- No window sashes – boarded up.</li> <li>- Non-original window in this portion of building.</li> </ul>				
045	E106	OXO sliders w/ fixed picture window	✓

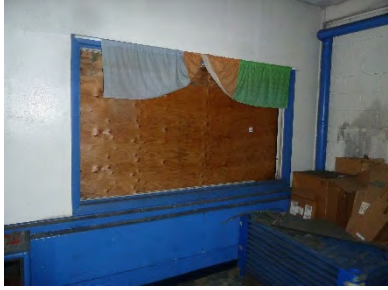
<p>E106-01: Interior view</p>

<p>E106-02: Exterior view – inaccessible and overgrown</p>		
<p><b>Condition Comments</b></p> <ul style="list-style-type: none"> <li>- Smoke / fire damage.</li> <li>- No window washes – boarded up.</li> <li>- Non-original window in this portion of building.</li> <li>- Slider sashes don't move.</li> </ul>				
045	E107	OXO sliders w/ fixed picture window	✓

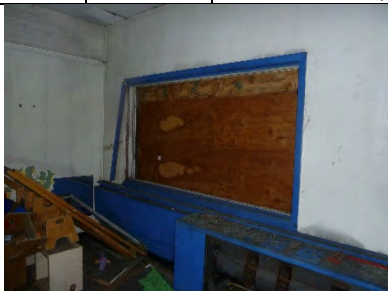
<p>E107-01: Interior view</p>

<p><b>Condition Comments</b></p> <ul style="list-style-type: none"> <li>- Smoke / fire damage.</li> <li>- No window sashes – boarded up.</li> <li>- Vinyl seals and track deformed.</li> <li>- Non-original window in this portion of building.</li> <li>- Slider sashes don't move.</li> <li>- Sashes are water damage and warped.</li> </ul>

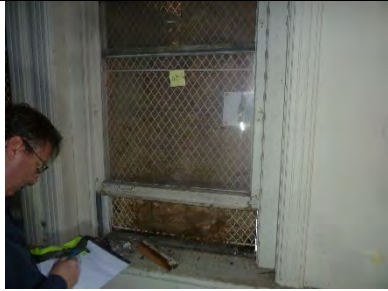
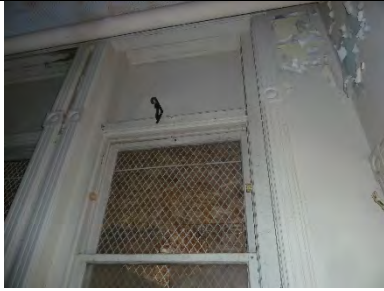
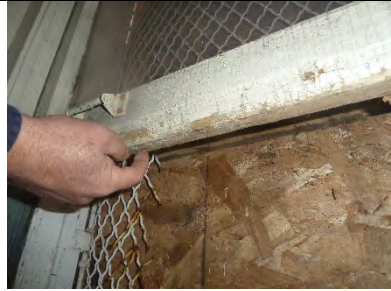
<p>N235-01: Interior view of lower sash      N235-02: Interior view of upper sash      N235-03: Bottom of sash is split out</p> <p><b>Condition Comments</b></p> <ul style="list-style-type: none"> <li>- Missing upper fixed transom sash - replaced with Transite (ACM) panel.</li> <li>- Broken glazing in both sashes.</li> <li>- Original hardware damaged / missing.</li> <li>- Casings and trims dive behind continuous wood sill. Sill needs to be removed to pull the weight boxes/jambs.</li> <li>- Paint is crazed (multiple layers of paint / lead paint).</li> <li>- Exterior sill is decayed.</li> <li>- Security screen mountings are mortised into the brickmold.</li> <li>- Upper sash painted in place.</li> <li>- Glazing caulk is tested as having ACM.</li> <li>- Accessing window weight box will require removing the galvanized metal jamb guides - access port is blocked.</li> <li>- Lower rail of bottom sash is split out at weather strip groove.</li> </ul>

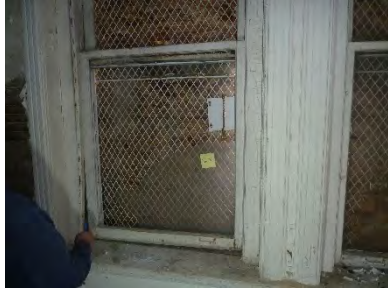
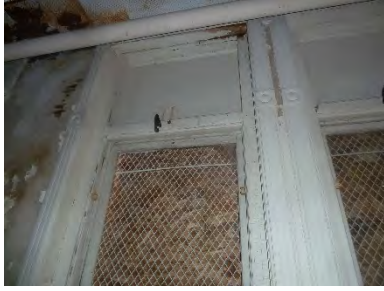
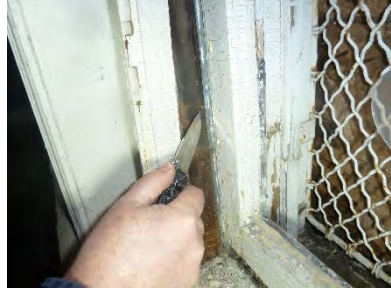
<p>N236-01: Interior view of lower sash      N236-02: Interior view of upper sash      N236-03: Severely rotted sill and jamb</p> <p><b>Condition Comments</b></p> <ul style="list-style-type: none"> <li>- Missing upper fixed transom sash - replaced with Transite (ACM) panel.</li> <li>- Broken glazing in both sashes.</li> <li>- Original hardware damaged / missing.</li> <li>- Casings and trims dive behind continuous wood sill. Sill needs to be removed to pull the weight boxes/jambs.</li> <li>- Paint is crazed (multiple layers of paint / lead paint).</li> <li>- Exterior sill is severely rotted. Blade penetration of 3".</li> <li>- Security screen mountings are mortised into the brickmold.</li> <li>- Upper sash painted in place.</li> <li>- Glazing caulk is tested as having ACM.</li> <li>- Accessing window weight box will require removing the galvanized metal jamb guides - access port is blocked.</li> <li>- Bottom sash not square / racked.</li> </ul>

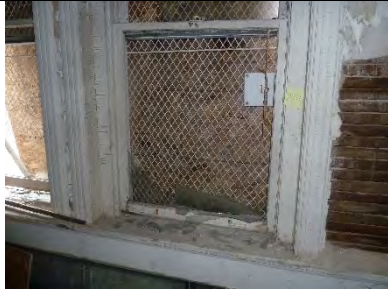
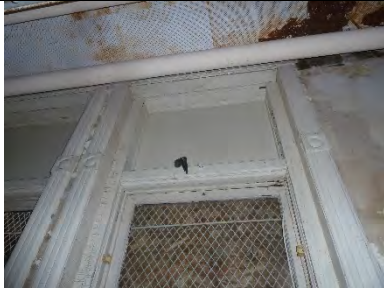
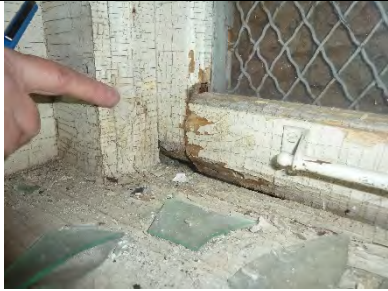
<p>N237-01: Interior view of lower sash      N237-02: Interior view of upper sash      N237-03: Galv. jamb guide blocking weight box access</p> <p><b>Condition Comments</b></p> <ul style="list-style-type: none"> <li>- Missing upper fixed transom sash - replaced with Transite (ACM) panel.</li> <li>- Broken glazing in both sashes.</li> <li>- Original hardware damaged / missing.</li> <li>- Casings and trims dive behind continuous wood sill. Sill needs to be removed to pull the weight boxes/jambs.</li> <li>- Paint is crazed (multiple layers of paint / lead paint).</li> <li>- Exterior sill is decayed.</li> <li>- Security screen mountings are mortised into the brickmold.</li> <li>- Upper sash painted in place.</li> <li>- Glazing caulk is tested as having ACM.</li> <li>- Accessing window weight box will require removing the galvanized metal jamb guides - access port is blocked.</li> <li>- Lower sash corners are open.</li> </ul>

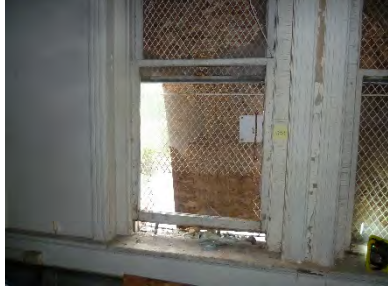
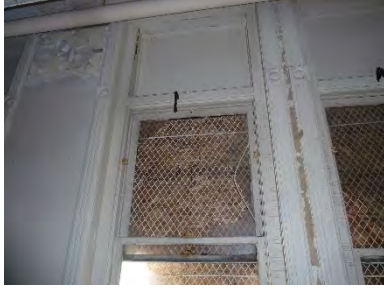
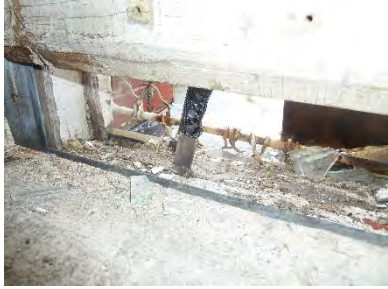
<p>N238-01: Interior view of lower sash      N238-02: Interior view of upper sash      N238-03: Severely rotted exterior sill</p> <p><b>Condition Comments</b></p> <ul style="list-style-type: none"> <li>- Missing upper fixed transom sash - replaced with Transite (ACM) panel.</li> <li>- Broken glazing in both sashes.</li> <li>- Original hardware damaged / missing.</li> <li>- Casings and trims dive behind continuous wood sill. Sill needs to be removed to pull the weight boxes/jambs.</li> <li>- Paint is crazed (multiple layers of paint / lead paint).</li> <li>- Exterior sill is severely rotted. Blade penetration of 3".</li> <li>- Security screen mountings are mortised into the brickmold.</li> <li>- Upper sash painted in place.</li> <li>- Glazing caulk is tested as having ACM.</li> <li>- Accessing window weight box will require removing the galvanized metal jamb guides - access port is blocked.</li> </ul>

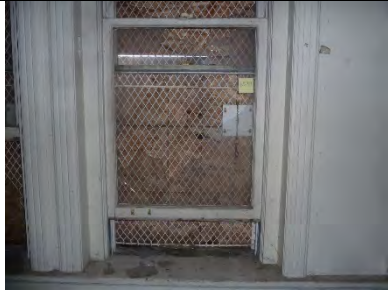
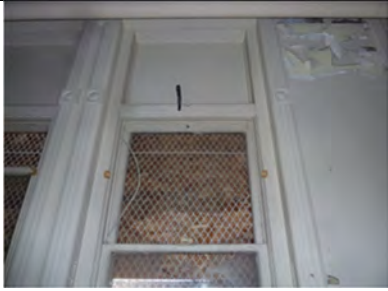
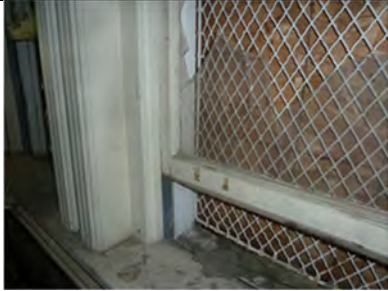
Room	Window	Window Configuration Type	Replace	Repair
101	N239	Double-hung with fixed transom above	✓

<p>N239-01: Interior view of lower sash</p> <p>N239-02: Interior view of upper sash</p> <p>N239-03: Galv. jamb guide blocking weight box access</p>		<p><b>Condition Comments</b></p> <ul style="list-style-type: none"> <li>- Missing upper fixed transom sash - replaced with Transite (ACM) panel.</li> <li>- Broken glazing in both sashes.</li> <li>- Original hardware damaged / missing.</li> <li>- Casings and trims dive behind continuous wood sill. Sill needs to be removed to pull the weight boxes/jambs.</li> <li>- Paint is crazed (multiple layers of paint / lead paint).</li> <li>- Exterior sill is decayed.</li> <li>- Security screen mountings are mortised into the brickmold.</li> <li>- Upper sash painted in place.</li> <li>- Glazing caulk is tested as having ACM.</li> <li>- Accessing window weight box will require removing the galvanized metal jamb guides - access port is blocked.</li> </ul>

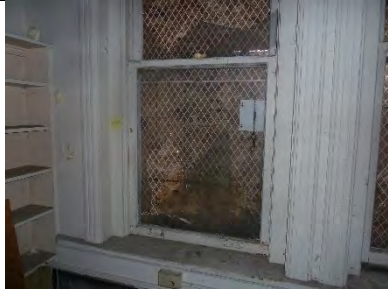
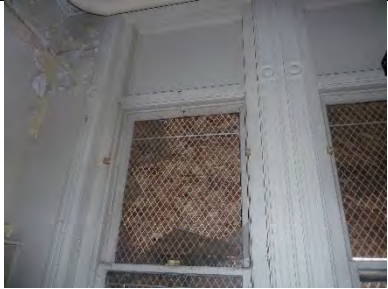
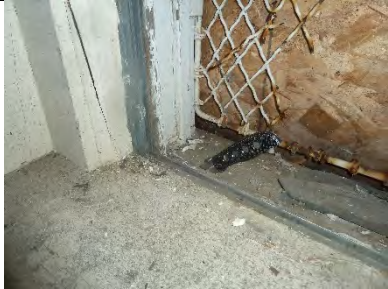
Room	Window	Window Configuration Type	Replace	Repair
101	N240	Double-hung with fixed transom above	✓

<p>N240-01: Interior view of lower sash</p> <p>N240-02: Interior view of upper sash</p> <p>N240-03: Severely rotted sill and jamb</p>		<p><b>Condition Comments</b></p> <ul style="list-style-type: none"> <li>- Missing upper fixed transom sash - replaced with Transite (ACM) panel.</li> <li>- Broken glazing in both sashes.</li> <li>- Original hardware damaged / missing.</li> <li>- Casings and trims dive behind continuous wood sill. Sill needs to be removed to pull the weight boxes/jambs.</li> <li>- Paint is crazed (multiple layers of paint / lead paint).</li> <li>- Exterior sill is severely rotted. Blade penetration of 3".</li> <li>- Security screen mountings are mortised into the brickmold.</li> <li>- Upper sash painted in place.</li> <li>- Glazing caulk is tested as having ACM.</li> <li>- Accessing window weight box will require removing the galvanized metal jamb guides - access port is blocked.</li> </ul>
