# Window Condition Survey

McKinley School Renovation

2001 W. Vliet St.  
Milwaukee WI, 53205

## **McKinley School Restoration Window Condition Survey**

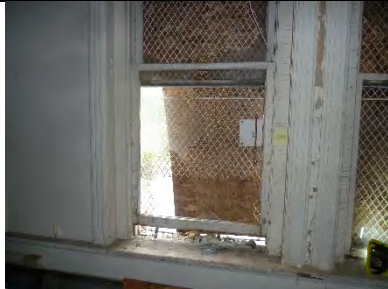
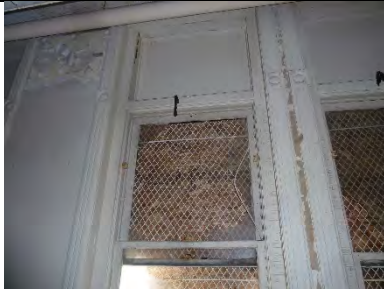
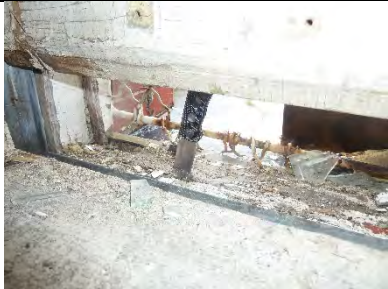
Room	Window	Window Configuration Type	Replace	Repair
101	N238	Double-hung with fixed transom above	✓

<p>N238-01: Interior view of lower sash      N238-02: Interior view of upper sash      N238-03: Severely rotted exterior sill</p> <p><b>Condition Comments</b></p> <ul style="list-style-type: none"> <li>- Missing upper fixed transom sash - replaced with Transite (ACM) panel.</li> <li>- Broken glazing in both sashes.</li> <li>- Original hardware damaged / missing.</li> <li>- Casings and trims dive behind continuous wood sill. Sill needs to be removed to pull the weight boxes/jambs.</li> <li>- Paint is crazed (multiple layers of paint / lead paint).</li> <li>- Exterior sill is severely rotted. Blade penetration of 3".</li> <li>- Security screen mountings are mortised into the brickmold.</li> <li>- Upper sash painted in place.</li> <li>- Glazing caulk is tested as having ACM.</li> <li>- Accessing window weight box will require removing the galvanized metal jamb guides - access port is blocked.</li> </ul>

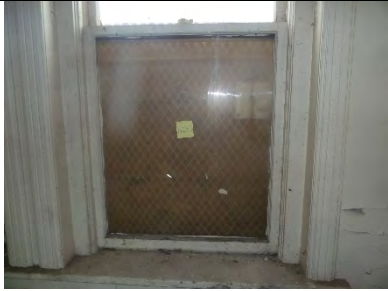
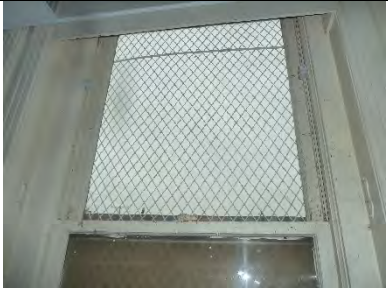
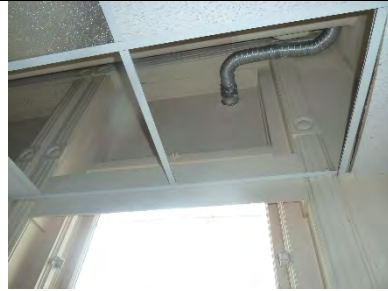
Room	Window	Window Configuration Type	Replace	Repair
101A	N233	Double-hung with fixed transom above	✓

<p>N233-01: Interior view of lower sash      N233-02: Interior view of upper sash      N233-03: View of fixed transom panel</p> <p><b>Condition Comments</b></p> <ul style="list-style-type: none"> <li>- Missing upper fixed transom sash - replaced with Transite (ACM) panel. Vent through existing transom panel.</li> <li>- Glazing in both sashes intact.</li> <li>- Original hardware damaged / missing.</li> <li>- Casings and trims dive behind continuous wood sill. Sill needs to be removed to pull the weight boxes/jamb.</li> <li>- Paint is crazed (multiple layers of paint / lead paint).</li> <li>- Exterior sill is decayed.</li> <li>- Security screen mountings are mortised into the brickmold.</li> <li>- Upper sash painted in place.</li> <li>- Glazing caulk is tested as having ACM.</li> <li>- Accessing window weight box will require removing the galvanized metal jamb guides - access port is blocked.</li> </ul>

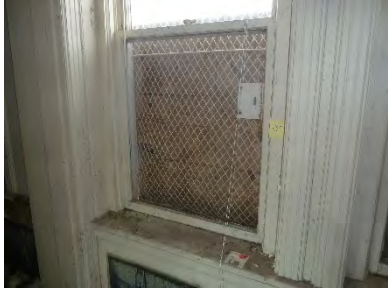
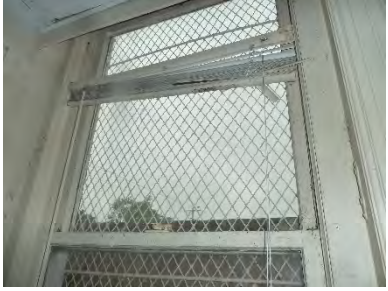
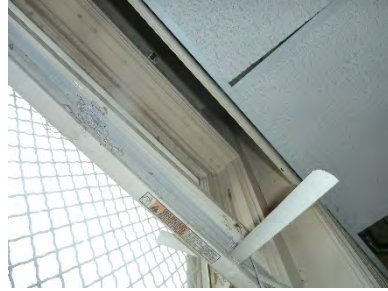
Room	Window	Window Configuration Type	Replace	Repair
101A	N234	Double-hung with fixed transom above	✓

<p>N234-01: Interior view of lower sash      N234-02: Interior view of upper sash      N234-03: Fixed transom above ceiling</p> <p><b>Condition Comments</b></p> <ul style="list-style-type: none"> <li>- Missing upper fixed transom sash - replaced with Transite (ACM) panel.</li> <li>- Glazing in both sashes intact.</li> <li>- Original hardware damaged / missing.</li> <li>- Casings and trims dive behind continuous wood sill. Sill needs to be removed to pull the weight boxes/jamb.</li> <li>- Paint is crazed (multiple layers of paint / lead paint).</li> <li>- Exterior sill is decayed.</li> <li>- Security screen mountings are mortised into the brickmold.</li> <li>- Upper sash painted in place.</li> <li>- Glazing caulk is tested as having ACM.</li> <li>- Accessing window weight box will require removing the galvanized metal jamb guides - access port is blocked.</li> <li>- Lower sash will not open.</li> </ul>

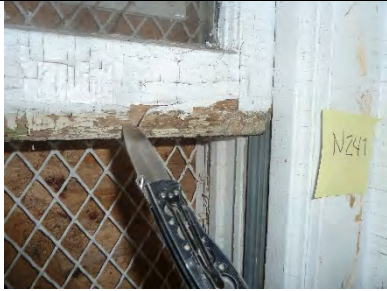
N241-01: Interior view of lower sash

- Missing upper fixed transom sash - replaced with Transite (ACM) panel. Vent through existing transom panel.
- Glazing at lower sash broken.
- Original hardware damaged / missing.
- Casings and trims dive behind continuous wood sill. Sill needs to be removed to pull the weight boxes/jamb.
- Paint is crazed (multiple layers of paint / lead paint).
- Exterior sill is decayed - 1/2" blade penetration
- Security screen mountings are mortised into the brickmold.
- Upper sash painted in place.
- Glazing caulk is tested as having ACM.
- Accessing window weight box will require removing the galvanized metal jamb guides - access port is blocked.
- Upper sash left corner at meeting rail showing signs of decay.
- Bottom sash rail soft - blade penetration of 3/8".

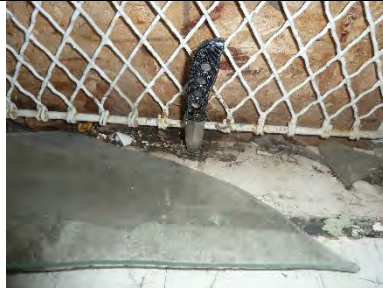
N241-02: View of rotted sill

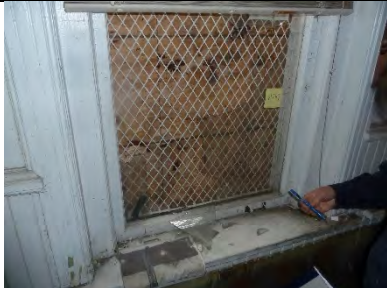
N242-01: Interior view of lower sash

- Missing upper fixed transom sash - replaced with Transite (ACM) panel.
- Broken glazing in lower sash.
- Original hardware damaged / missing.
- Casings and trims dive behind continuous wood sill. Sill needs to be removed to pull the weight boxes/jamb.
- Paint is crazed (multiple layers of paint / lead paint).
- Exterior sill is severely rotted. Blade penetration of 1".
- Security screen mountings are mortised into the brickmold.
- Upper sash painted in place.
- Glazing caulk is tested as having ACM.
- Accessing window weight box will require removing the galvanized metal jamb guides - access port is blocked.
- Water damage at fixed transom head.

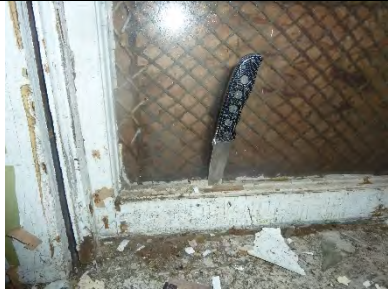
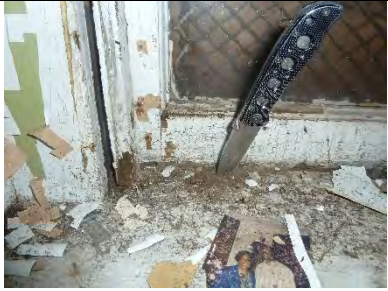
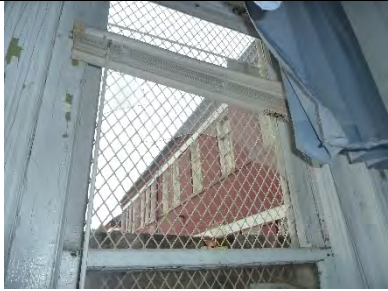
Room	Window	Window Configuration Type	Replace	Repair
102	N243	Double-hung with fixed transom above	✓

<p>N243-01: Interior view of lower sash      N243-02: View of rotted interior sill      N243-03: Interior view of upper sash</p> <p><b>Condition Comments</b></p> <ul style="list-style-type: none"> <li>- Missing upper fixed transom sash - replaced with Transite (ACM) panel. Vent through existing transom panel.</li> <li>- Glazing at upper sash broken.</li> <li>- Original hardware damaged / missing.</li> <li>- Casings and trims dive behind continuous wood sill. Sill needs to be removed to pull the weight boxes/jamb.</li> <li>- Paint is crazed (multiple layers of paint / lead paint).</li> <li>- Exterior sill is decayed. Interior sill is rotten.</li> <li>- Security screen mountings are mortised into the brickmold.</li> <li>- Upper sash painted in place.</li> <li>- Glazing caulk is tested as having ACM.</li> <li>- Accessing window weight box will require removing the galvanized metal jamb guides - access port is blocked.</li> <li>- Lower sash bottom rail is decayed - 3/8" blade penetration.</li> </ul>

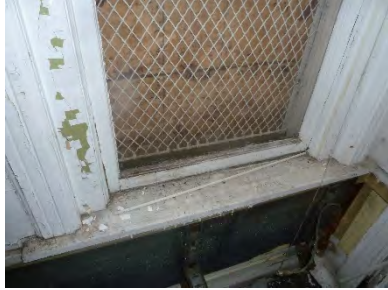
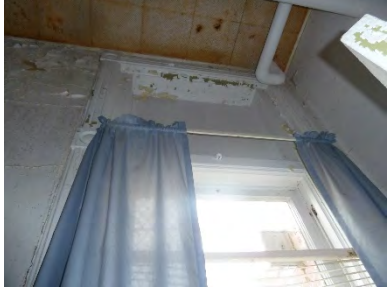
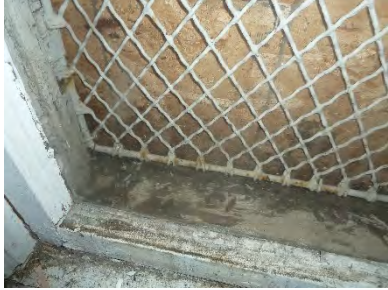
Room	Window	Window Configuration Type	Replace	Repair
102B	N244	Double-hung with fixed transom above	✓

<p>N244-01: Interior view of lower sash      N244-02: Interior view of upper sash and transom      N244-03: Exterior sill and security grille mortise into brickmold</p> <p><b>Condition Comments</b></p> <ul style="list-style-type: none"> <li>- Missing upper fixed transom sash - replaced with Transite (ACM) panel.</li> <li>- Glazing at both sashes intact.</li> <li>- Original hardware damaged / missing.</li> <li>- Casings and trims dive behind continuous wood sill. Sill needs to be removed to pull the weight boxes/jamb.</li> <li>- Paint is crazed (multiple layers of paint / lead paint).</li> <li>- Exterior sill is decayed.</li> <li>- Security screen mountings are mortised into the brickmold.</li> <li>- Upper sash painted in place.</li> <li>- Glazing caulk is tested as having ACM.</li> <li>- Accessing window weight box will require removing the galvanized metal jamb guides - access port is blocked.</li> <li>- Water damage at fixed transom head.</li> <li>- Broken sash cord.</li> </ul>

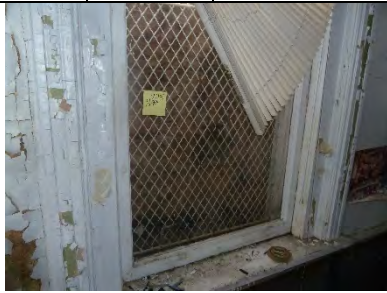
N245-01: Interior view of lower sash

- Missing upper fixed transom sash - replaced with Transite (ACM) panel. Vent through existing transom panel.
- Glazing intact at both sashes
- Original hardware damaged / missing.
- Casings and trims dive behind continuous wood sill. Sill needs to be removed to pull the weight boxes/ jambs.
- Paint is crazed / peeling (multiple layers of paint / lead paint).
- Exterior sill is decayed.
- Security screen mountings are mortised into the brickmold.
- Upper sash painted in place.
- Glazing caulk is tested as having ACM.
- Accessing window weight box will require removing the galvanized metal jamb guides - access port is blocked.
- Exterior stops damaged / decayed.
- Water damage at head of fixed transom - water damage at adjacent walls.

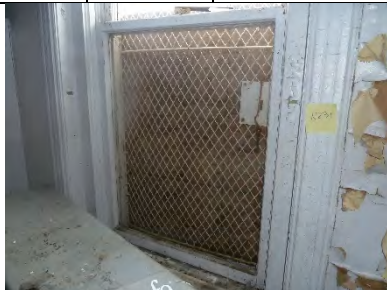
N231-01: Interior view of lower sash

- Missing upper fixed transom sash - replaced with Transite (ACM) panel.
- Broken glazing in lower sash.
- Original hardware damaged / missing.
- Casings and trims dive behind continuous wood sill. Sill needs to be removed to pull the weight boxes/jambs.
- Paint is crazed (multiple layers of paint / lead paint).
- Exterior sill is decayed.
- Security screen mountings are mortised into the brickmold.
- Upper sash painted in place. Lower sash is screwed to upper sash.
- Glazing caulk is tested as having ACM.
- Accessing window weight box will require removing the galvanized metal jamb guides - access port is blocked.
- Water damage at fixed transom head.
- Bottom rail of lower sash is decayed - 1/4" blade penetration.
- Exterior stops are decayed / damaged.

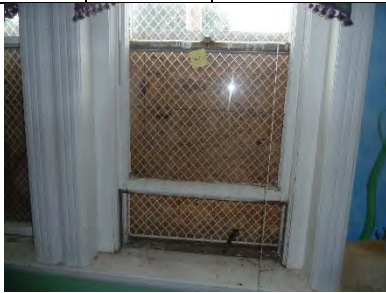
W203-01: Interior view of lower sash

- Missing upper fixed transom sash - replaced with Transite (ACM) panel.
- Glass intact at both sashes.
- Original hardware damaged / missing.
- Casings and trims dive behind continuous wood sill. Sill needs to be removed to pull the weight boxes/jamb.
- Paint is crazed (multiple layers of paint / lead paint).
- Exterior sill is rotted / checked. Blade penetration of 3/8".
- Security screen mountings are mortised into the brickmold.
- Upper sash painted in place.
- Glazing caulk is tested as having ACM.
- Accessing window weight box will require removing the galvanized metal jamb guides - access port is blocked.
- Jamb rot at bottom right.

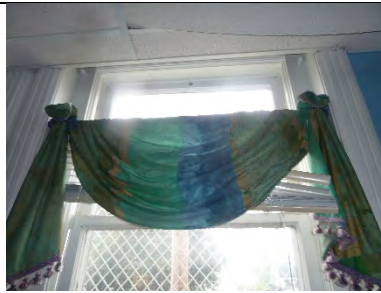
W203-02: Interior view of upper sash

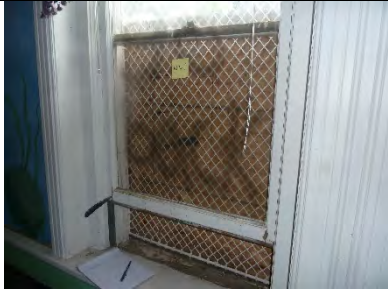
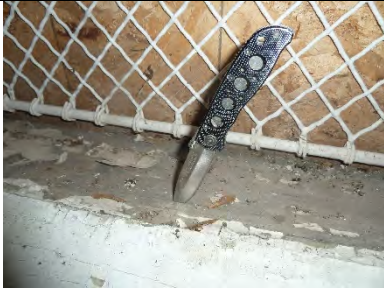
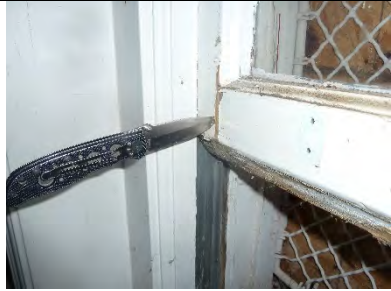
<p>W204-01: Interior view of lower sash      W204-02: View of rotted exterior sill      W204-03: lower sash left corner</p> <p><b>Condition Comments</b></p> <ul style="list-style-type: none"> <li>- Missing upper fixed transom sash - replaced with Transite (ACM) panel. Vent through existing transom panel.</li> <li>- Glazing at both sashes intact.</li> <li>- Original hardware damaged / missing.</li> <li>- Casings and trims dive behind continuous wood sill. Sill needs to be removed to pull the weight boxes/jamb.</li> <li>- Paint is crazed (multiple layers of paint / lead paint).</li> <li>- Exterior sill is decayed - 1/2" blade penetration</li> <li>- Security screen mountings are mortised into the brickmold.</li> <li>- Upper sash painted in place.</li> <li>- Glazing caulk is tested as having ACM.</li> <li>- Accessing window weight box will require removing the galvanized metal jamb guides - access port is blocked.</li> <li>- Bottom sash rail at left corner soft - blade penetration of 1/4".</li> </ul>

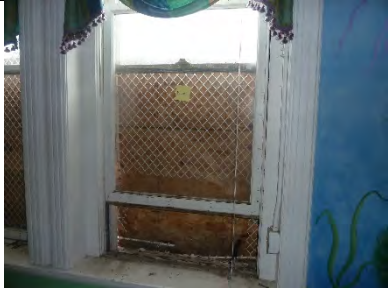
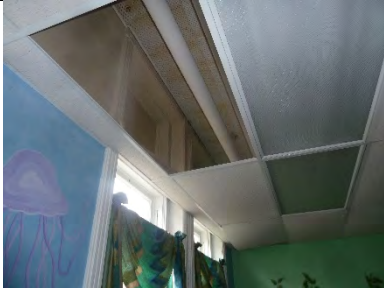
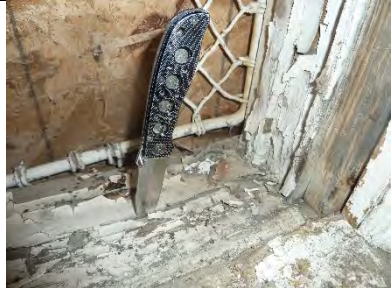
<p>W205-01: Interior view of lower sash      W205-02: Interior view of upper sash &amp; transom      W205-03: Sill and jamb condition</p> <p><b>Condition Comments</b></p> <ul style="list-style-type: none"> <li>- Missing upper fixed transom sash - replaced with Transite (ACM) panel.</li> <li>- Broken glazing in lower sash.</li> <li>- Original hardware damaged / missing.</li> <li>- Casings and trims dive behind continuous wood sill. Sill needs to be removed to pull the weight boxes/jamb.</li> <li>- Paint is crazed (multiple layers of paint / lead paint).</li> <li>- Exterior sill is severely rotted. Blade penetration of 1".</li> <li>- Security screen mountings are mortised into the brickmold.</li> <li>- Upper sash painted in place.</li> <li>- Glazing caulk is tested as having ACM.</li> <li>- Accessing window weight box will require removing the galvanized metal jamb guides - access port is blocked.</li> <li>- Window ropes broken.</li> </ul>

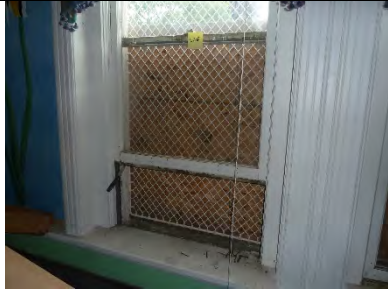
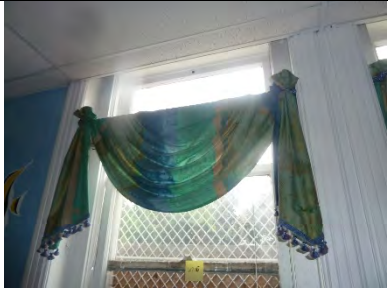
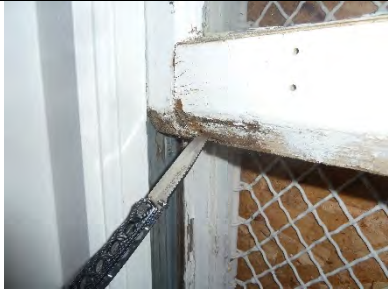
<p>W206-01: Interior view of lower sash      W206-02: Interior view of upper sash      W206-03: lower sash left corner</p> <p><b>Condition Comments</b></p> <ul style="list-style-type: none"> <li>- Missing upper fixed transom sash - replaced with Transite (ACM) panel. Vent through existing transom panel.</li> <li>- Glazing at both sashes intact.</li> <li>- Original hardware damaged / missing.</li> <li>- Casings and trims dive behind continuous wood sill. Sill needs to be removed to pull the weight boxes/jamb.</li> <li>- Paint is crazed (multiple layers of paint / lead paint).</li> <li>- Exterior sill is decayed / checked.</li> <li>- Security screen mountings are mortised into the brickmold.</li> <li>- Upper sash painted in place.</li> <li>- Glazing caulk is tested as having ACM.</li> <li>- Accessing window weight box will require removing the galvanized metal jamb guides - access port is blocked.</li> <li>- Bottom sash rail at left corner soft – blade penetration of 3/8”.</li> </ul>

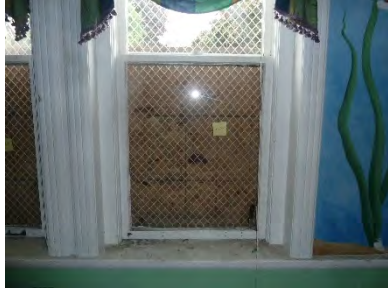
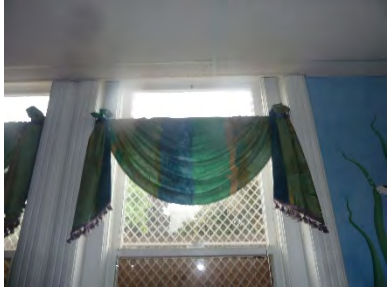
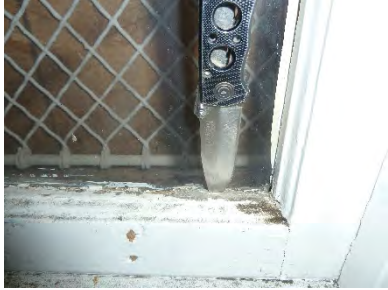
<p>W207-01: Interior view of lower sash      W207-02: Interior view of upper sash &amp; transom      W207-03: Lower sash rot at lower right</p> <p><b>Condition Comments</b></p> <ul style="list-style-type: none"> <li>- Missing upper fixed transom sash - replaced with Transite (ACM) panel.</li> <li>- Broken glazing in lower sash.</li> <li>- Original hardware damaged / missing.</li> <li>- Casings and trims dive behind continuous wood sill. Sill needs to be removed to pull the weight boxes/jamb.</li> <li>- Paint is crazed (multiple layers of paint / lead paint).</li> <li>- Exterior sill and stops decayed and in poor condition.</li> <li>- Security screen mountings are mortised into the brickmold.</li> <li>- Upper sash painted in place.</li> <li>- Glazing caulk is tested as having ACM.</li> <li>- Accessing window weight box will require removing the galvanized metal jamb guides - access port is blocked.</li> <li>- Lower sash won't open.</li> <li>- Lower sash rail soft at lower right corner.</li> </ul>

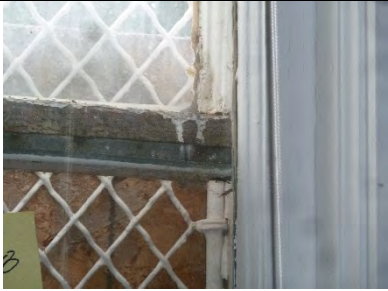
<p>W208-03: Upper sash lower right corner joint is open and decayed</p> </div> </div> <p><b>Condition Comments</b></p> <ul style="list-style-type: none"> <li>- Missing upper fixed transom sash - replaced with Transite (ACM) panel. Vent through existing transom panel.</li> <li>- Glazing at both sashes intact.</li> <li>- Original hardware damaged.</li> <li>- Casings and trims dive behind continuous wood sill. Sill needs to be removed to pull the weight boxes/jamb.</li> <li>- Paint is crazed (multiple layers of paint / lead paint).</li> <li>- Exterior sill is decayed - 1/2" blade penetration</li> <li>- Security screen mountings are mortised into the brickmold.</li> <li>- Upper sash painted in place.</li> <li>- Glazing caulk is tested as having ACM.</li> <li>- Accessing window weight box will require removing the galvanized metal jamb guides - access port is blocked.</li> <li>- Ropes are broken.</li> <li>- Upper sash meeting rail lower right corner blown.</li> </ul> <div style="text-align: center; margin-top: 20px;">

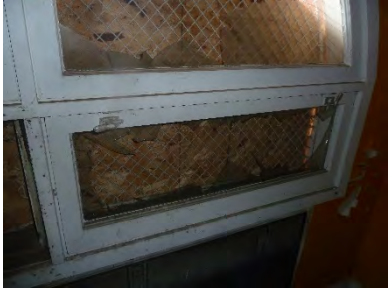
<p>W208.1-03: Sill and jamb condition</p> </div> </div> <p><b>Condition Comments</b></p> <ul style="list-style-type: none"> <li>- Original window was assumed to be a fixed transom above main entry doors at west. The entry and stairs were removed as part of a previous remodel and the floor at the first floor level was filled in. Original arched transom was replaced with arched fixed transom with simple exterior brickmold and interior trim.</li> <li>- Existing Plexiglas at left side of arched transom / broken Plexiglas at right side.</li> <li>- Inswing hopper unit on left is missing.</li> <li>- Inswing hopper on right has broken glazing.</li> <li>- Paint is crazed (multiple layers of paint / lead paint).</li> <li>- Exterior sill condition OK.</li> </ul> <div style="text-align: center; margin-top: 20px;">   <p>W208.1-04: Exterior view at center</p> </div>

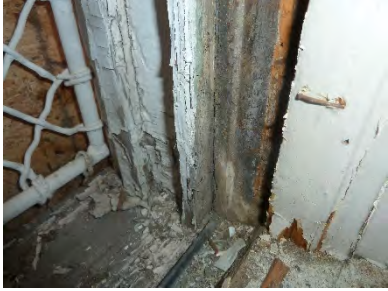
<p>W210-01: Interior view of lower sash      W210-02: Interior view of upper sash &amp; transom      W210-03: Sill and jamb condition</p> <p><b>Condition Comments</b></p> <ul style="list-style-type: none"> <li>- Missing upper fixed transom sash - replaced with Transite (ACM) panel.</li> <li>- Broken glazing in lower sash.</li> <li>- Casings and trims dive behind continuous wood sill. Sill needs to be removed to pull the weight boxes/jamb.</li> <li>- Paint is crazed (multiple layers of paint / lead paint).</li> <li>- Exterior sill and lower jambs deteriorated.</li> <li>- Security screen mountings are mortised into the brickmold.</li> <li>- Upper sash painted in place.</li> <li>- Glazing caulk is tested as having ACM.</li> <li>- Accessing window weight box will require removing the galvanized metal jamb guides - access port is blocked on one side. Jamb guide / weatherstrip missing at other side.</li> <li>- Ropes are missing.</li> <li>- Lower sash bottom rail is damaged.</li> </ul>   <p>W210-04: Exterior view at center</p>

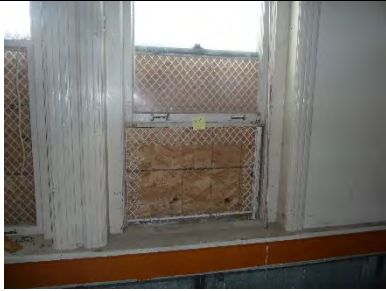
W211-01: Interior view of lower sash

- Missing upper fixed transom sash - replaced with Transite (ACM) panel. Vent through existing transom panel.
- Glazing at both sashes intact. Glazing at lower sash is Plexiglas.
- Original hardware damaged.
- Casings and trims dive behind continuous wood sill. Sill needs to be removed to pull the weight boxes/jamb.
- Paint is crazed (multiple layers of paint / lead paint).
- Exterior sill is rotted and checked - 3/8" blade penetration
- Security screen mountings are mortised into the brickmold.
- Upper sash painted in place.
- Glazing caulk is tested as having ACM.
- Accessing window weight box will require removing the galvanized metal jamb guides - access port is blocked.
- Lower sash bottom rail is damaged.
- Missing metal jamb glide / weatherstip at jamb.

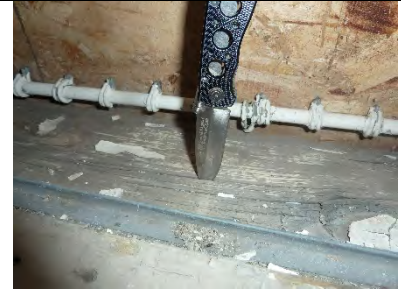
W211-03: Rotted sill

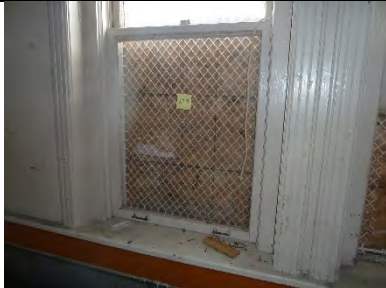
W212-01: Interior view of lower sash

- Missing upper fixed transom sash - replaced with Transite (ACM) panel.
- Glazing intact at both sashes.
- Original hardware damaged.
- Casings and trims dive behind continuous wood sill. Sill needs to be removed to pull the weight boxes/jamb.
- Paint is crazed (multiple layers of paint / lead paint).
- Exterior sill is decayed.
- Security screen mountings are mortised into the brickmold.
- Upper sash painted in place.
- Glazing caulk is tested as having ACM.
- Accessing window weight box will require removing the galvanized metal jamb guides - access port is blocked.
- Window rope broken.
- Lower sash is stuck in place.

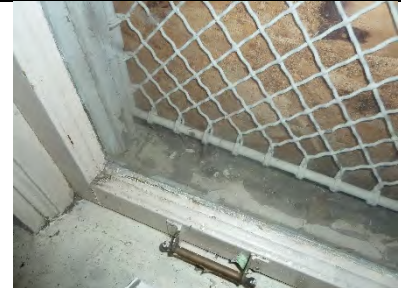
W212-03: Exterior jamb condition

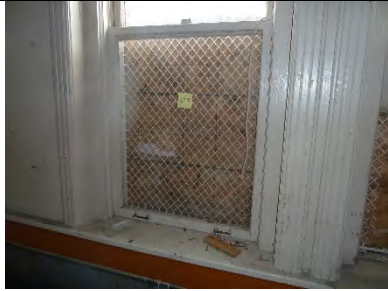
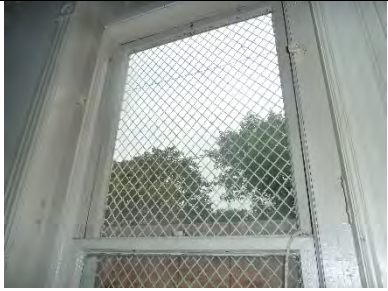
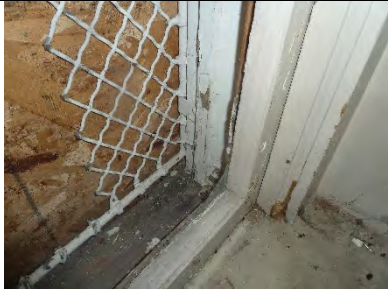
<p>W213-01: Interior view of lower sash      W213-02: View of rotted exterior sill      W213-03: lower sash left corner</p> <p><b>Condition Comments</b></p> <ul style="list-style-type: none"> <li>- Missing upper fixed transom sash - replaced with Transite (ACM) panel. Vent through existing transom panel.</li> <li>- Glazing at lower sash broken.</li> <li>- Original hardware damaged / missing.</li> <li>- Casings and trims dive behind continuous wood sill. Sill needs to be removed to pull the weight boxes/jamb.</li> <li>- Paint is crazed (multiple layers of paint / lead paint).</li> <li>- Exterior sill is decayed.</li> <li>- Security screen mountings are mortised into the brickmold.</li> <li>- Upper sash painted in place.</li> <li>- Glazing caulk is tested as having ACM.</li> <li>- Accessing window weight box will require removing the galvanized metal jamb guides - access port is blocked.</li> <li>- Upper sash lower rail is decayed.</li> </ul>

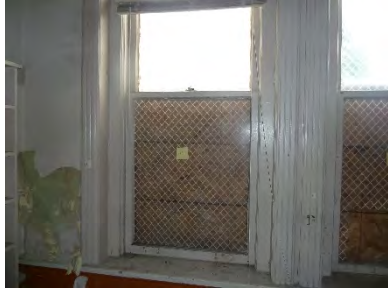
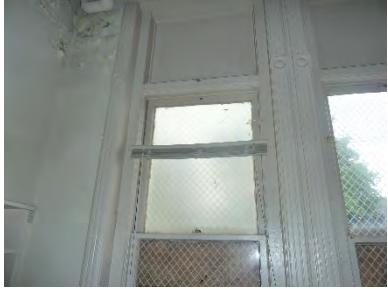
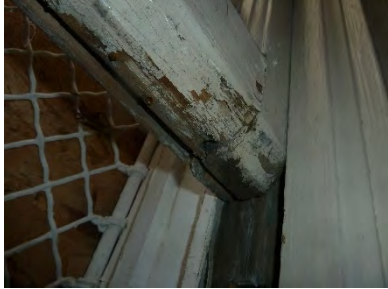
<p>W214-01: Interior view of lower sash      W214-02: Interior view of upper sash &amp; transom      W214-03: Lower sash corner rot.</p> <p><b>Condition Comments</b></p> <ul style="list-style-type: none"> <li>- Missing upper fixed transom sash - replaced with Transite (ACM) panel.</li> <li>- Glazing intact at lower sash. Plexiglas in upper sash.</li> <li>- Original hardware damaged / missing.</li> <li>- Casings and trims dive behind continuous wood sill. Sill needs to be removed to pull the weight boxes/jamb.</li> <li>- Paint is crazed (multiple layers of paint / lead paint).</li> <li>- Exterior sill is decayed.</li> <li>- Security screen mountings are mortised into the brickmold.</li> <li>- Upper sash painted in place.</li> <li>- Glazing caulk is tested as having ACM.</li> <li>- Accessing window weight box will require removing the galvanized metal jamb guides - access port is blocked.</li> <li>- Missing metal glides / weatherstrip at both jambs.</li> <li>- Exterior stops damaged / decayed.</li> <li>- Lower sash rail decayed.</li> </ul>

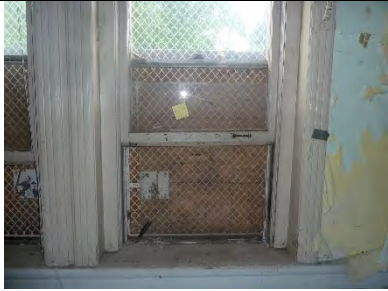
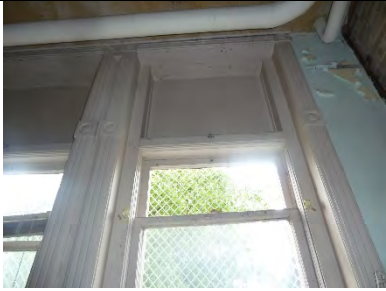
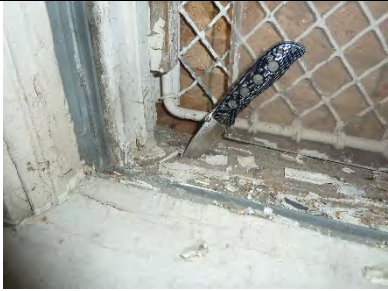
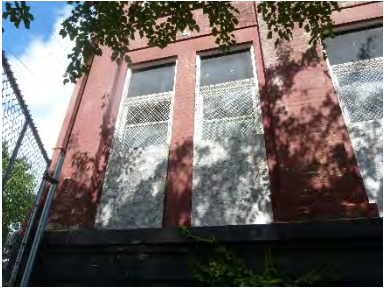
Room	Window	Window Configuration Type	Replace	Repair
106	S200	Double-hung with fixed transom above	✓

<p>S200-01: Interior view of lower sash</p> <p>S200-02: Interior view of upper sash</p> <p>S200-03: Exterior sill rot</p> <p><b>Condition Comments</b></p> <ul style="list-style-type: none"> <li>- Missing upper fixed transom sash - replaced with Transite (ACM) panel. Vent through existing transom panel.</li> <li>- Glazing at both sashes missing.</li> <li>- Original hardware damaged / missing.</li> <li>- Casings and trims dive behind continuous wood sill. Sill needs to be removed to pull the weight boxes/jamb.</li> <li>- Paint is crazed (multiple layers of paint / lead paint).</li> <li>- Exterior sill is severely rotted – 1/2" blade penetration.</li> <li>- Security screen mountings are mortised into the brickmold.</li> <li>- Upper sash painted in place.</li> <li>- Glazing caulk is tested as having ACM.</li> <li>- Accessing window weight box will require removing the galvanized metal jamb guides - access port is blocked.</li> <li>- Left corner of lower sash bottom rail is blown – open 1/8"</li> </ul>

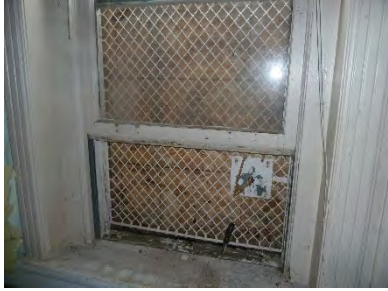
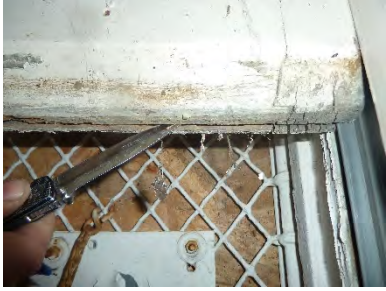
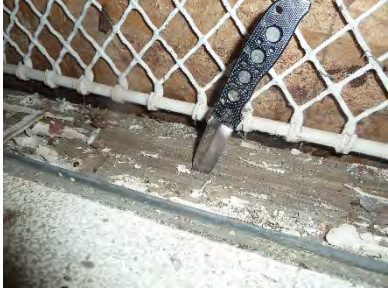
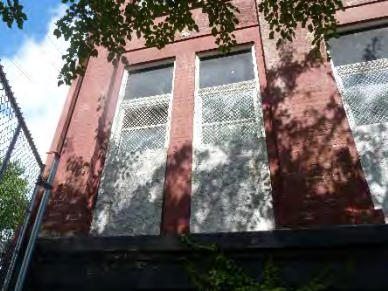
106	S201	Double-hung with fixed transom above	✓

<p>S201-01: Interior view of lower sash</p> <p>S201-02: Condition of bottom rail at lower sash</p> <p>S201-03: Exterior sill rot</p> <p><b>Condition Comments</b></p> <ul style="list-style-type: none"> <li>- Missing upper fixed transom sash - replaced with Transite (ACM) panel.</li> <li>- Glazing at both sashes intact.</li> <li>- Original hardware damaged / missing.</li> <li>- Casings and trims dive behind continuous wood sill. Sill needs to be removed to pull the weight boxes/jamb.</li> <li>- Paint is crazed (multiple layers of paint / lead paint).</li> <li>- Exterior sill is severely rotted – 1/2" blade penetration</li> <li>- Security screen mountings are mortised into the brickmold.</li> <li>- Upper sash painted in place.</li> <li>- Glazing caulk is tested as having ACM.</li> <li>- Accessing window weight box will require removing the galvanized metal jamb guides - access port is blocked.</li> <li>- Lower sash rail decayed.</li> </ul>

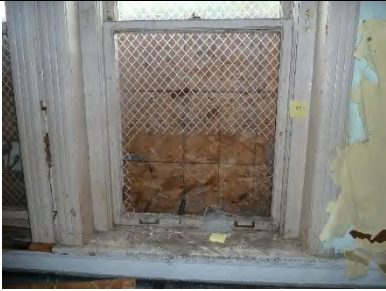
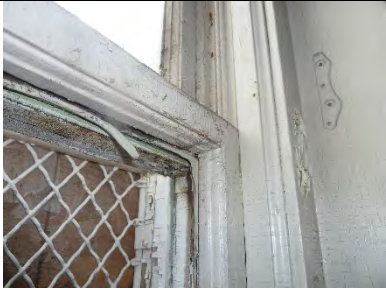
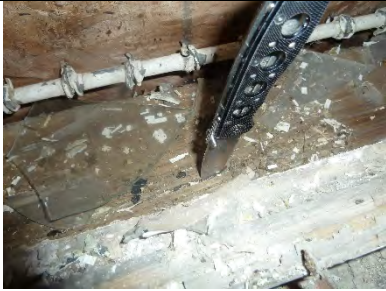
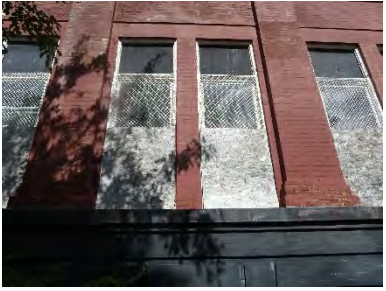
Room	Window	Window Configuration Type	Replace	Repair
106	S202	Double-hung with fixed transom above	✓

<p>S202-01: Interior view of lower sash</p> <p>S202-02: Lower rail of upper sash corner condition</p> <p>S202-03: Exterior sill rot</p> <p><b>Condition Comments</b></p> <ul style="list-style-type: none"> <li>- Missing upper fixed transom sash - replaced with Transite (ACM) panel. Vent through existing transom panel.</li> <li>- Glazing at lower sash missing.</li> <li>- Original hardware damaged.</li> <li>- Casings and trims dive behind continuous wood sill. Sill needs to be removed to pull the weight boxes/jamb.</li> <li>- Paint is crazed (multiple layers of paint / lead paint).</li> <li>- Exterior sill is severely decayed - 3/4" blade penetration.</li> <li>- Security screen mountings are mortised into the brickmold.</li> <li>- Upper sash painted in place.</li> <li>- Glazing caulk is tested as having ACM.</li> <li>- Accessing window weight box will require removing the galvanized metal jamb guides - access port is blocked.</li> <li>- Upper sash lower rail is decayed / damaged.</li> <li>- Exterior stops damaged.</li> </ul>

<p>S202-04: Exterior view at left</p>

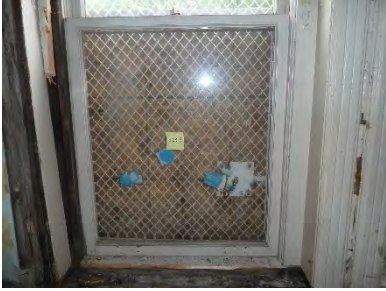
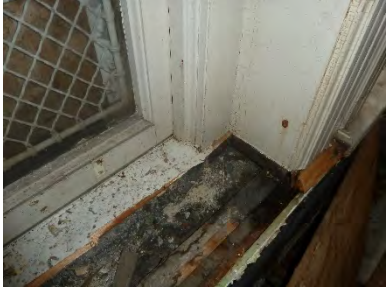
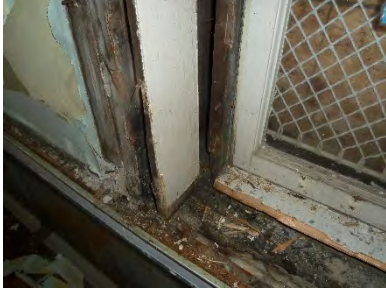
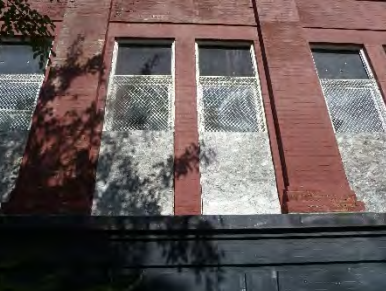
Room	Window	Window Configuration Type	Replace	Repair
106	S203	Double-hung with fixed transom above	✓

<p>S203-01: Interior view of lower sash</p> <p>S203-02: Mold and decayed blocking below interior sill</p> <p>S203-03: Condition of trim and window weight box lumber</p> <p><b>Condition Comments</b></p> <ul style="list-style-type: none"> <li>- Note: This window was further deconstructed to view the condition of the wood weight box and sill blocking at left jamb. Wood in these areas was damp and spongy.</li> <li>- Missing upper fixed transom sash - replaced with Transite (ACM) panel.</li> <li>- Glazing intact at lower sash. Plexiglas in upper sash.</li> <li>- Original hardware damaged / missing.</li> <li>- Casings and trims dive behind continuous wood sill. Sill needs to be removed to pull the weight boxes/jamb.</li> <li>- Paint is crazed (multiple layers of paint / lead paint).</li> <li>- Exterior and interior sills decayed and checked.</li> <li>- Wood at jambs is spongy and damp.</li> <li>- Security screen mountings are mortised into the brickmold.</li> <li>- Upper sash painted in place.</li> <li>- Glazing caulk is tested as having ACM.</li> <li>- Accessing window weight box will require removing the galvanized metal jamb guides - access port is blocked.</li> <li>- Exterior stops damaged / decayed.</li> </ul>

<p>S203-04: Exterior view at right</p>

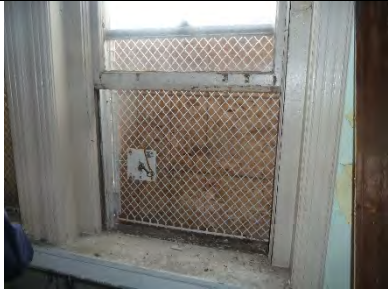
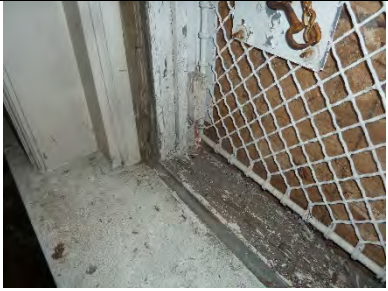
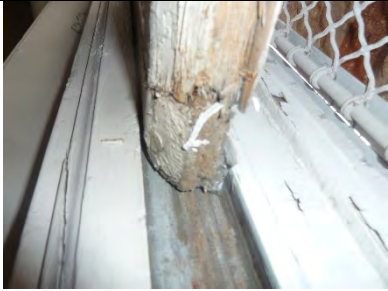
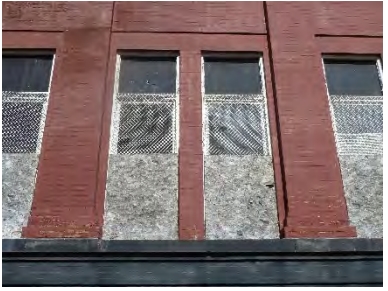
Room	Window	Window Configuration Type	Replace	Repair
106	S204	Double-hung with fixed transom above	✓

<p>S204-01: Interior view of lower sash      S204-02: View of rotted exterior sill      S204-03: Upper sash bottom left corner blown and rotted</p> <p><b>Condition Comments</b></p> <ul style="list-style-type: none"> <li>- Missing upper fixed transom sash - replaced with Transite (ACM) panel. Vent through existing transom panel.</li> <li>- Glazing both sashes intact.</li> <li>- Original hardware damaged / missing.</li> <li>- Casings and trims dive behind continuous wood sill. Sill needs to be removed to pull the weight boxes/jambs.</li> <li>- Paint is crazed (multiple layers of paint / lead paint).</li> <li>- Exterior sill is decayed / checked.</li> <li>- Security screen mountings are mortised into the brickmold.</li> <li>- Upper sash painted in place.</li> <li>- Glazing caulk is tested as having ACM.</li> <li>- Accessing window weight box will require removing the galvanized metal jamb guides - access port is blocked.</li> <li>- Upper sash lower rail left corner is blown and rotted.</li> <li>- Interior sill is damaged.</li> <li>- Metal jamb glides / weatherstip is missing.</li> <li>- Sash ropes are broken.</li> </ul>

<p>S204-04: Exterior view at left</p>

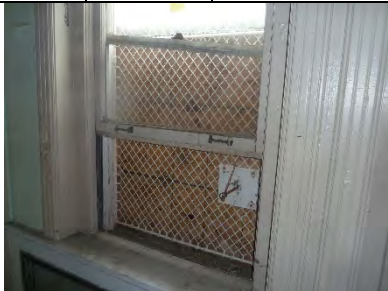
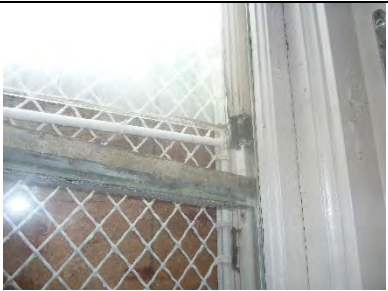
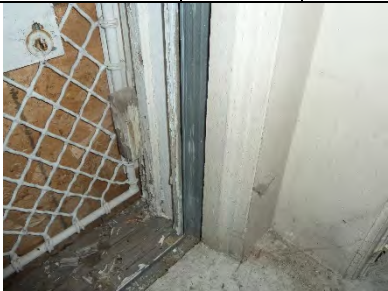
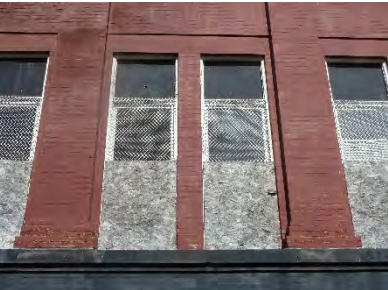
Room	Window	Window Configuration Type	Replace	Repair
106	S205	Double-hung with fixed transom above	✓

<p>S205-01: Interior view of lower sash      S205-02: Lower right corner of upper sash broken      S205-03: Lower sash corner decay.</p> <p><b>Condition Comments</b></p> <ul style="list-style-type: none"> <li>- Missing upper fixed transom sash - replaced with Transite (ACM) panel.</li> <li>- Glazing intact at lower sash. Plexiglas in upper sash.</li> <li>- Original hardware damaged / missing.</li> <li>- Casings and trims dive behind continuous wood sill. Sill needs to be removed to pull the weight boxes/jambs.</li> <li>- Paint is crazed (multiple layers of paint / lead paint).</li> <li>- Exterior sill is decayed.</li> <li>- Security screen mountings are mortised into the brickmold.</li> <li>- Upper sash painted in place.</li> <li>- Glazing caulk is tested as having ACM.</li> <li>- Accessing window weight box will require removing the galvanized metal jamb guides - access port is blocked.</li> <li>- Exterior stops damaged / decayed at lower right.</li> </ul>

<p>S205-04: Exterior view at right</p>

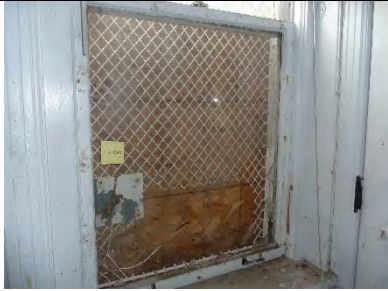
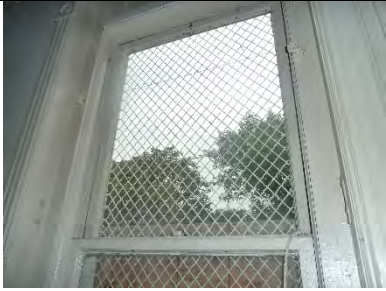
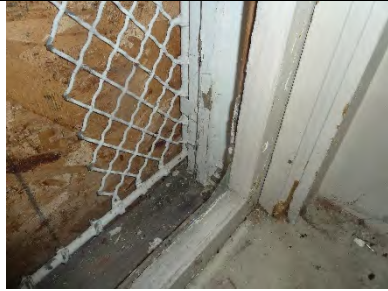
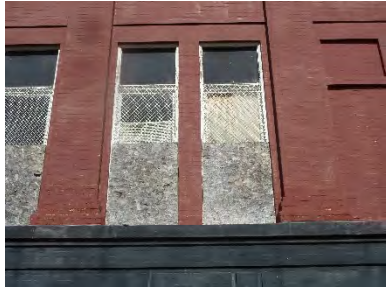
Room	Window	Window Configuration Type	Replace	Repair
106	S206	Double-hung with fixed transom above	✓

<p>S206-01: Interior view of lower sash      S206-02: View of rotted exterior sill      S206-03: lower sash left corner</p> <p><b>Condition Comments</b></p> <ul style="list-style-type: none"> <li>- Missing upper fixed transom sash - replaced with Transite (ACM) panel. Vent through existing transom panel.</li> <li>- Glazing at lower sash broken.</li> <li>- Original hardware damaged.</li> <li>- Casings and trims dive behind continuous wood sill. Sill needs to be removed to pull the weight boxes/jambs.</li> <li>- Paint is crazed (multiple layers of paint / lead paint).</li> <li>- Exterior sill is decayed.</li> <li>- Security screen mountings are mortised into the brickmold.</li> <li>- Upper sash painted in place.</li> <li>- Glazing caulk is tested as having ACM.</li> <li>- Accessing window weight box will require removing the galvanized metal jamb guides - access port is blocked.</li> <li>- Upper sash lower rail corner is blown.</li> <li>- Lower sash bottom rail is damaged.</li> <li>- Exterior stops are damaged / decayed.</li> </ul>

<p>S206-04: Exterior view at left</p>

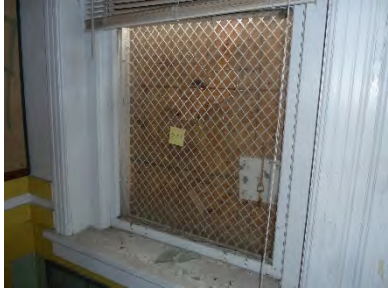
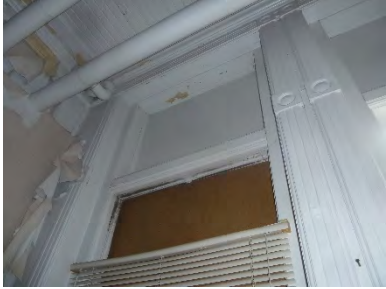
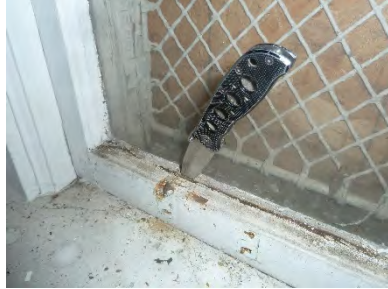
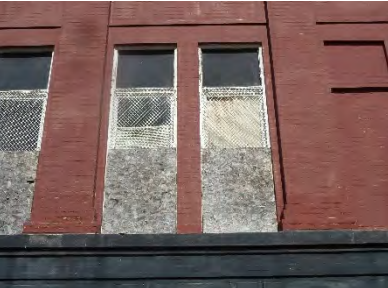
Room	Window	Window Configuration Type	Replace	Repair
106	S207	Double-hung with fixed transom above	✓

<p>S207-01: Interior view of lower sash      S207-02: Interior view of missing upper sash &amp; transom      S207-03: Lower sash corner rot.</p> <p><b>Condition Comments</b></p> <ul style="list-style-type: none"> <li>- Missing upper fixed transom sash - replaced with Transite (ACM) panel.</li> <li>- Glazing broken at lower sash.</li> <li>- Original hardware damaged / missing.</li> <li>- Casings and trims dive behind continuous wood sill. Sill needs to be removed to pull the weight boxes/jambs.</li> <li>- Paint is crazed (multiple layers of paint / lead paint).</li> <li>- Exterior sill is decayed.</li> <li>- Security screen mountings are mortised into the brickmold.</li> <li>- Upper sash is missing entirely.</li> <li>- Glazing caulk is tested as having ACM.</li> <li>- Accessing window weight box will require removing the galvanized metal jamb guides - access port is blocked.</li> <li>- Lower sash rail decayed - 3/8" blade penetration.</li> </ul>

<p>S207-04: Exterior view at right</p>

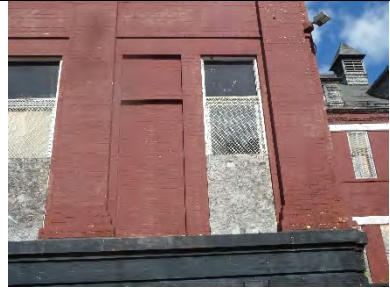
<p>S208-04: Exterior view at left</p>

Room	Window	Window Configuration Type	Replace	Repair
107B	S208	Bricked-in window opening	✓	
<b>Condition Comments</b> - Window opening bricked-in at exterior. Wall is plastered over at interior.

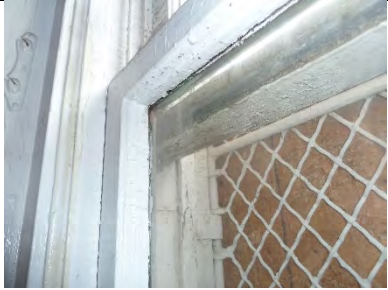
<p>S209-02: Blown corner at upper sash lower left</p>

<p>S209-04: Exterior view at right</p>	
<b>Condition Comments</b> - Missing upper fixed transom sash - replaced with Transite (ACM) panel. - Glazing intact at lower sash. Plexiglas in upper sash. - Original hardware damaged / missing. - Casings and trims dive behind continuous wood sill. Sill needs to be removed to pull the weight boxes/jamb. - Paint is crazed (multiple layers of paint / lead paint). - Exterior sill is decayed. - Security screen mountings are mortised into the brickmold. - Upper sash painted in place. - Glazing caulk is tested as having ACM. - Accessing window weight box will require removing the galvanized metal jamb guides - access port is blocked. - Upper sash lower rail corners are blown and decayed. - Sash ropes are broken.

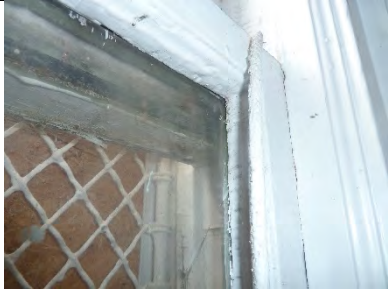
<p>S209-03: Blown corner at upper sash lower right</p>

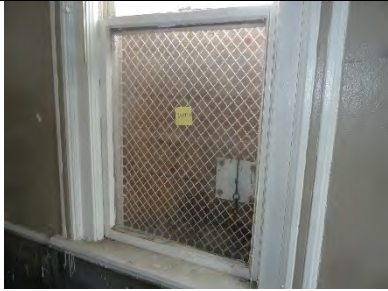
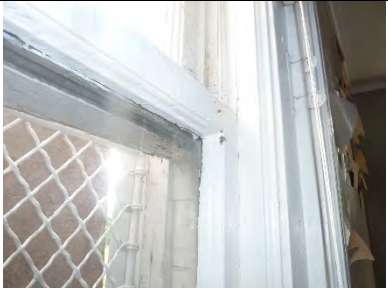
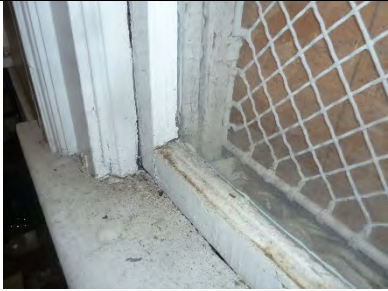
Room	Window	Window Configuration Type	Replace	Repair
107B	S210	Double-hung with fixed transom above	✓

<p>S210-01: Interior view of lower sash</p> <p>S210-02: Upper sash lower right corner blown and decayed</p> <p>S210-03: Lower sash bottom rail left corner blown</p> <p><b>Condition Comments</b></p> <ul style="list-style-type: none"> <li>- Missing upper fixed transom sash - replaced with Transite (ACM) panel. Vent through existing transom panel.</li> <li>- Glazing at both sashes is intact.</li> <li>- Original hardware damaged / missing.</li> <li>- Casings and trims dive behind continuous wood sill. Sill needs to be removed to pull the weight boxes/jambs.</li> <li>- Paint is crazed (multiple layers of paint / lead paint).</li> <li>- Exterior sill is decayed.</li> <li>- Security screen mountings are mortised into the brickmold.</li> <li>- Upper sash painted in place.</li> <li>- Glazing caulk is tested as having ACM.</li> <li>- Accessing window weight box will require removing the galvanized metal jamb guides - access port is blocked.</li> <li>- Upper sash lower rail right corner is blown / decayed.</li> <li>- Lower sash lower left corner is blown / opened.</li> <li>- Lower sash won't open.</li> </ul>

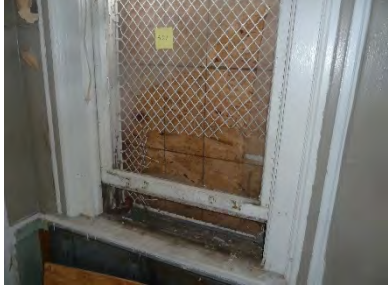
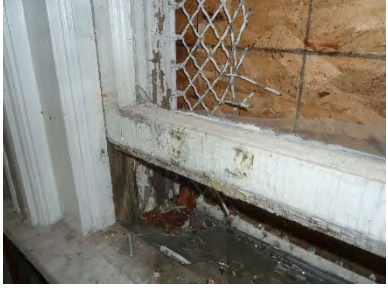
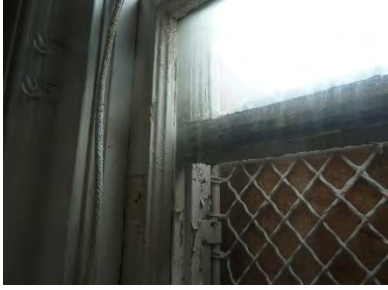
Room	Window	Window Configuration Type	Replace	Repair
107B	S211	Double-hung with fixed transom above	✓

<p>S211-01: Interior view of lower sash</p> <p>S211-02: Exterior sill, jamb and stop condition.</p> <p>S211-03: Upper sash lower rail rotted.</p> <p><b>Condition Comments</b></p> <ul style="list-style-type: none"> <li>- Missing upper fixed transom sash - replaced with Transite (ACM) panel.</li> <li>- Glazing at lower sash broken.</li> <li>- Original hardware damaged / missing.</li> <li>- Casings and trims dive behind continuous wood sill. Sill needs to be removed to pull the weight boxes/jambs.</li> <li>- Paint is crazed (multiple layers of paint / lead paint).</li> <li>- Exterior sill is decayed.</li> <li>- Security screen mountings are mortised into the brickmold.</li> <li>- Upper sash painted in place.</li> <li>- Glazing caulk is tested as having ACM.</li> <li>- Accessing window weight box will require removing the galvanized metal jamb guides - access port is blocked.</li> <li>- Missing metal glides / weatherstrip at both jambs.</li> <li>- Exterior jambs &amp; stops decayed at bottom.</li> <li>- Bottom rail of upper sash is rotted.</li> </ul>

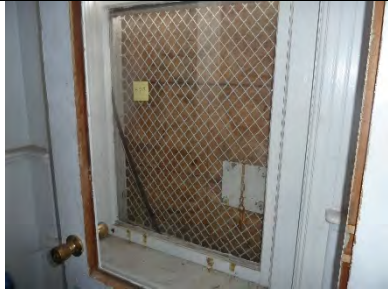
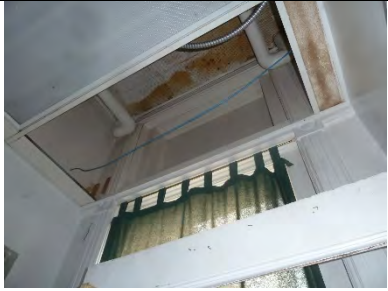
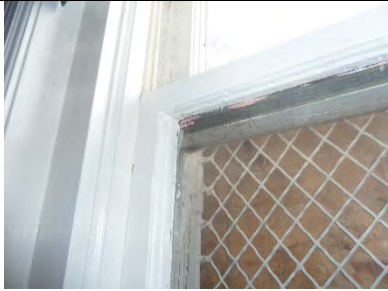
Room	Window	Window Configuration Type	Replace	Repair
107	S212	Double-hung with fixed transom above	✓

<p>S212-01: Interior view of lower sash</p> <p>S212-02: Interior view of upper sash and transom</p> <p>S212-03: Upper sash lower left corner decayed</p> <p><b>Condition Comments</b></p> <ul style="list-style-type: none"> <li>- Missing upper fixed transom sash - replaced with Transite (ACM) panel. Vent through existing transom panel.</li> <li>- Glazing at both sashes intact.</li> <li>- Original hardware damaged / missing.</li> <li>- Casings and trims dive behind continuous wood sill. Sill needs to be removed to pull the weight boxes/jamb.</li> <li>- Paint is crazed (multiple layers of paint / lead paint).</li> <li>- Exterior sill is decayed.</li> <li>- Security screen mountings are mortised into the brickmold.</li> <li>- Upper sash painted in place.</li> <li>- Glazing caulk is tested as having ACM.</li> <li>- Accessing window weight box will require removing the galvanized metal jamb guides - access port is blocked.</li> <li>- Upper sash lower rail left corner is decayed.</li> </ul>

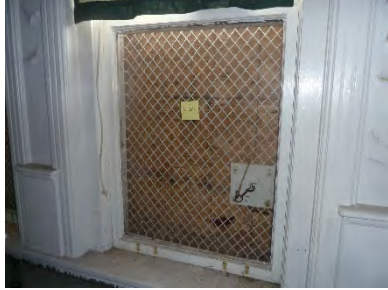
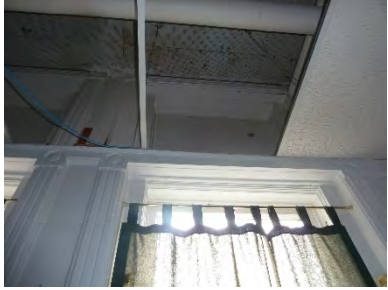
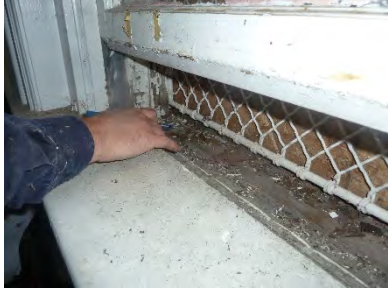
Room	Window	Window Configuration Type	Replace	Repair
107	S213	Double-hung with fixed transom above	✓

<p>S213-01: Interior view of lower sash</p> <p>S213-02: Interior view of upper sash &amp; transom</p> <p>S213-03: Lower jamb and exterior sill in poor condition.</p> <p><b>Condition Comments</b></p> <ul style="list-style-type: none"> <li>- Missing upper fixed transom sash - replaced with Transite (ACM) panel.</li> <li>- Glazing intact at upper sash broken.</li> <li>- Original hardware damaged / missing.</li> <li>- Casings and trims dive behind continuous wood sill. Sill needs to be removed to pull the weight boxes/jamb.</li> <li>- Paint is crazed (multiple layers of paint / lead paint).</li> <li>- Exterior sill is decayed.</li> <li>- Security screen mountings are mortised into the brickmold.</li> <li>- Upper sash painted in place.</li> <li>- Glazing caulk is tested as having ACM.</li> <li>- Accessing window weight box will require removing the galvanized metal jamb guides - access port is blocked.</li> <li>- Sash ropes are broken.</li> <li>- Exterior stops damaged / decayed at lower left.</li> </ul>

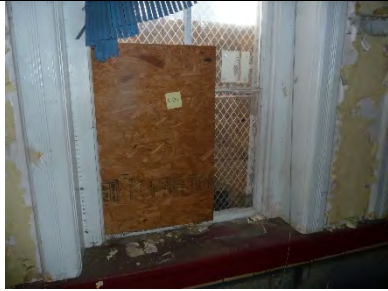
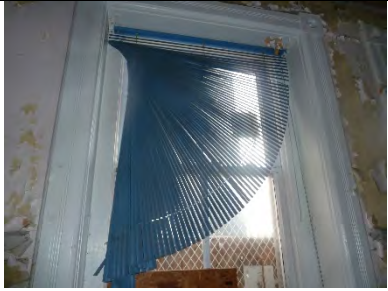
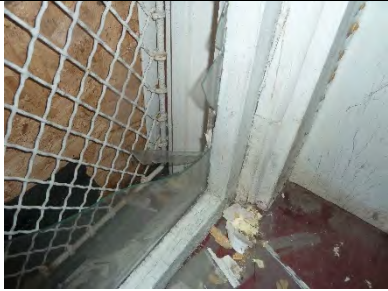
Room	Window	Window Configuration Type	Replace	Repair
108	N228	Double-hung with 2 / 4 cottage sash configuration	✓

<p>N228-01: Interior view of lower sash      N228-02: View of rotted exterior sill      N228-03: lower sash left corner</p> <p><b>Condition Comments</b></p> <ul style="list-style-type: none"> <li>- Glazing broken / missing at lower sash.</li> <li>- Window won't open.</li> <li>- Paint is crazed (multiple layers of paint / lead paint).</li> <li>- Exterior sill is decayed.</li> <li>- Damaged meeting rail at lock location – loss of material at extra-thin meeting rail.</li> <li>- Security screen mountings are mortised into the brickmold.</li> <li>- Upper sash painted in place.</li> <li>- Glazing caulk is tested as having ACM.</li> <li>- Adjacent walls and ceiling show evidence of long-term water damage.</li> <li>- Accessing window weight box will require removing the galvanized metal jamb guides - access port is blocked.</li> </ul>

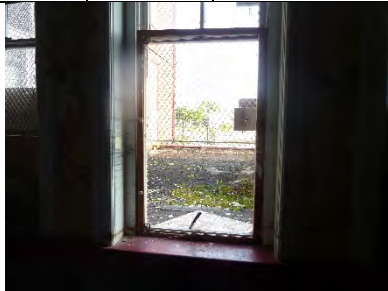
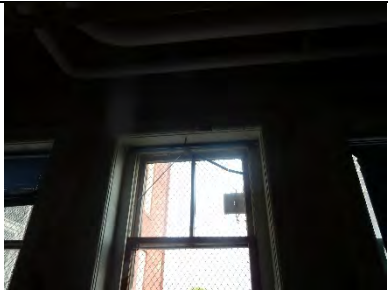
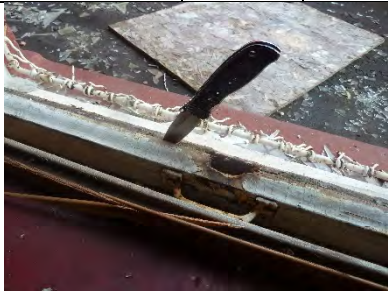
Room	Window	Window Configuration Type	Replace	Repair
108	N229	Double-hung with 2 / 4 cottage sash configuration	✓

<p>N229-01: Interior view of lower sash (missing muntins)      N229-02: Interior view of upper sash      N229-03: Lower sash rail rot.</p> <p><b>Condition Comments</b></p> <ul style="list-style-type: none"> <li>- Glazing broken / missing at lower sash.</li> <li>- Vertical and horizontal muntins at lower sash broken out.</li> <li>- Window won't open.</li> <li>- Paint is crazed (multiple layers of paint / lead paint).</li> <li>- Exterior sill is decayed.</li> <li>- Upper sash lower rail corners showing water damage – deterioration at mortised joints.</li> <li>- Security screen mountings are mortised into the brickmold.</li> <li>- Upper sash painted in place.</li> <li>- Glazing caulk is tested as having ACM.</li> <li>- Adjacent walls and ceiling show evidence of long-term water damage.</li> </ul>

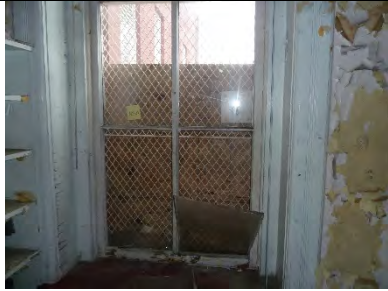
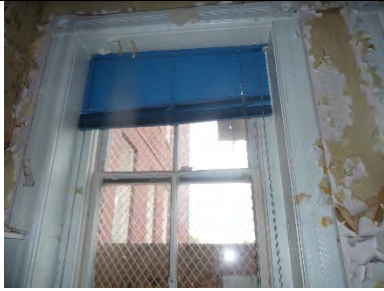
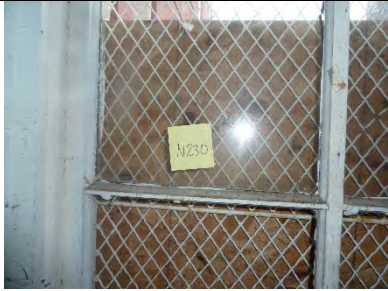
Room	Window	Window Configuration Type	Replace	Repair
108	N230	Double-hung with 2 / 4 cottage sash configuration	✓

<p>N230-01: Interior view of lower sash      N230-02: Interior view of upper sash – damage at lock      N230-03: Muntins at lower sash</p> <p><b>Condition Comments</b></p> <ul style="list-style-type: none"> <li>- Glazing broken / missing at lower sash.</li> <li>- Window won't open.</li> <li>- Paint is crazed (multiple layers of paint / lead paint).</li> <li>- Exterior sill is decayed.</li> <li>- Damaged meeting rail at lock location – loss of material at extra-thin meeting rail.</li> <li>- Security screen mountings are mortised into the brickmold.</li> <li>- Upper sash painted in place.</li> <li>- Glazing caulk is tested as having ACM.</li> <li>- Adjacent walls and ceiling show evidence of long-term water damage.</li> <li>- Accessing window weight box will require removing the galvanized metal jamb guides - access port is blocked.</li> </ul>
