# Window Condition Survey

McKinley School Renovation

2001 W. Vliet St.  
Milwaukee WI, 53205

## **McKinley School Restoration Window Condition Survey**

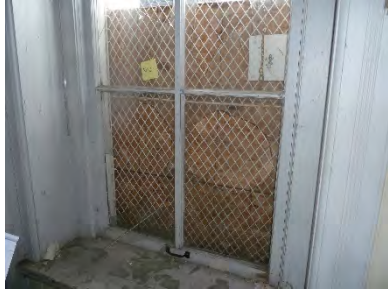
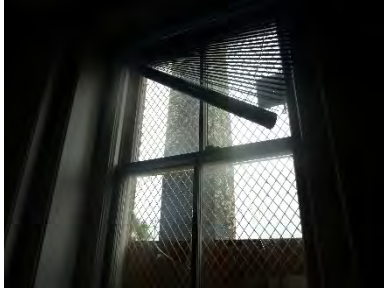
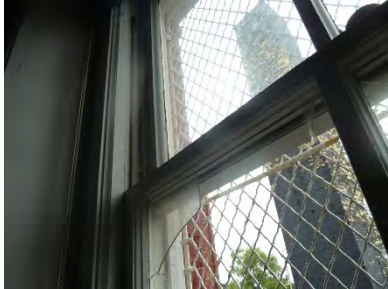
Room	Window	Window Configuration Type	Replace	Repair
108A	N224	Double-hung with 2 / 4 cottage sash configuration	✓

<p>N231-01: Interior view of lower sash      N231-02: Interior view of upper sash      N231-03: Different ogee &amp; muntin thickness at replaced lower sash</p> <p><b>Condition Comments</b></p> <ul style="list-style-type: none"> <li>- Glazing broken / missing at lower sash.</li> <li>- Window won't open.</li> <li>- Paint is crazed (multiple layers of paint / lead paint).</li> <li>- Exterior sill is decayed.</li> <li>- Lower sash is not original and is a replacement. Ogee is dissimilar and muntins are thicker than originals at typical window.</li> <li>- Security screen mountings are mortised into the brickmold.</li> <li>- Upper sash painted in place.</li> <li>- Glazing caulk is tested as having ACM.</li> <li>- Accessing window weight box will require removing the galvanized metal jamb guides - access port is blocked.</li> </ul>

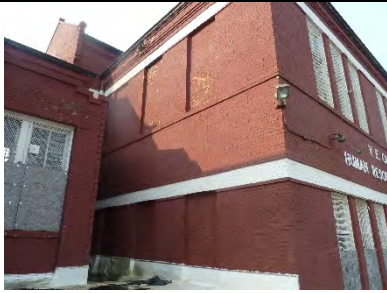
N214-N216-01: Exterior View at lower center

- Windows previously removed and bricked in when central stair addition was built.

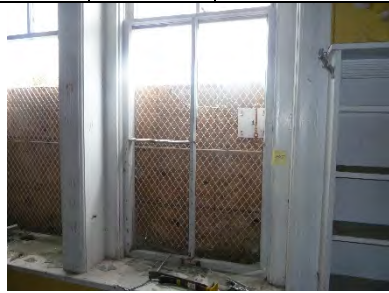
N217-01: Interior view of lower sash

- Glazing broken / missing at lower sash.
- Broken out muntin bar at lower sash. Damaged horizontal muntin bar.
- Lower sash bottom rail loose – blown corners.
- Window won't open.
- Paint is crazed (multiple layers of paint / lead paint).
- Exterior sill is decayed.
- Security screen mountings are mortised into the brickmold.
- Upper sash painted in place.
- Glazing caulk is tested as having ACM.
- Water damaged from long-term exposure to the elements.
- Accessing window weight box will require removing the galvanized metal jamb guides - access port is blocked.

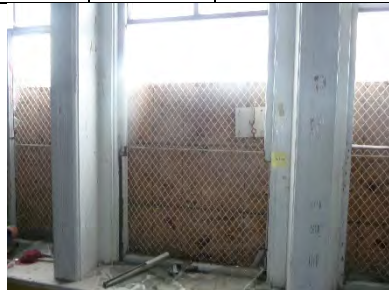
N218-01: Interior view of lower sash

- Glazing broken / missing at both sashes.
- Lower sash bottom rail broken out.
- Lower sash missing muntin bars.
- Lower sash is not original and is a replacement. Ogee is dissimilar and muntins are thicker than originals at typical window.
- Upper sash not original and is a replacement. Ogee is dissimilar and muntins are thicker than originals at typical window.
- Paint is crazed (multiple layers of paint / lead paint).
- Exterior sill is decayed.
- Security screen mountings are mortised into the brickmold.
- Upper sash painted in place.
- Glazing caulk is tested as having ACM.
- Accessing window weight box will require removing the galvanized metal jamb guides - access port is blocked.

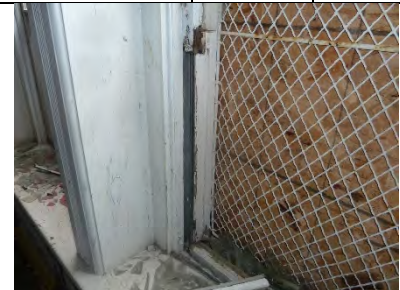
N218-03: Broken bottom rail

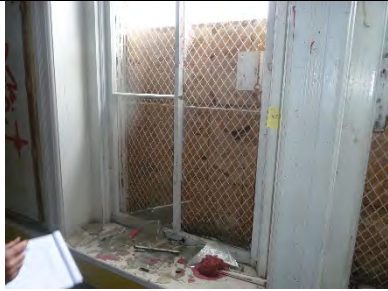
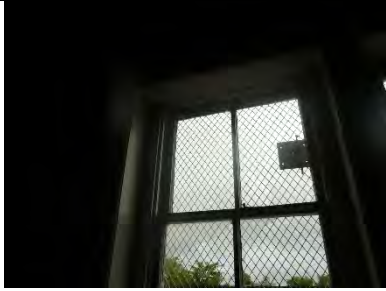
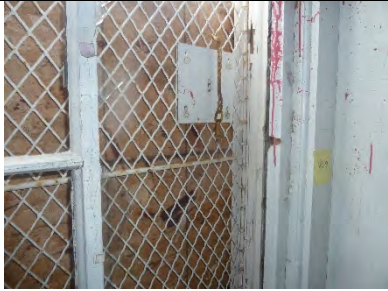
Room	Window	Window Configuration Type	Replace	Repair
109	N219	Double-hung with 2 / 4 cottage sash configuration	✓

<p>N219-01: Interior view of lower sash      N219-02: Interior view of upper sash      N219-03: Missing muntin bar</p> <p><b>Condition Comments</b></p> <ul style="list-style-type: none"> <li>- Glazing broken / missing at both sashes.</li> <li>- Lower sash missing muntin bar.</li> <li>- Paint is crazed (multiple layers of paint / lead paint).</li> <li>- Exterior sill is decayed.</li> <li>- Security screen mountings are mortised into the brickmold.</li> <li>- Upper sash painted in place.</li> <li>- Glazing caulk is tested as having ACM.</li> <li>- Accessing window weight box will require removing the galvanized metal jamb guides - access port is blocked.</li> <li>- Window sash won't open.</li> <li>- Evidence of long-term water damaged from being open to elements.</li> </ul>

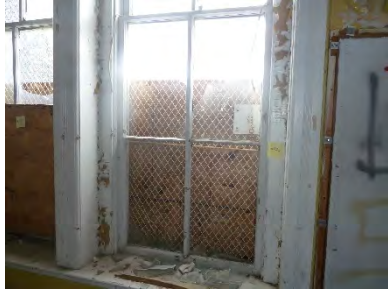
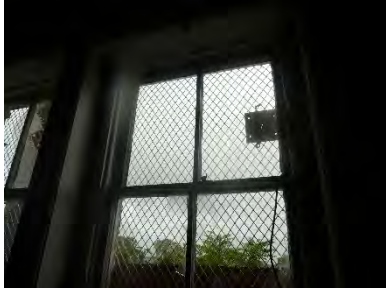
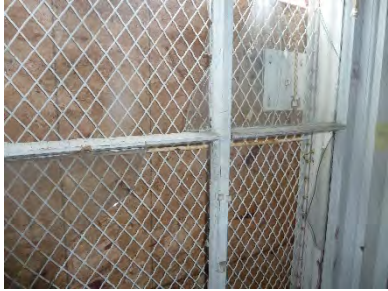
Room	Window	Window Configuration Type	Replace	Repair
109	N220	Double-hung with 2 / 4 cottage sash configuration	✓

<p>N220-01: Interior view of lower sash      N220-02: Interior view of upper sash      N220-03: Muntin bars at lower sash</p> <p><b>Condition Comments</b></p> <ul style="list-style-type: none"> <li>- Glazing broken / missing at both sashes.</li> <li>- Window sash ropes broken.</li> <li>- Muntin bars at lower sash are loose.</li> <li>- Paint is crazed (multiple layers of paint / lead paint).</li> <li>- Exterior sill is decayed.</li> <li>- Security screen mountings are mortised into the brickmold.</li> <li>- Upper sash painted in place.</li> <li>- Glazing caulk is tested as having ACM.</li> <li>- Accessing window weight box will require removing the galvanized metal jamb guides - access port is blocked.</li> <li>- Window sash won't open.</li> <li>- Evidence of long-term water damaged from being open to elements.</li> </ul>

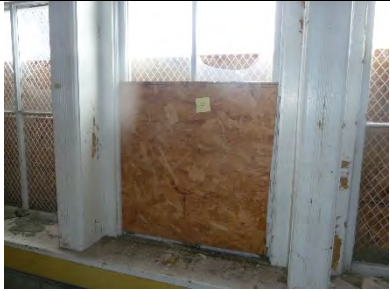
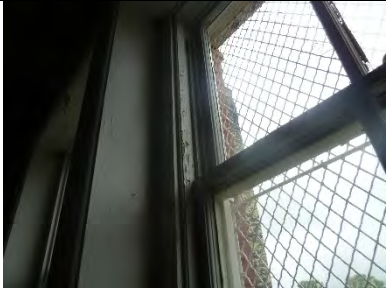
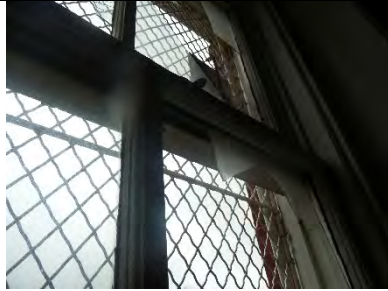
Room	Window	Window Configuration Type	Replace	Repair
109	N221	Double-hung with 2 /4 cottage sash configuration	✓

<p>N221-01: Interior view of lower sash      N221-02: Interior view of upper sash      N221-03: Non-original sashes – ogee design does not match</p> <p><b>Condition Comments</b></p> <ul style="list-style-type: none"> <li>- Glazing broken / missing at both sashes.</li> <li>- Muntin bars at lower sash are loose / damaged.</li> <li>- Lower sash is not original and is a replacement. Ogee is dissimilar and muntins are thicker than originals at typical window.</li> <li>- Upper sash not original and is a replacement. Ogee is dissimilar and muntins are thicker than originals at typical window.</li> <li>- Paint is crazed (multiple layers of paint / lead paint).</li> <li>- Exterior sill is decayed.</li> <li>- Security screen mountings are mortised into the brickmold.</li> <li>- Upper sash painted in place.</li> <li>- Glazing caulk is tested as having ACM.</li> <li>- Accessing window weight box will require removing the galvanized metal jamb guides - access port is blocked.</li> <li>- Window sash won't open.</li> <li>- Evidence of long-term water damaged from being open to elements.</li> </ul>

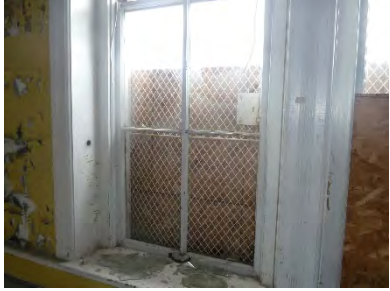
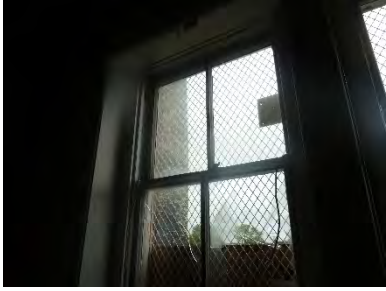
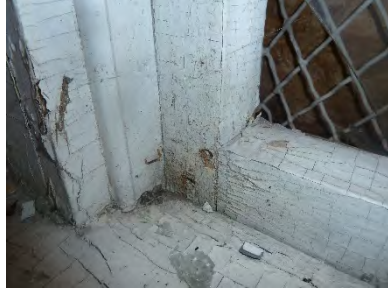
Room	Window	Window Configuration Type	Replace	Repair
109	N222	Double-hung with 2 /4 cottage sash configuration	✓

<p>N222-01: Interior view of lower sash      N222-02: Interior view of upper sash &amp; transom      N222-03: Lower sash repaired with screws</p> <p><b>Condition Comments</b></p> <ul style="list-style-type: none"> <li>- Glazing broken / missing at lower sash.</li> <li>- Sash ropes broken</li> <li>- Paint is crazed (multiple layers of paint / lead paint).</li> <li>- Exterior sill is decayed.</li> <li>- Left corner of lower sash bottom rail shows evidence of being repaired with screws</li> <li>- Security screen mountings are mortised into the brickmold.</li> <li>- Upper sash painted in place.</li> <li>- Damaged meeting rail at lock location – loss of material at extra-thin meeting rail.</li> <li>- Glazing caulk is tested as having ACM.</li> <li>- Accessing window weight box will require removing the galvanized metal jamb guides - access port is blocked.</li> <li>- Window sash won't open.</li> <li>- Evidence of long-term water damaged from being open to elements.</li> </ul>

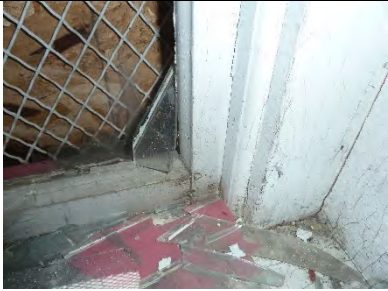
<p>N223-03: Screw repair at sash corner</p> </div> </div> <p><b>Condition Comments</b></p> <ul style="list-style-type: none"> <li>- Glazing broken / missing at lower sash.</li> <li>- Sash ropes broken</li> <li>- Paint is crazed (multiple layers of paint / lead paint).</li> <li>- Exterior sill is decayed.</li> <li>- Both corners of lower sash bottom rail show evidence of being repaired with screws.</li> <li>- Security screen mountings are mortised into the brickmold.</li> <li>- Upper sash painted in place.</li> <li>- Glazing caulk is tested as having ACM.</li> <li>- Accessing window weight box will require removing the galvanized metal jamb guides - access port is blocked.</li> <li>- Window sash won't open.</li> <li>- Evidence of long-term water damage from being open to elements.</li> </ul> <div style="text-align: right; margin-top: 20px;">   <p>N223-04: Exterior view at left</p> </div>

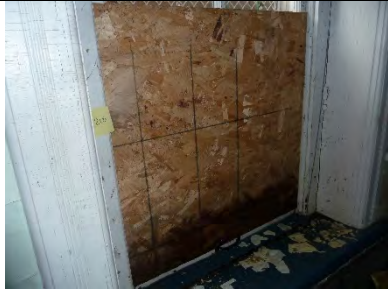
Room	Window	Window Configuration Type	Replace	Repair
110	S216	Double-hung with 2 / 4 cottage sash configuration	✓

<p>S216-01: Interior view of lower sash      S216-02: Interior view of upper sash</p> <p><b>Condition Comments</b></p> <ul style="list-style-type: none"> <li>- Glazing broken / missing at lower sash.</li> <li>- Lower sash is not original and is a replacement. Ogee is dissimilar and muntins are thicker than originals at typical window.</li> <li>- Sash ropes broken</li> <li>- Paint is crazed (multiple layers of paint / lead paint).</li> <li>- Exterior sill is decayed.</li> <li>- Security screen mountings are mortised into the brickmold.</li> <li>- Upper sash painted in place.</li> <li>- Glazing caulk is tested as having ACM.</li> <li>- Accessing window weight box will require removing the galvanized metal jamb guides - access port is blocked.</li> <li>- Window sash won't open.</li> <li>- Evidence of long-term water damage at interior sill.</li> </ul>

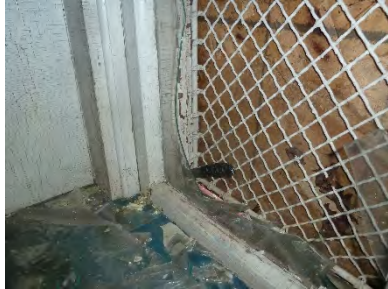
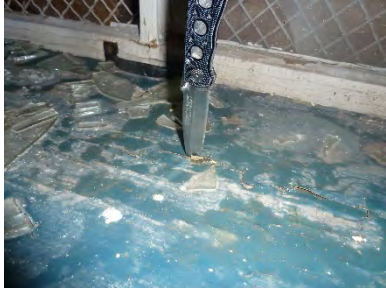
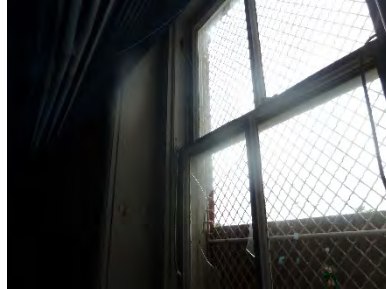
Room	Window	Window Configuration Type	Replace	Repair
110	S217	Double-hung with 2 / 4 cottage sash configuration	✓

<p>S217-01: Interior view of lower sash      S217-02: Interior view interior sill      S217-03: Meeting rail at lock damage</p> <p><b>Condition Comments</b></p> <ul style="list-style-type: none"> <li>- Glazing broken / missing at lower sash.</li> <li>- Sash ropes broken</li> <li>- Paint is crazed (multiple layers of paint / lead paint).</li> <li>- Exterior sill is decayed.</li> <li>- Exterior jamb and stops at left are decayed – 3/8" blade penetration.</li> <li>- Interior sill is water damaged and decayed – 3/8" blade penetration.</li> <li>- Upper sash bottom rail is damaged at lock - loss of material.</li> <li>- Security screen mountings are mortised into the brickmold.</li> <li>- Upper sash painted in place.</li> <li>- Glazing caulk is tested as having ACM.</li> <li>- Accessing window weight box will require removing the galvanized metal jamb guides - access port is blocked.</li> <li>- Window sash won't open.</li> </ul>

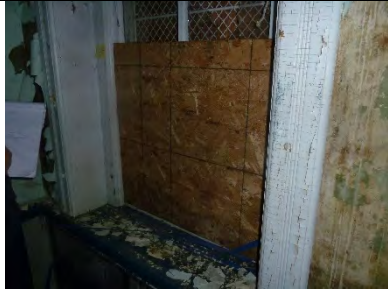
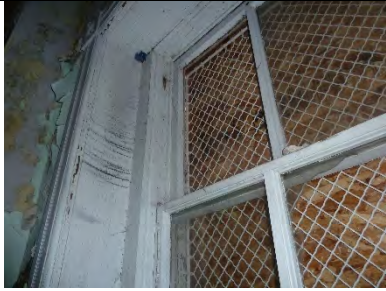
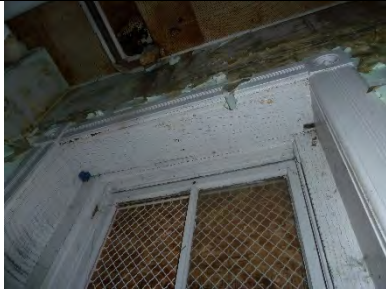
Room	Window	Window Configuration Type	Replace	Repair
110	S218	Double-hung with 2 / 4 cottage sash configuration	✓

<p>S218-01: Interior view of lower sash      S218-02: Interior view of upper sash      S218-03: Water damage above head</p> <p><b>Condition Comments</b></p> <ul style="list-style-type: none"> <li>- Glazing broken / missing at lower sash.</li> <li>- Lower sash is not original and is a replacement. Ogee is dissimilar and muntins are thicker than originals at typical window.</li> <li>- Sash ropes broken.</li> <li>- Paint is crazed (multiple layers of paint / lead paint).</li> <li>- Exterior sill is decayed.</li> <li>- Security screen mountings are mortised into the brickmold.</li> <li>- Upper sash painted in place.</li> <li>- Glazing caulk is tested as having ACM.</li> <li>- Accessing window weight box will require removing the galvanized metal jamb guides - access port is blocked.</li> <li>- Window sash won't open.</li> <li>- Evidence of water damage at interior sill and window head.</li> </ul>

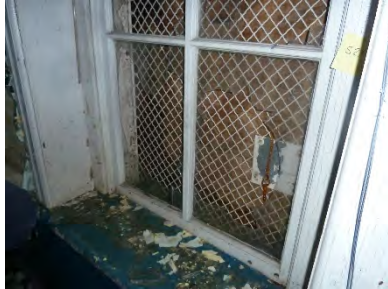
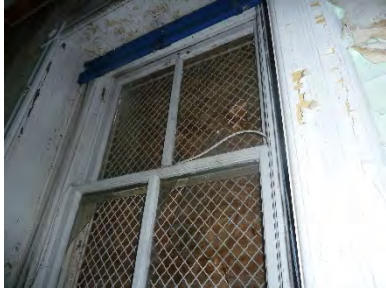
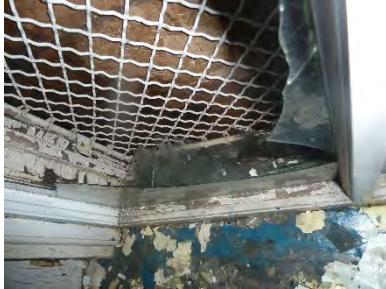
Room	Window	Window Configuration Type	Replace	Repair
110	S219	Double-hung with 2 / 4 cottage sash configuration	✓

<p>S219-01: Interior view of lower sash      S219-02: Interior view of upper sash      S219-03: Exterior sill and stops/jamb condition</p> <p><b>Condition Comments</b></p> <ul style="list-style-type: none"> <li>- Glazing broken / missing at lower sash.</li> <li>- Lower sash is not original and is a replacement. Ogee is dissimilar and muntins are thicker than originals at typical window.</li> <li>- Sash ropes broken.</li> <li>- Paint is crazed (multiple layers of paint / lead paint).</li> <li>- Exterior sill is decayed.</li> <li>- Exterior stops decayed / water damaged.</li> <li>- Security screen mountings are mortised into the brickmold.</li> <li>- Upper sash painted in place.</li> <li>- Glazing caulk is tested as having ACM.</li> <li>- Accessing window weight box will require removing the galvanized metal jamb guides - access port is blocked.</li> <li>- Window sash won't open.</li> <li>- Evidence of long-term water damaged at interior head and sill.</li> </ul>

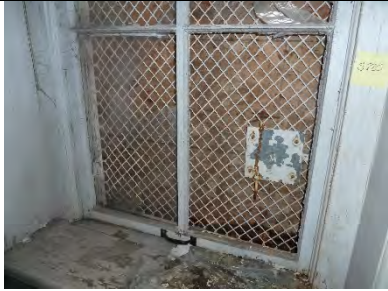
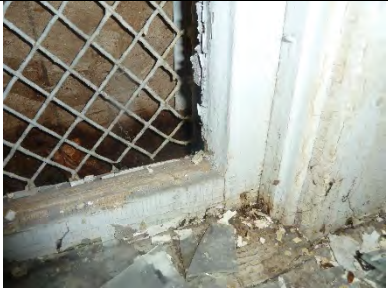
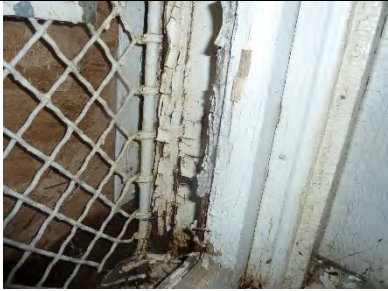
Room	Window	Window Configuration Type	Replace	Repair
110A	S220	Double-hung with 2 / 4 cottage sash configuration	✓

<p>S220-01: Interior view of lower sash      S220-02: View of rotted exterior sill      S220-03: Exterior jamb and stops rotted at right jamb</p> <p><b>Condition Comments</b></p> <ul style="list-style-type: none"> <li>- Glazing broken / missing at lower sash.</li> <li>- Sash ropes broken.</li> <li>- Paint is crazed (multiple layers of paint / lead paint).</li> <li>- Exterior sill is decayed.</li> <li>- Exterior stops decayed / water damaged.</li> <li>- Security screen mountings are mortised into the brickmold.</li> <li>- Upper sash painted in place.</li> <li>- Glazing caulk is tested as having ACM.</li> <li>- Accessing window weight box will require removing the galvanized metal jamb guides - access port is blocked.</li> <li>- Window sash won't open.</li> <li>- Evidence of long-term water damaged at interior head and sill.</li> </ul>

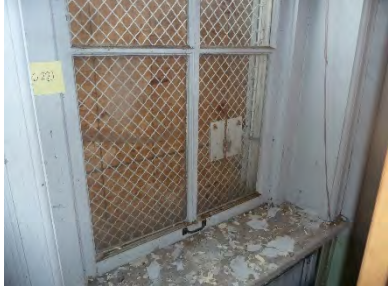
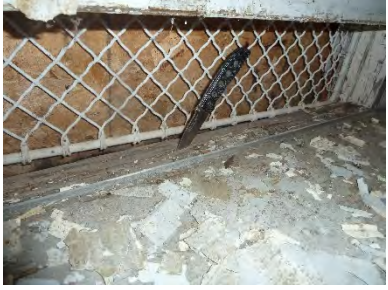
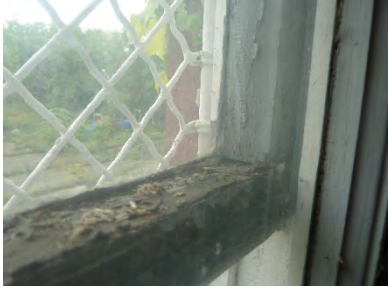
Room	Window	Window Configuration Type	Replace	Repair
111A	S221	Double-hung with 2 / 4 cottage sash configuration	✓

<p>S221-01: Interior view of lower sash      S221-02: Rotted exterior sill      S221-03: Upper sash corner decayed / blown</p> <p><b>Condition Comments</b></p> <ul style="list-style-type: none"> <li>- Glazing broken / missing at lower sash.</li> <li>- Sash ropes broken.</li> <li>- Paint is crazed (multiple layers of paint / lead paint).</li> <li>- Exterior sill is decayed – 1/2" blade penetration.</li> <li>- Exterior stops &amp; jamb decayed / water damaged.</li> <li>- Interior sill heavily water damaged – 3/8" blade penetration.</li> <li>- Upper sash lower rail corners visibly rotten and blown.</li> <li>- Security screen mountings are mortised into the brickmold.</li> <li>- Upper sash painted in place.</li> <li>- Glazing caulk is tested as having ACM.</li> <li>- Accessing window weight box will require removing the galvanized metal jamb guides - access port is blocked.</li> <li>- Window sash won't open.</li> <li>- Evidence of long-term water damaged at interior head and sill.</li> </ul>

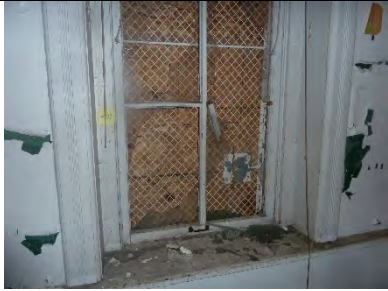
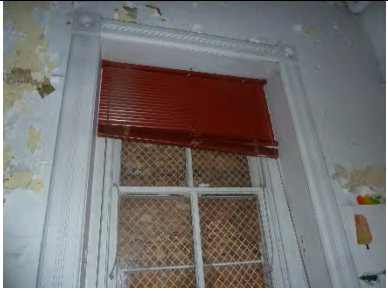
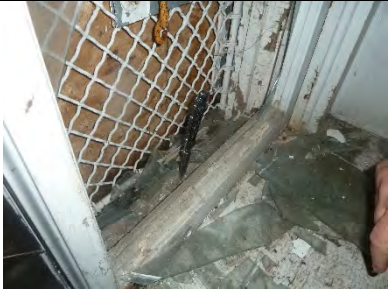
Room	Window	Window Configuration Type	Replace	Repair
111	S222	Double-hung with 2 / 4 cottage sash configuration	✓

<p>S222-01: Interior view of lower sash</p> <p>S222-02: Interior view of upper sash</p>		<p>S222-03: Condition of exterior and interior sills</p>		
<p><b>Condition Comments</b></p> <ul style="list-style-type: none"> <li>- Glazing broken / missing at lower sash.</li> <li>- Sash ropes broken.</li> <li>- Broken muntin bars at lower sash.</li> <li>- Lower sash is not original and is a replacement. Ogee is dissimilar and muntins are thicker than originals at typical window.</li> <li>- Paint is crazed (multiple layers of paint / lead paint).</li> <li>- Exterior sill is decayed – 1/4" blade penetration.</li> <li>- Security screen mountings are mortised into the brickmold.</li> <li>- Upper sash painted in place.</li> <li>- Glazing caulk is tested as having ACM.</li> <li>- Accessing window weight box will require removing the galvanized metal jamb guides - access port is blocked.</li> <li>- Window sash won't open.</li> <li>- Evidence of long-term water damaged at interior head and sill.</li> </ul>

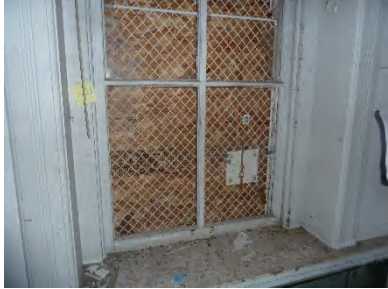
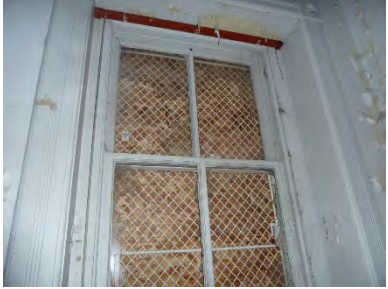
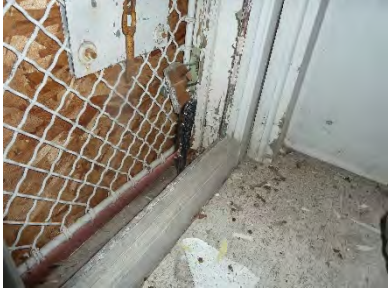
Room	Window	Window Configuration Type	Replace	Repair
111	S223	Double-hung with 2 / 4 cottage sash configuration	✓

<p>S223-01: Interior view of lower sash</p> <p>S223-02: Interior view of upper sash</p>		<p>S223-03: Exterior sill and lower jambs decayed</p>		
<p><b>Condition Comments</b></p> <ul style="list-style-type: none"> <li>- Glazing broken / missing at both sashes.</li> <li>- Lower sash is not original and is a replacement. Ogee is dissimilar and muntins are thicker than originals at typical window.</li> <li>- Sash ropes broken.</li> <li>- Pull hardware missing.</li> <li>- Paint is crazed (multiple layers of paint / lead paint).</li> <li>- Exterior sill is decayed – 1/2" blade penetration.</li> <li>- Exterior jambs and stops decayed at sill.</li> <li>- Security screen mountings are mortised into the brickmold.</li> <li>- Upper sash painted in place.</li> <li>- Glazing caulk is tested as having ACM.</li> <li>- Accessing window weight box will require removing the galvanized metal jamb guides - access port is blocked.</li> <li>- Window sash won't open.</li> <li>- Evidence of long-term water damaged at interior head and sill.</li> </ul>

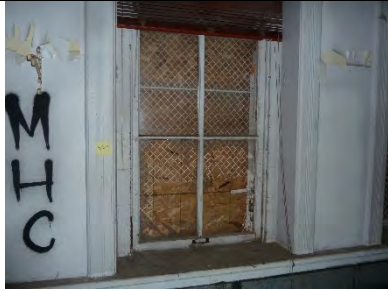
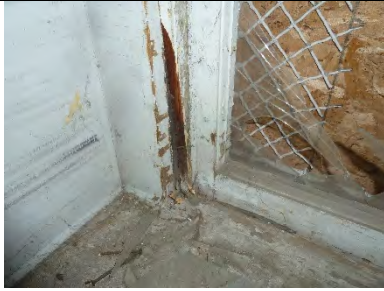
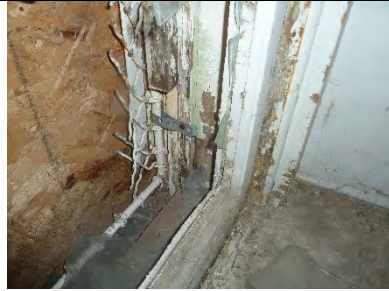
Room	Window	Window Configuration Type	Replace	Repair
111	S224	Double-hung with 2 /4 cottage sash configuration	✓

<p>S224-01: Interior view of lower sash      S224-02: Damage at interior stops      S224-03: Exterior sill, jambs and stops condition</p> <p><b>Condition Comments</b></p> <ul style="list-style-type: none"> <li>- Glazing broken / missing at both sashes.</li> <li>- Lower sash is not original and is a replacement. Ogee is dissimilar and muntins are thicker than originals at typical window.</li> <li>- Sash ropes broken.</li> <li>- Paint is crazed (multiple layers of paint / lead paint).</li> <li>- Exterior sill is decayed.</li> <li>- Exterior jambs and stops decayed at sill.</li> <li>- Security screen mountings are mortised into the brickmold.</li> <li>- Upper sash painted in place.</li> <li>- Glazing caulk is tested as having ACM.</li> <li>- Accessing window weight box will require removing the galvanized metal jamb guides - access port is blocked.</li> <li>- Window sash won't open.</li> <li>- Evidence of long-term water damaged at interior head and sill.</li> </ul>

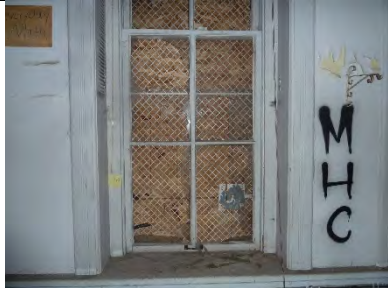
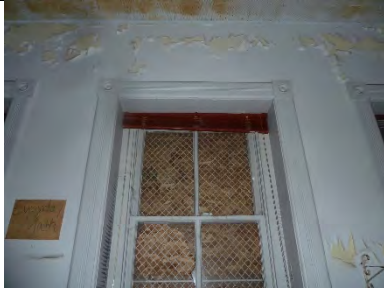
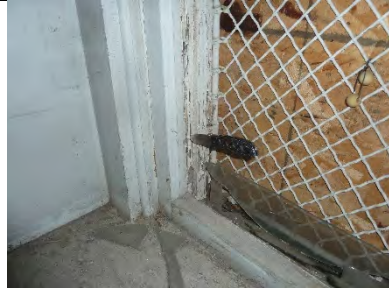
Room	Window	Window Configuration Type	Replace	Repair
111	S225	Double-hung with 2 /4 cottage sash configuration	✓

<p>S225-01: Interior view of lower sash      S225-02: Interior view of upper sash      S225-03: Decayed wood at jamb</p> <p><b>Condition Comments</b></p> <ul style="list-style-type: none"> <li>- Glazing broken / missing at lower sash.</li> <li>- Lower sash is not original and is a replacement. Ogee is dissimilar and muntins are thicker than originals at typical window.</li> <li>- Sash ropes broken / missing.</li> <li>- Paint is crazed (multiple layers of paint / lead paint).</li> <li>- Exterior sill is decayed.</li> <li>- Exterior jamb and stops are decayed – 3/8" blade penetration at left.</li> <li>- Security screen mountings are mortised into the brickmold.</li> <li>- Upper sash painted in place.</li> <li>- Glazing caulk is tested as having ACM.</li> <li>- Accessing window weight box will require removing the galvanized metal jamb guides - access port is blocked.</li> <li>- Window sash won't open.</li> </ul>

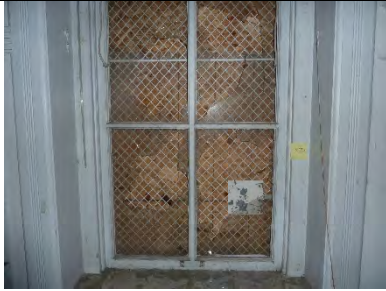
S226-01: Interior view of lower sash

- Glazing broken / missing at lower sash.
- Lower sash is not original and is a replacement. Ogee is dissimilar and muntins are thicker than originals at typical window.
- Sash ropes broken.
- Pull hardware missing.
- Paint is crazed (multiple layers of paint / lead paint).
- Exterior sill is decayed.
- Exterior jambs and stops decayed.
- Security screen mountings are mortised into the brickmold.
- Upper sash painted in place.
- Glazing caulk is tested as having ACM.
- Accessing window weight box will require removing the galvanized metal jamb guides - access port is blocked.
- Window sash won't open.

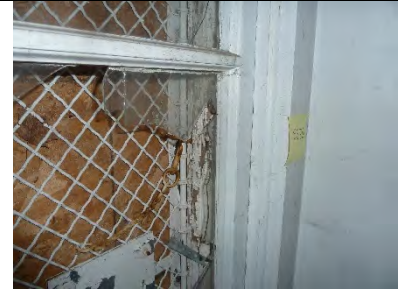
S226-03: Screw repair at sash corner

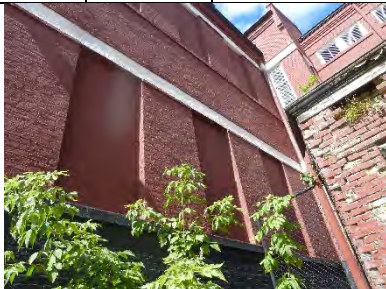
S227- S229-01: Exterior View at lower center

- Windows previously removed and bricked in when central stair addition was built.

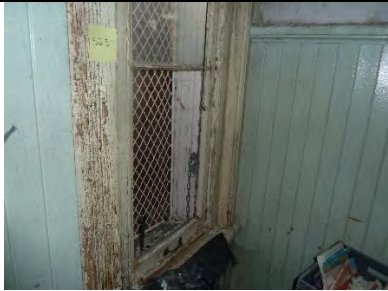
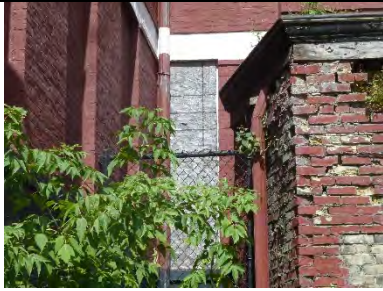
Room	Window	Window Configuration Type	Replace	Repair
111B	S230	Double-hung with 1 /1 cottage sash configuration	✓

<p>S230-01: Interior view of lower sash      S230-02: Exterior view</p> <p><b>Condition Comments</b></p> <ul style="list-style-type: none"> <li>- Glazing broken / missing.</li> <li>- Paint is crazed (multiple layers of paint / lead paint).</li> <li>- Exterior sill is decayed.</li> <li>- Exterior jambs and stops decayed at sill.</li> <li>- Security screen mountings are mortised into the brickmold.</li> <li>- Upper sash painted in place.</li> <li>- Glazing caulk is tested as having ACM.</li> </ul>

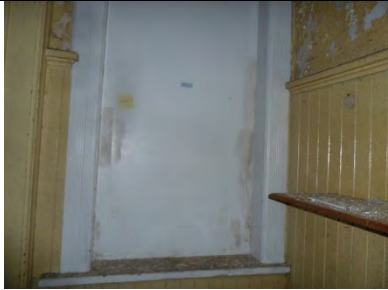
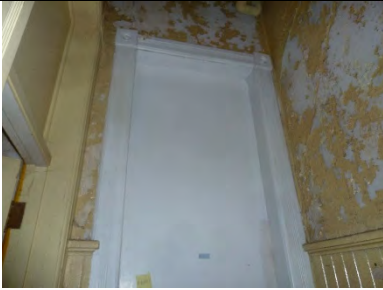
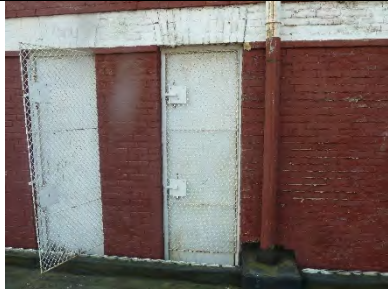
Room	Window	Window Configuration Type	Replace	Repair
113A	N207	Abandoned: Double-hung with 2/4 cottage sash configuration original	✓

<p>N207-01: Interior view of lower sash      N207-02: Interior view of upper sash      N207-03: Exterior view at center</p> <p><b>Condition Comments</b></p> <ul style="list-style-type: none"> <li>- Window boarded at both sides: Plywood at exterior and gypsum board at interior.</li> </ul>

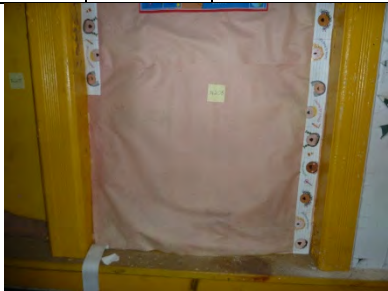
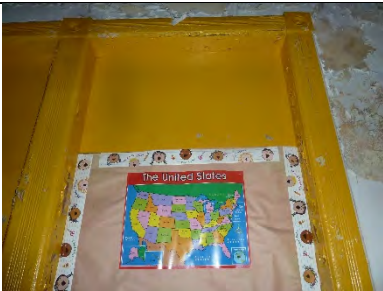
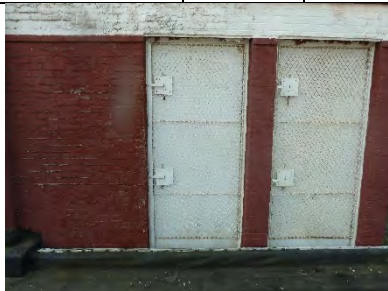
Room	Window	Window Configuration Type	Replace	Repair
113	N208	Abandoned: Double-hung with 2/4 cottage sash configuration original	✓

<p>N208-01: Interior view of lower sash      N208-02: Interior view of upper sash      N208-03: Exterior view at center</p> <p><b>Condition Comments</b></p> <ul style="list-style-type: none"> <li>- Window boarded at both sides: Plywood at exterior and finished gypsum board at interior. Assumed boarded by MPS due to condition being too far gone to repair.</li> </ul>

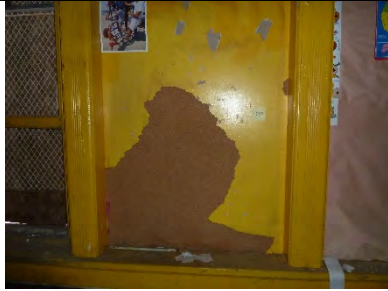
N209-01: Interior view of lower sash

- Window boarded at both sides: Plywood at exterior and gypsum board at interior. Assumed boarded by MPS due to condition being too far gone to repair.

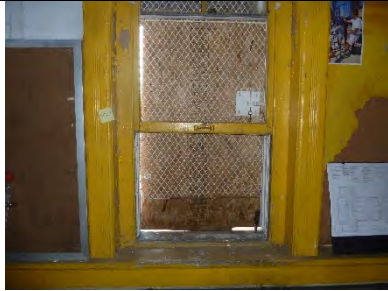
N210-01: Interior view of lower sash

- Glazing broken / missing at lower sash.
- Muntins missing at lower sash.
- Lower sash racked.
- Paint is crazed (multiple layers of paint / lead paint).
- Exterior sill is decayed – 3/8" blade penetration.
- Interior sill is decayed / water damaged.
- Security screen mountings are mortised into the brickmold.
- Upper sash painted in place.
- Glazing caulk is tested as having ACM.
- Accessing window weight box will require removing the galvanized metal jamb guides - access port is blocked.
- Window stuck in open position.

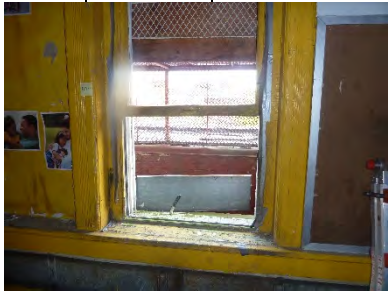
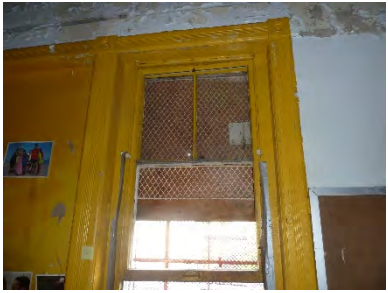
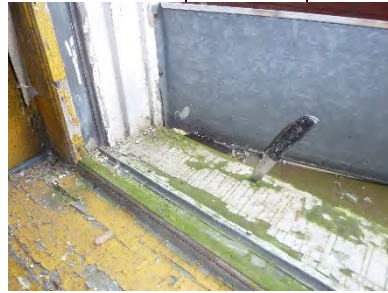
Room	Window	Window Configuration Type	Replace	Repair
113	N211	Double-hung with 2 /4 cottage sash configuration	✓

N211-01: Interior view of lower sash	N211-02: Interior view of upper sash	
		N211-03: Decayed wood at sill		
<b>Condition Comments</b>				
<ul style="list-style-type: none"> <li>- Glazing broken / missing at lower sash.</li> <li>- Muntins missing at lower sash.</li> <li>- Lower sash racked.</li> <li>- Paint is crazed (multiple layers of paint / lead paint).</li> <li>- Exterior sill is decayed – 3/8" blade penetration.</li> <li>- Interior sill is decayed / water damaged.</li> <li>- Security screen mountings are mortised into the brickmold.</li> <li>- Upper sash painted in place.</li> <li>- Glazing caulk is tested as having ACM.</li> <li>- Accessing window weight box will require removing the galvanized metal jamb guides - access port is blocked.</li> <li>- Window stuck in open position.</li> </ul>

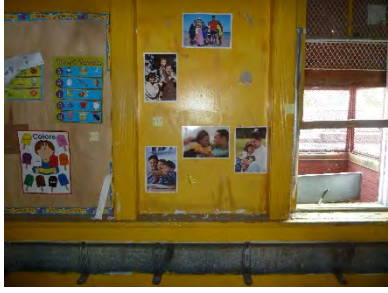
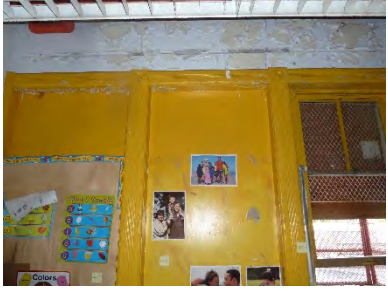
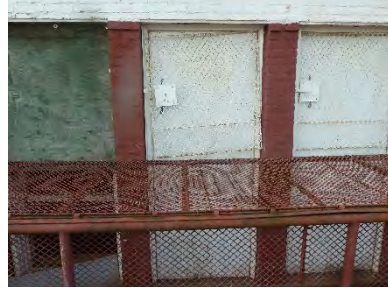
Room	Window	Window Configuration Type	Replace	Repair
113	N212	Abandoned: Double-hung with 2/4 cottage sash configuration original	✓

N212-01: Interior view of lower sash	N212-02: Interior view of upper sash	
		N212-03: Exterior view at center		
<b>Condition Comments</b>				
<ul style="list-style-type: none"> <li>- Window boarded at both sides: Plywood at exterior and gypsum board at interior. Assumed boarded by MPS due to condition being too far gone to repair.</li> </ul>

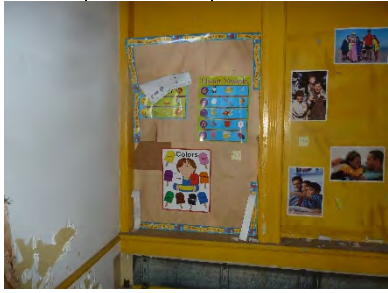
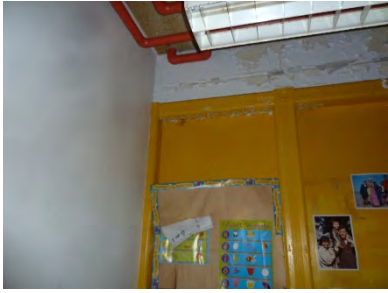
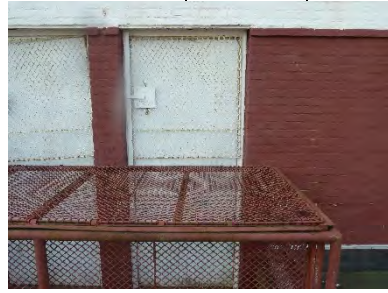
Room	Window	Window Configuration Type	Replace	Repair
113	N213	Abandoned: Double-hung with 2/4 cottage sash configuration original	✓

N213-01: Interior view of lower sash	N213-02: Interior view of upper sash	
		N213-03: Exterior view at center		
<b>Condition Comments</b>				
<ul style="list-style-type: none"> <li>- Window boarded at both sides: Plywood at exterior and gypsum board at interior. Assumed boarded by MPS due to condition being too far gone to repair.</li> </ul>

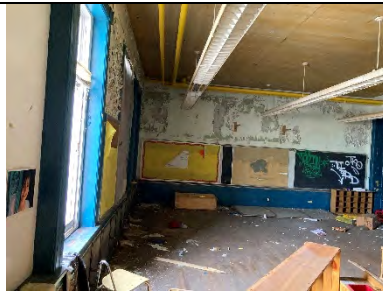
E207-E209-02: Interior View at far wall

- Windows previously removed and bricked in when central stair addition was built.

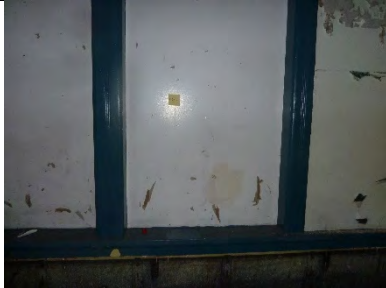
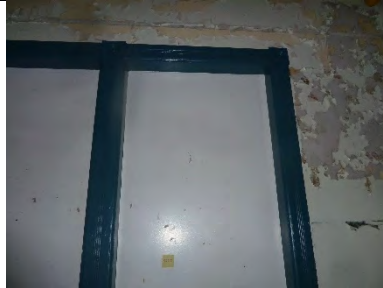
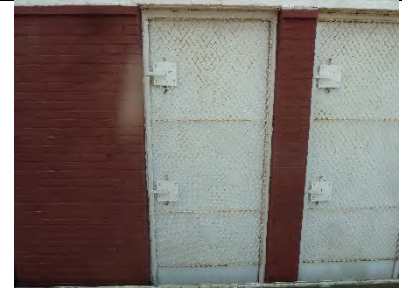
Room	Window	Window Configuration Type	Replace	Repair
114	N200	Abandoned: Double-hung with 2/4 cottage sash configuration original	✓

- Window boarded at both sides: Plywood at exterior and gypsum board at interior. Assumed boarded by MPS due to condition being too far gone to repair.

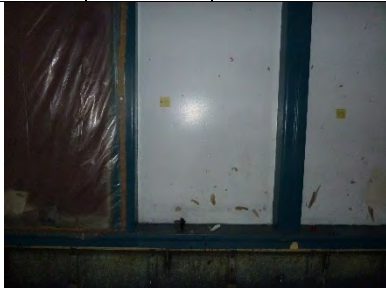
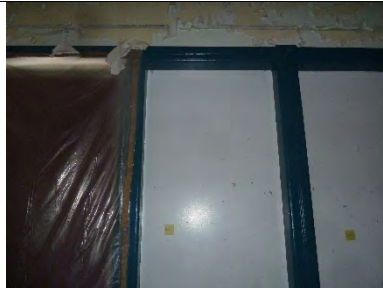
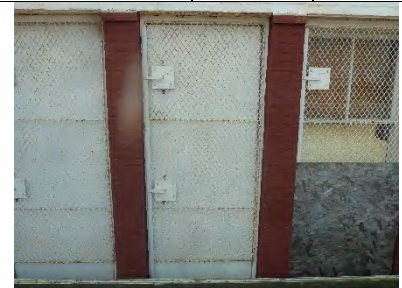
Room	Window	Window Configuration Type	Replace	Repair
114	N201	Abandoned: Double-hung with 2/4 cottage sash configuration original	✓

- Window boarded at both sides: Plywood at exterior and gypsum board at interior. Assumed boarded by MPS due to condition being too far gone to repair.

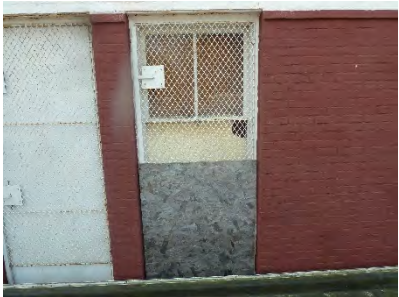
<p>N202-03: Exterior view at center</p>

<p>N202-01: Interior view of lower sash      N202-02: Interior view of upper sash</p> <p><b>Condition Comments</b></p> <ul style="list-style-type: none"> <li>- Glazing broken / missing at lower both sashes.</li> <li>- Muntins missing at lower sash.</li> <li>- Lower sash racked.</li> <li>- Paint is crazed (multiple layers of paint / lead paint).</li> <li>- Exterior sill is decayed.</li> <li>- Security screen mountings are mortised into the brickmold.</li> <li>- Upper sash painted in place.</li> <li>- Glazing caulk is tested as having ACM.</li> <li>- Accessing window weight box will require removing the galvanized metal jamb guides - access port is blocked.</li> <li>- Window covered at the interior with stapled plastic.</li> </ul>

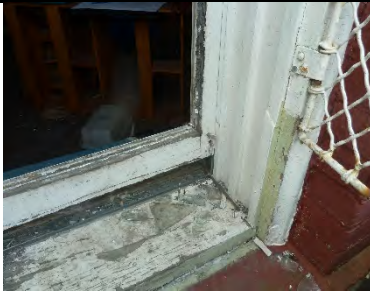
<p>N203-01: Interior view of lower sash      N203-02: Interior view of upper sash</p> <p><b>Condition Comments</b></p> <ul style="list-style-type: none"> <li>- Glazing broken / missing at both sashes.</li> <li>- Muntins missing at lower sash.</li> <li>- Lower sash racked.</li> <li>- Paint is crazed (multiple layers of paint / lead paint).</li> <li>- Exterior sill is decayed.</li> <li>- Security screen mountings are mortised into the brickmold.</li> <li>- Upper sash painted in place.</li> <li>- Glazing caulk is tested as having ACM.</li> <li>- Accessing window weight box will require removing the galvanized metal jamb guides - access port is blocked.</li> <li>- Window is covered at interior w/ plastic.</li> </ul>

<p>N203-02: Corner pegs distended and decayed</p>

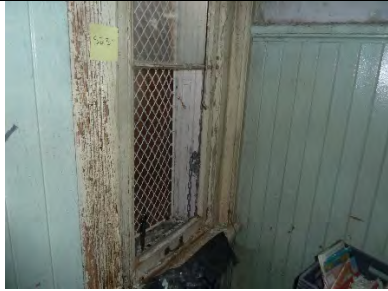
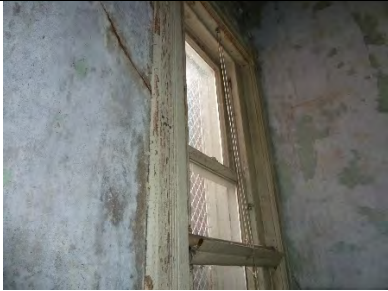
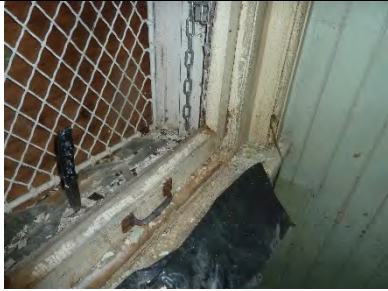
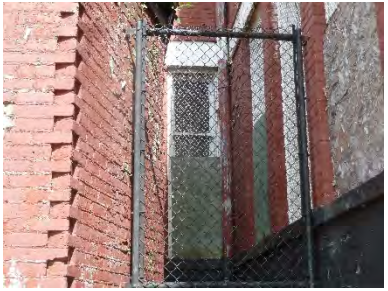
Room	Window	Window Configuration Type	Replace	Repair
115A	S231	Double-hung with 1 /1 cottage sash configuration	✓

<p>S231-01: Interior view of lower sash      S231-02: Interior view of upper sash      S231-03: Exterior sill condition</p> <p><b>Condition Comments</b></p> <ul style="list-style-type: none"> <li>- Glazing broken / missing at lower sash.</li> <li>- Pull hardware is rusty.</li> <li>- Paint is crazed (multiple layers of paint / lead paint).</li> <li>- Exterior sill is decayed – 3/8" blade penetration.</li> <li>- Security screen mountings are mortised into the brickmold.</li> <li>- Upper sash painted in place.</li> <li>- Glazing caulk is tested as having ACM.</li> <li>- Window sash won't open.</li> <li>- Interior casings and sill are water damaged as are adjacent walls.</li> </ul>

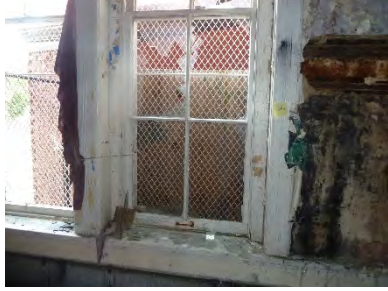
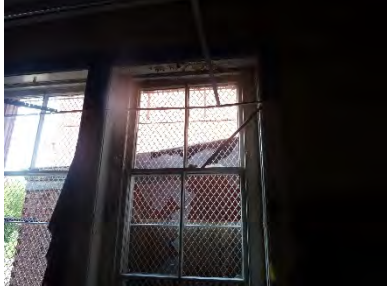
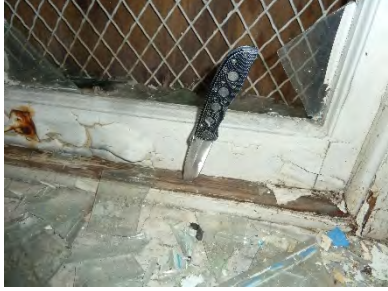
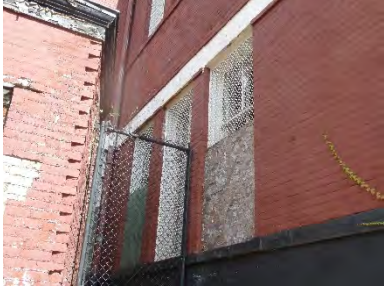
Room	Window	Window Configuration Type	Replace	Repair
115	S233	Double-hung with 2 /4 cottage sash configuration	✓

<p>S233-01: Interior view of lower sash      S233-02: Interior view of upper sash      S233-03: Rotted interior sill</p> <p><b>Condition Comments</b></p> <ul style="list-style-type: none"> <li>- Glazing broken / missing at both sashes.</li> <li>- Lower sash is not original and is a replacement. Ogee is dissimilar and muntins are thicker than originals at typical window.</li> <li>- Pull hardware is rusted.</li> <li>- Paint is crazed (multiple layers of paint / lead paint).</li> <li>- Exterior sill is decayed.</li> <li>- Exterior jambs and stops decayed.</li> <li>- Interior sill decayed – 3/8" blade penetration.</li> <li>- Security screen mountings are mortised into the brickmold.</li> <li>- Upper sash painted in place.</li> <li>- Glazing caulk is tested as having ACM.</li> <li>- Accessing window weight box will require removing the galvanized metal jamb guides - access port is blocked.</li> <li>- Window sash won't open.</li> <li>- Adjacent wall and ceiling extremely damaged by water infiltration. Wall directly to right has extreme mold infestation.</li> </ul>

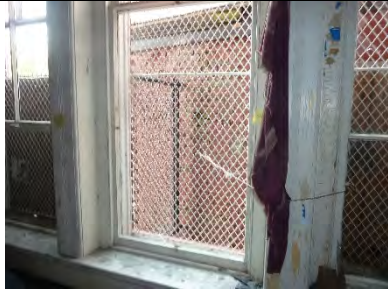
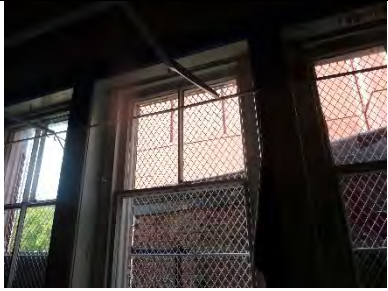
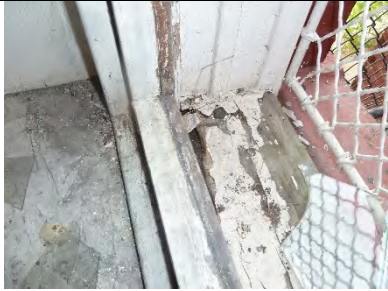
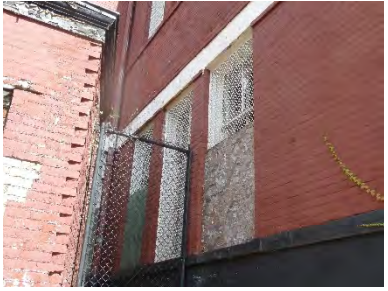
Room	Window	Window Configuration Type	Replace	Repair
115	S234	Double-hung with 2 / 4 cottage sash configuration	✓

<p>S234-01: Interior view of lower sash      S234-02: Interior view of upper sash      S234-03: Severely rotted exterior sill</p> <p><b>Condition Comments</b></p> <ul style="list-style-type: none"> <li>- Glazing broken / missing at both sashes.</li> <li>- Muntins missing at lower sash.</li> <li>- Sash ropes are broken.</li> <li>- Pull hardware is missing.</li> <li>- Paint is crazed (multiple layers of paint / lead paint).</li> <li>- Exterior sill is severely decayed / rotted.</li> <li>- Security screen mountings are mortised into the brickmold.</li> <li>- Upper sash painted in place.</li> <li>- Glazing caulk is tested as having ACM.</li> <li>- Accessing window weight box will require removing the galvanized metal jamb guides - access port is blocked.</li> <li>- Window sash won't open.</li> <li>- Adjacent wall and ceiling above damaged by water infiltration.</li> </ul>

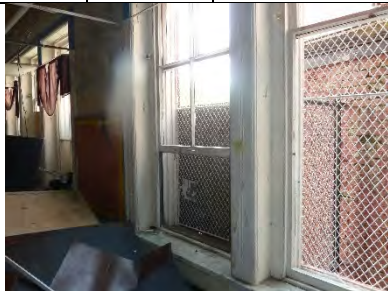
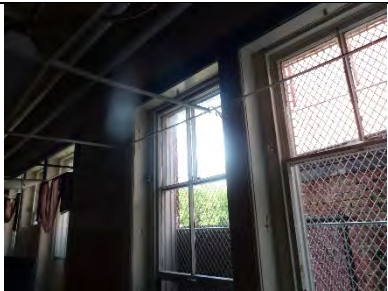
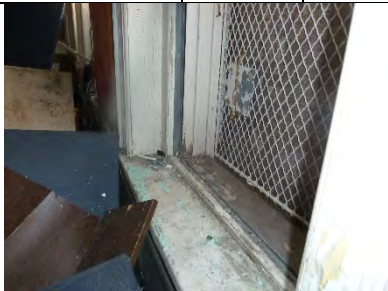
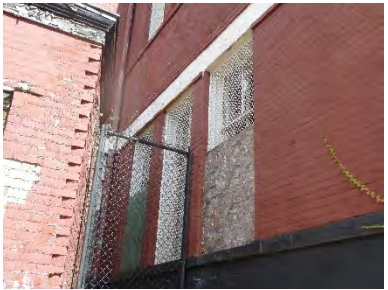
Room	Window	Window Configuration Type	Replace	Repair
115	S235	Double-hung with 2 / 4 cottage sash configuration	✓

<p>S235-01: Interior view of lower sash      S235-02: Interior view of upper sash      S235-03: Sill condition</p> <p><b>Condition Comments</b></p> <ul style="list-style-type: none"> <li>- Glazing broken / missing at both sashes.</li> <li>- Sash ropes are broken.</li> <li>- Paint is crazed (multiple layers of paint / lead paint).</li> <li>- Exterior sill is decayed.</li> <li>- Interior sill water damaged.</li> <li>- Security screen mountings are mortised into the brickmold.</li> <li>- Upper sash painted in place.</li> <li>- Glazing caulk is tested as having ACM.</li> <li>- Accessing window weight box will require removing the galvanized metal jamb guides - access port is blocked.</li> <li>- Adjacent wall and ceiling above damaged by water infiltration.</li> </ul>

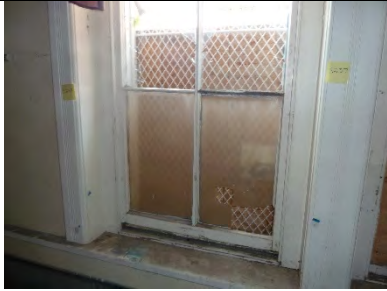
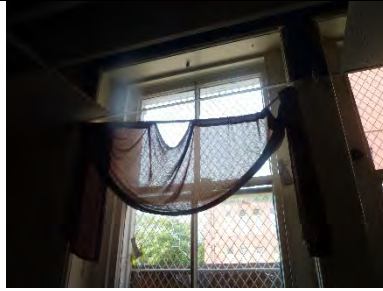
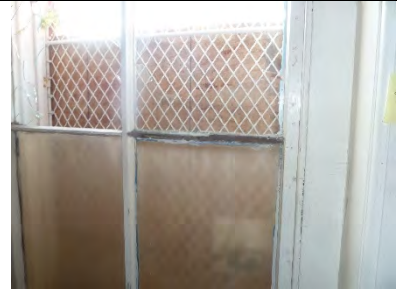
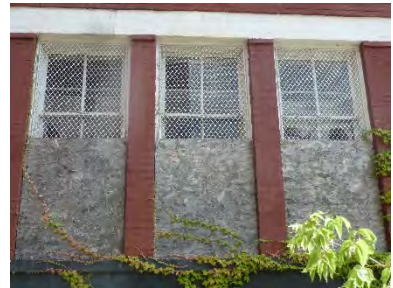
Room	Window	Window Configuration Type	Replace	Repair
115	S238	Double-hung with 2 / 4 cottage sash configuration	✓

- Glazing broken / missing at both sashes.
- Pull hardware is missing.
- Sash cords are broken.
- Paint is crazed (multiple layers of paint / lead paint).
- Exterior sill is decayed.
- Lower sash is racked (blown corner at lower right).
- Damaged / decayed muntin at lower sash.
- Interior sill water damaged.
- Security screen mountings are mortised into the brickmold.
- Upper sash painted in place.
- Glazing caulk is tested as having ACM.
- Accessing window weight box will require removing the galvanized metal jamb guides - access port is blocked.
- Window sash won't open.
- Adjacent ceiling damaged by water infiltration.

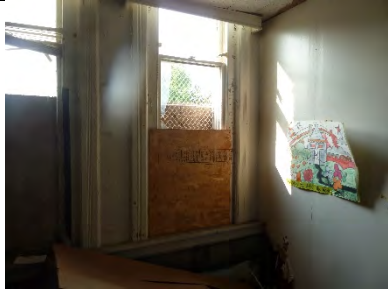
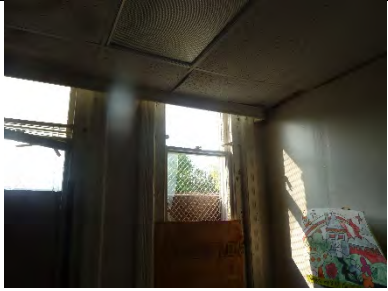
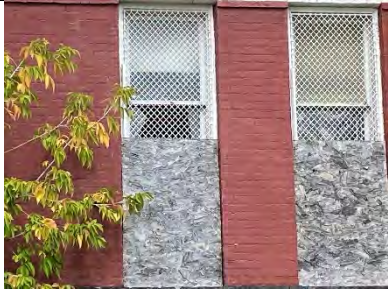
Room	Window	Window Configuration Type	Replace	Repair
120B	S243	Double-hung with 1 / 2 cottage sash configuration	✓

<p>S243-01: Interior view of lower sash      S243-02: Interior view of upper sash      S243-03: Exterior view at center</p> <p><b>Condition Comments</b></p> <ul style="list-style-type: none"> <li>- Glazing broken / missing at lower sash.</li> <li>- Missing horizontal muntin bar at lower sash.</li> <li>- Damage at top of lower sash upper rail by lock - loss of material.</li> <li>- Pull hardware is missing.</li> <li>- Paint is crazed (multiple layers of paint / lead paint).</li> <li>- Exterior sill is decayed.</li> <li>- Security screen mountings are mortised into the brickmold.</li> <li>- Upper sash painted in place.</li> <li>- Glazing caulk is tested as having ACM.</li> <li>- Accessing window weight box will require removing the galvanized metal jamb guides - access port is blocked.</li> <li>- Window sash won't open.</li> </ul>

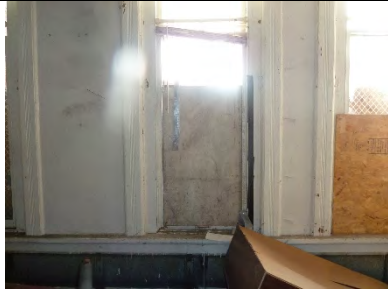
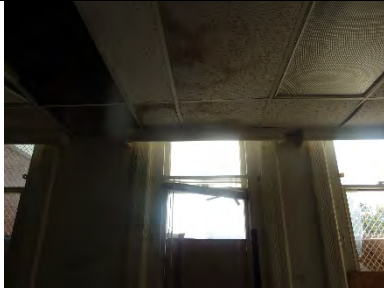
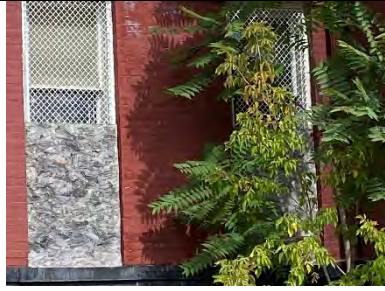
Room	Window	Window Configuration Type	Replace	Repair
120A	S244	Double-hung with 1/2 cottage sash configuration	✓

<p>S244-01: Interior view of lower sash      S244-02: Lower right jamb and stops      S244-03: Exterior view at left</p> <p><b>Condition Comments</b></p> <ul style="list-style-type: none"> <li>- Glazing broken / missing at lower sash / Plexiglas at upper.</li> <li>- Paint is crazed (multiple layers of paint / lead paint).</li> <li>- Exterior sill is decayed.</li> <li>- Pull hardware is rusted.</li> <li>- Lower sash bottom rail left corner is blown.</li> <li>- Security screen mountings are mortised into the brickmold.</li> <li>- Upper sash painted in place.</li> <li>- Glazing caulk is tested as having ACM.</li> <li>- Accessing window weight box will require removing the galvanized metal jamb guides - access port is blocked.</li> <li>- Window sash won't move.</li> </ul>

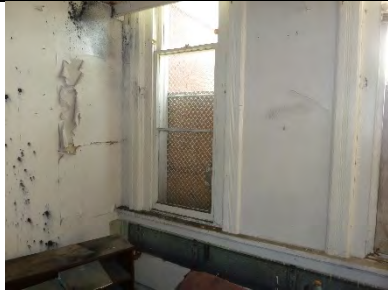
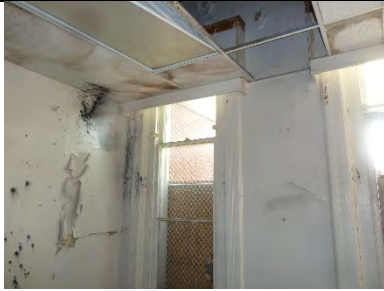
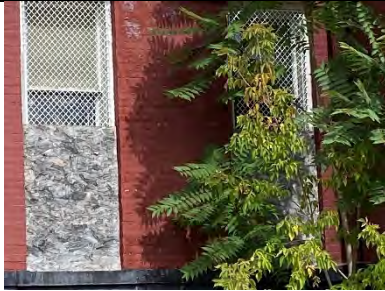
Room	Window	Window Configuration Type	Replace	Repair
120B	S245	Double-hung with 1 / 2 cottage sash configuration	✓

<p>S245-01: Interior view of lower sash      S245-02: Interior view of upper sash      S245-03: Exterior at right</p> <p><b>Condition Comments</b></p> <ul style="list-style-type: none"> <li>- Glazing broken / missing at lower sash.</li> <li>- Lower sash bottom rail is decayed – both corners are blown.</li> <li>- Pull hardware is missing.</li> <li>- Paint is crazed (multiple layers of paint / lead paint).</li> <li>- Exterior sill is decayed.</li> <li>- Interior sill is covered with mold.</li> <li>- Security screen mountings are mortised into the brickmold.</li> <li>- Upper sash painted in place.</li> <li>- Glazing caulk is tested as having ACM.</li> <li>- Accessing window weight box will require removing the galvanized metal jamb guides - access port is blocked.</li> <li>- Window sash won't open.</li> </ul>

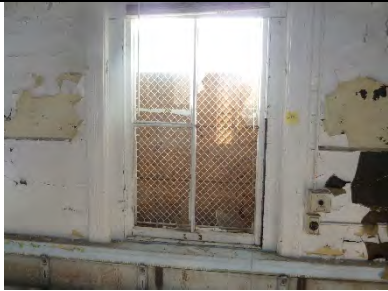
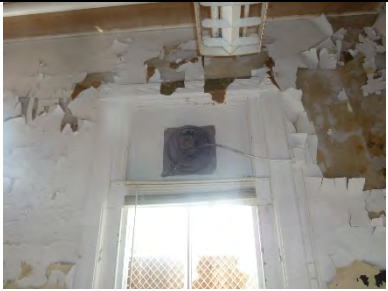
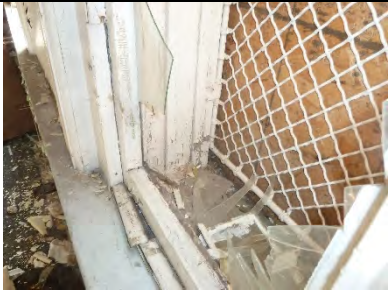
Room	Window	Window Configuration Type	Replace	Repair
116	S246	Double-hung with 2 / 4 cottage sash configuration	✓

<p>S246-01: Interior view of lower sash      S246-02: Interior view of upper sash      S246-03: Left jamb and sash corner</p> <p><b>Condition Comments</b></p> <ul style="list-style-type: none"> <li>- Glazing broken / missing at lower sash. Upper sash replaced by solid panels with vent fan.</li> <li>- Muntins missing / loose at lower sash.</li> <li>- Lower sash left bottom rail corner is loose and shows evidence of screw repair.</li> <li>- Damaged interior stops.</li> <li>- Pull hardware is missing.</li> <li>- Paint is crazed (multiple layers of paint / lead paint).</li> <li>- Exterior sill is decayed.</li> <li>- Security screen mountings are mortised into the brickmold.</li> <li>- Upper sash painted in place.</li> <li>- Glazing caulk is tested as having ACM.</li> <li>- Accessing window weight box will require removing the galvanized metal jamb guides - access port is blocked.</li> <li>- Window sash won't open.</li> <li>- Adjacent wall and ceiling above damaged by water infiltration.</li> </ul>

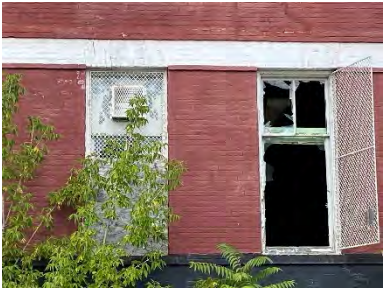
<p>S246-04: Exterior view at left</p>
