# Window Condition Survey

McKinley School Renovation

2001 W. Vliet St.  
Milwaukee WI, 53205

## **McKinley School Restoration Window Condition Survey**

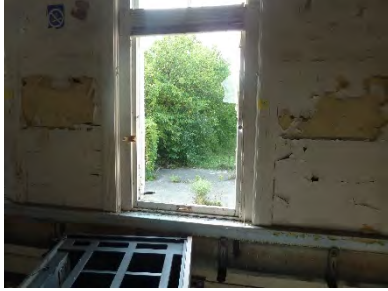
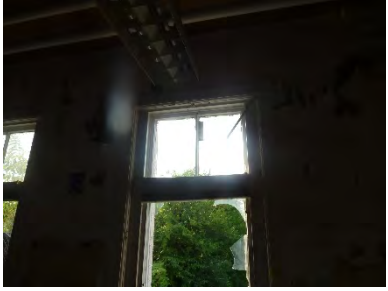
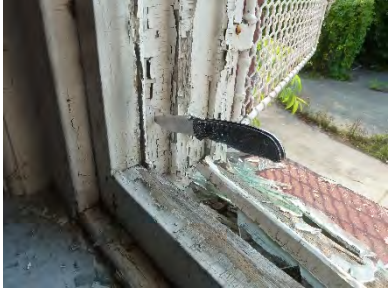
Room	Window	Window Configuration Type	Replace	Repair
116	S247	Double-hung with 2 / 4 cottage sash configuration	✓

<p>S247-01: Interior view of lower sash      S247-02: Interior view of upper sash      S247-03: Sill and jamb condition</p> <p><b>Condition Comments</b></p> <ul style="list-style-type: none"> <li>- Glazing broken / missing at both sashes.</li> <li>- Muntin bars missing at lower sash.</li> <li>- Sash ropes are broken.</li> <li>- Paint is crazed (multiple layers of paint / lead paint).</li> <li>- Exterior sill is decayed.</li> <li>- Exterior stops and jambs are decayed near sill.</li> <li>- Interior sill water damaged.</li> <li>- Security screen mountings are mortised into the brickmold.</li> <li>- Upper sash painted in place.</li> <li>- Glazing caulk is tested as having ACM.</li> <li>- Accessing window weight box will require removing the galvanized metal jamb guides - access port is blocked.</li> <li>- Window sash won't open.</li> <li>- Adjacent walls show signs of water infiltration.</li> </ul>

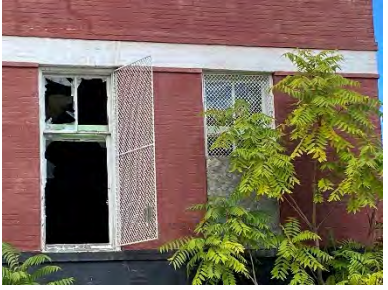
<p>S247-04: Exterior view at left</p>

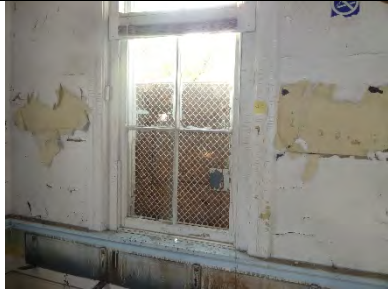
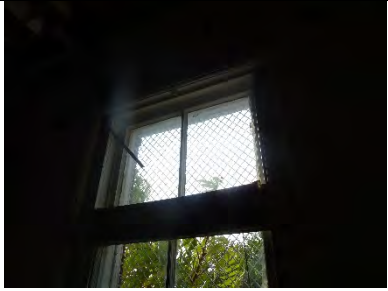
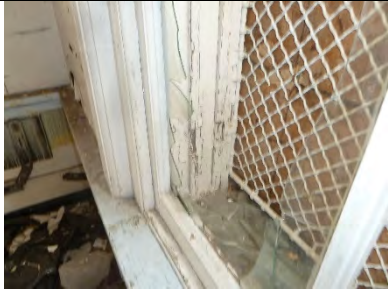
Room	Window	Window Configuration Type	Replace	Repair
116	S248	Double-hung with 2 / 4 cottage sash configuration	✓

<p>S248-01: Interior view of lower sash      S248-02: Interior view of upper sash      S248-03: Damaged sill</p> <p><b>Condition Comments</b></p> <ul style="list-style-type: none"> <li>- Glazing broken / missing at both sashes.</li> <li>- Sash ropes are broken.</li> <li>- Pull hardware is missing.</li> <li>- Paint is crazed (multiple layers of paint / lead paint).</li> <li>- Exterior sill is decayed.</li> <li>- Exterior stops and jambs are decayed near sill.</li> <li>- Interior stops damaged.</li> <li>- Security screen mountings are mortised into the brickmold.</li> <li>- Upper sash painted in place.</li> <li>- Glazing caulk is tested as having ACM.</li> <li>- Accessing window weight box will require removing the galvanized metal jamb guides - access port is blocked.</li> <li>- Window sash won't open.</li> <li>- Adjacent walls show signs of water infiltration.</li> </ul>

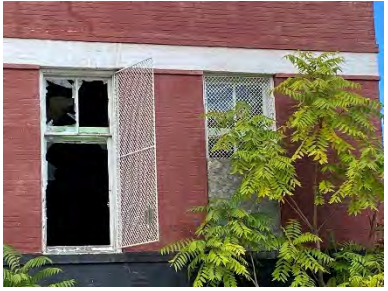
<p>S248-04: Exterior view at right</p>

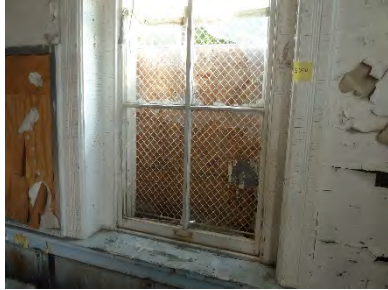
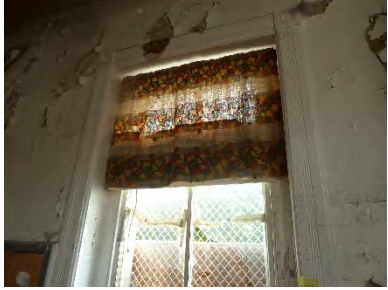
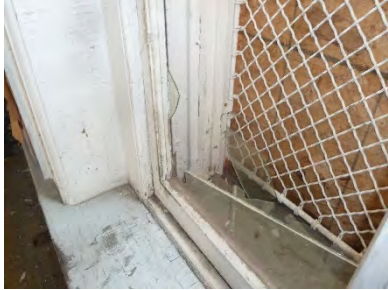
Room	Window	Window Configuration Type	Replace	Repair
116	E200	Double-hung with 2 / 4 cottage sash configuration	✓

<p>S200-01: Interior view of lower sash      S200-02: Interior view of upper sash      S200-03: Sill and jamb condition</p> <p><b>Condition Comments</b></p> <ul style="list-style-type: none"> <li>- Glazing broken / missing at lower sash.</li> <li>- Lower sash is not original and is a replacement. Ogee is dissimilar and muntins are thicker than originals at typical window.</li> <li>- Sash ropes are broken.</li> <li>- Paint is crazed (multiple layers of paint / lead paint).</li> <li>- Exterior sill is decayed.</li> <li>- Interior sill and lower sash rail are water damaged.</li> <li>- Security screen mountings are mortised into the brickmold.</li> <li>- Upper sash painted in place.</li> <li>- Glazing caulk is tested as having ACM.</li> <li>- Accessing window weight box will require removing the galvanized metal jamb guides - access port is blocked.</li> <li>- Window sash won't open.</li> <li>- Adjacent walls show signs of water infiltration.</li> </ul>

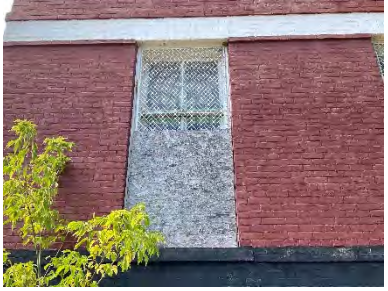
<p>S200-04: Exterior view</p>

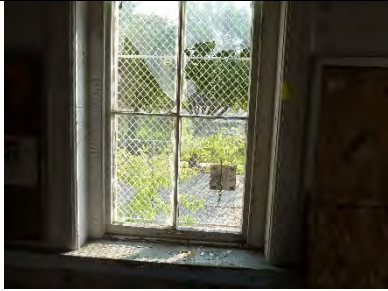
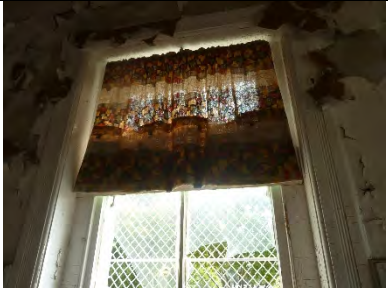
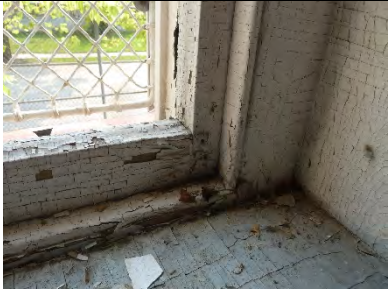
Room	Window	Window Configuration Type	Replace	Repair
116	E201	Double-hung with 2 /4 cottage sash configuration	✓

<p>S201-01: Interior view of lower sash</p> <p>S201-02: Interior view of upper sash &amp; adjacent wall damage</p> <p>S201-03: Lower right sash and interior sill</p> <p><b>Condition Comments</b></p> <ul style="list-style-type: none"> <li>- Glazing broken / missing at lower sash.</li> <li>- Sash ropes are broken.</li> <li>- Pull hardware is rusted.</li> <li>- Lower sash is decayed at bottom rail right corner</li> <li>- Paint is crazed (multiple layers of paint / lead paint).</li> <li>- Exterior sill is decayed.</li> <li>- Security screen mountings are mortised into the brickmold.</li> <li>- Upper sash painted in place.</li> <li>- Glazing caulk is tested as having ACM.</li> <li>- Accessing window weight box will require removing the galvanized metal jamb guides - access port is blocked.</li> <li>- Adjacent wall and ceiling above damaged by water infiltration – evidence of mold.</li> </ul>

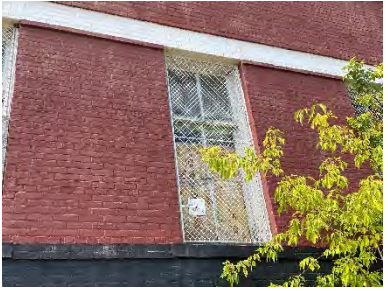
<p>S201-04: Exterior view</p>

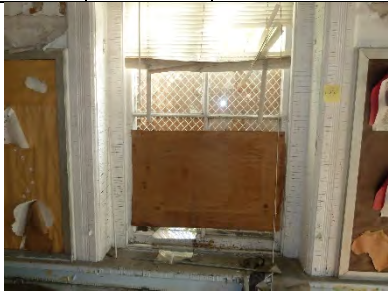
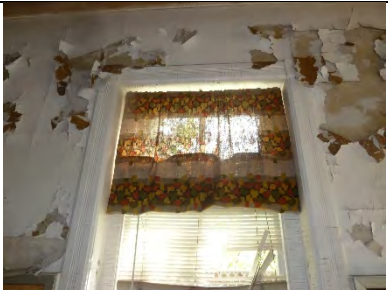
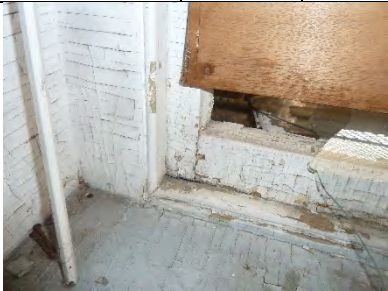
Room	Window	Window Configuration Type	Replace	Repair
116	E202	Double-hung with 2 /4 cottage sash configuration	✓

<p>S202-01: Interior view of lower sash</p> <p>S202-02: Interior view of upper sash</p> <p>S202-03: Lower left sash corner.</p> <p><b>Condition Comments</b></p> <ul style="list-style-type: none"> <li>- Glazing broken / missing at lower sash.</li> <li>- Sash ropes are broken.</li> <li>- Pull hardware is rusted.</li> <li>- Lower sash left corner at bottom rail is decayed.</li> <li>- Paint is crazed (multiple layers of paint / lead paint).</li> <li>- Exterior sill is decayed.</li> <li>- Security screen mountings are mortised into the brickmold.</li> <li>- Upper sash painted in place.</li> <li>- Glazing caulk is tested as having ACM.</li> <li>- Accessing window weight box will require removing the galvanized metal jamb guides - access port is blocked.</li> <li>- Window sash won't open.</li> <li>- Adjacent walls show signs of water infiltration.</li> </ul>

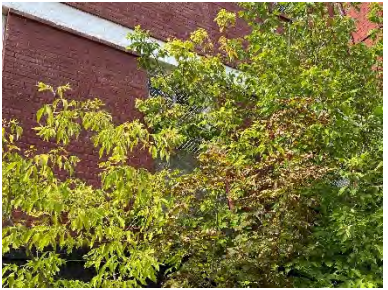
<p>S202-04: Exterior view at right of group of three</p>

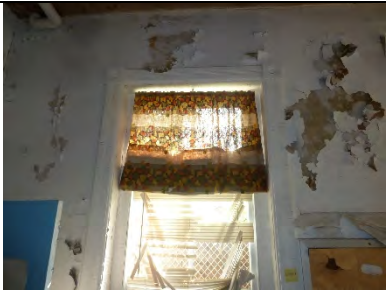
Room	Window	Window Configuration Type	Replace	Repair
116	E202.1	Double-hung with 2 / 4 cottage sash configuration	✓

<p>S202.1-01: Interior view of lower sash</p> <p>S202.1-02: Interior view of upper sash</p>		<p>S202.1-03: Severely rotted exterior sill</p>		
<p><b>Condition Comments</b></p> <ul style="list-style-type: none"> <li>- Glazing broken / missing at both sashes.</li> <li>- Sash ropes are broken.</li> <li>- Pull hardware is rusted.</li> <li>- Paint is crazed (multiple layers of paint / lead paint).</li> <li>- Exterior sill is decayed.</li> <li>- Lower left jamb, stops and sash corner are decayed.</li> <li>- Security screen mountings are mortised into the brickmold.</li> <li>- Upper sash painted in place.</li> <li>- Glazing caulk is tested as having ACM.</li> <li>- Accessing window weight box will require removing the galvanized metal jamb guides - access port is blocked.</li> <li>- Window sash won't open.</li> <li>- Adjacent walls show signs of water infiltration.</li> </ul>

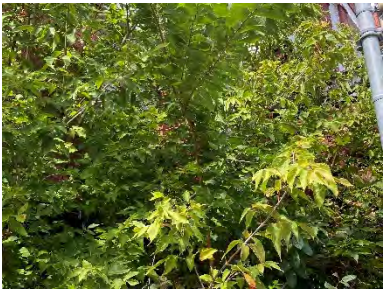
<p>S202.1-04: Exterior view at center of group of three</p>

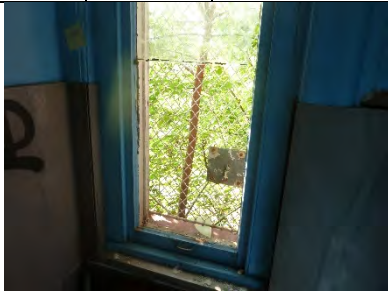
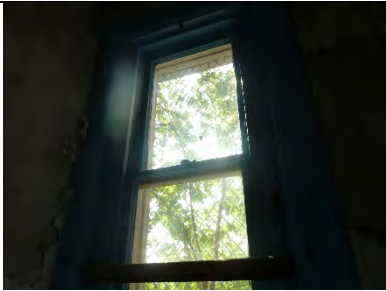
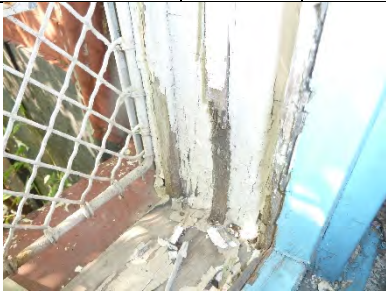
Room	Window	Window Configuration Type	Replace	Repair
116A	E202.2	Double-hung	✓

<p>S202.2-01: Interior view of lower sash</p> <p>S202.2-02: Interior view of upper sash</p>		<p>S202.2-03: Sill condition</p>		
<p><b>Condition Comments</b></p> <ul style="list-style-type: none"> <li>- Glazing broken / missing at both sashes.</li> <li>- Missing lower sash horizontal muntin bar.</li> <li>- Sash ropes are broken.</li> <li>- Paint is crazed (multiple layers of paint / lead paint).</li> <li>- Exterior sill is decayed.</li> <li>- Exterior jamb and stops decayed at lower right by sill.</li> <li>- Lower sash bottom rail decayed at exterior face.</li> <li>- Interior casings removed / cut to accommodate marble wall panels.</li> <li>- Security screen mountings are mortised into the brickmold.</li> <li>- Upper sash painted in place.</li> <li>- Glazing caulk is tested as having ACM.</li> <li>- Accessing window weight box will require removing the galvanized metal jamb guides - access port is blocked.</li> <li>- Adjacent wall and ceiling above damaged by water infiltration.</li> </ul>

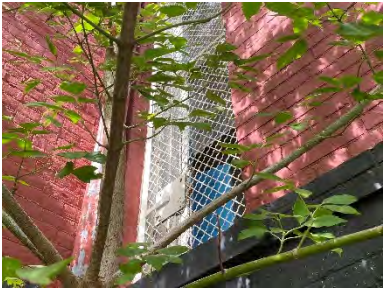
<p>S202.2-04: Exterior view at left</p>

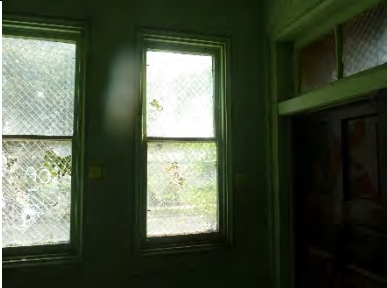
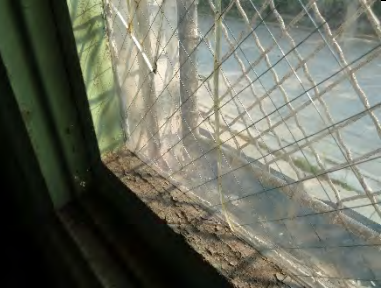
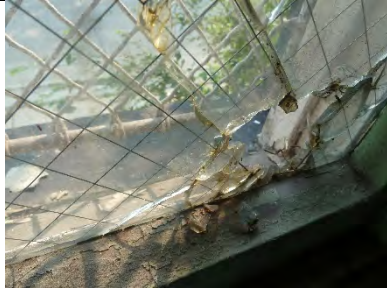
Room	Window	Window Configuration Type	Replace	Repair
ST-7	E203	Double-hung – fixed sashes	✓

<p>E203-01: Interior view (at right)      E203-02: Lower sash and sill at left      E203-03: Lower sash and sill at right</p> <p><b>Condition Comments (Typical of E203 – E206)</b></p> <ul style="list-style-type: none"> <li>- Glazing broken at some sashes – clear wired glazing.</li> <li>- Both sashes are fixed: held by pins – no ropes</li> <li>- Paint is crazed (multiple layers of paint / lead paint).</li> <li>- Exterior sill is decayed.</li> <li>- Interior sill water damaged.</li> <li>- Security screen mountings are mortised into the brickmold.</li> <li>- Glazing caulk is tested as having ACM.</li> <li>- Window is picture-framed at interior with simple ogee casing inside masonry opening – no separate interior sill.</li> </ul>

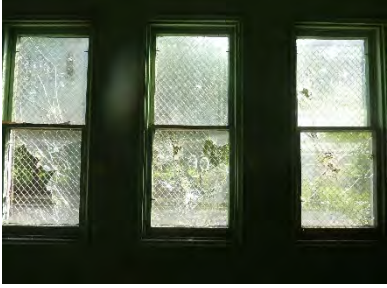
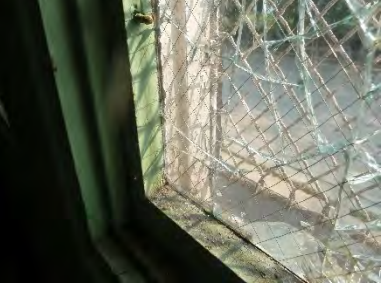
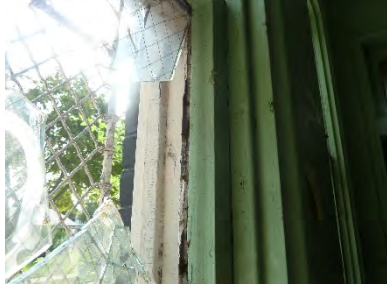
Room	Window	Window Configuration Type	Replace	Repair
ST-7	E204	Double-hung – fixed sashes	✓

<p>E204-01: Interior view (at center)      E204-02: Lower sash and sill at left      E204-03: Lower sash jamb at right</p>				
Room	Window	Window Configuration Type	Replace	Repair
ST-7	E205	Double-hung – fixed sashes	✓

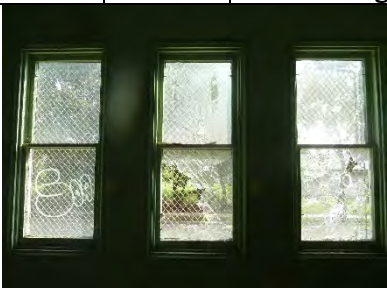
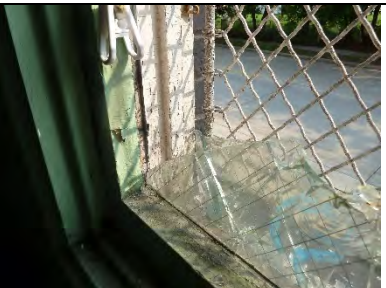
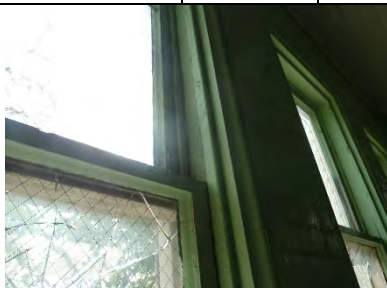
<p>E205-01: Interior view (at center)      E205-02: Lower sash and sill at left      E205-03: Meeting rail at right jamb</p>				
Room	Window	Window Configuration Type	Replace	Repair
ST-7	E206	Double-hung – fixed sashes	✓

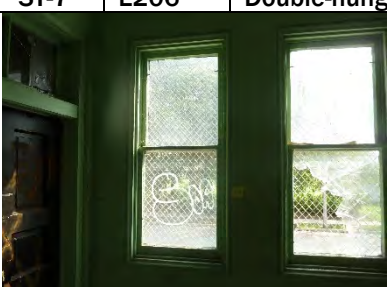
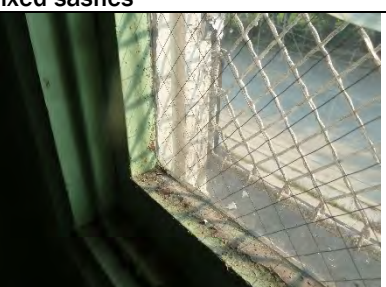
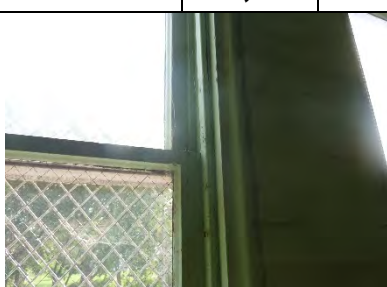
<p>E206-01: Interior view (at left)      E206-02: Lower sash and sill at left      E206-03: Meeting rail at right jamb</p>

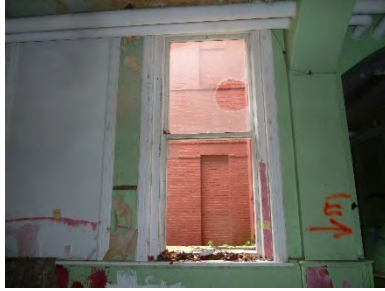
LC205-01: Interior view

- Broken / missing glazing in both sashes.
- Original hardware damaged / missing.
- Casings and trims dive behind continuous wood sill. Sill needs to be removed to pull the weight boxes/jamb.
- Paint is crazed (multiple layers of paint / lead paint).
- Exterior sill is severely decayed and covered with metal flashing.
- Upper sash painted in place.
- Glazing caulk is tested as having ACM.
- Accessing window weight box will require removing the galvanized metal jamb guides - access port is blocked.
- Lower rail of bottom sash is badly decayed at exterior face - covered with metal flashing.

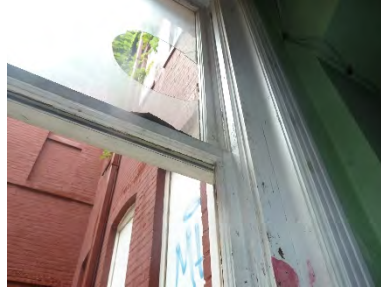
LC205-02: Interior view meeting rail

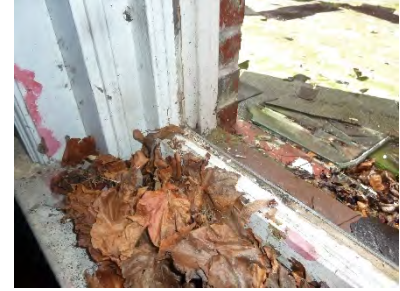
LC205-03: Bottom of sash is split out

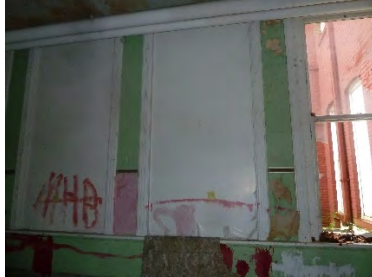
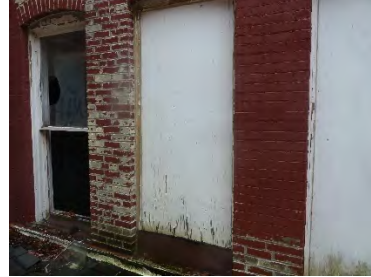
LC206-01: Interior view at center

LC206-02: Exterior view at center

- Covered both sides: Painted plywood at exterior and gypsum board at interior.
- Unknown whether any original window framing / sashes at interior. Assumed boarded by MPS due to being too badly deteriorated to repair.
- Exterior sill is severely decayed and covered with metal flashing.

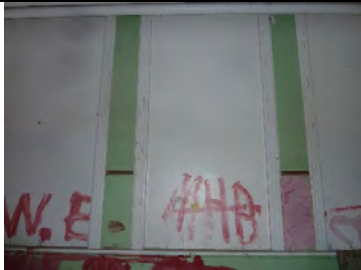
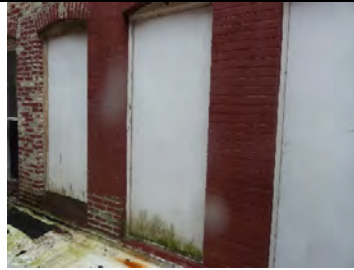
LC207-01: Interior view at center

LC207-02: Exterior view at center

- Covered both sides: Painted plywood at exterior and gypsum board at interior.
- Unknown whether any original window framing / sashes at interior. Assumed board by MPS for poor condition.
- Exterior wood sill is severely decayed. Stone sill covered in metal flashing.

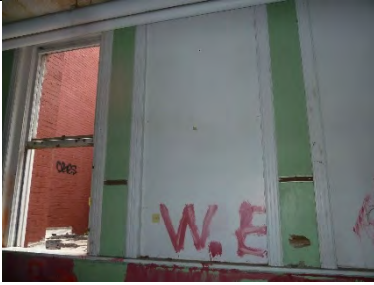
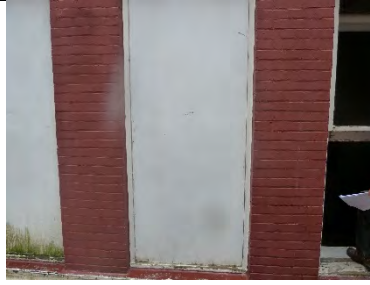
LC208-01: Interior view at center

LC208-02: Exterior view at center

- Covered both sides: Painted plywood at exterior and gypsum board at interior.
- Unknown whether any original window framing / sashes at interior. Assumed boarded by MPS due to condition being too far gone to repair.
- Exterior wood sill is severely decayed. Stone sill covered in metal flashing.

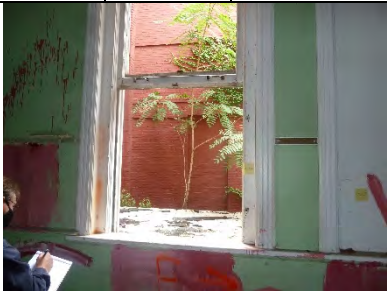
LC209-01: Interior view of lower sash

- Broken / missing glazing in both sashes.
- Casings and trims dive behind continuous wood sill. Sill needs to be removed to pull the weight boxes/jamb.
- Paint is crazed (multiple layers of paint / lead paint).
- Exterior wood sill is severely decayed - 1/2" blade penetration. Stone sill covered in metal flashing.
- Lower sash bottom rail decayed at exterior bottom rail edge and lower left corner is open.
- Upper sash painted in place.
- Glazing caulk is tested as having ACM.
- Accessing window weight box will require removing the galvanized metal jamb guides - access port is blocked.

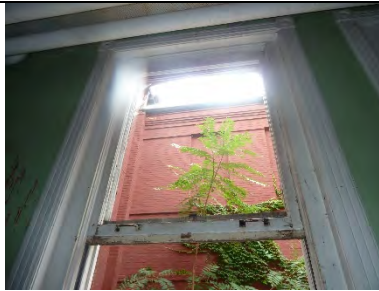
LC209-02: Interior view of upper sash

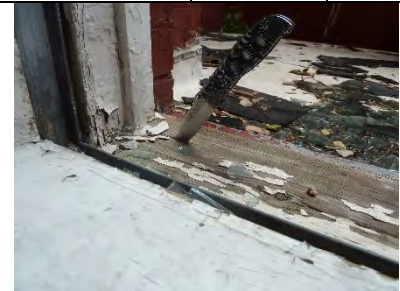
LC209-03: Exterior sill decay

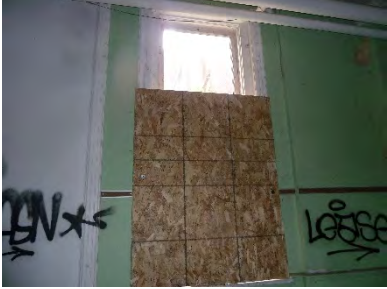
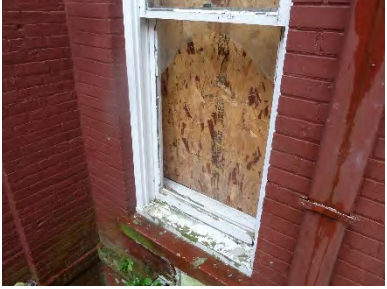
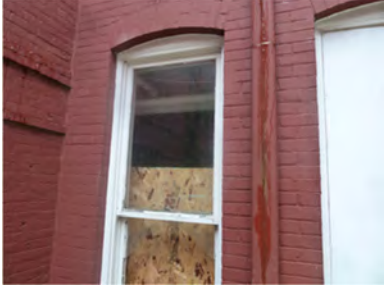
<p>LC210-01: Interior view      LC210-02: Exterior sill and sash      LC210-03: Exterior view</p> <p><b>Condition Comments</b></p> <ul style="list-style-type: none"> <li>- Broken / missing glazing at lower sash.</li> <li>- Casings and trims dive behind continuous wood sill. Sill needs to be removed to pull the weight boxes/jambs.</li> <li>- Paint is crazed (multiple layers of paint / lead paint).</li> <li>- Exterior wood sill is decayed.</li> <li>- Lower sash bottom rail left corner is open.</li> <li>- Upper sash painted in place.</li> <li>- Glazing caulk is tested as having ACM.</li> <li>- Accessing window weight box will require removing the galvanized metal jamb guides - access port is blocked.</li> </ul>

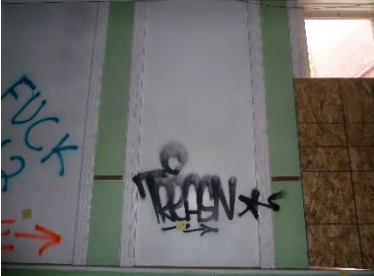
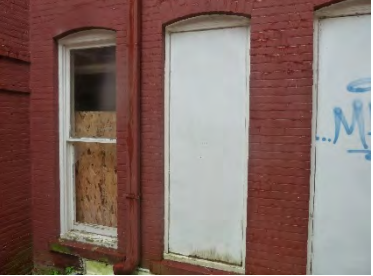
<p>LC211-01: Interior view at center      LC211-02: Exterior view at center</p> <p><b>Condition Comments</b></p> <ul style="list-style-type: none"> <li>- Covered both sides: Painted plywood at exterior and gypsum board at interior.</li> <li>- Unknown whether any original window framing / sashes at interior. Assumed boarded by MPS due to condition being too far gone to repair.</li> <li>- Exterior wood sill is probably water damaged according to staining on sill and panel.</li> </ul>

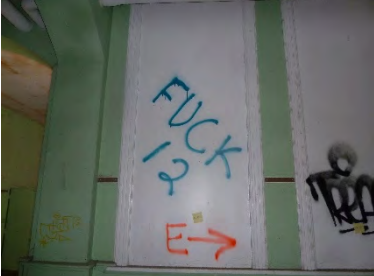
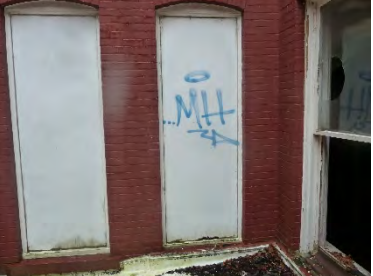
<p>LC212-01: Interior view at center      LC212-02: Exterior view at center</p> <p><b>Condition Comments</b></p> <ul style="list-style-type: none"> <li>- Covered both sides: Painted plywood at exterior and gypsum board at interior.</li> <li>- Unknown whether any original window framing / sashes at interior. Assumed boarded by MPS due to condition being too far gone to repair.</li> <li>- Exterior wood sill is severely decayed. Stone sill covered in metal flashing.</li> </ul>

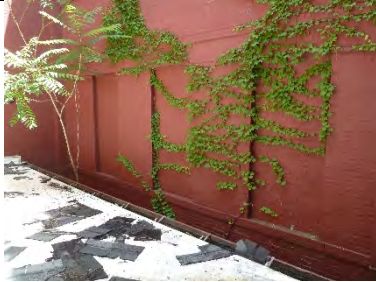
LC213-LC215-01: Exterior view (l to r)

- No plans to remove masonry and re-open.

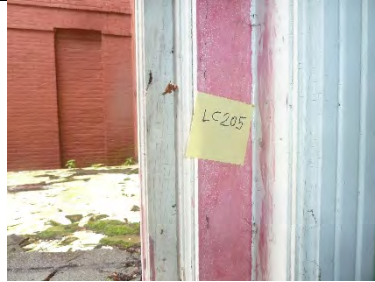
LC216-01: Exterior view beyond

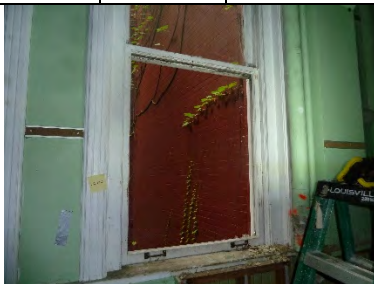
LC200-01: Interior view of lower sash

- Broken / missing glazing at lower sash.
- Casings and trims dive behind continuous wood sill. Sill needs to be removed to pull the weight boxes/jamb.
- Paint is crazed (multiple layers of paint / lead paint).
- Exterior wood sill is decayed.
- Lower sash bottom rail left corner is open.
- Upper sash painted in place.
- Glazing caulk is tested as having ACM.
- Accessing window weight box will require removing the galvanized metal jamb guides - access port is blocked.

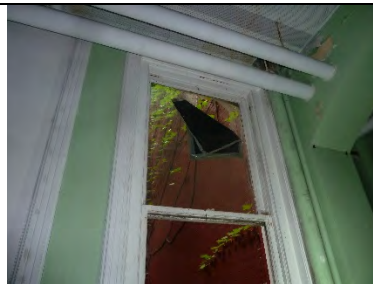
LC200-02: Interior view of upper sash

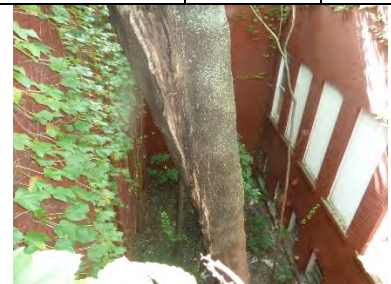
LC200-03: Exterior view at far left in corner

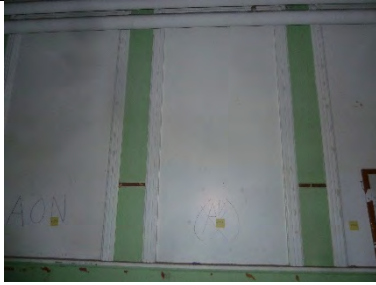
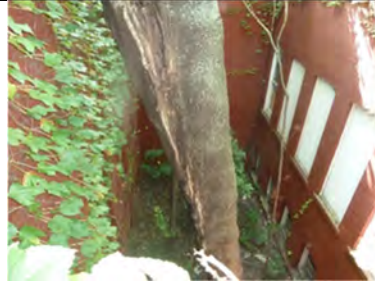
LC202-01: Interior view at center

LC202-02: Exterior view 2nd from left

- Covered both sides: Painted plywood at exterior and gypsum board at interior.
- Unknown whether any original window framing / sashes at interior. Assumed boarded by MPS due to condition being too far gone to repair.
- Exterior wood sill is probably water damaged according to staining on sill and panel.

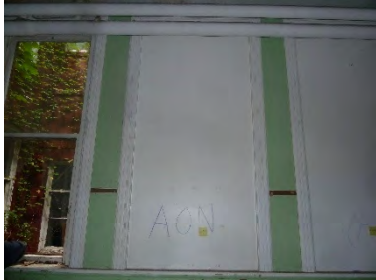
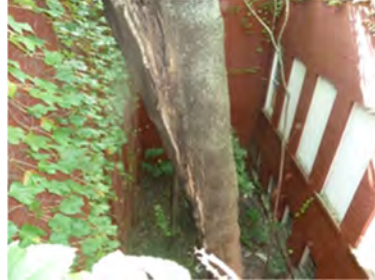
LC203-01: Interior view at center

LC203-02: Exterior view 3rd from left

- Covered both sides: Painted plywood at exterior and gypsum board at interior.
- Unknown whether any original window framing / sashes at interior. Assumed boarded by MPS due to condition being too far gone to repair.
- Exterior wood sill is probably water damaged according to staining on sill and panel.

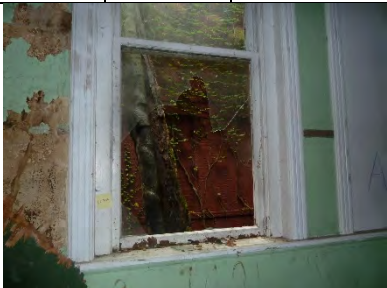
LC204-01: Interior view of lower sash

- Broken / missing glazing at lower sash.
- Casings and trims dive behind continuous wood sill. Sill needs to be removed to pull the weight boxes/jambes.
- Paint is crazed (multiple layers of paint / lead paint).
- Exterior wood sill is decayed.
- Lower sash bottom rail corners are open.
- Upper sash painted in place.
- Glazing caulk is tested as having ACM.
- Accessing window weight box will require removing the galvanized metal jamb guides - access port is blocked.

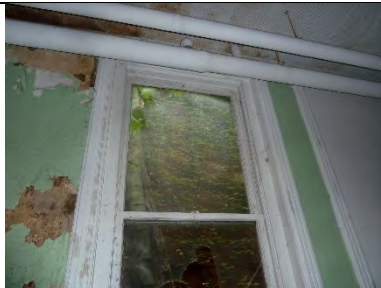
LC204-02: Interior view of upper sash

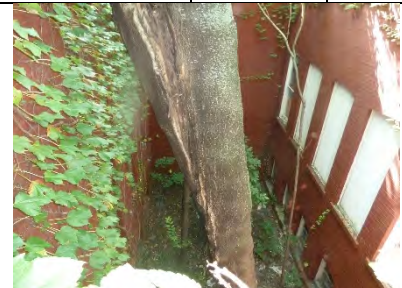
LC204-03: Exterior corner at far right

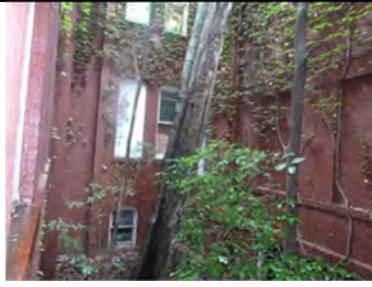
LC217-02: Exterior right of tree in corner

- Meeting rail sags at upper sash.
- Casings and trims dive behind continuous wood sill. Sill needs to be removed to pull the weight boxes/jamb.
- Paint is crazed (multiple layers of paint / lead paint).
- Exterior wood sill is decayed.
- Lower sash bottom rail right corner is open.
- Upper sash painted in place.
- Glazing caulk is tested as having ACM.
- Accessing window weight box will require removing the galvanized metal jamb guides - access port is blocked.

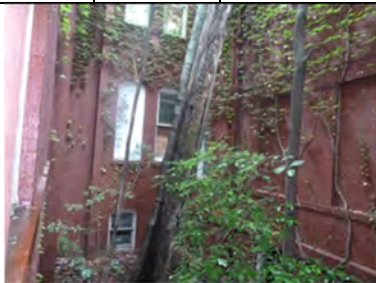
LC218-LC220-01: Brick openings at right

- No plans to remove masonry and re-open.

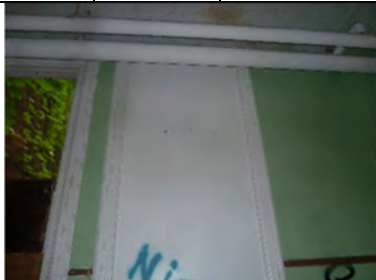
LC222-01: Interior view

- Covered both sides: Painted plywood at exterior and gypsum board at interior.
- Unknown whether any original window framing / sashes at interior. Assumed boarded by MPS due to condition being too far gone to repair.
- Exterior wood sill is probably water damaged according to staining on sill and panel.

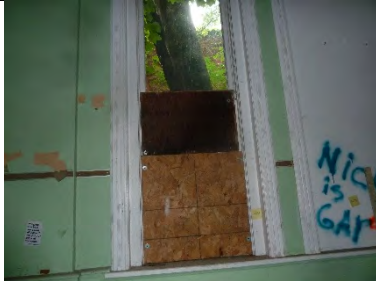
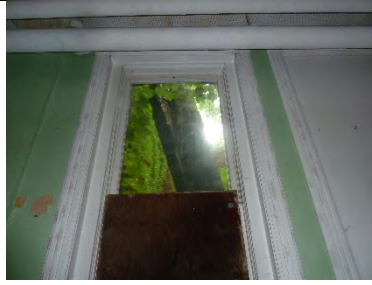
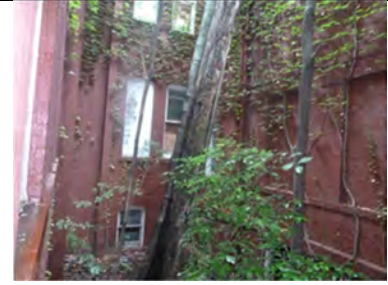
LC223-01: Interior view of lower sash

LC223-02: Interior view of upper sash

LC223-03: Exterior directly behind tree (to the left)

- Broken / missing glazing at lower sash.
- Casings and trims dive behind continuous wood sill. Sill needs to be removed to pull the weight boxes/jambs.
- Paint is crazed (multiple layers of paint / lead paint).
- Exterior wood sill is decayed.
- Lower sash bottom rail in poor condition.
- Upper sash painted in place.
- Glazing caulk is tested as having ACM.
- Accessing window weight box will require removing the galvanized metal jamb guides - access port is blocked.

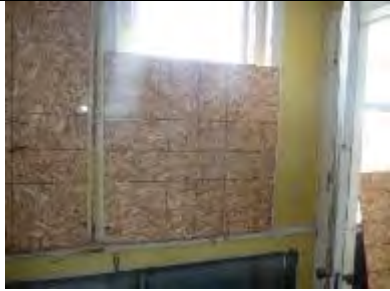
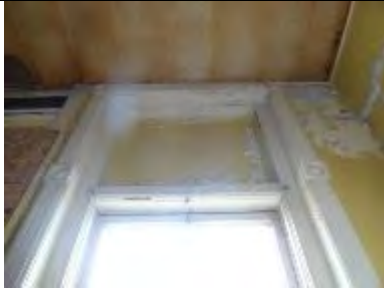
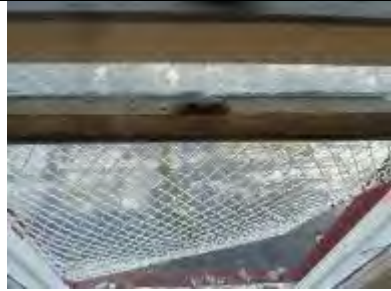
<p>N343-01: Interior view of lower sash      N343-02: Interior view of upper sash      N343-03: Top of sash is deteriorating</p> <p><b>Condition Comments</b></p> <ul style="list-style-type: none"> <li>- Missing upper fixed transom sash - replaced with Transite (ACM) panel.</li> <li>- Original hardware damaged / missing.</li> <li>- Casings and trims dive behind continuous wood sill. Sill needs to be removed to pull the weight boxes/jambs.</li> <li>- Paint is crazed (multiple layers of paint / lead paint).</li> <li>- Upper sash painted in place.</li> <li>- Glazing caulk is tested as having ACM.</li> <li>- Accessing window weight box will require removing the galvanized metal jamb guides - access port is blocked.</li> <li>- Water damage at transom head.</li> <li>- Lintel condition shared with N344 and is suspect.</li> </ul>

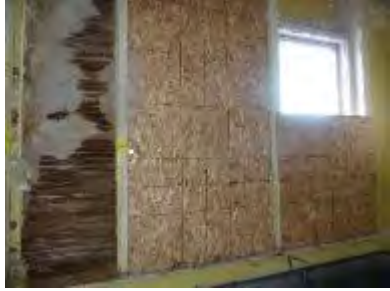
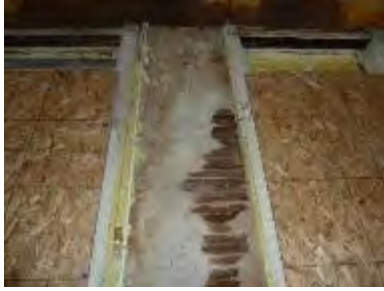
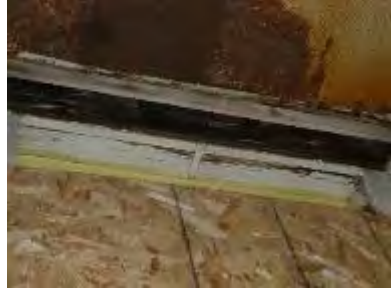
<p>N344-01: Interior view of window      N344-02: Wall next to window showing water damage      N344-03: Severely rotted header</p> <p><b>Condition Comments</b></p> <ul style="list-style-type: none"> <li>- Missing upper fixed transom sash - replaced with Transite (ACM) panel.</li> <li>- Original hardware damaged / missing.</li> <li>- Casings and trims dive behind continuous wood sill. Sill needs to be removed to pull the weight boxes/jambs.</li> <li>- Paint is crazed (multiple layers of paint / lead paint).</li> <li>- Upper sash painted in place.</li> <li>- Glazing caulk is tested as having ACM.</li> <li>- Accessing window weight box will require removing the galvanized metal jamb guides - access port is blocked.</li> <li>- Severe water damage at transom head jamb.</li> <li>- Bottom rail for upper sash broken.</li> <li>- Lintel condition in question.</li> <li>- Severe water damage to adjacent wall.</li> </ul>

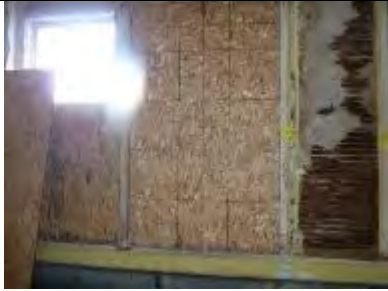
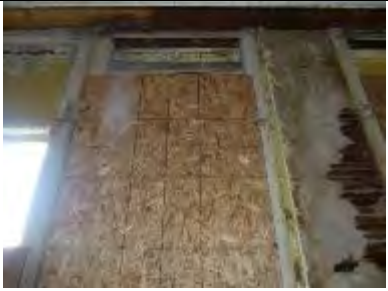
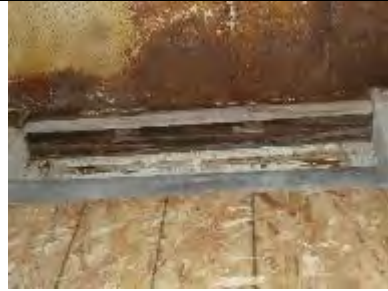
<p>N345-01: Interior view of lower sash      N345-02: Interior view of upper sash      N345-03: Severely rotted header</p> <p><b>Condition Comments</b></p> <ul style="list-style-type: none"> <li>- Missing upper fixed transom sash - replaced with Transite (ACM) panel.</li> <li>- Original hardware damaged / missing.</li> <li>- Casings and trims dive behind continuous wood sill. Sill needs to be removed to pull the weight boxes/jambs.</li> <li>- Paint is crazed (multiple layers of paint / lead paint).</li> <li>- Upper sash painted in place.</li> <li>- Glazing caulk is tested as having ACM.</li> <li>- Accessing window weight box will require removing the galvanized metal jamb guides - access port is blocked.</li> <li>- Severe water damage at transom head jamb.</li> <li>- Bottom rail for upper sash broken.</li> <li>- Lintel condition in question.</li> <li>- Severe water damage to adjacent wall.</li> </ul>

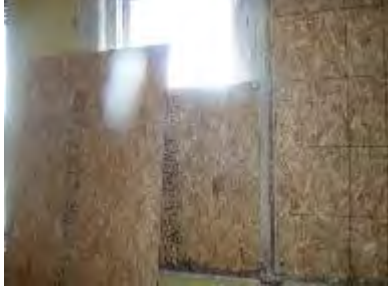
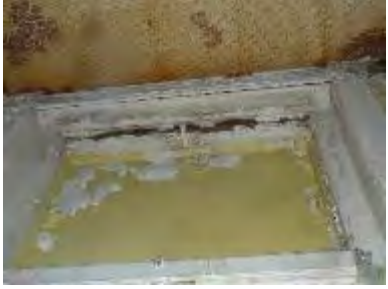
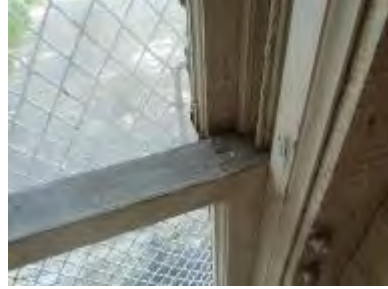
<p>N346-01: Interior view of lower sash      N346-02: Interior view of transom      N346-03: Missing rail of upper sash</p> <p><b>Condition Comments</b></p> <ul style="list-style-type: none"> <li>- Missing upper fixed transom sash - replaced with Transite (ACM) panel.</li> <li>- Original hardware damaged / missing.</li> <li>- Casings and trims dive behind continuous wood sill. Sill needs to be removed to pull the weight boxes/jambs.</li> <li>- Paint is crazed (multiple layers of paint / lead paint).</li> <li>- Upper sash painted in place.</li> <li>- Glazing caulk is tested as having ACM.</li> <li>- Accessing window weight box will require removing the galvanized metal jamb guides - access port is blocked.</li> <li>- Severe water damage at transom head jamb.</li> <li>- Bottom rail for upper sash missing.</li> </ul>

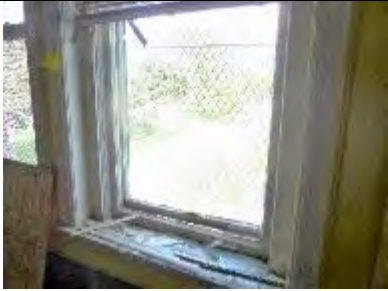
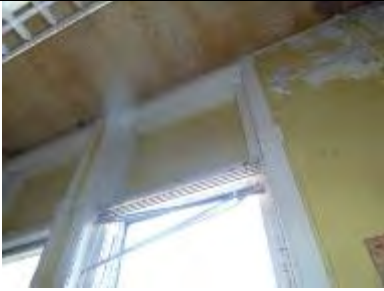
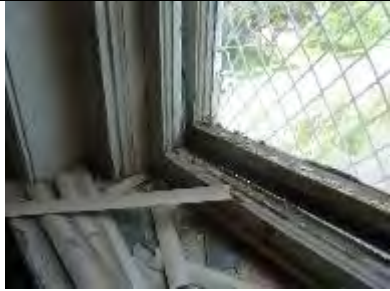
<p>N347-01: Interior view of lower sash      N347-02: Interior view of upper sash &amp; transom      N347-03: Blown corner of upper sash</p> <p><b>Condition Comments</b></p> <ul style="list-style-type: none"> <li>- Missing upper fixed transom sash - replaced with Transite (ACM) panel.</li> <li>- Broken glazing in both sashes.</li> <li>- Original hardware damaged / missing.</li> <li>- Casings and trims dive behind continuous wood sill. Sill needs to be removed to pull the weight boxes/jambs.</li> <li>- Paint is crazed (multiple layers of paint / lead paint).</li> <li>- Exterior sill is severely rotted.</li> <li>- Security screen mountings are mortised into the brickmold.</li> <li>- Upper sash painted in place.</li> <li>- Glazing caulk is tested as having ACM.</li> <li>- Accessing window weight box will require removing the galvanized metal jamb guides - access port is blocked.</li> <li>- Lower left exterior stop channel split in jamb.</li> <li>- Upper sash rail corners blown.</li> <li>- No visible water damage to transom head.</li> </ul>

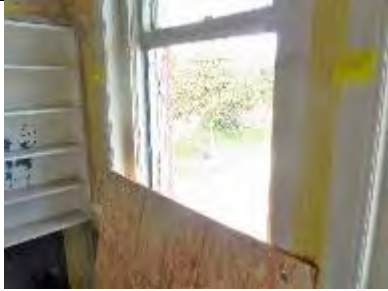
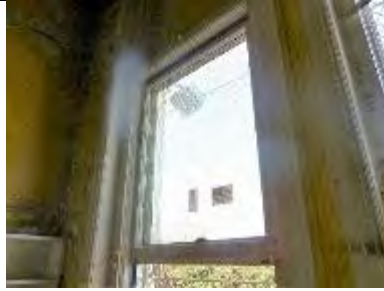
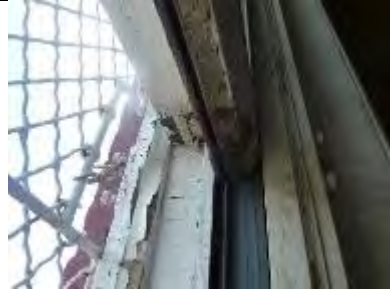
<p>N348-01: Interior view of lower sash      N348-02: Interior view of upper sash      N348-03: Blown corner of upper sash</p> <p><b>Condition Comments</b></p> <ul style="list-style-type: none"> <li>- Missing upper fixed transom sash - replaced with Transite (ACM) panel.</li> <li>- Broken glazing in lower sash.</li> <li>- Original hardware damaged / missing.</li> <li>- Casings and trims dive behind continuous wood sill. Sill needs to be removed to pull the weight boxes/jambs.</li> <li>- Paint is crazed (multiple layers of paint / lead paint).</li> <li>- Exterior sill is severely rotted.</li> <li>- Security screen mountings are mortised into the brickmold.</li> <li>- Upper sash painted in place.</li> <li>- Glazing caulk is tested as having ACM.</li> <li>- Accessing window weight box will require removing the galvanized metal jamb guides - access port is blocked.</li> <li>- Lower left exterior stop channel split in jamb.</li> <li>- Lower sash rail corners blown.</li> <li>- Upper sash rail corners poor.</li> <li>- Some water damage to transom head.</li> </ul>

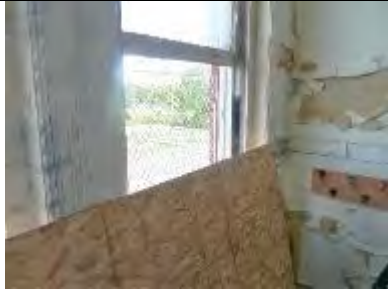
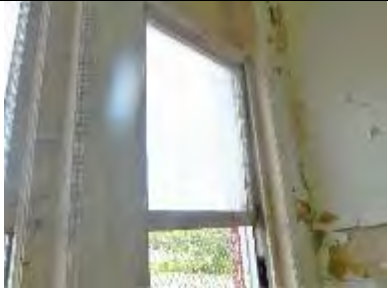
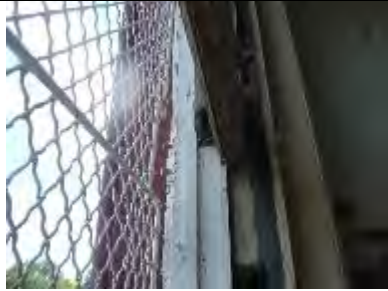
<p>N341-01: Interior view of lower sash      N341-02: Interior view of upper sash      N341-03: Missing rail of upper sash</p> <p><b>Condition Comments</b></p> <ul style="list-style-type: none"> <li>- Missing upper fixed transom sash - replaced with Transite (ACM) panel.</li> <li>- Lower sash screwed into place.</li> <li>- Original hardware damaged / missing.</li> <li>- Casings and trims dive behind continuous wood sill. Sill needs to be removed to pull the weight boxes/jambs.</li> <li>- Paint is crazed (multiple layers of paint / lead paint).</li> <li>- Exterior left stop is damaged.</li> <li>- Upper sash painted in place.</li> <li>- Glazing caulk is tested as having ACM.</li> <li>- Accessing window weight box will require removing the galvanized metal jamb guides - access port is blocked.</li> <li>- Upper sash meeting rail is missing.</li> <li>- Weight box cover missing from right jamb.</li> <li>- No interior stops.</li> </ul>

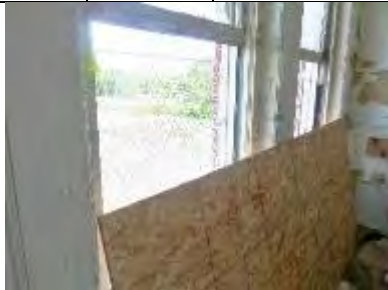
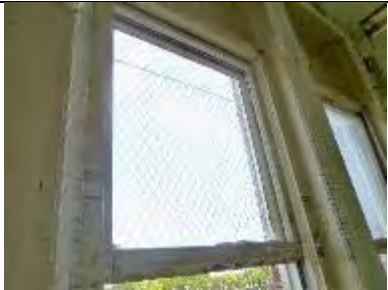
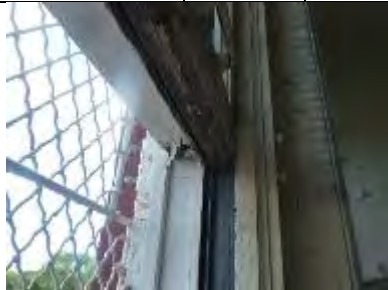
<p>N342-01: Interior view of lower sash      N342-02: Interior view of upper sash      N342-03: Blown corner of upper sash</p> <p><b>Condition Comments</b></p> <ul style="list-style-type: none"> <li>- Missing upper fixed transom sash - replaced with Transite (ACM) panel.</li> <li>- Original hardware damaged / missing.</li> <li>- Casings and trims dive behind continuous wood sill. Sill needs to be removed to pull the weight boxes/jambs.</li> <li>- Paint is crazed (multiple layers of paint / lead paint).</li> <li>- Upper sash painted in place.</li> <li>- Glazing caulk is tested as having ACM.</li> <li>- Accessing window weight box will require removing the galvanized metal jamb guides - access port is blocked.</li> <li>- Bottom rail of lower sash deteriorated – corners open.</li> <li>- Missing glazing for both sashes.</li> <li>- Upper sash lower right corner blown.</li> </ul>

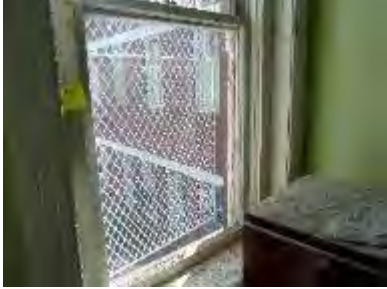
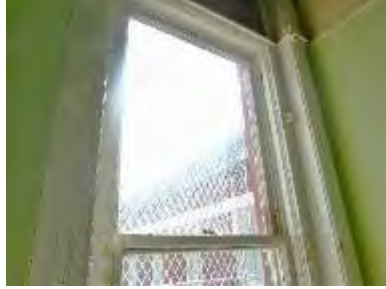
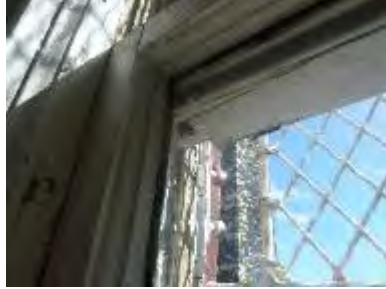
<p>N336-01: Interior view of lower sash      N336-02: Interior view of upper sash      N336-03: Blown corner of upper sash</p> <p><b>Condition Comments</b></p> <ul style="list-style-type: none"> <li>- Missing upper fixed transom sash - replaced with Transite (ACM) panel.</li> <li>- Glazing in both sashes intact.</li> <li>- Original hardware damaged / missing.</li> <li>- Water damage at header.</li> <li>- Upper sash blown left corner.</li> <li>- Lower sash lower left corner open.</li> <li>- Casings and trims dive behind continuous wood sill. Sill needs to be removed to pull the weight boxes/jamb.</li> <li>- Paint is crazed (multiple layers of paint / lead paint).</li> <li>- Exterior sill is decayed.</li> <li>- Upper sash painted in place.</li> <li>- Glazing caulk is tested as having ACM.</li> <li>- Accessing window weight box will require removing the galvanized metal jamb guides - access port is blocked.</li> </ul>

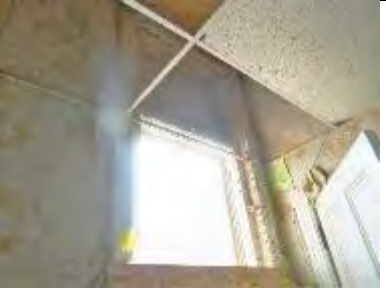
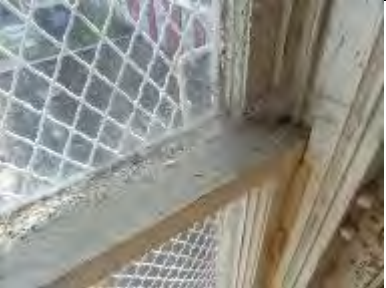
<p>N337-01: Interior view of lower sash      N337-02: Interior view of upper sash &amp; transom      N337-03: Rotted upper rail of lower sash</p> <p><b>Condition Comments</b></p> <ul style="list-style-type: none"> <li>- Missing upper fixed transom sash - replaced with Transite (ACM) panel.</li> <li>- Glazing in lower sash broken.</li> <li>- Original hardware damaged / missing.</li> <li>- Casings and trims dive behind continuous wood sill. Sill needs to be removed to pull the weight boxes/jamb.</li> <li>- Paint is crazed (multiple layers of paint / lead paint).</li> <li>- Exterior sill &amp; stops are decayed.</li> <li>- Security screen mountings are mortised into the brickmold.</li> <li>- Upper sash painted in place.</li> <li>- Glazing caulk is tested as having ACM.</li> <li>- Accessing window weight box will require removing the galvanized metal jamb guides - access port is blocked.</li> <li>- Water damage at header &amp; wall adjacent.</li> <li>- Upper sash corners blown out.</li> </ul>

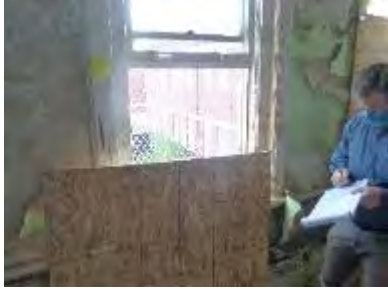
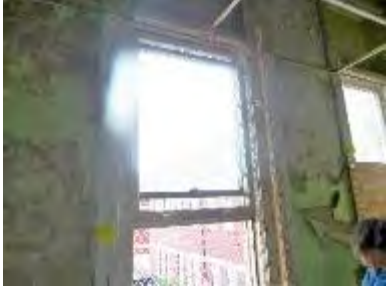
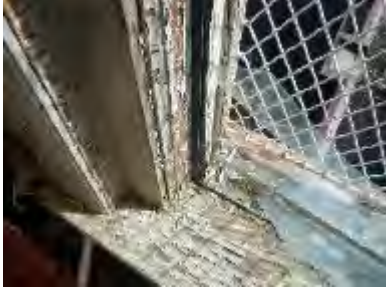
Room	Window	Window Configuration Type	Replace	Repair
202	N338	Double-hung with fixed transom above	✓

<p>N338-01: Interior view of lower sash      N338-02: Interior view of upper sash      N338-03: View of rotted sill</p> <p><b>Condition Comments</b></p> <ul style="list-style-type: none"> <li>- Missing upper fixed transom sash - replaced with Transite (ACM) panel.</li> <li>- Glazing in lower sash broken.</li> <li>- Original hardware damaged / missing.</li> <li>- Casings and trims dive behind continuous wood sill. Sill needs to be removed to pull the weight boxes/jambs.</li> <li>- Paint is crazed (multiple layers of paint / lead paint).</li> <li>- Exterior sill &amp; stops are decayed.</li> <li>- Security screen mountings are mortised into the brickmold.</li> <li>- Upper sash painted in place.</li> <li>- Glazing caulk is tested as having ACM.</li> <li>- Accessing window weight box will require removing the galvanized metal jamb guides - access port is blocked.</li> <li>- Water damage at header &amp; wall adjacent.</li> <li>- Upper sash corners blown out.</li> </ul>

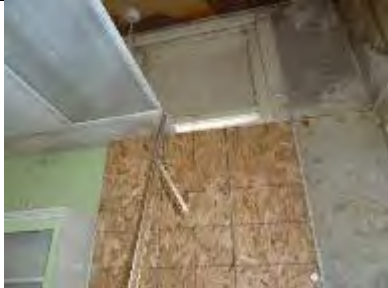
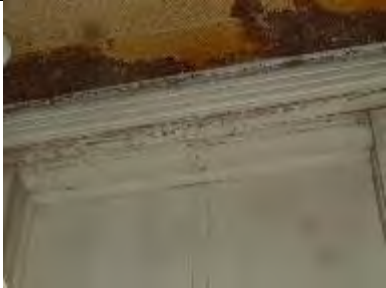
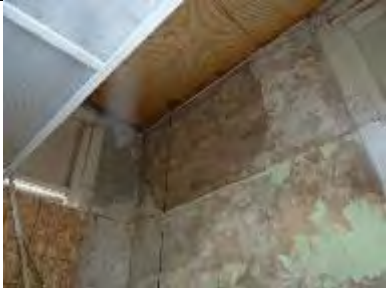
Room	Window	Window Configuration Type	Replace	Repair
202	N339	Double-hung with fixed transom above	✓

<p>N339-01: Interior view of upper sash &amp; transom      N339-02: Water damage &amp; rot at header      N339-03: Water damage of wall next to window</p> <p><b>Condition Comments</b></p> <ul style="list-style-type: none"> <li>- Missing upper fixed transom sash - replaced with Transite (ACM) panel.</li> <li>- Boarded up on interior</li> <li>- Casings and trims dive behind continuous wood sill. Sill needs to be removed to pull the weight boxes/jambs.</li> <li>- Paint is crazed (multiple layers of paint / lead paint).</li> <li>- Upper sash painted in place.</li> <li>- Glazing caulk is tested as having ACM.</li> <li>- Accessing window weight box will require removing the galvanized metal jamb guides - access port is blocked.</li> <li>- Severe water damage at fixed transom head &amp; surrounding wall.</li> <li>- Lintel condition suspect.</li> </ul>

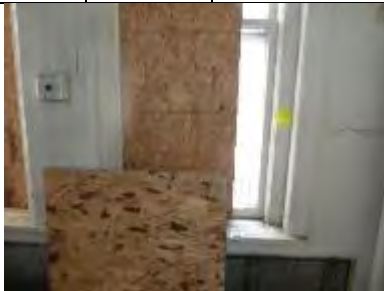
N334-01: Interior view of lower sash

- Missing upper fixed transom sash - replaced with Transite (ACM) panel. Vent through existing transom panel.
- Broken glazing lower sash
- Upper sash corners completely blown out.
- Original hardware damaged / missing.
- Casings and trims dive behind continuous wood sill. Sill needs to be removed to pull the weight boxes/jamb.
- Paint is crazed (multiple layers of paint / lead paint).
- Exterior sill & stops are decayed.
- Security screen mountings are mortised into the brickmold.
- Upper sash painted in place.
- Glazing caulk is tested as having ACM.
- Accessing window weight box will require removing the galvanized metal jamb guides - access port is blocked.
- Water damage at fixed transom head.

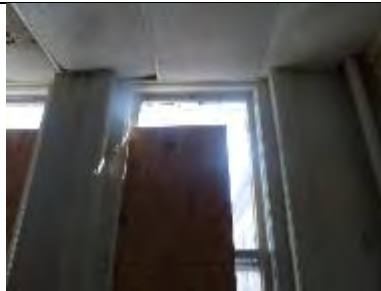
N334-02: Interior view of upper sash

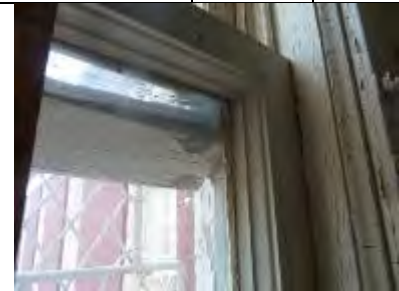
N334-03: Blown corner of upper sash

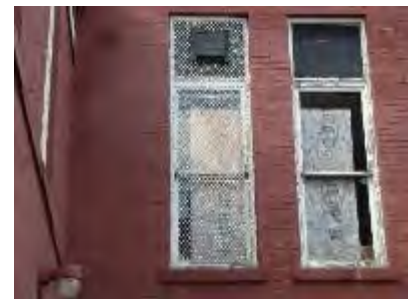
N334-04: Exterior view on left

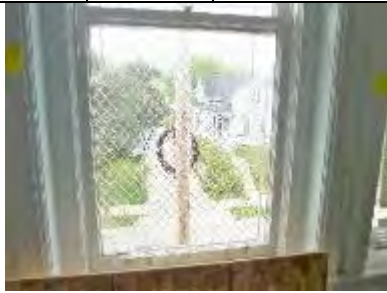
W310-01: Interior view of lower sash

- Missing upper fixed transom sash - replaced with Transite (ACM) panel.
- Original hardware damaged / missing.
- Casings and trims dive behind continuous wood sill. Sill needs to be removed to pull the weight boxes/jamb.
- Paint is crazed (multiple layers of paint / lead paint).
- Security screen mountings are mortised into the brickmold.
- Upper sash painted in place.
- Glazing caulk is tested as having ACM.
- Accessing window weight box will require removing the galvanized metal jamb guides - access port is blocked.
- Upper sash lower right corner blown.
- Window won't open.

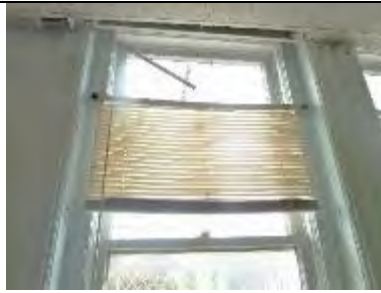
W310-02: Interior view of upper sash

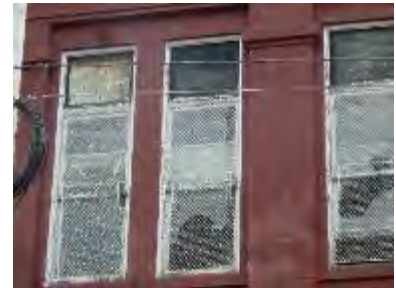
W310-04: Exterior view at center

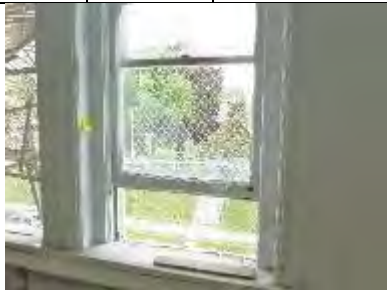
W311-01: Interior view of lower sash

- Missing upper fixed transom sash - replaced with Transite (ACM) panel.
- Original hardware damaged / missing.
- Casings and trims dive behind continuous wood sill. Sill needs to be removed to pull the weight boxes/jamb.
- Paint is crazed (multiple layers of paint / lead paint).
- Security screen mountings are mortised into the brickmold.
- Upper sash painted in place.
- Glazing caulk is tested as having ACM.
- Accessing window weight box will require removing the galvanized metal jamb guides - access port is blocked.
- Lower sash rail deteriorating.

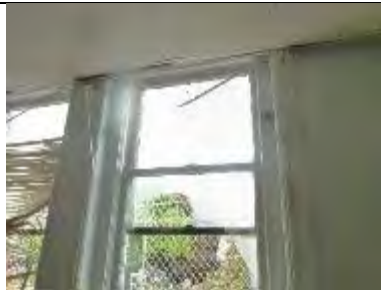
W311-02: Interior view of upper sash

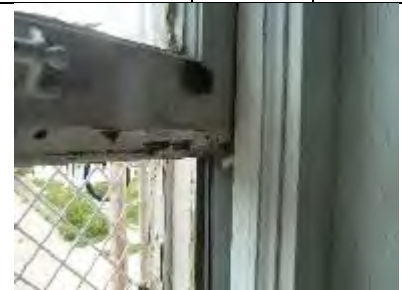
W311-03: Rotted rail of lower sash

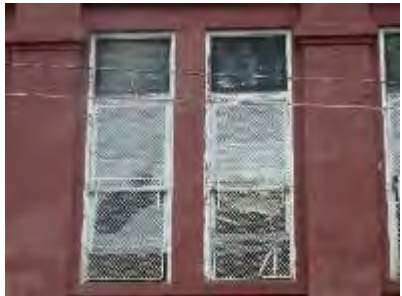
W311-04: Exterior view on left
