# Window Condition Survey

McKinley School Renovation

2001 W. Vliet St.  
Milwaukee WI, 53205

## **McKinley School Restoration Window Condition Survey**

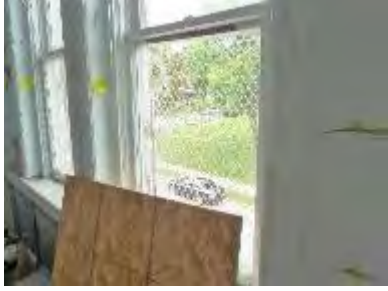
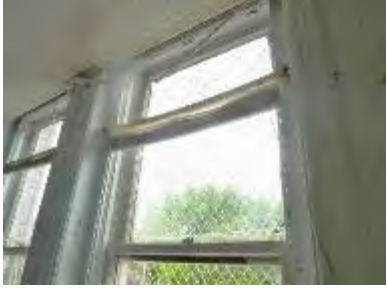
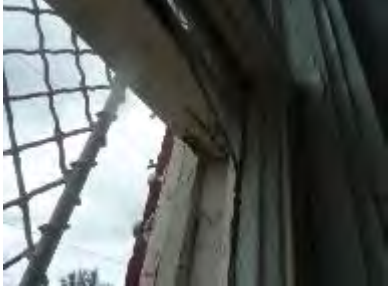
Room	Window	Window Configuration Type	Replace	Repair
204	W313	Double-hung with fixed transom above	✓

<p>W313-01: Interior view of lower sash      W313-02: Interior view of upper sash      W313-03: Blown corner of upper sash</p> <p><b>Condition Comments</b></p> <ul style="list-style-type: none"> <li>- Missing upper fixed transom sash - replaced with Transite (ACM) panel.</li> <li>- Original hardware damaged / missing.</li> <li>- Casings and trims dive behind continuous wood sill. Sill needs to be removed to pull the weight boxes/jambs.</li> <li>- Paint is crazed (multiple layers of paint / lead paint).</li> <li>- Exterior sill &amp; stops are decayed.</li> <li>- Security screen mountings are mortised into the brickmold.</li> <li>- Upper sash painted in place.</li> <li>- Glazing caulk is tested as having ACM.</li> <li>- Accessing window weight box will require removing the galvanized metal jamb guides - access port is blocked.</li> <li>- Upper &amp; lower sash corners blown.</li> <li>- Water damage at transom sill.</li> <li>- Broken glazing in lower sash.</li> </ul>

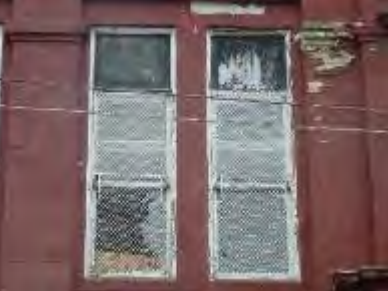
<p>W313-04: Exterior view at left</p>

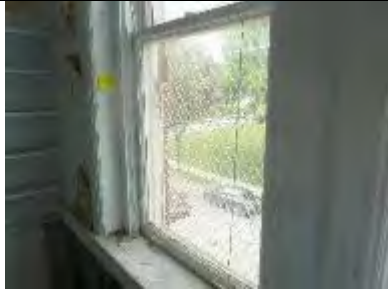
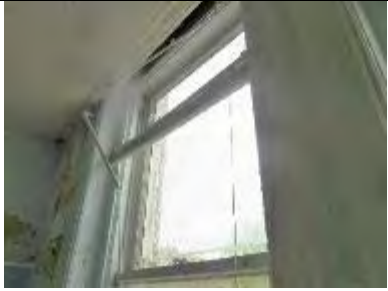
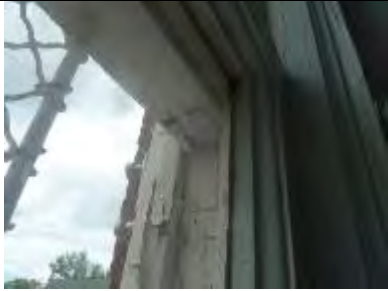
Room	Window	Window Configuration Type	Replace	Repair
204	W314	Double-hung with fixed transom above	✓

<p>W314-01: Interior view of lower sash      W314-02: Interior view of upper sash      W314-03: Blown corner of upper sash</p> <p><b>Condition Comments</b></p> <ul style="list-style-type: none"> <li>- Missing upper fixed transom sash - replaced with Transite (ACM) panel.</li> <li>- Original hardware damaged / missing.</li> <li>- Casings and trims dive behind continuous wood sill. Sill needs to be removed to pull the weight boxes/jamb.</li> <li>- Paint is crazed (multiple layers of paint / lead paint).</li> <li>- Exterior sill is decayed.</li> <li>- Security screen mountings are mortised into the brickmold.</li> <li>- Upper sash painted in place.</li> <li>- Glazing caulk is tested as having ACM.</li> <li>- Accessing window weight box will require removing the galvanized metal jamb guides - access port is blocked.</li> <li>- Upper sash corners deteriorating.</li> <li>- Window won't open.</li> <li>- Broken glazing in lower sash.</li> <li>- Water damage at right jamb at transom.</li> </ul>

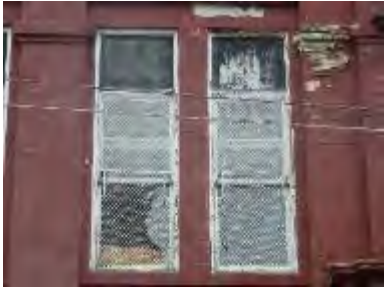
<p>W314-04: Exterior view at right</p>

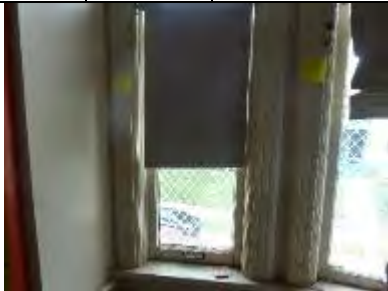
Room	Window	Window Configuration Type	Replace	Repair
206	W317	Double-hung with fixed transom above		✓

<p>W317-01: Interior view of window      W317-02: Interior view of upper sash      W317-03: Blown corners of lower sash</p> <p><b>Condition Comments</b></p> <ul style="list-style-type: none"> <li>- Missing upper fixed transom sash - replaced with Transite (ACM) panel.</li> <li>- Original hardware damaged / missing.</li> <li>- Exterior sill rotted.</li> <li>- Upper sash corners deteriorating.</li> <li>- Casings and trims dive behind continuous wood sill. Sill needs to be removed to pull the weight boxes/jambs.</li> <li>- Paint is crazed (multiple layers of paint / lead paint).</li> <li>- Security screen mountings are mortised into the brickmold.</li> <li>- Upper sash painted in place.</li> <li>- Glazing caulk is tested as having ACM.</li> <li>- Accessing window weight box will require removing the galvanized metal jamb guides - access port is blocked.</li> <li>- Lower sash won't open.</li> </ul>   <p>W317-04: Exterior view at right</p>

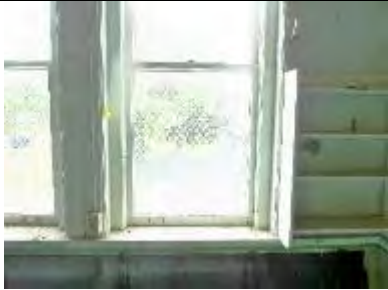
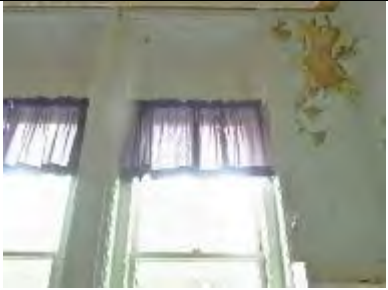
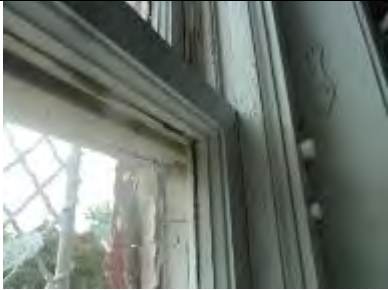
Room	Window	Window Configuration Type	Replace	Repair
207	W318	Double-hung with fixed transom above	✓

<p>W318-01: Interior view of lower sash      W318-02: Interior view of upper sash &amp; transom      W318-03: Blown corner of upper sash</p> <p><b>Condition Comments</b></p> <ul style="list-style-type: none"> <li>- Missing upper fixed transom sash - replaced with Transite (ACM) panel.</li> <li>- Original hardware damaged.</li> <li>- Casings and trims dive behind continuous wood sill. Sill needs to be removed to pull the weight boxes/jamb.</li> <li>- Paint is crazed (multiple layers of paint / lead paint).</li> <li>- Security screen mountings are mortised into the brickmold.</li> <li>- Upper sash painted in place.</li> <li>- Glazing caulk is tested as having ACM.</li> <li>- Accessing window weight box will require removing the galvanized metal jamb guides - access port is blocked.</li> <li>- Transom head has water damage, along with ceiling &amp; adjacent wall.</li> <li>- Exterior jambs are deteriorating.</li> <li>- Upper sash corners blown.</li> </ul>

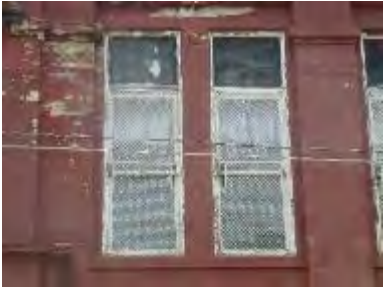
<p>W318-04: Exterior view at left</p>

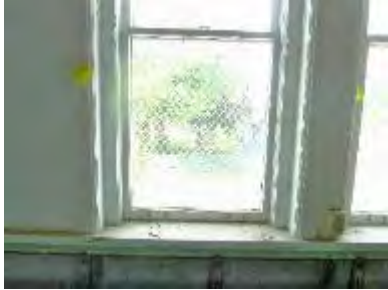
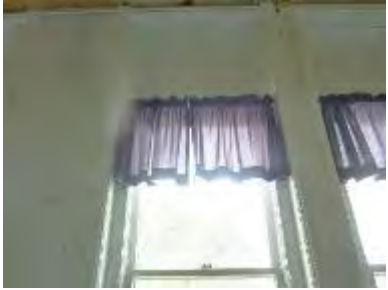
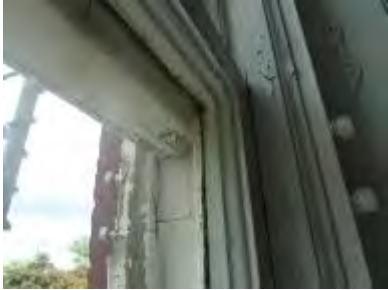
Room	Window	Window Configuration Type	Replace	Repair
207	W319	Double-hung with fixed transom above	✓

<p>W319-01: Interior view of lower sash      W319-02: Interior view of upper sash &amp; transom      W319-03: Blown corner of upper sash</p> <p><b>Condition Comments</b></p> <ul style="list-style-type: none"> <li>- Missing upper fixed transom sash - replaced with Transite (ACM) panel.</li> <li>- Missing hardware.</li> <li>- Casings and trims dive behind continuous wood sill. Sill needs to be removed to pull the weight boxes/jamb.</li> <li>- Paint is crazed (multiple layers of paint / lead paint).</li> <li>- Security screen mountings are mortised into the brickmold.</li> <li>- Upper sash painted in place.</li> <li>- Glazing caulk is tested as having ACM.</li> <li>- Accessing window weight box will require removing the galvanized metal jamb guides - access port is blocked.</li> <li>- Exterior jamb lower right deteriorating.</li> <li>- Upper sash corners blown.</li> </ul>

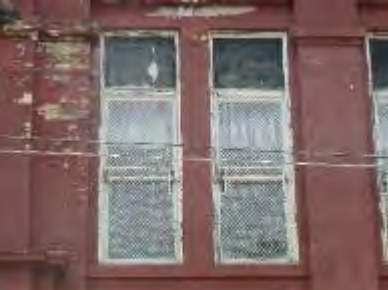
<p>W319-04: Exterior view at right</p>

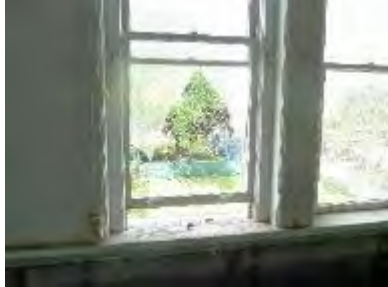
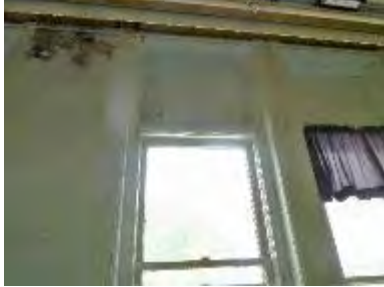
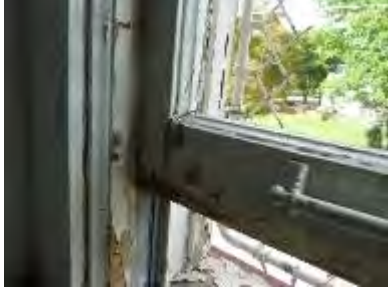
Room	Window	Window Configuration Type	Replace	Repair
207	W321	Double-hung with fixed transom above	✓

<p>W321-01: Interior view of lower sash</p> <p>W321-02: Interior view of upper sash &amp; transom</p> <p>W321-03: Blown corner of lower sash</p> <p><b>Condition Comments</b></p> <ul style="list-style-type: none"> <li>- Missing upper fixed transom sash - replaced with Transite (ACM) panel.</li> <li>- Original hardware damaged.</li> <li>- Casings and trims dive behind continuous wood sill. Sill needs to be removed to pull the weight boxes/jambs.</li> <li>- Paint is crazed (multiple layers of paint / lead paint).</li> <li>- Security screen mountings are mortised into the brickmold.</li> <li>- Upper sash painted in place.</li> <li>- Glazing caulk is tested as having ACM.</li> <li>- Accessing window weight box will require removing the galvanized metal jamb guides - access port is blocked.</li> <li>- Exterior sill rotted.</li> <li>- Exterior stop channel opened up.</li> <li>- Broken glazing in lower sash.</li> <li>- Blown lower right upper sash corner.</li> </ul>

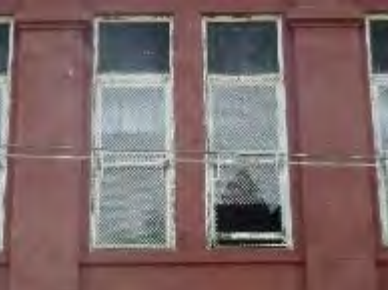
<p>W321-04: Exterior view at right</p>

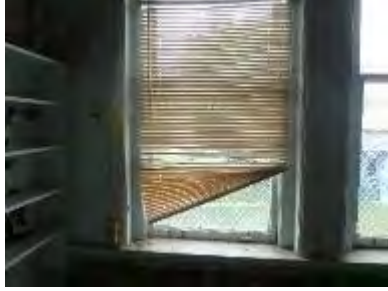
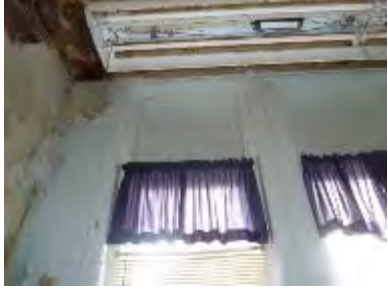
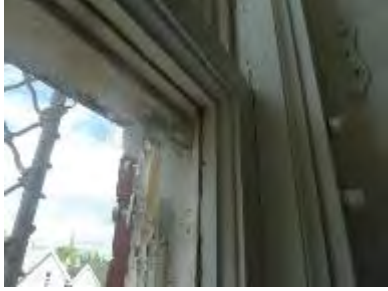
Room	Window	Window Configuration Type	Replace	Repair
207	W323	Double-hung with fixed transom above	✓

<p>W323-01: Interior view of lower sash      W323-02: Interior view of upper sash &amp; transom      W323-03: Blown corner of upper sash</p> <p><b>Condition Comments</b></p> <ul style="list-style-type: none"> <li>- Missing upper fixed transom sash - replaced with Transite (ACM) panel.</li> <li>- Missing hardware.</li> <li>- Casings and trims dive behind continuous wood sill. Sill needs to be removed to pull the weight boxes/jambs.</li> <li>- Paint is crazed (multiple layers of paint / lead paint).</li> <li>- Security screen mountings are mortised into the brickmold.</li> <li>- Upper sash painted in place.</li> <li>- Glazing caulk is tested as having ACM.</li> <li>- Accessing window weight box will require removing the galvanized metal jamb guides - access port is blocked.</li> <li>- Upper sash meeting rail corners blown.</li> </ul>

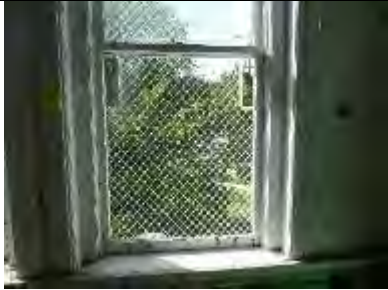
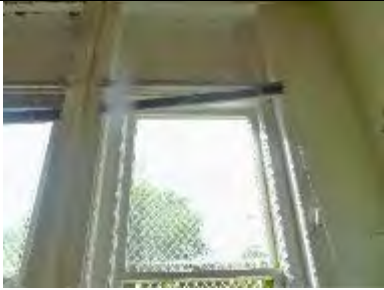
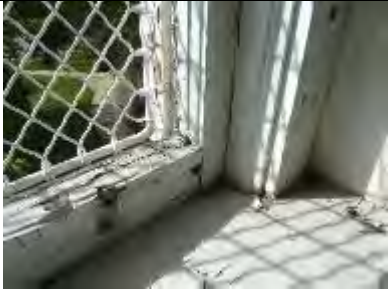
Room	Window	Window Configuration Type	Replace	Repair
208	S300	Double-hung with fixed transom above	✓

<p>S300-01: Interior view of lower sash      S300-02: Interior view of upper sash      S300-03: Rot of lower sash rail</p>		
<p><b>Condition Comments</b></p> <ul style="list-style-type: none"> <li>- Missing upper fixed transom sash - replaced with Transite (ACM) panel.</li> <li>- No hardware.</li> <li>- Casings and trims dive behind continuous wood sill. Sill needs to be removed to pull the weight boxes/jamb.</li> <li>- Paint is crazed (multiple layers of paint / lead paint).</li> <li>- Security screen mountings are mortised into the brickmold.</li> <li>- Upper sash painted in place.</li> <li>- Glazing caulk is tested as having ACM.</li> <li>- Accessing window weight box will require removing the galvanized metal jamb guides - access port is blocked.</li> <li>- Exterior sill &amp; lower jamb rotted.</li> <li>- Broken glazing in lower sash.</li> <li>- Lower sash rail corners blown.</li> <li>- No water damage visible, but ceiling above is stained.</li> </ul>

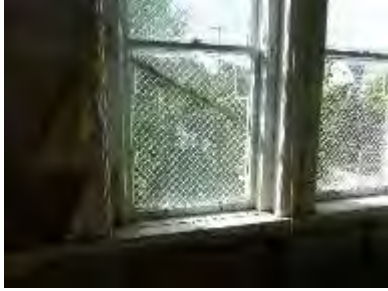
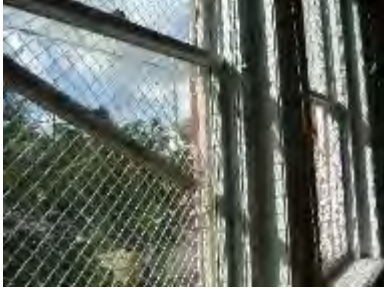
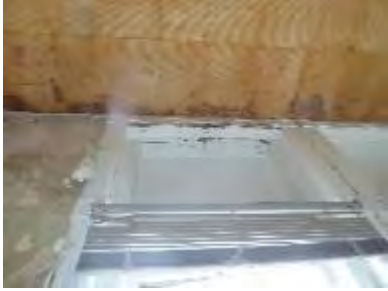
Room	Window	Window Configuration Type	Replace	Repair
208	S301	Double-hung with fixed transom above	✓

<p>S301-01: Interior view of lower sash      S301-02: Broken bottom rail at upper sash      S301-03: Water damage to header</p>		
<p><b>Condition Comments</b></p> <ul style="list-style-type: none"> <li>- Missing upper fixed transom sash - replaced with Transite (ACM) panel.</li> <li>- No hardware.</li> <li>- Casings and trims dive behind continuous wood sill. Sill needs to be removed to pull the weight boxes/jamb.</li> <li>- Paint is crazed (multiple layers of paint / lead paint).</li> <li>- Security screen mountings are mortised into the brickmold.</li> <li>- Upper sash painted in place.</li> <li>- Glazing caulk is tested as having ACM.</li> <li>- Accessing window weight box will require removing the galvanized metal jamb guides - access port is blocked.</li> <li>- Exterior sill &amp; lower jamb rotted.</li> <li>- Blown meeting rail right corner.</li> <li>- Upper sash meeting rail completely broken.</li> <li>- Water damage at head jamb of transom.</li> </ul>

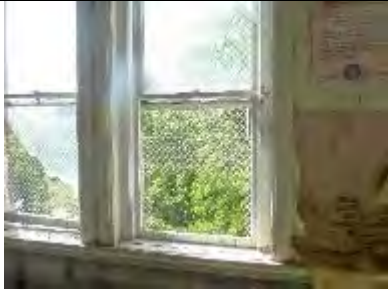
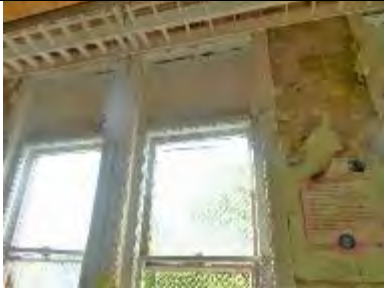
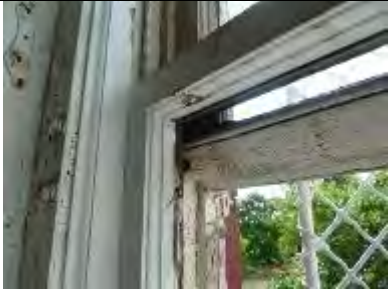
Room	Window	Window Configuration Type	Replace	Repair
208	S302	Double-hung with fixed transom above	✓

<p>S302-01: Interior view of lower sash      S302-02: Interior view of upper sash &amp; transom      S302-03: Blown corner of upper sash</p> <p><b>Condition Comments</b></p> <ul style="list-style-type: none"> <li>- Missing upper fixed transom sash - replaced with Transite (ACM) panel.</li> <li>- No hardware.</li> <li>- Casings and trims dive behind continuous wood sill. Sill needs to be removed to pull the weight boxes/jamb.</li> <li>- Paint is crazed (multiple layers of paint / lead paint).</li> <li>- Security screen mountings are mortised into the brickmold.</li> <li>- Upper sash painted in place.</li> <li>- Glazing caulk is tested as having ACM.</li> <li>- Accessing window weight box will require removing the galvanized metal jamb guides - access port is blocked.</li> <li>- Exterior sill &amp; lower jamb rotted.</li> <li>- Lower sash rail deteriorating.</li> <li>- Blown meeting rail right corner.</li> <li>- Broken glazing in lower sash.</li> <li>- Upper sash meeting rail completely broken.</li> <li>- Water damage at head jamb of transom.</li> </ul>

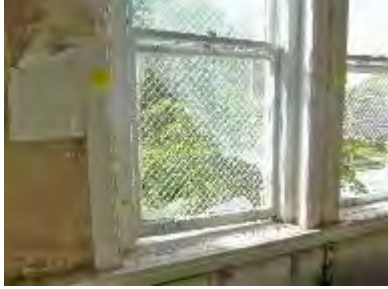
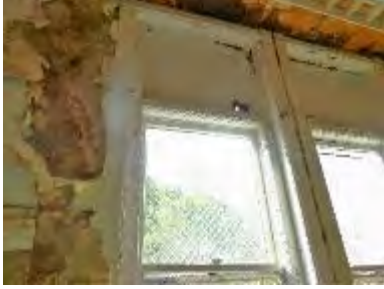
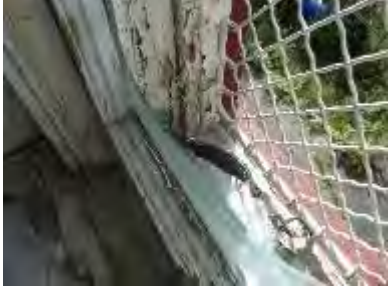
Room	Window	Window Configuration Type	Replace	Repair
208	S303	Double-hung with fixed transom above	✓

<p>S303-01: Interior view of lower sash      S303-02: Water damage above transom      S303-03: Condition of trim and window weight box lumber</p> <p><b>Condition Comments</b></p> <ul style="list-style-type: none"> <li>- Missing upper fixed transom sash - replaced with Transite (ACM) panel.</li> <li>- No hardware.</li> <li>- Casings and trims dive behind continuous wood sill. Sill needs to be removed to pull the weight boxes/jamb.</li> <li>- Paint is crazed (multiple layers of paint / lead paint).</li> <li>- Security screen mountings are mortised into the brickmold.</li> <li>- Upper sash painted in place.</li> <li>- Glazing caulk is tested as having ACM.</li> <li>- Accessing window weight box will require removing the galvanized metal jamb guides - access port is blocked.</li> <li>- Exterior sill &amp; lower jamb rotted.</li> <li>- Lower sash rail deteriorating.</li> <li>- Blown meeting rail right corner.</li> <li>- Broken glazing in lower sash.</li> </ul>

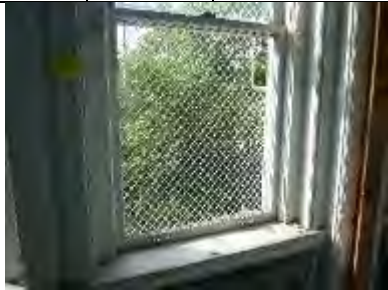
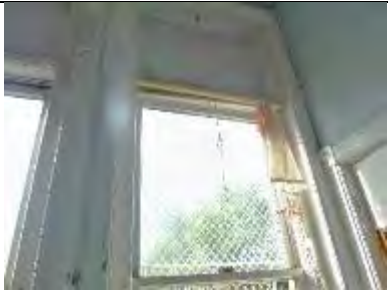
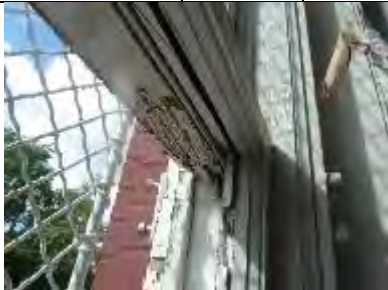
Room	Window	Window Configuration Type	Replace	Repair
208A	S306	Double-hung with fixed transom above	✓

<p>S306-01: Interior view of lower sash      S306-02: Interior view of upper sash      S306-03: Blown corner of upper sash</p> <p><b>Condition Comments</b></p> <ul style="list-style-type: none"> <li>- Missing upper fixed transom sash - replaced with Transite (ACM) panel.</li> <li>- Original hardware damaged.</li> <li>- Casings and trims dive behind continuous wood sill. Sill needs to be removed to pull the weight boxes/jamb.</li> <li>- Paint is crazed (multiple layers of paint / lead paint).</li> <li>- Security screen mountings are mortised into the brickmold.</li> <li>- Upper sash painted in place.</li> <li>- Glazing caulk is tested as having ACM.</li> <li>- Accessing window weight box will require removing the galvanized metal jamb guides - access port is blocked.</li> <li>- Exterior sill &amp; lower left jamb rotted.</li> <li>- Lower rail sash is in poor condition on exterior.</li> <li>- Upper sash meeting rail corners blown.</li> <li>- Broken glazing in lower sash.</li> </ul>

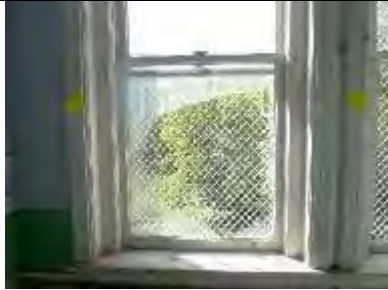
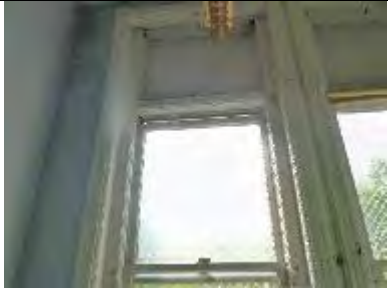
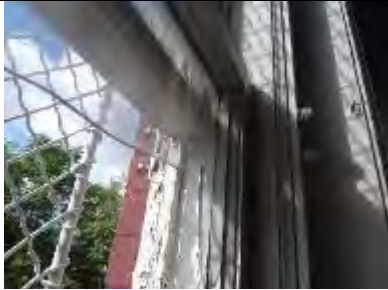
Room	Window	Window Configuration Type	Replace	Repair
208A	S307	Double-hung with fixed transom above	✓

<p>S307-01: Interior view of lower sash      S307-02: Interior view of upper sash &amp; transom      S307-03: Blown corner of upper sash</p> <p><b>Condition Comments</b></p> <ul style="list-style-type: none"> <li>- Missing upper fixed transom sash - replaced with Transite (ACM) panel.</li> <li>- No hardware.</li> <li>- Casings and trims dive behind continuous wood sill. Sill needs to be removed to pull the weight boxes/jamb.</li> <li>- Paint is crazed (multiple layers of paint / lead paint).</li> <li>- Security screen mountings are mortised into the brickmold.</li> <li>- Upper sash painted in place.</li> <li>- Glazing caulk is tested as having ACM.</li> <li>- Accessing window weight box will require removing the galvanized metal jamb guides - access port is blocked.</li> <li>- Exterior sill &amp; lower jambs rotted.</li> <li>- Upper sash meeting rail right corner blown.</li> <li>- Broken glazing in lower sash.</li> </ul>

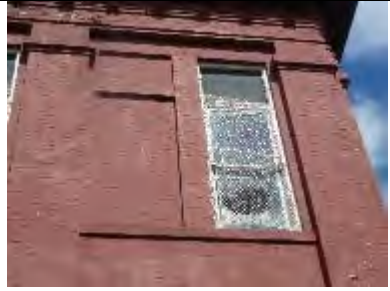
Room	Window	Window Configuration Type	Replace	Repair
209	S308	Bricked-in window opening	✓	
<b>Condition Comments</b> - Window opening bricked-in at exterior. Wall is plastered over at interior.

<p>S308-01: Exterior view at left</p>	
Room	Window	Window Configuration Type	Replace	Repair
209	S309	Double-hung with fixed transom above	✓

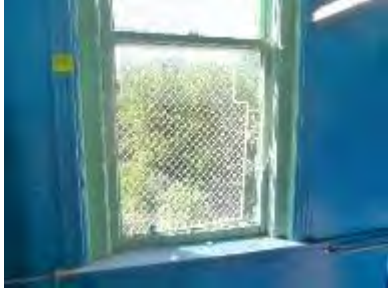
<p>S309-01: Interior view of lower sash</p>

<p>S309-04: Exterior view at right</p>	
<b>Condition Comments</b> <ul style="list-style-type: none"> <li>- Missing upper fixed transom sash - replaced with Transite (ACM) panel.</li> <li>- No hardware.</li> <li>- Casings and trims dive behind continuous wood sill. Sill needs to be removed to pull the weight boxes/jamb.</li> <li>- Paint is crazed (multiple layers of paint / lead paint).</li> <li>- Security screen mountings are mortised into the brickmold.</li> <li>- Upper sash painted in place.</li> <li>- Glazing caulk is tested as having ACM.</li> <li>- Accessing window weight box will require removing the galvanized metal jamb guides - access port is blocked.</li> <li>- Exterior &amp; interior sills are decayed.</li> <li>- Exterior jambs &amp; stops are rotted.</li> <li>- Broken glazing in upper sash.</li> <li>- Sash won't move.</li> <li>- Upper sash corners completely broken.</li> <li>- Broken ropes for weights.</li> </ul>

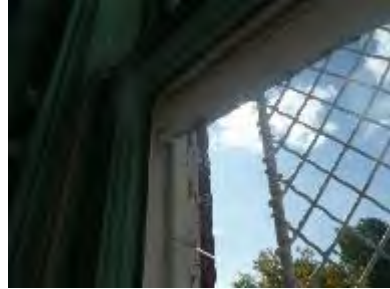
<p>S309-03: Blown corner at upper sash</p>

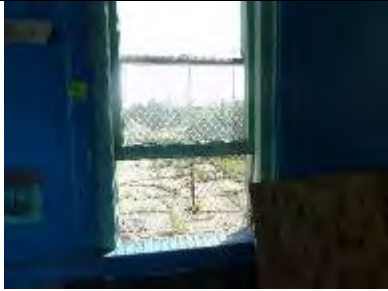
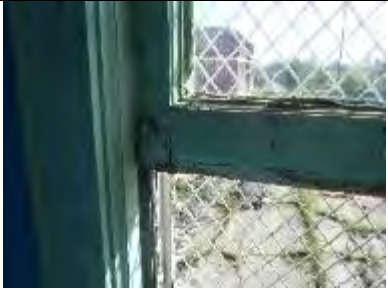
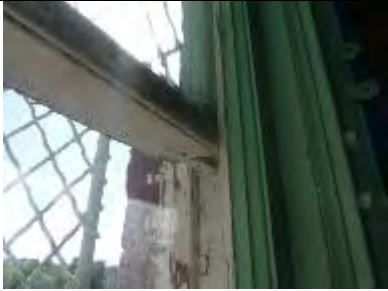
Room	Window	Window Configuration Type	Replace	Repair
209	S310	Double-hung with fixed transom above	✓

<p>S310-01: Interior view of lower sash</p> <p>S310-02: Lower sash lower left corner blown and decayed</p> <p>S310-03: Lower sash bottom rail right corner blown</p> <p><b>Condition Comments</b></p> <ul style="list-style-type: none"> <li>- Missing upper fixed transom sash - replaced with Transite (ACM) panel.</li> <li>- No hardware.</li> <li>- Casings and trims dive behind continuous wood sill. Sill needs to be removed to pull the weight boxes/jamb.</li> <li>- Paint is crazed (multiple layers of paint / lead paint).</li> <li>- Security screen mountings are mortised into the brickmold.</li> <li>- Upper sash painted in place.</li> <li>- Glazing caulk is tested as having ACM.</li> <li>- Accessing window weight box will require removing the galvanized metal jamb guides - access port is blocked.</li> <li>- Exterior &amp; interior sills are decayed.</li> <li>- Exterior jambs &amp; stops are rotted.</li> <li>- Broken glazing in upper sash.</li> <li>- Sash won't move.</li> <li>- Upper sash corners completely broken.</li> </ul>

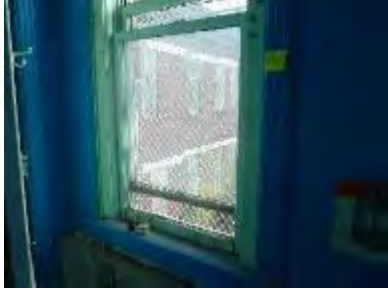
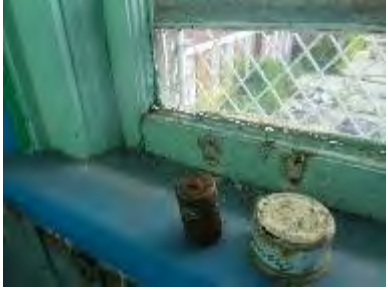
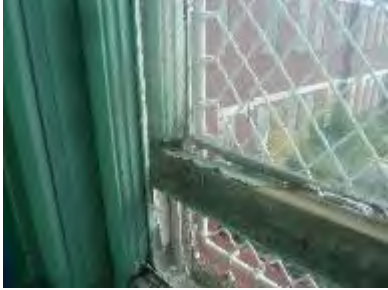
Room	Window	Window Configuration Type	Replace	Repair
209	S311	Double-hung with fixed transom above	✓

<p>S311-01: Interior view of lower sash</p> <p>S311-02: Blown corner of lower sash</p> <p>S311-03: Upper sash lower rail rotted</p> <p><b>Condition Comments</b></p> <ul style="list-style-type: none"> <li>- Missing upper fixed transom sash - replaced with Transite (ACM) panel.</li> <li>- No hardware.</li> <li>- Casings and trims dive behind continuous wood sill. Sill needs to be removed to pull the weight boxes/jamb.</li> <li>- Paint is crazed (multiple layers of paint / lead paint).</li> <li>- Security screen mountings are mortised into the brickmold.</li> <li>- Upper sash painted in place.</li> <li>- Glazing caulk is tested as having ACM.</li> <li>- Accessing window weight box will require removing the galvanized metal jamb guides - access port is blocked.</li> <li>- Exterior &amp; interior sills are decayed.</li> <li>- Exterior jambs &amp; stops are rotted.</li> <li>- Broken glazing in upper sash.</li> <li>- Sash won't move.</li> <li>- Upper sash corners completely broken.</li> </ul>

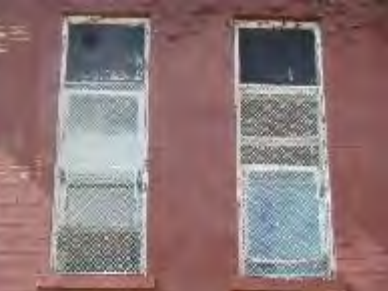
<p>S311-04: Exterior view on right</p>

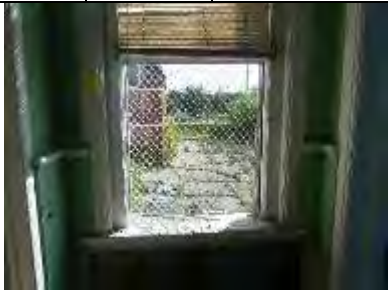
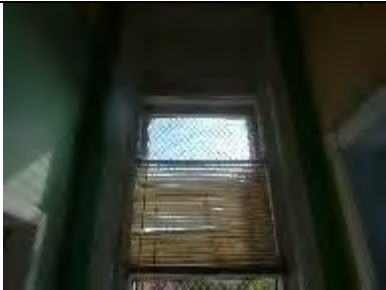
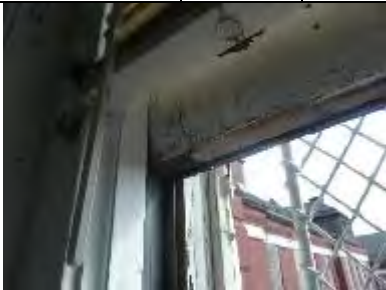
Room	Window	Window Configuration Type	Replace	Repair
209	S312	Double-hung with fixed transom above	✓

<p>S312-01: Interior view of lower sash      S312-02: Interior view of upper sash and transom      S312-03: Lower sash lower left corner decayed</p> <p><b>Condition Comments</b></p> <ul style="list-style-type: none"> <li>- Missing upper fixed transom sash - replaced with Transite (ACM) panel.</li> <li>- Original hardware damaged.</li> <li>- Casings and trims dive behind continuous wood sill. Sill needs to be removed to pull the weight boxes/jamb.</li> <li>- Paint is crazed (multiple layers of paint / lead paint).</li> <li>- Security screen mountings are mortised into the brickmold.</li> <li>- Upper sash painted in place.</li> <li>- Glazing caulk is tested as having ACM.</li> <li>- Accessing window weight box will require removing the galvanized metal jamb guides - access port is blocked.</li> <li>- Exterior &amp; interior sills are decayed.</li> <li>- Exterior jambs &amp; stops are rotted.</li> <li>- Broken glazing in both sashes.</li> <li>- Sash won't move.</li> <li>- Upper sash corners blown out.</li> </ul>

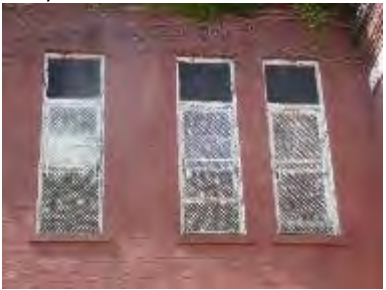
<p>S312-04: Exterior view on left</p>

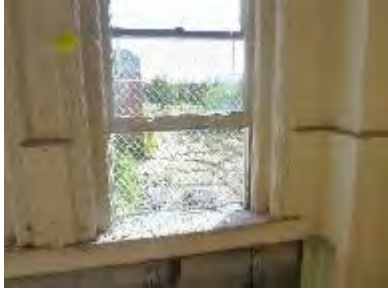
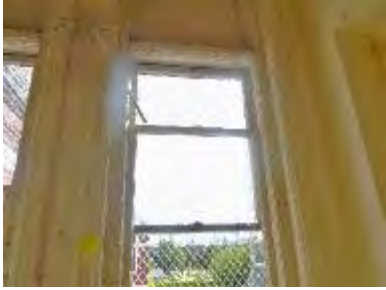
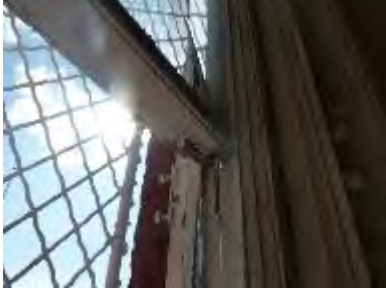
Room	Window	Window Configuration Type	Replace	Repair
210	S313	Double-hung with fixed transom above	✓

<p>S313-01: Interior view of lower sash      S313-02: Interior view of upper sash &amp; transom      S313-03: Blown corner of lower sash</p> <p><b>Condition Comments</b></p> <ul style="list-style-type: none"> <li>- Missing upper fixed transom sash - replaced with Transite (ACM) panel.</li> <li>- Original hardware damaged.</li> <li>- Casings and trims dive behind continuous wood sill. Sill needs to be removed to pull the weight boxes/jamb.</li> <li>- Paint is crazed (multiple layers of paint / lead paint).</li> <li>- Security screen mountings are mortised into the brickmold.</li> <li>- Upper sash painted in place.</li> <li>- Glazing caulk is tested as having ACM.</li> <li>- Accessing window weight box will require removing the galvanized metal jamb guides - access port is blocked.</li> <li>- Exterior &amp; interior sills are decayed.</li> <li>- Exterior jambs &amp; stops are rotted.</li> <li>- Broken glazing in both sashes.</li> <li>- Sash won't move.</li> <li>- Upper sash corners blown out.</li> </ul>

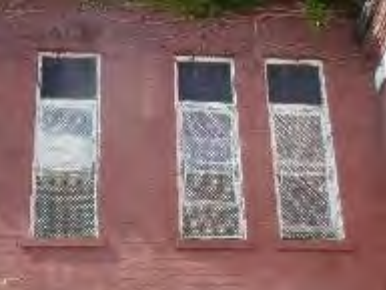
<p>S313-04: Exterior view at center</p>

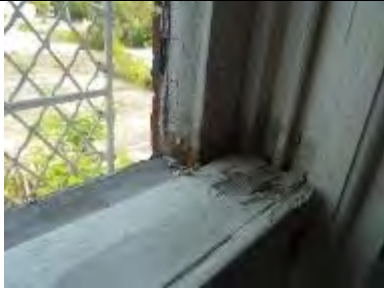
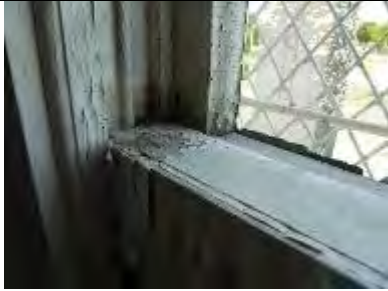
Room	Window	Window Configuration Type	Replace	Repair
211A	N329	Double-hung with 2 /4 cottage sash configuration		✓

<p>N329-01: Interior view of window</p> <p>N329-02: View of meeting rail jamb area damage on right side</p> <p>N329-03: View of meeting rail jamb area damage on left side</p> <p><b>Condition Comments</b></p> <ul style="list-style-type: none"> <li>- Plywood covering lower half.</li> <li>- Window partially covered by raised stage platform.</li> <li>- Upper sash corners blown out.</li> <li>- Security screen mountings are mortised into the brickmold.</li> <li>- Upper sash painted in place.</li> <li>- Glazing caulk is tested as having ACM.</li> <li>- Adjacent walls and ceiling show evidence of long-term water damage.</li> <li>- Accessing window weight box will require removing the galvanized metal jamb guides - access port is blocked.</li> <li>- Paint is crazed (multiple layers of paint / lead paint).</li> </ul>

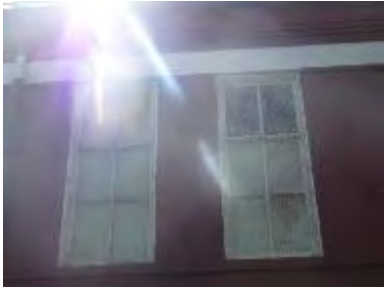
<p>N329-04: Exterior view on right</p>

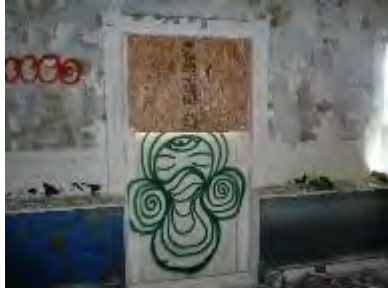
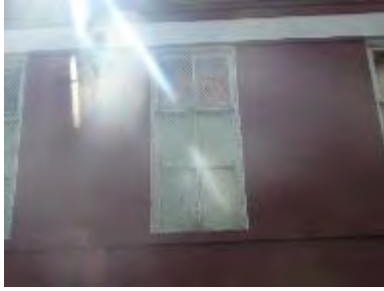
Room	Window	Window Configuration Type	Replace	Repair
211A	N330	Double-hung with 2 /4 cottage sash configuration		✓

<p>N330-01: Interior view of window</p> <p>N330-02: Exterior view of window</p> <p><b>Condition Comments</b></p> <ul style="list-style-type: none"> <li>- Plywood covering lower half.</li> <li>- Window partially covered by raised stage platform.</li> <li>- Upper sash corners blown out.</li> <li>- Security screen mountings are mortised into the brickmold.</li> <li>- Upper sash painted in place.</li> <li>- Glazing caulk is tested as having ACM.</li> <li>- Adjacent walls and ceiling show evidence of long-term water damage.</li> <li>- Accessing window weight box will require removing the galvanized metal jamb guides - access port is blocked.</li> <li>- Paint is crazed (multiple layers of paint / lead paint).</li> </ul>

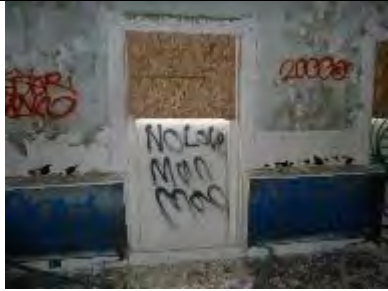
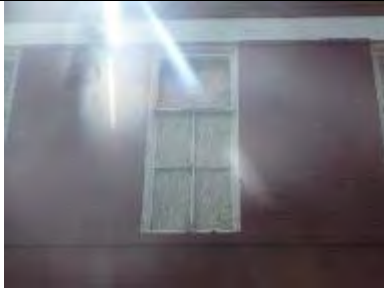
Room	Window	Window Configuration Type	Replace	Repair
211A	N331	Double-hung with 2 /4 cottage sash configuration		✓

<p>N331-01: Interior view of window      N331-02: Exterior view of window</p> <p><b>Condition Comments</b></p> <ul style="list-style-type: none"> <li>- Plywood covering lower half.</li> <li>- Window partially covered by raised stage platform.</li> <li>- Upper sash corners blown out.</li> <li>- Security screen mountings are mortised into the brickmold.</li> <li>- Upper sash painted in place.</li> <li>- Glazing caulk is tested as having ACM.</li> <li>- Adjacent walls and ceiling show evidence of long-term water damage.</li> <li>- Accessing window weight box will require removing the galvanized metal jamb guides - access port is blocked.</li> <li>- Paint is crazed (multiple layers of paint / lead paint).</li> </ul>

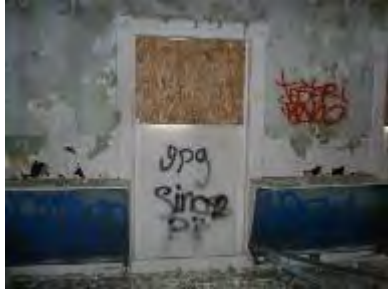
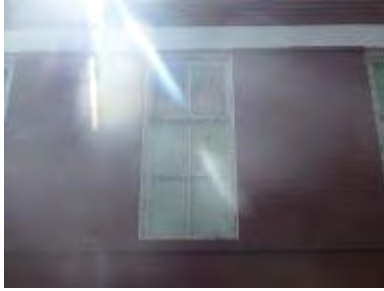
Room	Window	Window Configuration Type	Replace	Repair
211A	N332	Double-hung with 2 /4 cottage sash configuration		✓

<p>N332-01: Interior view of window      N332-02: Exterior view of window</p> <p><b>Condition Comments</b></p> <ul style="list-style-type: none"> <li>- Plywood covering lower half.</li> <li>- Window partially covered by raised stage platform.</li> <li>- Upper sash corners blown out.</li> <li>- Security screen mountings are mortised into the brickmold.</li> <li>- Upper sash painted in place.</li> <li>- Glazing caulk is tested as having ACM.</li> <li>- Adjacent walls and ceiling show evidence of long-term water damage.</li> <li>- Accessing window weight box will require removing the galvanized metal jamb guides - access port is blocked.</li> <li>- Paint is crazed (multiple layers of paint / lead paint).</li> </ul>

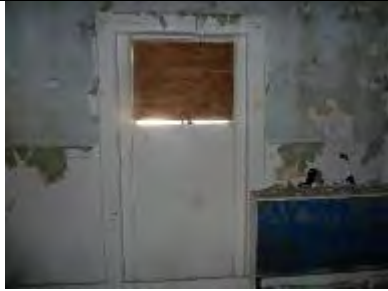
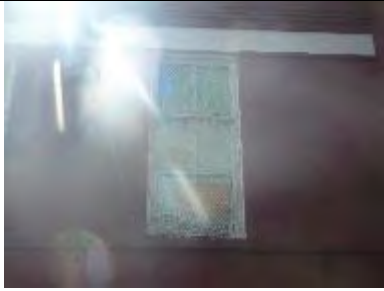
Room	Window	Window Configuration Type	Replace	Repair
211A	N333	Double-hung with 2 /4 cottage sash configuration		✓

<p>N333-01: Interior view of window      N333-02: Exterior view of window</p> <p><b>Condition Comments</b></p> <ul style="list-style-type: none"> <li>- Plywood covering lower half.</li> <li>- Window partially covered by raised stage platform.</li> <li>- Upper sash corners blown out.</li> <li>- Security screen mountings are mortised into the brickmold.</li> <li>- Upper sash painted in place.</li> <li>- Glazing caulk is tested as having ACM.</li> <li>- Adjacent walls and ceiling show evidence of long-term water damage.</li> <li>- Accessing window weight box will require removing the galvanized metal jamb guides - access port is blocked.</li> <li>- Paint is crazed (multiple layers of paint / lead paint).</li> </ul>

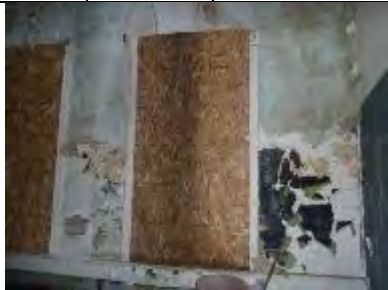
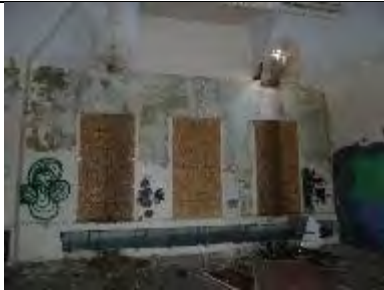
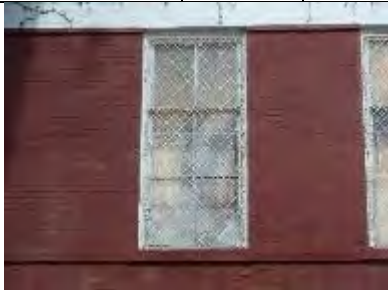
Room	Window	Window Configuration Type	Replace	Repair
211B	S315	Double-hung with 2 /4 cottage sash configuration	✓

<p>S315-01: Interior view of window      S315-02: Hole in roof &amp; ceiling above window      S315-03: Exterior view of window</p> <p><b>Condition Comments</b></p> <ul style="list-style-type: none"> <li>- Temporary plywood covering on interior side.</li> <li>- Severe water damage &amp; structural damage to wall.</li> <li>- Roof is open above.</li> <li>- Paint is crazed (multiple layers of paint / lead paint).</li> <li>- Security screen mountings are mortised into the brickmold.</li> <li>- Upper sash painted in place.</li> <li>- Glazing caulk is tested as having ACM.</li> <li>- Accessing window weight box will require removing the galvanized metal jamb guides - access port is blocked.</li> </ul>

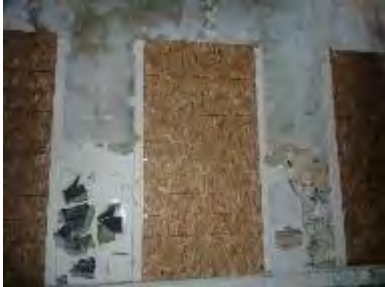
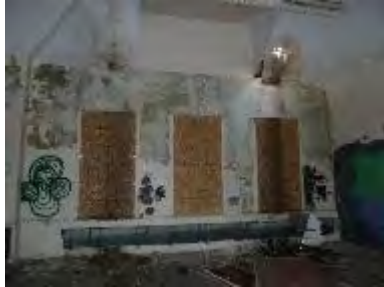
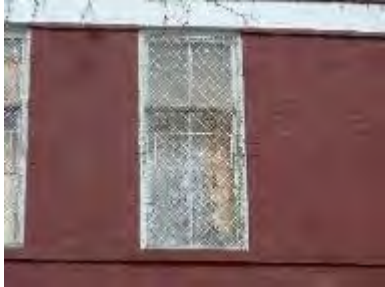
Room	Window	Window Configuration Type	Replace	Repair
211B	S316	Double-hung with 2 /4 cottage sash configuration	✓

<p>S316-01: Interior view of window</p> <p>S316-02: Hole in roof &amp; ceiling above window</p> <p>S316-03: Exterior view of window</p> <p><b>Condition Comments</b></p> <ul style="list-style-type: none"> <li>- Temporary plywood covering on interior side.</li> <li>- Severe water damage &amp; structural damage to wall.</li> <li>- Roof is open above.</li> <li>- Paint is crazed (multiple layers of paint / lead paint).</li> <li>- Security screen mountings are mortised into the brickmold.</li> <li>- Upper sash painted in place.</li> <li>- Glazing caulk is tested as having ACM.</li> <li>- Accessing window weight box will require removing the galvanized metal jamb guides - access port is blocked.</li> </ul>

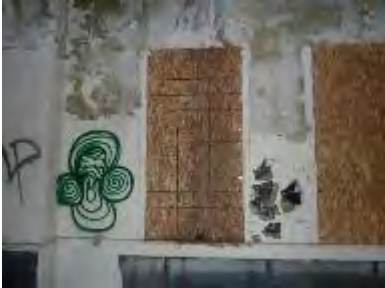
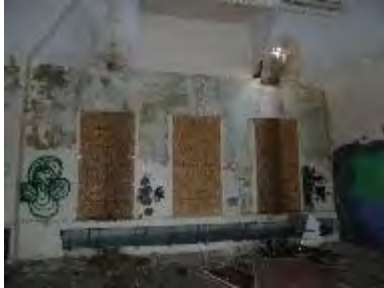
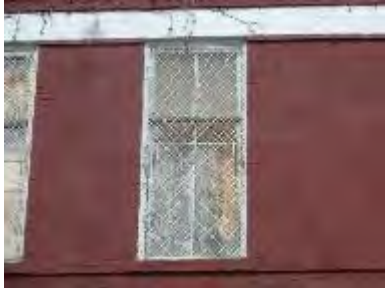
Room	Window	Window Configuration Type	Replace	Repair
211B	S317	Double-hung with 2 /4 cottage sash configuration	✓

<p>S317-01: Interior view of window</p> <p>S317-02: Hole in roof &amp; ceiling above window</p> <p>S317-03: Exterior view of window</p> <p><b>Condition Comments</b></p> <ul style="list-style-type: none"> <li>- Temporary plywood covering on interior side.</li> <li>- Severe water damage &amp; structural damage to wall.</li> <li>- Roof is open above.</li> <li>- Paint is crazed (multiple layers of paint / lead paint).</li> <li>- Security screen mountings are mortised into the brickmold.</li> <li>- Upper sash painted in place.</li> <li>- Glazing caulk is tested as having ACM.</li> <li>- Accessing window weight box will require removing the galvanized metal jamb guides - access port is blocked.</li> </ul>

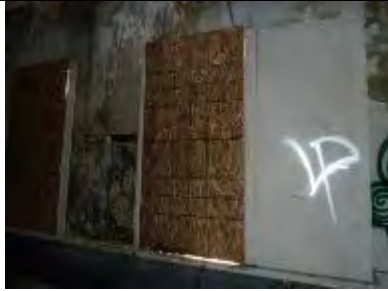
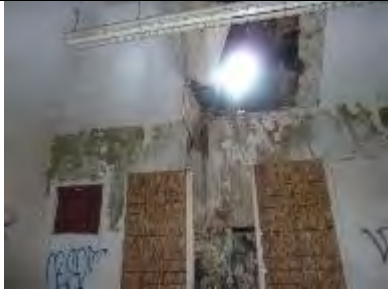
Room	Window	Window Configuration Type	Replace	Repair
211B	S318	Double-hung with 2 / 4 cottage sash configuration	✓

<p>S318-01: Interior view of window      S318-02: Water damage above window      S318-03: Hole in roof &amp; ceiling above window</p> <p><b>Condition Comments</b></p> <ul style="list-style-type: none"> <li>- Temporary plywood covering on interior side.</li> <li>- Severe water damage &amp; structural damage to wall.</li> <li>- Roof is open above.</li> <li>- Paint is crazed (multiple layers of paint / lead paint).</li> <li>- Security screen mountings are mortised into the brickmold.</li> <li>- Upper sash painted in place.</li> <li>- Glazing caulk is tested as having ACM.</li> <li>- Accessing window weight box will require removing the galvanized metal jamb guides - access port is blocked.</li> </ul>

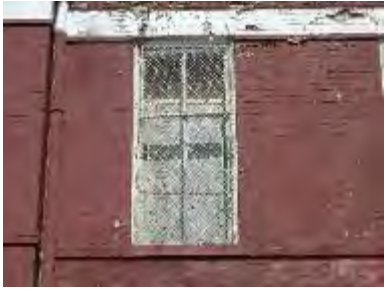
<p>S318-04: Exterior view at window</p>

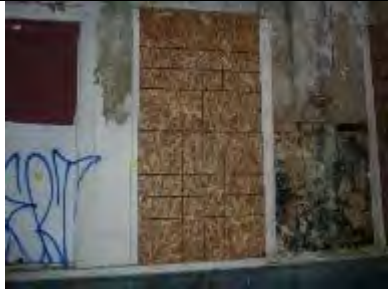
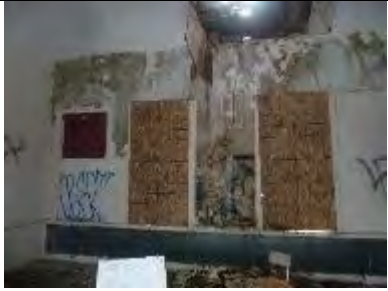
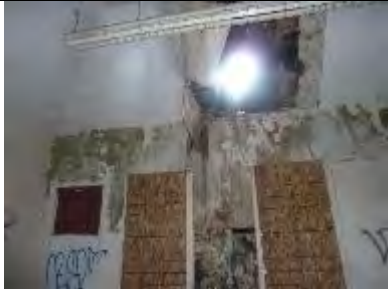
Room	Window	Window Configuration Type	Replace	Repair
211B	S319	Double-hung with 2 / 4 cottage sash configuration	✓

<p>S319-01: Interior view of window      S319-02: Water damage above window      S319-03: Hole in roof &amp; ceiling above window</p> <p><b>Condition Comments</b></p> <ul style="list-style-type: none"> <li>- Temporary plywood covering on interior side.</li> <li>- Severe water damage &amp; structural damage to wall.</li> <li>- Roof is open above.</li> <li>- Paint is crazed (multiple layers of paint / lead paint).</li> <li>- Security screen mountings are mortised into the brickmold.</li> <li>- Upper sash painted in place.</li> <li>- Glazing caulk is tested as having ACM.</li> <li>- Accessing window weight box will require removing the galvanized metal jamb guides - access port is blocked.</li> </ul>

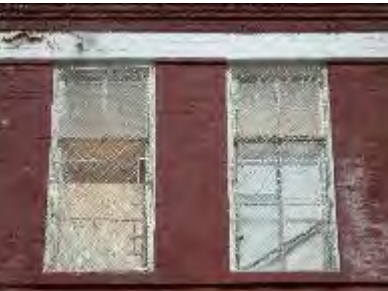
<p>S319-04: Exterior view on left</p>

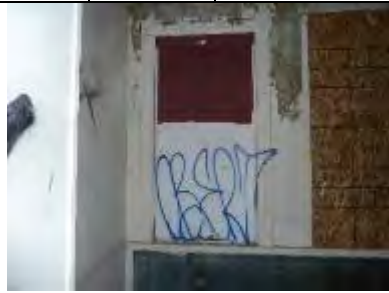
N320-01: Interior view of window

- Plywood covering on interior side.
- Severe water damage & structural damage to wall.
- Roof is open above.
- Paint is crazed (multiple layers of paint / lead paint).
- Security screen mountings are mortised into the brickmold.
- Upper sash painted in place.
- Glazing caulk is tested as having ACM.
- Accessing window weight box will require removing the galvanized metal jamb guides - access port is blocked.

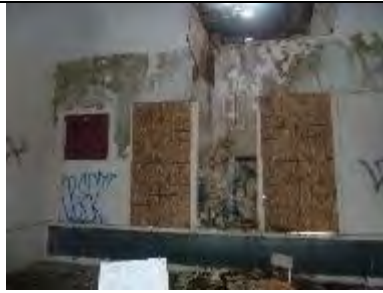
N320-02: Water damage above window

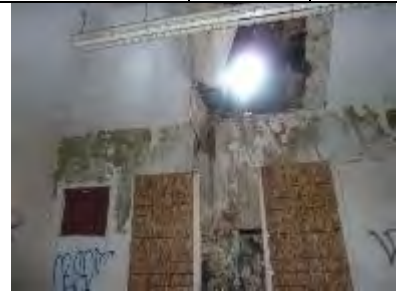
N320-03: Hole in roof & ceiling above window

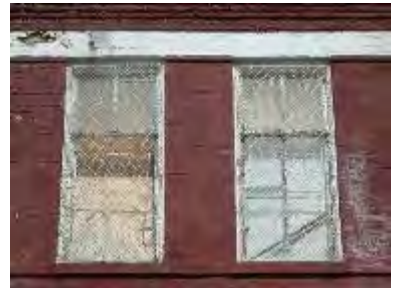
N320-04: Exterior view on right

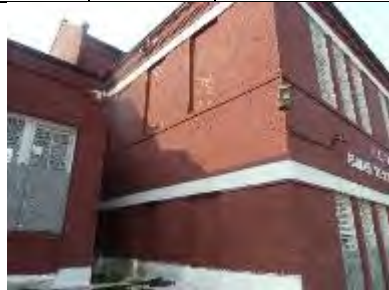
Room	Window	Window Configuration Type	Replace	Repair
212	N319	Bricked-in window opening		
212	N320	Bricked-in window opening		
212	N321	Bricked-in window opening

N319-N321-01: Exterior view of bricked-in openings

**Condition Comments**

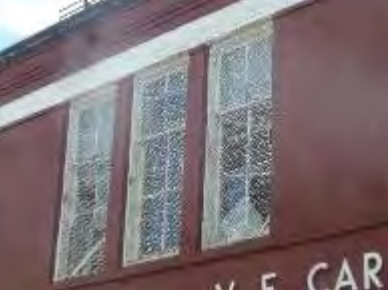
Room	Window	Window Configuration Type	Replace	Repair
212	N323	Double-hung with 2 /4 cottage sash configuration	✓	
      <p>N323-01: Interior view of lower sash      N323-02: Interior view of upper sash      N323-03: Damaged corner of upper sash</p> <p><b>Condition Comments</b></p> <ul style="list-style-type: none"> <li>- Paint is crazed (multiple layers of paint / lead paint).</li> <li>- Security screen mountings are mortised into the brickmold.</li> <li>- Upper sash painted in place.</li> <li>- Glazing caulk is tested as having ACM.</li> <li>- Accessing window weight box will require removing the galvanized metal jamb guides - access port is blocked.</li> <li>- Sash won't open.</li> <li>- Upper sash meeting rail corners damaged.</li> </ul>

<p>N323-04: Exterior view at center</p>

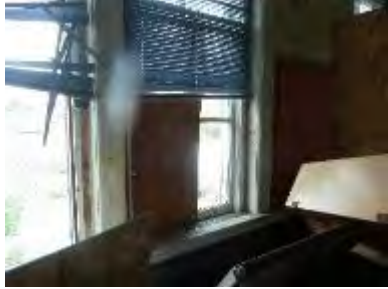
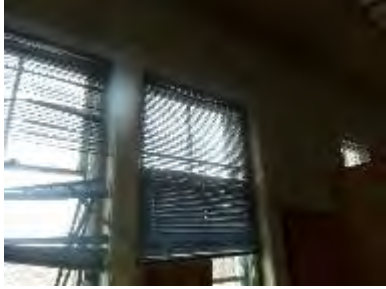
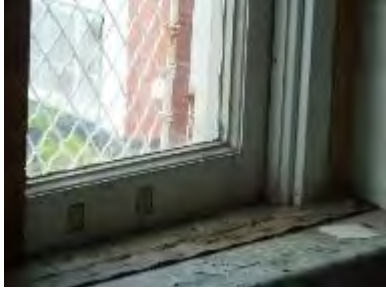
Room	Window	Window Configuration Type	Replace	Repair
212	N325	Double-hung with 2 /4 cottage sash configuration	✓

<p>N325-01: Interior view of lower sash      N325-02: Interior view of upper sash      N325-03: Rotted sill</p> <p><b>Condition Comments</b></p> <ul style="list-style-type: none"> <li>- Paint is crazed (multiple layers of paint / lead paint).</li> <li>- Security screen mountings are mortised into the brickmold.</li> <li>- Upper sash painted in place.</li> <li>- Glazing caulk is tested as having ACM.</li> <li>- Accessing window weight box will require removing the galvanized metal jamb guides - access port is blocked.</li> <li>- Broken glazing on lower sash.</li> <li>- Missing hardware.</li> <li>- Upper sash corners decayed.</li> <li>- Sash won't open.</li> </ul>

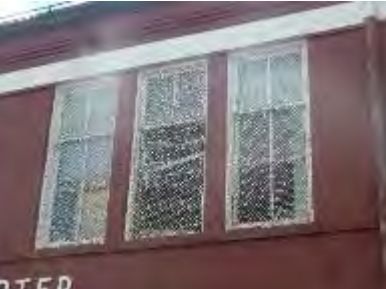
<p>N325-04: Exterior view on left</p>

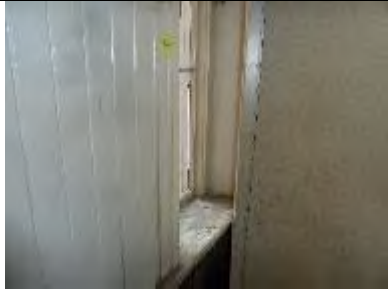
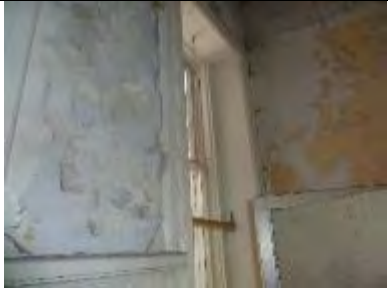
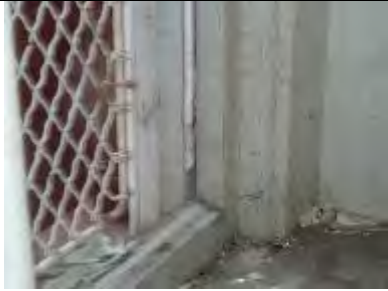
Room	Window	Window Configuration Type	Replace	Repair
212B	N318	Double-hung with 2 /4 cottage sash configuration	✓

<p>N318-01: Interior view of lower sash      N318-02: Interior view of upper sash      N318-03: Damage of lower sash lower rail &amp; sill</p> <p><b>Condition Comments</b></p> <ul style="list-style-type: none"> <li>- Paint is crazed (multiple layers of paint / lead paint).</li> <li>- Security screen mountings are mortised into the brickmold.</li> <li>- Upper sash painted in place.</li> <li>- Glazing caulk is tested as having ACM.</li> <li>- Accessing window weight box will require removing the galvanized metal jamb guides - access port is blocked.</li> <li>- Rotten sill.</li> <li>- Broken muntins.</li> <li>- Upper sash meeting rail corners blown.</li> </ul>

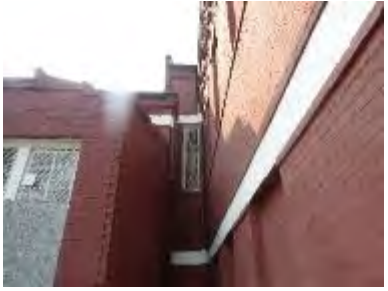
<p>N318-04: Exterior view</p>

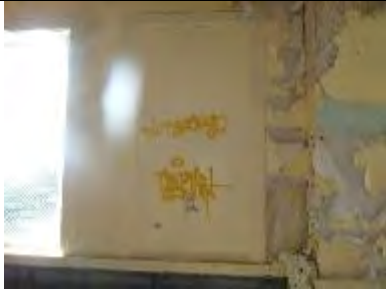
S322-01: Interior view of window

- Window boarded on interior: gypsum board at interior.

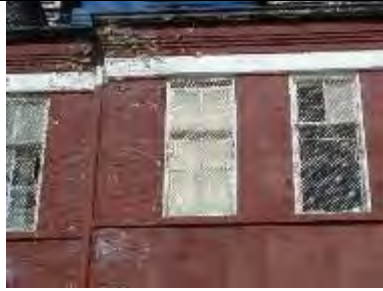
S322-02: Exterior view of window at center

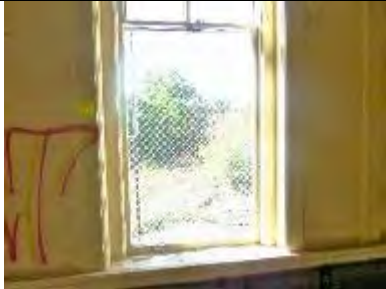
S323-01: Interior view of lower sash

- Paint is crazed (multiple layers of paint / lead paint).
- Security screen mountings are mortised into the brickmold.
- Upper sash painted in place.
- Glazing caulk is tested as having ACM.
- Accessing window weight box will require removing the galvanized metal jamb guides - access port is blocked.
- Missing muntins.
- Exterior & interior sills rotted.
- Blown corners on upper sash meeting rail.
- Broken glazing & ropes for weights.

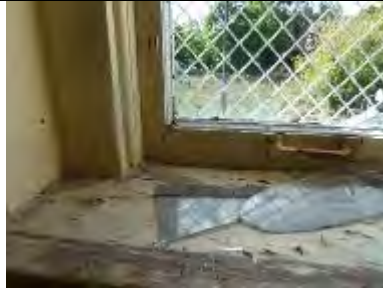
S323-02: Rotted interior sill & damage to lower rail

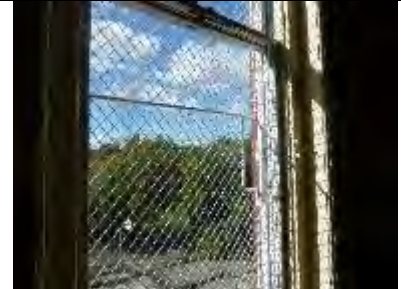
S323-03: Missing muntins on lower sash

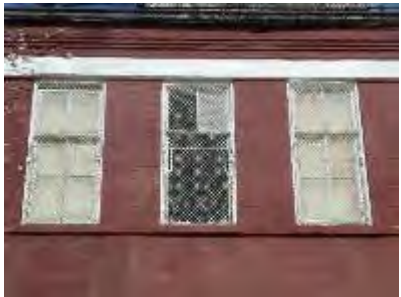
S323-04: Exterior view at center

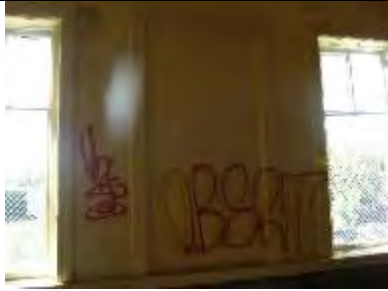
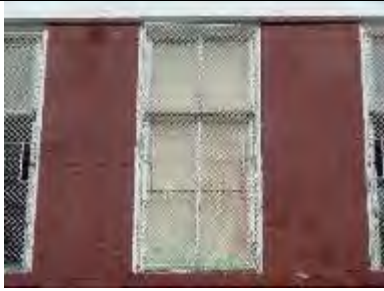
Room	Window	Window Configuration Type	Replace	Repair
213	S324	Abandoned: Double-hung with 2 /4 cottage sash configuration original	✓

<p>S324-01: Interior view of window      S324-02: Exterior view</p> <p><b>Condition Comments</b> Window boarded on interior: gypsum board at interior.</p>

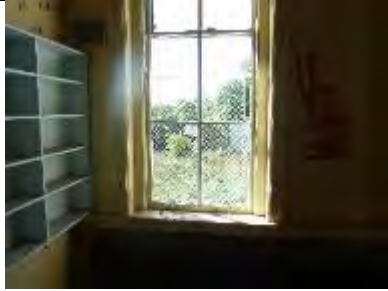
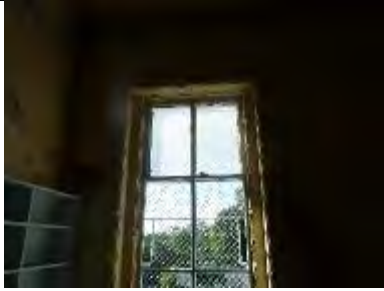
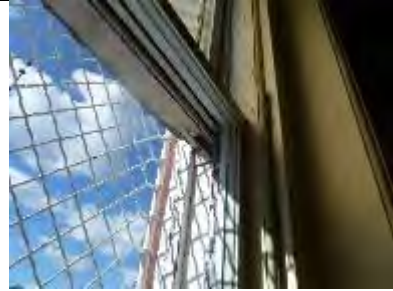
Room	Window	Window Configuration Type	Replace	Repair
213	S325	Double-hung with 2 /4 cottage sash configuration	✓

<p>S325-01: Interior view of lower sash      S325-02: Interior view of upper sash      S325-03: Blown corner of upper sash</p> <p><b>Condition Comments</b></p> <ul style="list-style-type: none"> <li>- Paint is crazed (multiple layers of paint / lead paint).</li> <li>- Security screen mountings are mortised into the brickmold.</li> <li>- Upper sash painted in place.</li> <li>- Glazing caulk is tested as having ACM.</li> <li>- Accessing window weight box will require removing the galvanized metal jamb guides - access port is blocked.</li> <li>- Exterior &amp; interior sills rotted.</li> <li>- Lower sash rail deteriorating.</li> <li>- Blown corners on upper sash meeting rail.</li> <li>- Broken glazing &amp; ropes for weights.</li> </ul>

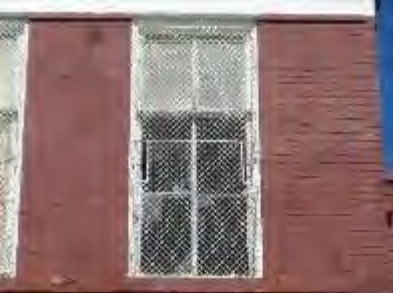
<p>S325-04: Exterior view</p>
