# Window Condition Survey

McKinley School Renovation

2001 W. Vliet St.  
Milwaukee WI, 53205

## **McKinley School Restoration Window Condition Survey**

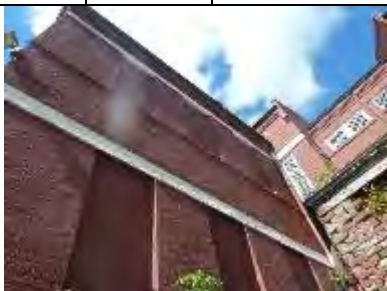
Room	Window	Window Configuration Type	Replace	Repair
213	S326	Bricked-in window opening		
213	S327	Bricked-in window opening		
213	S328	Bricked-in window opening

S326-S328-01: Exterior view

- Window opening bricked-in at exterior. Wall is plastered over at interior.

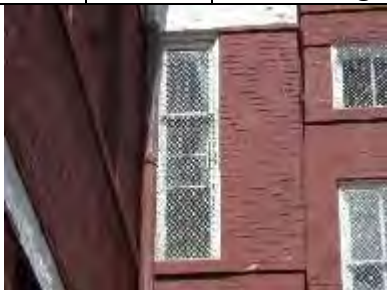
Room	Window	Window Configuration Type	Replace	Repair
213B	S329	Double-hung with fixed transom above	✓

S329-01: Exterior view of window

- Paint is crazed (multiple layers of paint / lead paint).
- Security screen mountings are mortised into the brickmold.
- Upper sash painted in place.
- Glazing caulk is tested as having ACM.
- Accessing window weight box will require removing the galvanized metal jamb guides - access port is blocked.

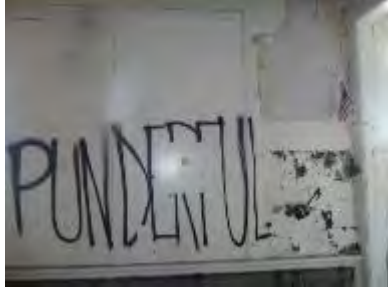
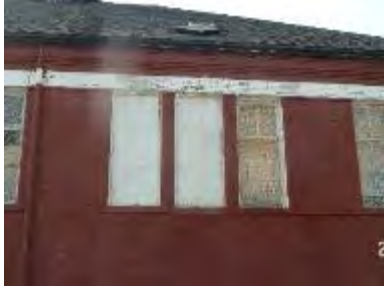
Room	Window	Window Configuration Type	Replace	Repair
214	N308	Abandoned: Double-hung with 2 /4 cottage sash configuration original	✓

<p>N308-01: Interior view of window      N308-02: Exterior view on left</p> <p><b>Condition Comments</b></p> <ul style="list-style-type: none"> <li>- Window boarded at both sides: Plywood at exterior and gypsum board at interior. Assumed boarded by MPS due to condition being too far gone to repair.</li> </ul>

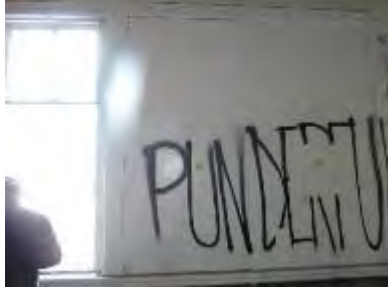
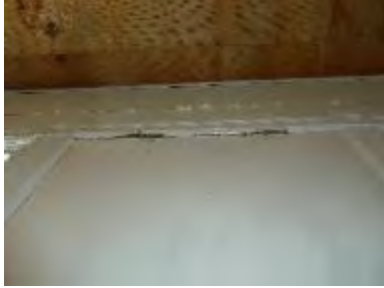
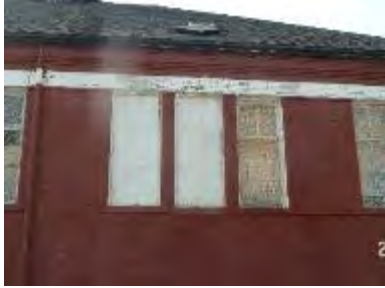
Room	Window	Window Configuration Type	Replace	Repair
214	N309	Abandoned: Double-hung with 2 /4 cottage sash configuration original	✓

<p>N309-01: Interior view of window      N309-02: Damage around header      N309-03: Exterior view at center</p> <p><b>Condition Comments</b></p> <ul style="list-style-type: none"> <li>- Window boarded at both sides: Plywood at exterior and gypsum board at interior. Assumed boarded by MPS due to condition being too far gone to repair.</li> </ul>

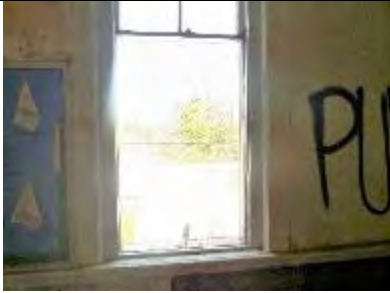
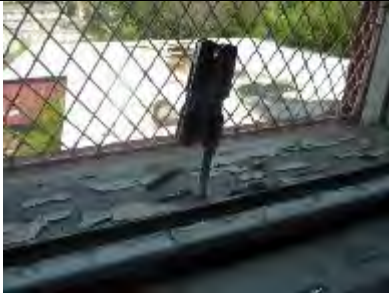
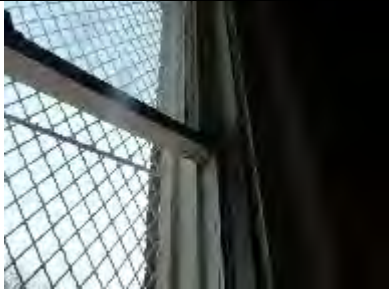
Room	Window	Window Configuration Type	Replace	Repair
214	N310	Double-hung with 2 / 4 cottage sash configuration	✓

<p>N310-01: Interior view of lower sash      N310-02: Rotted exterior sill      N310-03: Blown corner of upper sash</p> <p><b>Condition Comments</b></p> <ul style="list-style-type: none"> <li>- Paint is crazed (multiple layers of paint / lead paint).</li> <li>- Security screen mountings are mortised into the brickmold.</li> <li>- Upper sash painted in place.</li> <li>- Glazing caulk is tested as having ACM.</li> <li>- Accessing window weight box will require removing the galvanized metal jamb guides - access port is blocked.</li> <li>- Missing lower sash.</li> <li>- Sill rot.</li> <li>- Blown corners on meeting rail.</li> <li>- Water damage at head jamb.</li> </ul>

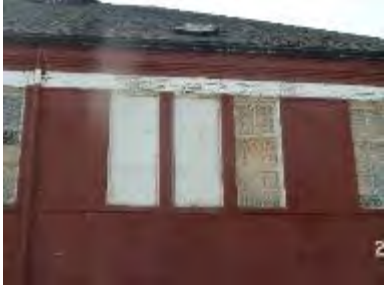
<p>N310-04: Exterior view on right</p>

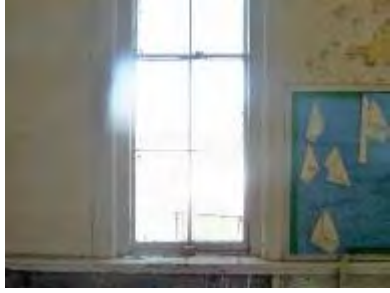
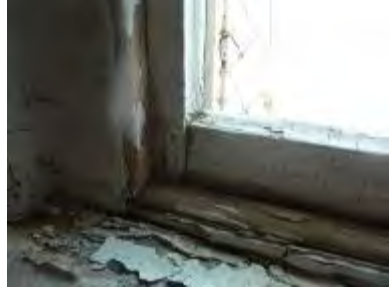
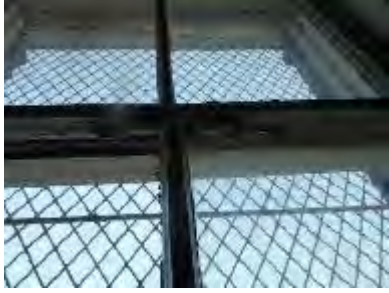
Room	Window	Window Configuration Type	Replace	Repair
214	N311	Double-hung with 2 / 4 cottage sash configuration	✓

<p>N311-01: Interior view of lower sash      N311-02: Blown corner of lower sash      N311-03: Damage along meeting rail</p> <p><b>Condition Comments</b></p> <ul style="list-style-type: none"> <li>- Paint is crazed (multiple layers of paint / lead paint).</li> <li>- Security screen mountings are mortised into the brickmold.</li> <li>- Upper sash painted in place.</li> <li>- Glazing caulk is tested as having ACM.</li> <li>- Accessing window weight box will require removing the galvanized metal jamb guides - access port is blocked.</li> <li>- Water damage at interior sill &amp; stops.</li> <li>- Damage to meeting rail.</li> <li>- Water damage at head jamb.</li> </ul>

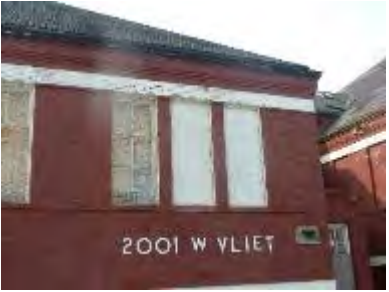
<p>N311-04: Exterior view on left</p>

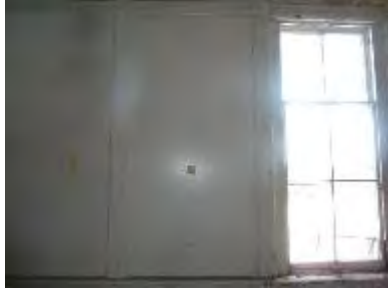
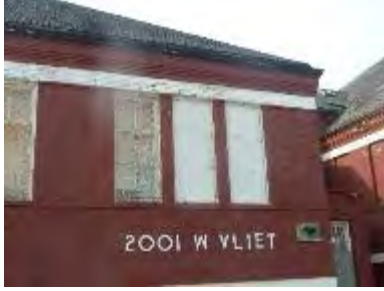
Room	Window	Window Configuration Type	Replace	Repair
214	N312	Abandoned: Double-hung with 2/4 cottage sash configuration original	✓

<p>N312-01: Interior view of window      N312-02: Exterior view at center</p> <p><b>Condition Comments</b></p> <ul style="list-style-type: none"> <li>- Window boarded at both sides: Plywood at exterior and gypsum board at interior. Assumed boarded by MPS due to condition being too far gone to repair.</li> </ul>

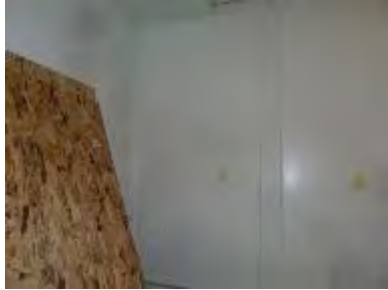
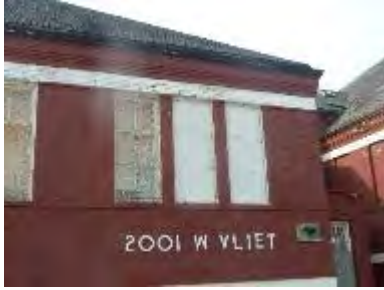
Room	Window	Window Configuration Type	Replace	Repair
214	N313	Abandoned: Double-hung with 2/4 cottage sash configuration original	✓

<p>N313-01: Interior view of window      N313-02: Interior view of upper sash</p> <p><b>Condition Comments</b></p> <ul style="list-style-type: none"> <li>- Window boarded at both sides: Plywood at exterior and gypsum board at interior. Assumed boarded by MPS due to condition being too far gone to repair.</li> </ul>

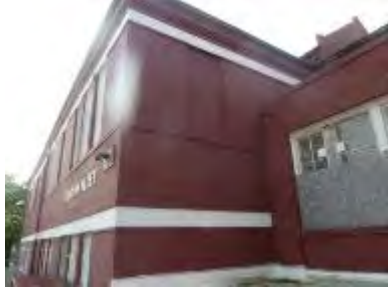
Room	Window	Window Configuration Type	Replace	Repair
214	N314	Bricked-in window opening

<p>N314-01: Exterior view</p> <p><b>Condition Comments</b></p> <ul style="list-style-type: none"> <li>- Window opening bricked-in at exterior. Wall is plastered over at interior.</li> </ul>

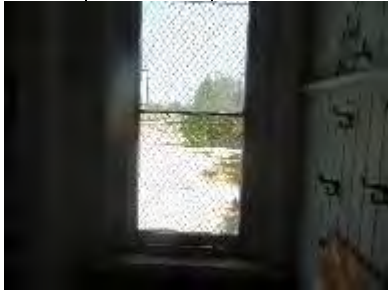
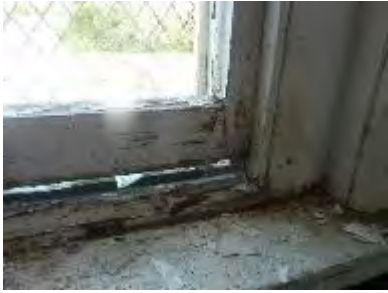
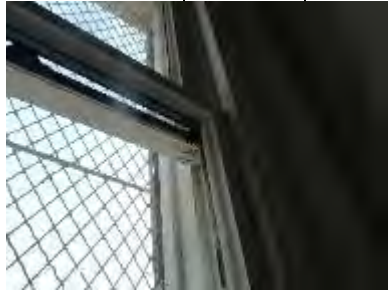
Room	Window	Window Configuration Type	Replace	Repair
214B	N307	Double-hung with fixed transom above	✓

<p>N307-01: Interior view of lower sash</p> <p>N307-02: Damage along lower rail of lower sash</p> <p>N307-03: Blown corner of upper sash</p>		
		<p><b>Condition Comments</b></p> <ul style="list-style-type: none"> <li>- Paint is crazed (multiple layers of paint / lead paint).</li> <li>- Security screen mountings are mortised into the brickmold.</li> <li>- Upper sash painted in place.</li> <li>- Glazing caulk is tested as having ACM.</li> <li>- Accessing window weight box will require removing the galvanized metal jamb guides - access port is blocked.</li> <li>- Sill rotten.</li> <li>- Damaged lower sash rail.</li> <li>- Blown corners at upper sash meeting rail.</li> <li>- Broken glazing.</li> <li>- Water damage at head jamb.</li> </ul>

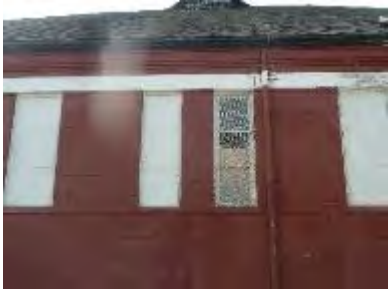
N307-04: Exterior view on right

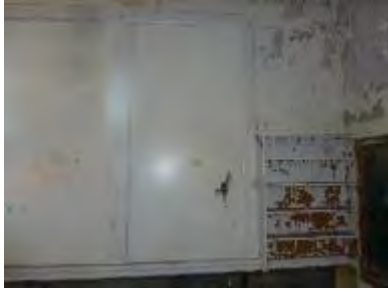
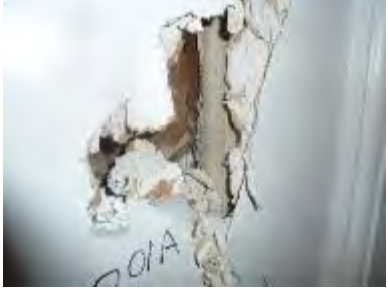
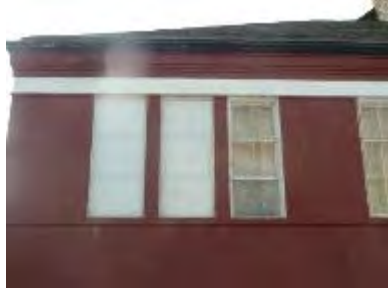
Room	Window	Window Configuration Type	Replace	Repair
215	N300	Abandoned: Double-hung with 2/4 cottage sash configuration original	✓

<p>N300-01: Interior view of window</p> <p>N300-02: View of behind gypsum board</p> <p>N300-03: Exterior view on left</p>		
		<p><b>Condition Comments</b></p> <ul style="list-style-type: none"> <li>- Window boarded at both sides: Plywood at exterior and gypsum board at interior.</li> <li>- Window still inside. Glazing broken out and hardware removed. Portion of sash rail below viewed through the hole was water damaged.</li> </ul>

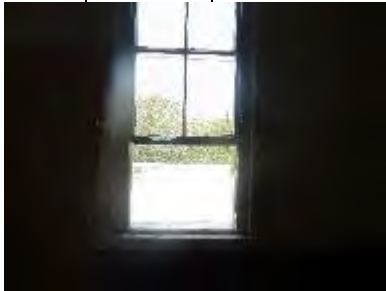
N302-01: Interior view of lower sash

- Paint is crazed (multiple layers of paint / lead paint).
- Security screen mountings are mortised into the brickmold.
- Upper sash painted in place.
- Glazing caulk is tested as having ACM.
- Accessing window weight box will require removing the galvanized metal jamb guides - access port is blocked.
- Lower sash bottom rail corner completely broken.
- Broken glazing on lower sash.
- Interior stop rotted at sill.
- Metal guides.
- Decayed muntins.

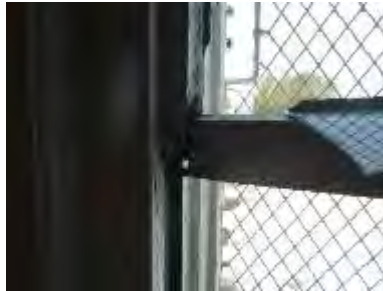
N302-02: Blown corner of lower sash

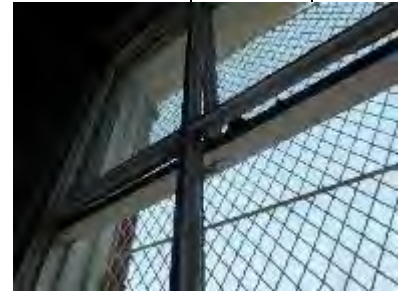
N302-03: Damage at meeting rail

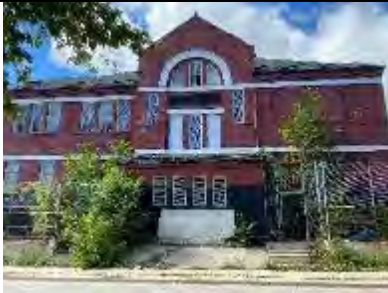
E311-E313-01: Exterior View

- Window opening bricked-in at exterior. Wall is plastered over at interior.

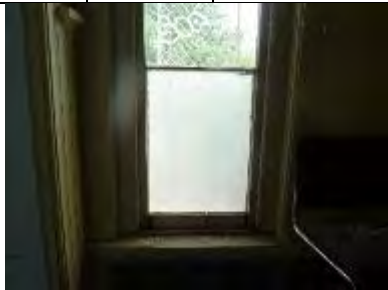
E310-01: Interior view of lower sash

- Paint is crazed (multiple layers of paint / lead paint).
- Security screen mountings are mortised into the brickmold.
- Upper sash painted in place.
- Glazing caulk is tested as having ACM.
- Accessing window weight box will require removing the galvanized metal jamb guides - access port is blocked.
- Plexiglass at lower sash.
- Sill rotten.
- Broken glazing on upper sash.
- Rotten corners on lower sash rail.
- No hardware.

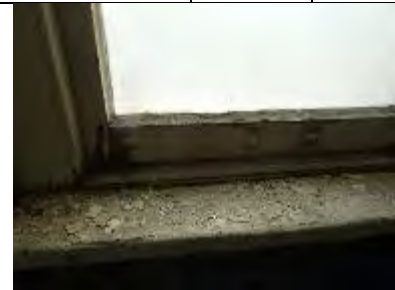
E310-03: Damage along lower rail

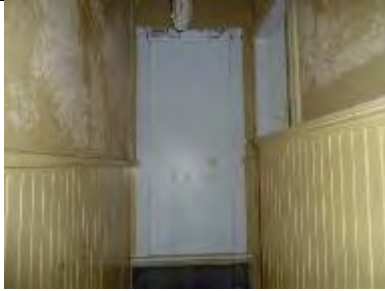
N306-01: Interior view of window

- Window boarded at both sides: Plywood at exterior and gypsum board at interior. Assumed boarded by MPS due to condition being too damaged to repair.

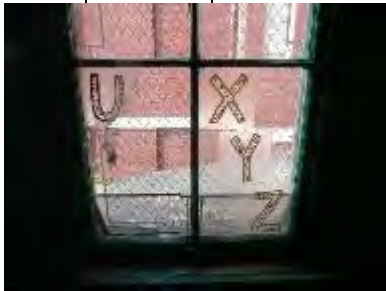
S332-01: Interior view of lower sash

- Paint is crazed (multiple layers of paint / lead paint).
- Security screen mountings are mortised into the brickmold.
- Upper sash painted in place.
- Glazing caulk is tested as having ACM.
- Accessing window weight box will require removing the galvanized metal jamb guides - access port is blocked.
- Severe water damage to structure in this area.
- Head rot
- Broken glazing

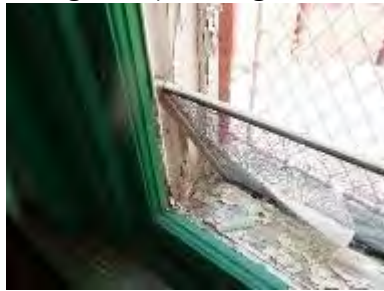
S332-02: Rot to exterior sill & jamb

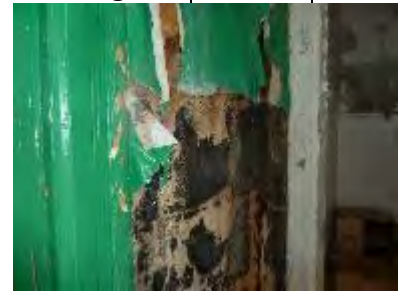
S332-03: Water damage to wall to right of window

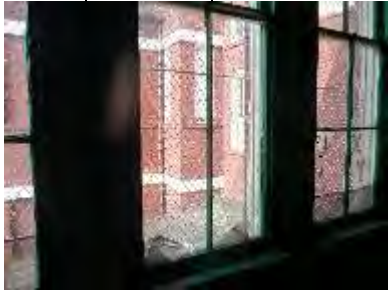
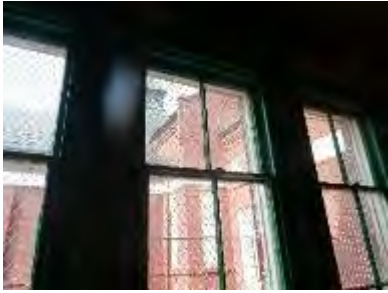
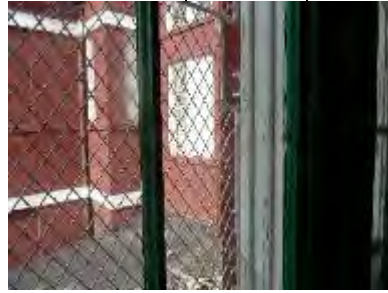
Room	Window	Window Configuration Type	Replace	Repair
216	S333	Double-hung with 2/4 cottage sash configuration	✓

<p>S333-01: Interior view of lower sash      S333-02: Interior view of upper sash      S333-03: Missing muntin on lower sash</p> <p><b>Condition Comments</b></p> <ul style="list-style-type: none"> <li>- Paint is crazed (multiple layers of paint / lead paint).</li> <li>- Security screen mountings are mortised into the brickmold.</li> <li>- Upper sash painted in place.</li> <li>- Glazing caulk is tested as having ACM.</li> <li>- Accessing window weight box will require removing the galvanized metal jamb guides - access port is blocked.</li> <li>- Missing muntins.</li> <li>- Rotted sill.</li> </ul>

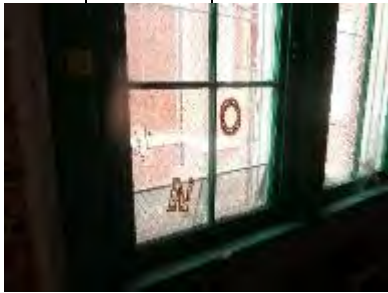
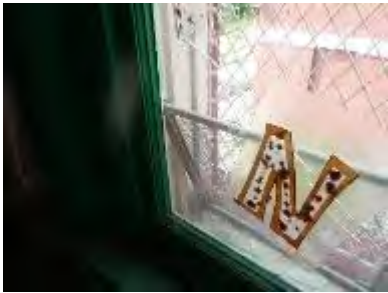
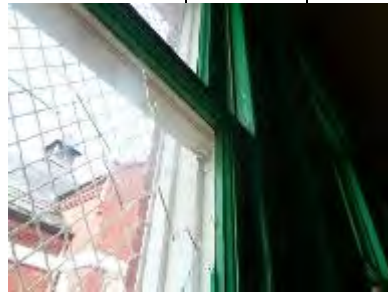
Room	Window	Window Configuration Type	Replace	Repair
216	S334	Double-hung with 2/4 cottage sash configuration	✓

<p>S334-01: Interior view of lower sash      S334-02: Interior view of upper sash      S334-03: Exterior view at center</p> <p><b>Condition Comments</b></p> <ul style="list-style-type: none"> <li>- Paint is crazed (multiple layers of paint / lead paint).</li> <li>- Security screen mountings are mortised into the brickmold.</li> <li>- Upper sash painted in place.</li> <li>- Glazing caulk is tested as having ACM.</li> <li>- Accessing window weight box will require removing the galvanized metal jamb guides - access port is blocked.</li> <li>- Broken glazing.</li> <li>- Upper sash meeting rail right corner blown out.</li> </ul>

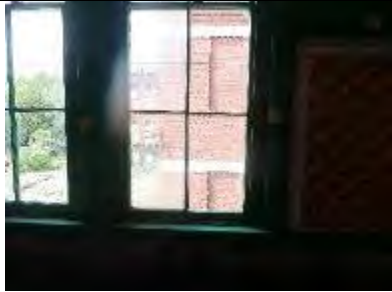
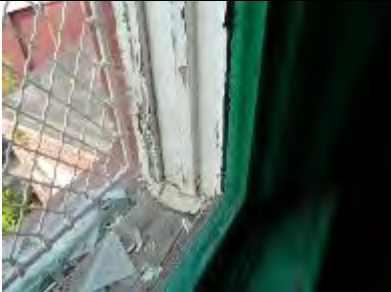
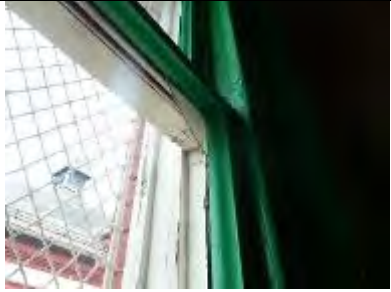
Room	Window	Window Configuration Type	Replace	Repair
216	S335	Double-hung with 2 / 4 cottage sash configuration	✓

<p>S335-01: Interior view of lower sash      S335-02: Damage along jamb on right side      S335-03: Blown corner of upper sash</p> <p><b>Condition Comments</b></p> <ul style="list-style-type: none"> <li>- Paint is crazed (multiple layers of paint / lead paint).</li> <li>- Security screen mountings are mortised into the brickmold.</li> <li>- Upper sash painted in place.</li> <li>- Glazing caulk is tested as having ACM.</li> <li>- Accessing window weight box will require removing the galvanized metal jamb guides - access port is blocked.</li> <li>- Exterior stops &amp; sill decayed/checked.</li> <li>- Damaged muntins.</li> <li>- Broken glazing &amp; ropes for weights.</li> <li>- Blown corners on upper sash meeting rail.</li> <li>- No hardware.</li> </ul>

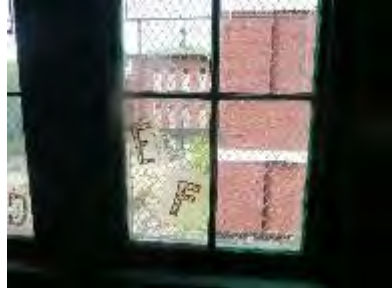
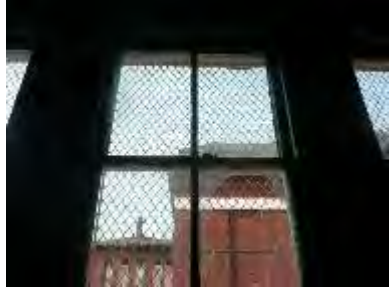
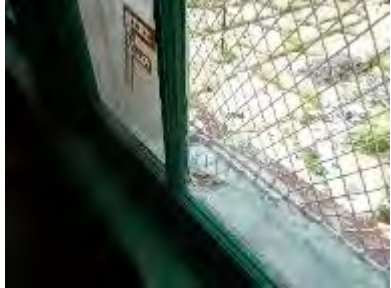
Room	Window	Window Configuration Type	Replace	Repair
216	S336	Double-hung with 2 / 4 cottage sash configuration	✓

<p>S336-01: Interior view of lower sash      S336-02: Interior view of upper sash      S336-03: Rotted exterior sill</p> <p><b>Condition Comments</b></p> <ul style="list-style-type: none"> <li>- Paint is crazed (multiple layers of paint / lead paint).</li> <li>- Security screen mountings are mortised into the brickmold.</li> <li>- Upper sash painted in place.</li> <li>- Glazing caulk is tested as having ACM.</li> <li>- Accessing window weight box will require removing the galvanized metal jamb guides - access port is blocked.</li> <li>- Exterior stops &amp; sill decayed/checked.</li> <li>- Damaged muntins.</li> <li>- Broken glazing &amp; ropes for weights.</li> <li>- Blown corners on upper sash meeting rail.</li> <li>- No hardware.</li> </ul>

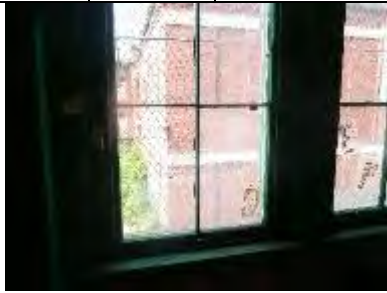
S337-01: Interior view of lower sash

- Paint is crazed (multiple layers of paint / lead paint).
- Security screen mountings are mortised into the brickmold.
- Upper sash painted in place.
- Glazing caulk is tested as having ACM.
- Accessing window weight box will require removing the galvanized metal jamb guides - access port is blocked.
- Exterior stops & sill decayed/checked.
- Damaged muntins.
- Broken glazing & ropes for weights.
- Blown corners on upper sash meeting rail.

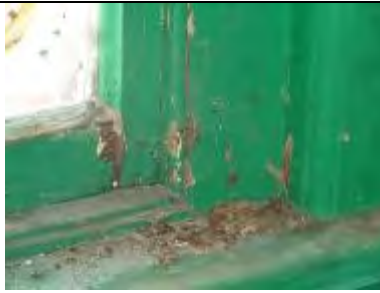
S337-02: Damage on interior sill & trim

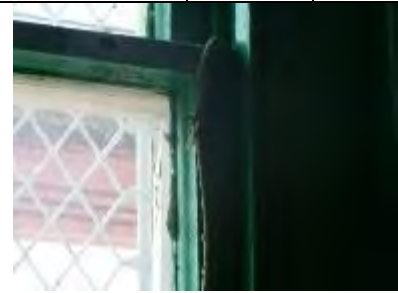
S337-03: Broken rope for weight

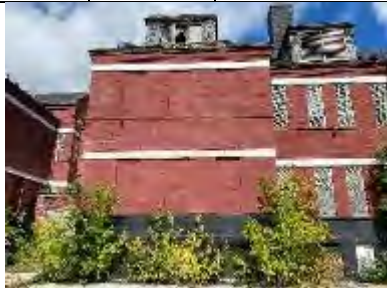
S338-S340-01: Exterior view

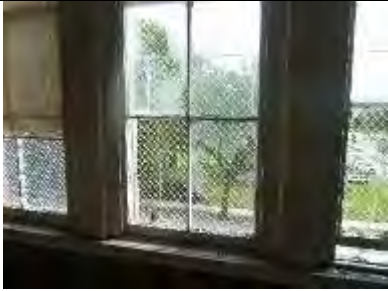
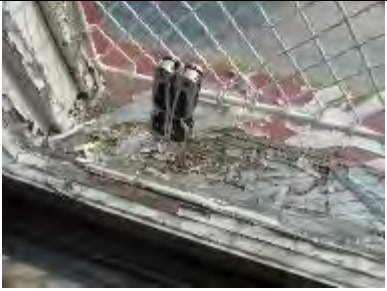
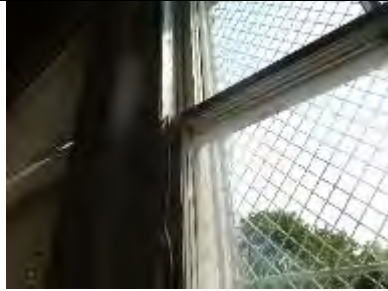
<p>E301-01: Interior view of lower sash      E301-02: Rotted exterior sill      E301-03: Broken rope for weight</p> <p><b>Condition Comments</b></p> <ul style="list-style-type: none"> <li>- Paint is crazed (multiple layers of paint / lead paint).</li> <li>- Security screen mountings are mortised into the brickmold.</li> <li>- Upper sash painted in place.</li> <li>- Glazing caulk is tested as having ACM.</li> <li>- Accessing window weight box will require removing the galvanized metal jamb guides - access port is blocked.</li> <li>- Rotten sill - ¼" penetration</li> <li>- Broken glazing on lower sash.</li> <li>- Broken ropes for weights.</li> </ul>

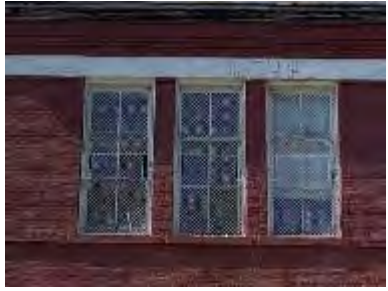
<p>E301-04: Exterior view at center</p>

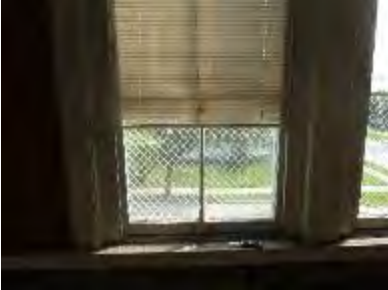
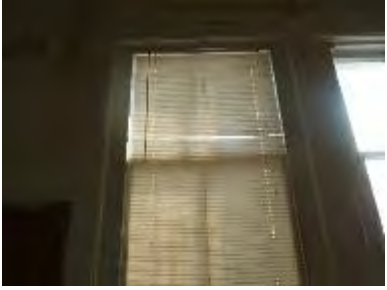
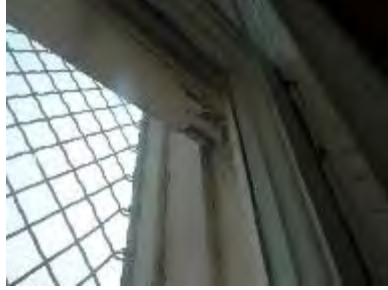
<p>E302-01: Interior view of lower sash      E302-02: Interior view of upper sash      E302-03: Blown corner of upper sash</p> <p><b>Condition Comments</b></p> <ul style="list-style-type: none"> <li>- Paint is crazed (multiple layers of paint / lead paint).</li> <li>- Security screen mountings are mortised into the brickmold.</li> <li>- Upper sash painted in place.</li> <li>- Glazing caulk is tested as having ACM.</li> <li>- Accessing window weight box will require removing the galvanized metal jamb guides - access port is blocked.</li> <li>- Rotten bottom left casing on interior.</li> <li>- Metal glides.</li> <li>- Broken glazing on lower sash.</li> <li>- Blown corners on upper sash meeting rail.</li> </ul>

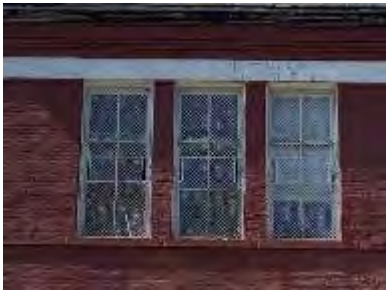
<p>E302-04: Exterior view on right</p>

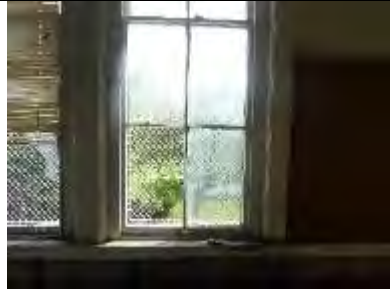
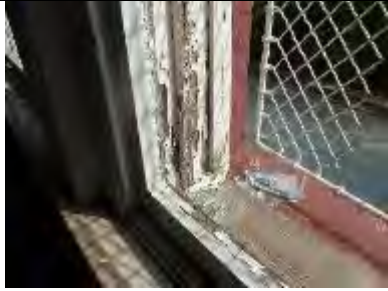
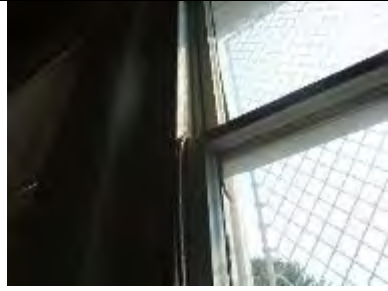
<p>E303-01: Interior view of lower sash      E303-02: Damage to jamb on left side      E303-03: Broken rope for weight</p> <p><b>Condition Comments</b></p> <ul style="list-style-type: none"> <li>- Paint is crazed (multiple layers of paint / lead paint).</li> <li>- Security screen mountings are mortised into the brickmold.</li> <li>- Upper sash painted in place.</li> <li>- Glazing caulk is tested as having ACM.</li> <li>- Accessing window weight box will require removing the galvanized metal jamb guides - access port is blocked.</li> <li>- Muntins are lose.</li> <li>- Broken glazing.</li> <li>- Exterior stops damaged.</li> <li>- Checking at exterior sill.</li> <li>- Broken ropes for weights.</li> </ul>

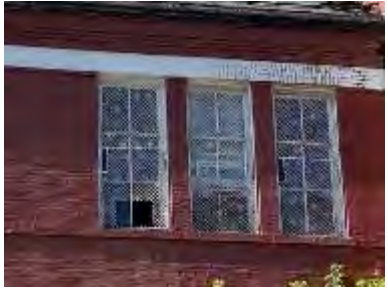
<p>E303-04: Exterior view at left</p>

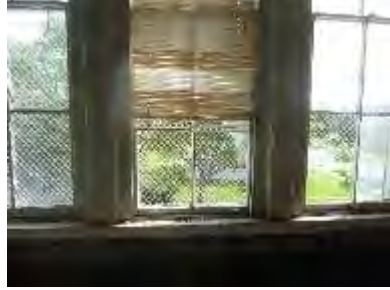
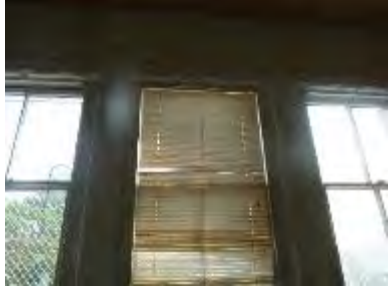
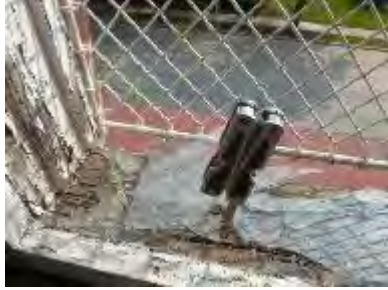
<p>E304-01: Interior view of lower sash      E304-02: Interior view of upper sash      E304-03: Rotted exterior sill</p> <p><b>Condition Comments</b></p> <ul style="list-style-type: none"> <li>- Paint is crazed (multiple layers of paint / lead paint).</li> <li>- Security screen mountings are mortised into the brickmold.</li> <li>- Upper sash painted in place.</li> <li>- Glazing caulk is tested as having ACM.</li> <li>- Accessing window weight box will require removing the galvanized metal jamb guides - access port is blocked.</li> <li>- Exterior sill rotten.</li> <li>- Exterior stops in poor condition.</li> <li>- Broken glazing &amp; ropes for weights.</li> </ul>

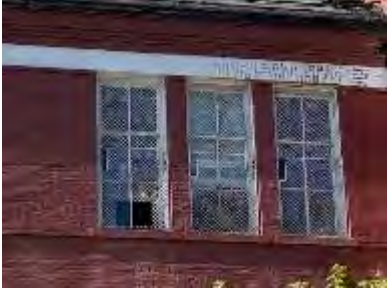
<p>E304-04: Exterior view at center</p>

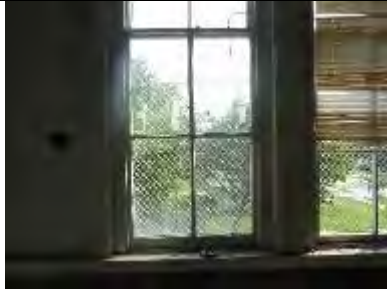
E305-01: Interior view of lower sash

- Paint is crazed (multiple layers of paint / lead paint).
- Security screen mountings are mortised into the brickmold.
- Upper sash painted in place.
- Glazing caulk is tested as having ACM.
- Accessing window weight box will require removing the galvanized metal jamb guides - access port is blocked.
- Rotten bottom left casing on interior.
- Metal glides.
- Broken glazing & ropes for weights.
- Blown corner on upper sash meeting rail.

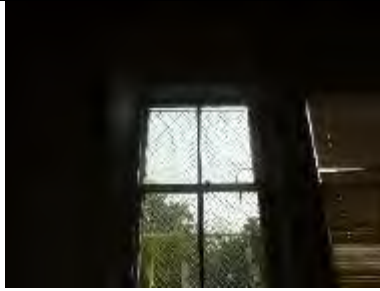
E305-02: Interior view of upper sash

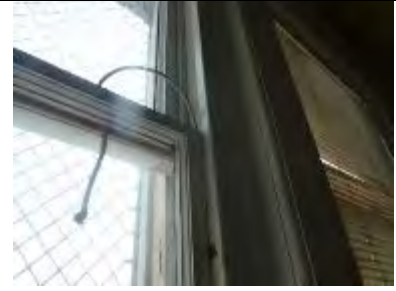
E305-03: Broken rope for weight

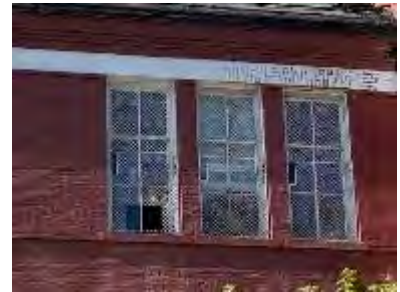
E305-03: Exterior view at right

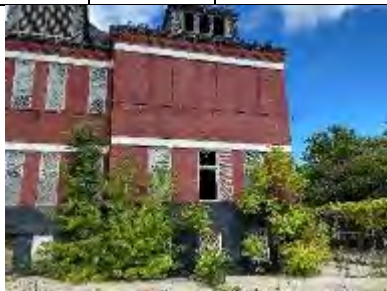
S345-S347-01: Exterior view

- Window opening bricked-in at exterior. Wall is plastered over at interior.

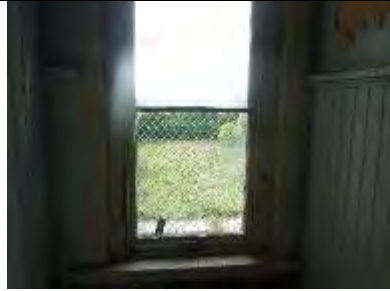
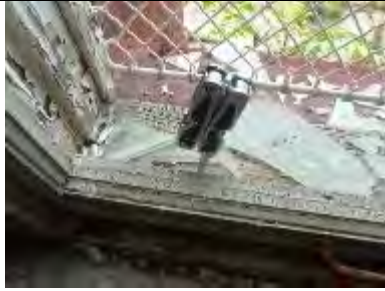
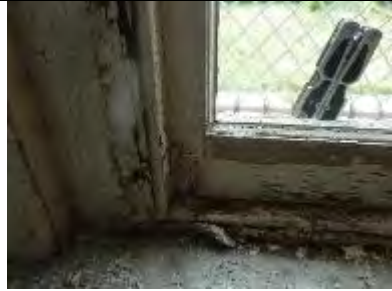
<p>S344-01: Interior view of lower sash      S344-02: Rotted exterior sill      S344-03: Left jamb and sash corner</p> <p><b>Condition Comments</b></p> <ul style="list-style-type: none"> <li>- Paint is crazed (multiple layers of paint / lead paint).</li> <li>- Security screen mountings are mortised into the brickmold.</li> <li>- Upper sash painted in place.</li> <li>- Glazing caulk is tested as having ACM.</li> <li>- Accessing window weight box will require removing the galvanized metal jamb guides - access port is blocked.</li> <li>- Rotten sill &amp; stops.</li> <li>- Severe water damage.</li> <li>- Broken glazing.</li> </ul>

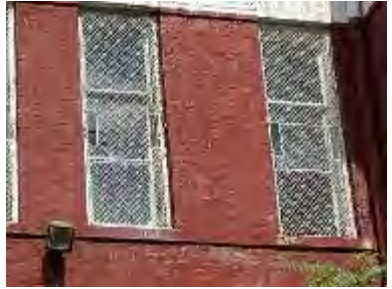
<p>S344-04: Exterior view at right</p>

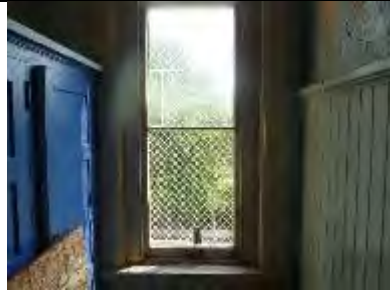
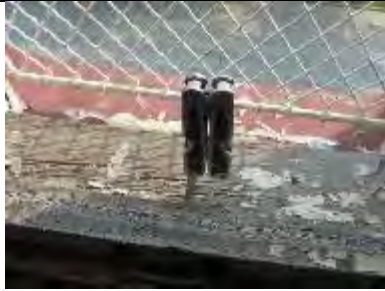
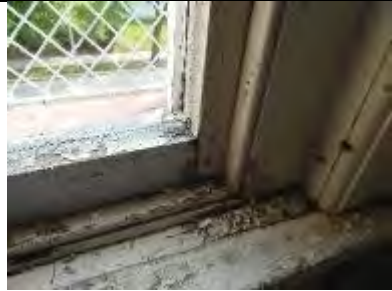
<p>E306-01: Interior view of lower sash      E306-02: Rotted exterior sill      E306-03: Sill and jamb condition</p> <p><b>Condition Comments</b></p> <ul style="list-style-type: none"> <li>- Paint is crazed (multiple layers of paint / lead paint).</li> <li>- Security screen mountings are mortised into the brickmold.</li> <li>- Upper sash painted in place.</li> <li>- Glazing caulk is tested as having ACM.</li> <li>- Accessing window weight box will require removing the galvanized metal jamb guides - access port is blocked.</li> <li>- Exterior sill rotten.</li> <li>- Upper sash meeting rail corner blown.</li> <li>- Lower sash rotten with blown corners.</li> <li>- Broken glazing on lower sash.</li> </ul>

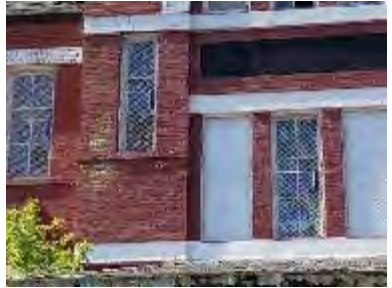
<p>E306-04: Exterior view at left</p>

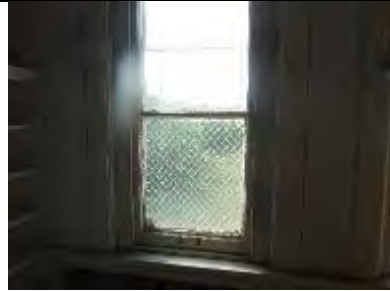
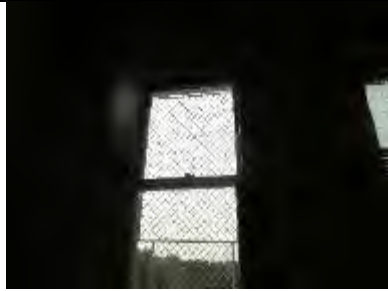
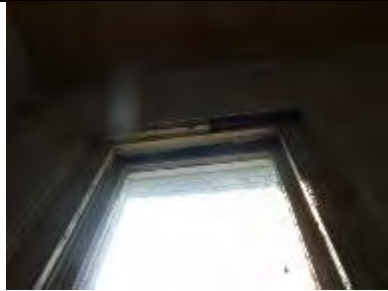
<p>S343-01: Interior view of lower sash      S343-02: Interior view of upper sash      S343-03: Header condition</p> <p><b>Condition Comments</b></p> <ul style="list-style-type: none"> <li>- Paint is crazed (multiple layers of paint / lead paint).</li> <li>- Security screen mountings are mortised into the brickmold.</li> <li>- Upper sash painted in place.</li> <li>- Glazing caulk is tested as having ACM.</li> <li>- Accessing window weight box will require removing the galvanized metal jamb guides - access port is blocked.</li> <li>- Rotted sill &amp; stops.</li> <li>- Missing hardware.</li> <li>- Blown corners at upper sash meeting rail.</li> <li>- Severe rot with interior head.</li> </ul>

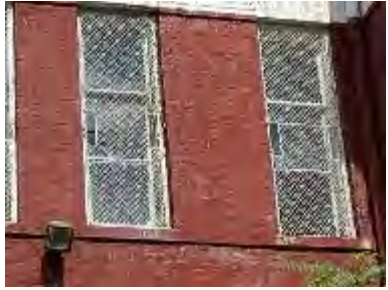
<p>S343-04: Exterior view on left</p>

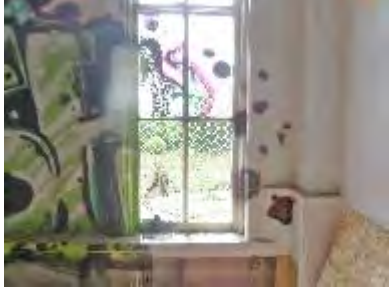
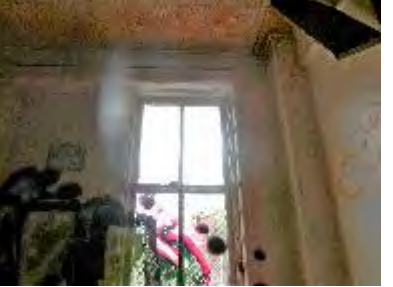
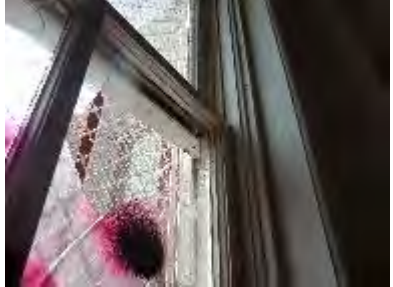
<p>S330A-01: Interior view of lower sash      S330A-02: Interior view of upper sash      S330A-03: Blown corner on upper sash</p> <p><b>Condition Comments</b></p> <ul style="list-style-type: none"> <li>- Paint is crazed (multiple layers of paint / lead paint).</li> <li>- Security screen mountings are mortised into the brickmold.</li> <li>- Upper sash painted in place.</li> <li>- Glazing caulk is tested as having ACM.</li> <li>- Accessing window weight box will require removing the galvanized metal jamb guides - access port is blocked.</li> <li>- Rotted sill.</li> <li>- Damaged lower sash rail</li> <li>- Broken glazing.</li> <li>- Upper sash meeting rail corners damaged.</li> </ul>

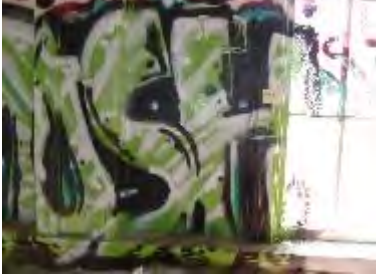
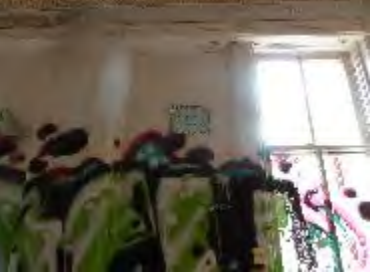
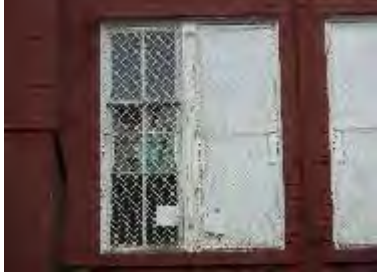
Room	Window	Window Configuration Type	Replace	Repair
ST-4	S330B	Abandoned: Double-hung with 2/4 cottage sash configuration original		✓

<p>S330B-01: Interior view of lower half      S330B-02: Interior view of upper half      S330B-03: Exterior view on right</p> <p><b>Condition Comments</b></p> <ul style="list-style-type: none"> <li>- Window boarded at both sides: Plywood at exterior and gypsum board at interior. Assumed boarded by MPS due to condition being too far gone to repair.</li> </ul>

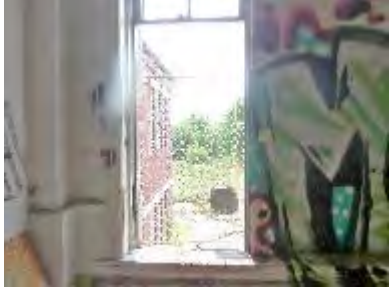
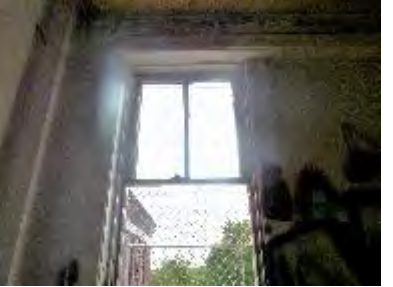
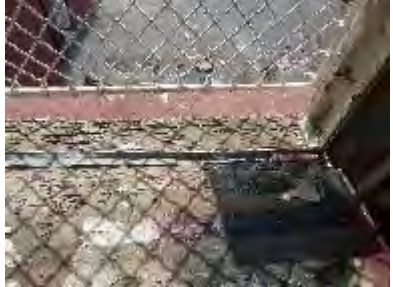
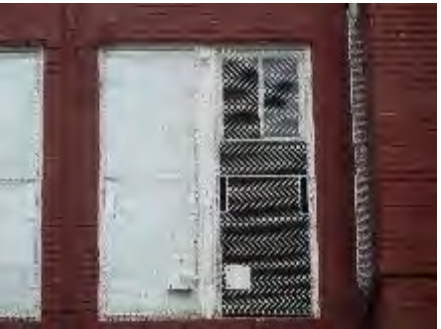
Room	Window	Window Configuration Type	Replace	Repair
ST-4	S331A	Double-hung with 2/4 cottage sash configuration		✓

<p>S331A-01: Interior view of lower sash      S331A-02: Interior view of upper sash      S331A-03: Exterior sill condition</p> <p><b>Condition Comments</b></p> <ul style="list-style-type: none"> <li>- Paint is crazed (multiple layers of paint / lead paint).</li> <li>- Security screen mountings are mortised into the brickmold.</li> <li>- Upper sash painted in place.</li> <li>- Glazing caulk is tested as having ACM.</li> <li>- Accessing window weight box will require removing the galvanized metal jamb guides - access port is blocked.</li> <li>- Missing lower sash &amp; interior stops.</li> <li>- Rotted &amp; damaged exterior &amp; interior sills.</li> </ul>

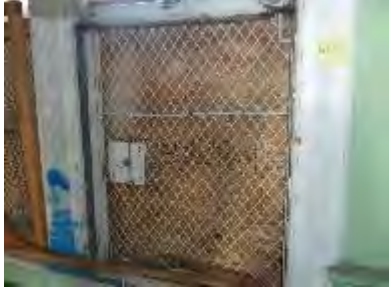
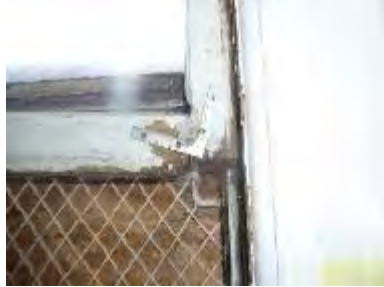
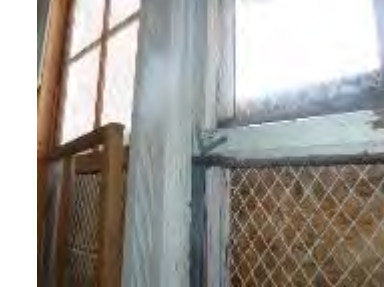
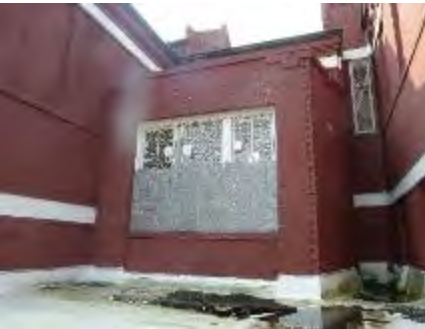
Room	Window	Window Configuration Type	Replace	Repair
ST-4	N315	Double-hung with 4/4 cottage sash configuration	✓

<p>N315-01: Interior view of lower sash      N315-02: Blown corner on lower sash      N315-03: Blown corner on lower sash</p> <p><b>Condition Comments</b></p> <ul style="list-style-type: none"> <li>- Paint is crazed (multiple layers of paint / lead paint).</li> <li>- Security screen mountings are mortised into the brickmold.</li> <li>- Upper sash painted in place.</li> <li>- Glazing caulk is tested as having ACM.</li> <li>- Accessing window weight box will require removing the galvanized metal jamb guides - access port is blocked.</li> <li>- Broken muntins - not original.</li> <li>- Sill rotten.</li> <li>- Missing portion of left jamb.</li> <li>- Upper sash meeting rail corners blown.</li> </ul>

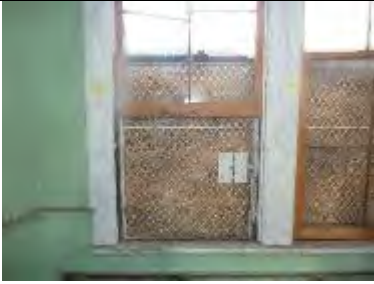
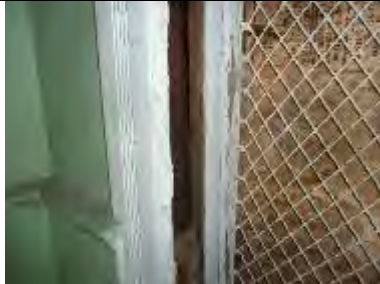
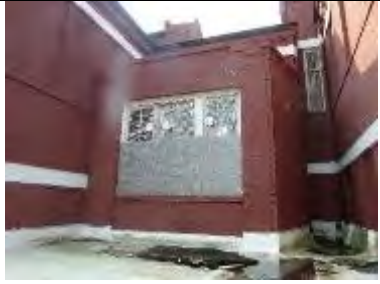
Room	Window	Window Configuration Type	Replace	Repair
ST-4	N317	Double-hung with 4/4 cottage sash configuration	✓

<p>N317-01: Interior view of lower sash      N317-02: Missing jamb &amp; trim pieces      N317-03: Exterior view on right</p> <p><b>Condition Comments</b></p> <ul style="list-style-type: none"> <li>- Paint is crazed (multiple layers of paint / lead paint).</li> <li>- Security screen mountings are mortised into the brickmold.</li> <li>- Upper sash painted in place.</li> <li>- Glazing caulk is tested as having ACM.</li> <li>- Accessing window weight box will require removing the galvanized metal jamb guides - access port is blocked.</li> <li>- Lower sash corners blown out &amp; strapped.</li> <li>- Missing muntins.</li> <li>- Missing jambs.</li> <li>- Upper sash meeting rail corners blown.</li> </ul>				
Room	Window	Window Configuration Type	Replace	Repair
ST-7	E307	Abandoned: Double-hung – fixed sashes		✓

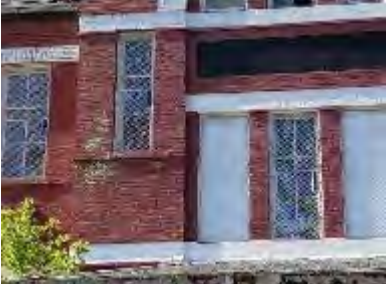
<p>E307-01: Interior view of lower half      E307-02: Interior view of upper half      E307-03: Exterior view at center</p> <p><b>Condition Comments</b></p> <ul style="list-style-type: none"> <li>- Window boarded at both sides: Plywood at exterior and gypsum board at interior. Assumed boarded by MPS due to condition being too far gone to repair.</li> </ul>				
Room	Window	Window Configuration Type	Replace	Repair
ST-7	E309	Abandoned: Double-hung – fixed sashes		✓

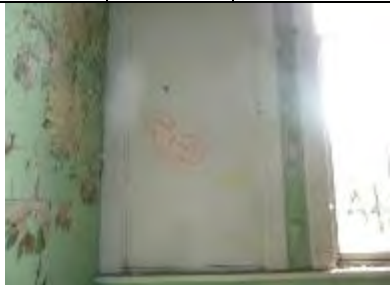
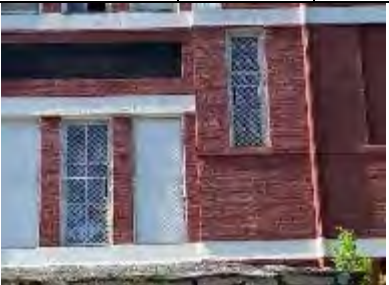
<p>E309-01: Interior view of lower half      E309-02: Interior view of upper half      E309-03: Exterior view at center</p> <p><b>Condition Comments</b></p> <ul style="list-style-type: none"> <li>- Window boarded at both sides: Plywood at exterior and gypsum board at interior. Assumed boarded by MPS due to condition being too far gone to repair.</li> </ul>

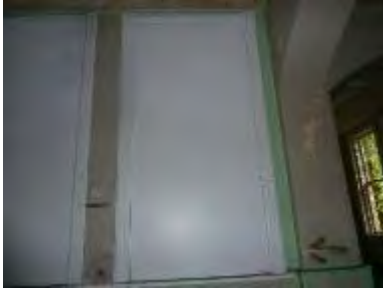
LC305-01: Interior view

- Covered both sides: Painted plywood at exterior and gypsum board at interior. Assumed boarded by MPS due to condition being too damaged to repair.
- Unknown whether any original window framing / sashes at interior.
- Exterior wood sill is severely decayed. Stone sill covered in metal flashing.

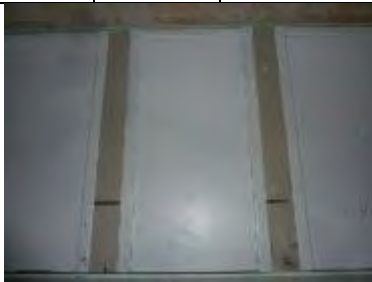
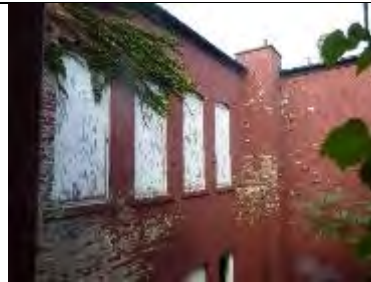
LC306-01: Interior view at center

- Covered both sides: Painted plywood at exterior and gypsum board at interior. Assumed boarded by MPS due to condition being damaged gone to repair.
- Unknown whether any original window framing / sashes at interior.
- Exterior sill is severely decayed and covered with metal flashing.

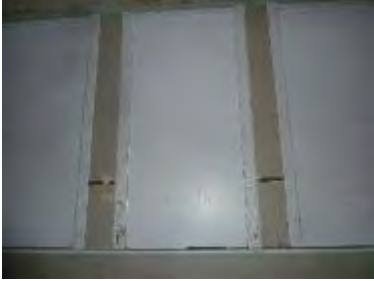
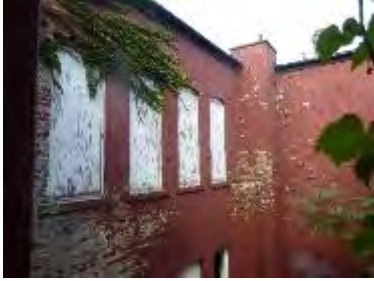
Room	Window	Window Configuration Type	Replace	Repair
Light Court A	LC307	Abandoned: Double-hung w/arched wood head at exterior original	✓

<p>LC307-01: Interior view at center      LC308-02: Exterior view at center left</p> <p><b>Condition Comments</b></p> <ul style="list-style-type: none"> <li>- Covered both sides: Painted plywood at exterior and gypsum board at interior. Assumed boarded by MPS due to condition being too damaged to repair.</li> <li>- Unknown whether any original window framing / sashes at interior.</li> <li>- Exterior wood sill is severely decayed. Stone sill covered in metal flashing.</li> </ul>		
Room	Window	Window Configuration Type	Replace	Repair
Light Court A	LC308	Abandoned: Double-hung w/arched wood head at exterior original	✓

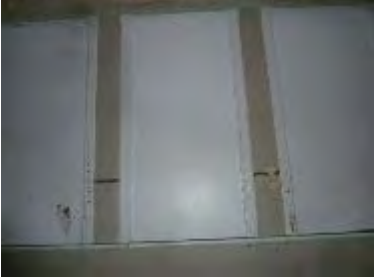
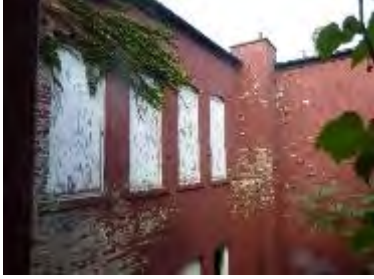
<p>LC308-01: Interior view at center      LC308-02: Exterior view at center right</p> <p><b>Condition Comments</b></p> <ul style="list-style-type: none"> <li>- Covered both sides: Painted plywood at exterior and gypsum board at interior. Assumed boarded by MPS due to condition being too damaged to repair.</li> <li>- Unknown whether any original window framing / sashes at interior.</li> <li>- Exterior wood sill is severely decayed. Stone sill covered in metal flashing.</li> </ul>

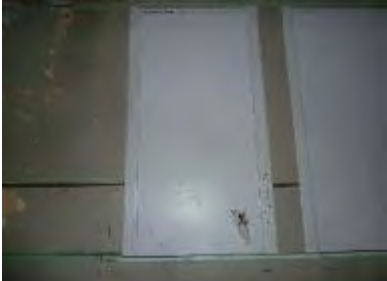
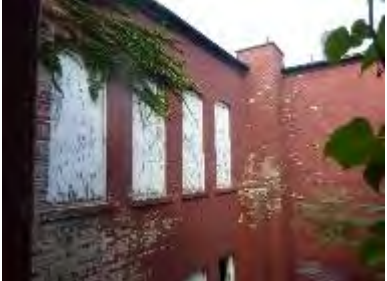
Room	Window	Window Configuration Type	Replace	Repair
Light Court A	LC309	Abandoned: Double-hung w/arched wood head at exterior original	✓

<p>LC309-01: Interior view of window      LC309-02: Exterior view at far right</p> <p><b>Condition Comments</b></p> <ul style="list-style-type: none"> <li>- Covered both sides: Painted plywood at exterior and gypsum board at interior. Assumed boarded by MPS due to condition being too damaged to repair.</li> <li>- Unknown whether any original window framing / sashes at interior.</li> <li>- Exterior wood sill is severely decayed. Stone sill covered in metal flashing.</li> </ul>

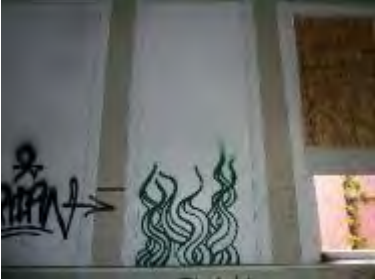
Room	Window	Window Configuration Type	Replace	Repair
Light Court A	LC311	Abandoned: Double-hung w/arched wood head at exterior original	✓

<p>LC311-01: Interior view at center</p> <p><b>Condition Comments</b></p> <ul style="list-style-type: none"> <li>- Covered both sides: Painted plywood at exterior and gypsum board at interior. Assumed boarded by MPS due to condition being too damaged to repair.</li> <li>- Unknown whether any original window framing / sashes at interior.</li> <li>- Exterior wood sill is probably water damaged according to staining on sill and panel.</li> </ul>

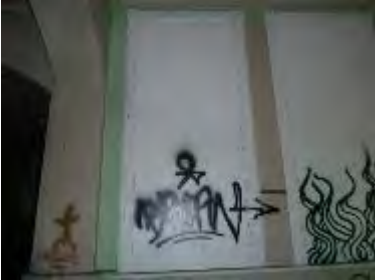
Room	Window	Window Configuration Type	Replace	Repair
Light Court A	LC312	Abandoned: Double-hung w/arched wood head at exterior original	✓

<p>LC312-01: Interior view</p> <p><b>Condition Comments</b></p> <ul style="list-style-type: none"> <li>- Covered both sides: Painted plywood at exterior and gypsum board at interior. Assumed boarded by MPS due to condition being too damaged to repair.</li> <li>- Unknown whether any original window framing / sashes at interior.</li> <li>- Exterior wood sill is severely decayed. Stone sill covered in metal flashing.</li> </ul>

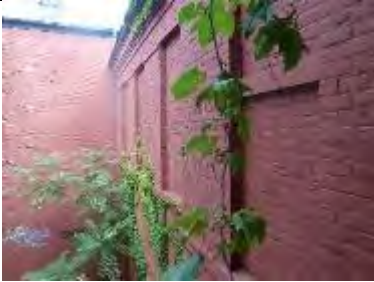
LC313-LC316-01: Exterior view (l to r)

- No plans to remove masonry and re-open.

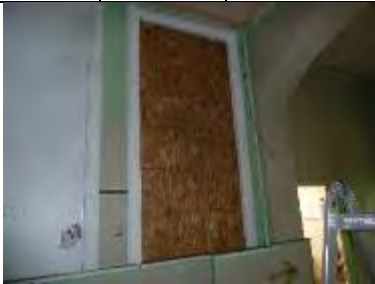
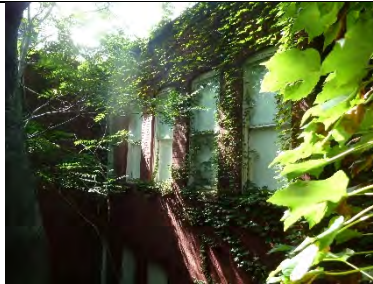
Room	Window	Window Configuration Type	Replace	Repair
Light Court B	LC300	Double-hung with arched wood trim head at exterior	✓

LC300-01: Interior view of window

LC300-02: Exterior view at far left

- Couldn't remove interior plywood covering. Not boarded at exterior.
- Upper sash corners blown out.
- Rotted exterior sill.

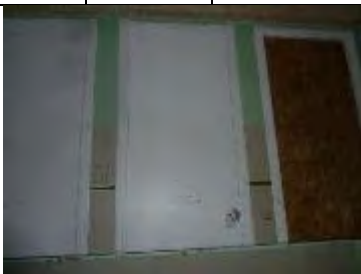
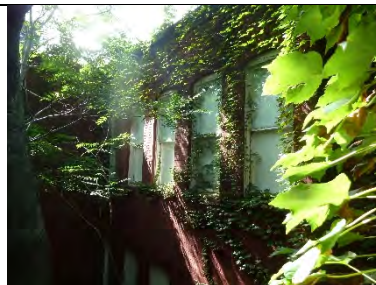
Room	Window	Window Configuration Type	Replace	Repair
Light Court B	LC301	Abandoned: Double-hung w/arched wood head at exterior original	✓

LC301-01: Interior view at center

LC301-02: Exterior – 2nd from left

- Covered at interior with painted gypsum board. Not boarded at exterior.
- Meeting rail at upper sash corners decayed.
- Exterior wood sill is decayed.

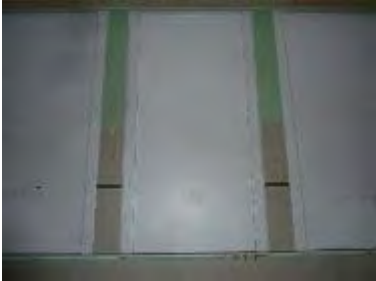
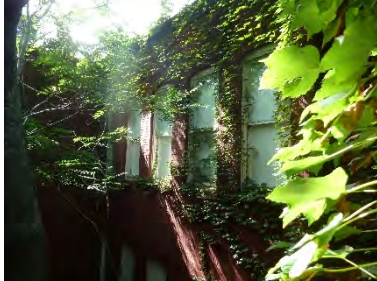
Room	Window	Window Configuration Type	Replace	Repair
Light Court B	LC302	Abandoned: Double-hung w/arched wood head at exterior original	✓

<p>LC302-01: Interior view at center      LC302-02: Exterior 3rd from left</p> <p><b>Condition Comments</b></p> <ul style="list-style-type: none"> <li>- Covered at interior with painted gypsum board. Not boarded at exterior.</li> <li>- Meeting rail at upper sash corners decayed.</li> <li>- Exterior wood sill is decayed.</li> </ul>

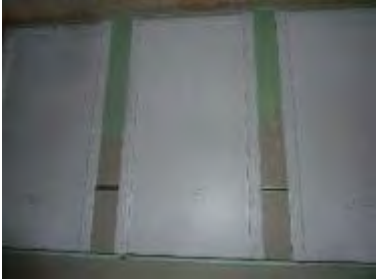
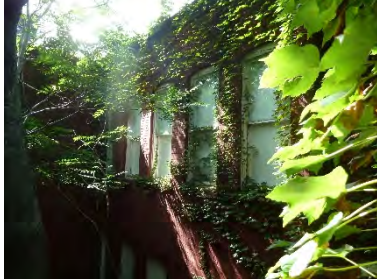
Room	Window	Window Configuration Type	Replace	Repair
Light Court B	LC303	Abandoned: Double-hung w/arched wood head at exterior original	✓

<p>LC303-01: Interior view at center      LC303-02: Exterior – 2<sup>nd</sup> from right</p> <p><b>Condition Comments</b></p> <ul style="list-style-type: none"> <li>- Covered at interior with painted gypsum board. Not boarded at exterior.</li> <li>- Meeting rail at upper sash corners decayed.</li> <li>- Exterior wood sill is decayed.</li> </ul>

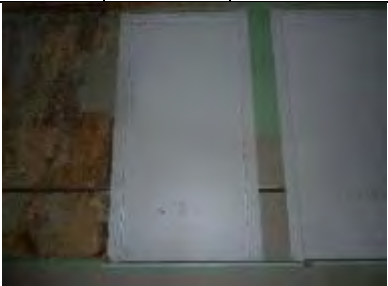
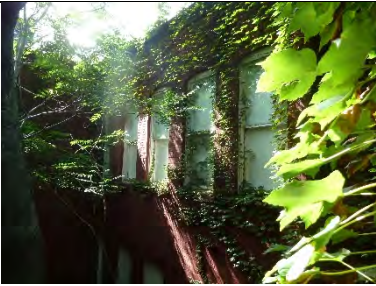
Room	Window	Window Configuration Type	Replace	Repair
Light Court B	LC304	Abandoned: Double-hung w/arched wood head at exterior original	✓

<p>LC304-01: Interior view      LC304-02: Exterior view at right</p> <p><b>Condition Comments</b></p> <ul style="list-style-type: none"> <li>- Covered at interior with painted gypsum board. Not boarded at exterior.</li> <li>- Meeting rail at upper sash corners decayed.</li> <li>- Exterior wood sill is decayed.</li> </ul>

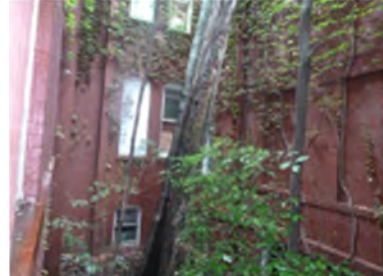
<p>LC318-LC320-01: Brick openings at upper right</p> <p><b>Condition Comments</b></p> <ul style="list-style-type: none"> <li>- No plans to remove masonry and re-open.</li> </ul>
