# Window Condition Survey

McKinley School Renovation

2001 W. Vliet St.  
Milwaukee WI, 53205

## **McKinley School Restoration Window Condition Survey**

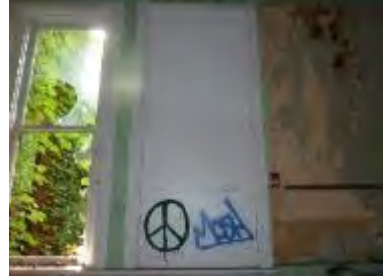
<p>LC322-01: Interior view</p> <p><b>Condition Comments</b></p> <ul style="list-style-type: none"> <li>- Covered both sides: Painted plywood at exterior and gypsum board at interior.</li> <li>- Unknown whether any original window framing / sashes at interior.</li> <li>- Exterior wood sill is probably water damaged according to staining on sill and panel.</li> </ul>

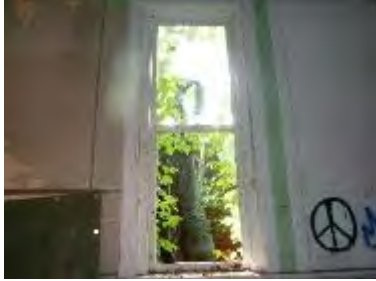
LC323-01: Interior view of window

- Broken / missing glazing for both sashes.
- Casings and trims dive behind continuous wood sill. Sill needs to be removed to pull the weight boxes/jambs.
- Paint is crazed (multiple layers of paint / lead paint).
- Exterior wood sill is decayed.
- No hardware
- Open joints at lower sash rail
- Lower sash bottom rail in poor condition.
- Upper sash painted in place.
- Glazing caulk is tested as having ACM.
- Accessing window weight box will require removing the galvanized metal jamb guides - access port is blocked.

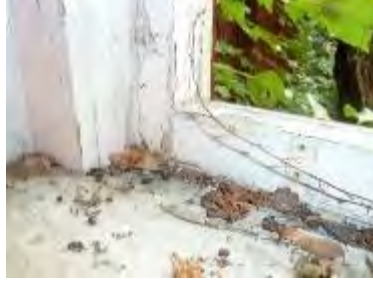
LC323-02: Damage along lower rail

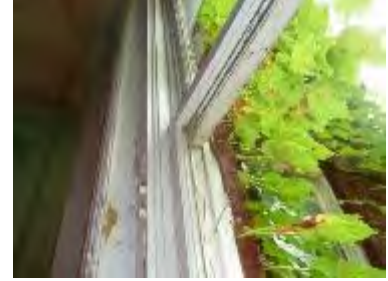
LC323-03: Jamb & meeting rail condition

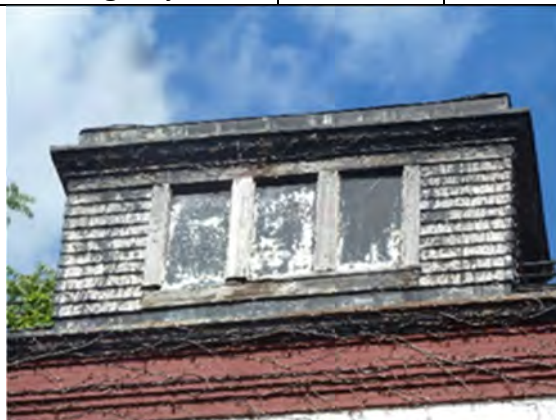
S400/S401/S402-01: Exterior view from left

- Severely decayed sill and jambs.
- Exterior casings decayed and warped.
- Window sashes missing – Transite panel installed in opening.
- Interior side inaccessible due to lack of access to west attic.

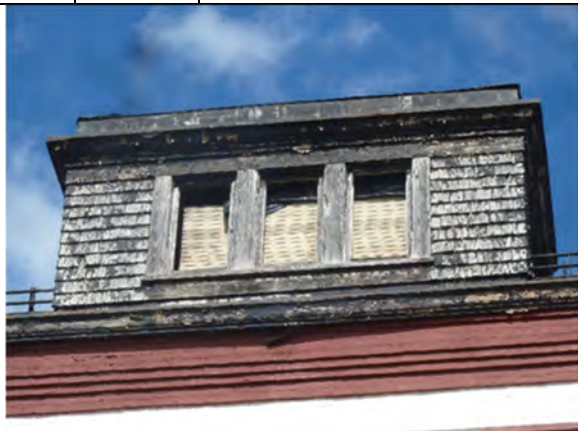
S404/S405/S406-01: Exterior view from left

- Severely decayed sill and jambs.
- Exterior casings decayed and warped.
- Window sashes missing – openings blocked from interior side with beadboard.
- Exterior jambs apparently only ever had one coat of paint.
- Windows possibly were always fixed sashes. No evidence of hinge or latch hardware.

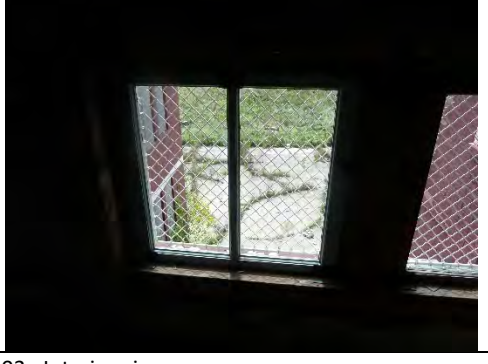
S407A/S407B-01: Exterior view from left		S407A-02: Interior view		
<p><b>Condition Comments</b></p> <p><b>S407A</b></p> <ul style="list-style-type: none"> <li>- Severely decayed sill.</li> <li>- Sash joints loose.</li> <li>- Glazing is broken</li> </ul> <p><b>S407B</b></p> <ul style="list-style-type: none"> <li>- Severely decayed sill.</li> <li>- Hopper hardware still functional</li> <li>- Sash is not original – has been replaced.</li> </ul>

S407B-03: Interior view		
Room	Window	Window Configuration Type	Replace	Repair
Attic	S408A	In-swing hopper	✓	
Attic	S408B	In-swing hopper	✓

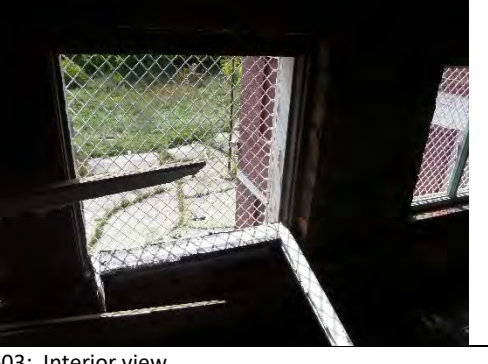
S408B-03: Interior view

S408A/S408B-01: Exterior view from right		S408A-02: Interior view from right		
<p><b>Condition Comments</b></p> <p><b>S408A</b></p> <ul style="list-style-type: none"> <li>- Severely decayed sill.</li> <li>- Bottom sash rail is loose.</li> <li>- Glazing is broken</li> </ul> <p><b>S408B</b></p> <ul style="list-style-type: none"> <li>- Severely decayed sill.</li> <li>- Sash is completely broken.</li> </ul>

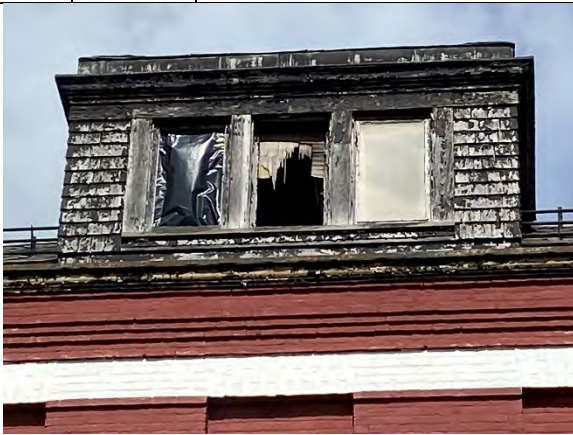
S409/S410/S411-01: Exterior view from left

- Sill assumed to be heavily weathered.
- Exterior casings decayed and warped.
- (2) sashes remaining with no glazing. Sashes do not appear to be original.
- (2) sash remaining with Plexiglas glazing. Sash does not appear to be original.

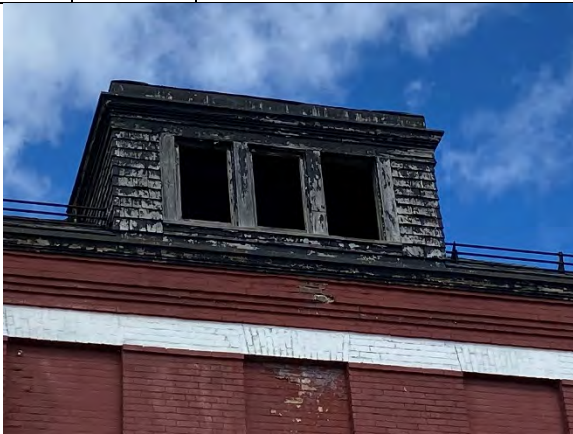
S413/S414/S415-01: Exterior view from left

- Sills heavily checked and in poor condition.
- Exterior casings decayed and warped.
- (1) window sash missing - (2) sashes remaining with no glazing.
- Sashes do not appear to be original.

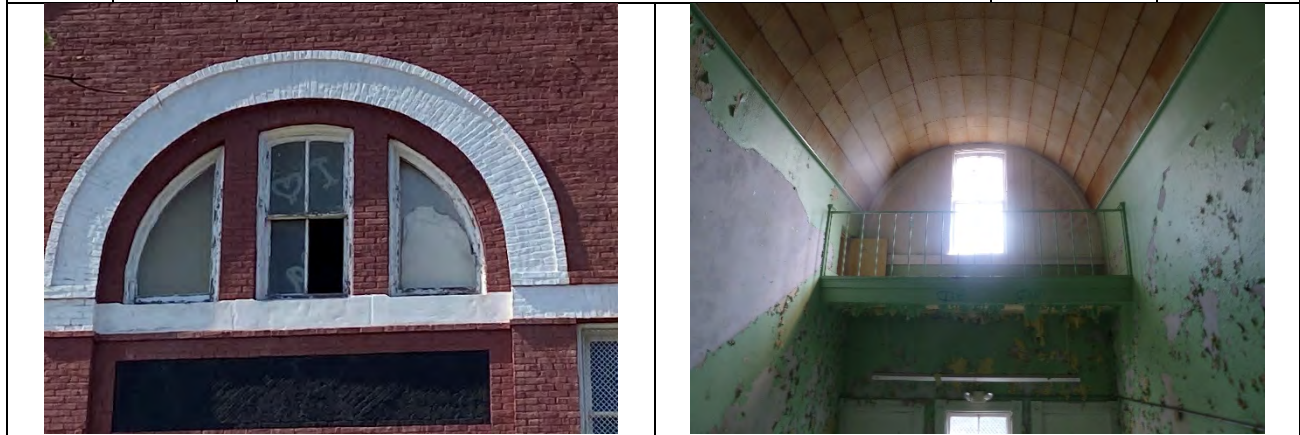
E400/E401/E402-01: Exterior view from left

- Windows are located on a small balcony above the second floor landing of the east stairway. The only access to the windows from the interior is via a scuttle on the north end of the balcony that can only be accessed by a ladder from the adjacent room
- Center arched window appears to be original and in poor shape on the exterior. Window is missing glass at the lower sash.
- Side half-arch windows appear to be original, in poor condition, and are covered at interior side with an opaque panel. From the street below, these windows appear to have glass or Plexiglas at the exterior. The windows do not appear to have muntins.
- These windows were a major focal point when the school faced North 20<sup>th</sup> Street.
