PROPOSAL AND SCOPE OF WORK

819 North Cass, Milwaukee, Wi

Rustic Restoration Inc.

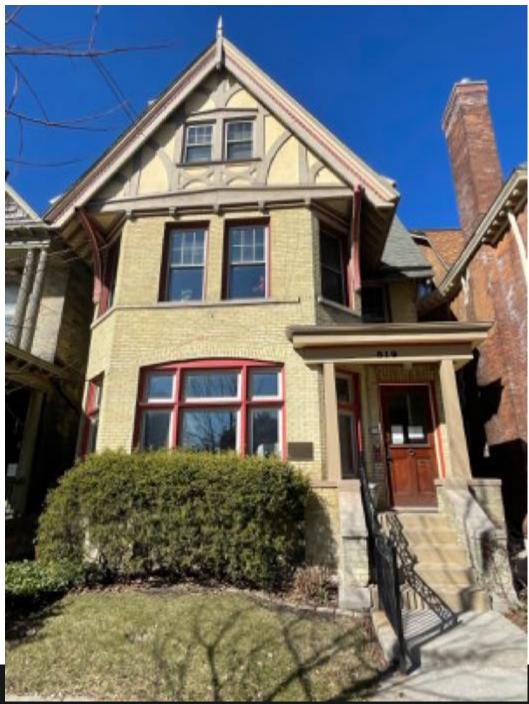
Item No. 1: East Elevation

The front of the building facing East is in overall good condonation. The largest issue is the check walls along the stairs are falling apart and need to be rebuilt. We also find some of the joints within the face brick have deteriorated. Overall, 10% of the elevation would require spot pointing.

- 1. Take down coping stones on cheek walls and remove brick
- a. Clean off mortar to reuse stone and brick
- 2. Address any foundation issues.
 - a. Review and repair foundation as needed.
 - b. Repairs to be charged as change order
- 3. Rebuild Cheek Walls
 - a. New mortar
 - b. Sealant at coping joints
- 4. Install sealant at vertical joints at water table stone.
- 5. Spot point 10% of mortar joints
- 6. Repair cracks in entry stone
- 7. Staging and site protection
