CERTIFICATE OF APPROPRIATENESS APPLICATION FORM

East Side Commercial Historic District

611 N. Broadway

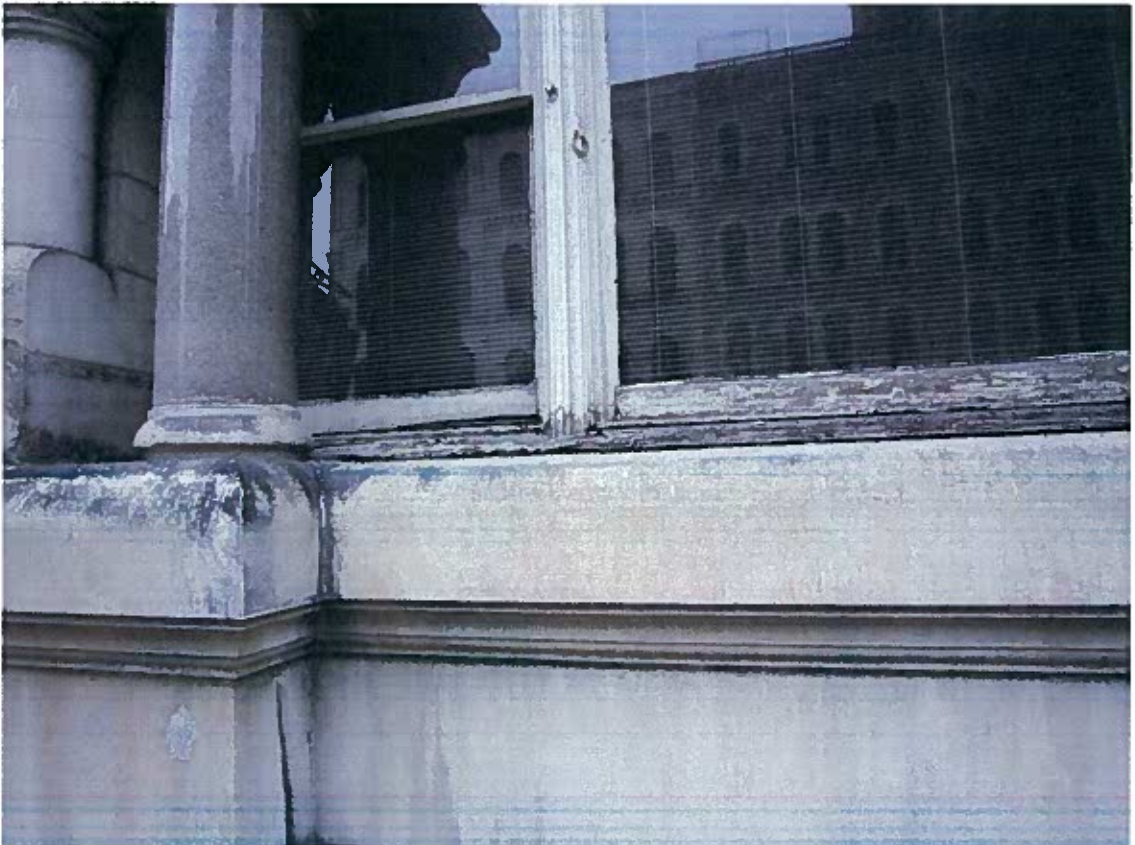
Photo 20: Typical window condition

Windows are in fair condition (Photos 13-16). Most of the windows in the building appear to be original wood sash with single-pane glazing. Storm sashes are not present. The windows have not been painted recently, so show significant areas of bare wood. Sills throughout the building exhibit severe checking (Photo 20). Some windows show deterioration of the bottom rail. Transom lites at the first floor of the Broadway façade have been infilled with an opaque material. A few windows have been replaced, particularly at the ground level of the Broadway façade, in the area well (Photo 17).

Windows will be scraped and sanded in preparation for painting. Sills will be repaired with Abatron LiquidWood and WoodEpoxy or equal by West System. Deteriorated sash members will be repaired with wood epoxy if possible, or replaced in kind. Windows will be fixed shut and repainted with exterior latex paint. Interior storm windows will be added for energy efficiency.

Where windows have previously been replaced or modified beyond repair, new double-hung wood sashes will be installed.
