CERTIFICATE OF APPROPRIATENESS APPLICATION FORM

MRS. WILLIS DANFORD HOUSE
819 N. CASS STREET

Certificate of Appropriateness Application

21 August 2023

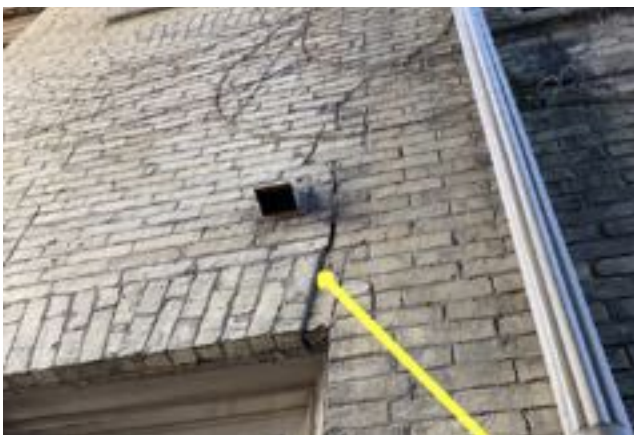
IMAGE 8: North elevation third-floor window head is near collapse.

No steel lintel is present at original window heads. Wood-head blocks are located on the interior; however, there is nothing supporting the exterior wythe soldier course elliptical. Step cracks and bulging are located atop each window rough opening. At the north elevation third-floor stair window and west elevation second-floor bedroom window brick units are loose and have slipped. Bulging is significant. (Both areas have been exposed to prolonged moisture.) Brick will be reset in the areas with the project mortar. Steel lintels will be installed at all flat-head arches with cotton rope weeps. Work efforts will begin with the most dire conditions until all window units are repaired.-

- Repoint deteriorated mortar joints as necessary using lime-patty mortar above the water table line.
- Repoint deteriorated joints below the water table line as needed utilizing NHL 3.5 mortar.
- Remove cracked/deteriorated mortar using the center-cut approach; do not over cut the brick.
- Finish new mortar to match historic raked profile.
- Do not artificially color mortar; use mortar with a sand

- mix that is similar in color or matches the original mortar
- Rebuild areas of severe cracking/dislodged brick by resetting the existing wherever possible. Replace with matching brick units only as necessary.

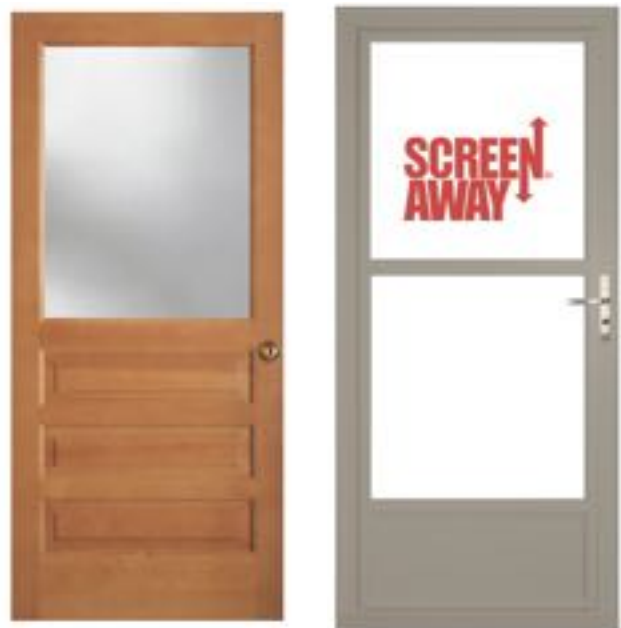
The existing second-floor entry door consists of a modern era steel six-panel leaf unit. The top two panels in this configuration are small rectangular lights. The doors style does not fit the building and the door is damaged from wear and lack of maintenance. The existing door leaf is 34" x 80". A jamb extension was utilized to reduce the opening size. An aluminum storm door with screen was installed years after the main door (undated).

IMAGE 11: Proposed replacement door and storm door.

- Replace the main door leaf with a 36" x 80" Simpson Door Company, 7118 Thermal Sash, Wood: Fir, clear upper light, three lower recessed panels. Finish: Painted.
- Note: If a storm door is permitted, the wood species and finish will be change to reflect a varnish to match the historic main east entry door.
- Replace the existing storm door with a powdered-coated aluminum Larson Premier Classic Elegance EasyVent® with Retractable Screen Away®, 2/3 glass doors with retractable Screen Away® design converts the storm door to a screen door with an unobstructed view
