Scot W. McLean, ASHI
333 W. Brown Deer Rd. #117, Bayside, WI 53217
Phone: 414-228-6573
<http://www.tandinspection.com>

Inspection Summary

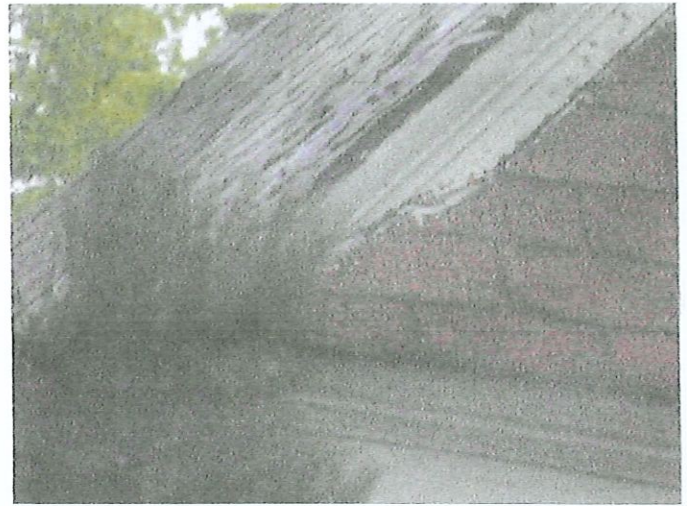
Siding Flashings

Inadequate flashings/sealants appear, There does not appear to be flashing on horizontal trim. This can cause deterioration. Ensure that a secure seal of caulk

is
maintained
as a temporary
measure which
may lead or
install proper
metal flashing.
Missing cap
flashing.
Add flashing to
prevent deterioration
and other water
penetration issues.
Lack of kick
out flashing
noted. Add
as needed.

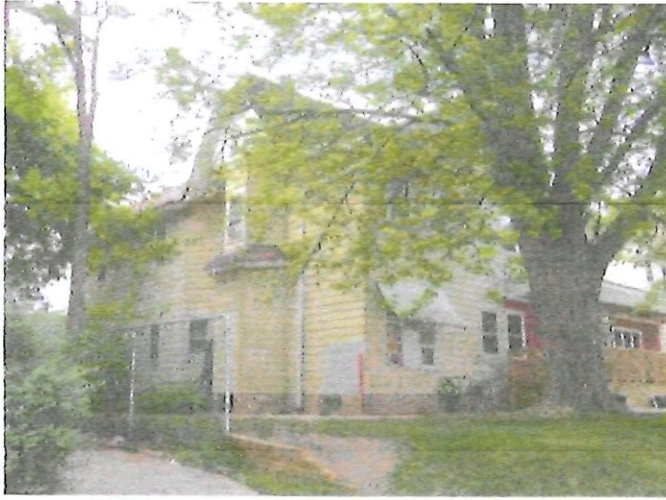
Masonry Siding:

Stone, Decorative cement block, Weeps and draining plane not visible/verified, Appears intact, Appears functional, Typical for age, Older/worn, Fracturing noted (typical for age). Prior tuckpointing observed, Areas that were tuckpointed have re-cracked. This suggests further movement. Unconventional/curious workmanship. Caulking/mastic materials on masonry often means there has been water intrusion or other issues. Verify and repair as needed. Siding needs repair by a masonry restoration contractor now. Evaluate now for common maintenance needs including flashing maintenance. Seal any gaps/openings. Seasonally evaluate for future maintenance needs.

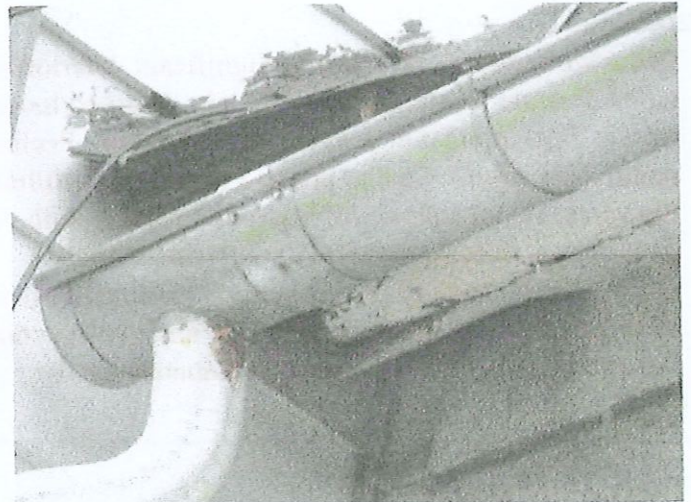
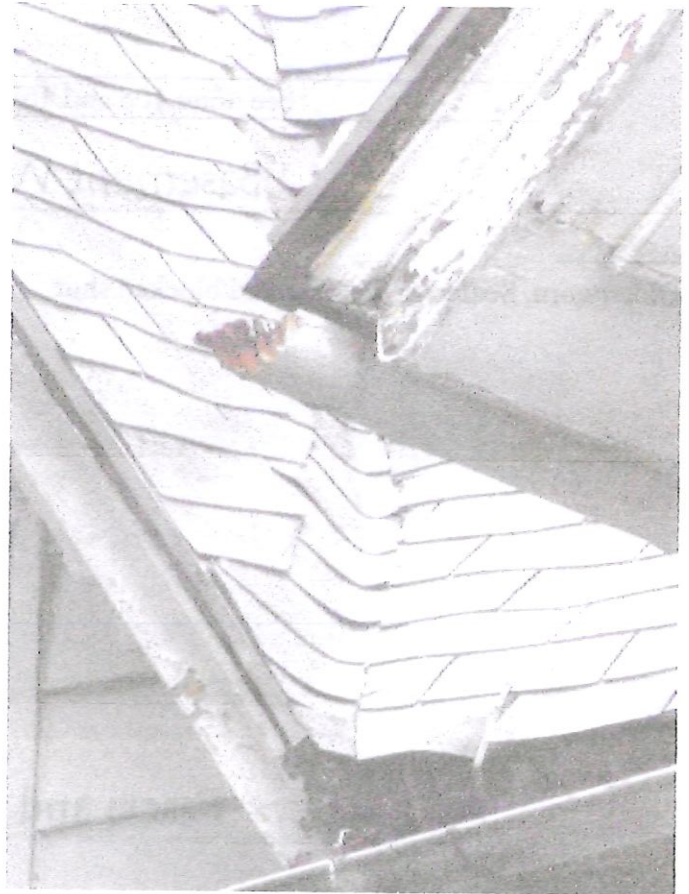
Condition:

Older/worn, Needs paint/stain, Significant deterioration noted at some locations. Needs repair. Warped/loose panels. Seal to prevent pest/water infiltration. Peeling paint. Holes/gaps. Seal to prevent pest/water infiltration. No vents, Water stains, Holes/gaps consistent with vermin entry points. Needs common maintenance/touch up/repairs. Evaluate now for common maintenance needs including flashing maintenance. Seal any gaps/openings. Seasonally evaluate for future maintenance needs.

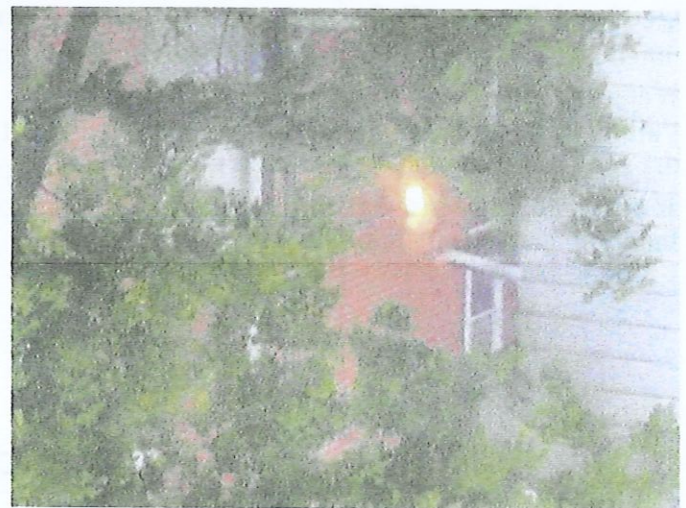
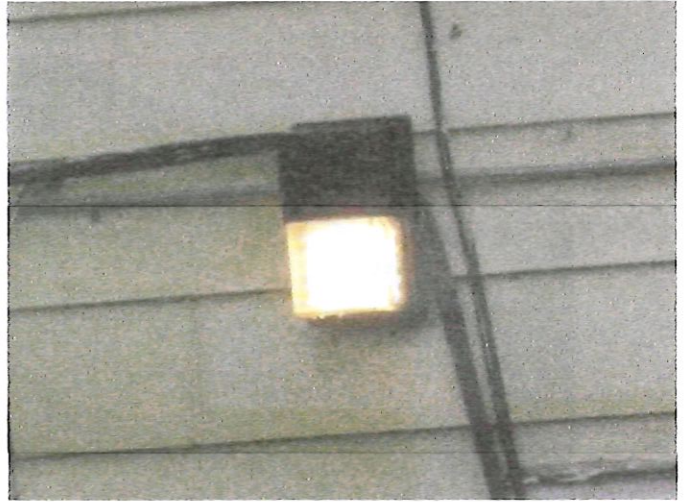
Lighting: (7)(a) 6.

Older/worn, Possibly some sodium vapor bright lighting is commonly not allowed in a neighborhood setting.

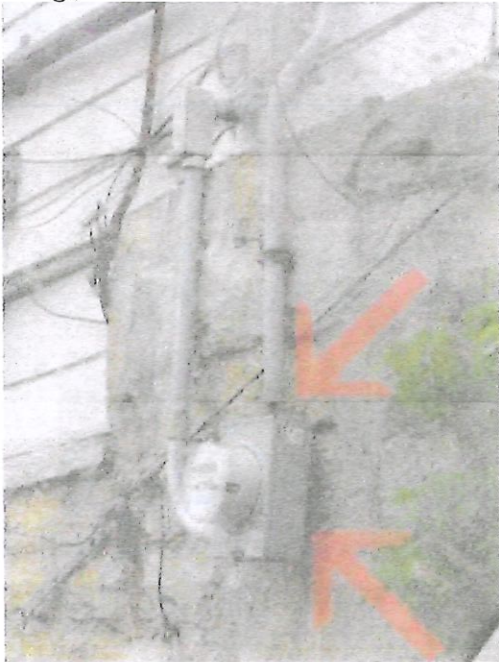
Electric Service Type (7) (a) 4.

Overhead, Cloth vintage era service wire at mast head at exterior. Older/worn. There appears to be fraying present. Overhead, Improperly fastened service conduit, Corrosion noted at service conduit. May need replacement in coming years. Consult an electrician for recommendations. Pulling away from building. This can pull on and detach the service wire connections. Have evaluated and repaired as needed by a licensed electrician for safety and good function. Detached conduit at alley,.

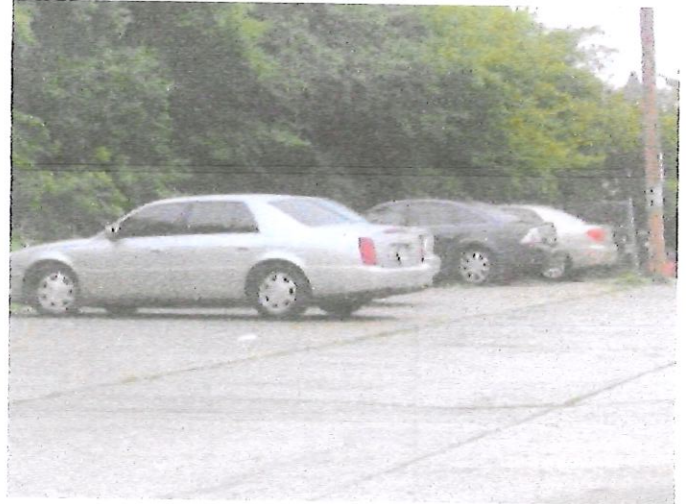
Gravel:

Trip hazard, Water may pond and freeze. Driveway needs major repair or replacement.

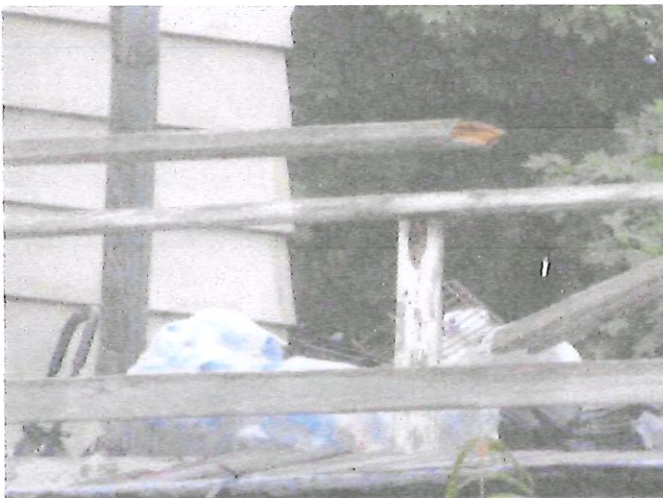
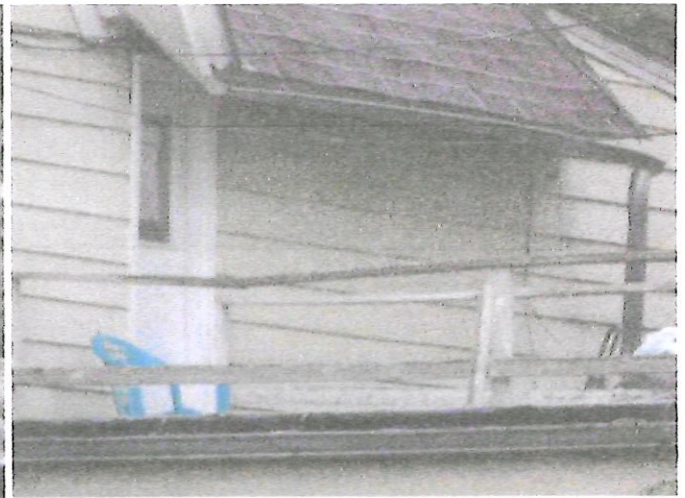
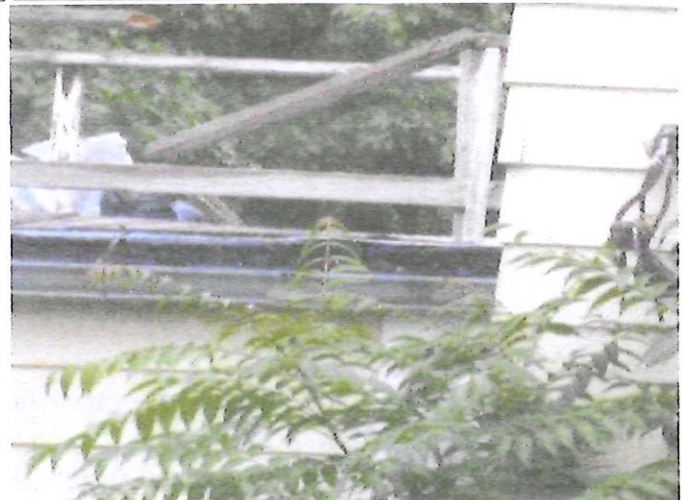
Central roof structure first larger vintage building.

Older/worn, Loose boards, Unconventional construction, Consider changing to a 4" maximum space between

railing balusters for child safety. Railing is low (typical for age). Consider a minimum height of 30" at stairways and 36" at balconies/landings as an improvement. Consider changing to vertical balusters for improved safety. Railing loose, Damaged railing, Missing railing, Blistering/lifting paint/stain surfaces noted. Some Recent paint/stain in visible areas restricts view of materials. Water management system not observable. No lag bolts observed.

Balcony needs repair now. Safety concerns noted at balcony. Needs repair now.

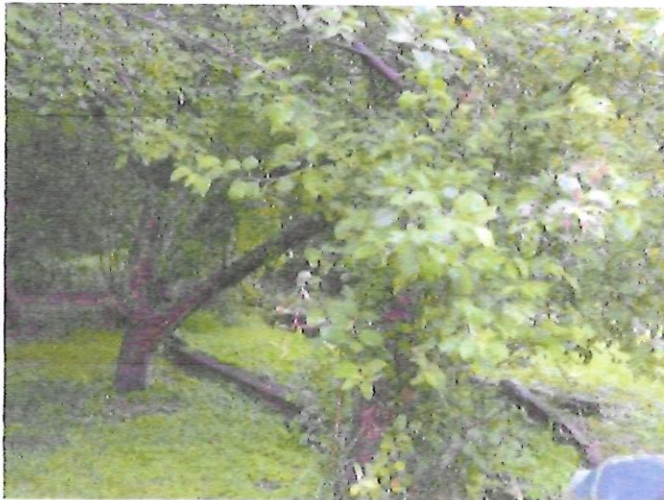
Trees /Shrubbery too close to building; house

Trees too close to roof/screeping on roof.

Correct to prevent damage and evaluate/repair shingles as needed. Need trimming or removing. Verifying the health of the vegetation on the property is beyond the scope of this inspection. In this region, Ash trees in partic

and/or other plants should be kept at least 12 inches away from buildings to prevent trapped moisture and advanced wear to siding/roofing.

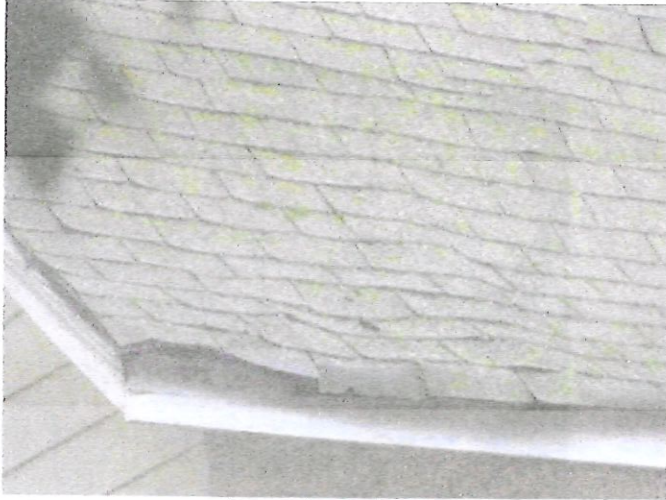
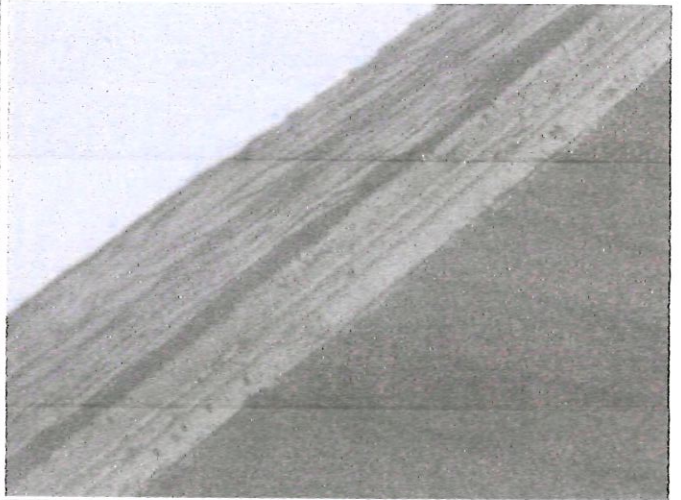
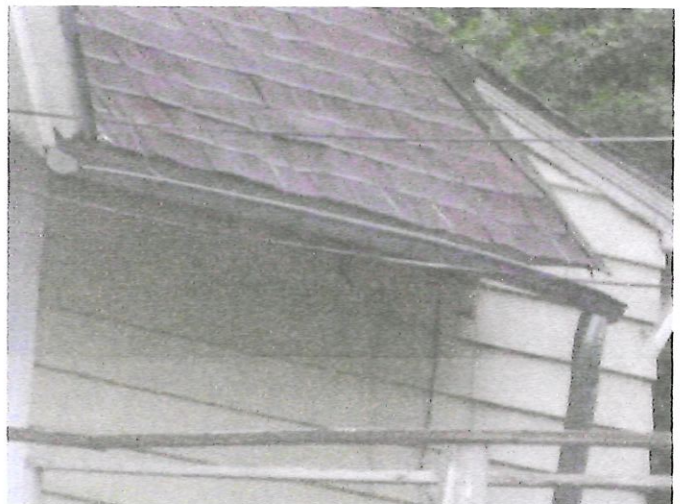
Asphalt/fiberglass shingle, Questionable installation of asphalt/fiberglass shingles at some low slope roofs. If premature wear, ice damming, or leakage occurs, consider replacement with a flat roofing material. Asphalt roll.

Serious signs of wear/aging. Some general observations include: Brittle/loss of elasticity/inflexible, Granule loss, Curling, Shrinkage, Waviness. Underlayment and decking structure are hidden from view and can not be evaluated by our visual Inspection; therefore, our observational review is not a guarantee or warranty against roof system leaks, seepage or structural condition, nor is a certification. Expect leaks. Cracking, Missing/loose/broken shingles/tabs. This may indicate a general area of loose/detached shingles that may not appear to be loose. Tar/caulk sealant patching may indicate a history of and potential for leakage. Ask owner for history. Exposed nail heads, Algae (dark streaking/staining) present on shingles. This discolors the shingles but does not generally harm the roof or structure. Replaced shingles noted. Ask seller for history. This may indicate a general area of loose/detached shingles that may not appear to be loose. More wear noted at some locations than others (possible ice chipping). Fiberglass visible through granules. See note 117 in Reference Addendum. Physical damage, Short shingle installation (not enough overlap of shingles). Pieces of shingles in yard/driveway, Shingles at peak are worn. This is common and easily repairable. Appears as insufficient overlap of dimensional shingles. Nail popping, Lacks drip edge flashing. Lacks gable end flashing. Trim overhanging trees, Caulk sealant is a short term patch and subject to deterioration and seepage if not maintained. Multiple roofs present. Roofs were installed at different times and are in different conditions. Generalized and accurate over all observations of several roof surface systems. Structure unknown at interior. lichen growth noted.

Re-roof as soon as possible. Correct any roof deficiencies in a timely manner to prevent damage to structure and finishes. Expect leaks. The next re-roof will require a tear-off of the old roofing layers. Flashing(s) may need to be re-anchored/secured/replaced.

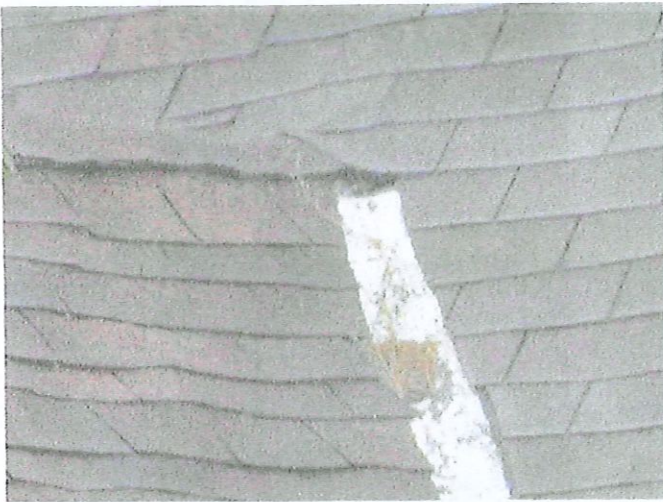
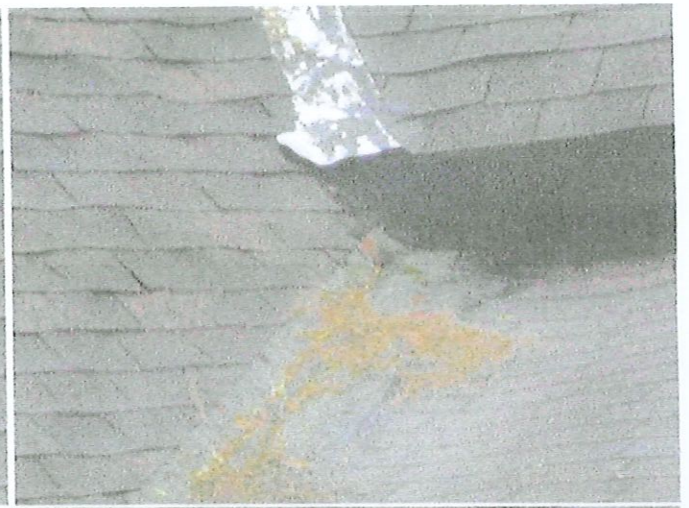
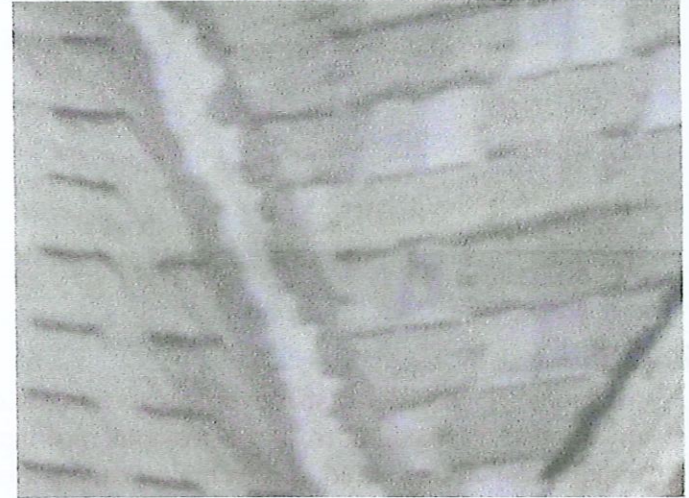
Roof/Wall:

No/restricted access, Water management system not observable. No flashing visible, Evidence of prior repairs, It appears that the flashing from the previous roof installation has been re-used for current roof.

Lifting/gaps/openings noted. Needs maintenance. Sealed with roofing mastic sealant. See note 121 in Reference Addendum. This restricts inspection of the presence or absence and condition of the flashing at this location. Little clearance between siding and roof. (Recommend a 1" minimum.) This restricts inspection of the presence or absence and condition of the flashing at this location. This can cause deterioration and water penetration issues. Multiple locations.

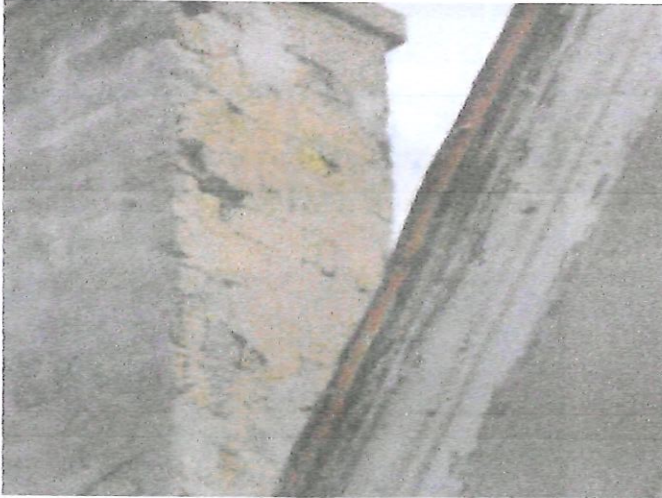
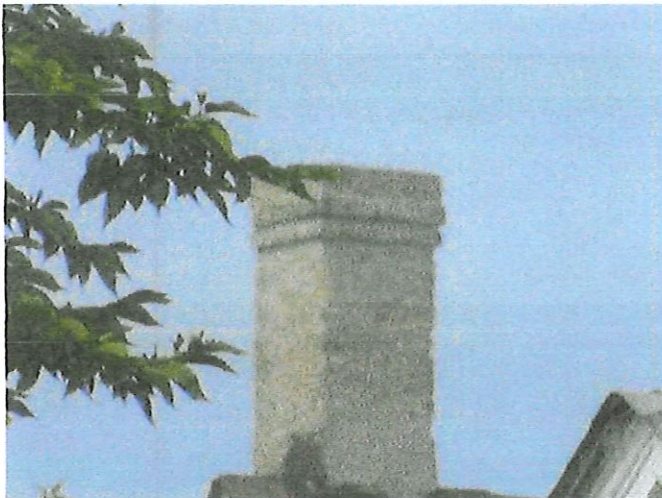
Interi
or not
inspe
cted.
No
opini
on
offere
d.
Dama
ge/cra
cks/fl
aking
/shali
ng
noted
at
expos
ed
flue
tile at
top of
chim
ney.
Flaki
ng/sh
aling/
crack
ed,
Missi
ng.

Older/worn, Unconventional/temporary repairs noted, Typical loose mortar, Typical brick spalling/shaling, Prior tuckpointing observed. Areas that were tuckpointed have re-cracked. Unconventional/temporary repairs, Caulking/mastic materials on masonry often means there has been water intrusion or other issues. Verify and repair as needed. Caulking/mastic is not a structural repair. Suggest separate inspection by chimney specialist now.
