## **TURNER HALL**

## **FEMA Grant Safety and Security Project**

Certificate of Appropriateness Application  
Drawings and Photo Exhibits

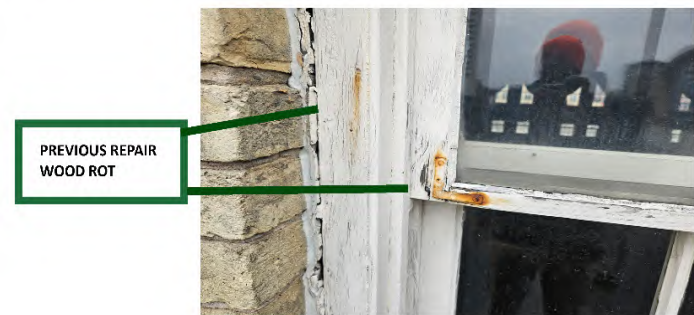
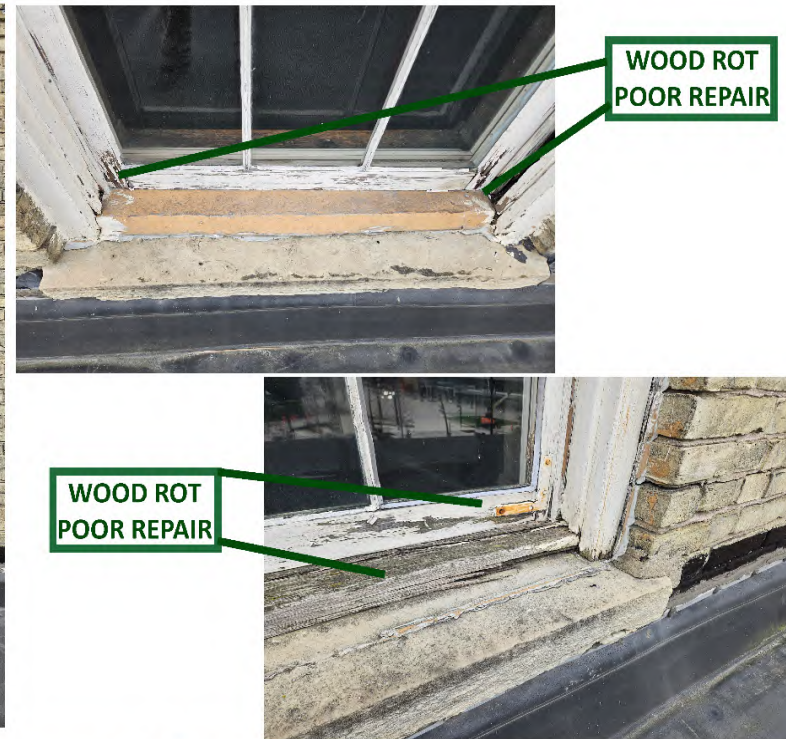
### NORTH ELEVATION - 3RD FLOOR

-ORIGINAL WOOD WINDOWS ON THIRD FLOOR. WEATHERING, WOOD ROT, AND PREVIOUS POOR QUALITY REPAIRS HAVE MADE IT INFEASIBLE TO REPAIR WINDOWS.

-THE SCOPE OF WORK FOR THIS PROPOSES TO REPLACE THE WINDOWS IN KIND WITH NEW WOOD WINDOWS MATCHING THE ORIGINAL CONFIGURATION AND PROFILE WITH NEW LAMINATED SAFETY GLASS

**3** NEW WOOD WINDOWS REBUILT TO MATCH ORIGINALS. NEW GLAZING TO BE LAMINATED SAFETY GLASS

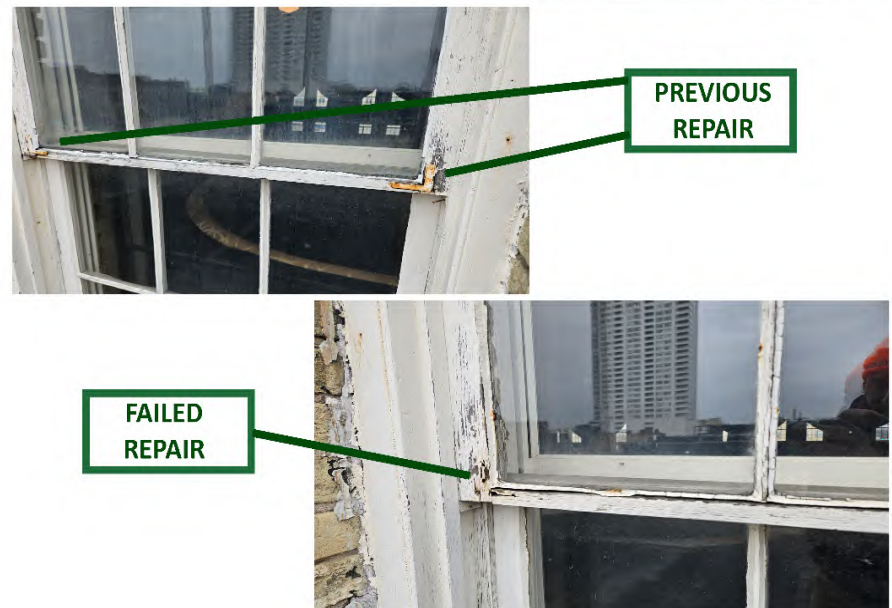
### NORTH ELEVATION - 3RD FLOOR

-ORIGINAL WOOD WINDOWS ON THIRD FLOOR. WEATHERING, WOOD ROT, AND PREVIOUS POOR QUALITY REPAIRS HAVE MADE IT INFEASIBLE TO REPAIR WINDOWS.

-THE SCOPE OF WORK FOR THIS PROPOSES TO REPLACE THE WINDOWS IN KIND WITH NEW WOOD WINDOWS MATCHING THE ORIGINAL CONFIGURATION AND PROFILE WITH NEW LAMINATED SAFETY GLASS

**3** NEW WOOD WINDOWS REBUILT TO MATCH ORIGINALS. NEW GLAZING TO BE LAMINATED SAFETY GLASS
