## FOUNDATION INSPECTION REPORT

Client: <u>Mr. Jim Sterns</u>	Present: <u>Yes</u>
Inspection Address: <u>2605 N. Summit Ave. Milwaukee WI</u>	
Billing Address: <u>-</u>	
Telephone: <u>414-745-1201</u>	Email: <u>Aggies.stuff@gmail.com</u> <u>JCMeridan@gmail.com</u>

## ENGINEERING REPORT

Property type: Single Family historical home

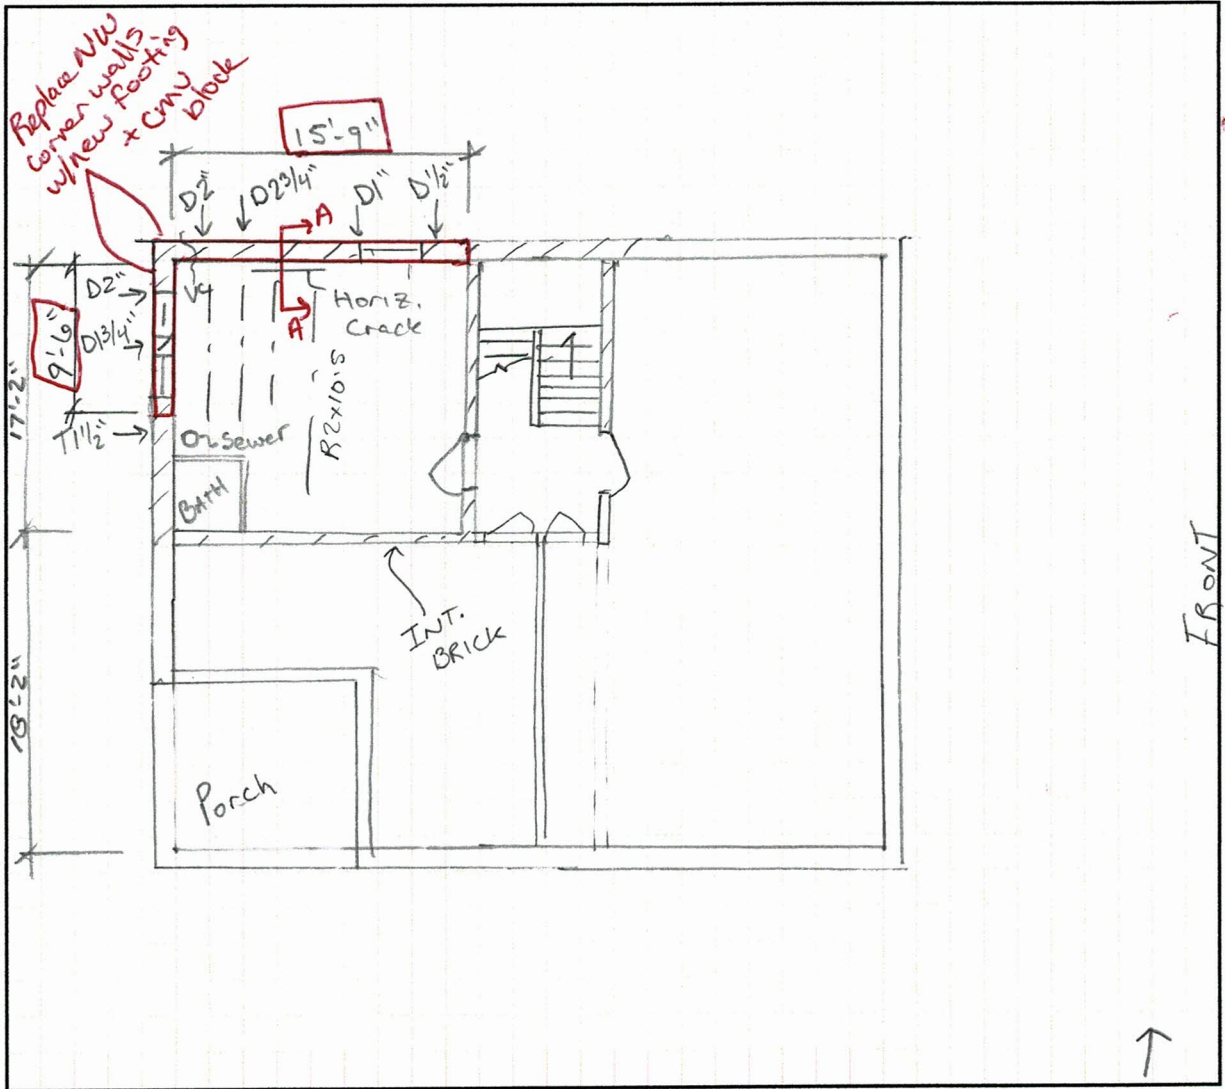
**KEY:**

D - Measurement of wall displacement  
 T - Measurement of wall tipping  
 H x - Horizontal crack at course x from top of wall  
 SC - Step Cracks  
 EFF- Efflorescence

VC - Vertical Cracks  
 BS - Measurement of base shear  
 SP - Sump pump  
 WS - Water stains  
 (X") - Differential elevation measurement

North Wall – As built = – Max = D 2 3/4" Differential = –

Signs of active wall movement: Yes at west end. Buckling + Cracks

Signs of active wall movement: Yes at North end. Cracks + bow

REPORT SUMMARY AND RECOMMENDATIONS
<b>All repairs to be completed per the State of Wisconsin Uniform Building Code (WIUBC)</b>
The Northwest corner foundation walls were found to be excessively displaced. The west ±15'-9" of North wall and North ±9'-6" of the west wall are bowed >2" with damage to brick. It is recommended to shore the structure (two-story brick ext), excavate the NW corner, demo walls and rebuild with new footings and cmu block. See attached wall section detail. The brick exterior must be maintained for historical preservation.
During wall replacement new interior and exterior drain tile is needed with a new sump crack + pump. Follow WIUBC standards.
The exterior sidewalk will require replacement during excavation and should be pitched to the driveway.
