2044 NORTH 2ND STREET
MILWAUKEE, WI

Southern Porch Column Repair Plan
for the Historic Preservation Commission
to secure a Certificate of Appropriateness

August 2023

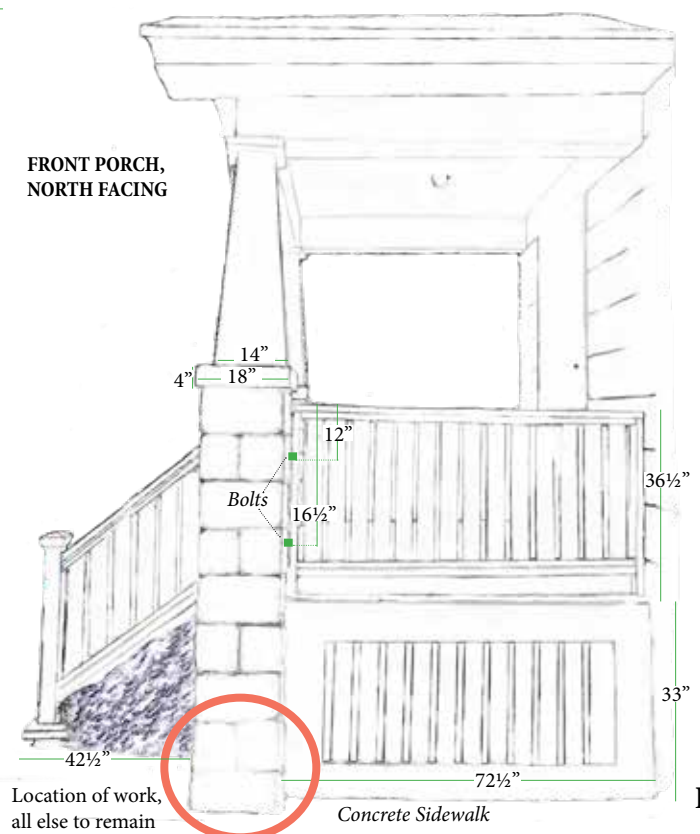
FRONT PORCH,
NORTH FACING

Thank you for taking the time to review my latest proposal for a COA so that I might repair a porch column that is starting to fall over on my property. Please see the images below that show that the rock-face block has begun to crumble at the base of the Southern most column and the ensuing tilt happening in the lower section. What follows is a detailed description of the porch and column dimensions, materials, etc. so this might get repaired as quickly as possible. Thank you in advance for your thoughts and assistance in this matter.

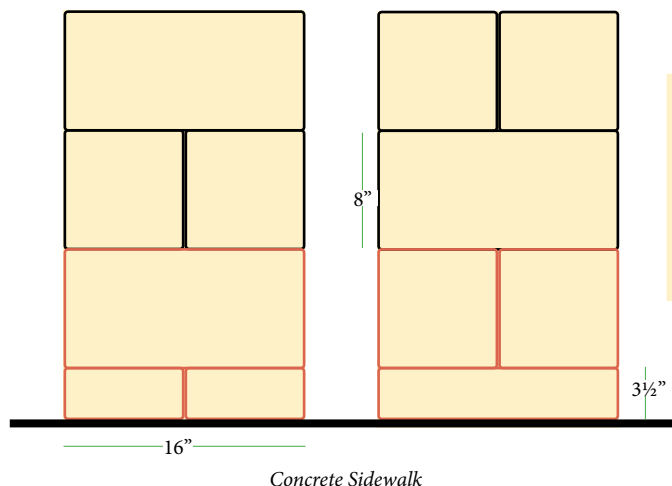
VERTICAL STACK PATTERN, FACING NORTH

2 courses to be
repaired and replaced
at bottom of column

3-sided rock-
face pattern
results in
visible pattern
on all parts
and sides of
the column
(see more on
pg 7)

The new block work will replicate the existing pattern and dimensions before damage. An estimated total of 4 replacement blocks (2 blocks, 2 courses) will be installed at the foot of the column after the upper portion is carefully removed and salvaged. Because the Southern block column sits directly on concrete sidewalk, there is no footing requirement like on the Northern column. To account for the slight (~2") change in grade, the lowermost replacement blocks will need to be cut (see images on pg 2) to maintain overall block/column height, taking it's cue from the existing block pattern. The exact measurement of the cut can not be determined until damaged blocks have been removed to account for any potential inlay in the concrete sidewalk. If the grade is consistent with the concrete sidewalk at the time of removal, the cut would be 3½" from the top of the block.

Replacement course =
16" x 16" x 8"

Lower most
replacement course =
16" x 16" x ~3½"

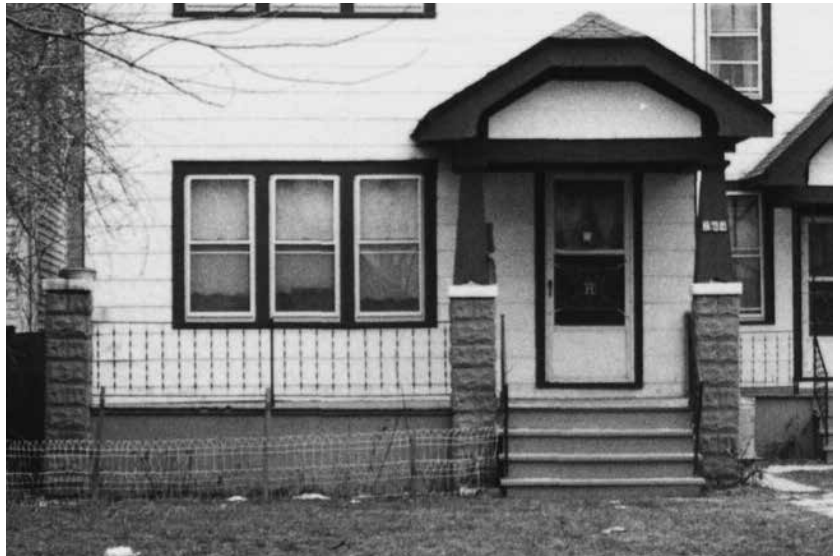
Applicant has worked with IPC to complete the necessary repairs. All work was painted upon completion. All work was done according to the attached photograph.
