MPS - Existing Window Condition

3360 N Sherman Boulevard Milwaukee, Wisconsin

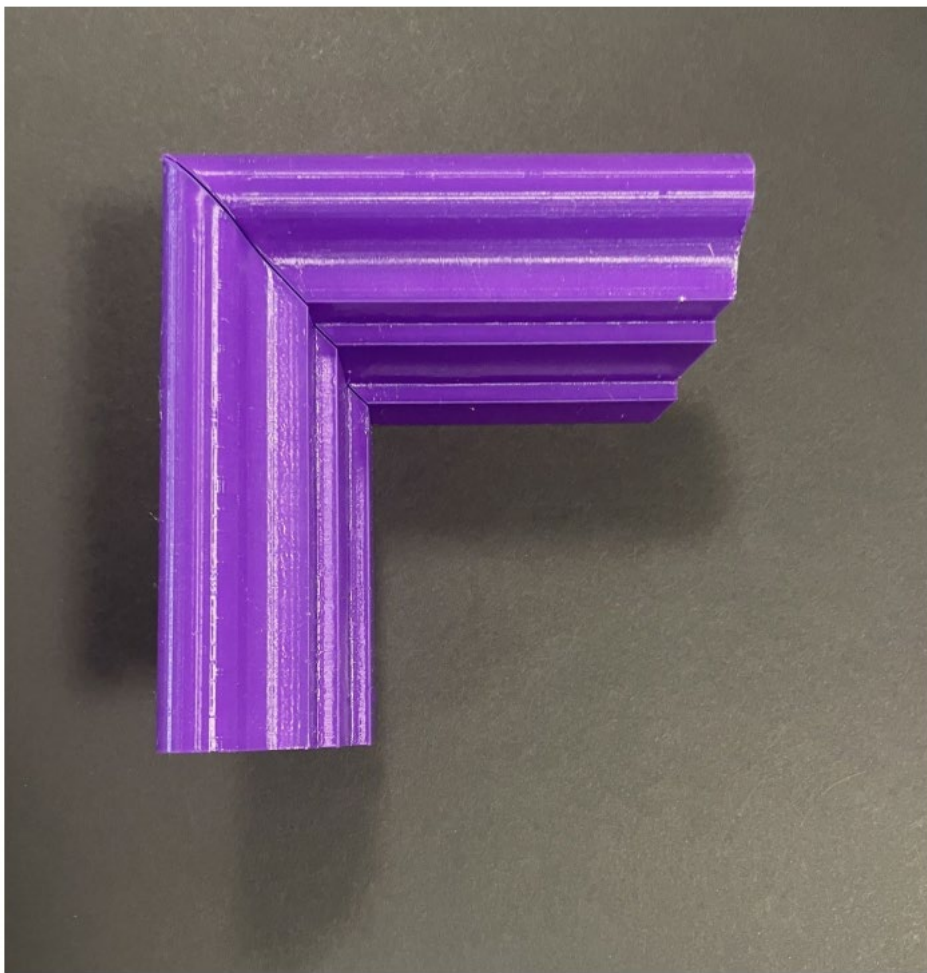
Photograph of 3-D Model replicating existing Townsend Window profile

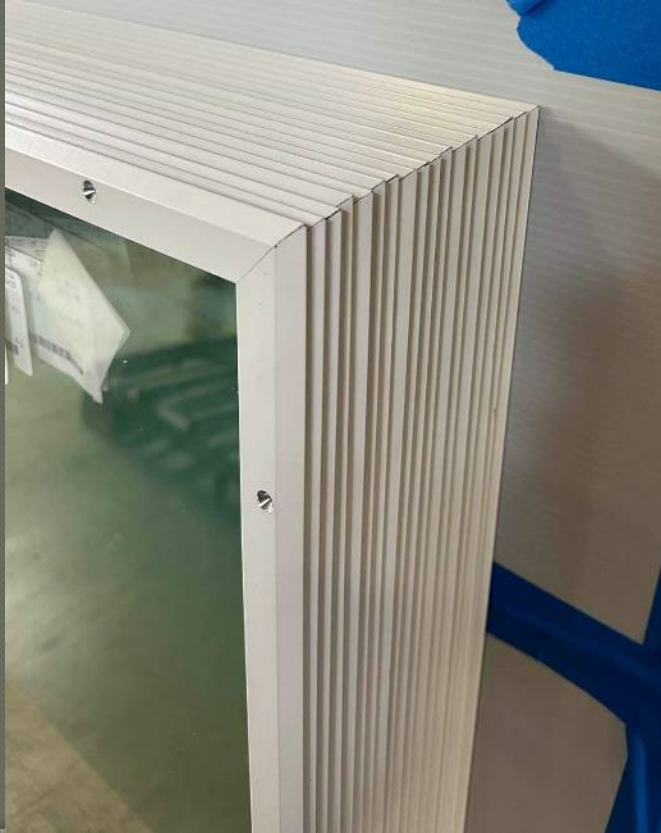
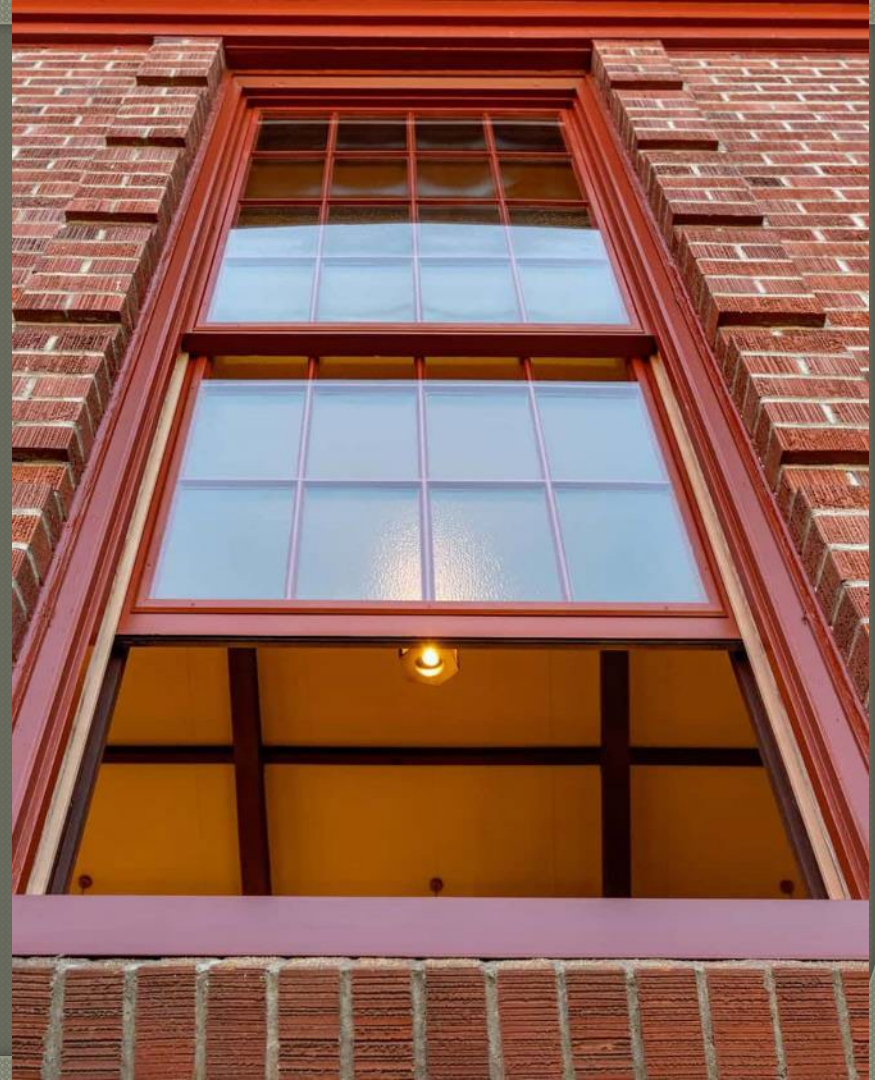
72% energy retention improvement
By attaching insulating panel to existing
window and adjusting weatherstripping

Recommendation

Approve with conditions

- Approve replacement of all ordinary, two-sash double-hung windows, all glass block windows, filled-in windows, ground floor windows, and attic windows
- Tower windows appear to be readily repairable
