# MILWAUKEE CITY HALL FOUNDATION RESTORATION

October 19, 2016  
Project Update

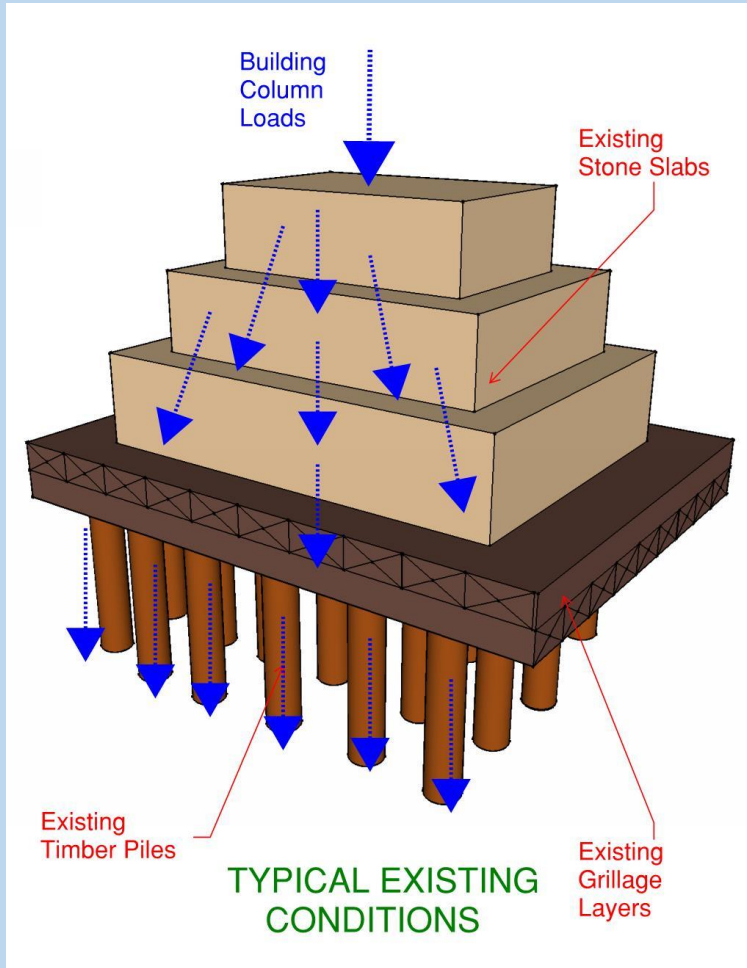
# Milwaukee City Hall Existing Foundation System

- ❖ City Hall is supported by over 2,500 untreated wood piles driven in marshy land adjacent to the Milwaukee River
- ❖ Pile lengths are estimated between 23ft and 27ft
- ❖ Oak “grillage” layers are placed horizontally in alternating directions directly on top of the wood piles
- ❖ The oak grillage supports stone pile caps which in turn support the exterior walls and interior columns/piers of the building
- ❖ The building has experienced differential settlement over the years as a result of fungal rot/decay of the grillage and pilings, a process that is difficult to forecast and predict
- ❖ The differential settlement is monitored through a series of survey points around the building

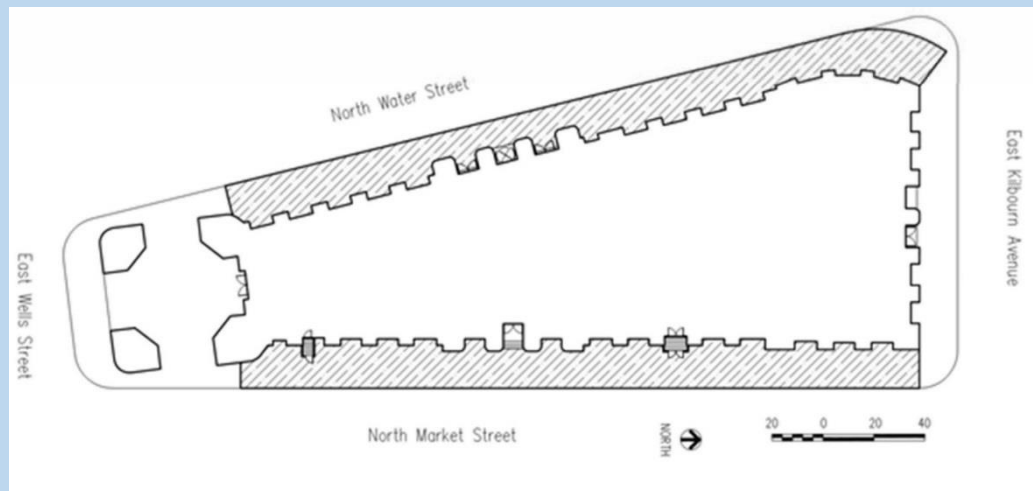
- ❖ City Hall was originally constructed with a hollow access corridor located around the perimeter of the building beneath the street-level sidewalk extending along the east, north, and west sides.
- ❖ The north hollow walk area was previously abandoned/filled-in.
- ❖ The structural steel, reinforced concrete and structural masonry that support the sidewalk slabs are deteriorating
- ❖ Water and moisture intrusion has been an ongoing problem in the hollow walk areas
- ❖ The hollow walk areas currently serve as hallways, utility corridors, or back-of-house/storage areas

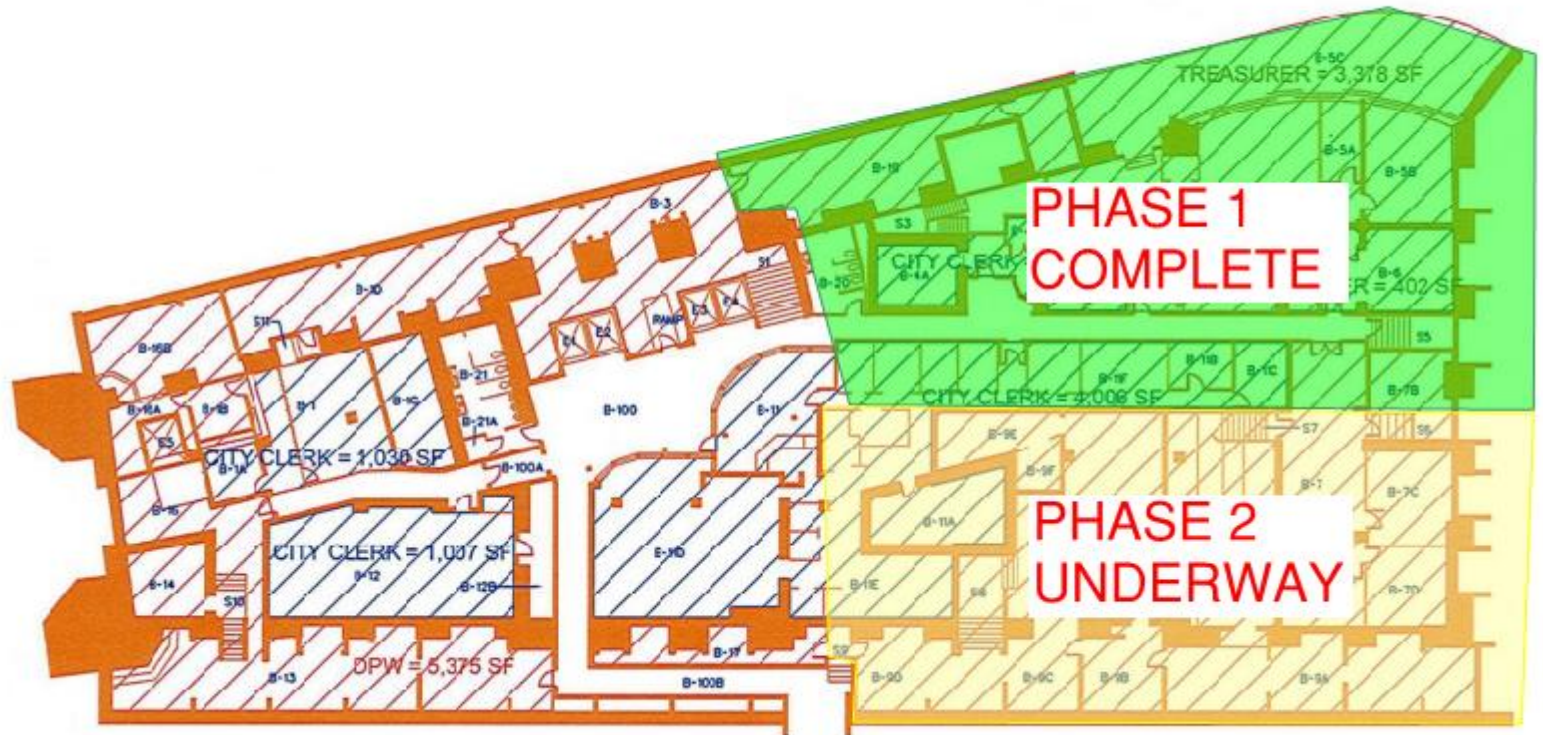
## PHASE 2 REPAIR AREA- NE QUADRANT

TIMEFRAME: 2017 - 2018

REPAIR FOUNDATIONS;

DECOMMISSION OLD MECHANICAL AND

ELECTRICAL EQUIPMENT ROOMS

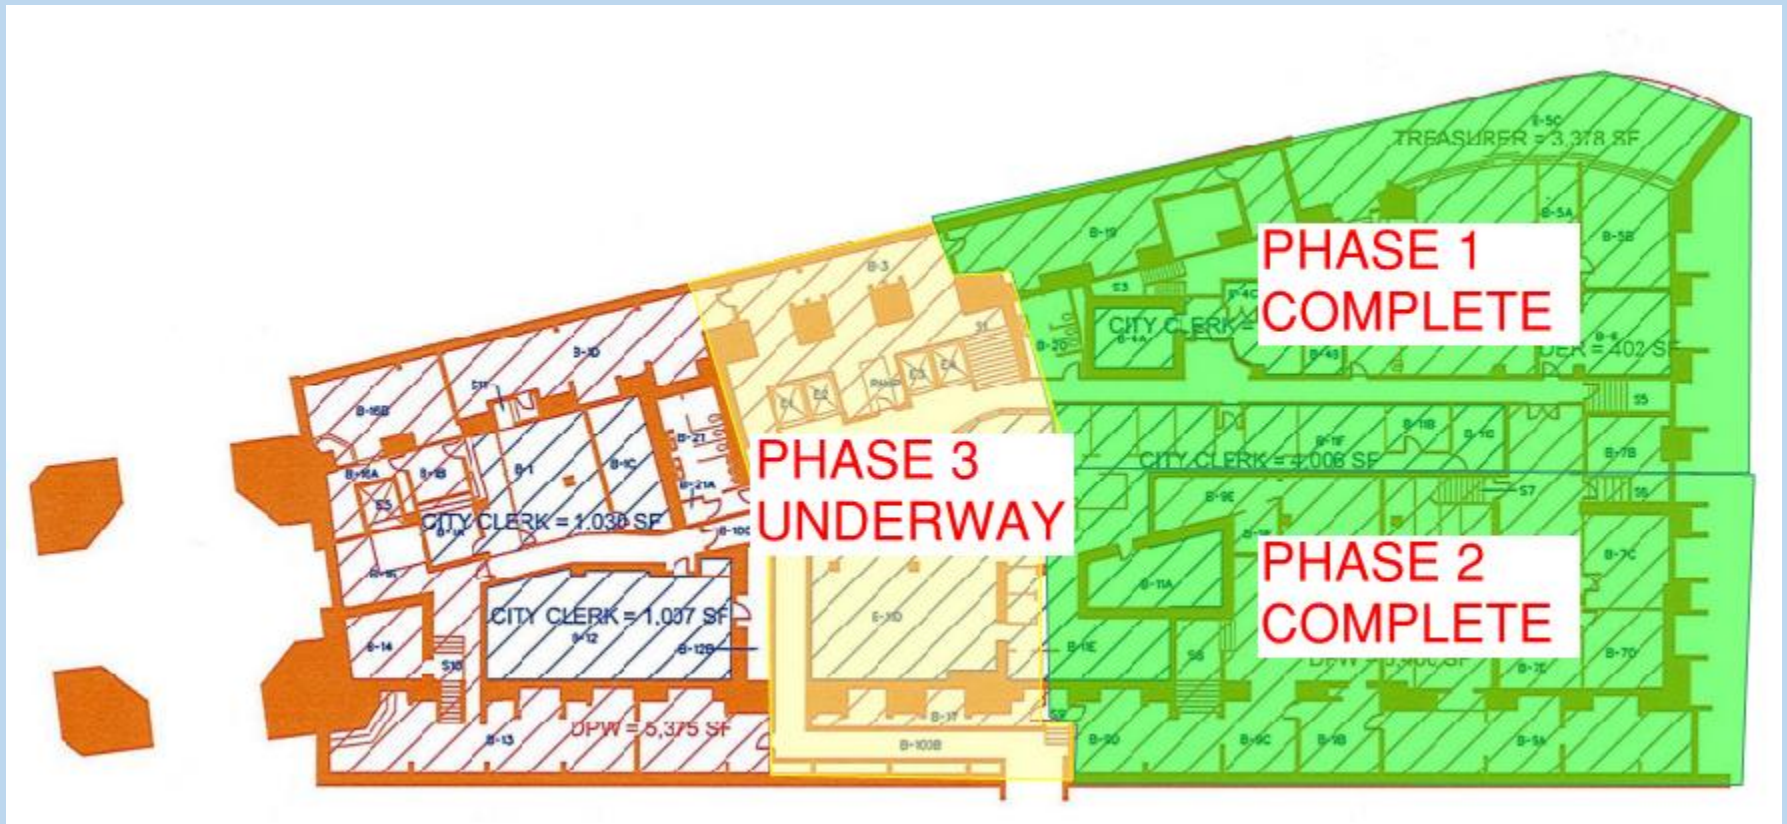
# PHASE 3 REPAIR AREA- BUILDING CENTRAL CORE

TIMEFRAME: 2018 – 2019

REPAIR FOUNDATIONS;

REROUTE ZEIDLER ACCESS TUNNEL

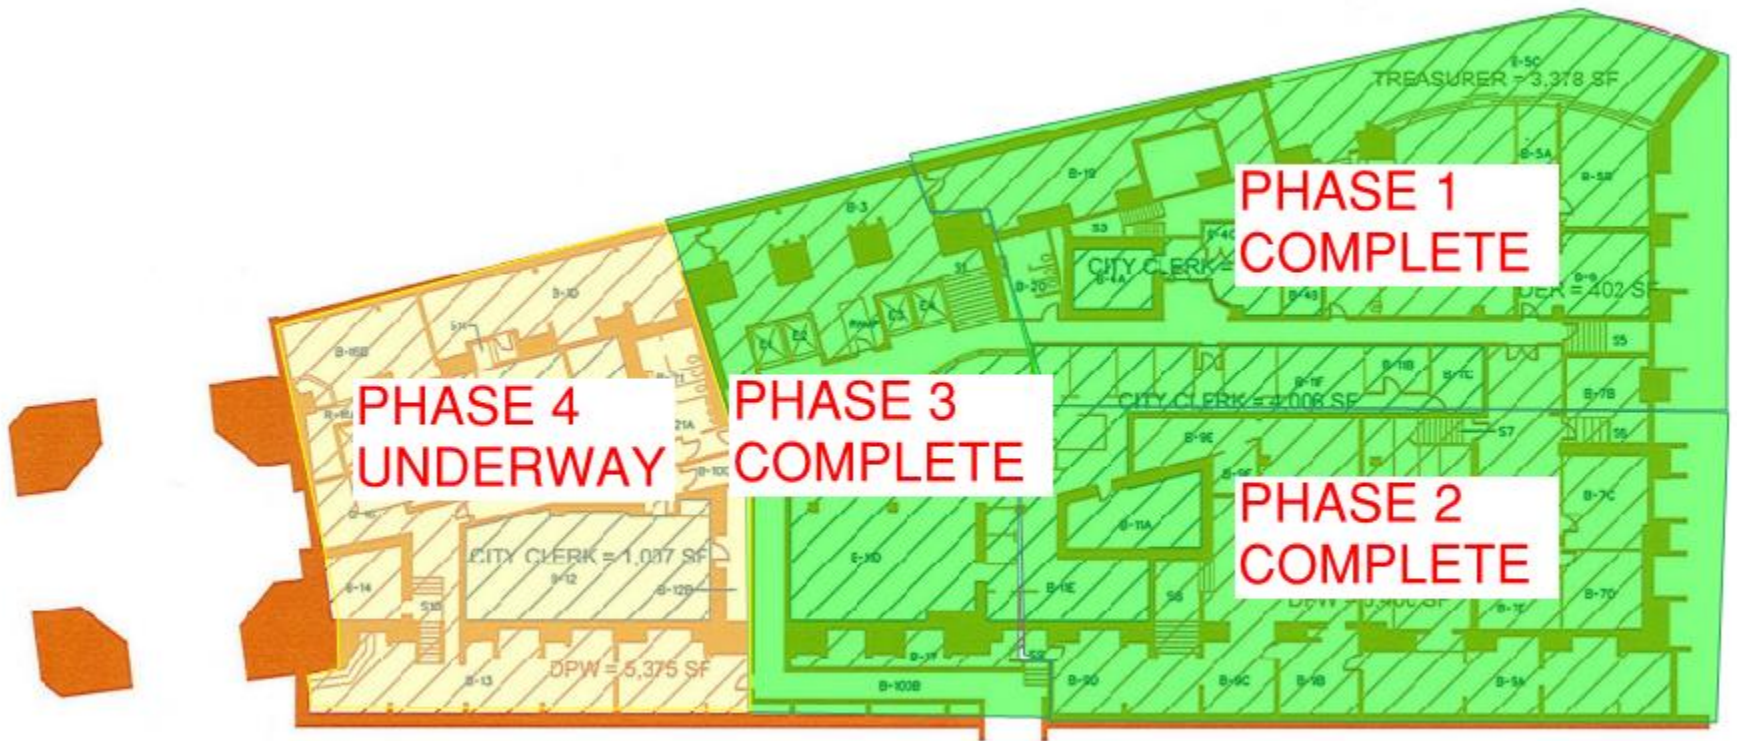
# PHASE 4 REPAIR AREA- SOUTH END

TIMEFRAME: 2019 – 2020

REPAIR FOUNDATIONS;

REROUTE TELECOM INFRASTRUCTURE

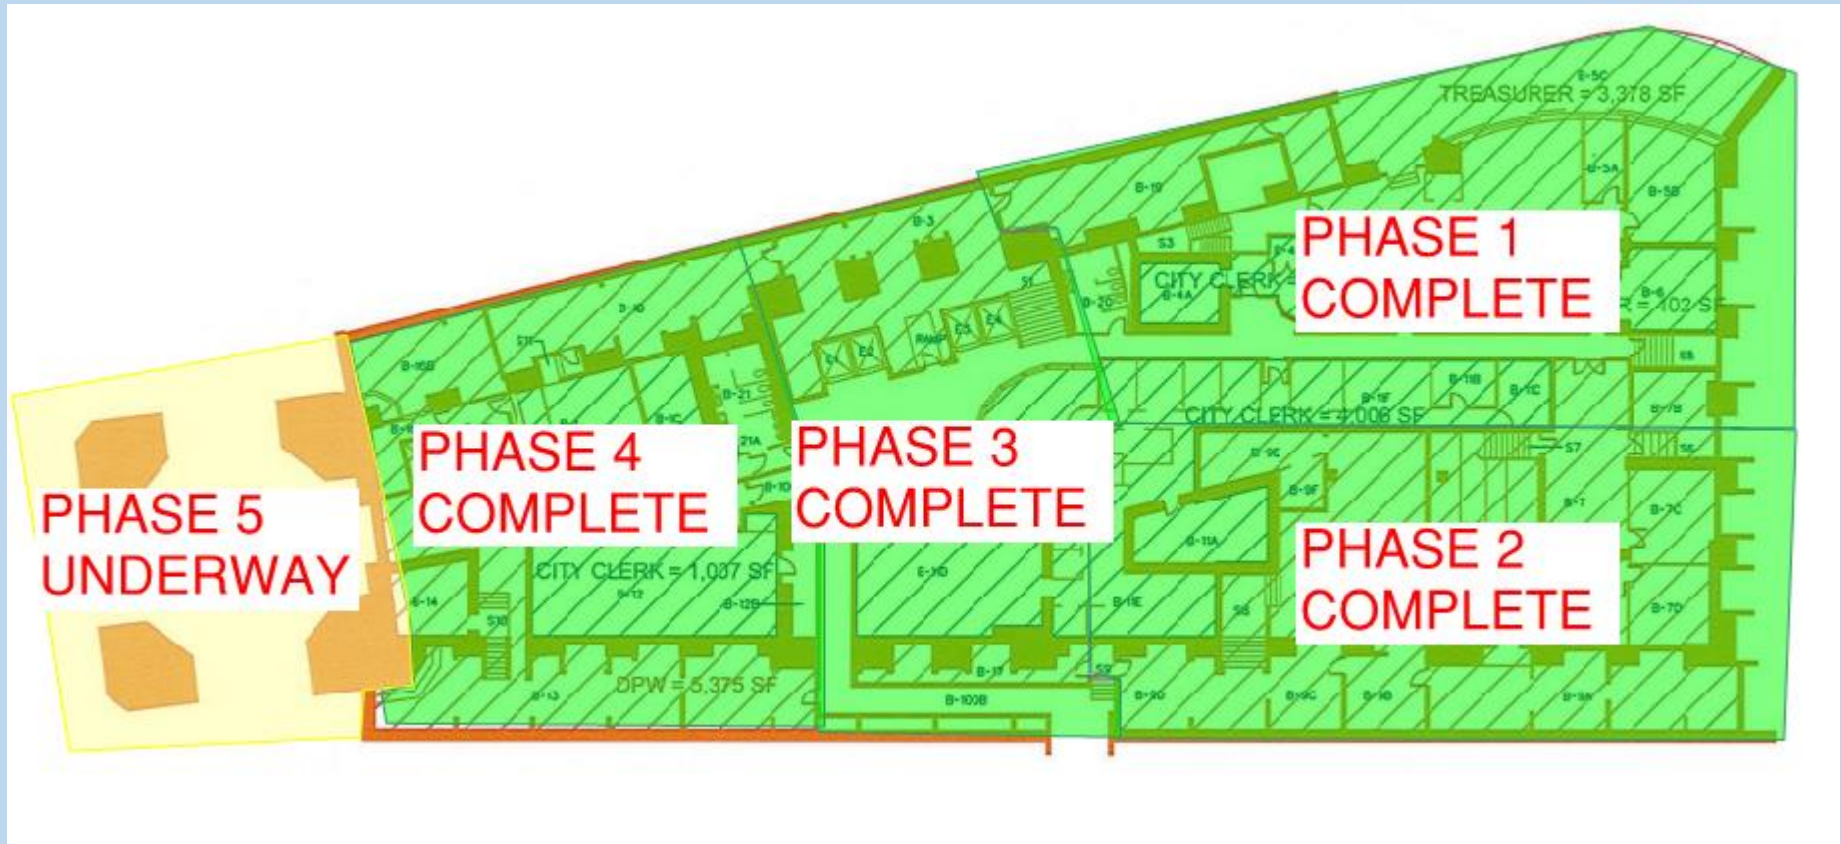
# PHASE 5 REPAIR AREA- SOUTH TOWER

TIMEFRAME: 2020 – 2021

REPAIR FOUNDATIONS
