City of Milwaukee  
DPW, ISD, FDM

2011 Recreational Facilities  
Condition Assessment Program

#### Facility Condition Assessment Program Summary for Recreational Facilities 100% of Play Areas (Based on conditions as of 12.01.2012)

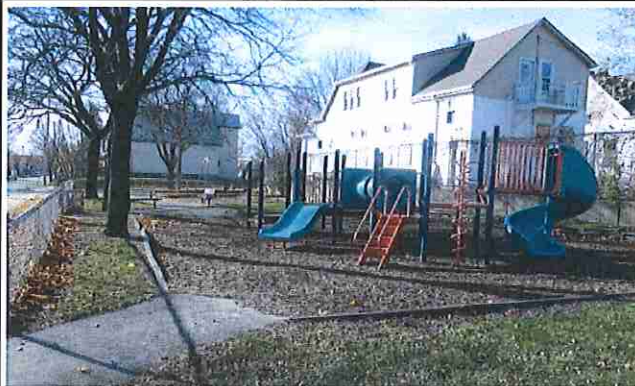
## 31st and Lloyd Play Area 3100 West Lloyd Street

- A small site with a play structure and a swing set. Contaminated soil had to be removed before the 1994 reconstruction.
- ADA accessibility retrofit is scheduled for 2012. The grass area along the alley at north end of the site needs to be replaced with asphalt and the woodchips are in need of replenishment.

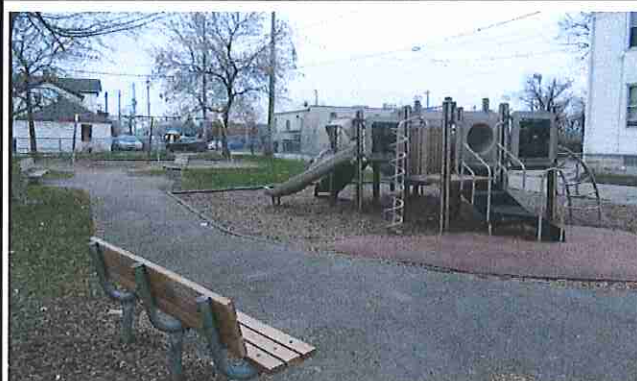
## 34th and Mt. Vernon Play Area 325 North 34th Street

- A small site with a play structure and a swing set. In 2009 one game panel was burned, it was removed and a wood blocking panel was installed.

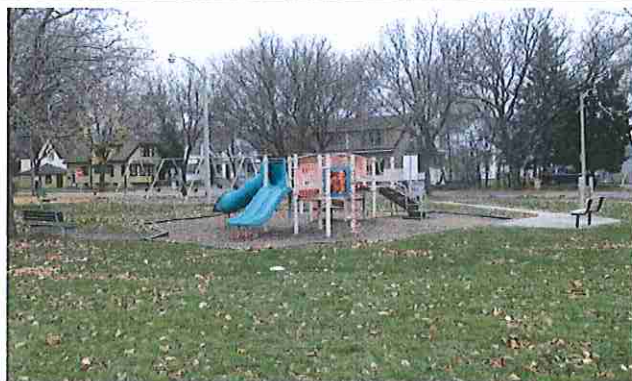
## 36th and Rogers Play Area 3514 West Rogers Street

- A large site with a play structure and a swing set. The play structure was retrofitted to make it ADA accessible and two swing units were replaced with one larger unit in 2007.
- The woodchips are in need of replenishment.

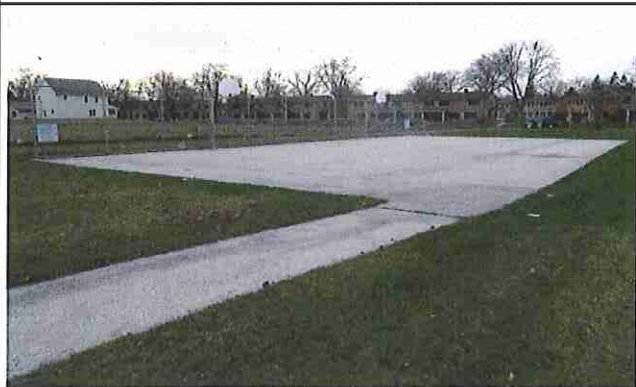
## 40th and Douglas Play Area 3919 West Douglas Avenue

- A large site with basketball courts. A very wet site, the original basketball goals and posts for the tennis nets were reset but continued to heave until the basketball courts were reconstructed and the tennis courts were removed in 2006.

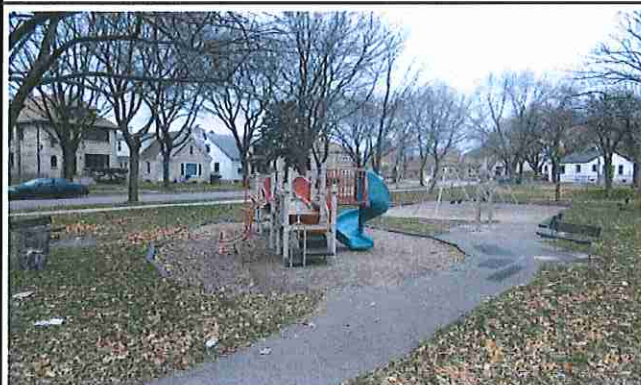
## 45th and Keefe Play Area 3512 North 45th Street

- A small site with a play structure and a swing set. The play structure was retrofitted to make it ADA accessible and two swing units were replaced with one larger unit in 2006. The Spanish-English play panel that was vandalized is not recommended for this neighborhood. The buckle bridge was replaced with an arch bridge because of vandalism in 2011.
- The woodchips are in need of replenishment. The catch basin needs to be cleaned out periodically.

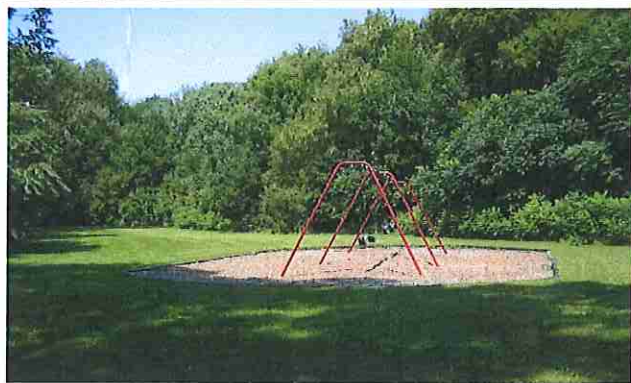
## 49th and Juneau Play Area 5000 West Juneau Avenue

- A large wooded site with a swing set. Because of late night activity the basketball court was removed in 2002. Also because of late night activity and the lack of use by children the old play equipment was removed and only a new swing set was installed in 2003.
- The woodchips are in need of replenishment.

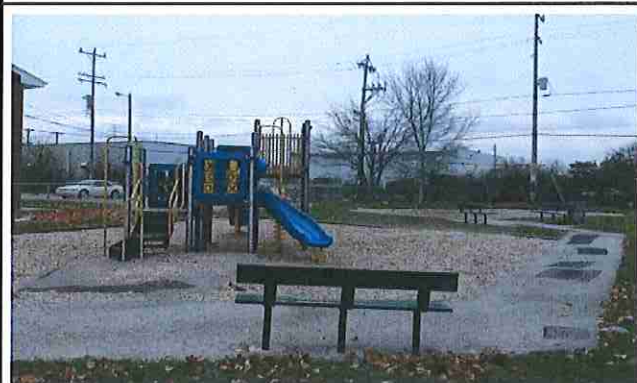
## 62nd and Kaul Play Area 6210 West Kaul Avenue

- A small site with a play structure and a swing set. All the plastic bench boards were replaced with wood in 2007, because of vandalism and the spiral slide was removed in 2008 after being burned for the second time.
- Install another type of apparatus at the former spiral slide location and the resilient surface needs minor repairs.

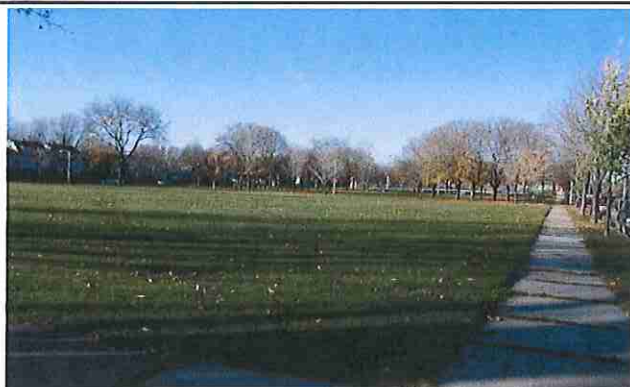
## 65th and Stevenson Passive Area 165 North 65th Street

- A large passive area with trees and benches. As the concrete legs to the benches deteriorate the benches are removed.
- Our responsibility is the benches, Forestry is responsible for pick-up trash and grass cutting.

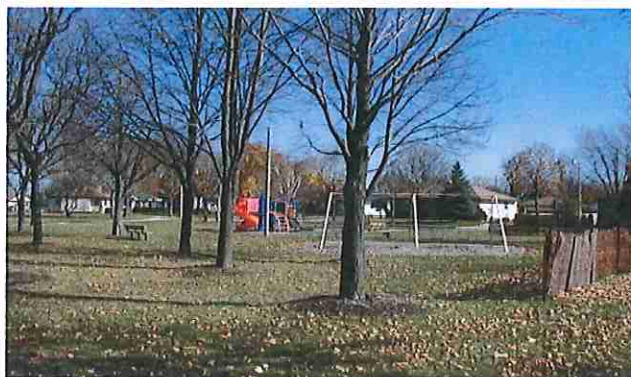
## 67th and Spokane Play Area 6632 West Hustis Avenue

- A large area with a play structure, swing set and benches. This site has drainage issues that seem to cause the engineered wood fiber to degrade faster.
- ADA retrofit and maintenance cannot be done, the structure manufacturer is no longer in business.

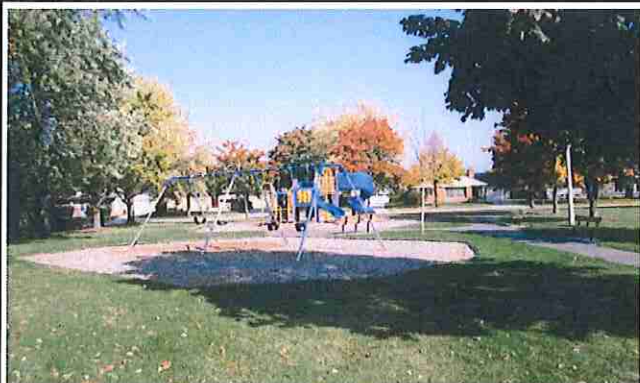
## 78th and Fiebrantz Play Area 4137 North 78th Street

- A large triangular area with a play structure, swing set & benches. The spiral slide was removed after it cracked in 2009.
- Install another type of apparatus at the former spiral slide location and the resilient surface is in need of replacement.

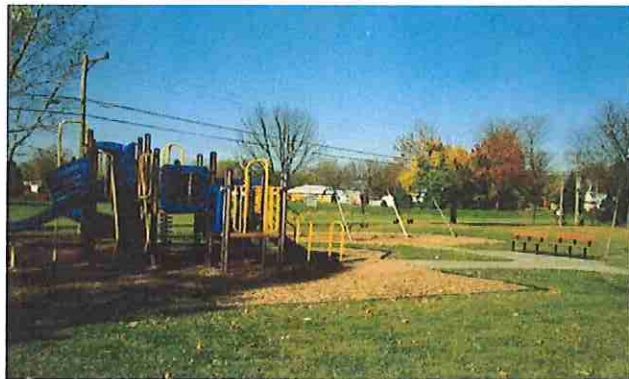
## 84th and Burbank Play Area 6671 North 84th Street

- A small site with a play structure, swing set & benches. Graffiti has been a problem at this site and use of the site for picnics and drinking has been a complaint of neighbors for years.
- The woodchips are in need of replenishment.

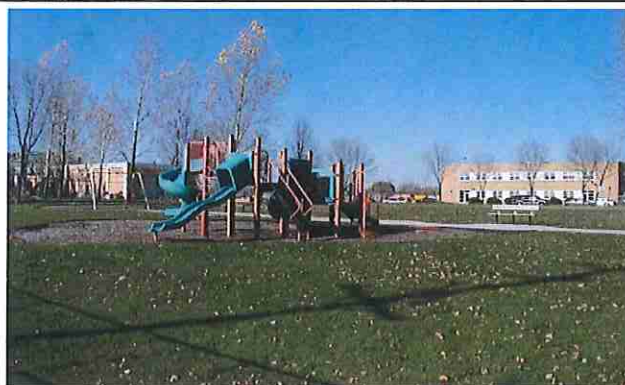
## 84th and Florist Play Area 5969 North 84th Street

- A small site with a play structure, swing set & benches. Burning of various components of the play equipment has been a problem at this site.
- The resilient surface is in need of replacement and the woodchips are becoming over grown with weeds and are in need of replacement.

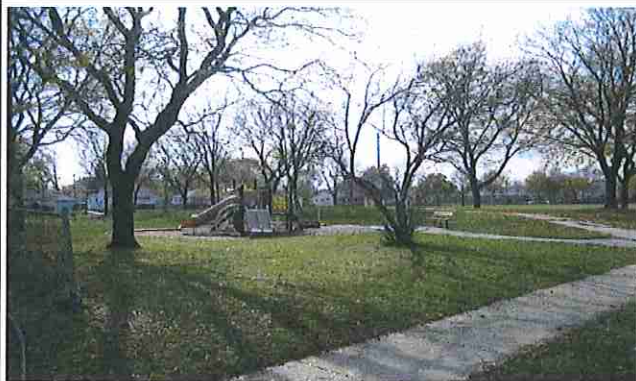
## 90th and Bender Play Area 8900 West Bender Road

- A large area with a play structure, swing set and benches. The baseball diamonds are overgrown and not used. Because of water problems drain tile was added in 2004. The spiral slide was damaged and removed in 2011, because replacement parts are not available.

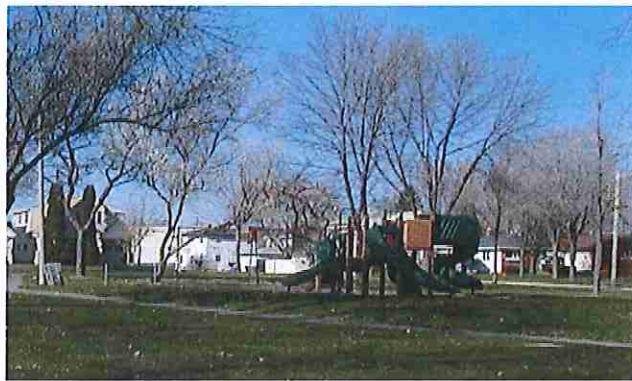
## 97th and Thruston Play Area 9714 West Reichert Avenue

- A large site with a play structure, swing set & benches. The damaged basketball court and drinking fountain were removed when the site was reconstructed in 2000. An anti-graffiti coating was applied to the play structure after the site was reconstructed, but it soon peeled away.
- The woodchips are in need of replacement.

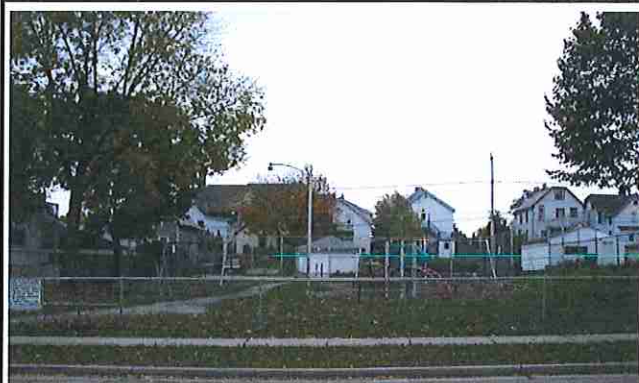
## Allis and Lincoln Play Area 2156 South Allis Street

- A small site with play structures, swing sets & benches. The metal slide does not meet current ASTM standards and the play structure is not ADA accessible.
- This site is scheduled to be reconstructed in 2013 and the old asphalt area that was a basketball court at one time will be removed.

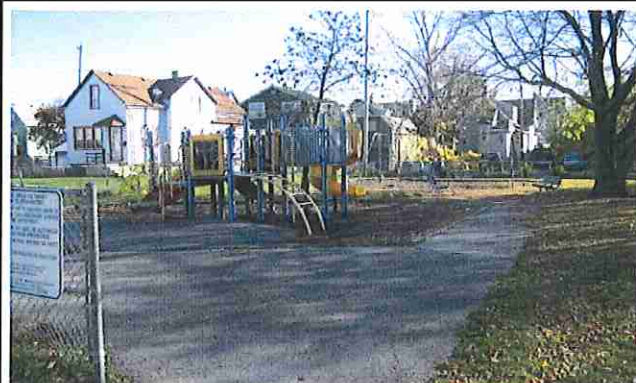
## Buffum and Center Play Area 2628 North Buffum Street

- A small site with a play structure, swing set & benches. The fence to the alley was closed in 2008.
- The woodchips are in need of replenishment. All the fence lines are overgrown with weeds, which need to be removed. The dumping of debris and trash at this site has been a problem for years and needs to be collected on a regular basis.

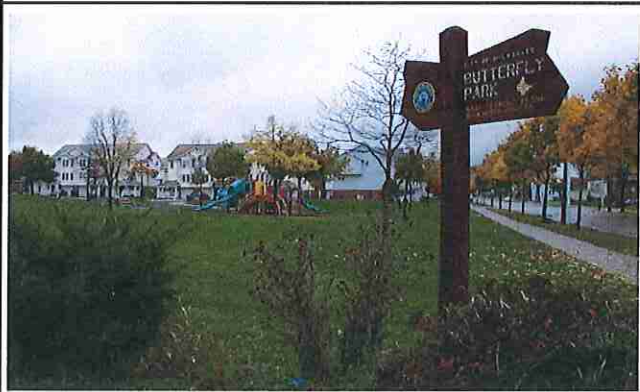
## Butterfly Park 3717 West Meinecke Avenue

- A large site with a play structure, swing set and benches. The Milwaukee Jaycees at one time sponsored this site. New Covenant Church uses this site as a playground for their School.
- Graffiti has been a problem here and the resilient surface is in need of some minor repairs.

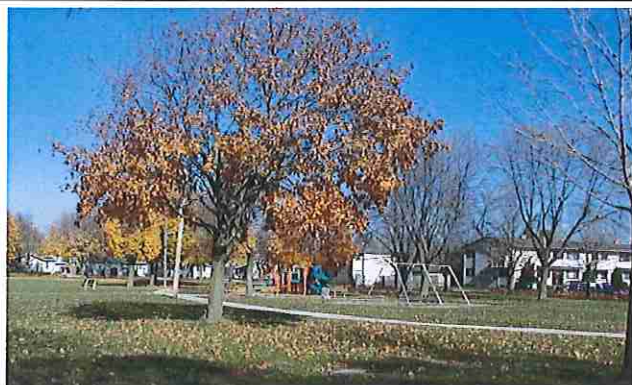
## Darien and Kiley Play Area 6952 North Darien Street

- A large triangular green area with a play structure, swing set and benches. There are periodic problems with people cutting holes in the fence to create a shortcut to the apartments to the east. As the concrete legs to the wood benches deteriorate they are removed.

- The resilient surface is in need of some minor repairs.

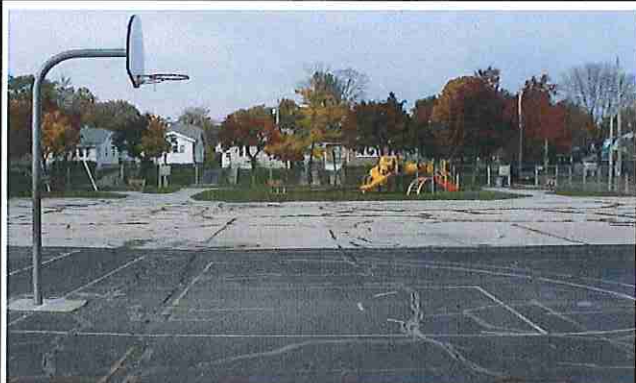
## DeBack Park 2461 North 55th Street

- A large site with a play structure, swing set and benches. The site was reconstructed in 1995 and renamed in May, 1996 after Marcus DeBack was killed there while watching a basketball game.
- The park sign needs to be repainted. The large asphalt area is overgrown with weeds and needs to be removed. Because of all the debris that is thrown into them the catch basins need to be cleaned out periodically. The resilient surface is in need of replacement.

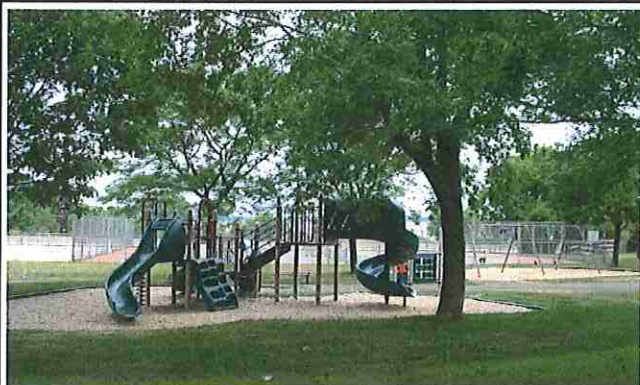
## Ellen Park 1829 East Fernwood Avenue

- The tennis nets need to be replaced with nylon nets and the woodchips are in need of replenishment.

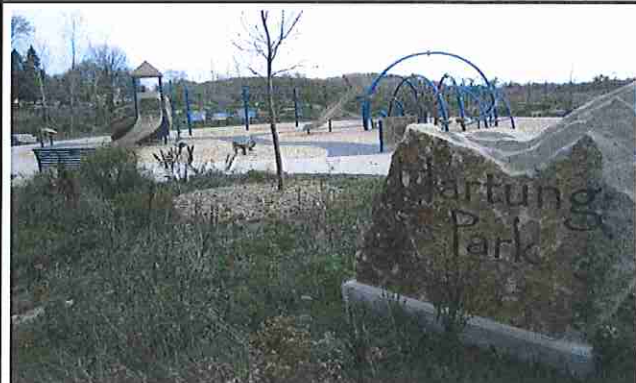
## Hartung Park 3342 North Argonne Drive

- A large site constructed on a former landfill. There is a rain garden, out cropping stone with bronze sculptures, woodchip paths and a stone labyrinth. Maintenance of the site is shared between the City of Milwaukee and the City of Wauwatosa.

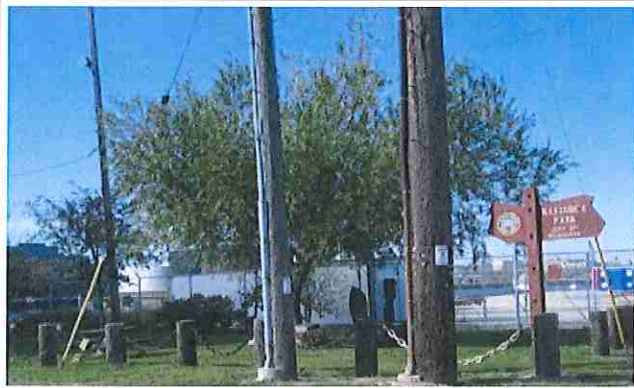
## Kaszube's Park 1421 South Careferry Drive

- A small passive area located on Jones Island with an anchor and a Historical marker. New wood pilings were supplied by the Port of Milwaukee and installed by City Forces in 2005. The two large trees were cut down, new trees replanted and the area was landscaped in 2008 by Forestry.

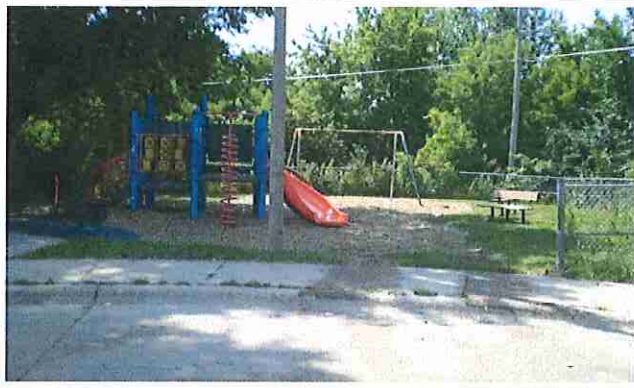
## Long Island and Custer Play Area 5320 North Long Island Drive

- A small site with a play structure, swing set and benches. Vandalism and large debris dumping are major problems at this site, several components of the play structure have been removed because of damage or being burned.
- ADA retrofit and maintenance cannot be done, the structure manufacturer is no longer in business. The resilient surface is in need of replacement.

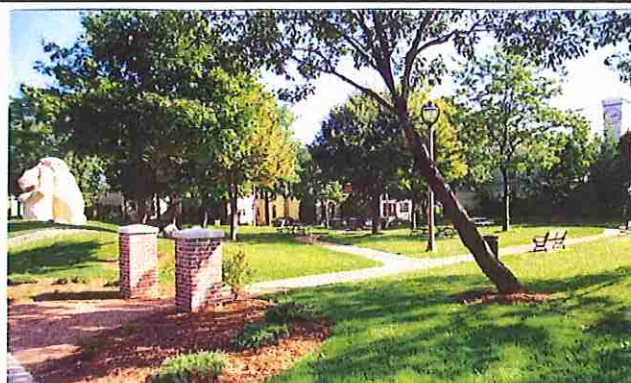
## Paliafito Park 901 South 3rd Street

- A small passive area with benches and picnic tables. This site is named after Robert Paliafito who donated the land from the former Skyview Nursing Home.
- This is a hangout for homeless people and students from Bradley School of Technology and Trade. Graffiti on the picnic tables is a constant problem.

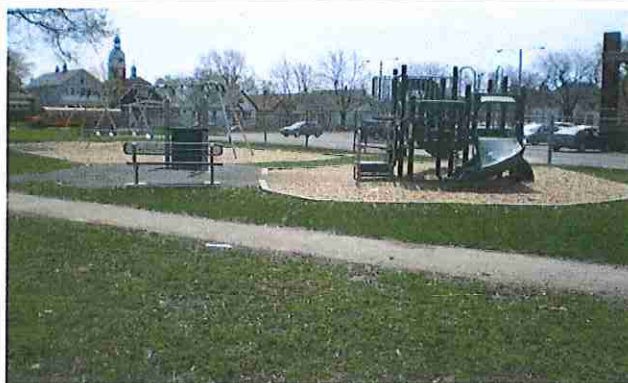
## Reiske Park 1640 South 24th Street

- A large site with a play structure, swing set and benches. The tennis courts were converted into parking spaces for the South Side Health Center in 2005.
- The asphalt is in very poor condition and needs to be replaced. Graffiti is a constant problem here , along with braking of the wood bench boards.

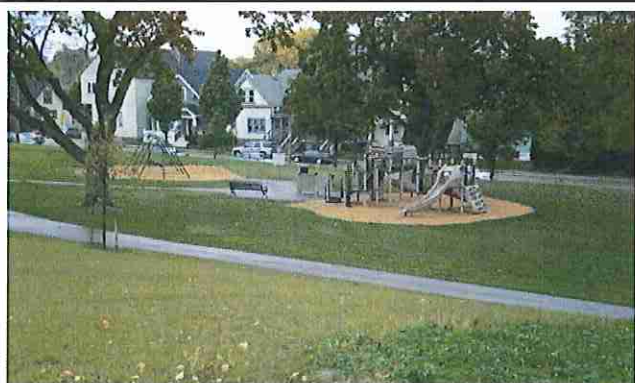
## Reservoir Park 801 East Meinecke Avenue

- The building is not used and in very poor condition and needs to be removed. The woodchips are in need of replenishment.

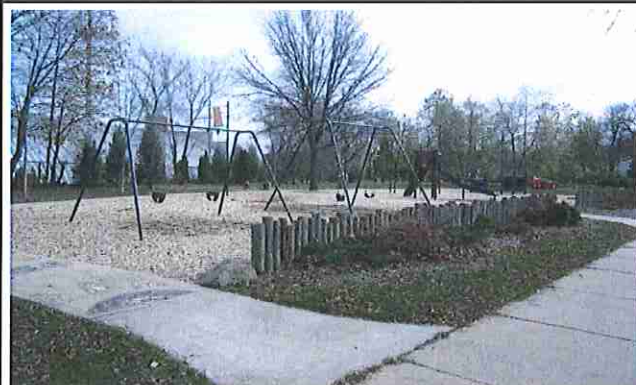
## Snails Crossing Park 3050 North Bremen Street

- A small site reconstructed in the shape of a giant snail. The benches and art work were donated and are maintained by a Riverwest community group.
- Electrical Services needs to finish installing a light pole and the ruts in the grass in that area needs to be repaired.

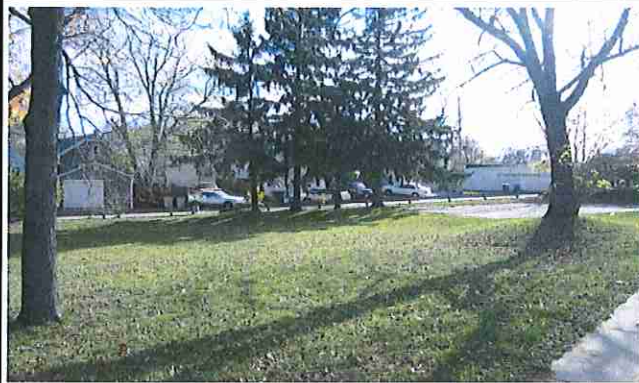
## Teutonia and Fairmount Passive Area 5040 North Teutonia Avenue

- A small green site with an asphalt area. The play equipment was removed in 1983, the backboards and rims in 1990, the fence along Teutonia Ave. and the alley in 2000 and the goal posts in 2003, all was done by neighborhood request.
- The asphalt area is in very poor condition and needs to be removed. The site should be landscaped with a path and benches added.

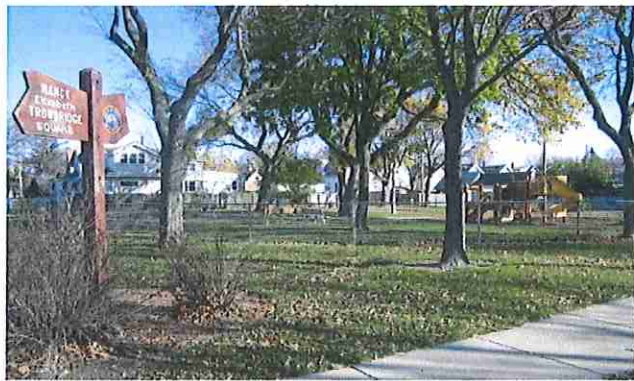
## Trowbridge Square 1530 South 38th Street

- A small site with a play structure, swing sets and benches. The land was donated to the City of Milwaukee by the estate of Nancy Elizabeth Trowbridge for use as a playground/park. If the City wants to sell or convert this area to another purpose it reverts back to her heirs.
- Gang graffiti is a major problem, the park sign needs to be repainted and the asphalt walk is heaving in areas and will need replacement soon.

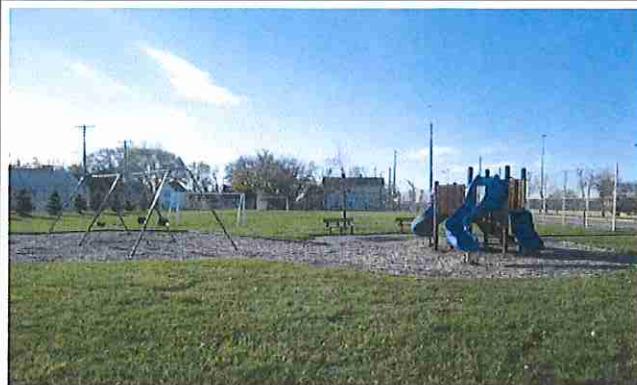
## Witkowiak Park 1648 South 4th Street

- A large area that was the old Allen School and under MPS control until 1994 and expanded north to encompass the former Public Natatorium site. In 2011 sections of the retaining wall were removed to eliminate blind corners at the alley. In 2012 goals were installed converting the baseball diamond into youth soccer field.
- The basketball court is in need of resurfacing and the resilient surface needs to be replaced.

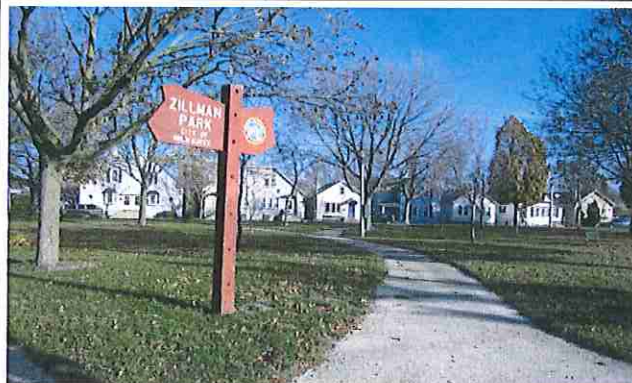
## Zillman Park 2180 South Kinnickinnic Avenue

- A small triangular passive area with benches only. In 1998 a Historic marker was installed for the "Green Bay Ethnic Trail". The large bushes were removed by Forestry in 2009.
- The asphalt walks and benches are starting to deteriorate and will need replacement in a few years. The park sign is in need of painting.
