# Certificate of Appropriateness

**Property** 1702 N. HUMBOLDT AV. **Brady Street Historic District**  
**Description of work** The church, rectory and garage will be tuck-pointed in areas as needed. Test panels will be done in inconspicuous places on the buildings for HPC staff to review and approve. On the school, the chimney in the back of the building will be demolished, decked-in and roofed-over with shingles to match.

**Date issued** 10/31/2014 **PTS ID** 98733 **COA, tuckpointing, removal of chimney on school**

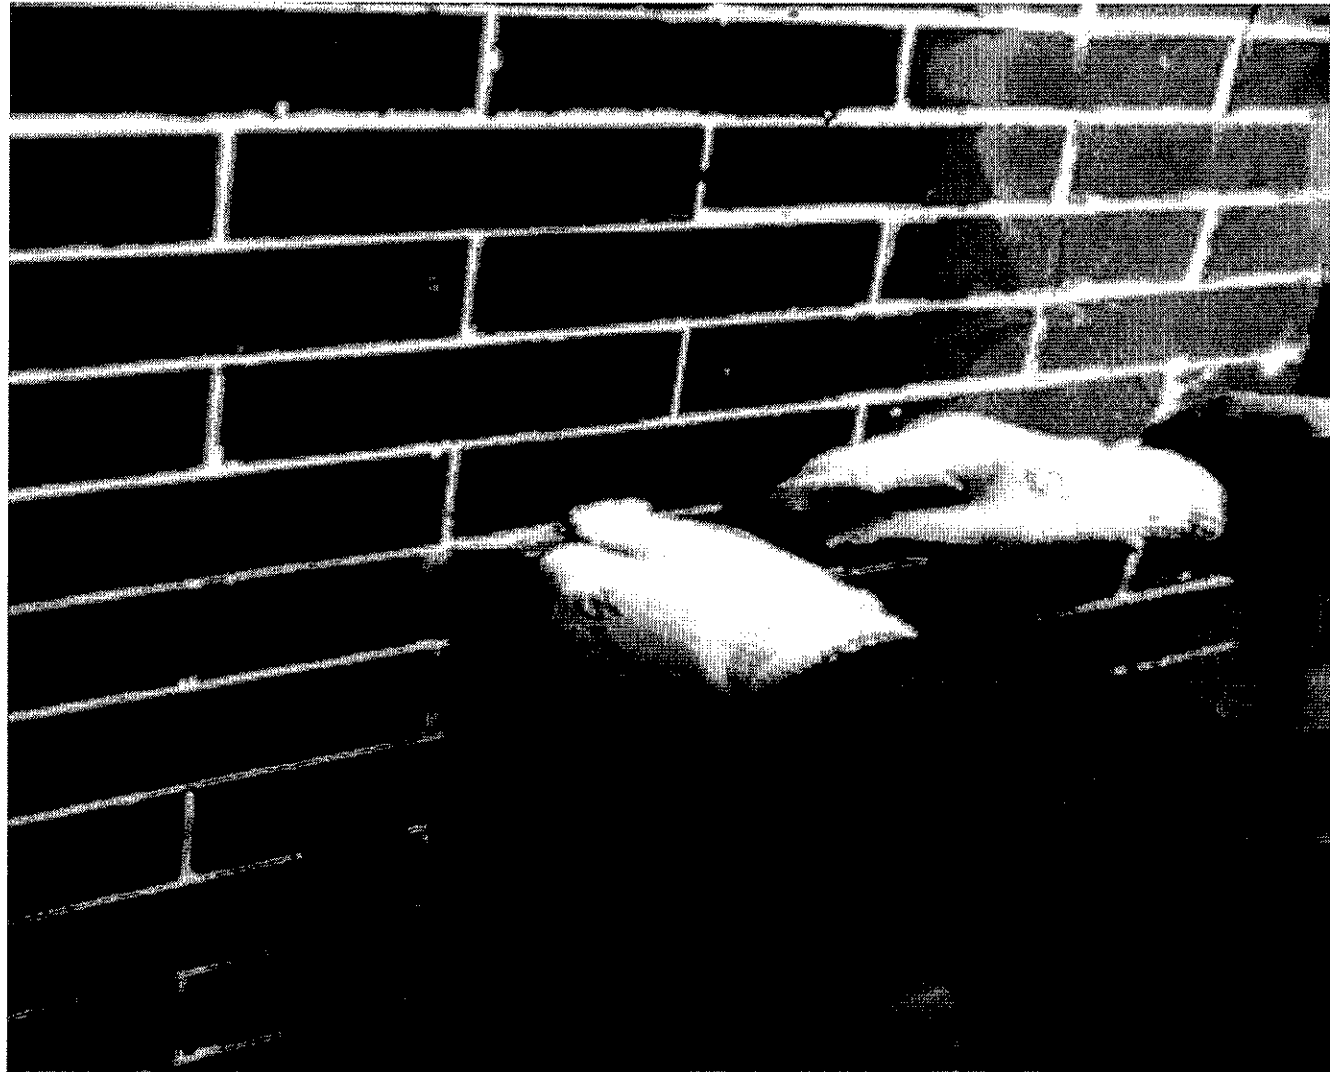
**This test panel on the rectory (East Elevation) shows some wobble in the butter joint that was cut and re-pointed. This must be avoided and only mortar that is missing, loose or deteriorated should be replaced. Otherwise the color and texture of the replacement mortar in this panel is acceptable.**

For removal of butter joint mortar on the rectory, choose the technique that makes the least impact on the masonry. The use of hand tools is always recommended. Grout keys work well to remove mortar from butter joints unless they are extremely thin. A caulking cutter or an air-powered stone chisel set up for repointing can also be used. Most grinding wheels are too large for use on butter joints and tend to wobble creating nicks in the edges of the brick.
