**The Home Inspector**[\(http://www.startribune.com/variety/homegarden/blogs/Reuben\\_Saltzman/\)](http://www.startribune.com/variety/homegarden/blogs/Reuben_Saltzman/)

## Many problems with installations of LP SmartSide siding

By Reuben Saltzman | OCTOBER 6, 2015 — 6:19AM

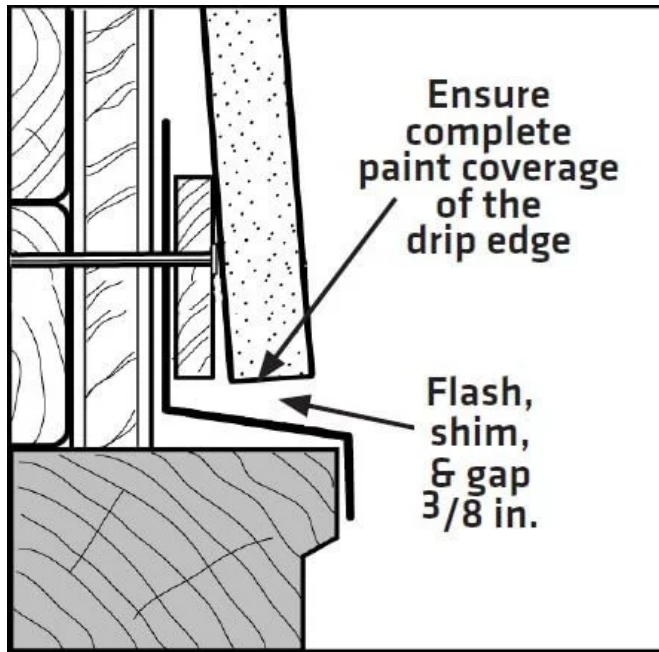
The manufacturer requires a 3/8" gap above windows and other similar penetrations.

This is rarely done.

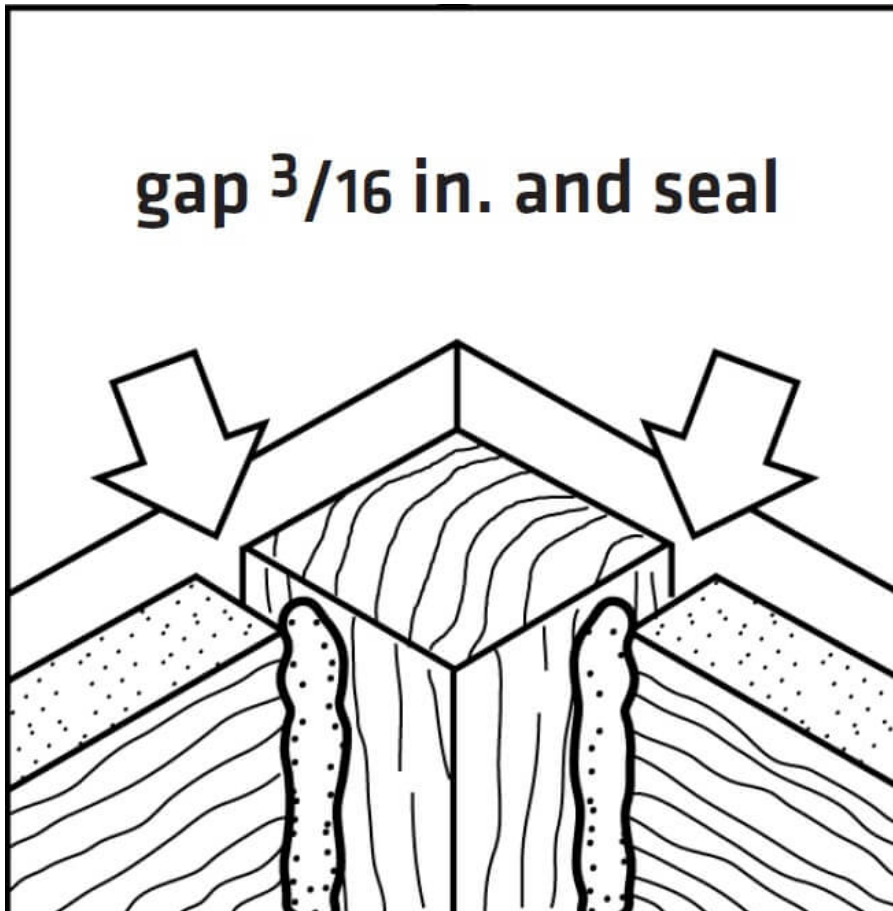
The manufacturer requires a 3/16" gap at the end of each piece of siding. This includes butt joints, and places where the siding terminates vertically against windows, doors, and other fixtures.

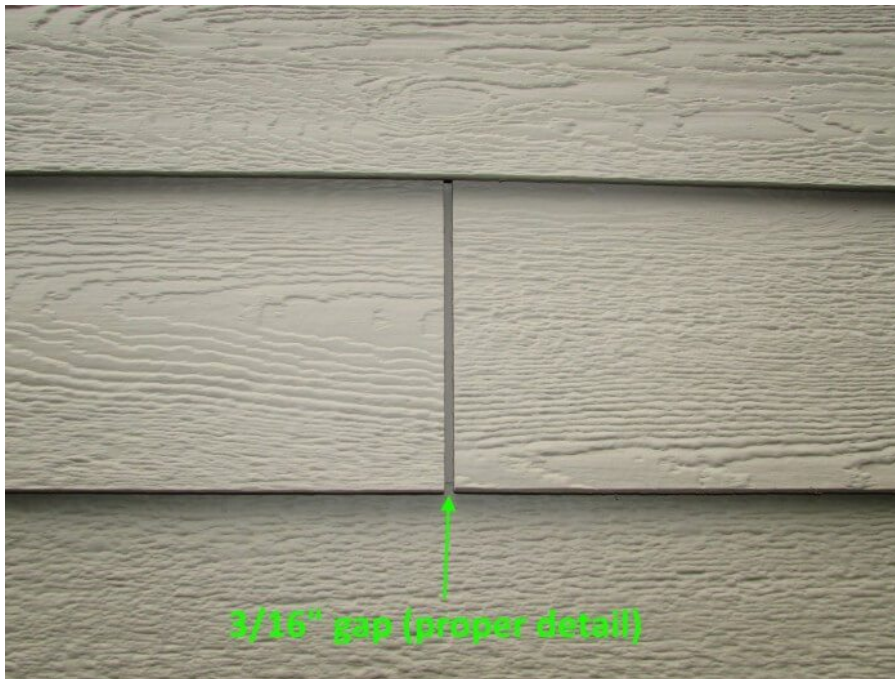
A 3/16" gap is a pretty large gap. Here's what a proper 3/16" gap looks like:

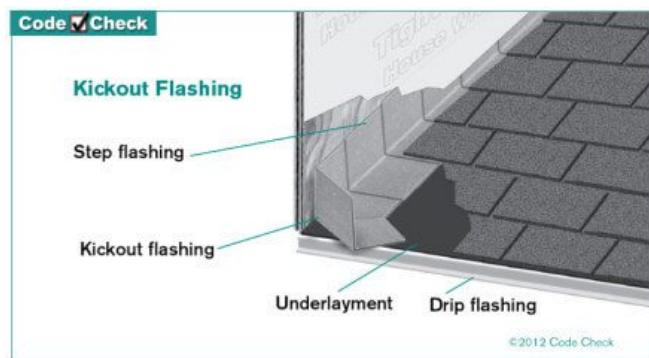
Kickout flashing (<http://www.structuretech1.com/2013/05/kickout-flashing/>) is a piece of metal at a roof end that prevents water from leaking into the wall. See below.

LP SmartSide® requires flashing to have a 4" upper leg. This means the kickout flashing needs to be 4" high. This usually isn't done.

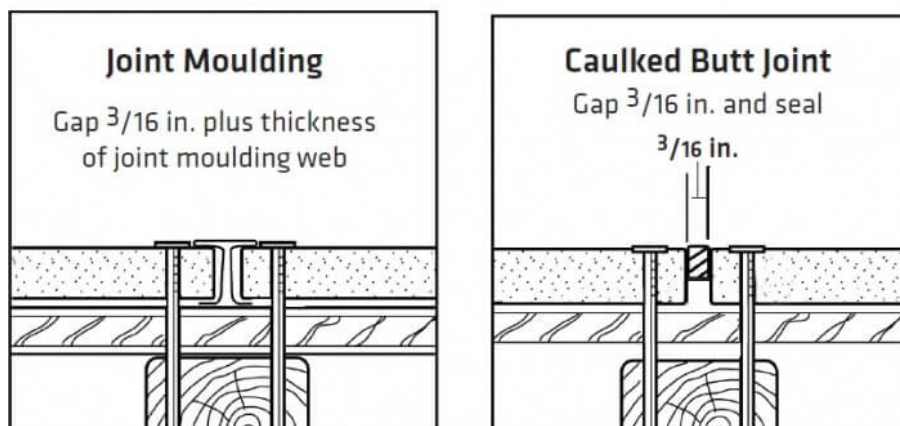
## Alternate Butt Joint Treatments

There are three options for keeping water out of the butt joints. The first and second options are to have the joints caulked or have joint molding installed.

The third option is to have flashing at least 4" wide installed at the joints, as long as the ends of the siding are factory finished, and the siding is prefinished by an approved or preferred prefinisher. That means no cut edges at the butt joints. When field-cut edges are present, flashing at the joints is *not* an appropriate installation method.
