## The Home Inspector

# Many problems with installations of LP SmartSide siding

By Reuben Saltzman | OCTOBER 6, 2015 — 6:19AM

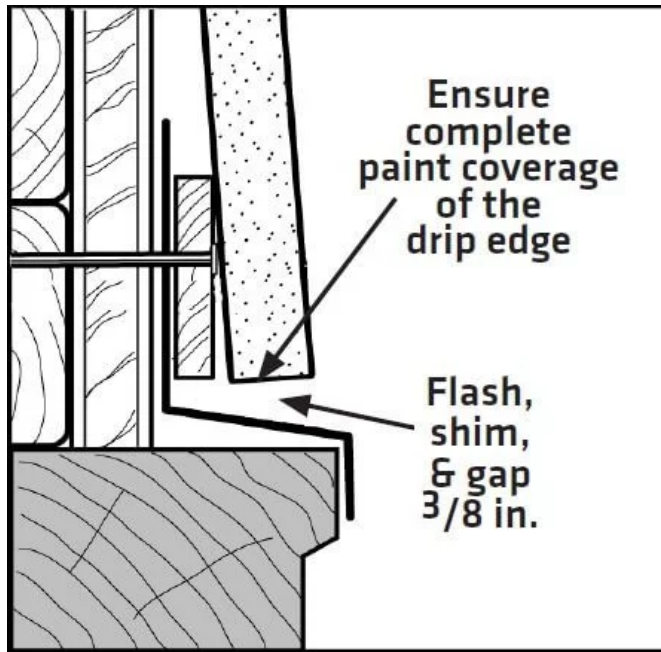
The manufacturer requires a 3/8" gap above windows and other similar penetrations.

This is rarely done.

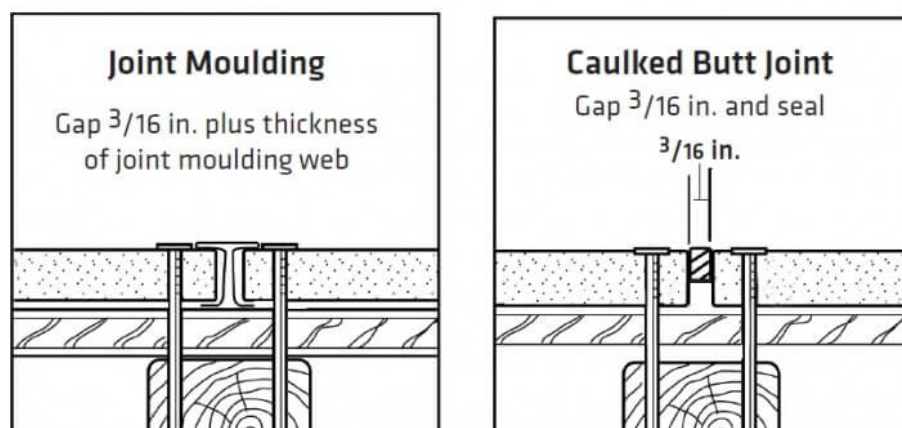
## Alternate Butt Joint Treatments

There are three options for keeping water out of the butt joints. The first and second options are to have the joints caulked or have joint molding installed.

The third option is to have flashing at least 4" wide installed at the joints, as long as the ends of the siding are factory finished, and the siding is prefinished by an approved or preferred prefinisher. That means no cut edges at the butt joints. When field-cut edges are present, flashing at the joints is *not* an appropriate installation method.
