# Certificate of Appropriateness

**Property** 3034 W. STATE ST. Concordia Historic District

**Description of work** Correct violations as indicated below on violation notice and in manner indicated.

**Date issued** 10/29/2019 PTS ID 114880 COA: Correct violations

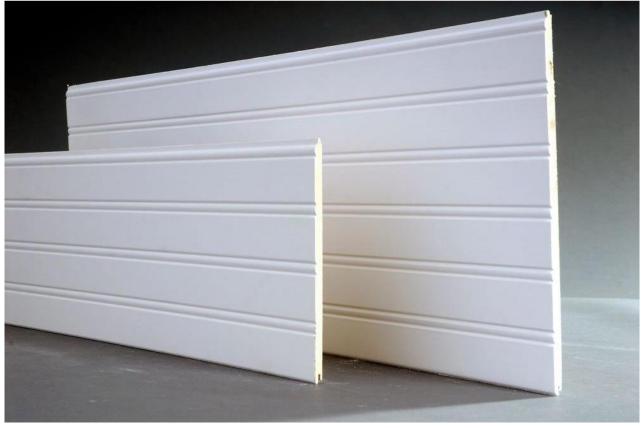
3) 275-32.3.g Replace defective boards in porch ceiling. bead board

Replace porch ceiling boards with new, painted wood beadboard per example below

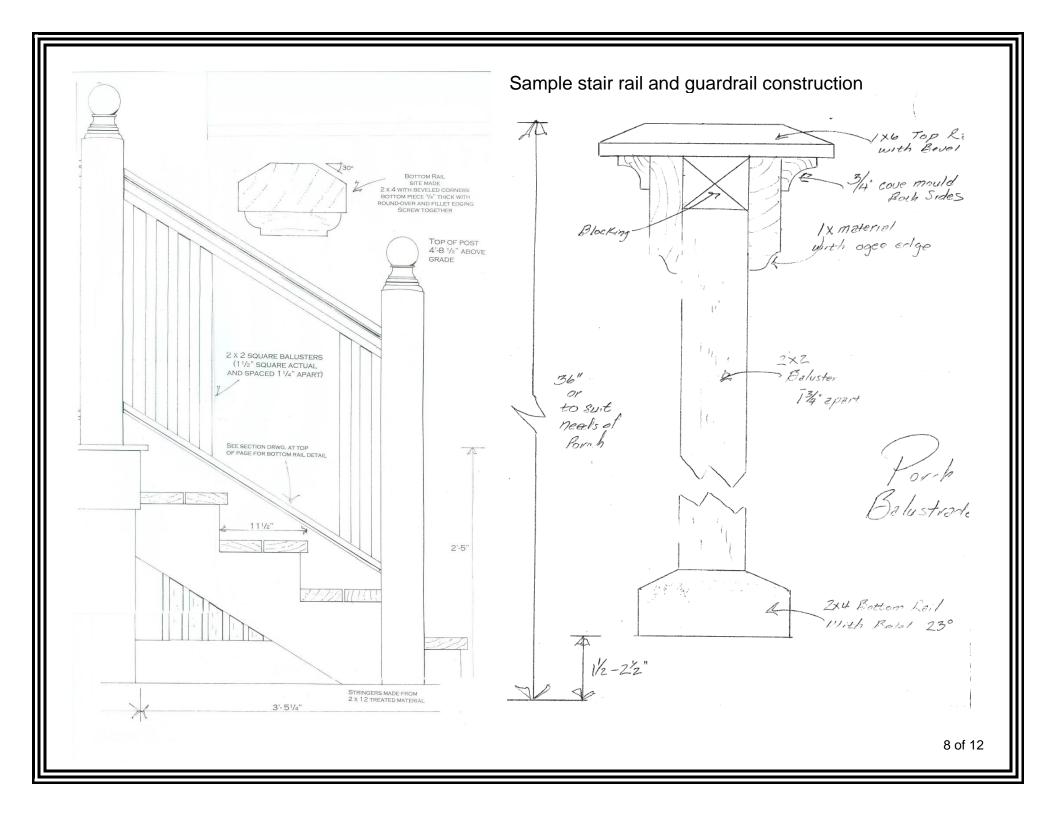
4) 275-32.3.g Provide an approved guardrail for porch. use cedar balusters to match Violation Location: South Side circled style on p. 182 of As Good As New

Balusters shall be a painted, naturally rot resistant wood species and painted. The same design shall be used to replace the stair railing at the east of the porch.

Photo c. 1980. New porch railing and stair railing shall be constructed of urn balusters similar to this design (at least 4x4" in size). See previous page.

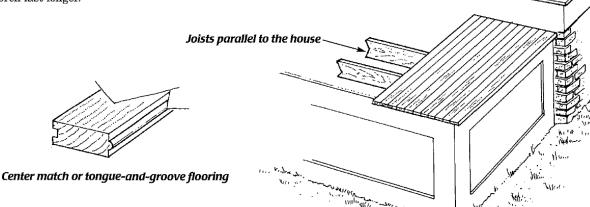
5) 275-32.3.g Replace defective porch floor boards and secure to supporting structure. New Natural wood lation Location: South Side Vouglas First or other hatural wood

Porch floors should be constructed of center matched or tongue-and-groove wooden flooring, which typically measures 2-1/4" wide by 3/4" thick. This flooring gives the porch a fine finished appearance. The joists, which are the structural framing members to which the flooring is attached, should always be run parallel to the house so that the floor boards can be installed perpendicular to the house. The porch floor should also be very slightly pitched away from the house. This method of construction for a porch floor will shed water and make the porch last longer.

Replace porch decking with new Douglas fir center-match flooring. Maximum acceptable board width is 5.5".
