Jacqueline,
We would like to thank you for your review and consideration for our work proposal on the Milwaukee Journal Sentinel Complex project. This letter is to provide you and the commission with more detail of the project description and more existing condition photos from what was provided on the application form.

Infill of door opening on the third and fourth floors

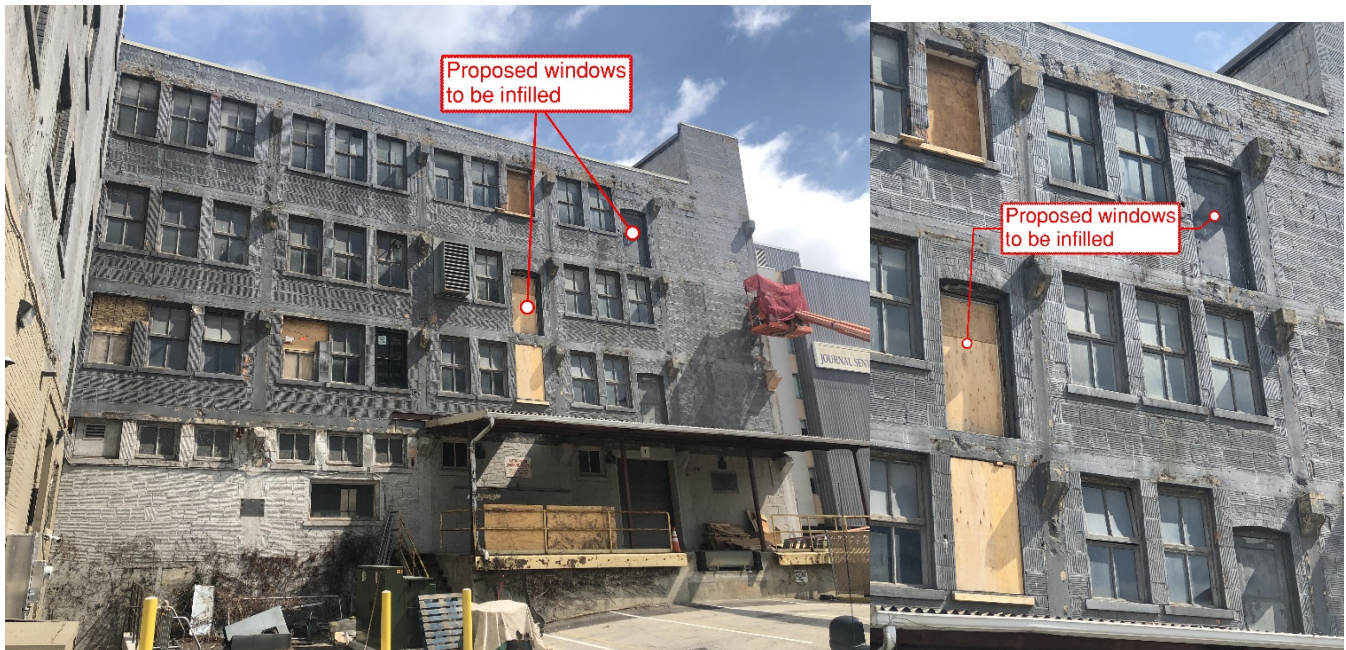
After the removal of the metal screen, two doors were discovered on the third and fourth floors of the south elevation. We believe these doors lead to an exterior fire escape that has been removed sometime in the past. With the fire escape already being removed and no longer needed for egressing out of the building, the Owner is proposing to infill these two door openings with masonry and mortar to match. The Owner is requesting to infill these two openings with matching masonry flush with the existing masonry. However, if the commission deem it necessary to pay tribute to the original door locations with the new masonry infill, the Owner is willing to install the masonry an inch setback from the face of the adjacent masonry to provide a silhouette outlining the original location of the doors.

We believe our proposal meets the Secretary's Standards for Rehabilitation as the windows/doors proposed for removal are not character defining (meeting Standards #2 & #5). Infilling the window/door openings while preserving the window sills and brick door headers show a record of what was historically there and does not create a false sense of history (meeting Standard #3). This approach is also consistent with the Secretary of Interior's Standards for the Treatment of Historic Properties with Guidelines for Rehabilitation, we are preserving the overall glazing pattern on primary or highly-visible elevations and character-defining features of the building. We appreciate your consideration and look forward to working with the HPC staff on this exciting project. If you have any questions, please feel free to call me directly at (414) 291-8181.

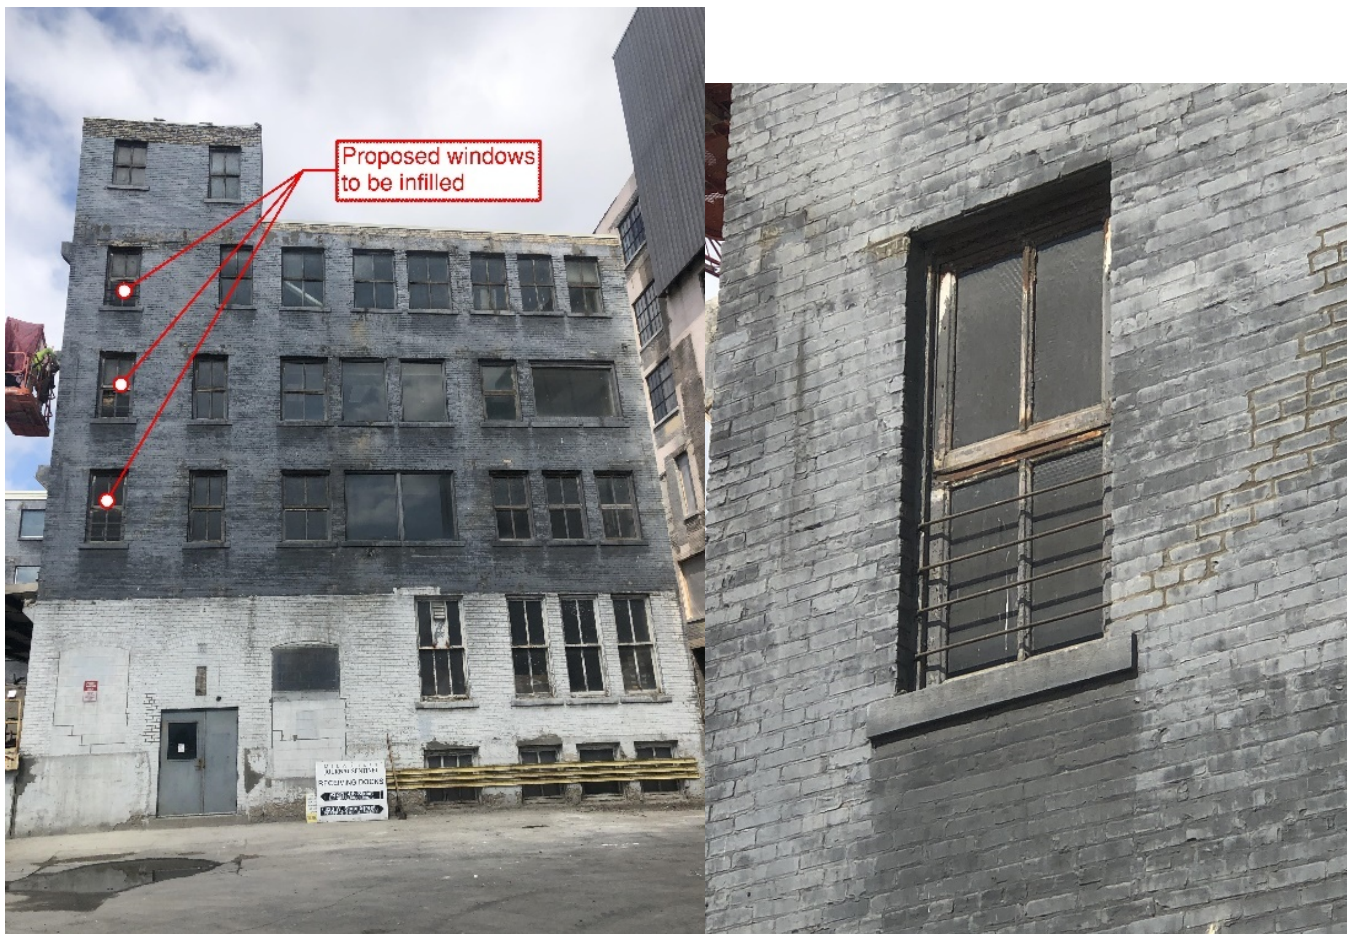
Infill of window opening in existing elevator shaft

After the removal of the metal screen, three windows were uncovered within the existing elevator shaft. Prioritizing life safety for students and other occupants of the school we propose to infill the openings to meet the 2-hour shaft enclosure rating. In doing so, the shaft will be protected from potential fire propagation from floor to floor through the shaft windows. The Owner is proposing to infill these three windows with masonry and mortar to match. While we understand removing the three windows and infilling them with like kind masonry is removing an original feature of the building, it will also be preserving the original lift shaft. We do not view these three windows to be distinctive character defining elements nor are they on a primary highly visible elevation as they are on the alley side of the building.

Infilling these windows to meet a 2-hour fire rating is required by the International Building Code (IBC); the International Existing Building Code (IEBC) allows deviation for historic buildings, but only if it would damage contributing historic features, as previously stated, we do not believe these windows meet that criteria and we are therefore required to bring this up to code. The Owner is requesting to infill these three openings with matching masonry flush with the existing masonry. However, if the commission deem it necessary to pay tribute to the original windows with the new masonry infill, the Owner is willing to install the masonry an inch setback from the face of the adjacent masonry to provide a silhouette outlining the original location of the windows.
