St. Benedict the Moor Catholic Church

Basement Level Window Replacement Project

Submission for Certificate of Appropriateness

Appendix 1: Drawings & Photographs

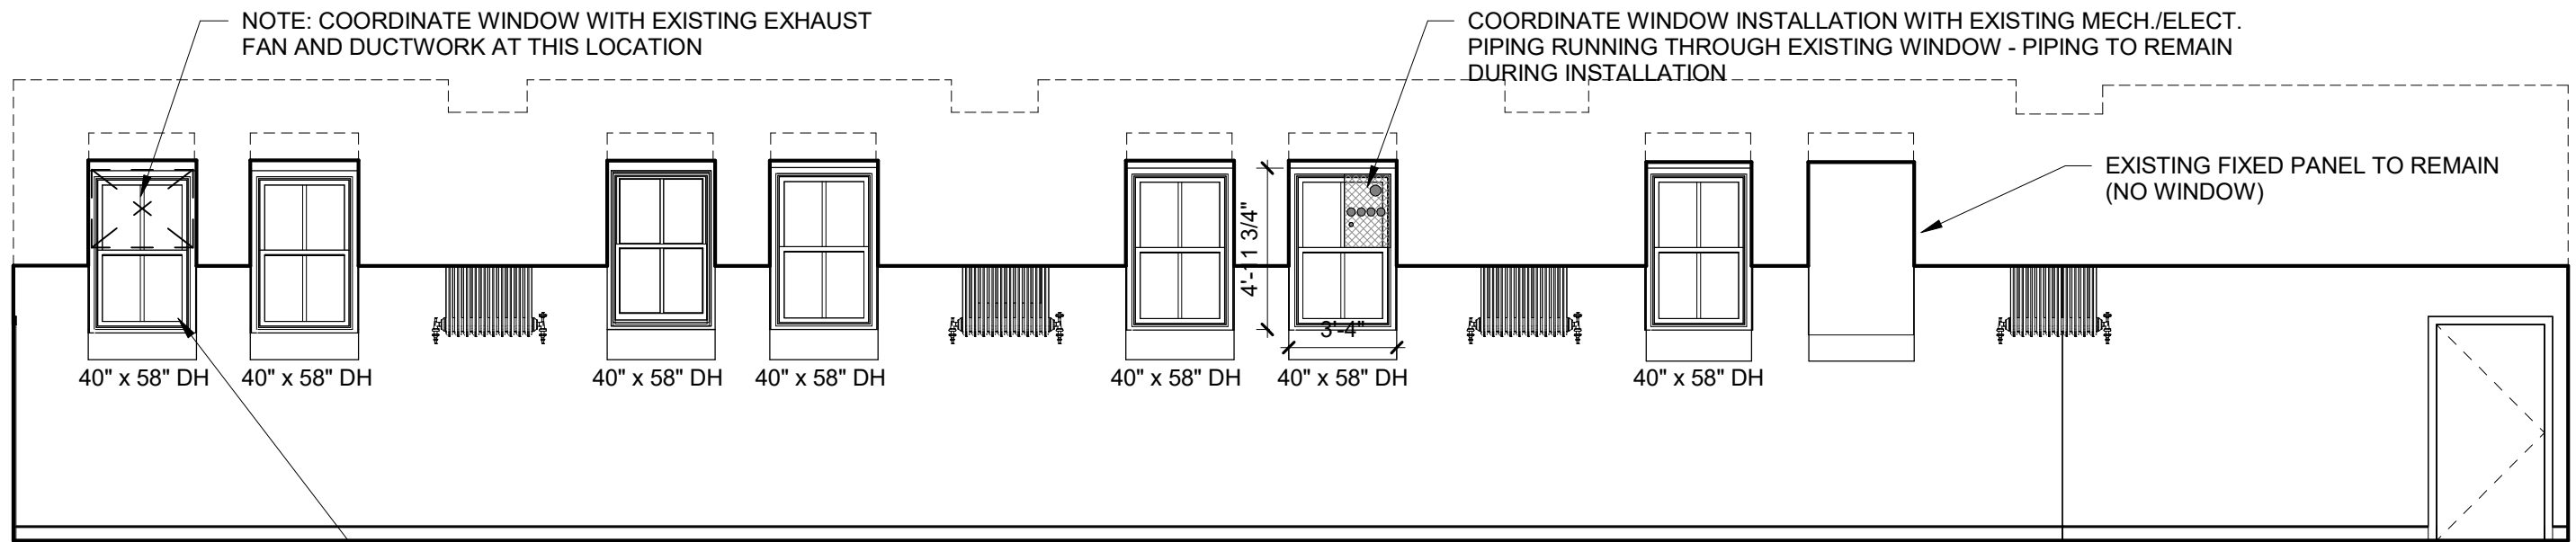
1 West Elevation

SCALE: 3/16" = 1'-0"
 0' 2' 4' 10'

NOTE: FIXED WINDOW UNIT AT THIS LOCATION TO ACCOMODATE EXISTING MECHANICAL DUCTWORK.

Remove existing Basement Level windows as shown (Coordinate with lead paint abatement by others). Remove exterior security grates and repair masonry as required. Install new aluminum clad wood replacement windows as follows: Match frame width and exterior brick mold trim profiles as closely as is practical. Provide operable sash with true divided lights (match existing muntin bar thickness and profile as closely as possible). Provide clear vision insulating glass with low-e coating. Windows to meet current Energy Codes. Verify aluminum and wood finishes (to be chosen from manufacturer's standard range.) Coordinate installation with Owner's security vendor for installation of contacts, glass break sensors as required. Note: at West windows, provide alternate pricing to provide safety glass at exterior side of window. Verify all sizes and frame conditions in the field.

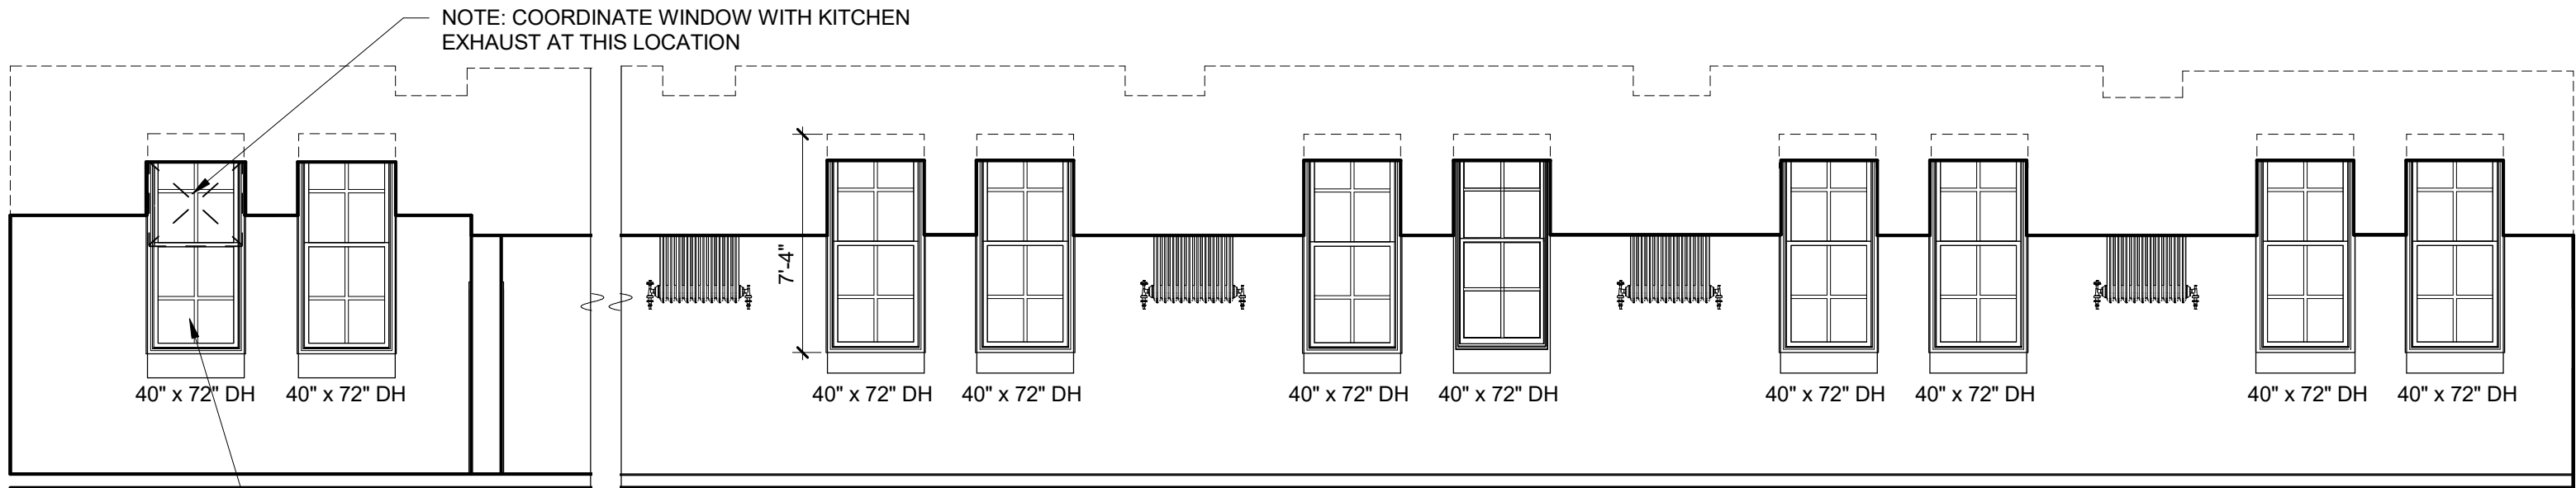
2 East Elevation

SCALE: 3/16" = 1'-0"
 0' 2' 4' 10'

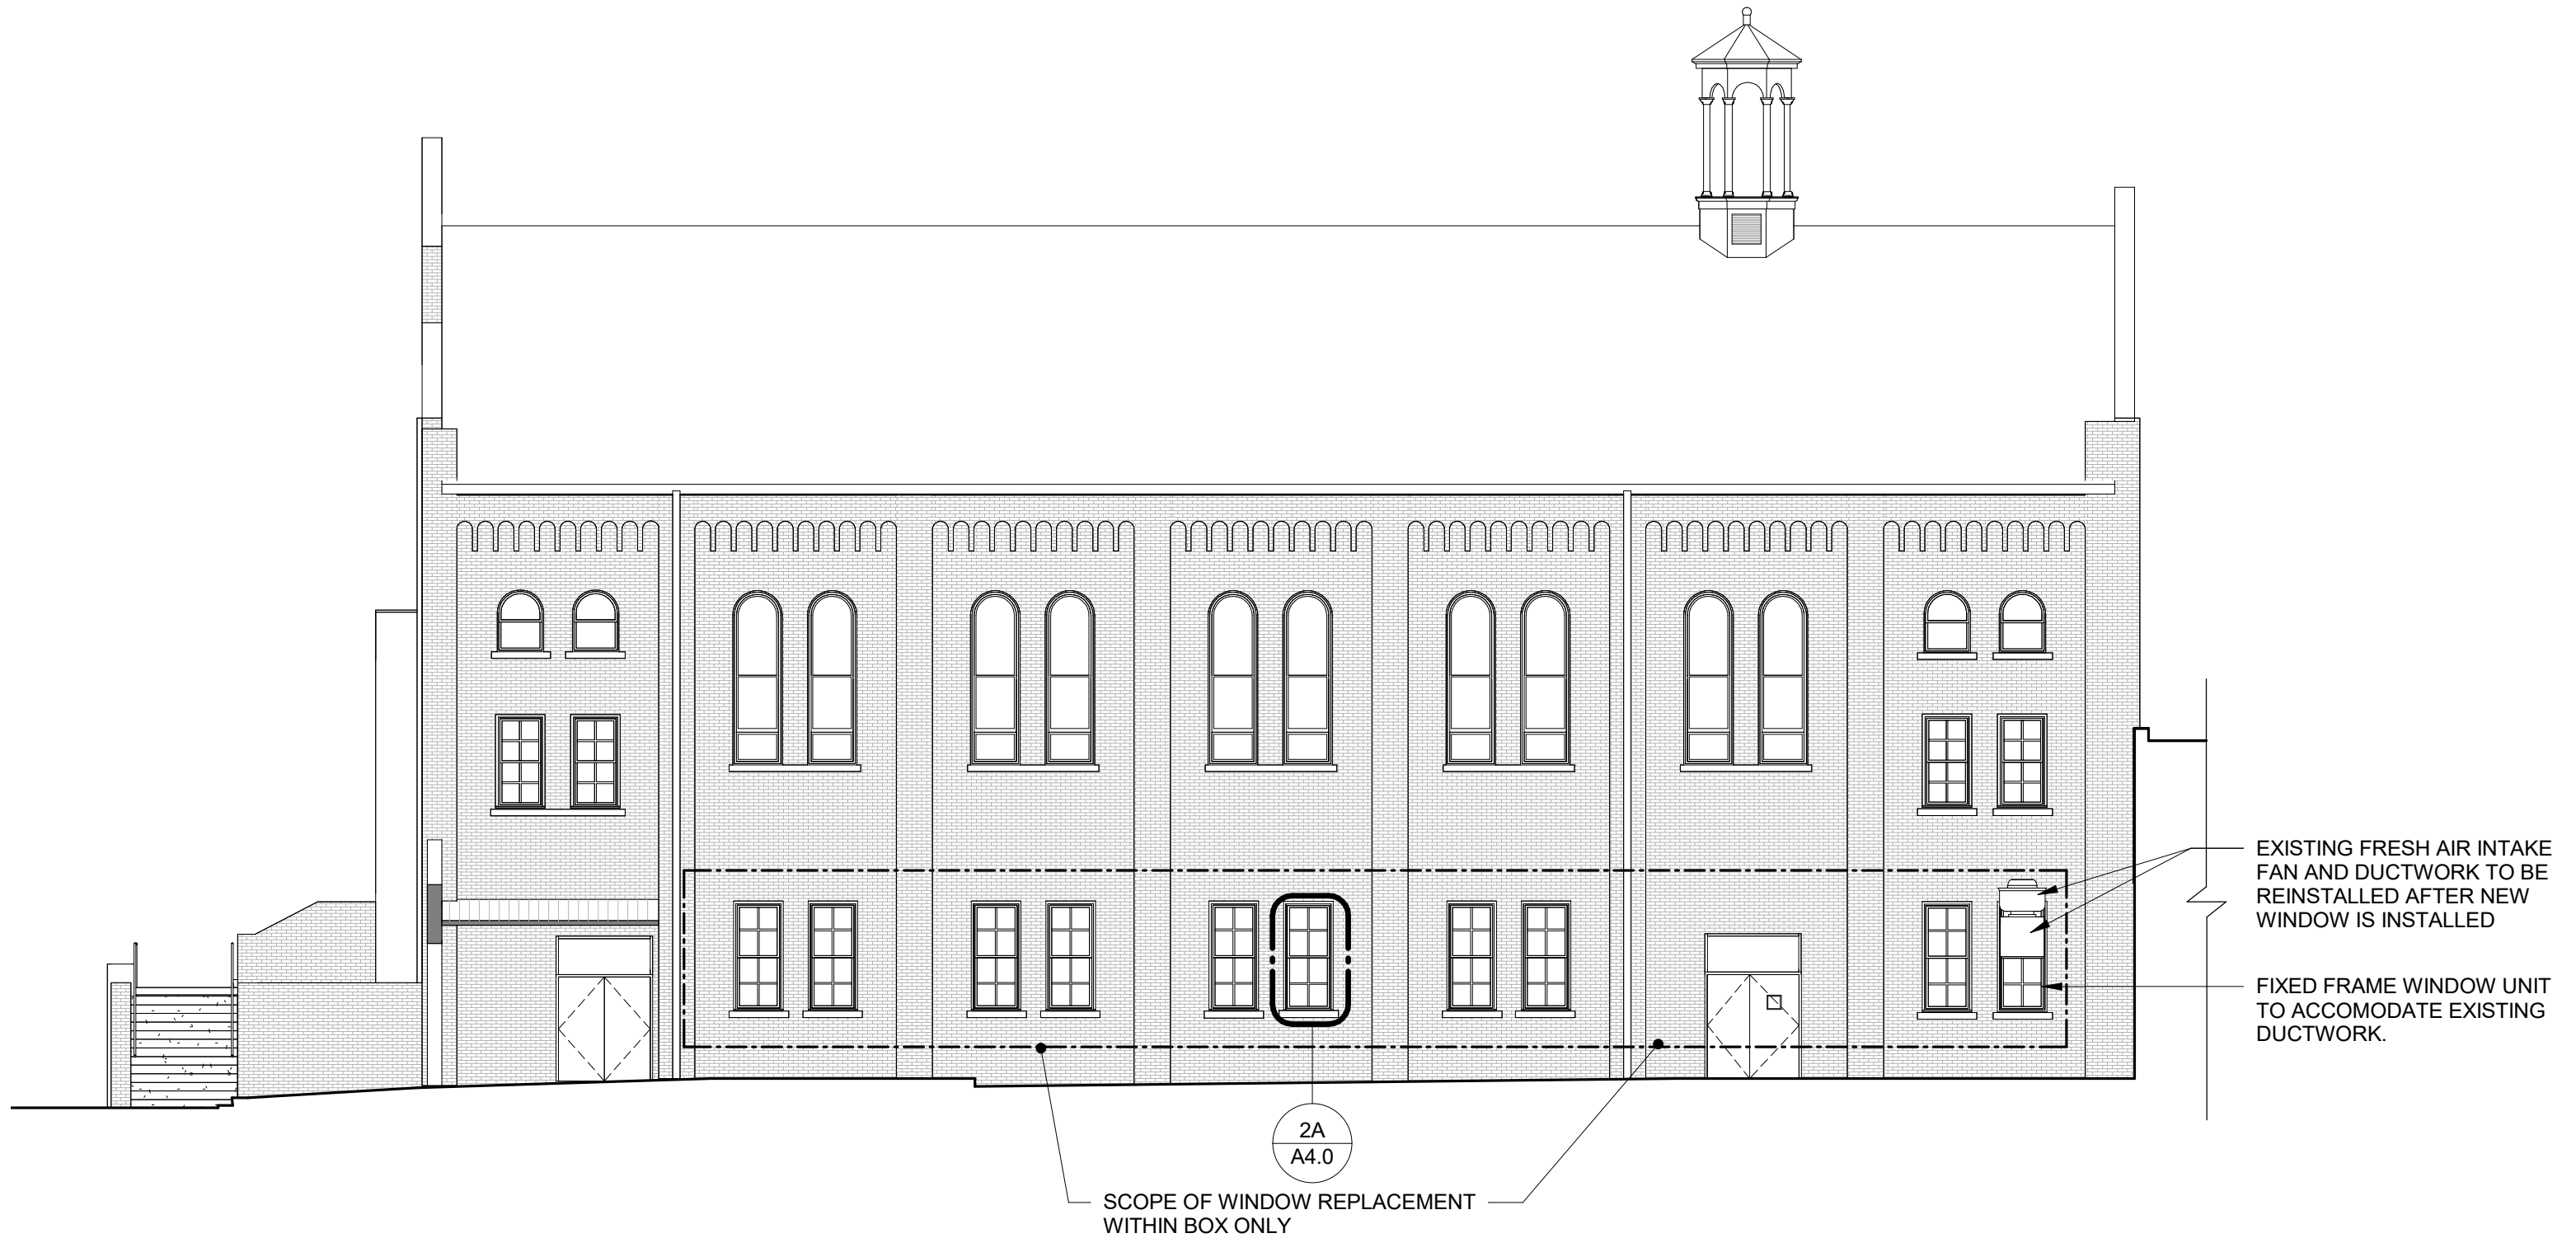
EXTERIOR ELEVATION - EAST

SCOPE OF WINDOW REPLACEMENT WITHIN BOX ONLY

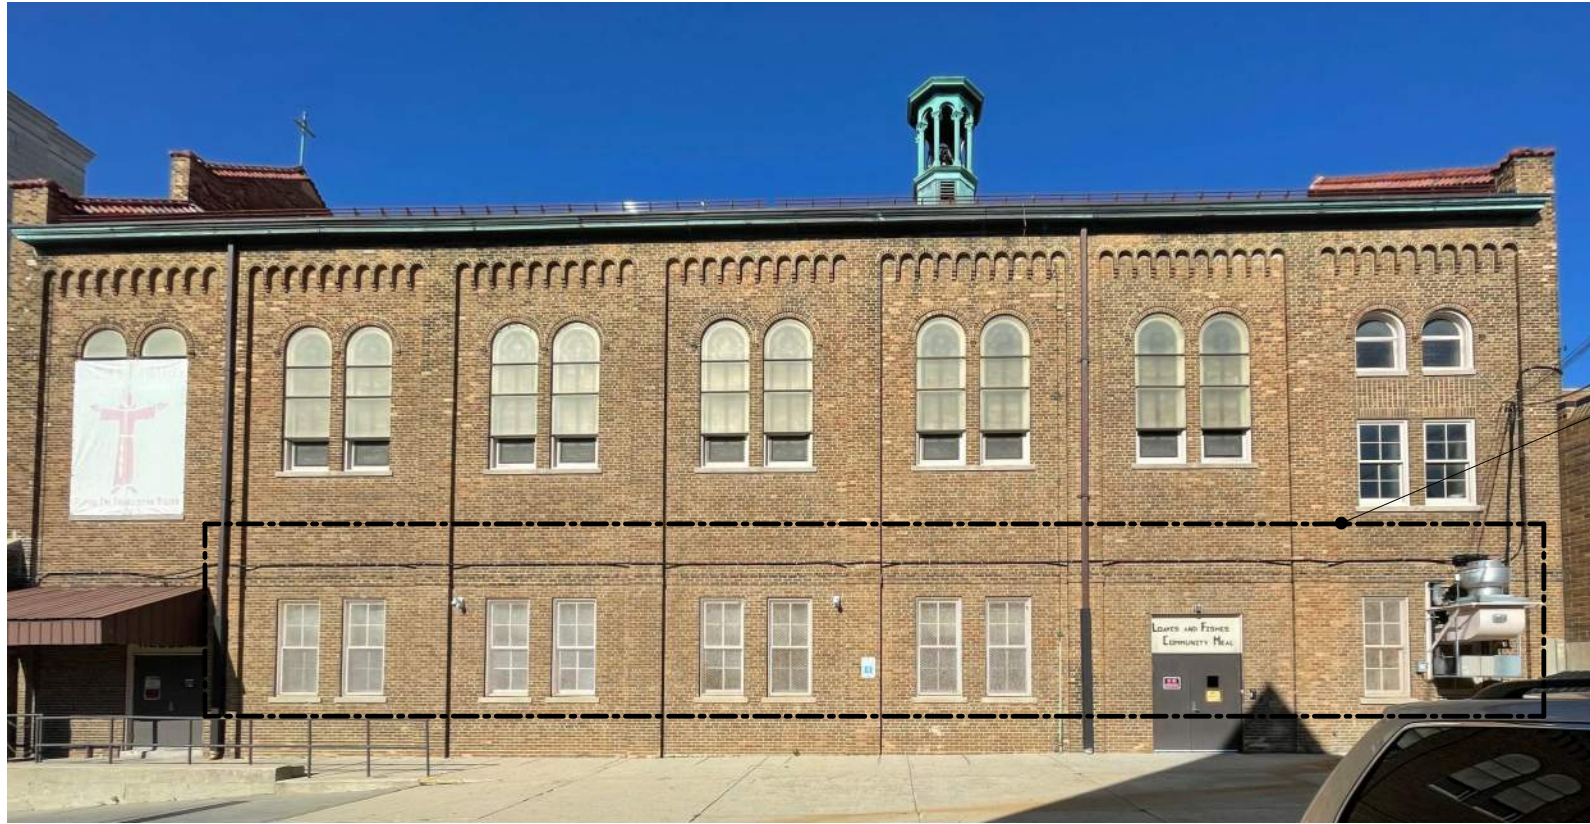
EAST ELEVATION OVERALL

SCOPE OF WINDOW
REPLACEMENT
WITHIN BOX ONLY

EXISTING SECURITY
GRATES TO BE
REMOVED (TYP.)

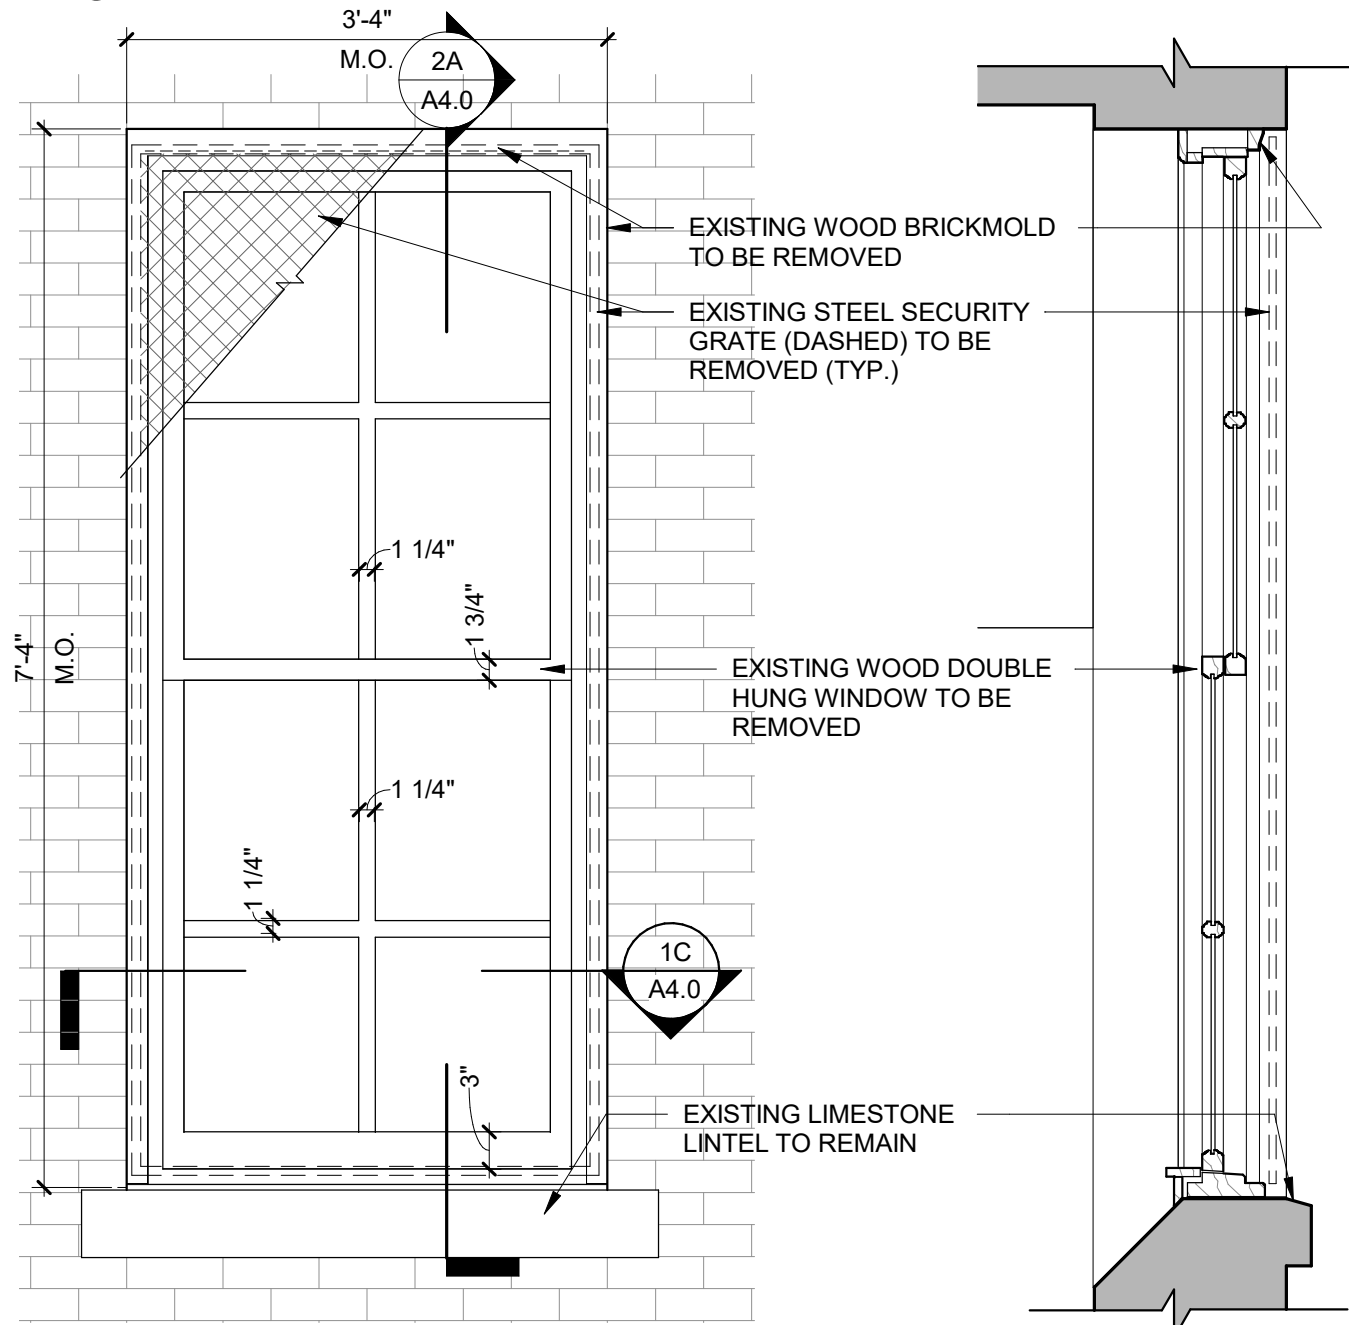
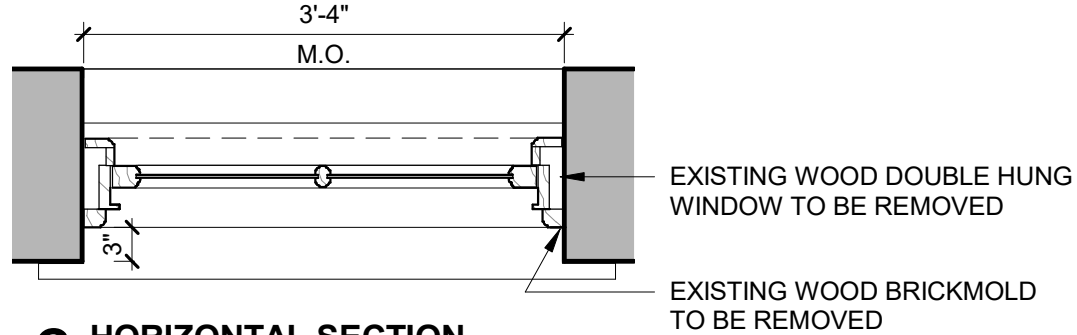
1 EXISTING EAST WINDOWS

C HORIZONTAL SECTION

A ELEVATION

B SECTION

SCALE: 3/4" = 1'-0"

As noted above, this project focuses ONLY on the Lower Level windows located on the east and west facades. In general, both facades feature existing wood double-hung basement windows, which are different heights and configurations on each side of the building. On the east side, the windows are taller, and each sash is divided into 4 equal lights by muntin bars. On the west side, the windows are shorter in height due to a higher finished grade at the face of the building. These windows are also double-hung, but each sash is divided into only two equal lights by muntin bars.

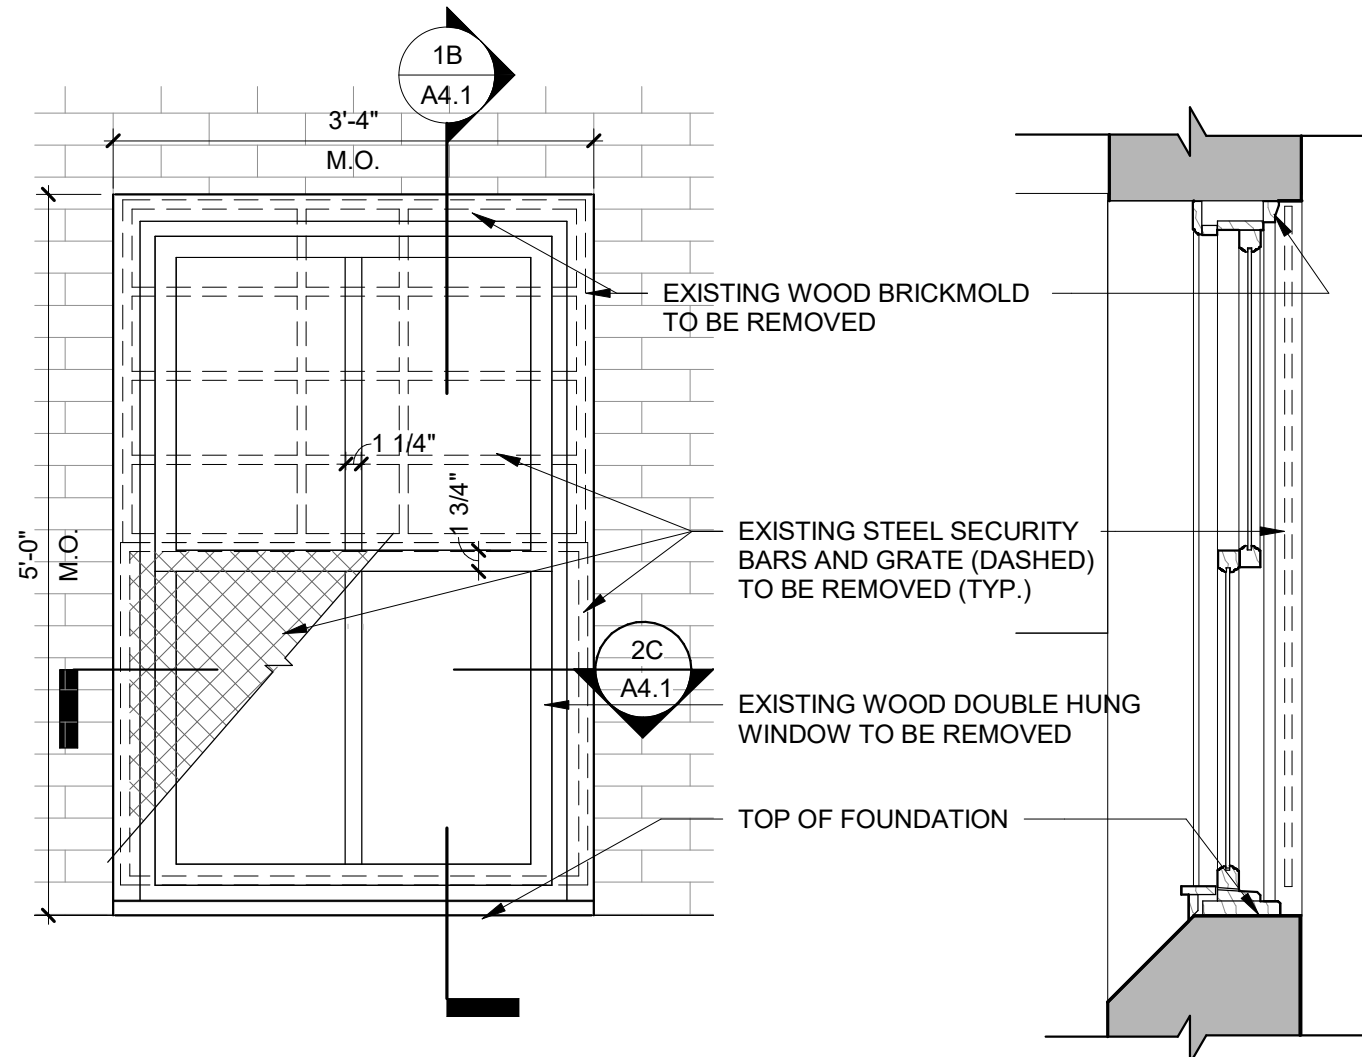
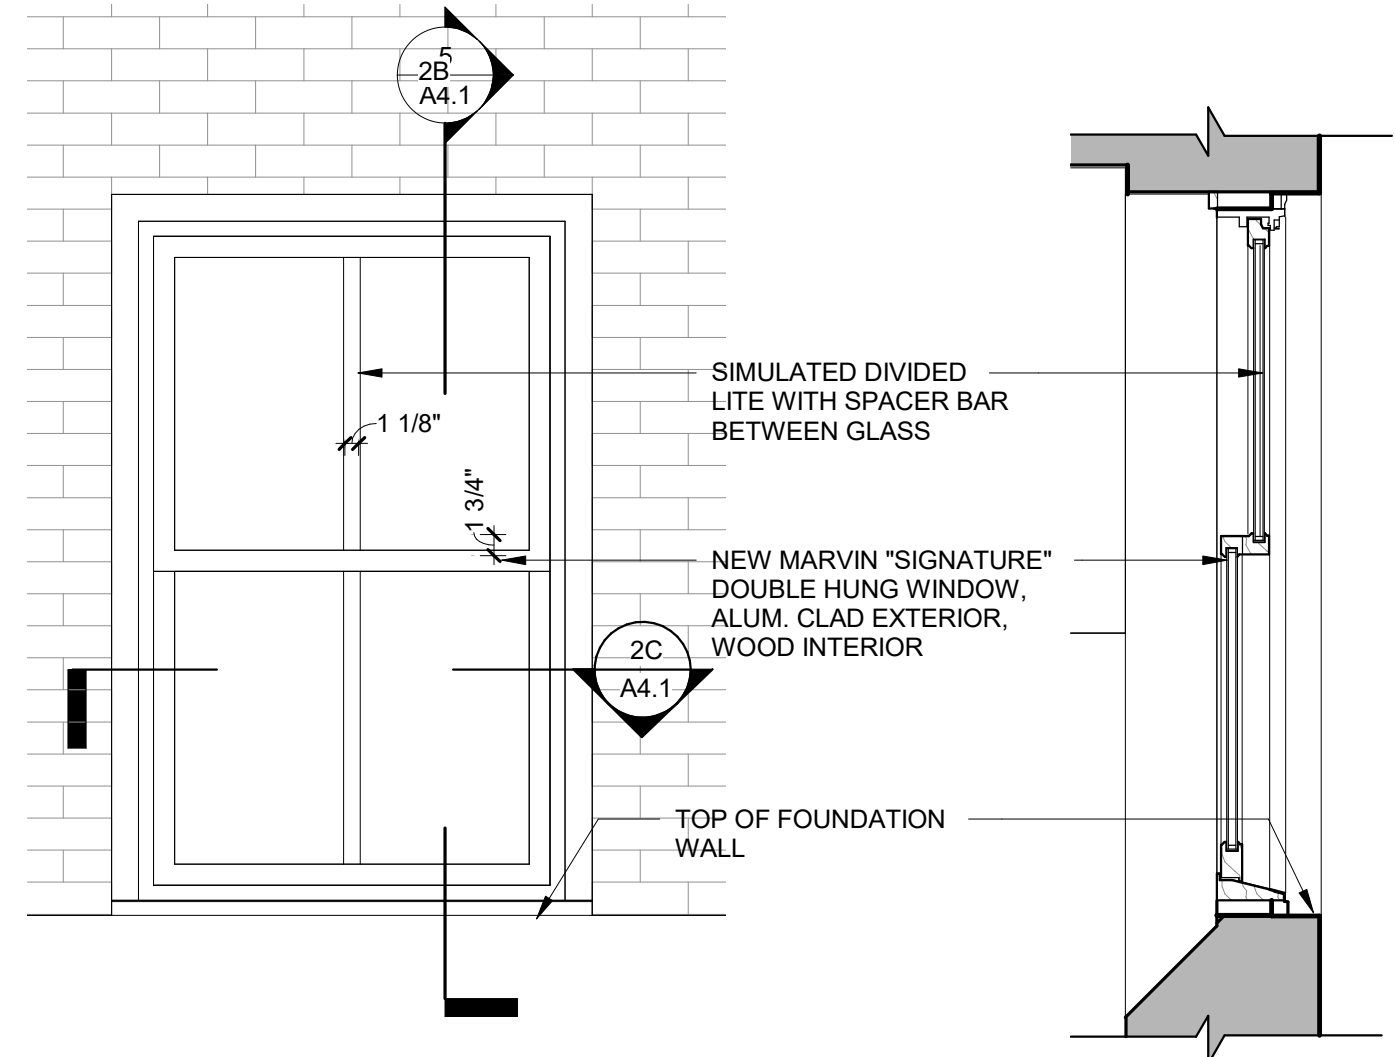
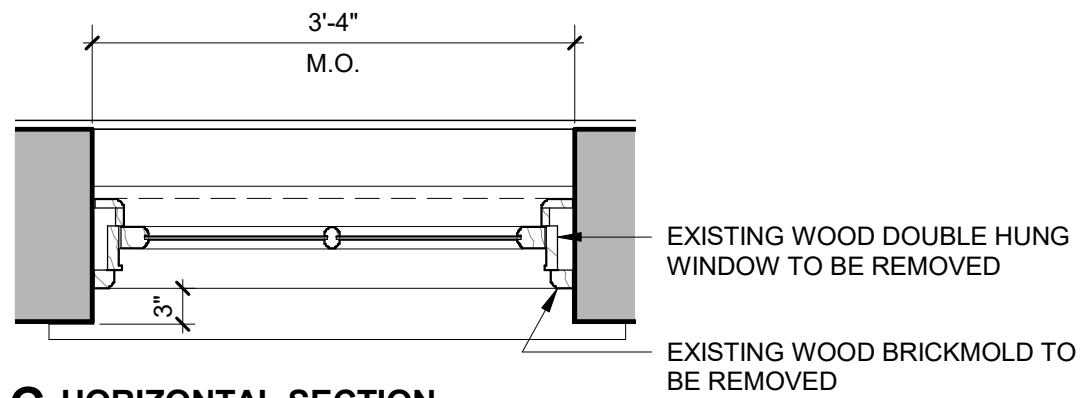
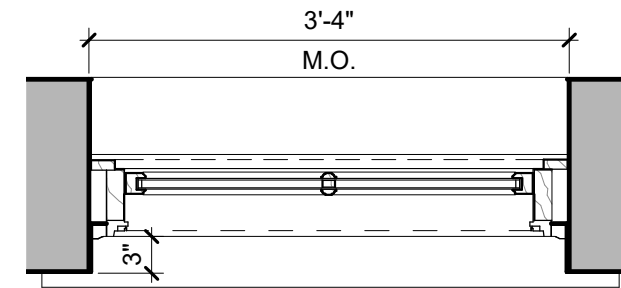
A4.1
09/06/22

C HORIZONTAL SECTION

A ELEVATION

B SECTION

The proposed window replacement system for the basement windows in this facility are Marvin Ultimate Series G-2 Single-Hung windows. The proposed windows are aluminum clad wood windows fabricated to fit the existing masonry openings without modification. The proposed windows are intended to match the appearance of the existing wood windows that they would be replacing, and they would feature a similar type of operation and frame and sash sight lines. (Note that the single hung units match the manufacturer's double hung units in appearance, but only one sash is mobile. This change is intended to address security concerns. This will result in a better-looking alternative to replacing the security grates at all openings.) The windows would also feature insulated glass with narrow muntin bars matching the existing ones in configuration (with inner and outer components and an interior spacer bar to further mimic true divided lights). Low-E vision glass is being proposed to allow for visual connection to the outside in lieu of the current mis-matched patterned glass. And as noted above, the security grates and burglar bars currently covering the window openings from the outside would be removed, further improving the appearance of the building. Window exterior color is to be selected from Manufacturer standards to match existing as closely as possible.

Note that several of the existing window openings have been modified from the original over time by the installation of exhaust ductwork or piping serving mechanical equipment. These openings are to receive replacement windows matching the others, but in slightly modified configurations to reflect the conditions at those openings.

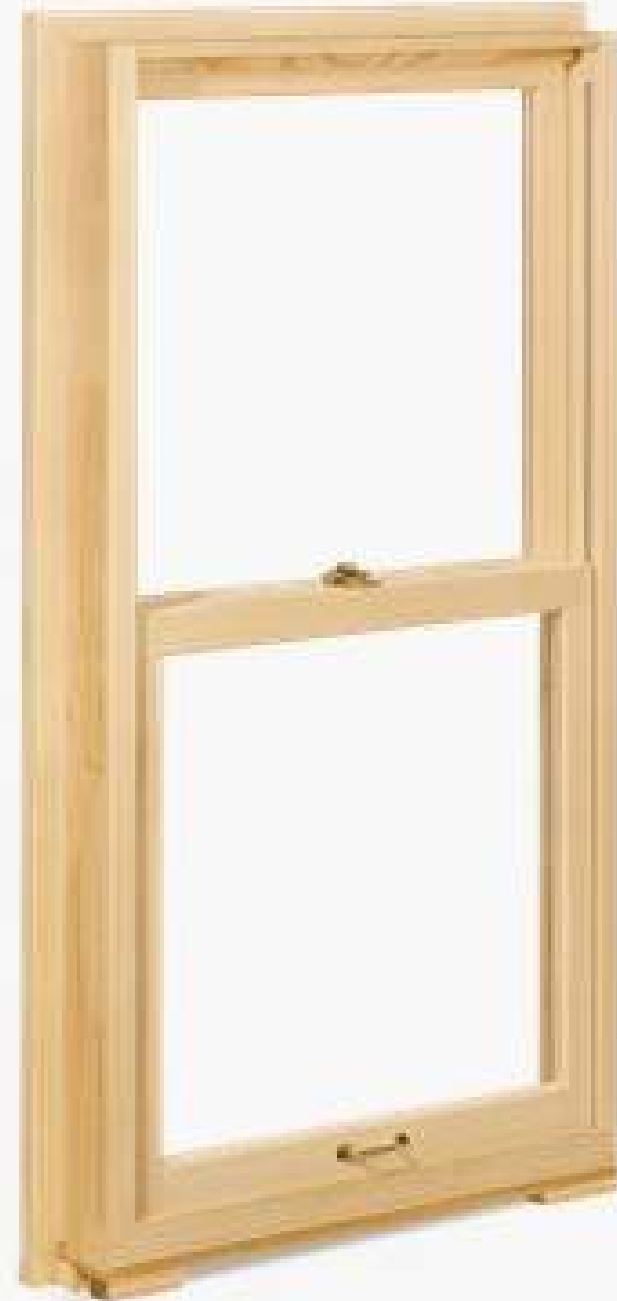
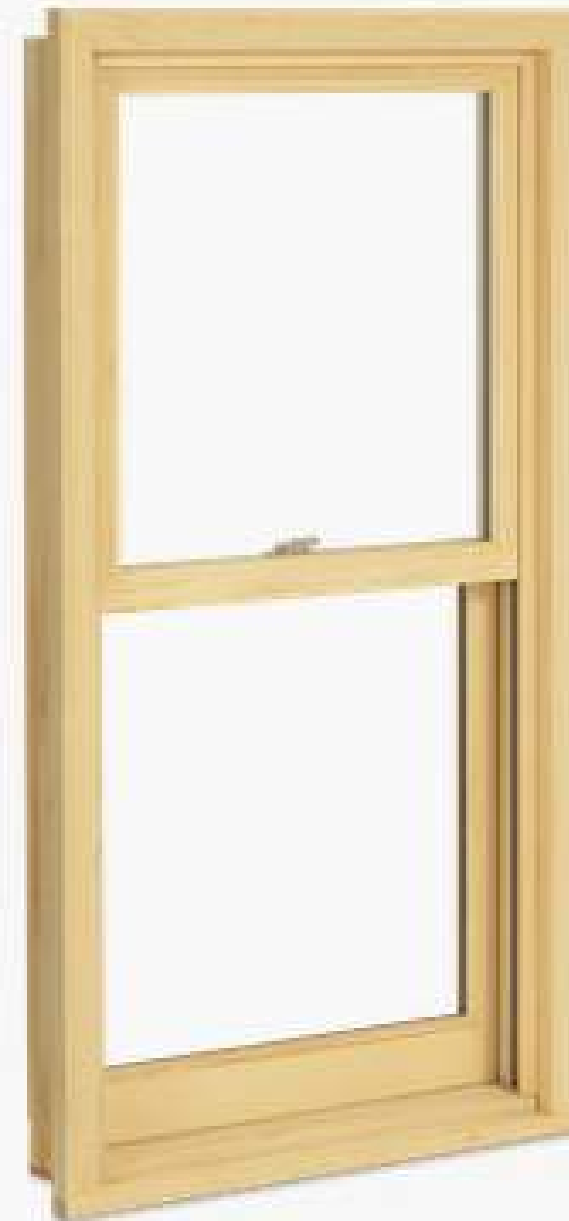
ULTIMATE DOUBLE HUNG G2

INTERIOR

EXTERIOR

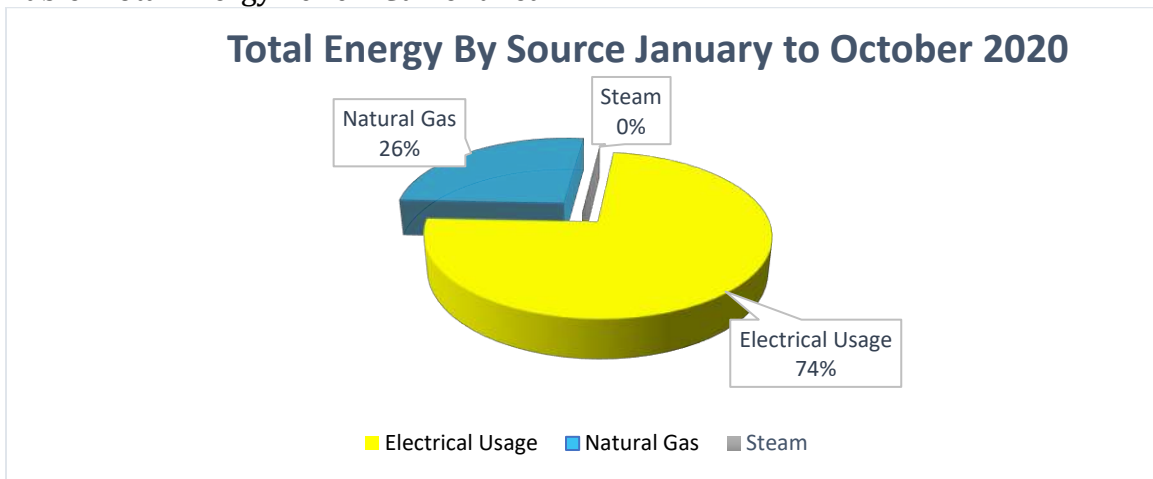
Table: Total Energy 2020 – Current Year

*Note: no steam data is available for 2020 comparison

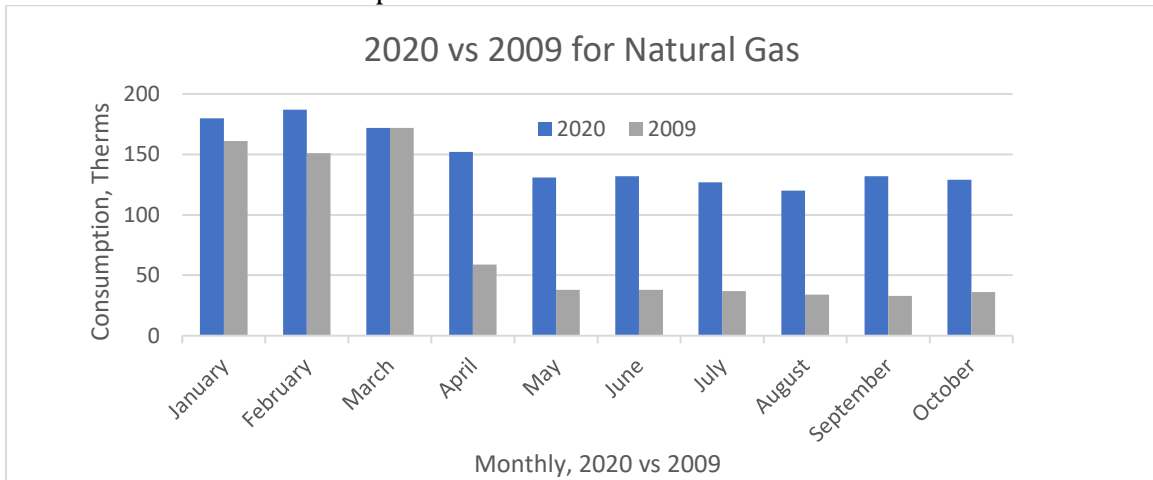
Table: Natural Gas Consumption

*Note: the 2020 values indicate meter issues.

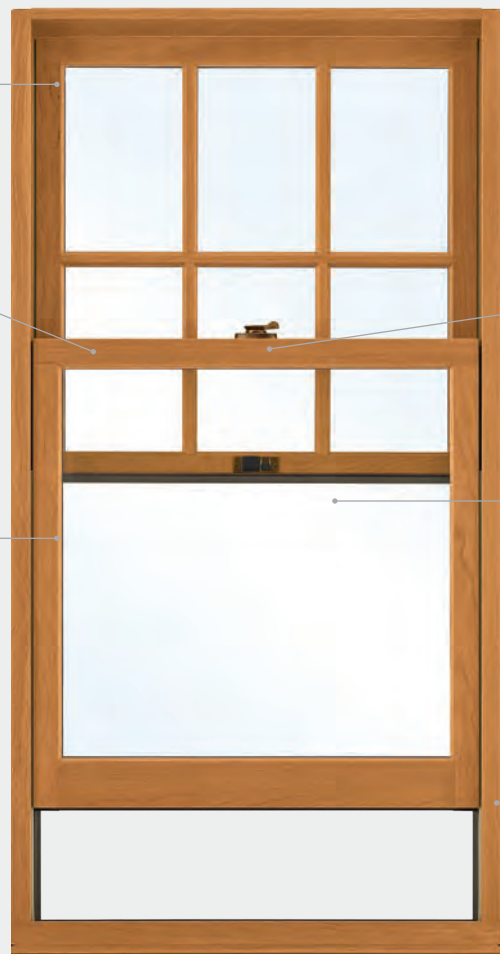
EXCLUSIVE AUTOLOCK

Activates when the sashes are closed, locking the window.

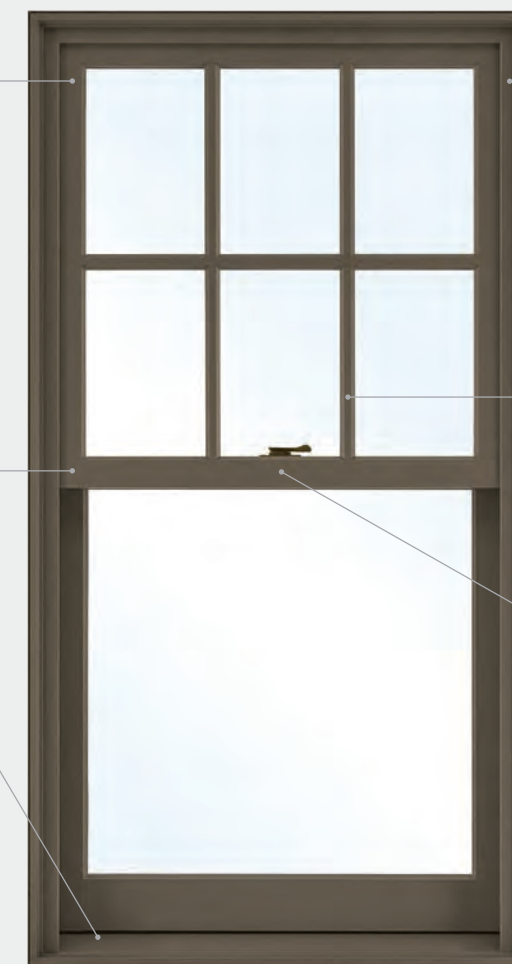
SUPERIOR WEATHER PERFORMANCE

LC-PG50 on most sizes. Optional commercial (CW) performance and IZ3 certified coastal performance on most sizes.

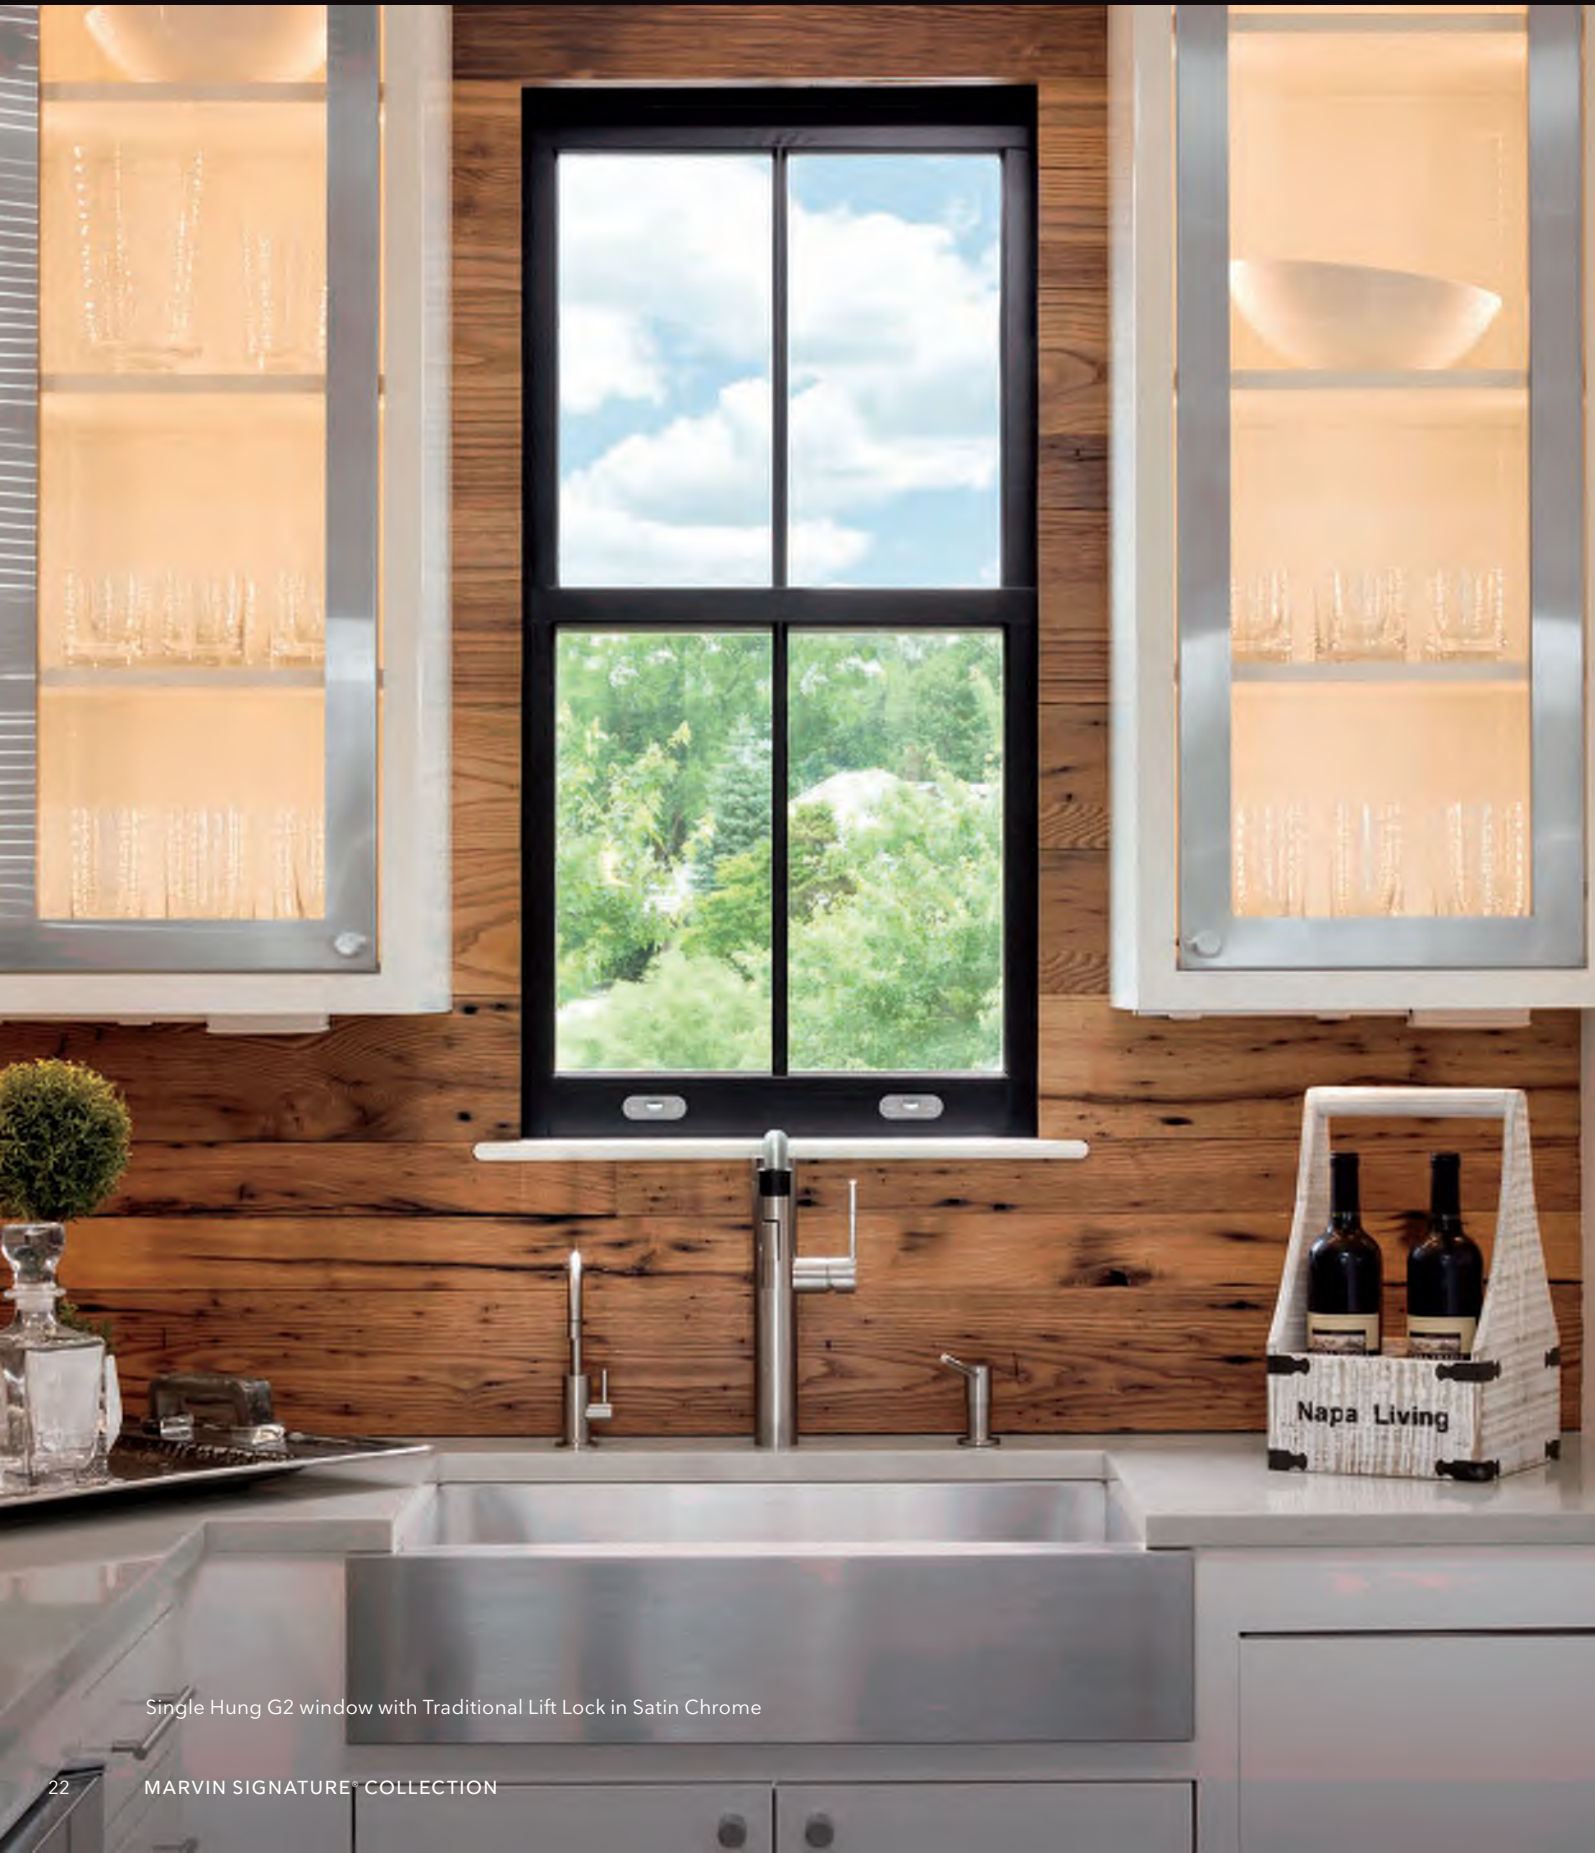
Single Hung G2 window with Traditional Lift Lock in Satin Chrome

A contemporary classic, the Ultimate Single Hung G2 window blends traditional beauty and state-of-the-art performance. With the top sash stationary and the bottom sash operable, a single hung style is often preferred in a cottage-style window with a small top sash that doesn't need to open. Reliable and energy efficient, the Ultimate Single Hung G2 window offers an auto-lock feature for convenient security, durable hardware for smooth operation, and Marvin's unique Wash Mode for easy cleaning. Customize your design with round top styles or optional Lift Lock, Marvin's exclusive bottom rail locking mechanism for easier operation in hard-to-reach areas.

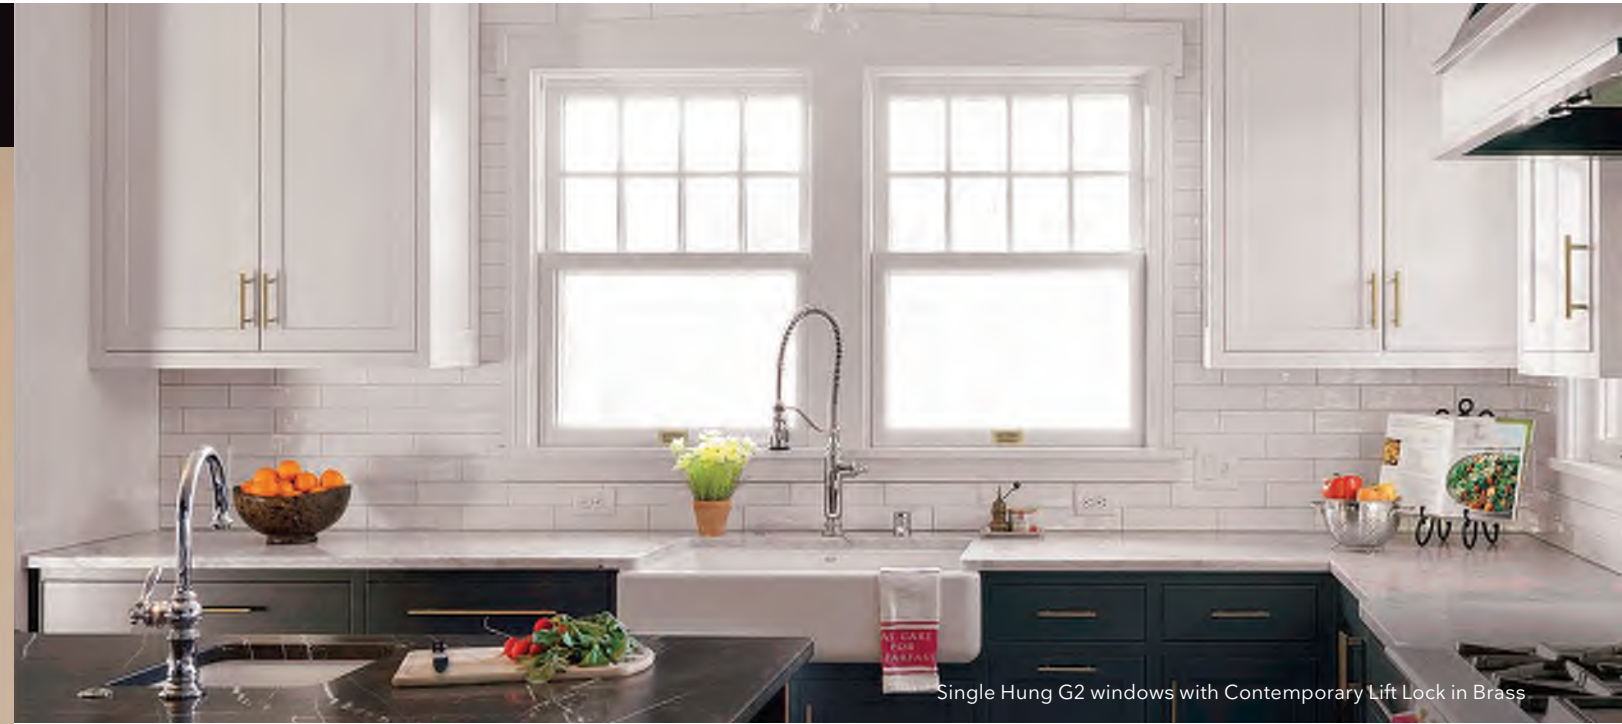
Single Hung G2 windows with Contemporary Lift Lock in Brass

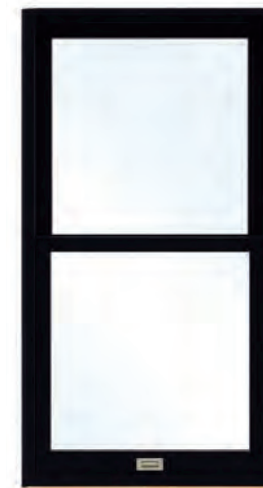
INTERIOR VIEW WITH CONTEMPORARY LIFT LOCK

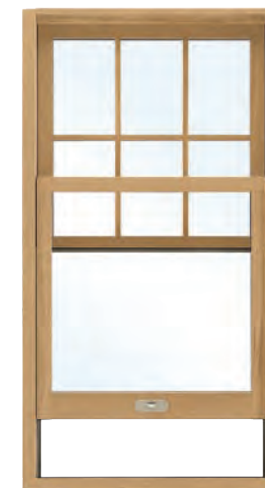
INTERIOR VIEW WITH TRADITIONAL LIFT LOCK

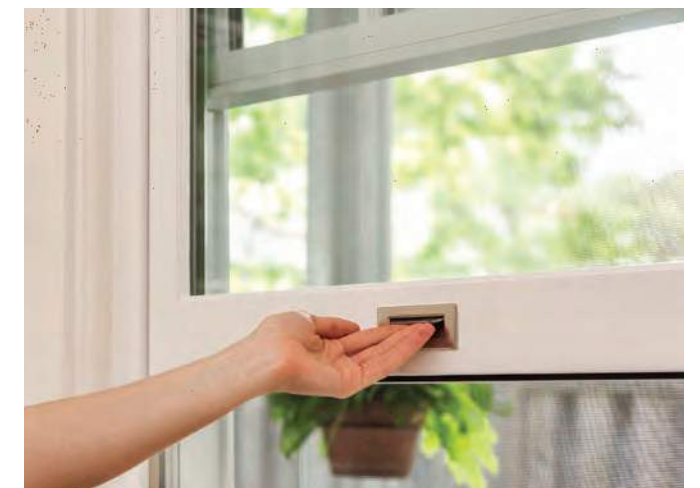
CONTEMPORARY LIFT LOCK OPERATION SHOWN IN SATIN NICKEL
