St. Benedict the Moor Catholic Church

Basement Level Window Replacement Project

Submission for Certificate of Appropriateness

Appendix 1: Drawings & Photographs

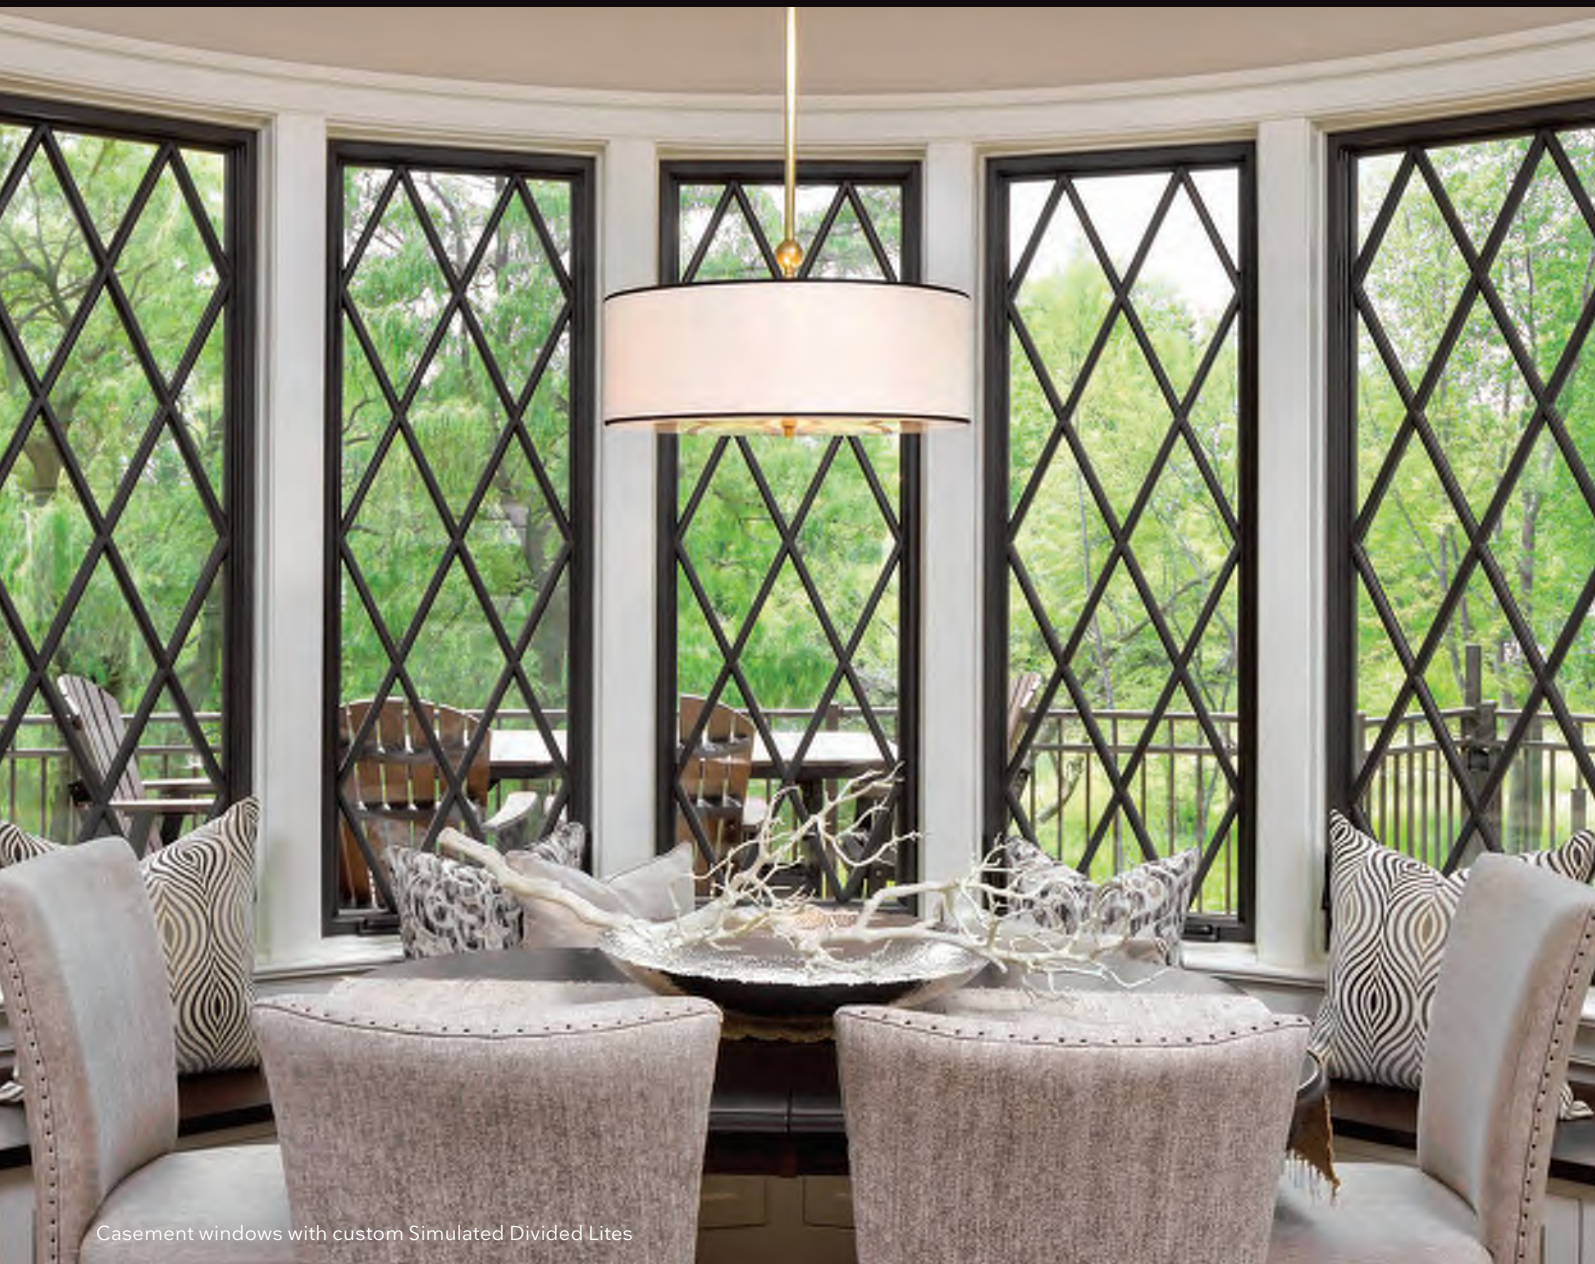
Casement windows with custom Simulated Divided Lites

Simulated divided lites, available in a number of different styles, mimic the look of individual panes of glass with the energy efficiency of dual pane insulated glass.

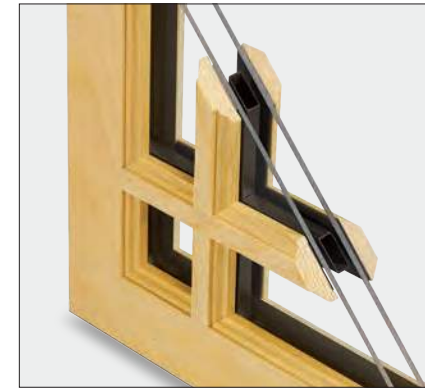
SIMULATED DIVIDED LITE (SDL)

SDL bars are permanently adhered to both sides of the glass. Simulated Divided Lites with Spacer Bars (SDLs) are an energy-efficient way to create the look of authentic divided lites.

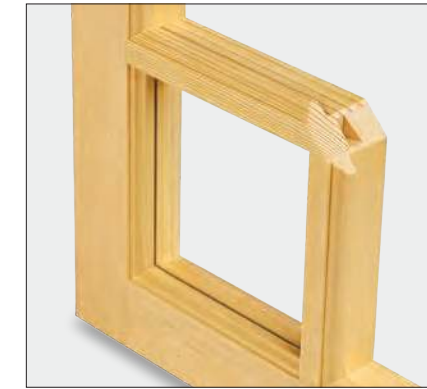
AUTHENTIC DIVIDED LITE (ADL)

Separate panes of glass are glazed between muntin bars for historical accuracy. Available exclusively with wood exterior units.

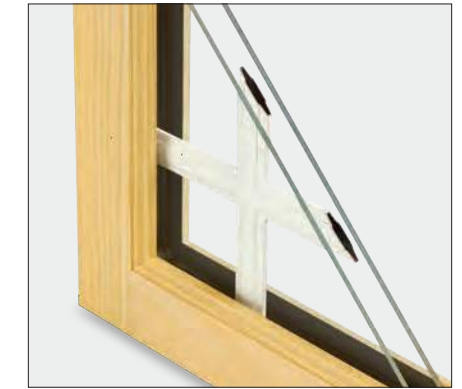
GRILLES-BETWEEN-THE-GLASS (GBG)

Grilles are permanently installed between the glass panes. This low-maintenance grille offers the look of a divided lite pattern with the ease of cleaning just one pane of glass. Available with different interior and exterior colors.

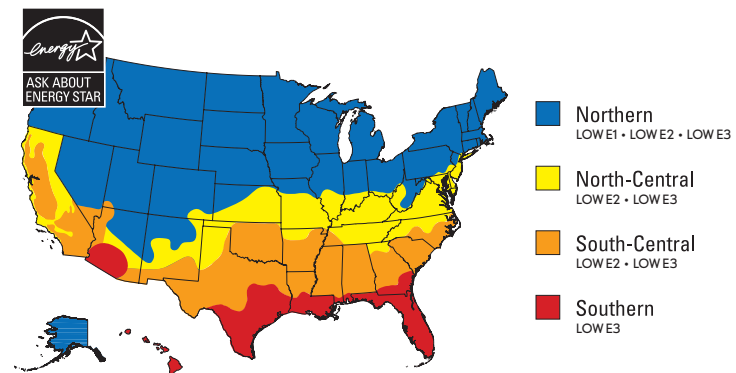
LOW E1

Low E1 coating is a good choice when you want maximum solar heat gain and radiant heating properties. This type of coating is generally used in Northern climates where heating is prioritized over cooling. You'll reap maximum benefits when windows with this type of coating are positioned to receive direct sun exposure.

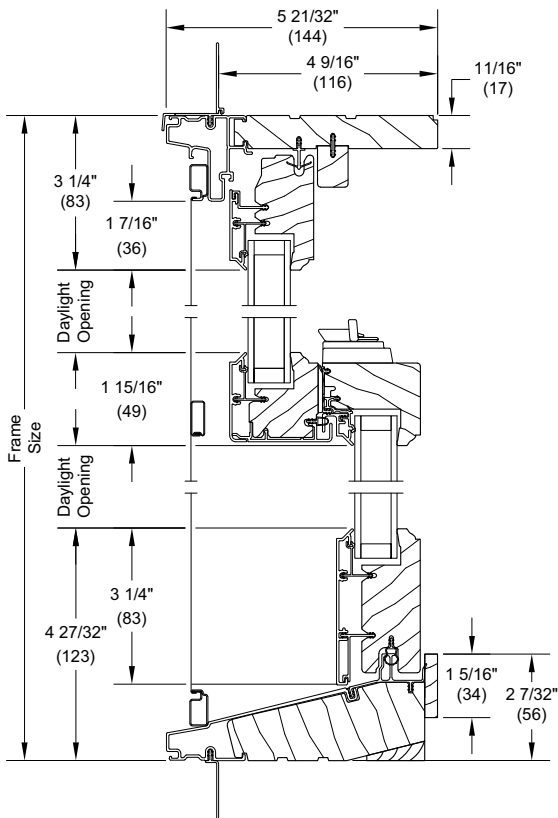
Lower Sash

Upper Sash
