CERTIFICATE OF APPROPRIATENESS APPLICATION FORM

Mitchell Building

207 E. Mitchell Street

MITCHELL BUILDING - CUPOLA ROOF & SHEET METAL

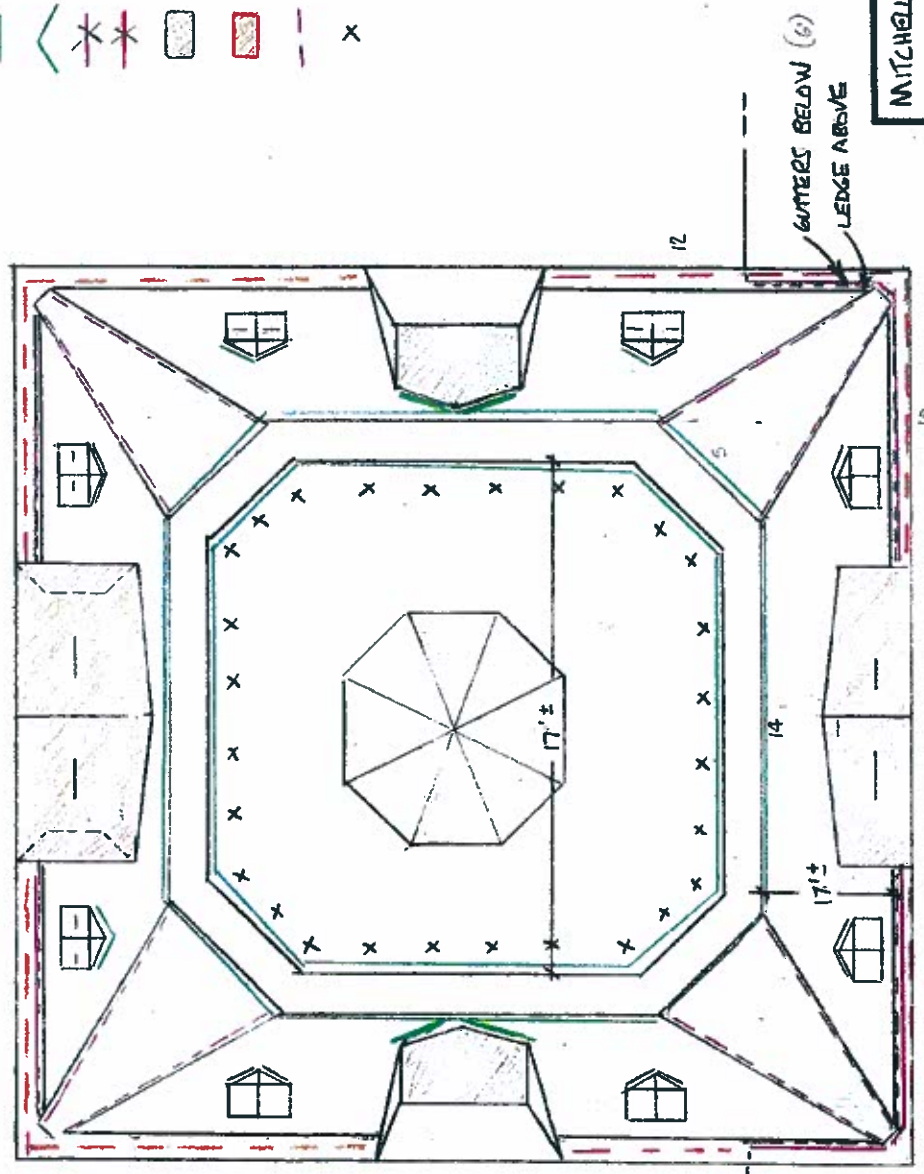
FITCH PANS

GUTTERS BELOW (6)
LEDGE ABOVE

PLAN VIEW

Remove and replace EPDM roof on top of cupola.
Remove and replace slate shingles and lead coated copper flashings on cupola.

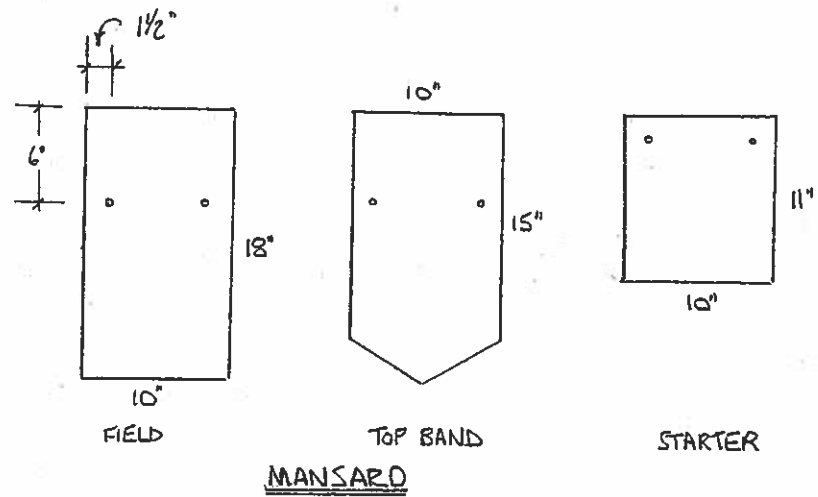
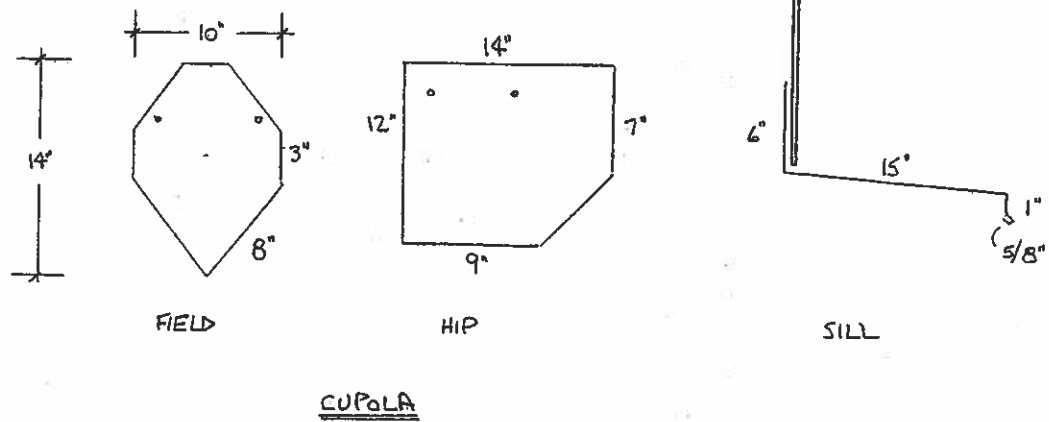
NOTE: STARTER AND FIRST COURSE ON CUPOLA IS SAME AS MANSARD

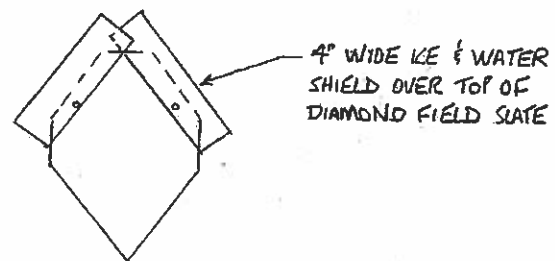
SLATE CATALOG

CUPOLA FIELD APPLICATION

- 1) Inspect the substrate after removing the slate.
- 2) Deteriorated tile joints will be re-grouted and loose topping will be removed and replaced during this process on a time and material basis as necessary.
- 3) We will prime the substrate and install an ice and water shield membrane. This membrane will also serve to provide temporary waterproofing during construction.
- 4) Over the ice and water membrane, new clear unfading black slate matching the existing color, shape and dimensions of the original slate will be installed utilizing 10-gauge stainless steel slating nails.

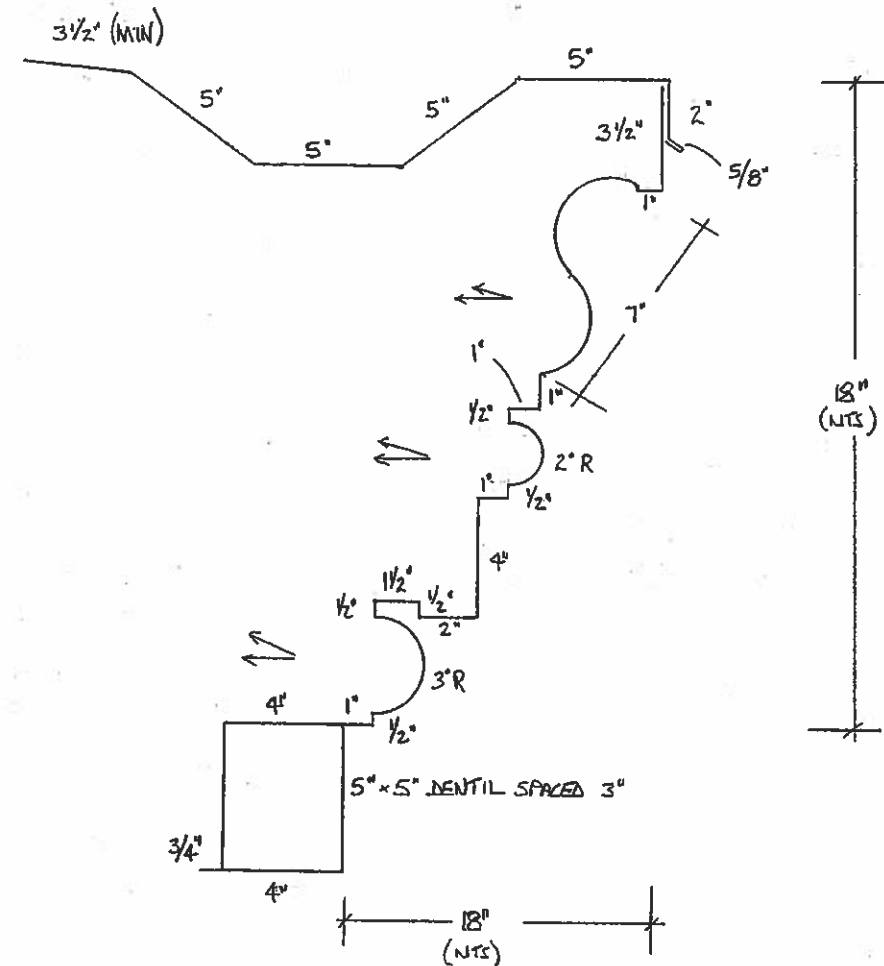
SOUTH & EAST CORNICE

SHEET METAL GUTTER, CORNICE AND DENTIL

Tin was used to fabricate the flat seam decks and cornice that apparently failed prematurely due to corrosive elements in the masonry and cementitious components. While we have indicated below that lead coated copper will be used predominantly, lead sheet may also be incorporated where necessary. Note: The following components will be fabricated from 16-ounce lead coated copper (LCC) unless otherwise noted. Please be advised, this proposal is priced with copper at \$4.15 per pound plus \$1.59 per square foot for the lead coating.
