MILWAUKEE HISTORIC PRESERVATION COMMISSION

STAFF REPORT

2536 N. Sherman Boulevard

Sherman Boulevard HD

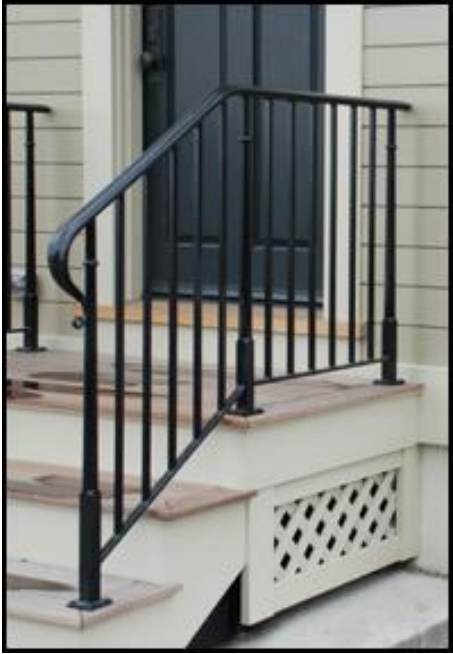
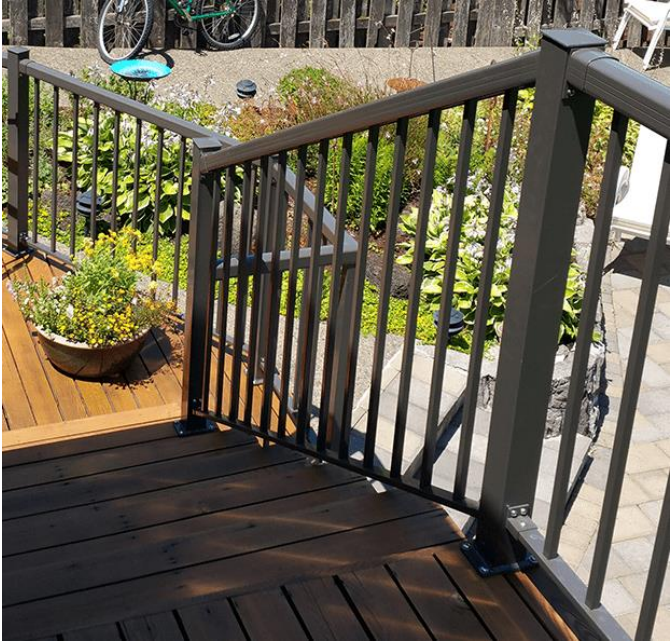
SAMPLE ACCEPTABLE RAILINGS

1. Steps shall meet code requirements; treads shall be at least 9" deep. [SPS 321.04\(c\)](#) Handrails are
2. to be metal and in as simple of a design as possible. No curlicues or filigree shall be present.
