Re: 2803 E Bradford Ave, Milwaukee, WI 53211

Window Replacement

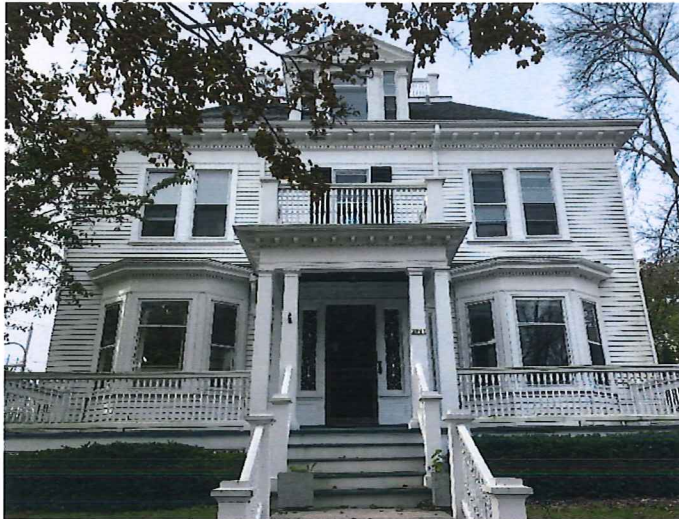
North Façade – 2803 E Bradford Ave

1. North Bay Windows, first floor (typical of 2): Currently there are two north facing bay windows on the first floor. The current configuration is a cottage style double hung window in the center section with two double hung windows on either side. The side double hung windows are not exactly equal, the lower sash is 2" larger than the upper sash. The interior wood which is stained on these windows is not consistent between the center window and the flanking windows. In looking at the window details and parts it appears that these flanking windows are not the original window sashes.

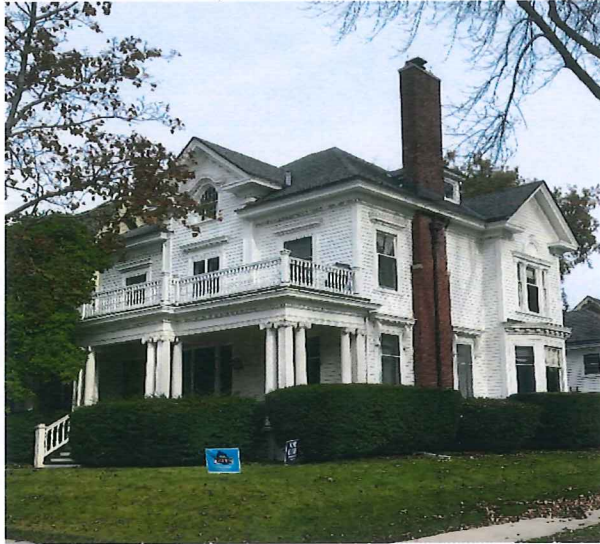
2734 E Bradford, South & East Facades

Furthermore, the home which is located at 2734 E Bradford Ave (diagonally across the intersection from 2803 E Bradford) has a bay window with all cottage style double hung windows. In looking at these two homes, it appears that they were built at the same time, potentially by the same builder as they share many similarities and design details, including moldings, windows and siding.

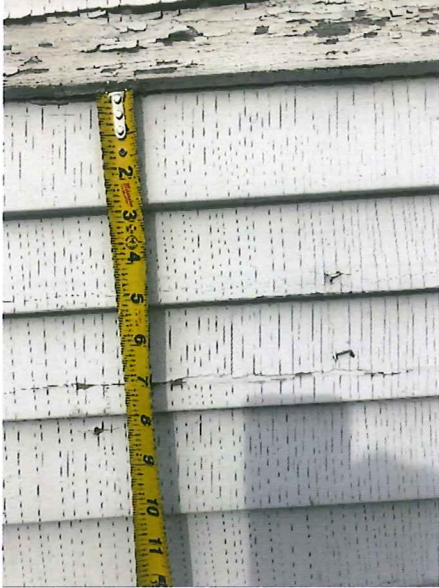
Existing Photo of Original Siding under Vinyl Siding

Currently there is vinyl siding covering the original wood siding. We are proposing to remove the vinyl siding and replace all the original wood siding with smooth cedar siding (painted), exposure to be 2 3/4" to match the original siding.

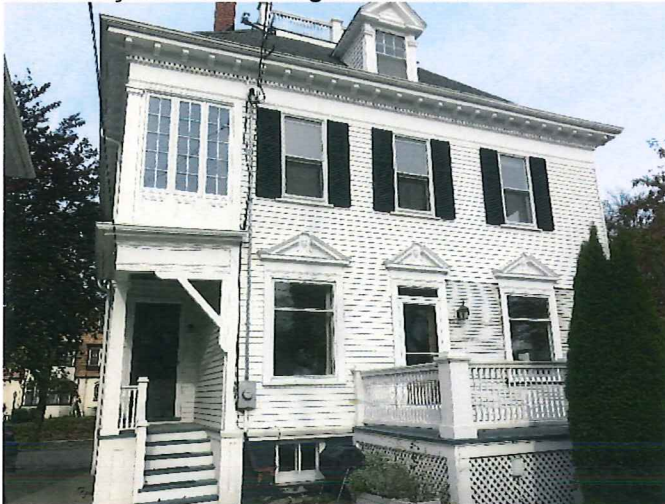
East Façade with Fiberglass Door & Transom

On the east side of the first floor there is a door which leads to the raised porch. This door is not original to the home, it is a fiberglass door with a fiberglass transom window. A custom oak door to match the details of the existing front door is to be fabricated. See drawings for door size and details.
